Addington Brook Baseline Aquatic Ecology Survey

June 2023

Prepared for:
Christchurch City Council

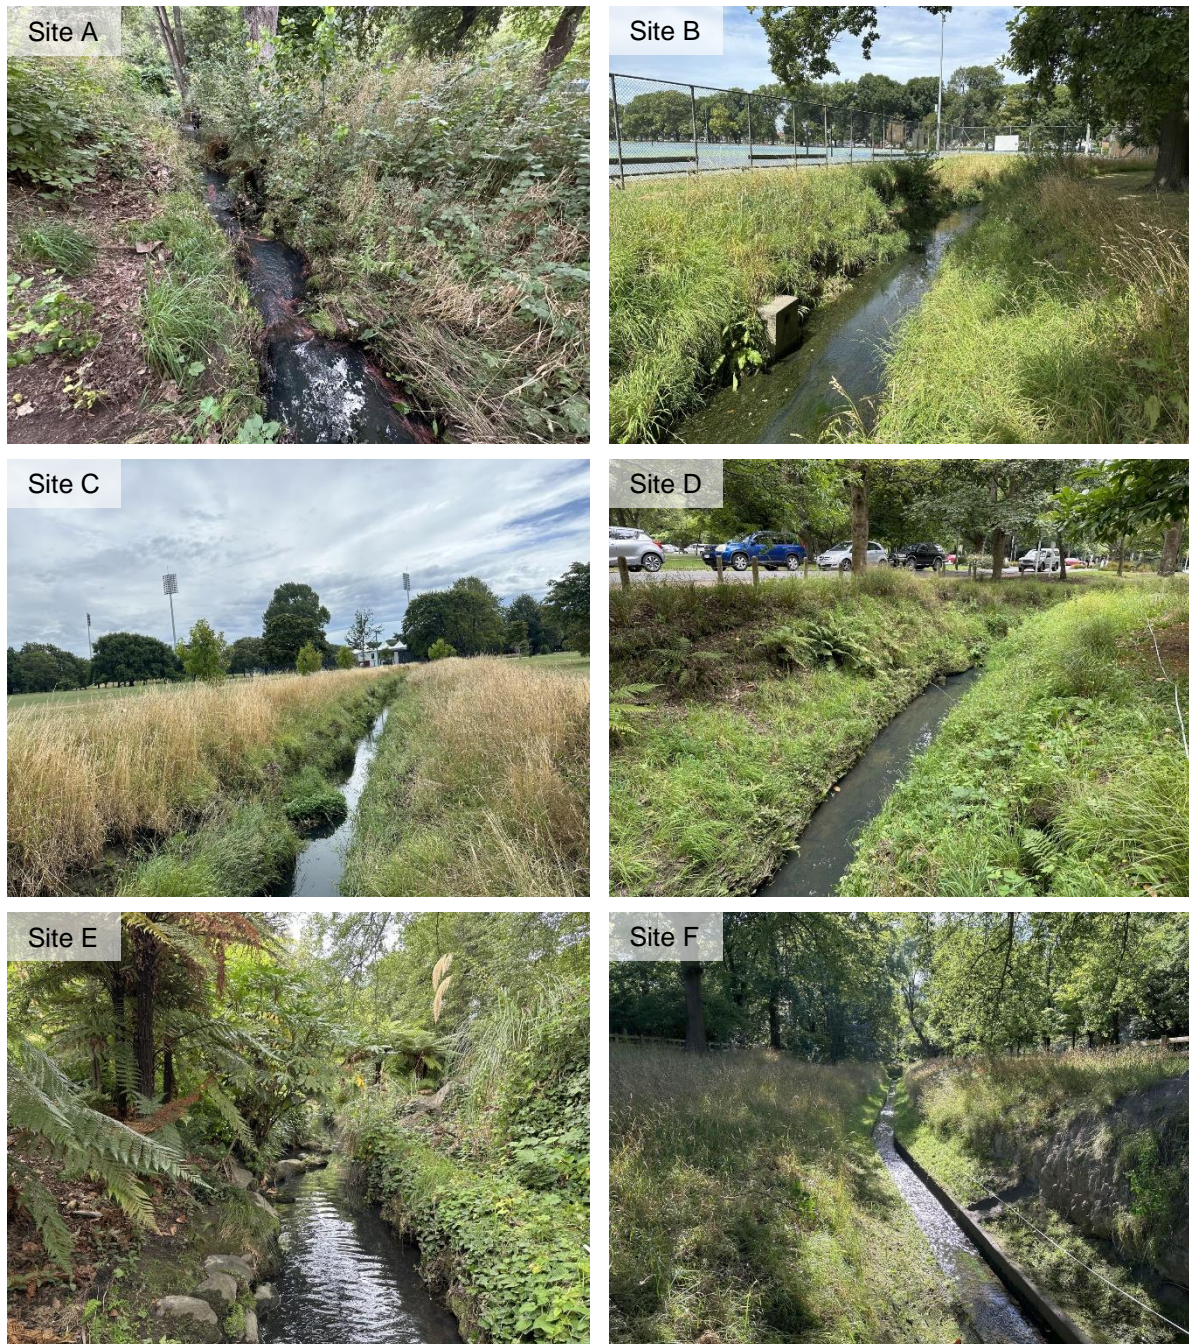
Figure 2: Sampling site photographs.

Riparian vegetation varied markedly amongst the sampling sites, ranging from exotic grasses, with no trees or shrubs at Site C, through to a mixture of exotic tree canopy underplanted with well-established native shrubs and trees at Site E (Figure 2). Most sites were well shaded by tall canopy trees, with mean shade ranging from 68–82%. The exception was Site C, which was in an open section, with a mean shade of only 3% at the water surface. Bank cover with low ‘ground cover’ vegetation exceeded 90% at all sites except Site E, in the Botanic Gardens, where lower vegetated ground cover (56%) was associated with landscaping boulders and pathways. The high level of cover with ground vegetation at most sites would both help prevent bank erosion and intercept overland flow. Riparian buffer widths were narrow at most sites, ranging from 4–6 m. The exception was Site F (Riccarton Stream), where the mean buffer width was 11 m.

Waterway banks were comprised of natural earth at Sites A–D, where overly-steep banks were associated with bank erosion (mean of 30% bank erosion at Sites A–D). The banks were also steep at Sites E and F, but no erosion was recorded, because the banks were made of rock at Site E and concrete at Site F. Mean channel width ranged from a minimum of 1.22 m at Site F on Riccarton Stream to a maximum of 2.02 m at Site D on Addington Brook (Table 3). Mean water depth ranged from 0.16 m at Site F to 0.33 at Site D. Mean water velocity was very slow at all the Addington Brook sites (range of 0.03–0.06 m/s) but was comparatively swift in Riccarton Stream (mean of 0.33 m/s). In Addington Brook, coarse bed sediments (i.e., stones >2 mm diameter) dominated at Sites D and E, while fine sediments dominated at the other three sites. Coarse sediments covered 45% of the bed at Site F on Riccarton Stream, but the entire channel was concrete-lined. Bed cover with fine sediment was high and exceeded guidelines at all sites but was highest at Sites A–D (Table 4).

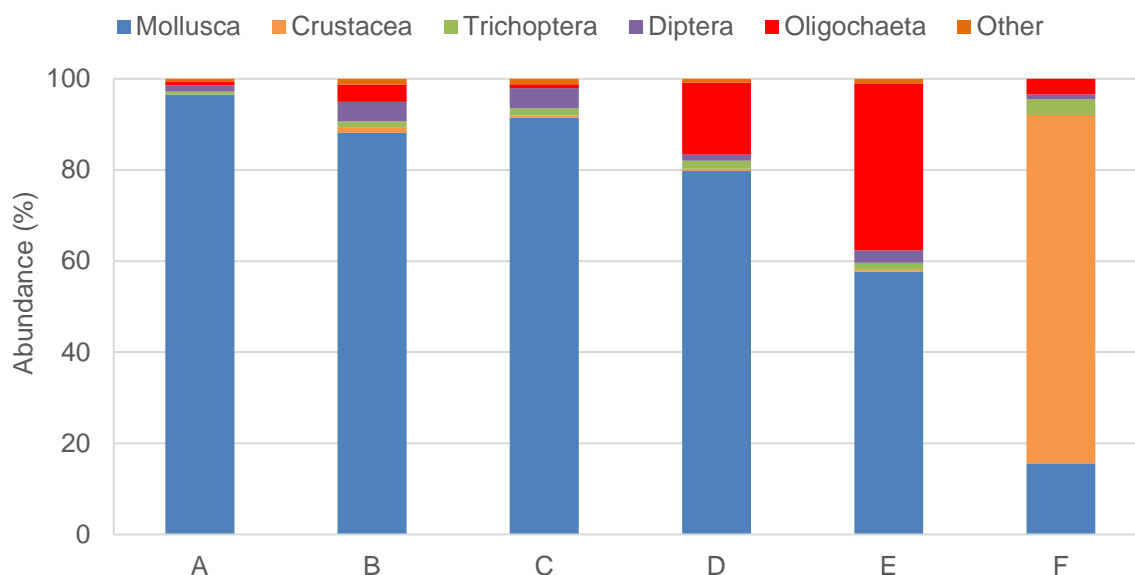
The invertebrate community at all sites was dominated by pollution-tolerant taxa, particularly the common mud snail *Potamopyrgus antipodarum* (Mollusca), which comprised 67% of all invertebrates counted. The common amphipod crustacean *Paracalliope fluviatilis* was the second most abundant taxon, comprising 14% of all invertebrates, but they were only abundant at Site F (Riccarton Stream), where they comprised 73% of invertebrates in the sample. Oligochaete worms were common and widespread, comprising 10% of total abundance, and they were most abundant at Site E, where they comprised 37% of total abundance (Figure 5).

Figure 5: Invertebrate community composition at each sampling site.

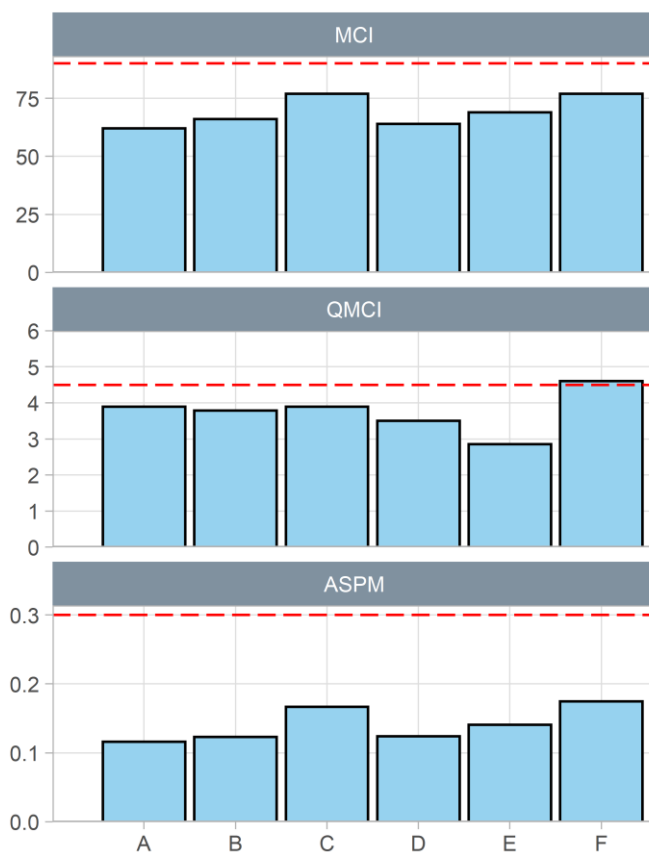
The only pollution-sensitive invertebrate taxon⁴ found was restricted to a single individual of the free-living caddisfly (Trichoptera) *Psilochorema* (MCI=8) found at Site F. No mayflies (Ephemeroptera) or stoneflies (Plecoptera) were found at any of the sites. All three indices of invertebrate community health, the MCI, QMCI, and ASPM, fell below guidelines at all sites (Figure 6). The exception was Site F, where the QMCI score was 4.6, which was just above the national bottom line value of 4.5. The slightly higher QMCI score at Site F was due to a higher relative abundance of *P. fluviatilis*.

Figure 6: Invertebrate community metrics at each site compared with guidelines (red dashed line).
