Halswell and Heathcote Aquatic Values; selected aspects; monitoring round # 4

Prepared for:
Christchurch City Council

AEL Report No. 90

September 2012

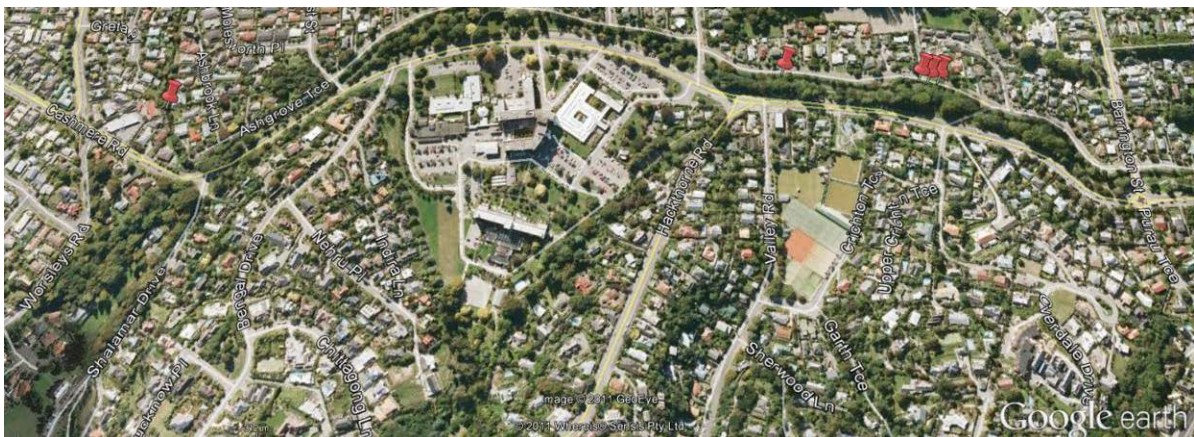
Figure 3. The 5 monitored trout redds on the Heathcote River upstream of Barrington Street. Four redds were located adjacent to Cashmere High School, with a fifth redd upstream of the Cashmere Stream confluence.

These were conducted in a similar way as previous studies over the last few years, with intragravel dissolved oxygen levels (IGDO) being extracted from trout redds over the egg development period (3-4 weeks). Field surveys were initially undertaken to identify 'fresh' redds upstream of the Colombo Street bridge, targeting redds which were fully excavated, and just after when the attendant hen (female) trout had finished excavating. Several field trips were required to locate and monitor five fresh redds (Fig. 3), with field trips involving a combination of obtaining IGDO data from existing monitored redds, and monitoring hen trout activity on partially excavated redd constructions.

On each redd, three IGDO probes were inserted equidistantly along the midline of the gravel tailspill in each of five monitored redds. Every few days, 2 replicate water samples (30 mls) were aspirated by syringe from each of the three probes, and the dissolved oxygen (DO) measured and recorded using a calibrated commercial grade DO meter.

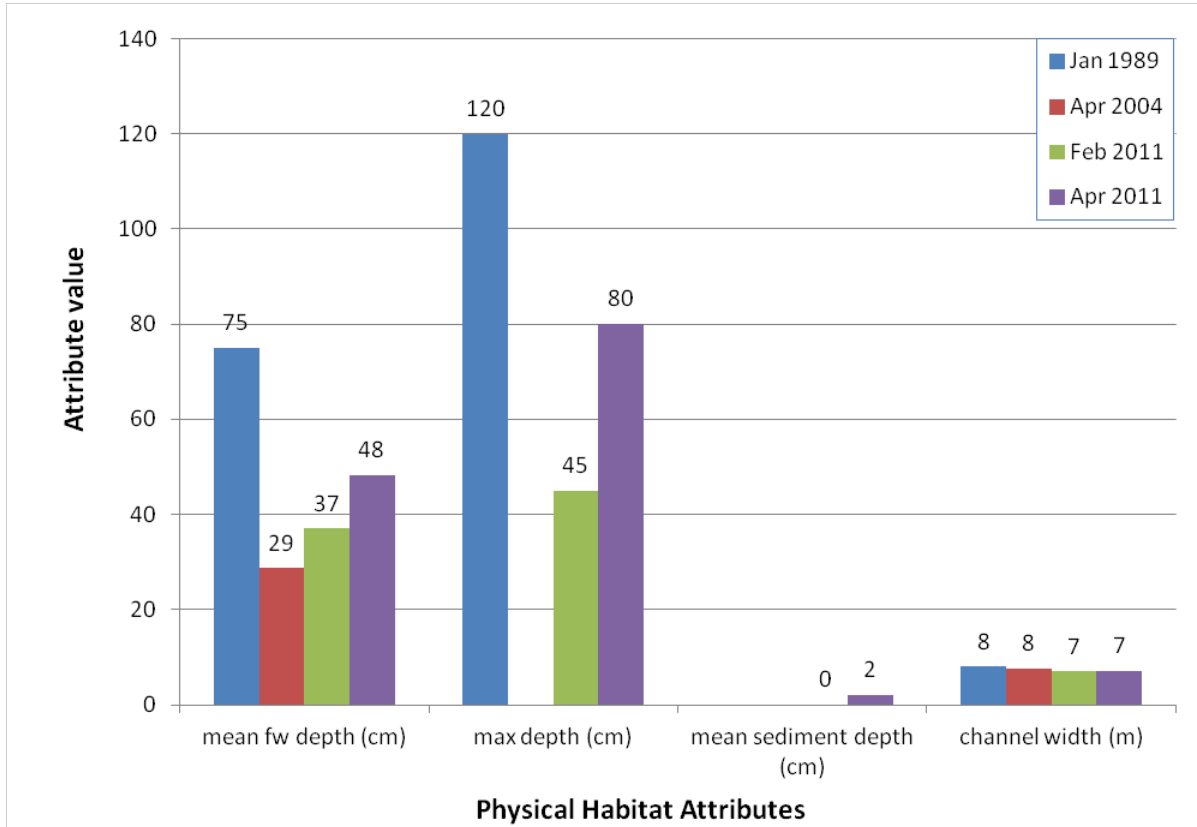
Figure 4. Temporal changes in mean depth, maximum depth, mean sediment depth, and channel width at a re-surveyed reach near Tennyson Street.

In later surveys, depths were much reduced, with a minor, but measureable, component of surficial sediment in April 2011. This sediment is apparent from the 'before and after' photos in Figs. 5a-c, both along the true right (eastern) bank, and elsewhere on the bed. Sand and silt was also deposited amongst the riparian grasses to a level approximately 1 m above the observed water level in April 2011. In one part of the reach, a distinct hollow had formed in the bed, (causing a higher maximum depth), whereas, near the upstream site boundary section of uncompacted stream gravels had uplifted (Fig. 5d).

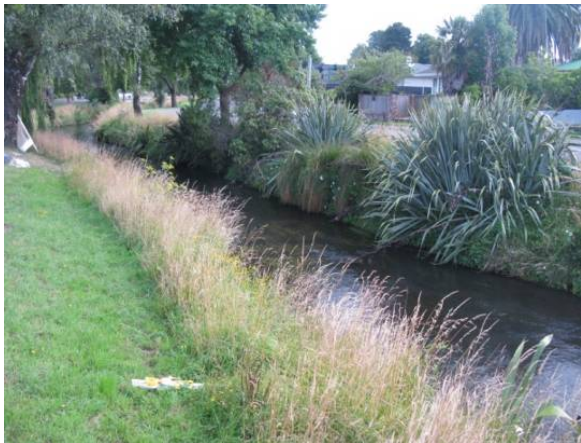
Figure 5a. The Tennyson Street reach in 10 February 2011, prior to the Feb 22 earthquake

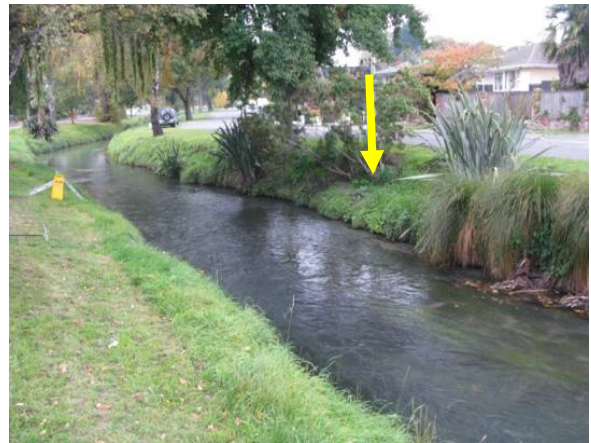
Figure 5b. The Tennyson Street reach in April 2011. The true right bank (arrowed) has slumped significantly

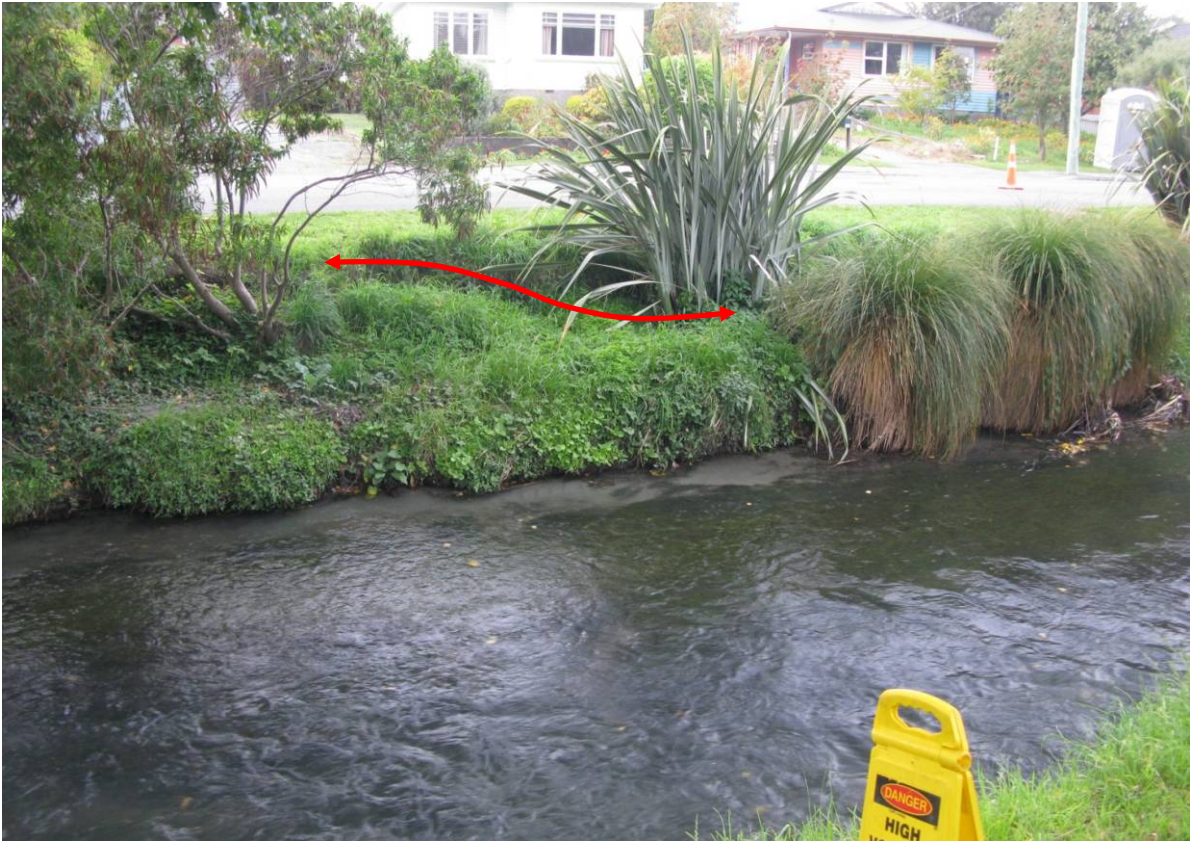
Figure 5c. Significant slumping along the true right bank (arrowed). Earthquake-mediated sediment is apparent along the bank.

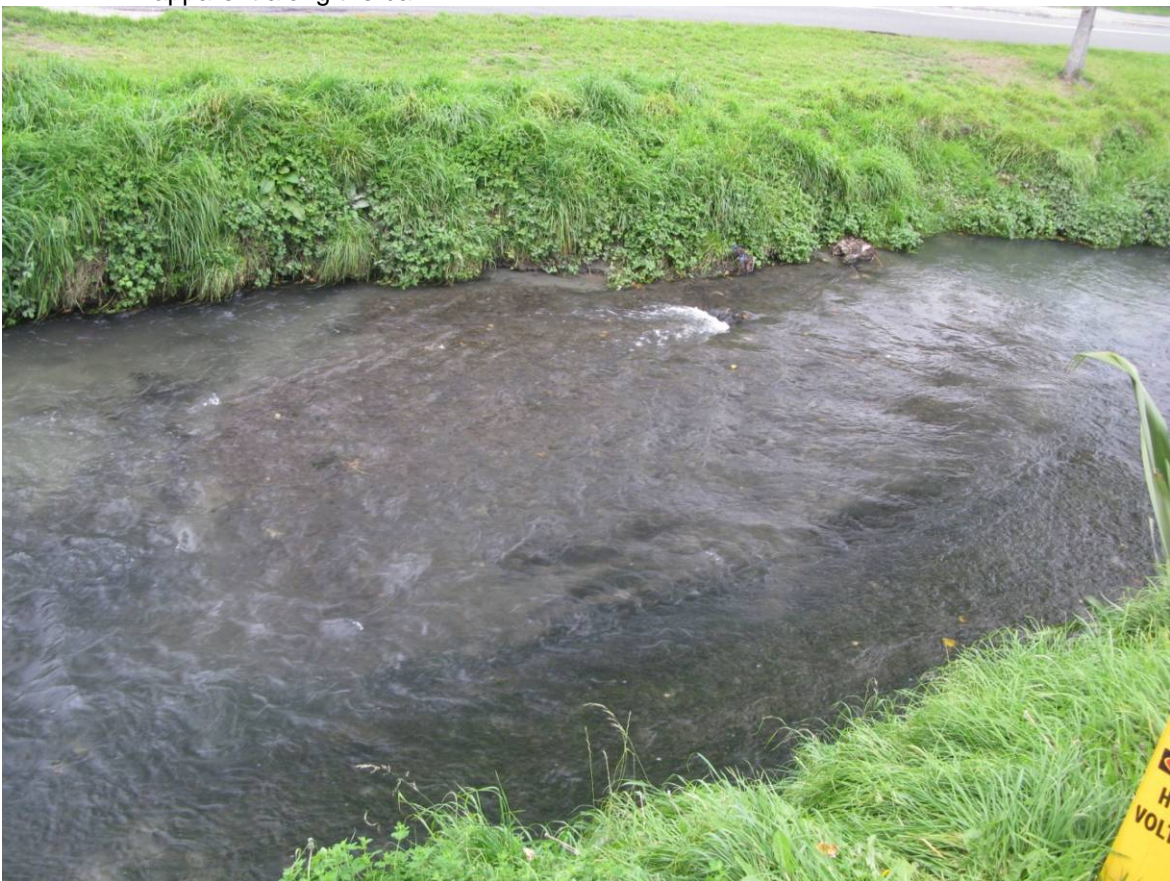
Figure 5d. An uplifted gravel bed section at the upstream margin of the site. This habitat contained a multitude of shortfin elvers.

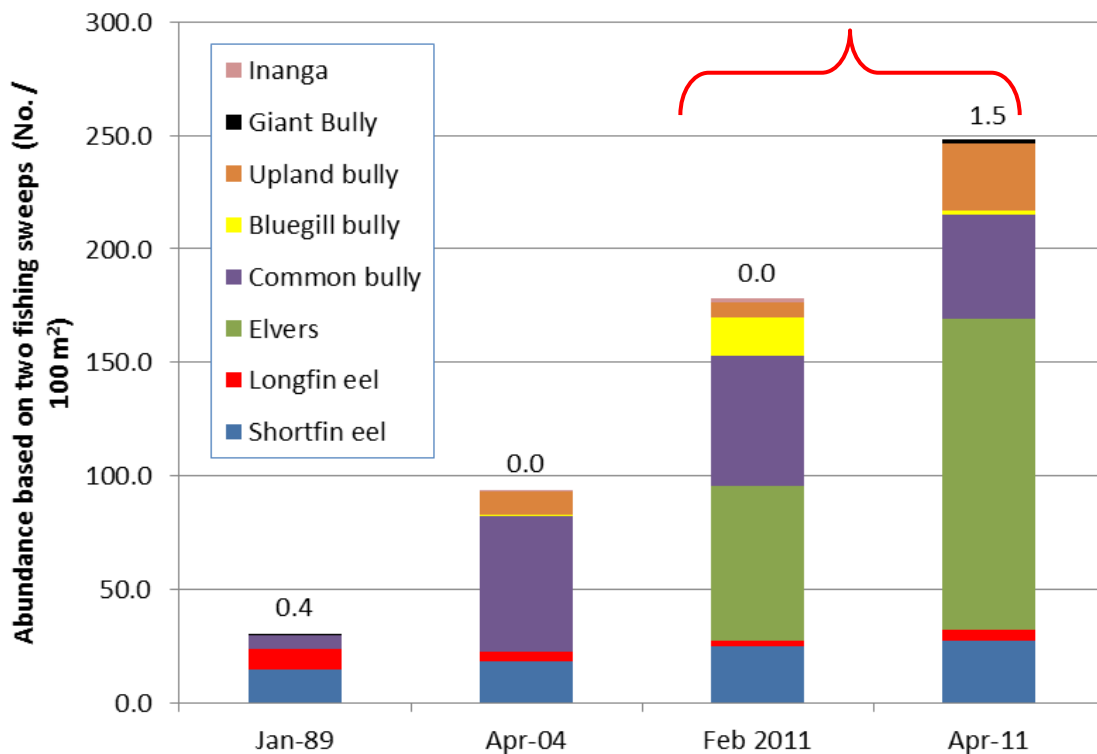
Figure 6. The change in fish abundance of common species over time at the Tennyson Street site. The bracketed data represents samples immediately before and after the 11th February earthquake. All of the elvers were identified as shortfin eels and were defined as having a length of less than 120 mm. The numerals represent the catch per unit area, of giant bullies, which are otherwise indicated by the thin black lines in this figure.

The reduction in bluegill bully numbers at the Tennyson Street site (see Fig. 6) may be due to the increase in sediment depth at this site, from negligible before the earthquake, to an overall mean sediment depth of 2 cm. This trend in bluegill bully reduction was echoed in bluegill numbers at downstream of Colombo Street, and Hoon Hay Valley Road. It is suspected that bluegill bullies are sensitive to substrate sedimentation, and the decrease in number could be due to the settled fines reducing the spaces under the cobbles in which they feed and spawn. The bluegill bully is invariably found in fast-flowing waters with clean substrate, and are morphologically (and probably behaviourally) adapted for feeding on the invertebrates on undersides of rocks, as demonstrated by the undershot jaw (McDowall 1990). This same under-rock habitat is also considered likely to serve as a spawning substrate for these small fish, similar to other bullies (McDowall 1990).

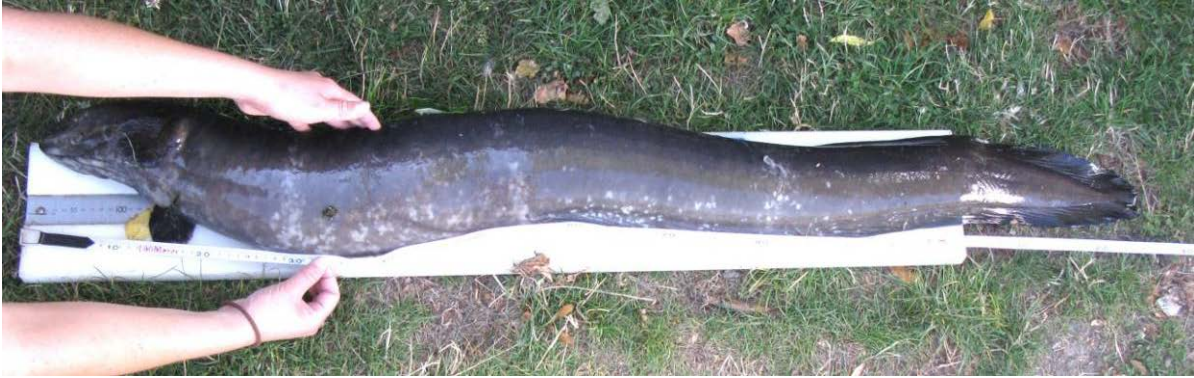
Figure 7. A very large (1250 mm T.L.) migrant female longfin eel captured from the Tennyson Street site shortly before the February 2011 earthquake. We failed to relocate this fish in April.

Prior to the February earthquake, but after the September 2010 earthquake, bluegill bully abundance was higher than in 2004, as were numbers of elvers (almost all shortfin eels < 120 mm T.L.). After the February 2011 earthquake, over the same reach, and using identical methods, shortfin eels numbers had nearly doubled compared to that prior to the earthquake, and the number of upland bullies had increased. However, the number of bluegill bullies was heavily reduced. Common bully numbers had decreased slightly between 2004 to 2011 period, but were much more abundant than in 1989. This pattern is consistent with a shift from a lower-river saline-influenced fish fauna (due to the operation of the Woolston Diversion) to one with perennial freshwater, when the Diversion was decommissioned for normal river flows. Of note was the capture of a very large migrant longfin eel, exhibiting the distinctive mottled underbelly which characterises this life-stage (Fig. 7).

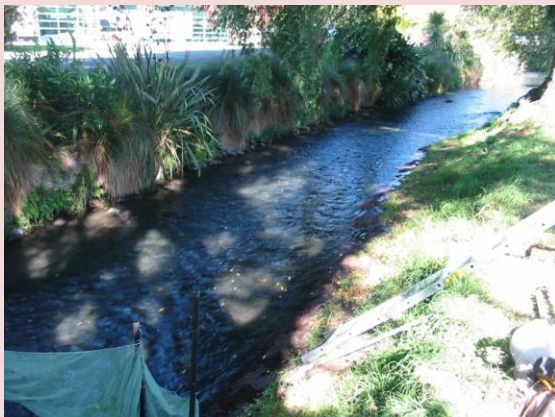
Figure 8a. Looking upstream from downstream margin of site in 2nd April 2004.

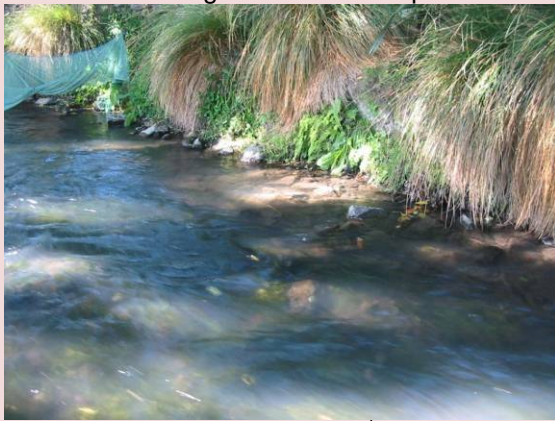
Figure 8c. Clean substrate, 2nd April 2004.

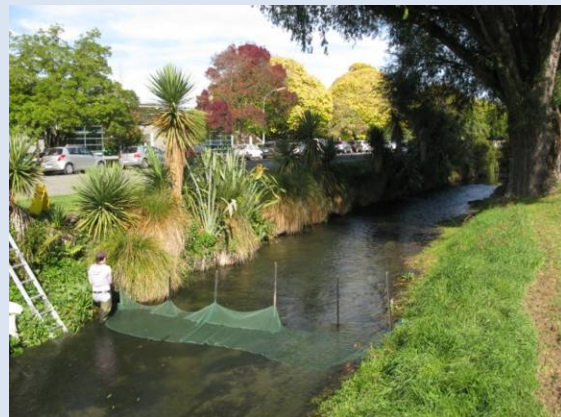
Figure 8b. Colombo Street reach, looking upstream (13th April 2011).

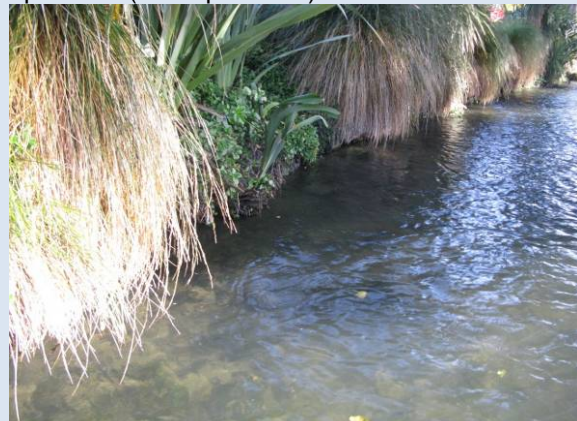
Figure 8d. Silted habitat, 13th April 2011.

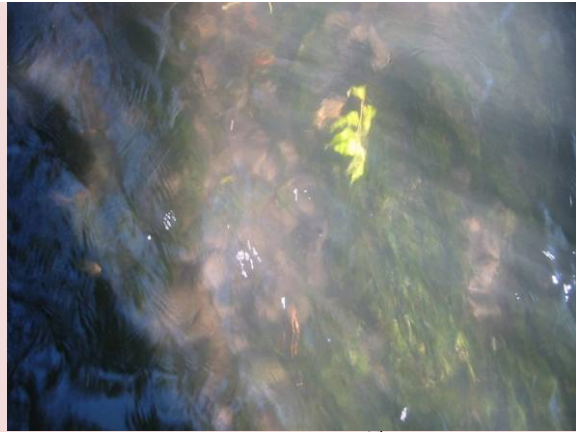
Figure 8e. Clean substrate, 2nd April 2004

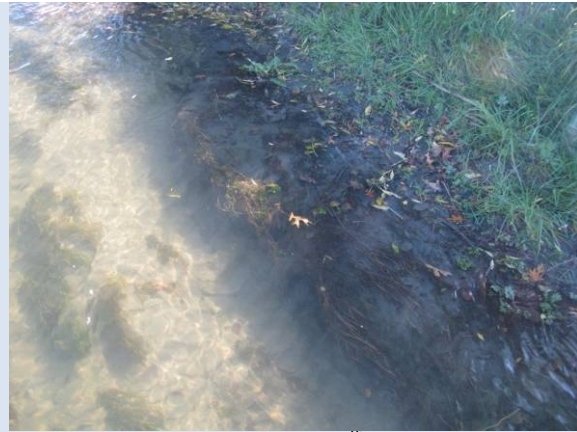
Figure 8f. Silted margins, 13th April 2011.

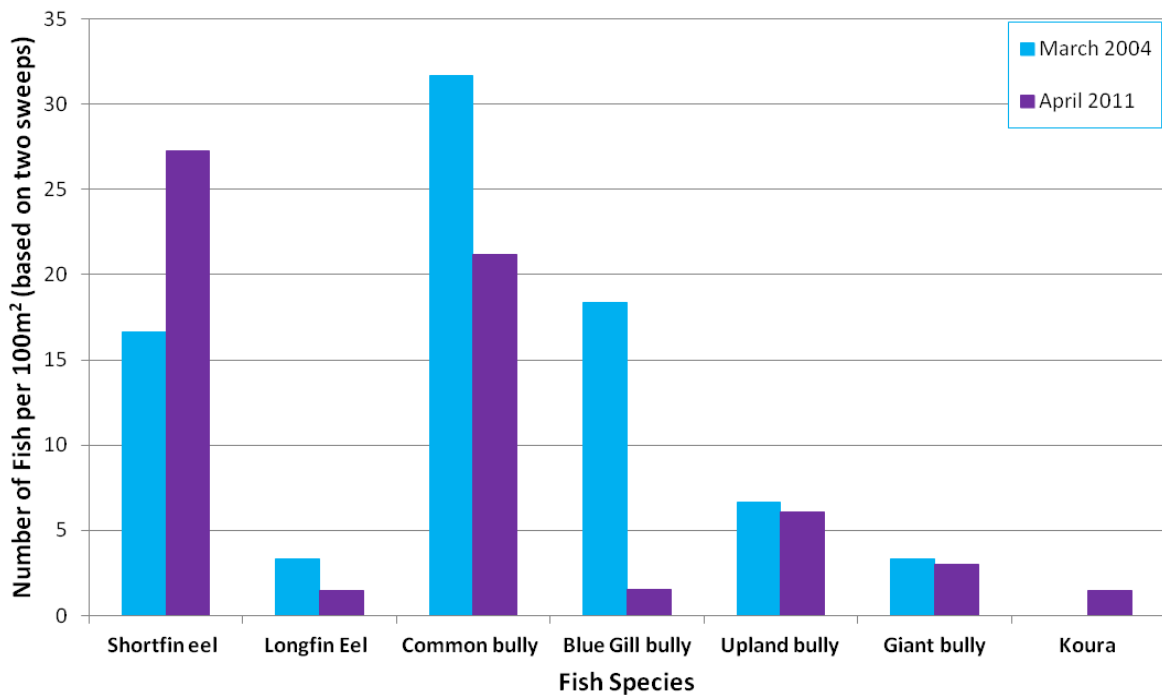
Similar to the Tennyson Street reach 3 km downstream, there was a marked decrease in bluegill bully abundance between 2004 and April (post-earthquake) 2011, and an increase in the number of shortfin eels (Fig. 9). There was a reduction in the number of longfin eels, but due to the low numbers of this species, this reduction may not be significant. There was also a reduction in common bully abundance, over time, between 2004 and 2011, of approximately the same proportion as observed at Tennyson Street. One surprise was the presence of a single large freshwater crayfish or koura, with a body length of 110mm (Fig. 10). Koura were not recorded at this location in 2004, despite a section of bank being electric fished. However, little weight can be placed on the presence or absence of just one individual.

Figure 9. Temporal changes in freshwater fish composition in the riffle downstream of the Colombo Street bridge.

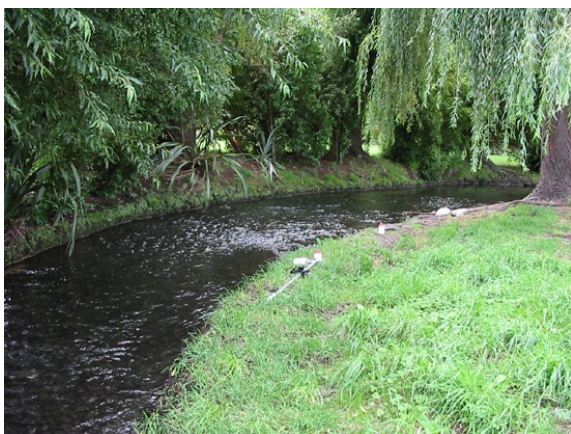
Figure 11a. Centennial Park site, 2nd February 2004

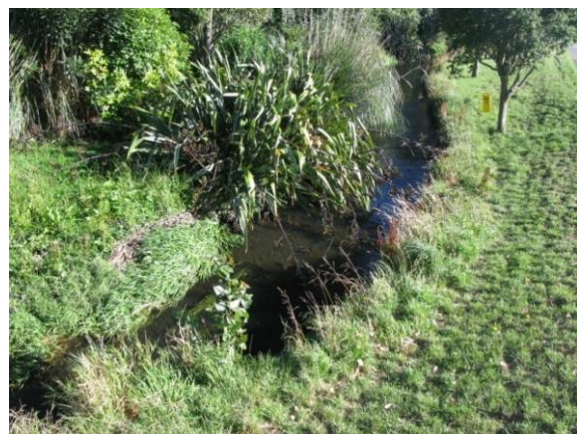
Figure 11b. Centennial Park site, 10th February 2011. The yellow sign demarcates the upstream boundary of the fished section.

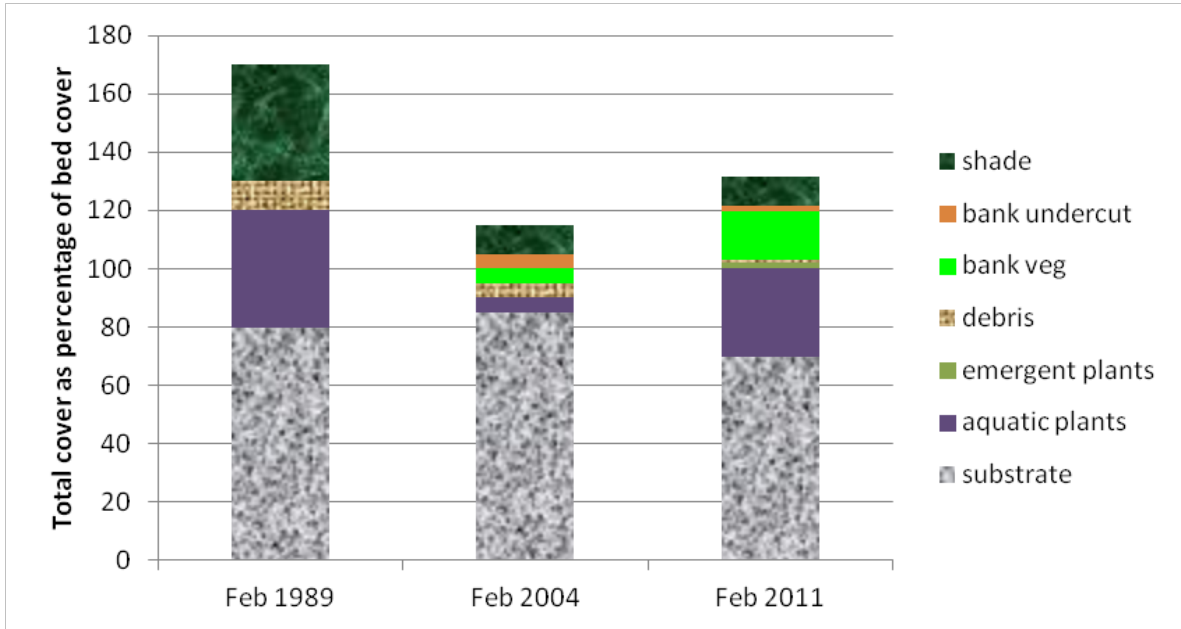
Figure 11c. Reduction in tree shade, and increase in bank vegetation over time at the Centennial Park site.

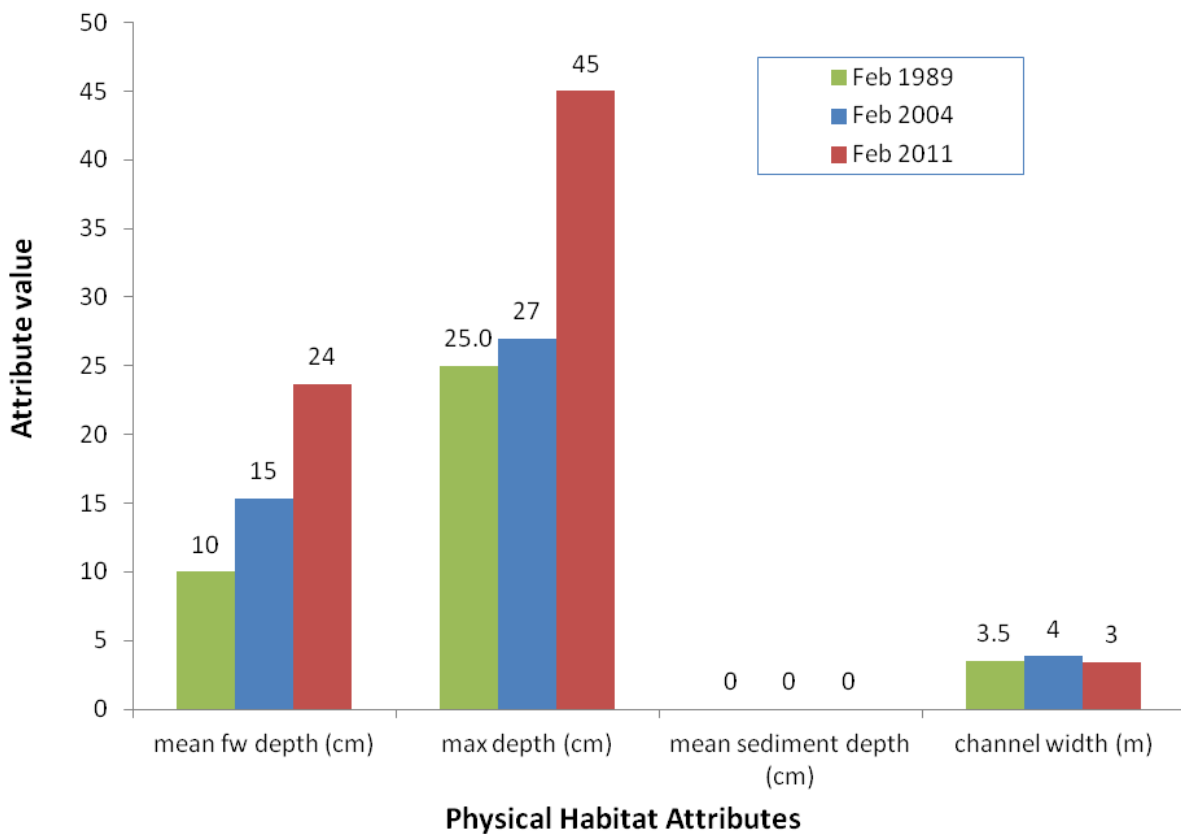
Figure 12. Basic physical habitat attributes of the Centennial Park habitat through Centennial Park. Numerals represent actual attribute values. The magnitude of the attribute value is provided at the top of each column.

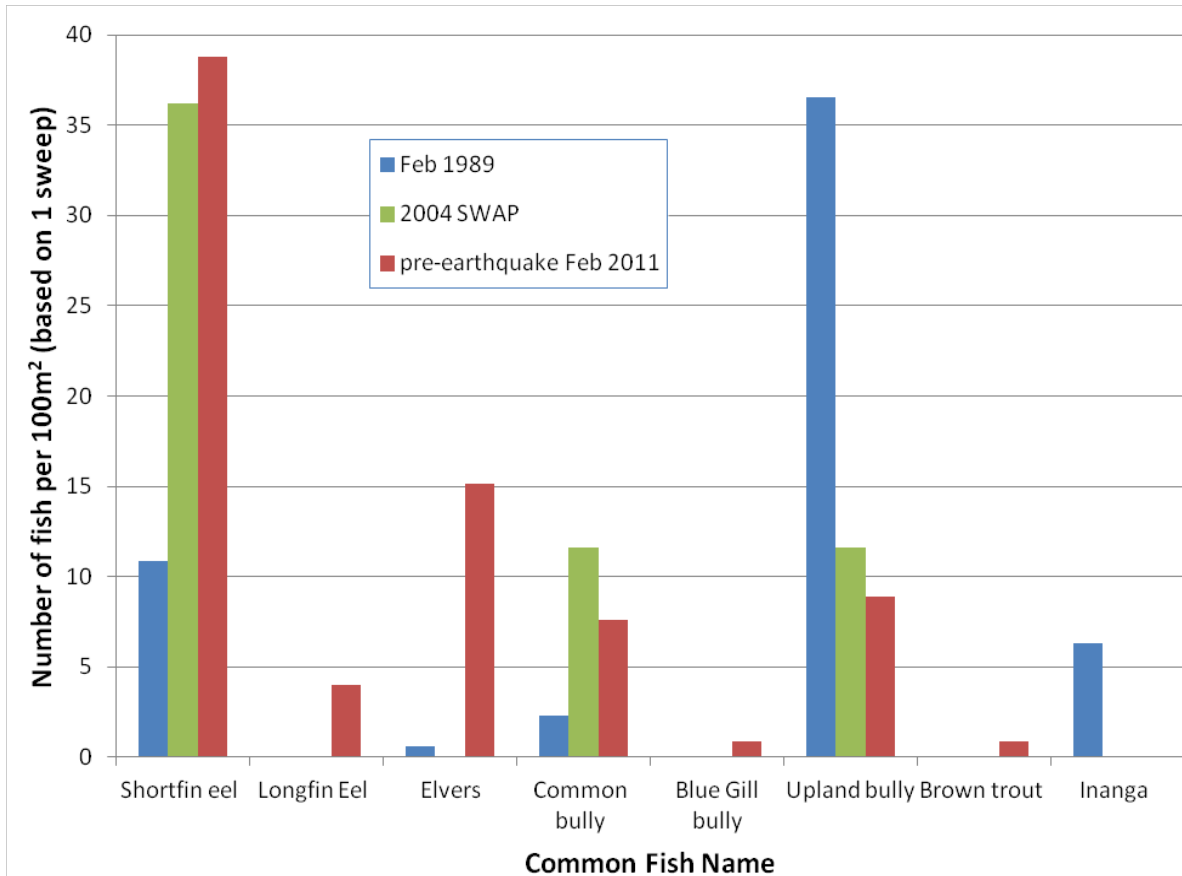
To provide comparable figures (and assuming escapement levels remain about the same), the first pass fishing CPUE is provided below (Fig. 13). Of note, was the identification of bluegill bully (a single specimen), which have not been identified from this site previously. The numbers of common bullies and eels (especially shortfin elvers) had increased. Also in 2011, two adult trout were identified from this section, possibly due to the increasing depth, and bank cover at this site (F.L. = 415 mm, 290 mm). No follow-up survey has been conducted at this site following the February 22nd earthquake.

Figure 13. Changes in the fish community structure in the Heathcote River over three fishing surveys.

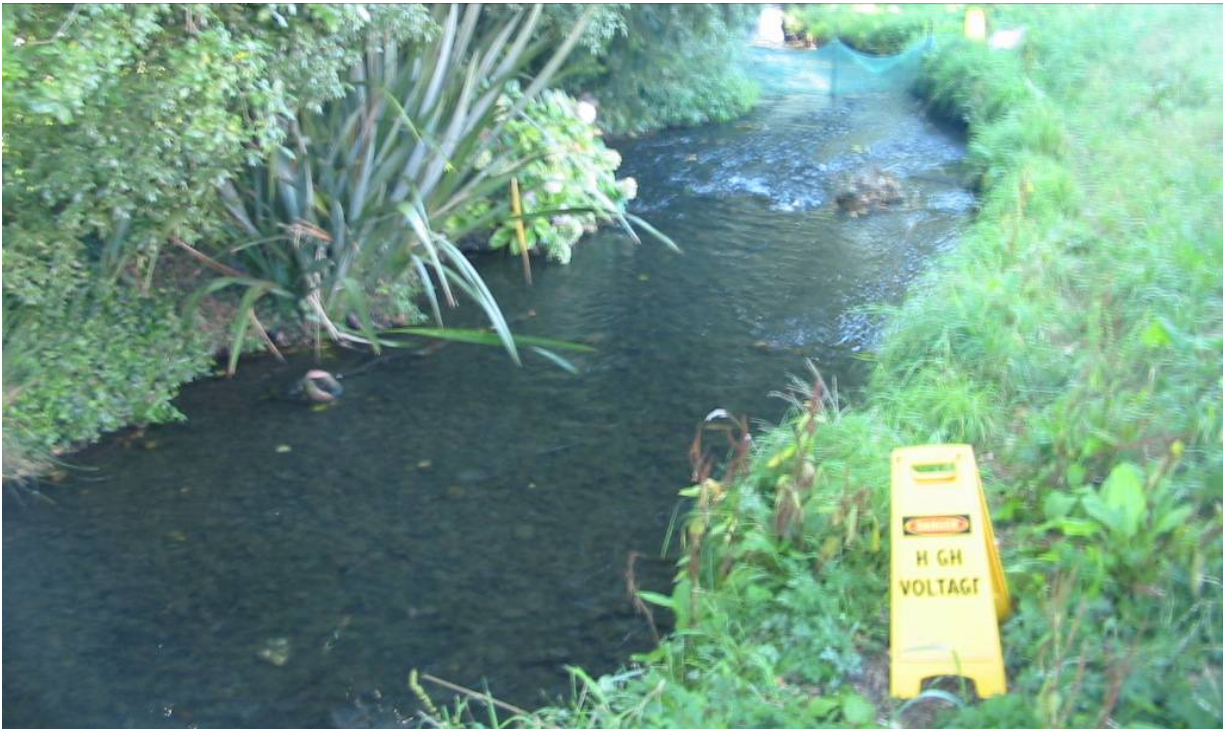
Figure 14. Looking downstream at the Heathcote River reach downstream of Halswell/Lincoln Road.

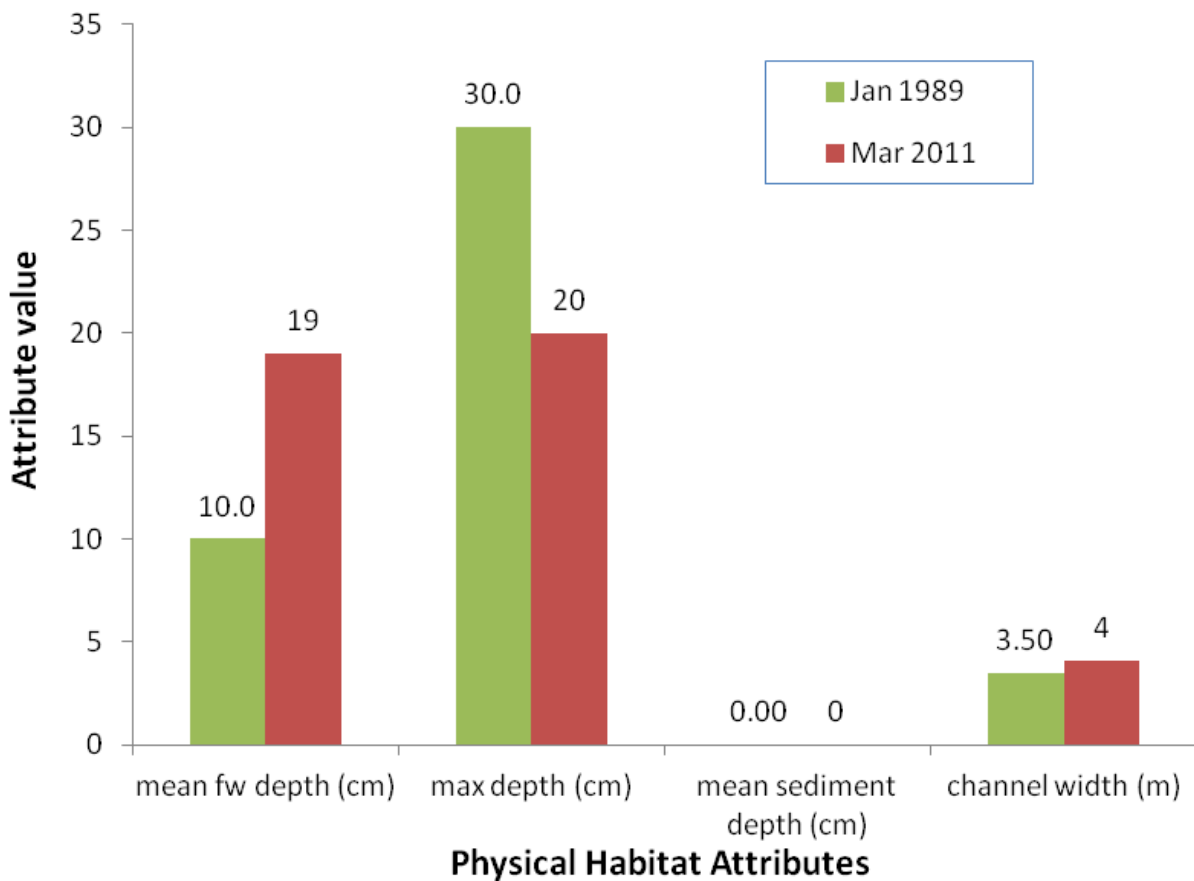
Figure 15. Basic physical habitat attributes of the Heathcote River habitat downstream of Halswell Road.

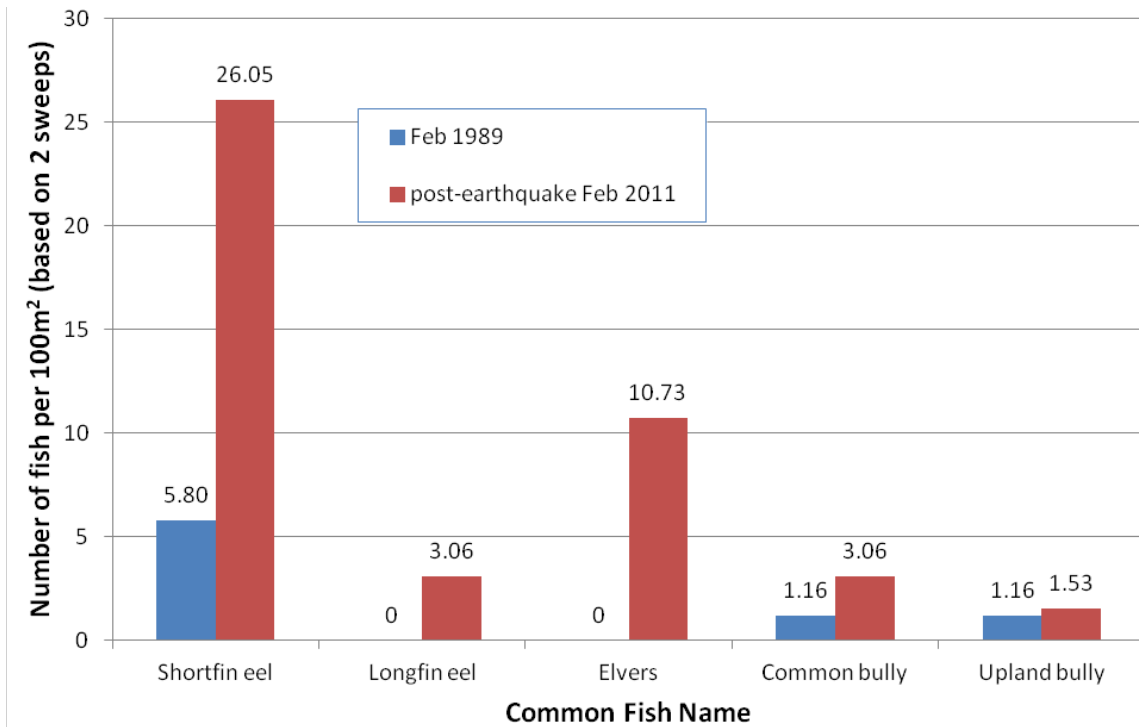
The fish catch per unit effort is provided in Fig. 16, which demonstrated a significant increase in fish numbers (and almost certainly biomass) over the survey reach compared to the drought conditions in 1989. A longfin eel, not identified from this site in 1989, and many shortfin elvers were also recorded.

Figure 16. The fish catch based on 2 electric-fishing sweeps on a habitat downstream of Halswell Road.

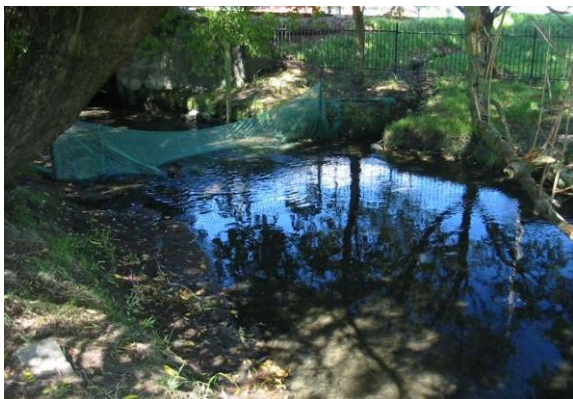
Figure 17a. Looking downstream at the stopnet upstream of Lincoln Road. Spreydon School is on the true right bank.

This reach was a mixture of riffle and run-type flow with a recent planting of luxuriant *Carex* for a portion of the true left bank (Fig. 17a, b). The habitat was a mixture of riffle and run-type flow, with substrate compositions of gravel and silt respectively. Overall, the mean sediment depth was 3 cm (Fig. 18), with silt covering about 40% of the bed. The 1989 physical data is provided on NZFFDB record 10352 (Site 96 in Eldon *et al.* (1989)). It is clear that 90% of the bed was mud in 1989, but there is no information on the depth of the soft substrate. The apparent width reduction over time, may not be 'real', as the 1989 width is based on a fished length and area, which may only be approximate.

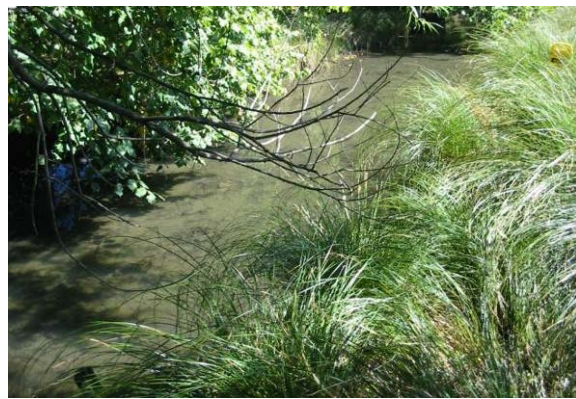
Figure 17b. Looking upstream towards the upstream end of the fished section (yellow sign).

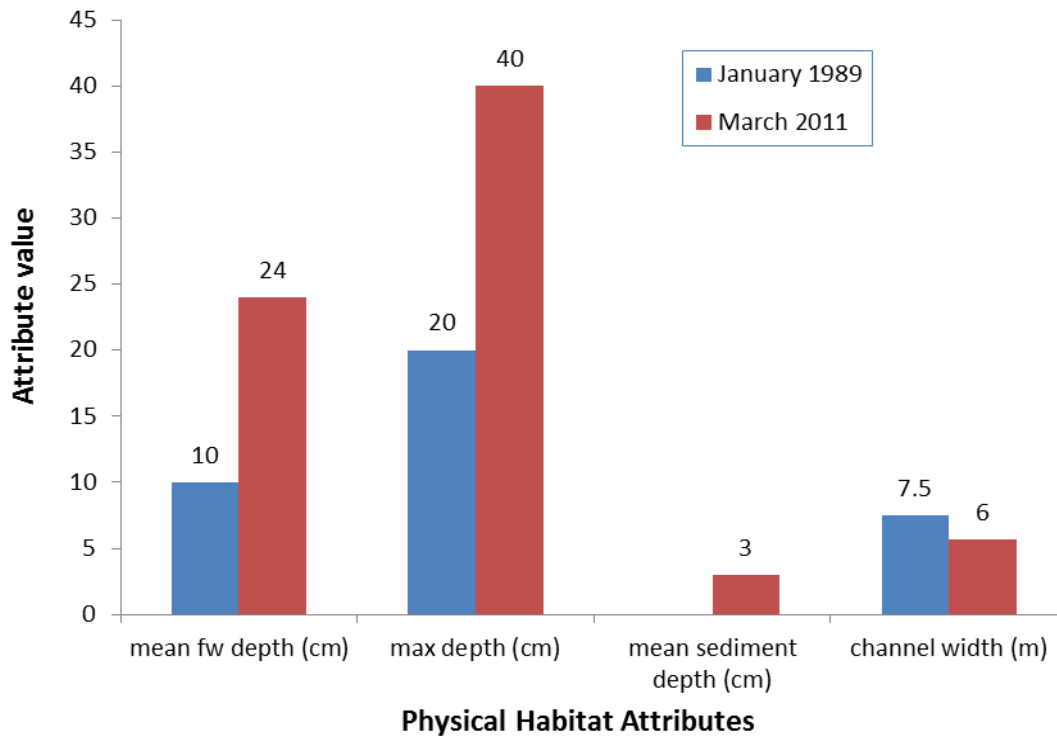
Figure 18. Basic habitat attributes of the Spreydon School site, upstream of Lincoln Road. Sediment depth was not recorded in 1989.

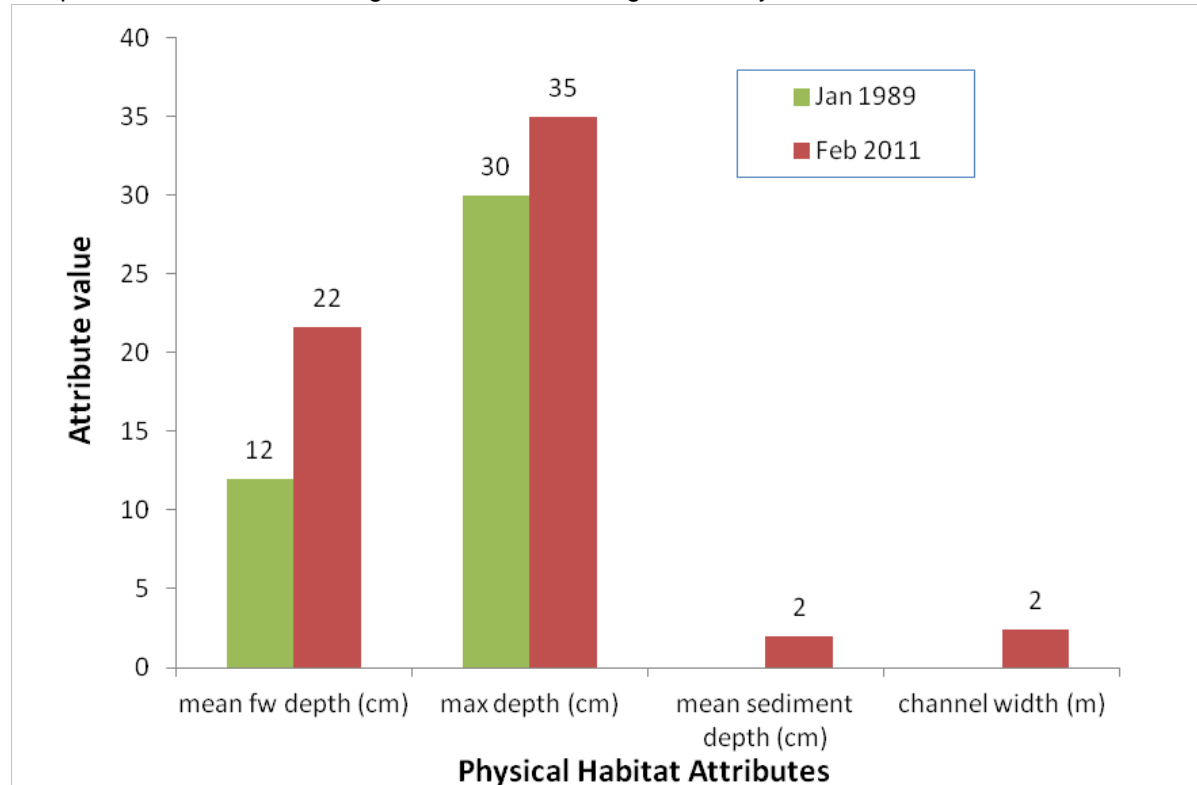
Typically the river bed is dry and cracked at that time of year. In 1989, the channel was composed of three distinct pools, and provided only standing very warm water (32 °C). The NZFFDB record relating to this site (10353) does not provide a defined channel width. Unfortunately recent photographs of this site are missing, due to the destruction of a work computer during the earthquake a few days after the survey. However, the 2011 catch was similar to that of 1989, consisting of just shortfin eels, and elvers, but our catch rate was higher, with a catch rate of 35 shortfin eels and elvers / 100 m² (based on one fishing sweep) compared to 23.7 fish/100 m² in 1989 from the three pools, where the fish were concentrated. This rise in catch rate would reflect the healthier perennial environment in 2011 compared to the warm standing water habitat existing in January 1989.

Figure 20. Basic habitat parameters from the normally ephemeral Nash Road site. Sediment depth was not recorded during the 1989 survey, and channel width was not applicable as the habitat was ponded.

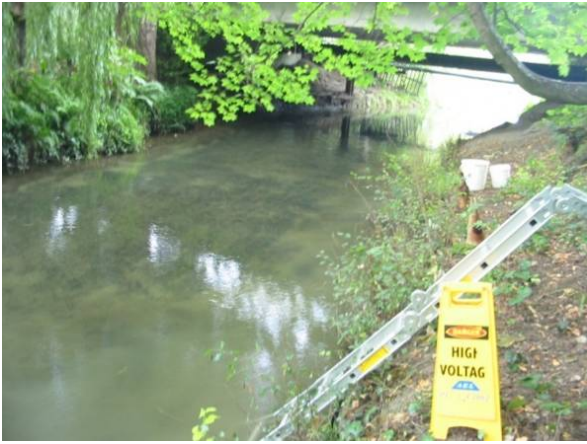
Figure 21a. The shaded silty bed of lower Cashmere Stream at Worselys Road. The ladder facilitates access to the river bed.

Worsleys Road is in the heavily wooded section of the lower Cashmere Road. The bed of Cashmere Stream was heavily sedimented, and comprised a sluggish run (Figs. 21a, b). The basic nature of the habitat would appear to have little changed since 1989, although was slightly deeper in March 2011 (Fig. 22)

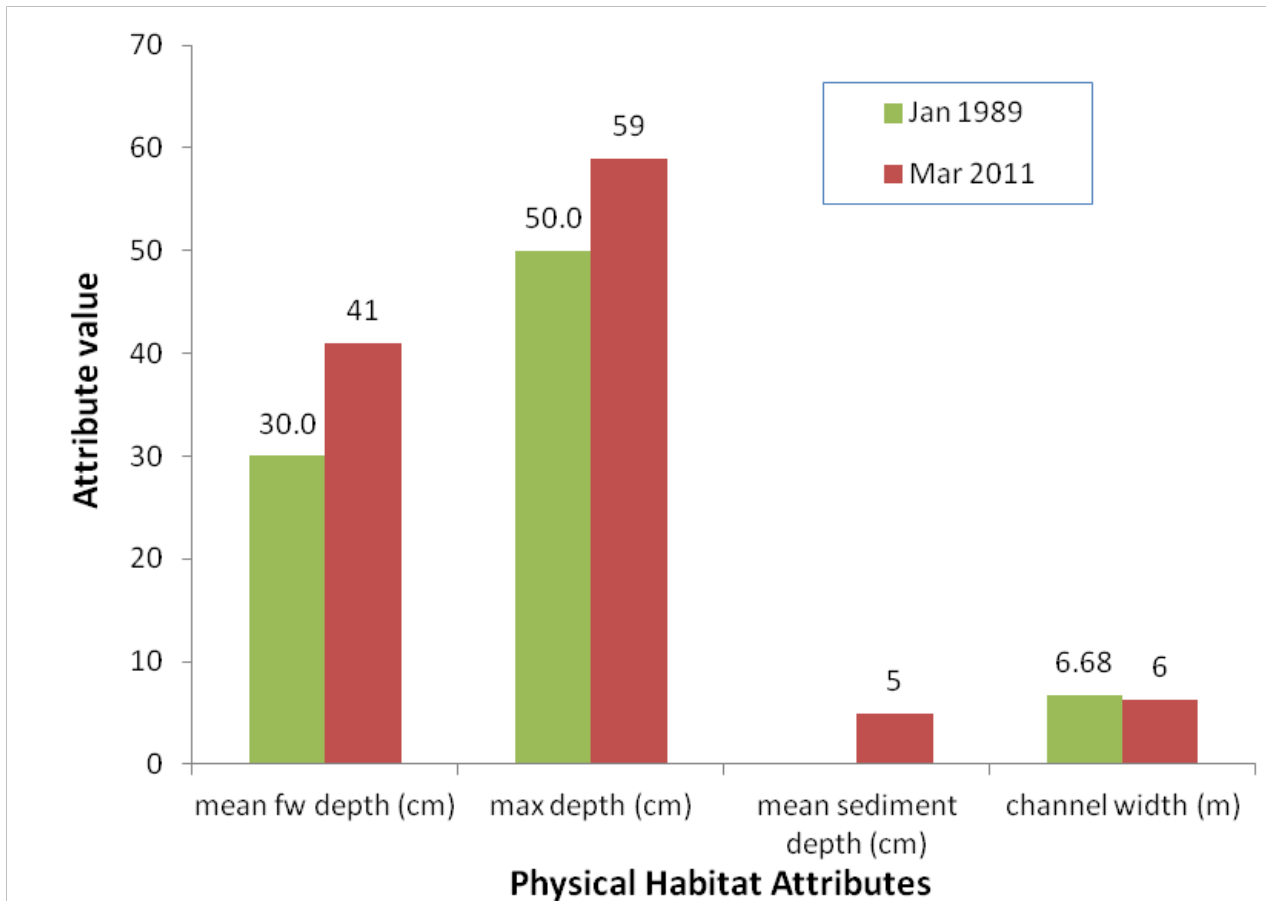
Figure 22. Basic habitat parameters for the Worsley Road reserve site. Sediment depth was not recorded during the inaugural 1989 survey.

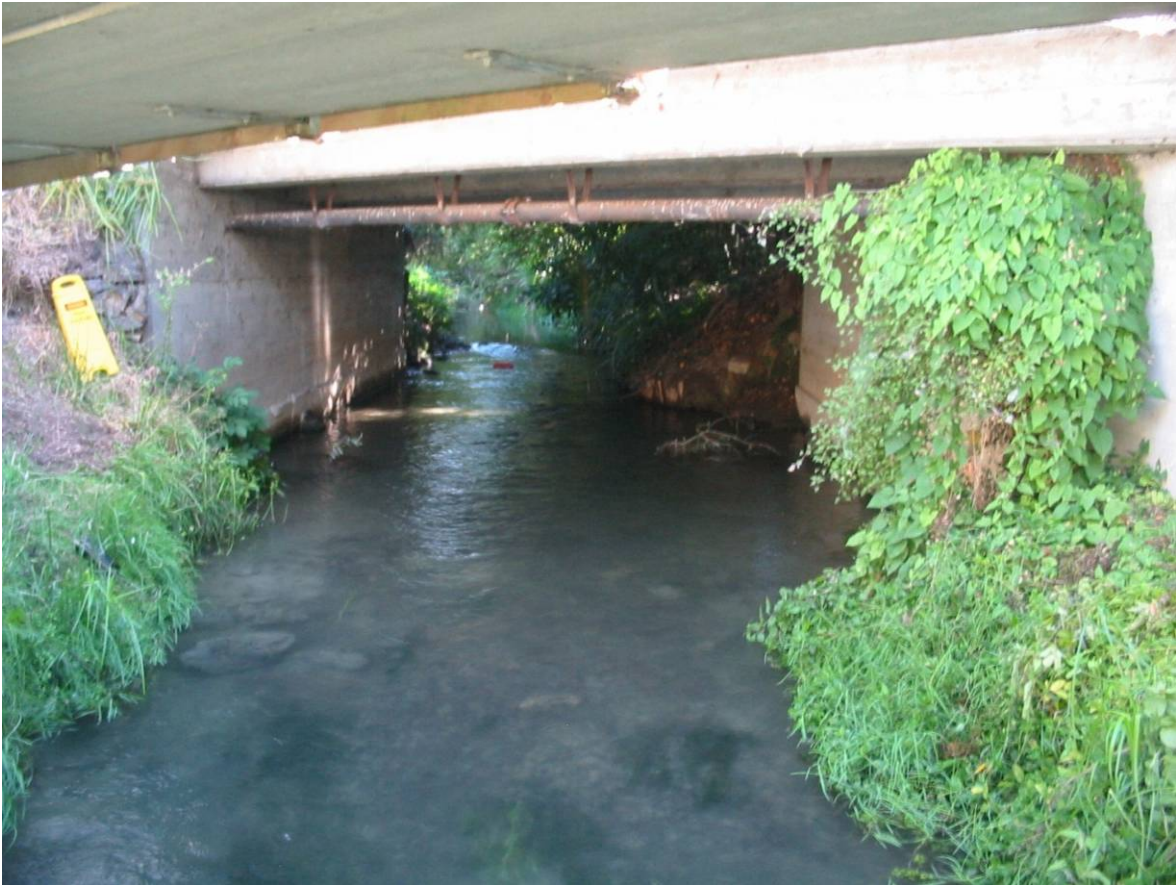
Figure 24. Looking upstream at the shallow fished section of Cashmere Stream. Little detritus was in the fished section, although a small amount can be see upstream of the fished section (i.e. beyond the yellow sign).

This site represents the fastest flowing reach in Cashmere Stream (Fig. 24), and one of the last known remaining reaches in Cashmere Stream where some exposed gravels are retained. This site is approximately 175 m upstream of the Eldon's 1989 Westmorland Site near Brookford Place.

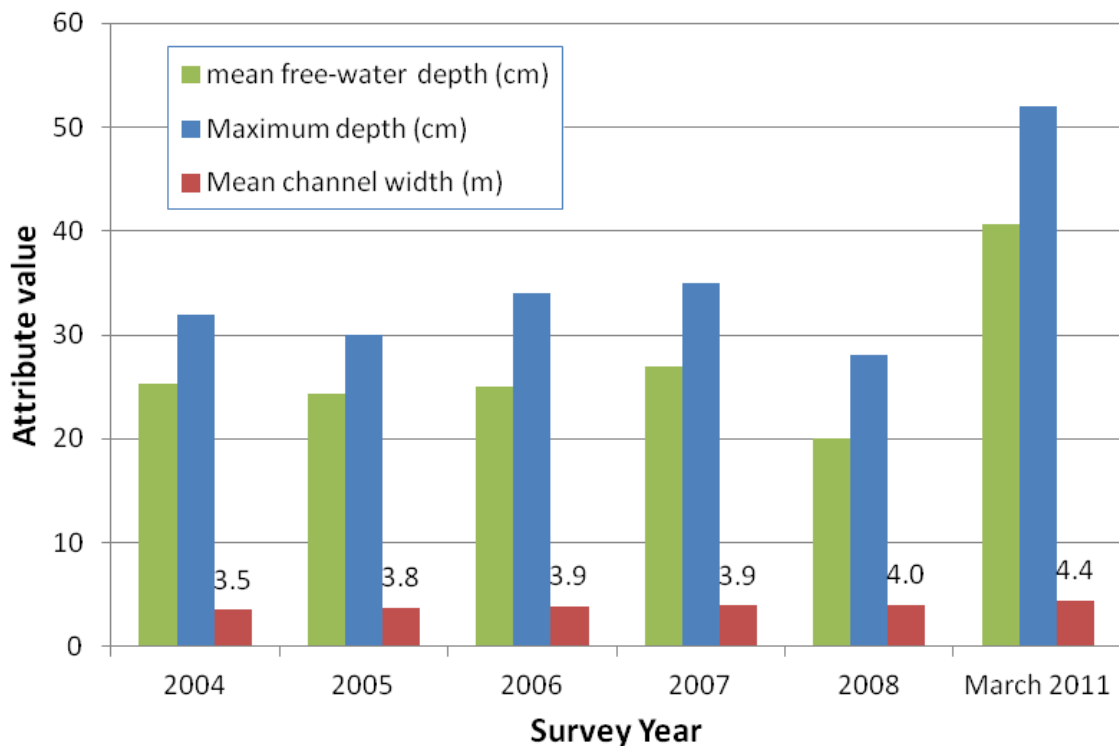
Figure 25. Basic habitat parameters for the Hoon Hay Valley Road site over a six year monitoring period. Channel widths are printed above the columns for clarity.
