Halswell and Heathcote Aquatic Values; selected aspects; monitoring round # 4

Prepared for:
Christchurch City Council

AEL Report No. 90

September 2012

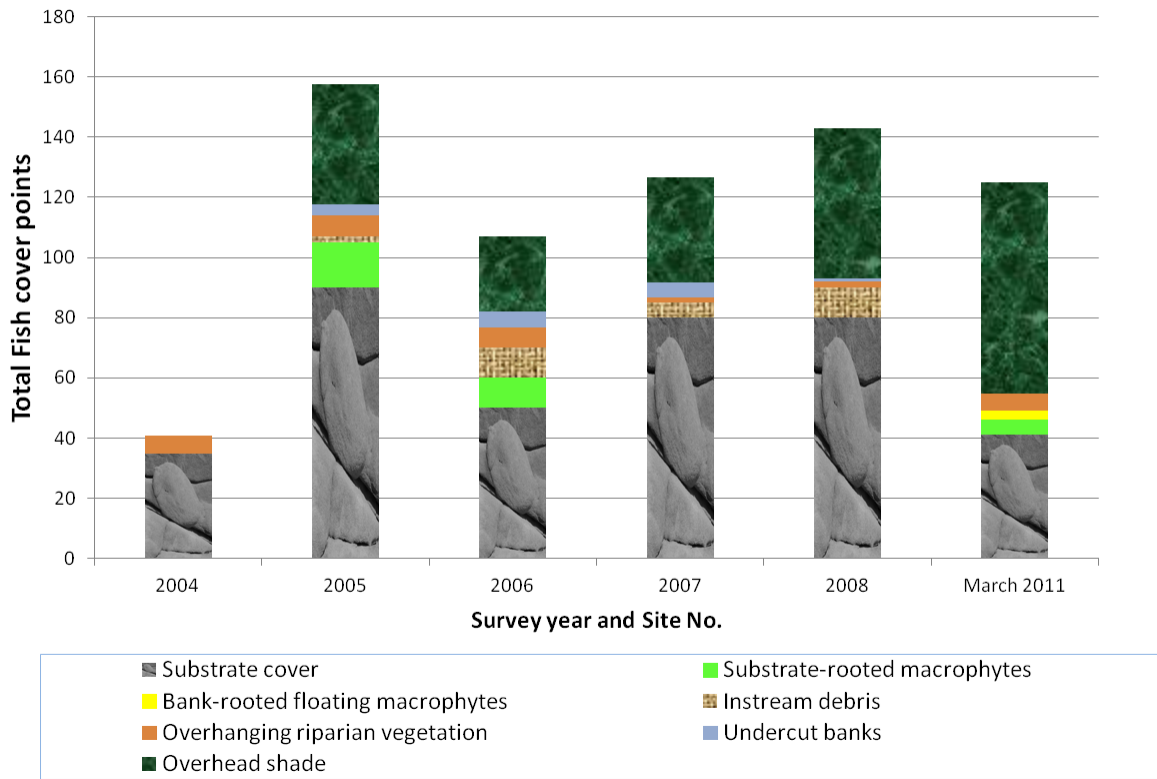
Figure 26a. Fish cover (refuge) changes over six habitat assessments (2004-2011).

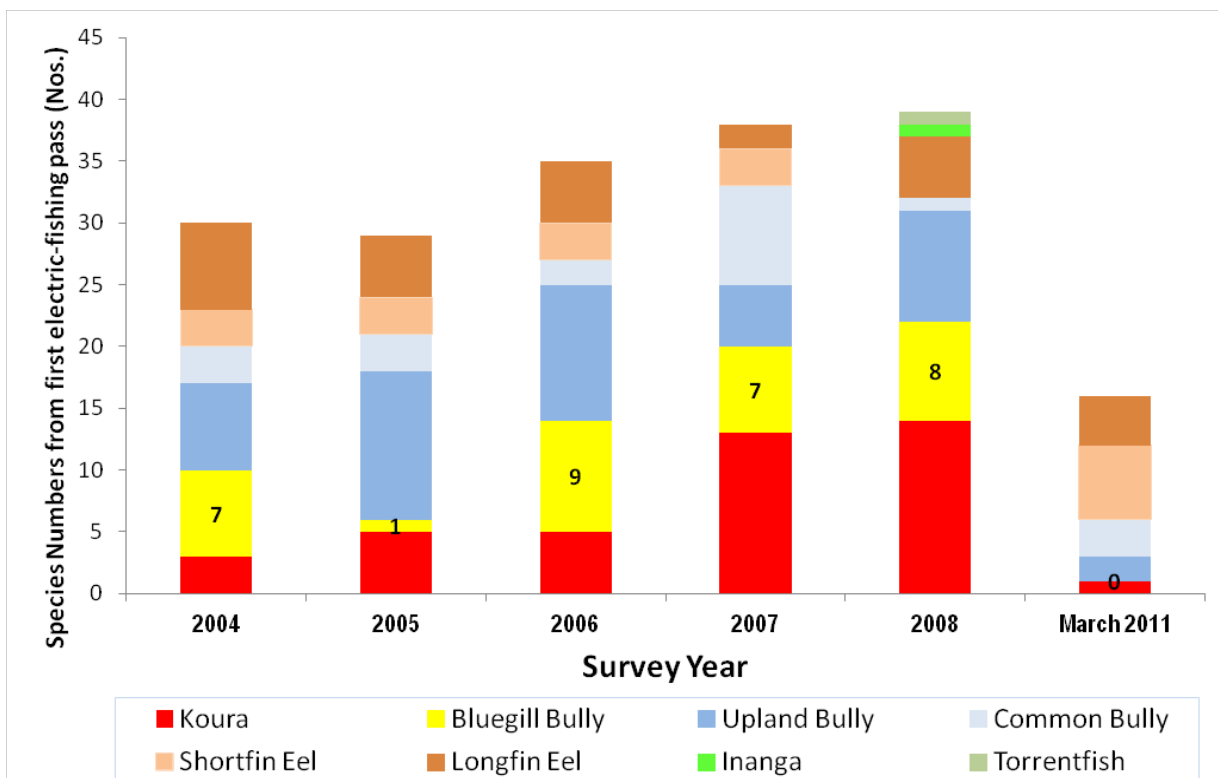
Fish species richness, fish abundance, and koura abundance, were well down in March 2011 compared to previous years (Figs. 27, 28). Notably, only one small koura (60 mm body length) was obtained from the site at this time. This is despite fishing time for each of 2 passes being approximately double in March 2011 compared to previous years. Notably no bluegill bullies were identified in the catch, the first time in six years that this site has been fished by this agency.

Figure 27. 'First-pass' electric fishing numbers of fish and koura from 2004 to 2011 for the standard fishing area at this site. The numerals relate to bluegill bully abundance.

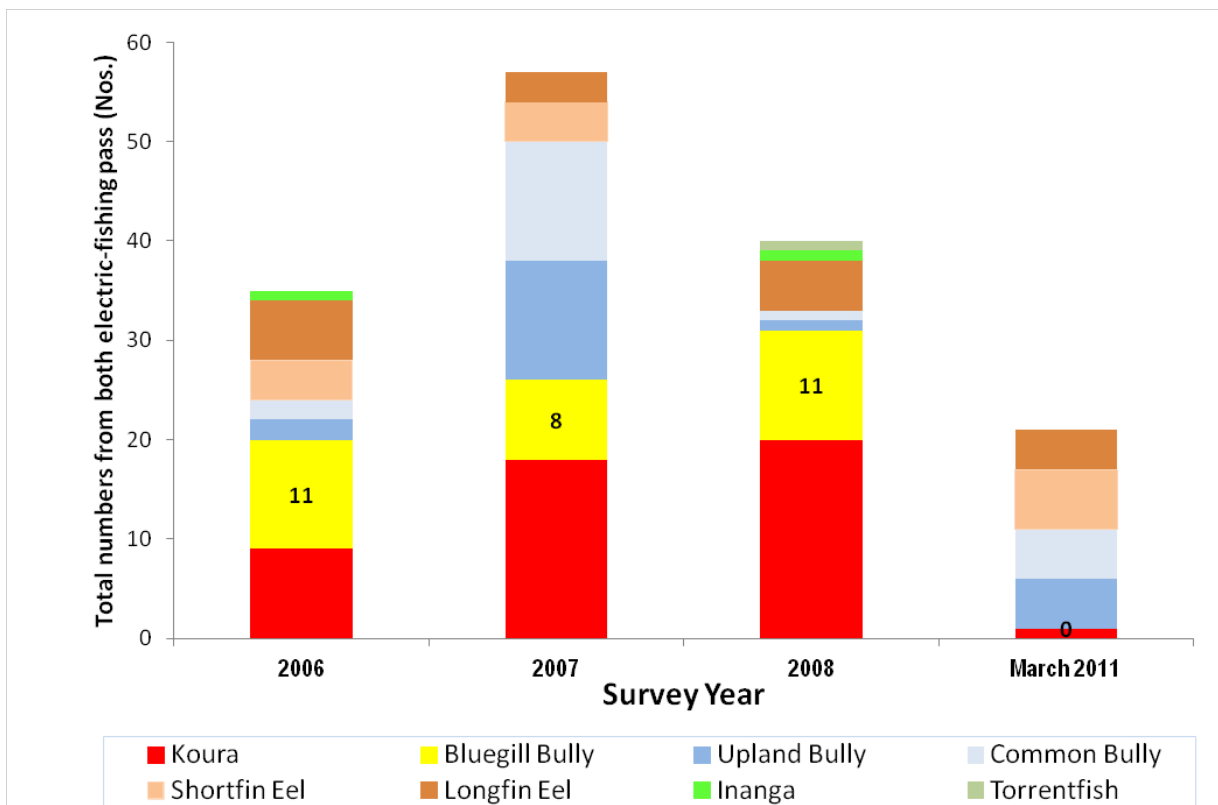
Figure 28. Fish and koura abundance based on two electric fishing passes over the standard fishing area at this site. Bluegill bully numbers are printed on the respective column categories.

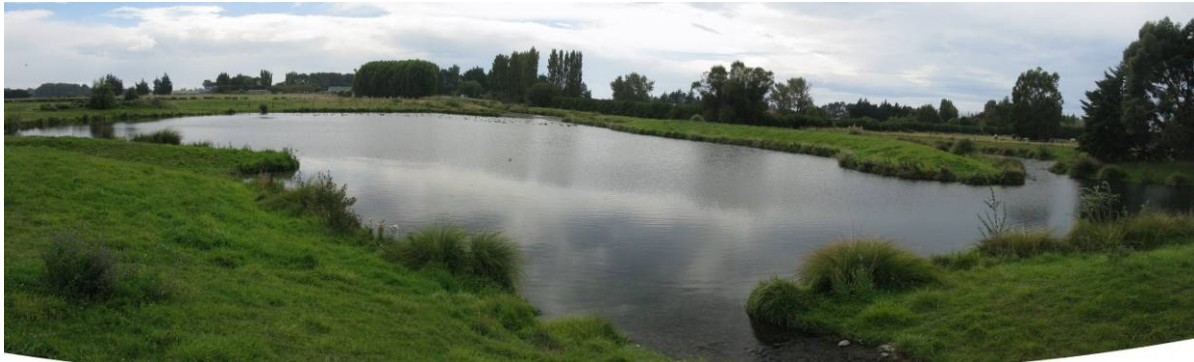
Figure 29. The upper Quaifes Pond, looking north (17/3/11). It is approximately 110 m long by 78 m wide.

The 'Quaifes Ponds' are a two large ponds constructed on the lower reach of Quaifes Drain (Fig. 29). A proportion of the flow of the spring-fed Quaifes Drain is diverted through two ponds before being rediverted back into the lower reaches of the drain, whereby it flows into Knights Stream and the Halswell River.

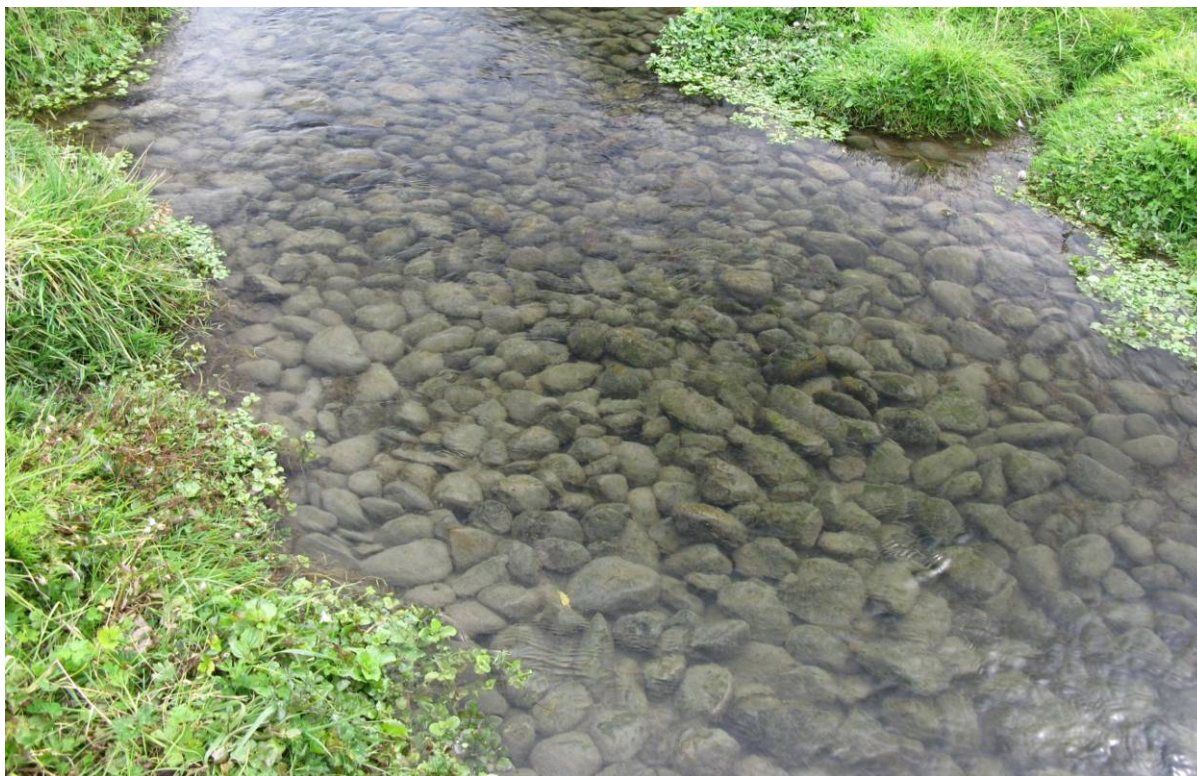
Figure 30. The clean stony channel between the two channel provides a spawning and rearing habitat for upland bullies.

It is evident that the CPUE of eels and perch has increased appreciably within the ponds, and schools of juvenile perch were observed in the margins of the upper pond. However, high numbers of upland bullies were present in the stony channel between the two ponds (Fig. 30), and a single wild goldfish was caught, and it is likely more are present in these habitats (Fig. 31). No inanga were seen during our site visit.

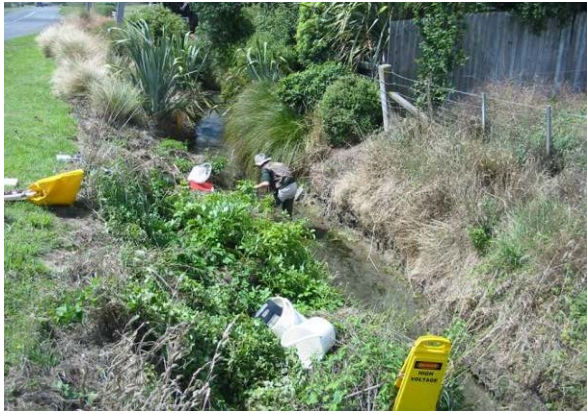
Figure 32a. Quafes Drain koura habitat (10/2/2004), looking upstream.

It was clear from our results and habitat assessment that this koura habitat has been damaged by the earthquake, probably due to the attendant lateral spread and bank slumping collapsing the burrows. This damage was apparent after the September earthquake, and the re-visit in March 2011 confirmed the ecological impact of this event, and the February 11 aftershock.

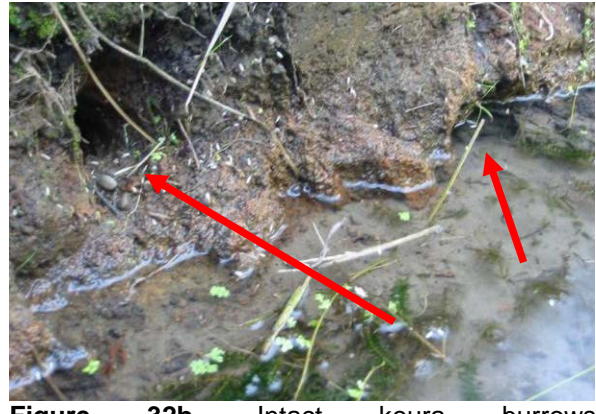
Figure 32b. Intact koura burrows (arrowed)(10/2/2004).

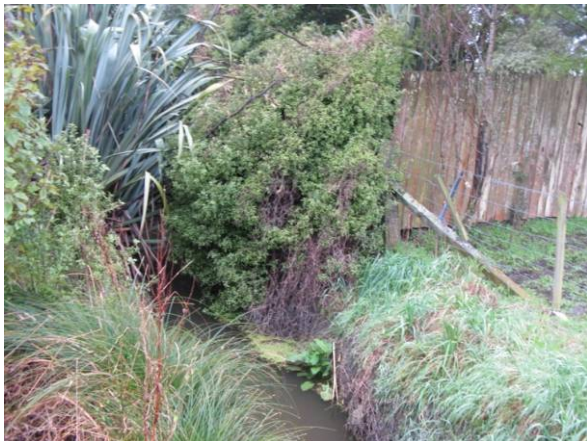
Figure 32c. The same site 8 September 2010, this photo left bank was subject to significant lateral spread from the 4 September 2010 earthquake.

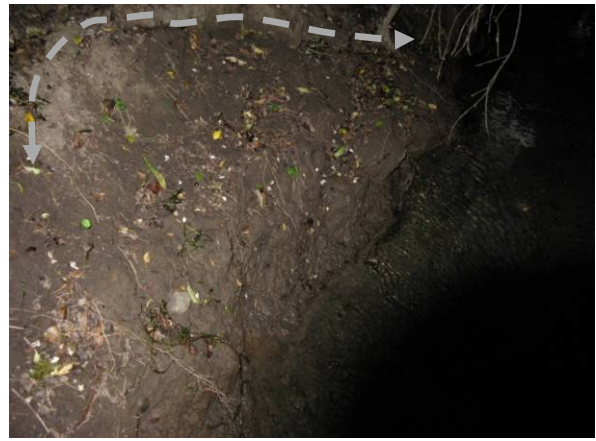
Figure 32d. 8/9/10, slumping on the true right bank, probably due to seismic activity on the 4th September 2010.

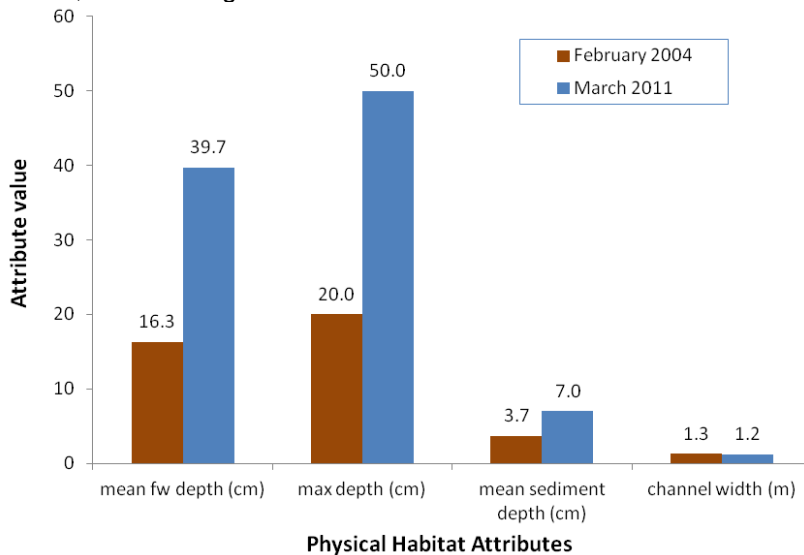
The physical habitat had changed dramatically, with the substrate overlaid with more soft-sediment, greater water depth, and slightly narrower wetted width (Fig. 33). Repeat fishing of the koura breeding reach yielded no crayfish, with a tenfold increase in the number of shortfin eels. Longfin eels were now present, but absent from the previous SWAP survey. A single brown trout (c. 250 mm) was observed, but not caught in the fished section.

Figure 33. Basic habitat parameters for the koura breeding habitat on Quafes Drain near corner of Sabys and Candys Road.

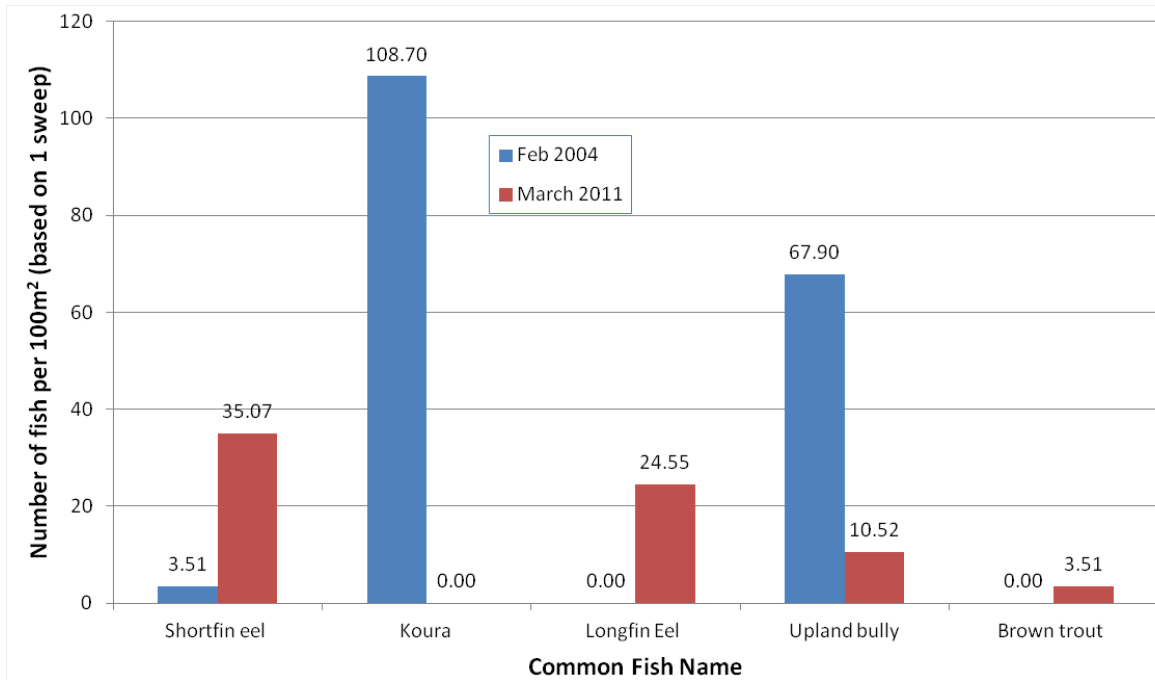
Figure 34. Change in fish and koura population density at the koura breeding habitat on Quaifes Drain near corner of Sabys and Candys Road.

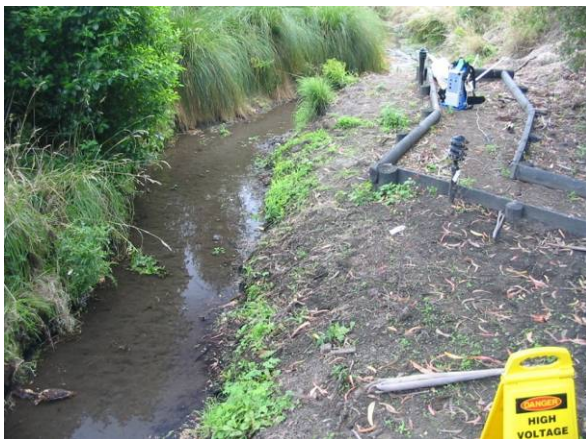
Figure 35a. 11/2/2004, looking upstream from the site's downstream boundary.

In the vicinity of this site, the waterway adopted a meandering gentle run (Fig. 35a, b). Since the 2004 survey, the true left bank has been planted in *Carex* and tree ferns, and the native vegetation on the right bank has matured. At the time of survey, large willow trees were being removed downstream of the section. The upper Knights stream was carrying significantly more flow than in February 2004, although the channel width remained the same (Fig. 3.6). Soft-sediment depth has also increased.

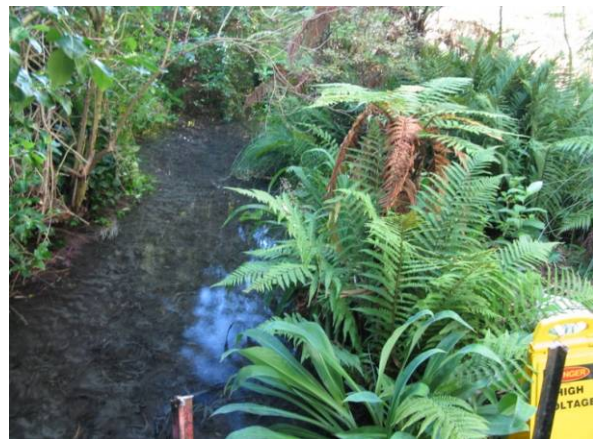
Figure 35b. 29/3/2011. Looking upstream from the site's downstream boundary. The waratahs indicate the downstream stopnet location.

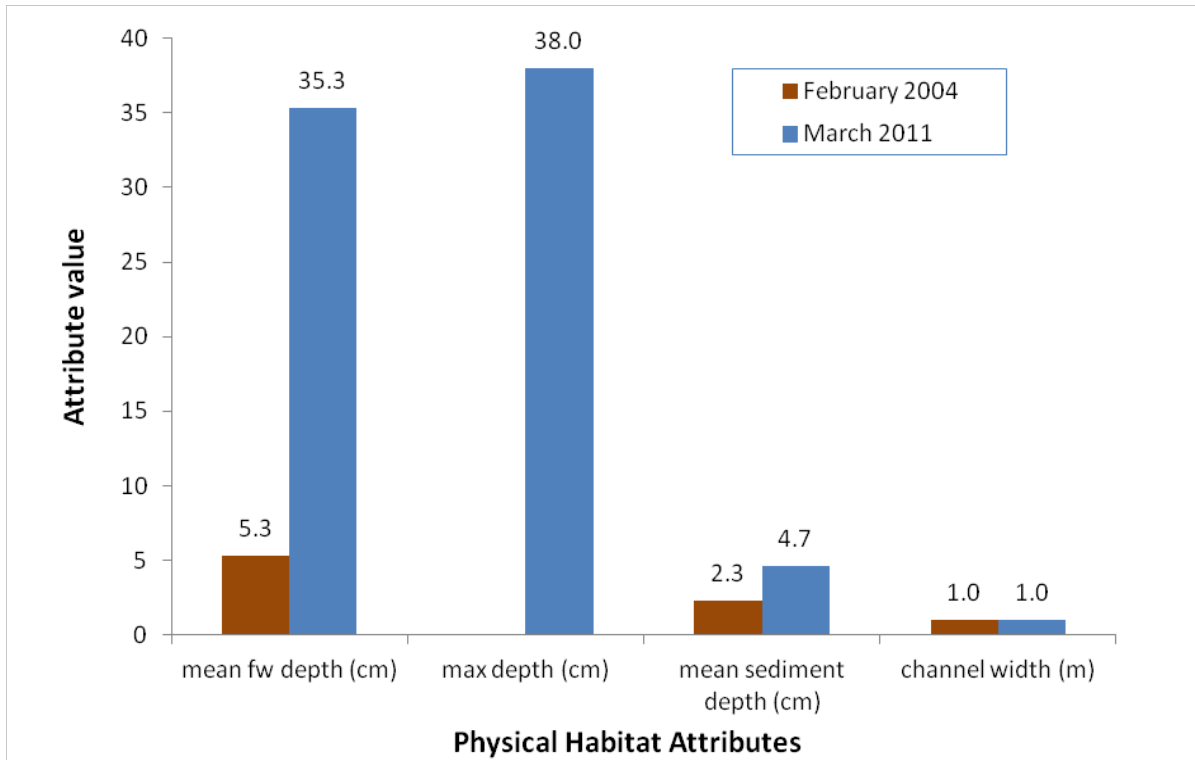
Figure 36. Basic habitat attributes of the Knights Stream site.

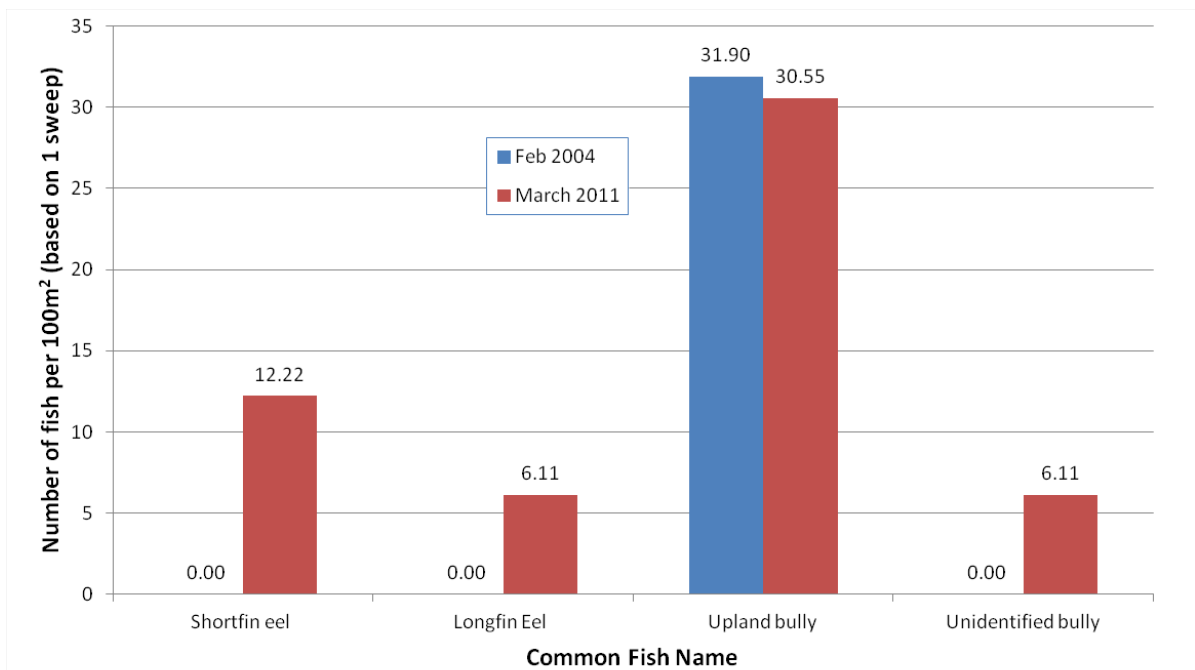
In terms of catch, the numbers of upland bully remained similar to the previous 2004 survey, but diversity had increased with shortfin eels and longfin eels also present (Fig. 37). One large longfin eel, of approximately 900 mm in length was observed just downstream of the section.

Figure 37. Increased biodiversity at the Knights Stream site compared to 2004.

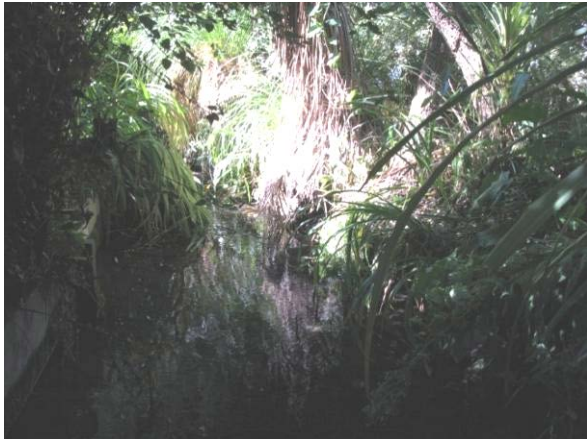
Figure 38a. 30 March 2011. Looking downstream at the shaded channel of Nottingham Stream. Most of the channel was boxed through private property

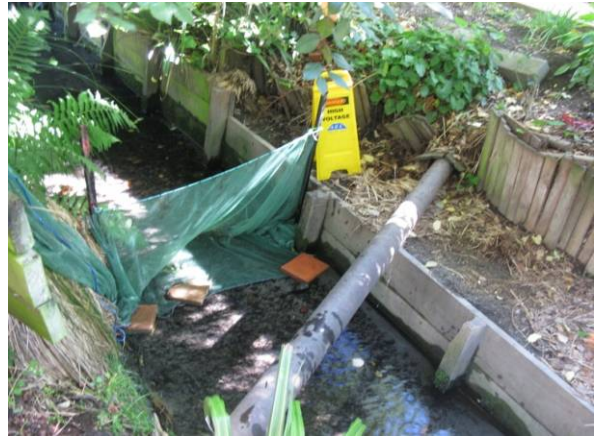
Figure 38b. 30 March 2011. The stopnet at the bottom of the fished section.

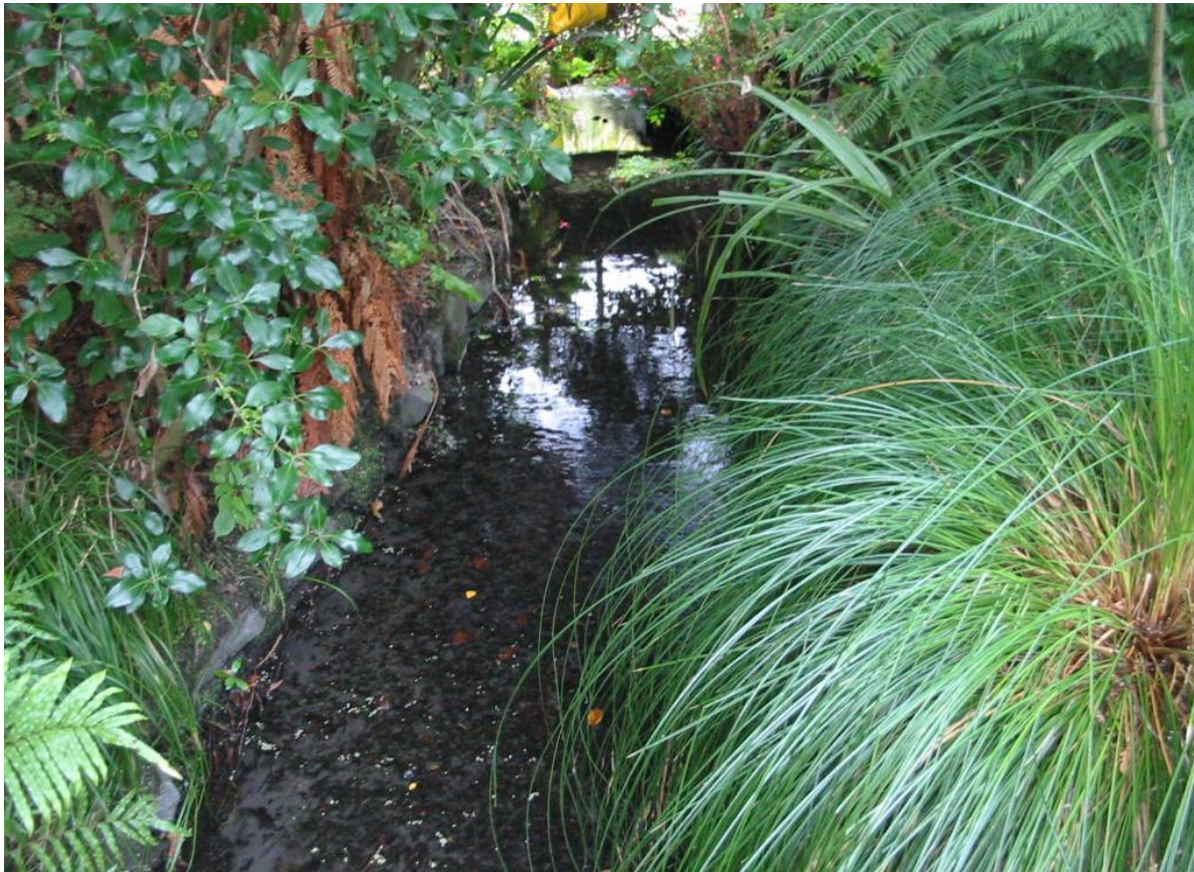
Figure 39c. 17/2/2004. The fished section of Site 20, on Nottingham Stream. A gravel substrate, quite embedded into sand

Hydraulically, the stream flows as a shallow run, over a gravel substrate somewhat embedded in sand, both in 2004 and in 30 March 2011. The flow depth was somewhat greater in 2011, but otherwise was very similar to the environment observed in 2004. No sediment depth data was recorded in 2004. However, since 2004, and possibly due to the earthquakes, some of the dry stone cladding had collapsed, and the banks were in the process of being re-clad in wood, which explains the change in wetted width.

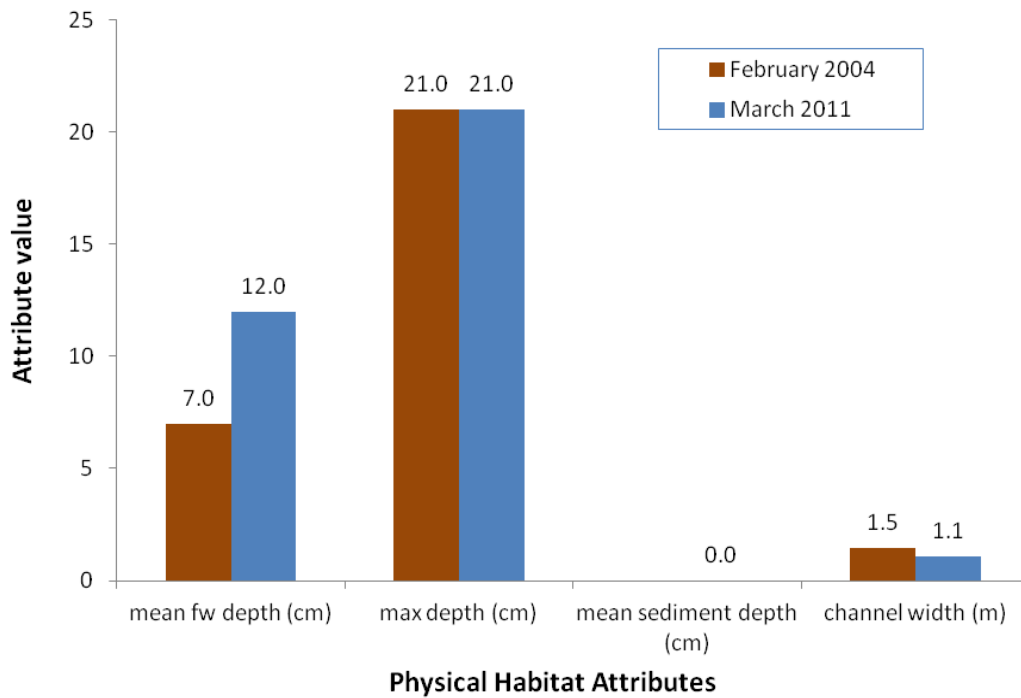
Figure 39. Basic habitat attributes of the upper Nottingham Stream site (SWAP Site 20).

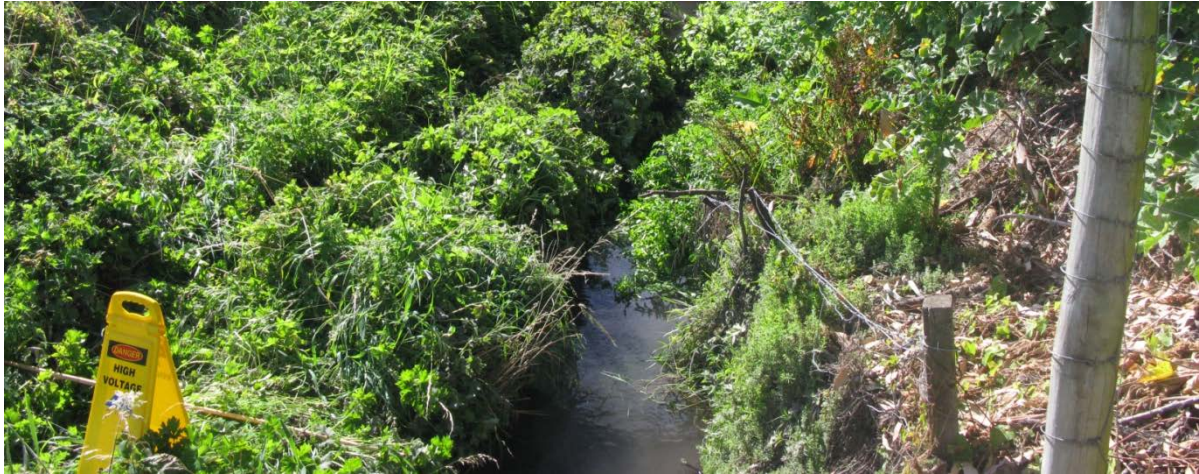
Figure 41a. SWAP site, Site 19, 30 March 2001. Looking upstream along Nottingham Stream, which was heavily overgrown with instream and riparian vegetation.

This reach is referred to as Site 19 in the SWAP surveys (EOS Ecology Limited *et al.* 2005). This particular reach of Nottingham Stream is conveniently accessible from Halswell Road at this location. At the time of the recent survey (30/3/11), and possibly at most times, the channel was heavily overgrown with *Carex*, flax, some water-emergent water cress, and water celery (Figs. 41a, b). Aquatic plants included curly pondweed, and charophytes. In 2011, the waterway flowed as a slightly meandering run over a totally embedded silted bed with an appreciable silt depth (Fig. 41). However, in 2004, the channel was more open (Fig. 41b) substrate cobbles and gravels were slightly exposed, and the exposed cobbles and gravel was about 60% embedded.

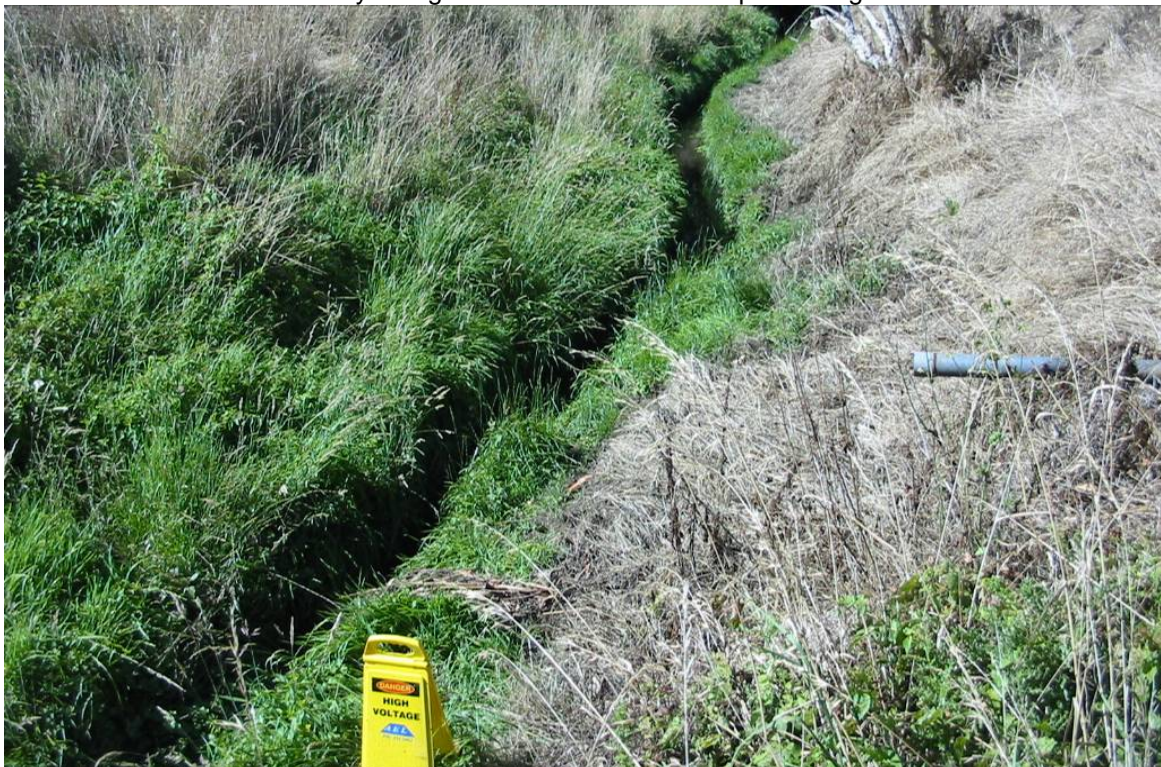
Figure 41b. SWAP site, Site 19, 16 February 2004 looking upstream. The channel was less overgrown than in 2011.

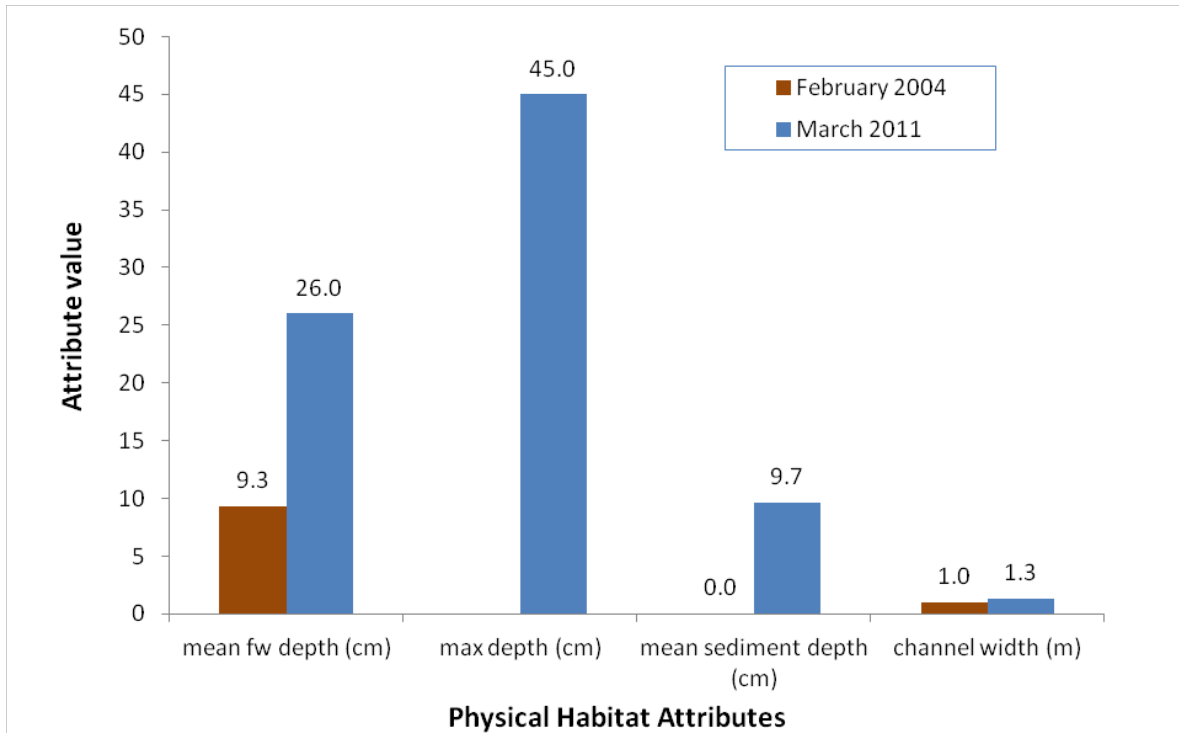
Figure 42. Change in physical habitat attributes between 2004 and 2011. Sediment depth has increased appreciably since 2004.

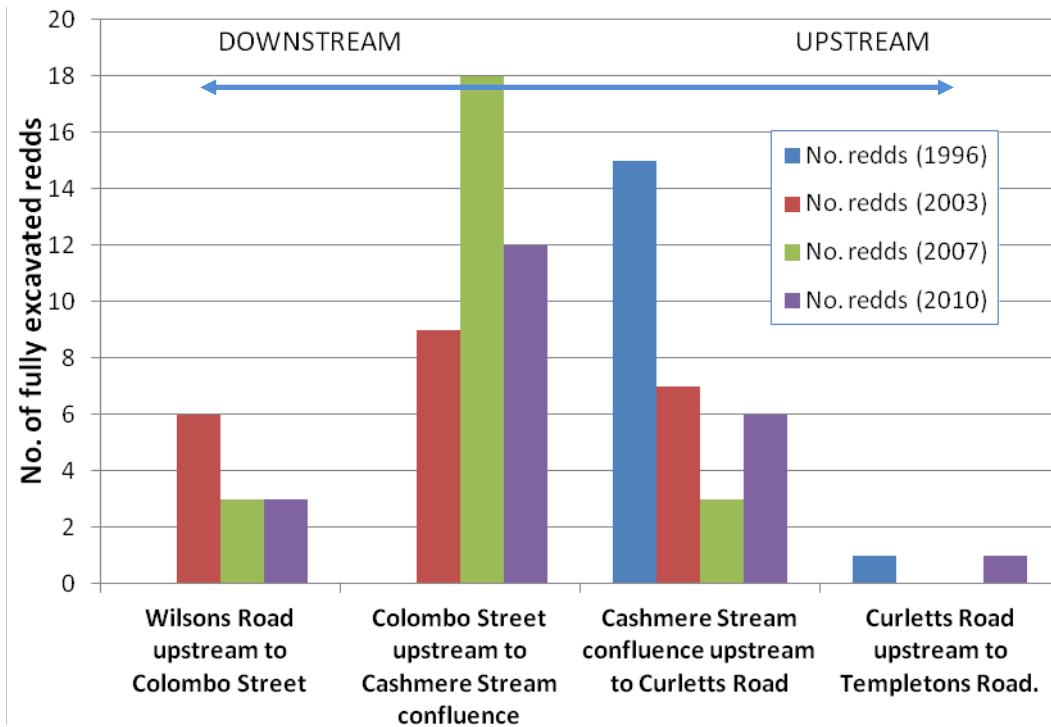
Figure 46. Numbers of complete trout redds over the four historically recent trout spawning surveys.

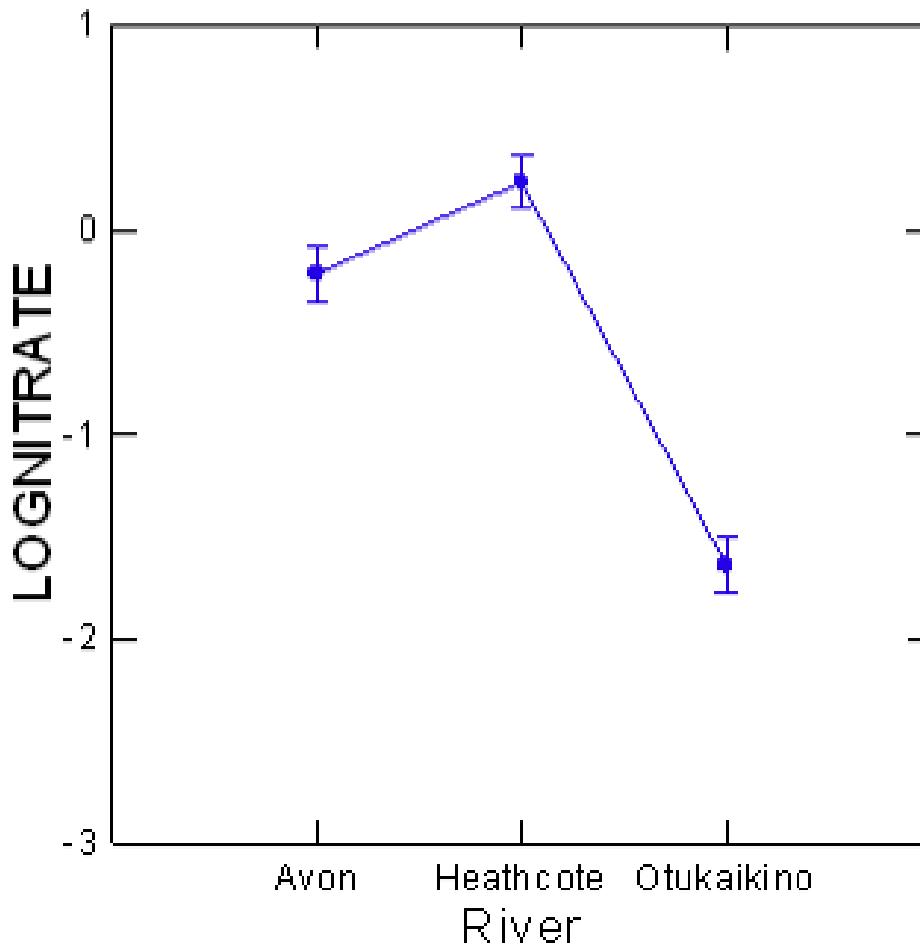
Figure 47. ANOVA Factor influence plot of least-squares means of log-transformed Nitrate levels against location (River) (SYSTAT 12 output).
