Effects of Seismic Activity on Inaka spawning grounds on City Rivers

AEL Report No. 91

Final Report

June 2011

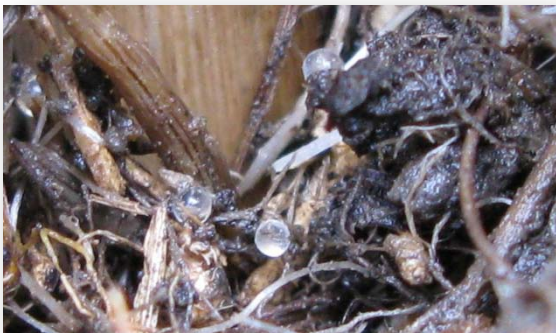
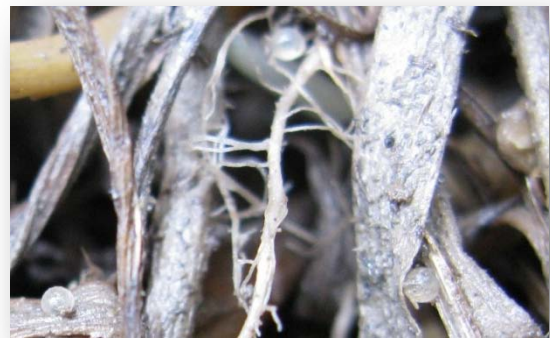
Inaka eggs at the Avondale spawning site, April 2011, from clean (left), and silted (right) habitats

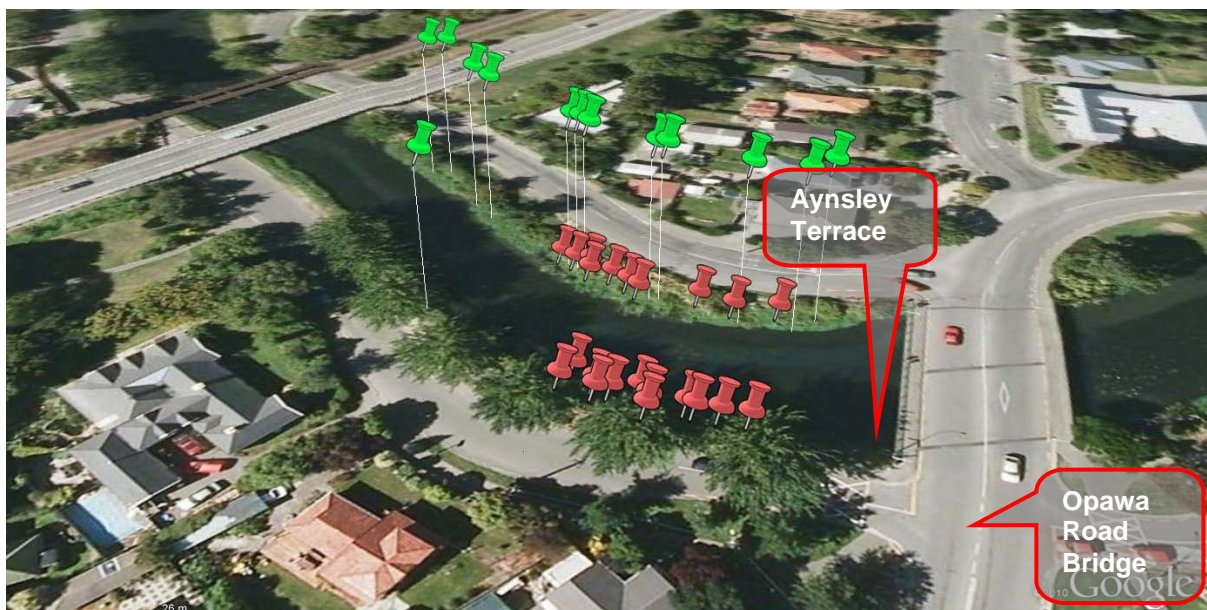
Figure 2. Opawa Inaka Spawning site. Green pins = inaka egg masses logged in March 2004, red pins= negative egg searches in April 2011. Pins represent field waypoints.

No eggs were recorded from this site (Fig. 2) The banks were heavily dominated by a luxuriant sward of reed canary grass (*Phalaris arundinacea*) that extended out over the water surface as a raft. At low to mid-tide a conspicuous zone of aquatic macrophytes (dominated by *P. crispus*) bordered the spawning habitat, but this was overtopped during higher tides when the inaka spawn (Figs. 3 a,b). There was a conspicuous silt coating which smothered the root mat microhabitat for inaka eggs (Fig. 4), but this silt coating was absent during previous surveys at this site (Fig. 5). The silt coating had a distinct demarcation at the high tide level, which suggested the silt was water borne, rather than being transported across the banks, at least at this site, as overland flow.

There were no apparent longitudinal cracks along the banks, and we have no data to indicate how much the banks had dropped vertically, although the roads in the vicinity had some distinct dips.

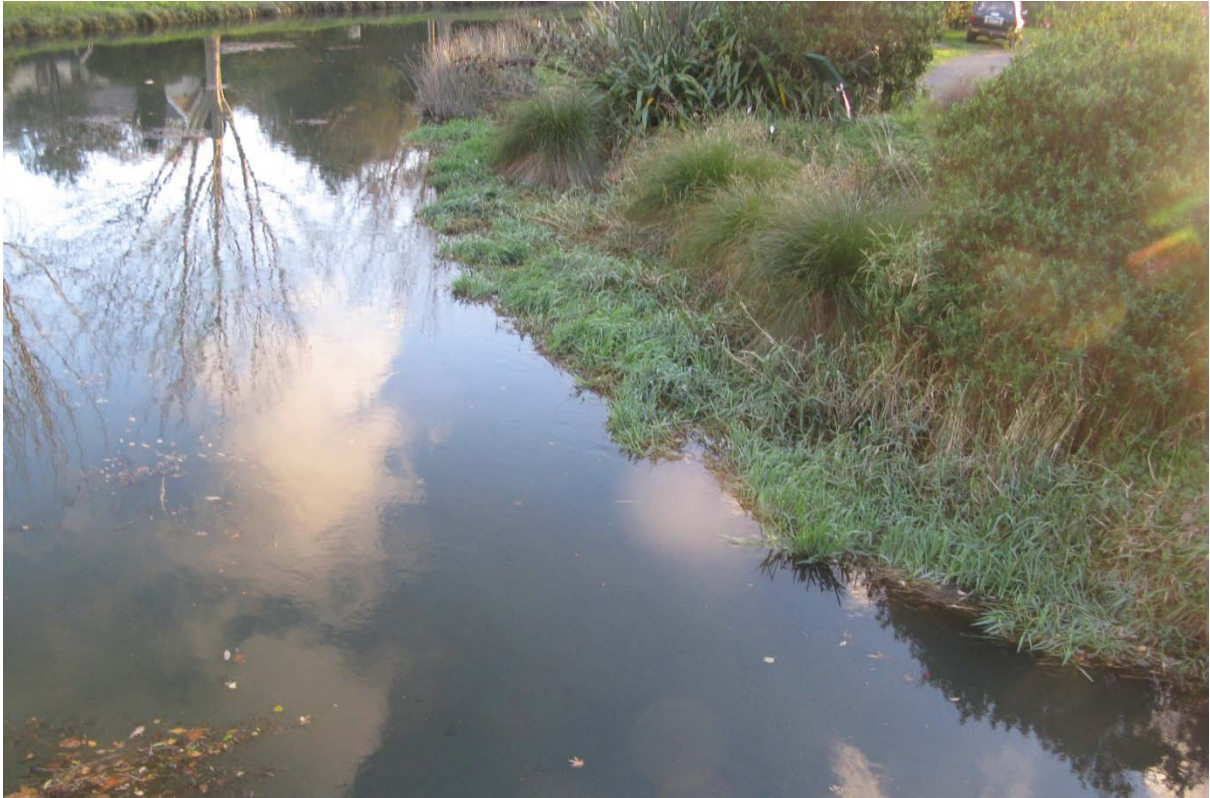
Figure 3a. The Opawa inaka spawning site at mid-tide. A thick raft of canary reed grass extends out across the water surface, and into the intertidal zone.

Earthquake mediated silt has caused a thin coating of silt at this site, and this is probably sufficient to deter inaka from spawning. However, the thick floating raft of reed canary grass is likely to deny the spawning shoals access to this site in any case, and inaka do not appear to favour this grass. Thus, the deleterious impact of seismic activity on this spawning ground has been predated by weed invasion. The reason for the unsuitability of this grass may be at least partly due to its excessively luxuriant growth habit. Given that inaka is a communal spawning fish, and the hatched larvae have to gain access to open river water to reach the sea, the spawning behaviour of the adult inaka may be adapted to ensure shoals have reasonably easy access from open water to the egg microhabitat during the flood tides. North Island studies indicated that even suitable *Festuca* grass sites, if not managed by mowing or periodic grazing, become too rank, and the sites are abandoned by the spawning shoals (Mitchell 1990). This is why it is recommended that urban grassy spawning sites are mown in early summer (December), for example at the Avondale spawning site. In addition to controlling woody adventives, it prevents the grasses from becoming too thick.

It is recommended that the Opawa spawning site be regraded and replanted, although this is not a by-product of the adverse effects of earthquake effects, but a necessity caused by plant community succession. The original landscape planting strategy worked well, and the site was well utilised, until the lack of weed control became an issue. Therefore, in terms of management, weed control is critical at this site. We are unaware of herbicide sprays that would selectively kill reed canary grass but leave other suitable grasses (Tall fescue, Yorkshire fog etc.). Hand weeding unsuitable adventives from the site prior to the spawning season may be a good option at this site, especially if reed canary grass can be controlled to a manageable level where it does not dominate the intertidal zone, or form rafts over the water surface.

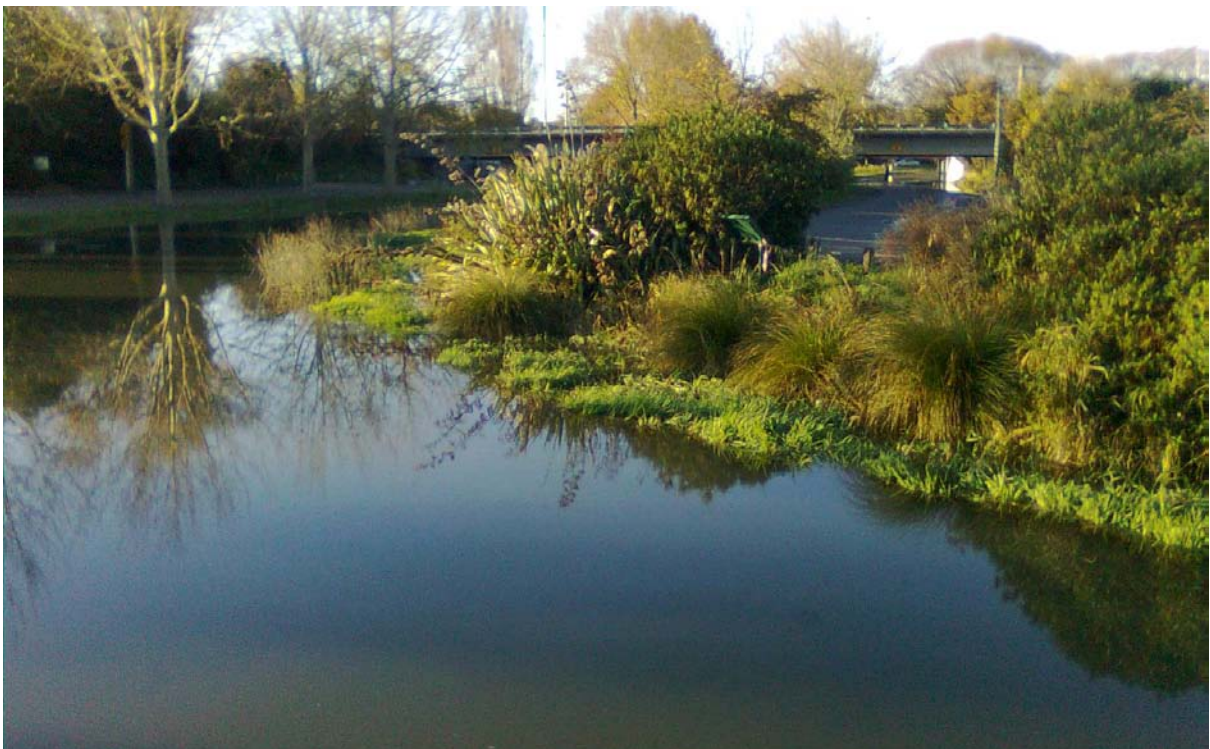
Figure 3b. The Opawa inaka spawning site at high spring tide (15/5/11; 4:00 pm). The raft of canary reed grass tends to float over the water surface.

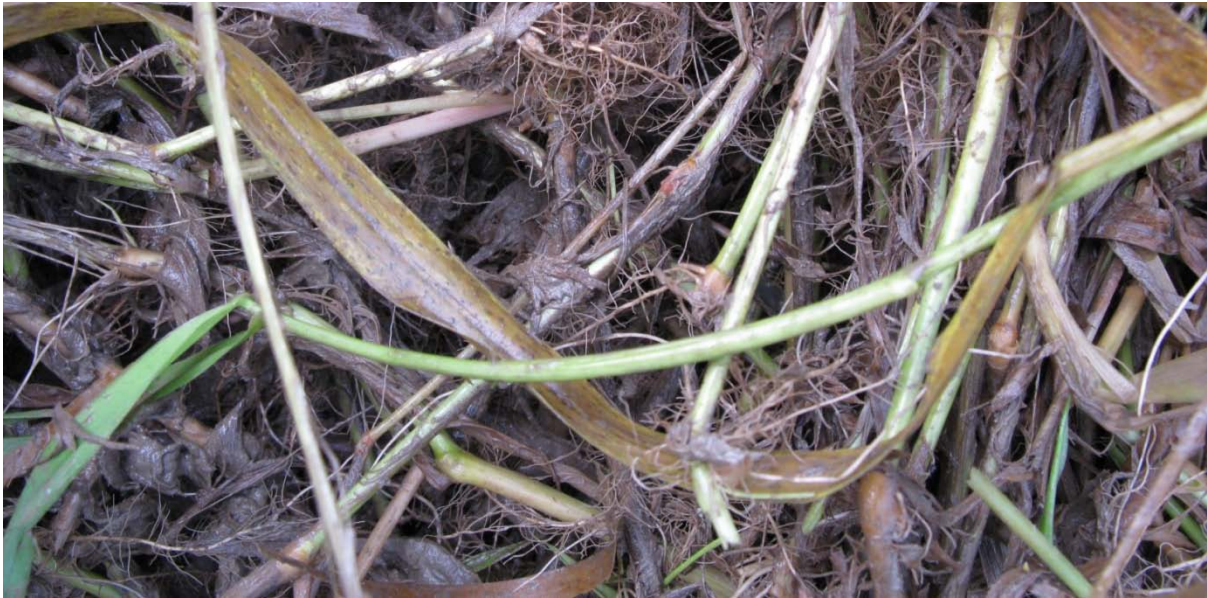
Figure 4. The silty microhabitat at the former Opawa inaka spawning site (28/4/11).

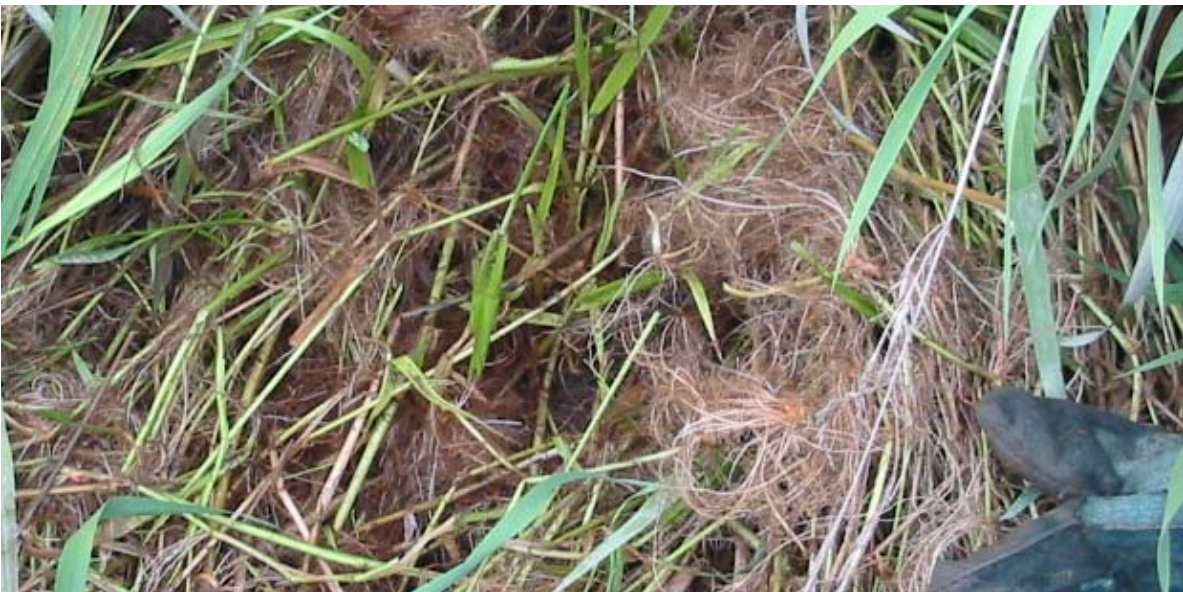
Figure 5. Cleaner microhabitat in 2004, when the site was well utilised (19/04/04).

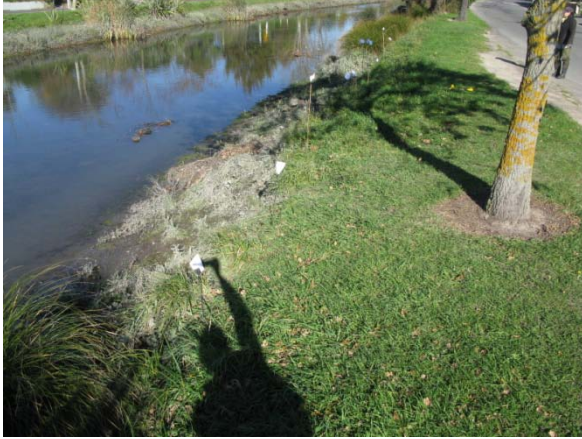
The inaka spawning microhabitat, and the intertidal zone generally, was markedly more silty in 2012 (Figs. 6b, 6c), than in the previous year (Figs. 7a, b).

Figure 6a. The silty intertidal zone on the lower Heathcote river (28/4/11). The tidal limit was over the bank toe here.

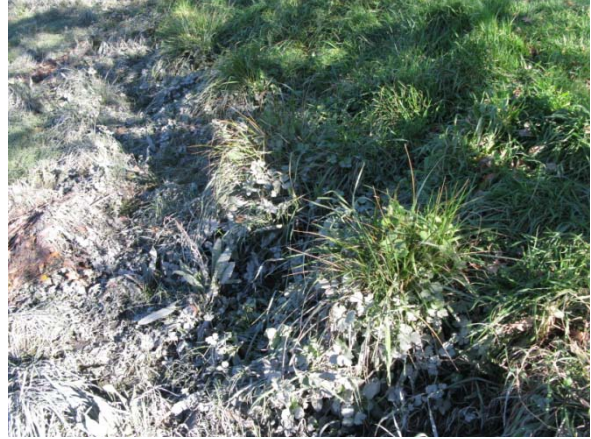
Figure 6b. The thick silt covering the intertidal zone at the Woolston Park site.

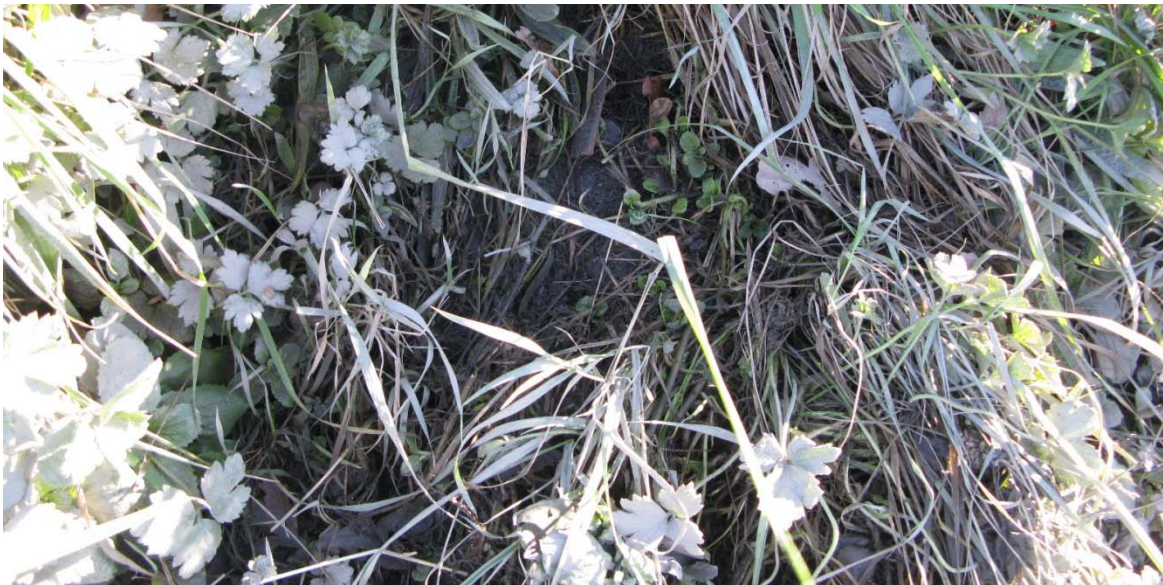
Figure 5c. Silt covered foliage at the Woolston Park inaka spawning site (28/4/11)

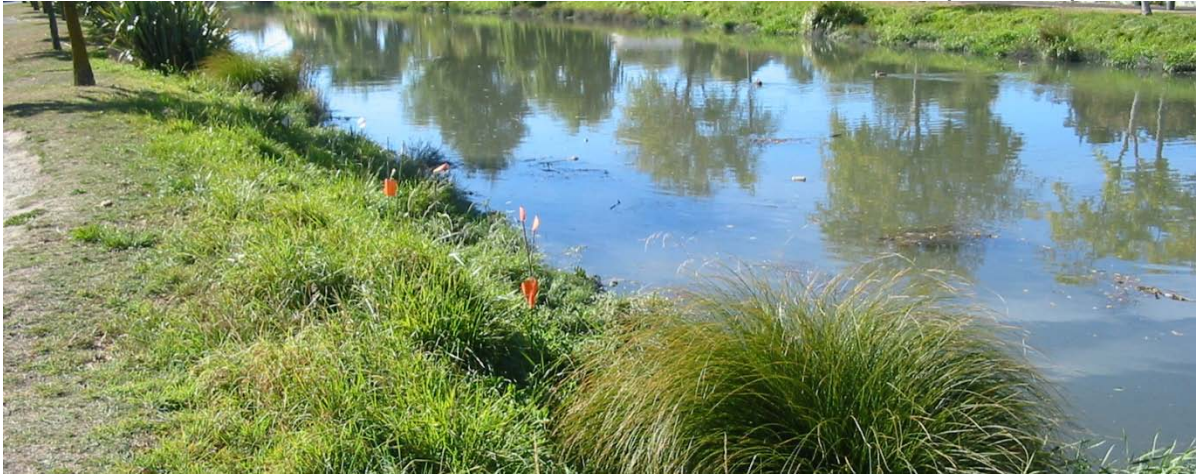
PRE EARTHQUAKE – WOOLSTON PARK INAKA SPAWING SITE (23/4/2010)

Figure 7a. Clean intertidal zone in 2010. Flags indicate inaka egg masses in longer grass well below the bank toe.

This site is 960 m downstream of the former inaka spawning site at Opawa Bridge, and is a short 12 m reach. The habitat is not (yet) dominated by reed canary grass. Inaka eggs were positively identified from this site in April 2010, but during our recent visit (28/4/11) no inaka eggs were found at this small site. The current vegetation is composed of monkey musk, a soft herb, and twitch grass, both of which provide suitable microhabitats for inaka egg development. Comparing photographs from last year, it would appear the bank has slumped at this location, and the spring tide level encroached over the toe in 2012, and onto the mown esplanade strip (Fig. 6a). That was not the case in 2011, when the spring tides were well down the bank, and inaka eggs distributed below the bank toe in longer grass (Fig. 7a).

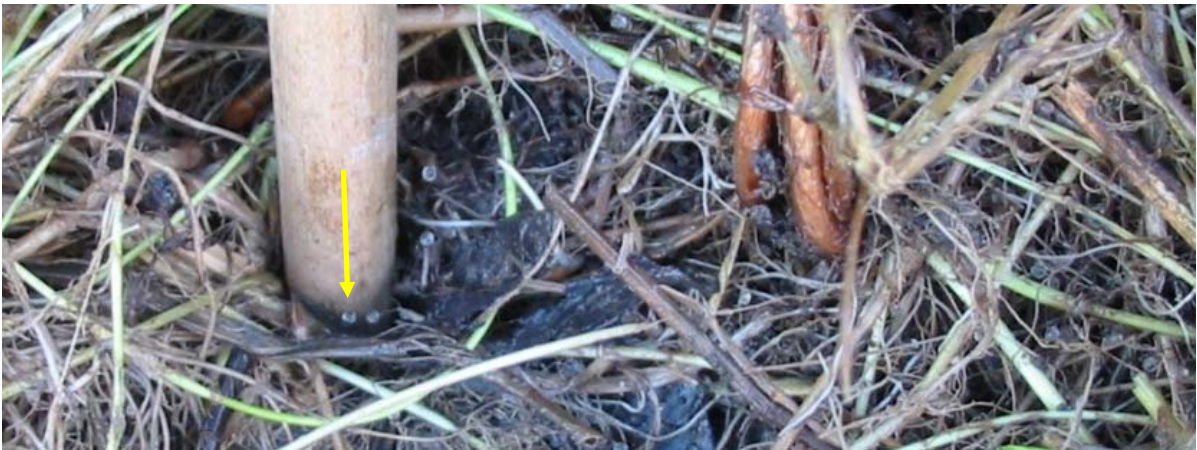
Figure 7b. Inaka egg mass amongst clean root hair mat at Woolston Park site in 2010. One of the many eggs present is arrowed.

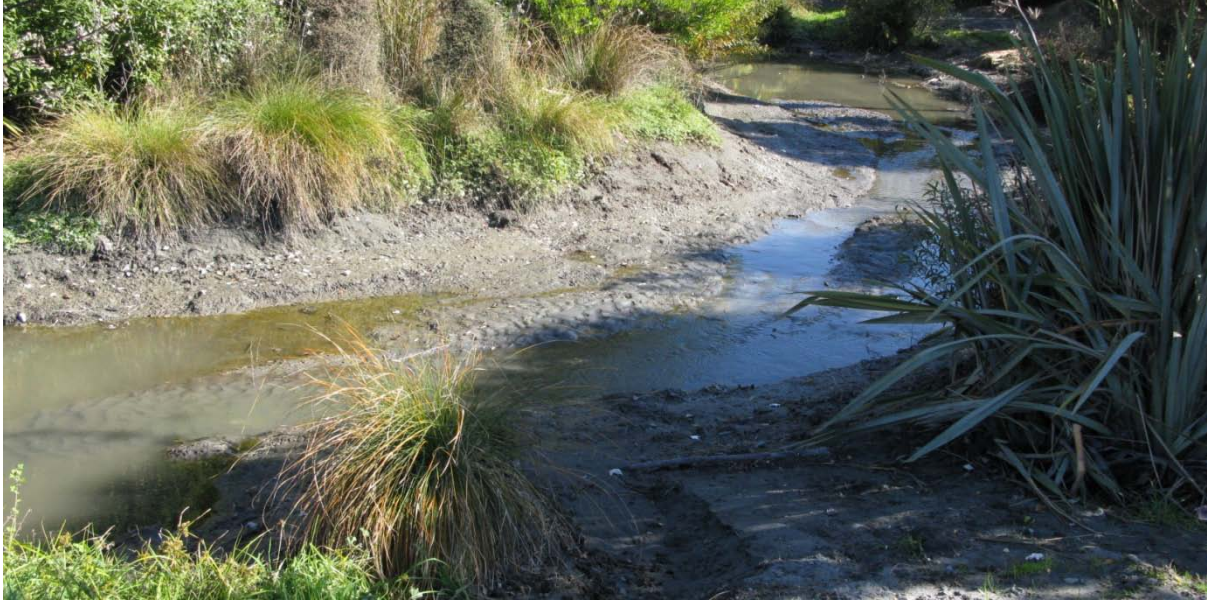
No inaka eggs were found at the Steamwharf Stream inaka site, and the banks appeared to have slumped, and in places collapsed (Figs. 8 a, b). A thin distribution of eggs were found in March 2004 amongst a community of introduced and native vegetation, but no inaka eggs were found during the most recent check in April 2007 (Fig. 8c). The condition of the habitat when many eggs were found, are presented in Figs. 9a-c.

Figure 8a. The bed of Steamwharf Stream appeared silted more than normal, and the banks appeared slumped. Looking upstream from Dyers Road. Flags indicate 9 spot egg searches.

6. Dredge the Steamwharf Stream channel to a greater depth, and consolidate the slumped banks. This will provide habitat conditions more suitable for inaka rearing.

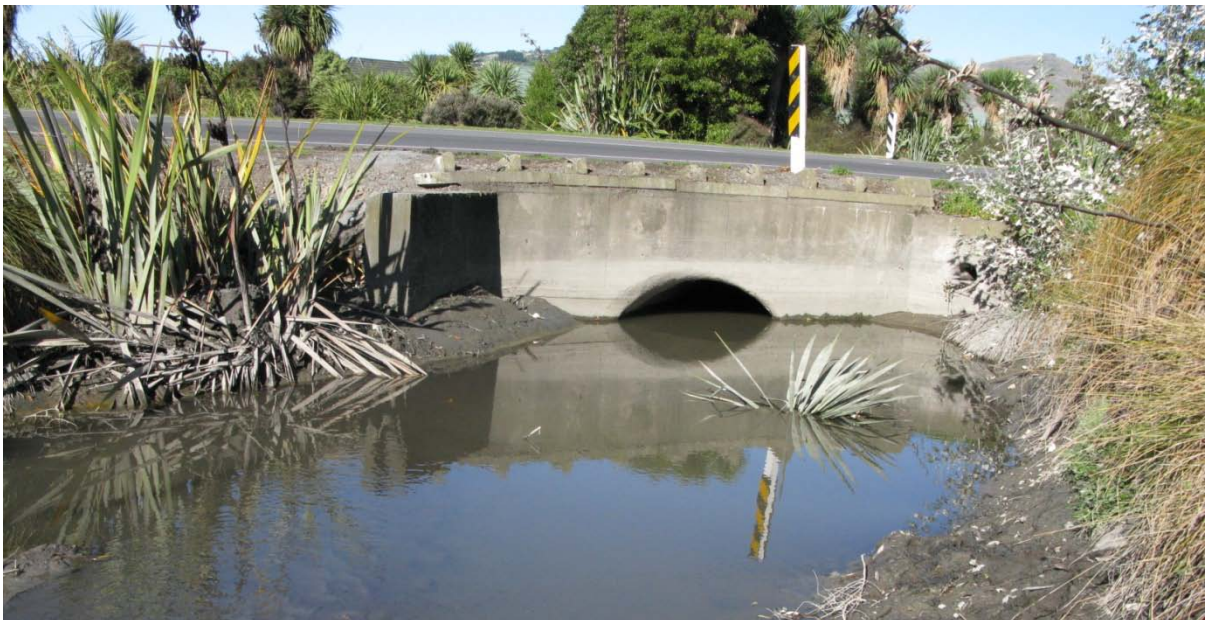
Figure 8b. Steamwharf Stream, looking downstream at Dyers Road. The disruption to the bed is evident here with flaxes on the banks slumped and collapsed into the channel.

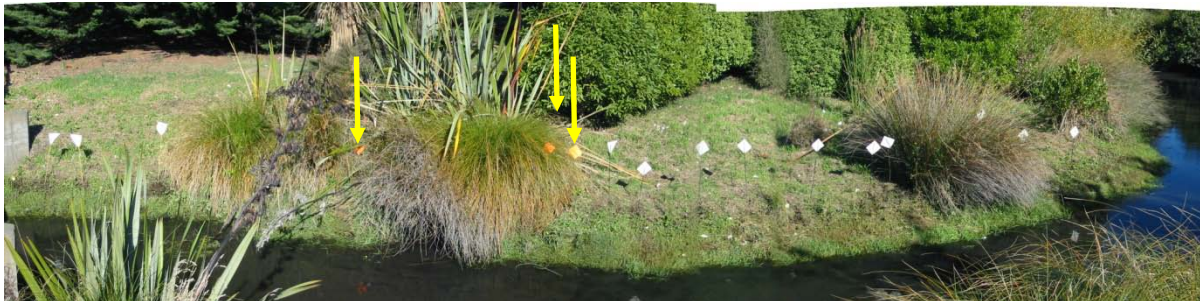
PRE-EARTHQUAKE CONDITION OF STEAMWHARF STREAM

Figure 9a. Inaka egg masses at the downstream limit of their distribution in 2004.

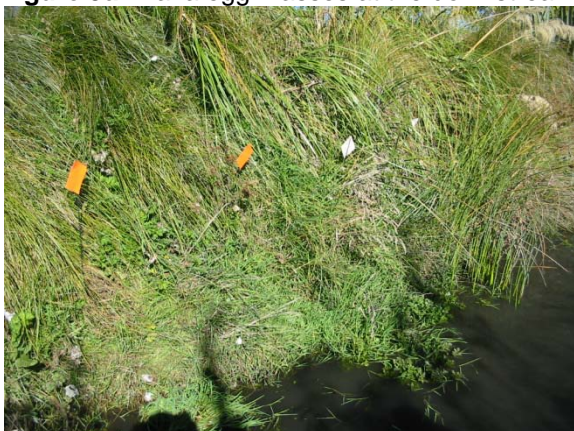
Figure 9b. Close-up of the inaka spawning environment in March 2004.

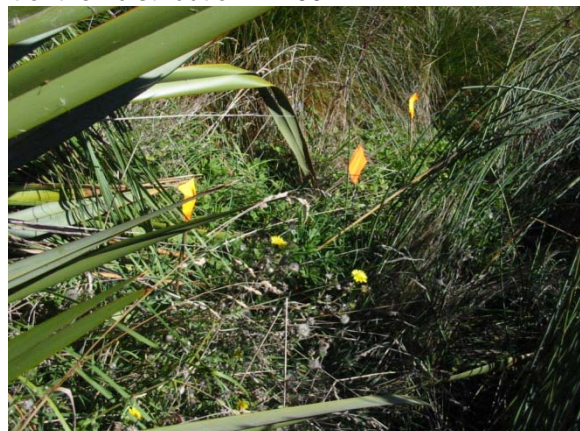
Figure 9c. Three egg deposits amongst creeping buttercup, tall fescue, and dandelion, bordered by water-emergent *Juncus pallidus*, and flax and tall fescue (March 2004).

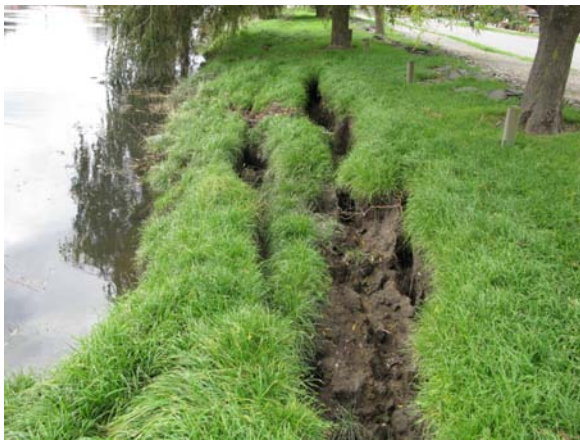
The Avondale inaka spawning site possessed many deep cracks parallel to the banks, an artefact of the seismically-related phenomenon called lateral spread, with a particularly severe example illustrated below (Fig. 11a). Such regions could be stabilised by re-grading the slope to a shallower angle, and re-sown in grass. It was also clear from the road edge that the bank had probably buckled significantly in a vertical plane, although that was not obvious from our cursory field survey away from the roadside. In most locations along the reach, there is sufficient elevation in the managed habitat to accommodate some bank slump. Over a short distance, where eggs have been located during previous surveys, we identified two egg nests, one from a relatively clean microhabitat (Figs. 11b, 11c), and the other from a more silted environment (Figs. 12a, b). The silted eggs and microhabitat were down slope of the deep ground cracks, and the roadside. Both road runoff and silt boils were potential sources of liquefaction silt. All eggs, including those covered in silt had clear yolks, and had “eyed”, a developmental stage. There was no indication of fungal infection which can occur with physical disruption.

Figure 11a. The deep cracks formed by a bank section suffering particularly severe lateral spread at the Avondale site.

However, generally the Avondale inaka spawning site appeared to be satisfactory condition, and the vegetation and physical habitat looks suitable for inaka spawning. Should road or footpath reconstruction be necessary, then the precaution of a riparian fence should be installed between the habitat and the construction zone.

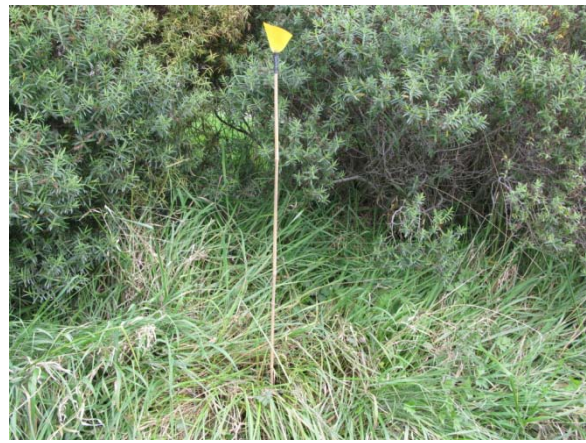
Figure 11b. A 'clean' inaka spawning habitat, with tall fescue grasses, with *Hebe* shrubs further upslope. The microhabitat photo is provided in Fig. 9c.

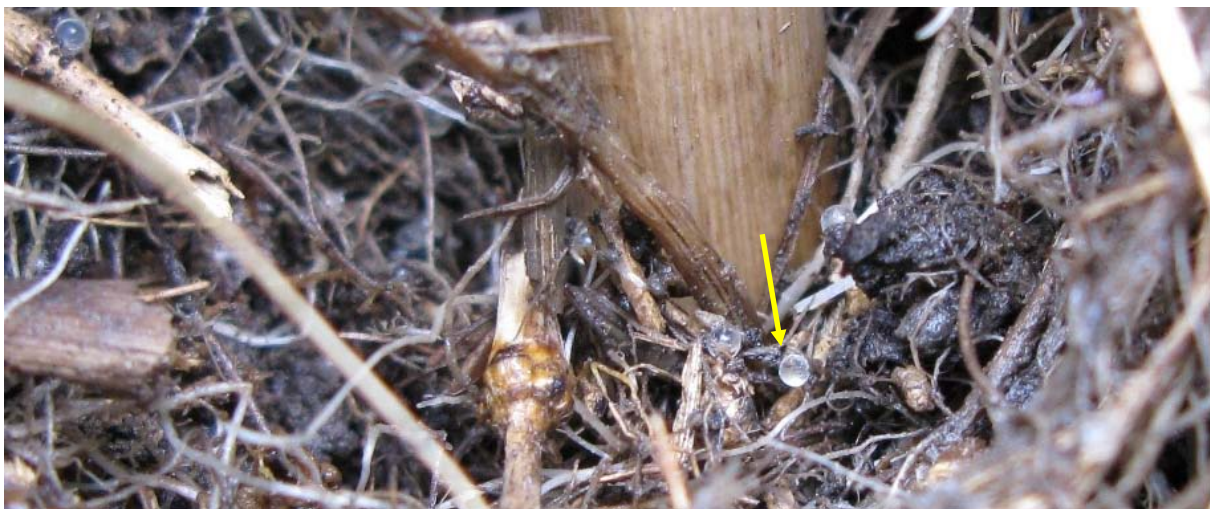
Figure 11c. Inaka eggs from the clean Avondale microhabitat (*in situ*). One of the many eggs is arrowed. Egg diameter is c. 1 mm life size.

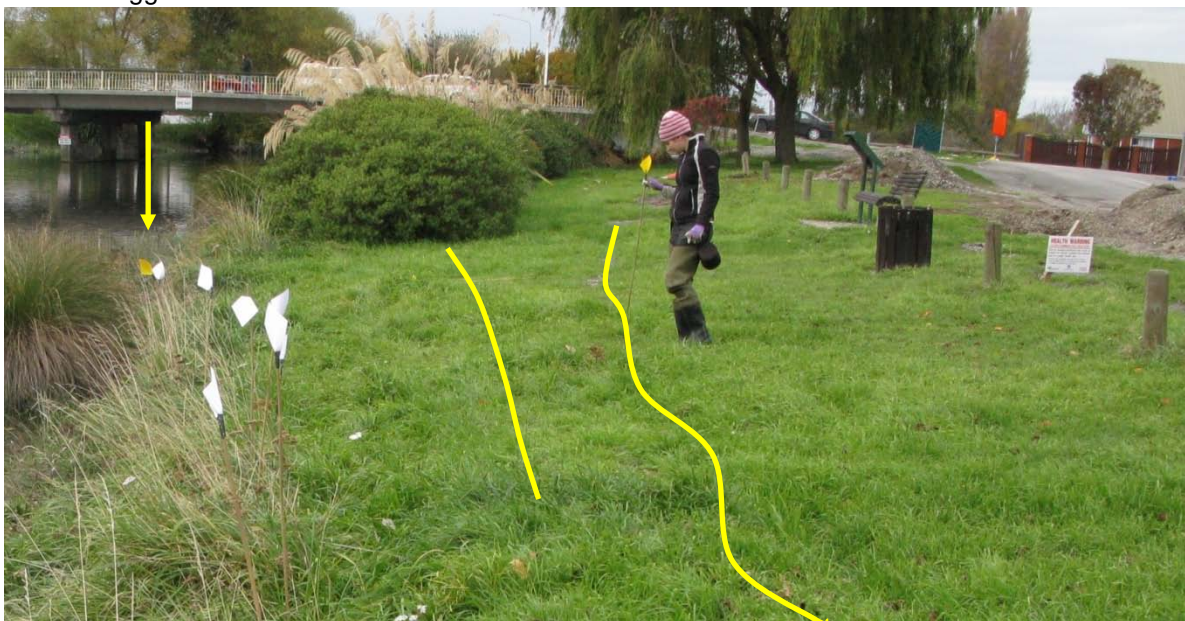
Figure 12a. The yellow flag (arrowed) indicates the habitat of a silty inaka nest, with upslope ground cracks indicated in yellow, obscured by the grass. These were mapped separately, using the marker sticks and were about 0.5 m deep.

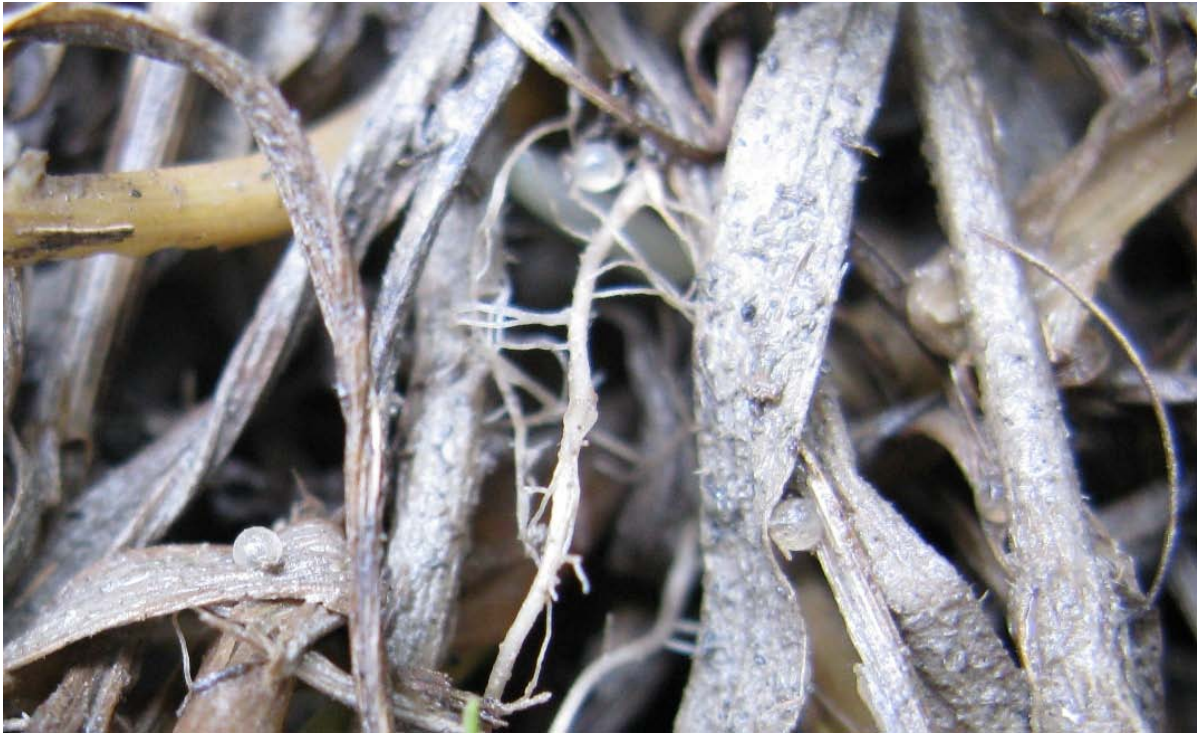
Figure 12b. Inaka eggs (*in situ*) from a silted Avondale microhabitat. Egg diameter is 1 mm. These eggs are viable.

The typical inaka spawning microhabitat is often relatively free of conspicuous silt on surrounding foliage, and the discovery of habitats with silt-covered eggs are rare. The observation of silt-covered eggs at the Avondale site is therefore an unusual event. Inaka eggs have an adhesive outer surface (Benzie 1968a) which become coated in silt particles if suspended silt levels are high. At the levels we observed at Avondale, it would appear that egg development is not jeopardised, but a heavy coating of sediment may suffocate the eggs.

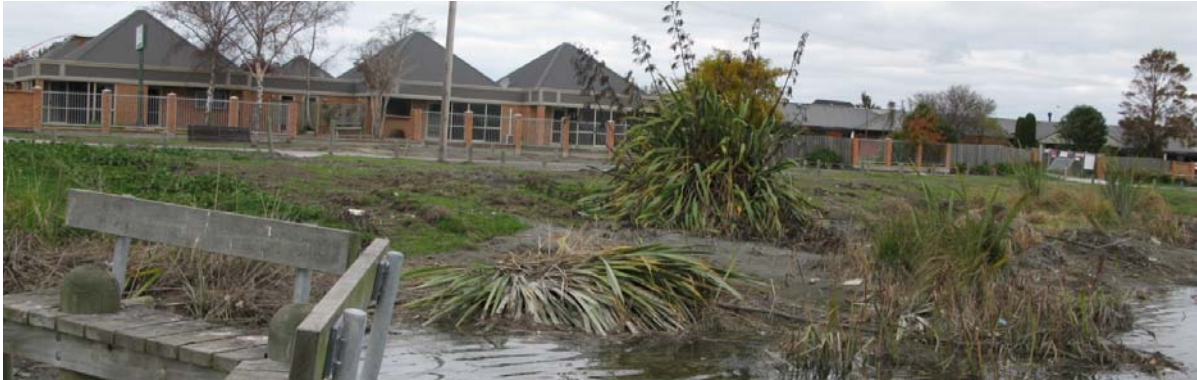
Post-earthquake, no inaka eggs were found from the disrupted habitat, and the locations where inaka eggs were located in 2007 were largely buried in silt (Fig. 14a). Most of the riparian vegetation in 2011 was either not visible, presumably buried in silt, or those that were visible were flattened, or beginning to wilt. By way of comparison, a 2007 photograph of essentially the same vista is provided in Fig. 14b. Scraping back the coarse liquefaction silt revealed the original soil level and root hair matrix which forms the inaka egg microhabitat. The mean depth of the silt was about 10 cm (Fig. 15), but the depth varied spatially, and was up to 30 cm in some areas. Lateral spread and uplift was evident in the periphery around the southern lake edge (Fig. 16).

Figure 14a. The former inaka spawning reach south of the jetty, May 2011.

Many of the remaining flaxes and shrubs appeared to be in ill health probably due to root disruption. The best option may be to re-grade the periphery of this wetland habitat and replace the flaxes, cabbage trees, soft sedges and grasses with new specimens. Regrading and replanting would be an opportune time to remove the yellow-flag iris which was beginning to gain a foothold at this locality.

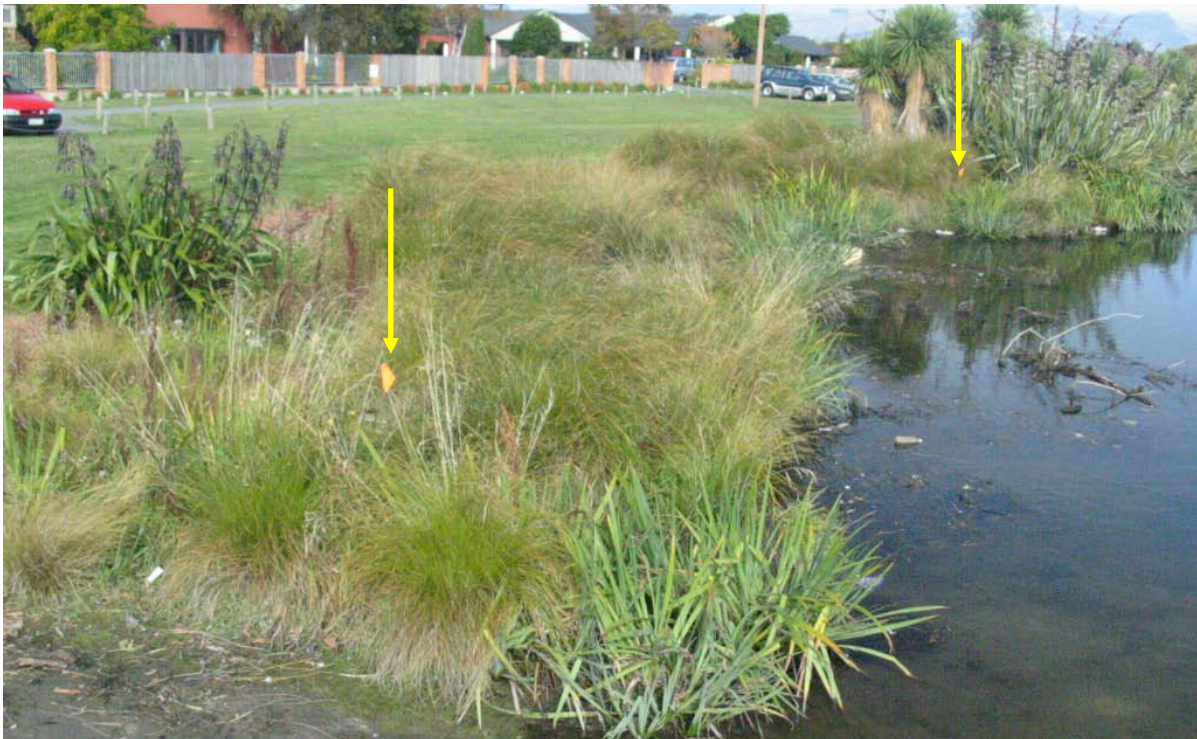
Figure 14b. The inaka spawning ground around the periphery of Lake Kate Sheppard (19 April 2007), egg masses were located below the arrows. This is essentially the same habitat as depicted in Fig. 12a.

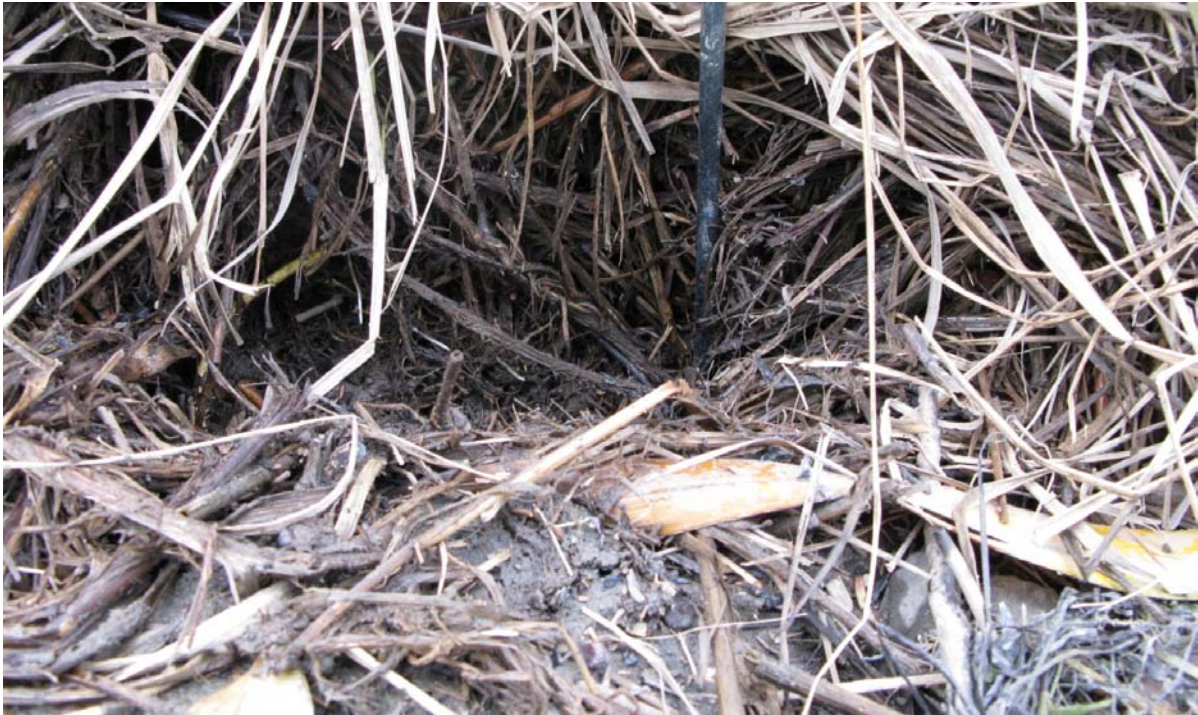
Figure 15. At this location, the original soil level, and grass root hair matrix, has been buried under about 10 cm of liquefaction silt.

Removal of liquefaction silt from the basin of Lake Kate Sheppard is also recommended so that habitat depth is retained for adult inaka that are likely to rear there, or at least congregate in shoals prior to spawning. Draining the pond may be a good option during late summer when groundwater levels are low. The wetland may serve as a breeding habitat for rudd, an illegally introduced pest fish in the Travis Wetland sub-catchment. These can be removed as part of the dewatering process.

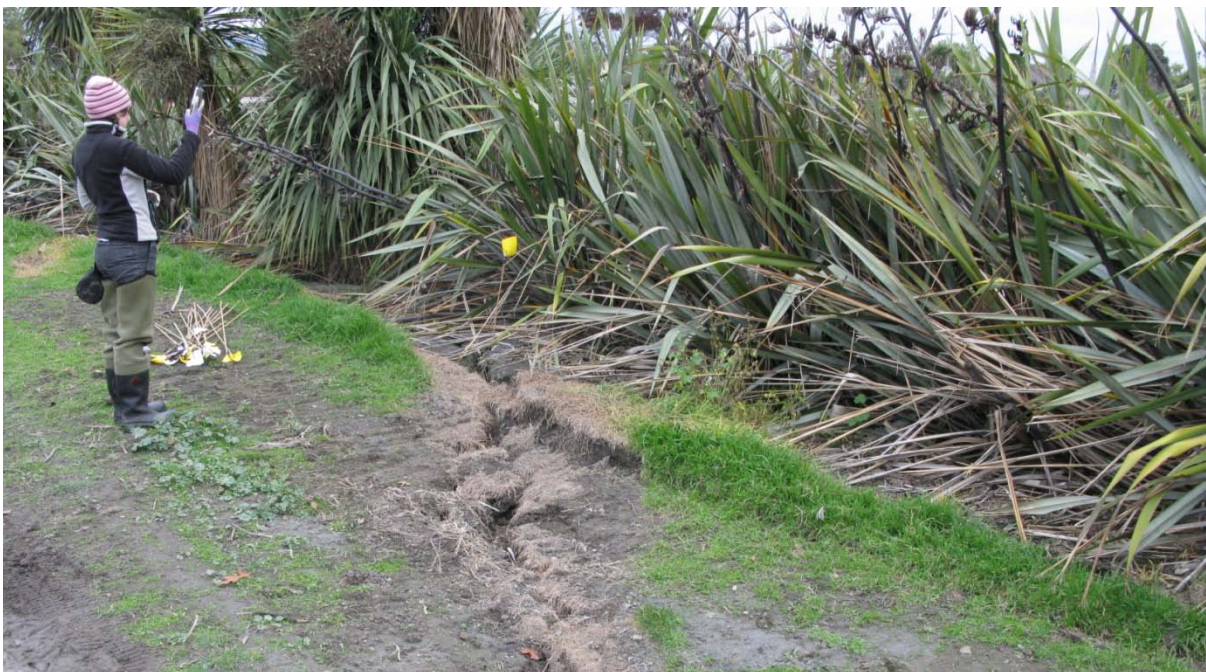
Figure 16. Both lateral spread and uplift on the eastern site of Lake Kate Sheppard. However, the esplanade has also been subject to compaction by heavy-construction vehicles.

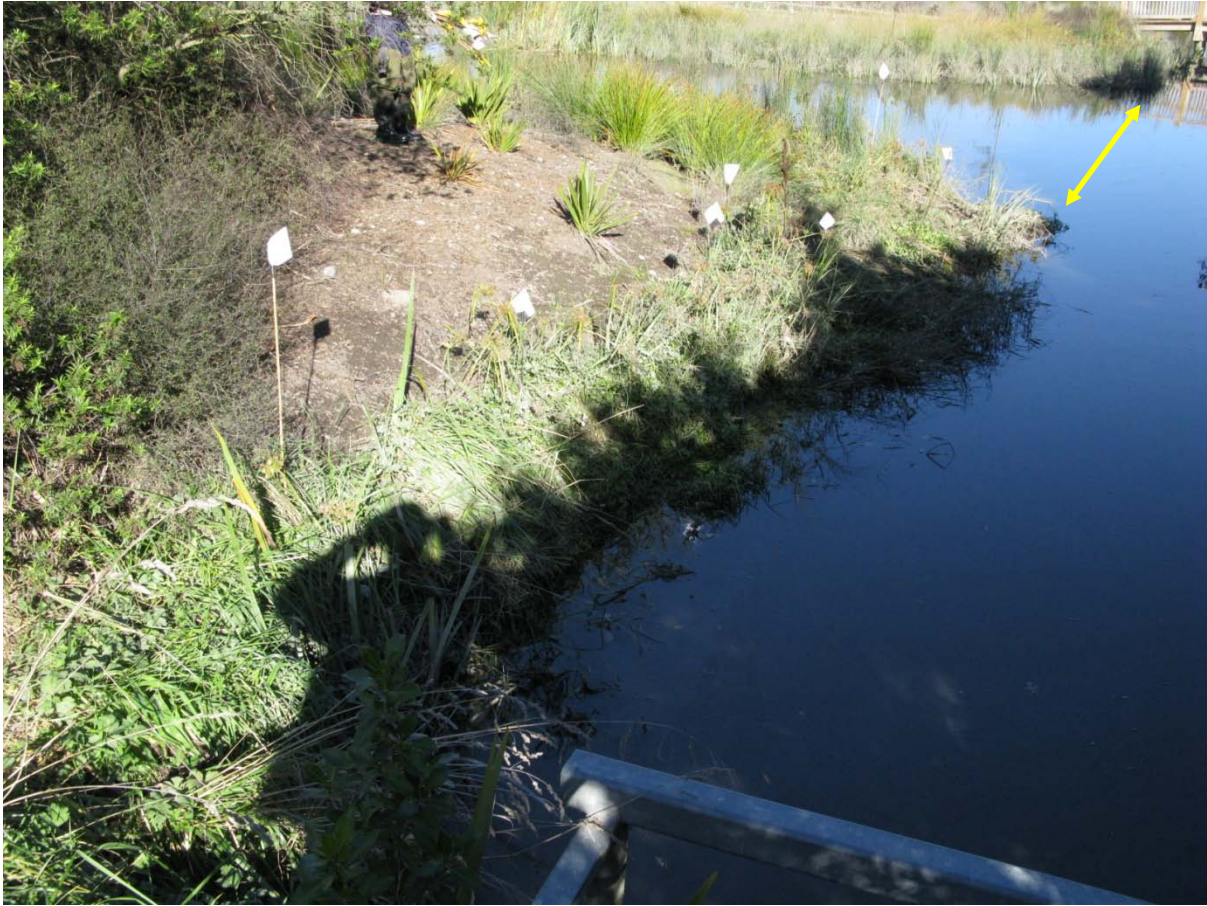
liquefaction silt within the mature bank vegetation was evident here up to a depth of 3 cm, and a conspicuous layer of silt covered the intertidal vegetation. Some of the mature vegetation had been cleared for the recent landscaping, and a significant section of the bank had also been lost to form the new channel mouth (Fig. 17, arrowed).

Figure 17. The remnant of the inaka spawning habitat on Corsers Stream. The recent landscaping for the new section of the habitat has compromised the grassy sward in the short term. The new outlet area has been subject to liquefaction. The double-arrowed section indicates the length of mature spawning habitat lost to form the new mouth.

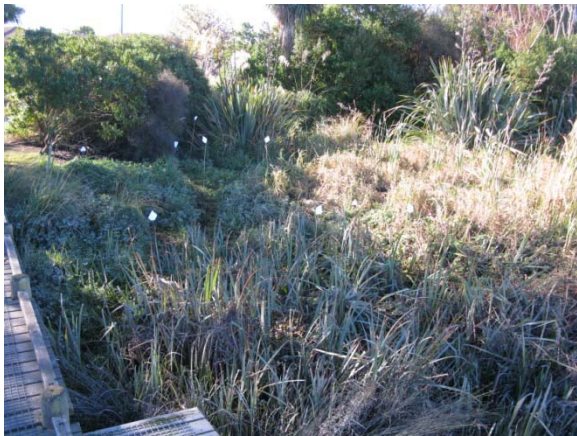
Figure 18. Negative egg searches (white markers) around the Amelia Rogers jetty.

In May 2011, some seismic movement was indicated by deep wide cracks near Avonside Drive, a side effect of lateral spread, and the piles of the jetty were off vertical. Approximately a dozen egg searches through the intertidal zone were undertaken, all negative. Reed canary grass is becoming more prevalent at this site, but not yet at the density as at the Opawa spawning site. At the time of the survey, the reed canary grass stand was browning off, prior to winter (Fig. 18). A low sward of creeping buttercup (*Ranunculus repens*) was also present, which is associated with suitable inaka microhabitat (Fig. 19). Upon inspection, the potential inaka spawning microhabitat appeared clean of liquefaction silt, and numbers of snail eggs were found at this location, indicative of humid conditions (Fig. 20).

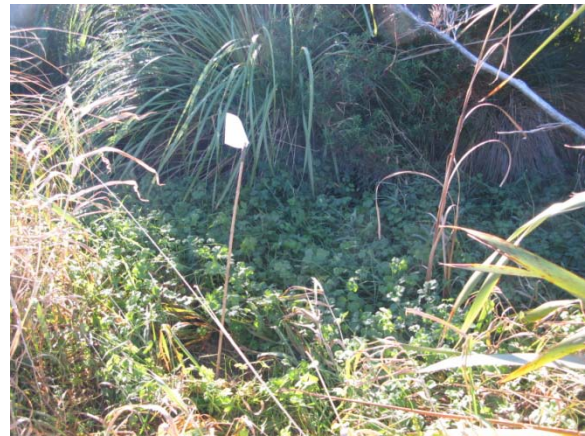
Figure 19. A sward of creeping buttercup around the bases of Carex, and reed canary grass

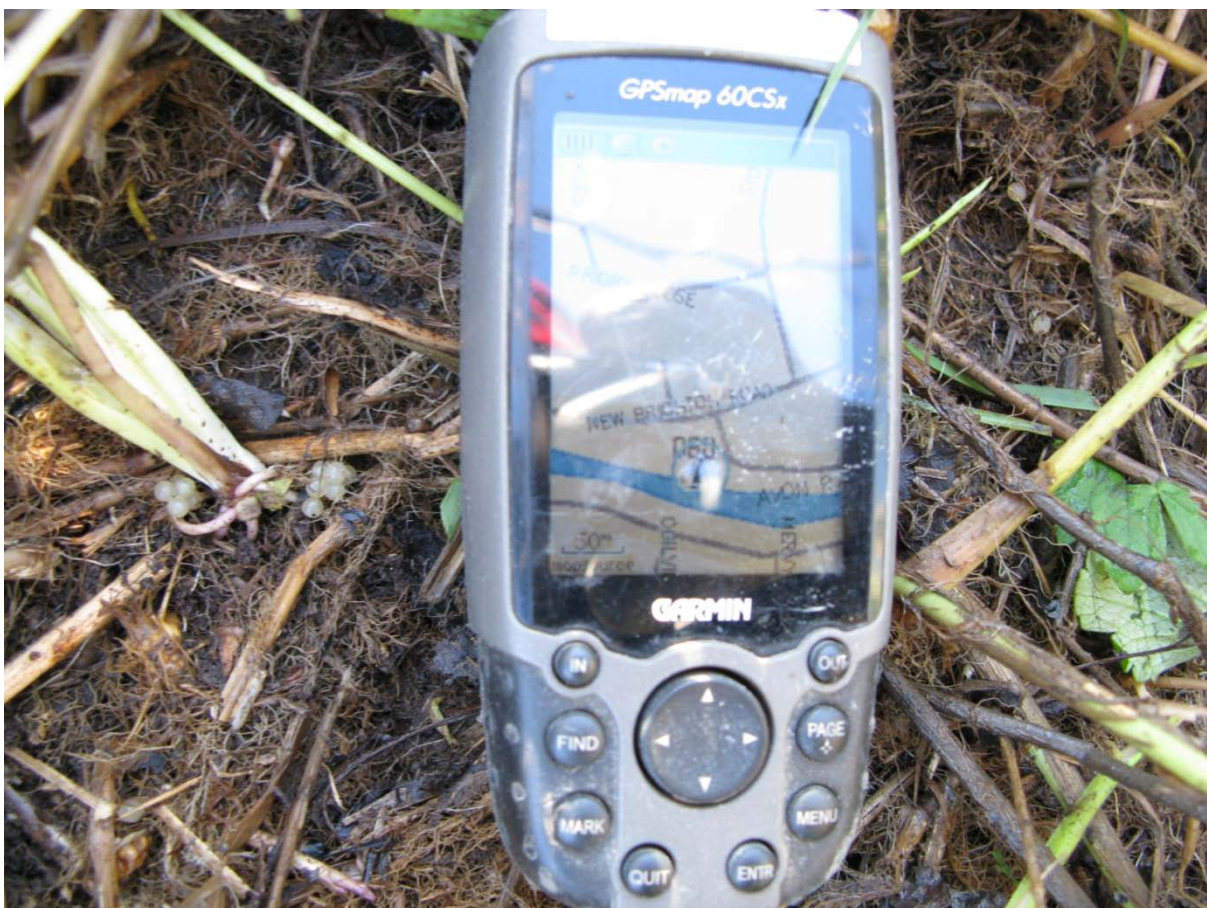
Figure 20. The microhabitat at the Amelia Rogers jetty was clear of silt. Note the deposition of creamy white snail eggs in this photo, which are about 5 mm in diameter, too large to be confused with the 1mm inaka eggs. The GPS receiver is 110 mm high.

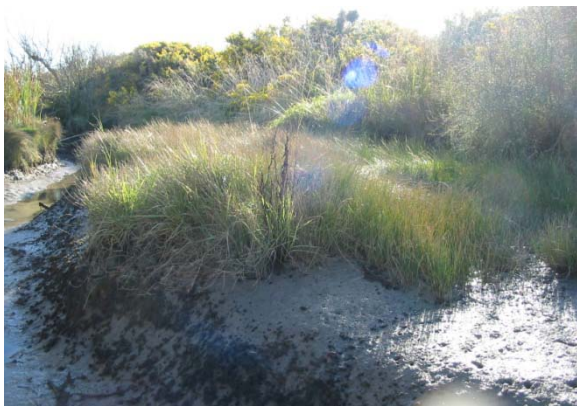
Figure 22. Southern channel, with stands of tall fescue with gorse in the background. The feeding channel was shallow and fast flowing on the low and ebbing tide.

The southern channel, Channel 1, was investigated first. In this branch the riparian vegetation was composed of spike rush (*Eleocharis acuta*), jointed wire rush (*Leptocarpus similus*), and three square (*Schoenoplectus pungens*) common inhabitant of salt marsh, but with the common grass tall fescue well above the low tide level (Fig. 22). Further upstream, the channel appeared to diffuse into a raupo wetland (*Typha orientalis*) (Fig. 23). The draining channel on the low and ebbing tide was narrow (c. 1m), shallow (c 5 cm), and fast flowing. No inaka were observed in this channel.

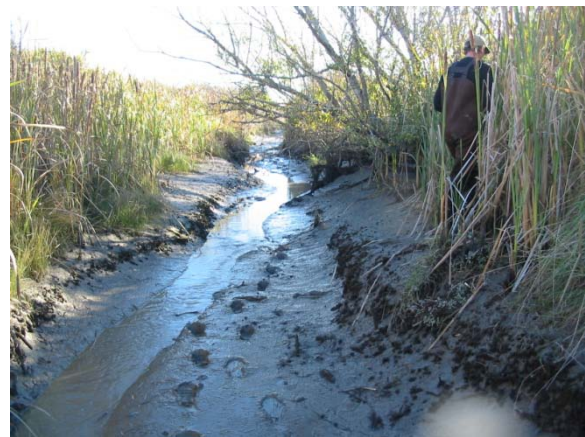
Figure 23. Near the terminus of the southern channel the riparian flora was dominated by raupo.

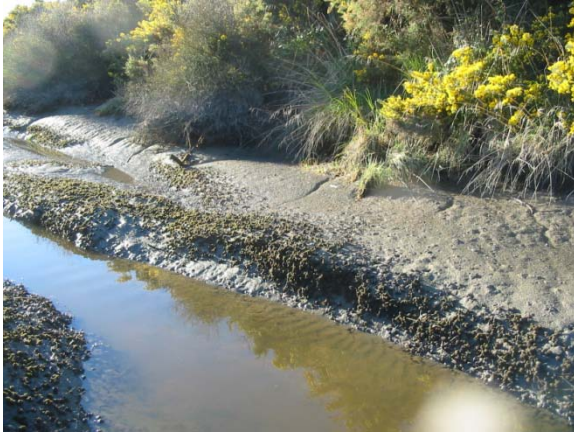
Figure 24. Northern channel with a riparian zone composed of creeping bent and tall fescue.

The northern channel (Channel 2) was more substantial in respect to width and depth variation, and inaka shoals, composed of hundreds of fish, were observed, particularly in the deeper pools. Approaching the northern tip of the channel, the vegetation changed from salt marsh type vegetation to swards of the grass creeping bent (*Agrostis stolonifera*) and tall fescue (*Schedonorus phoenix*) (Figs. 24, 25).

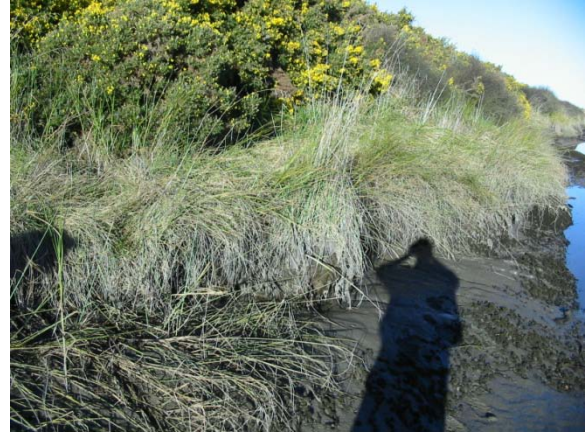
Figure 25. Northern channel, with high terraces composed of dense stands of tall fescue, adjacent to a deep pool with inaka.
