Effects of Seismic Activity on Inaka spawning grounds on City Rivers

AEL Report No. 91

Final Report

June 2011

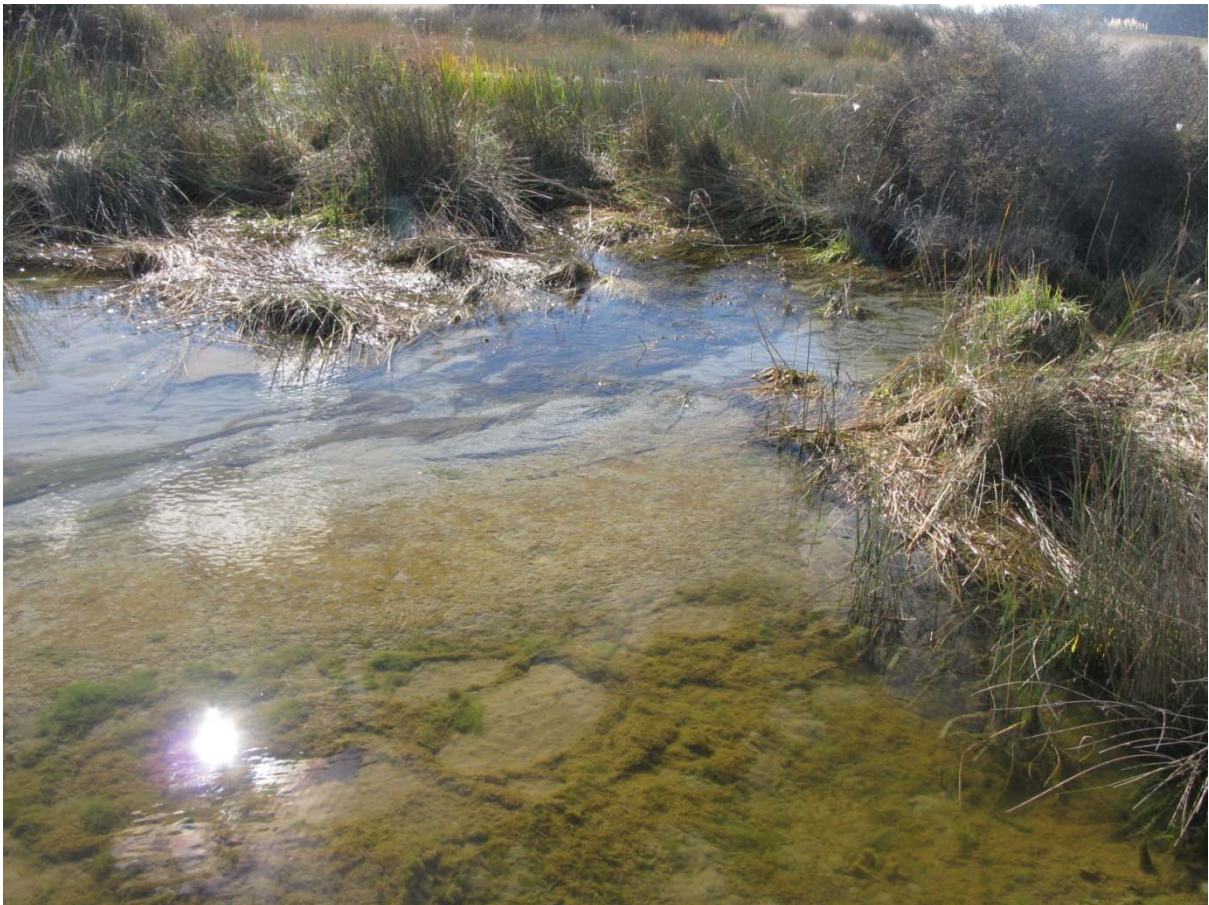
Figure 26. A shallow tidal wetland contained schools of inaka.

A second visit to the northern channel of the lower Styx River was undertaken on a falling high tide after the April springs (i.e. 24/4/11). Of interest was that a large shallow tidal basin (Fig. 24), which included inaka, was discharging into the channel. The conductivity of this water was 6.3 mS/cm, and at 15.8 °C. However, a search around the periphery of the tidal basin failed to locate inaka eggs.

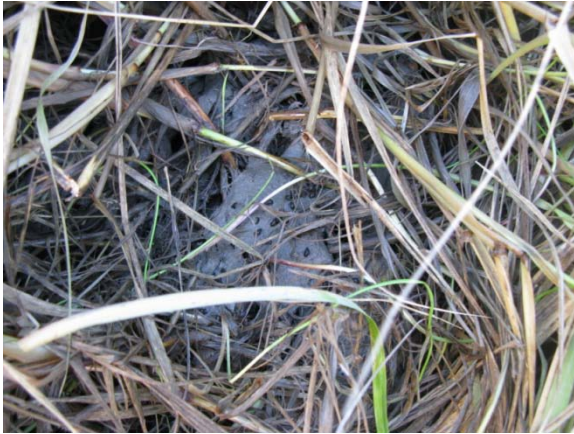
Noted along the channel intertidal zone, was that a layer of silt was suspended several centimetres above the root hair mat, and this layer was supported by the stems of surrounding rushes and grasses (Figs. 27, 28). Around this location, about 125 m downstream of the tidal basin, the conductivity had increased to 8.2 mS/cm, 16.7 °C, and the root-hair complex was unsuitably (for inaka spawning) muddy and wet. It was also noticed that at a location in the main channel, a long (c. 100 m)

Figure 27. The unusual layer of silt suspended above ground level.

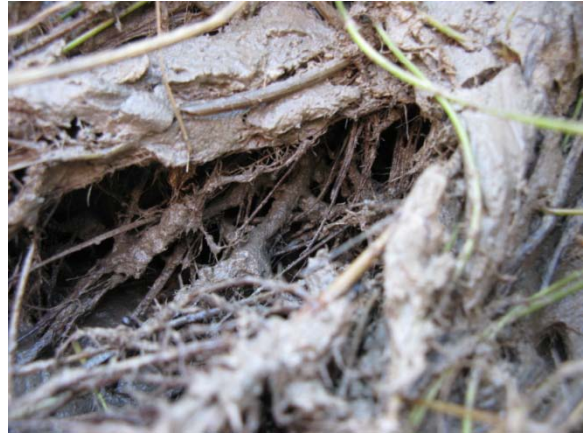
Figure 28. The unusual layer of silt suspended above the root-hair mat.

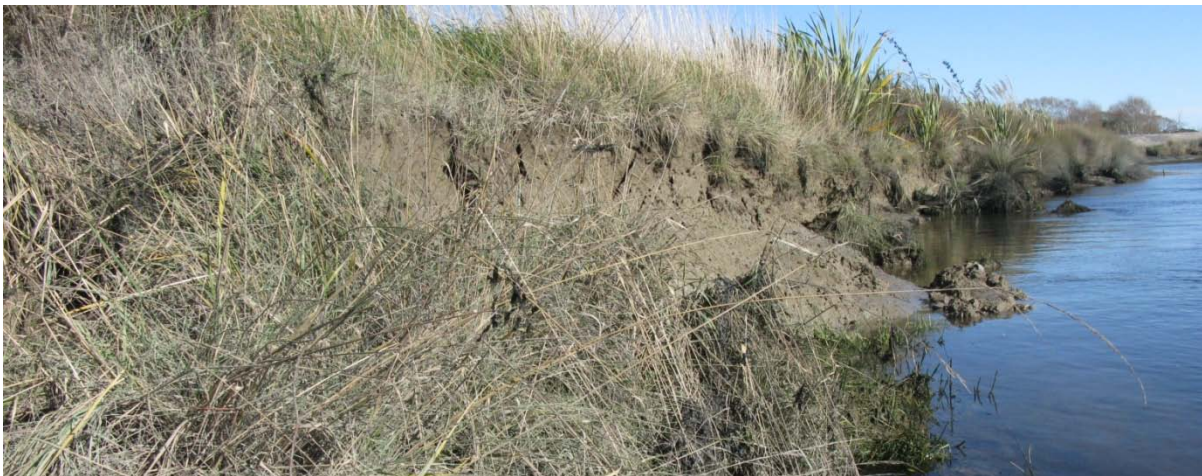
section of the bank has collapsed, and from its jagged-edge appearance, quite recently (Fig. 29). The conductivity here was much lower (1.1 mS/cm, 15.9 °C), and lower again (0.27 mS/cm, 16.4 °C), at the tidegates.

Figure 29. A large section of bank of the lower Styx River appears to have collapsed recently. There is no stock in the area, nor walking tracks.

Further field investigations are recommended to identify the spawning area in the Lower Styx, given that the principal area has been narrowed. This work would best be undertaken next February or March. At this stage any remedial action is not recommended on the Styx until the precise location and state of the inaka spawning grounds are established.

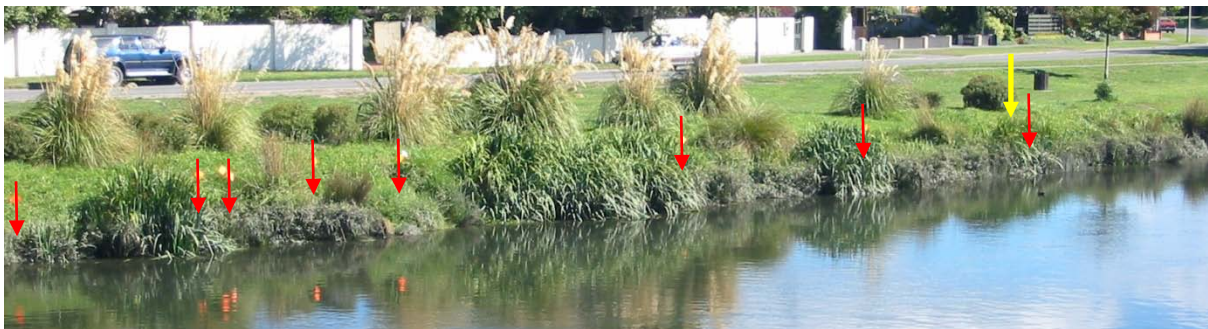
However, displacement of the inaka egg zone higher up the bank into the mowing strip is unlikely to be a problem at the Avondale site because there remains a significant swathe of suitable grass up gradient of the spring tide level. It would appear that the clean viable inaka egg mass we found was higher up the bank compared to the egg distribution from 2004 (Fig. 32). The second egg mass is too difficult to place accurately on the 2004 photo.

Figure 32. The line of inaka eggs deposited in April 2004 (red arrows), vs. the approximate location of where eggs were found in May 2011 (yellow arrow).
