# Christchurch February Earthquake

## EFFECT ON FRESHWATER FISH OF THE UPPER AVON RIVER

EOS Ecology Report No: 11011-CIV01-01 | May 2011  
Prepared for: Environment Canterbury and Christchurch City Council  
Prepared by: EOS Ecology; Alex James and Shelley McMurtrie

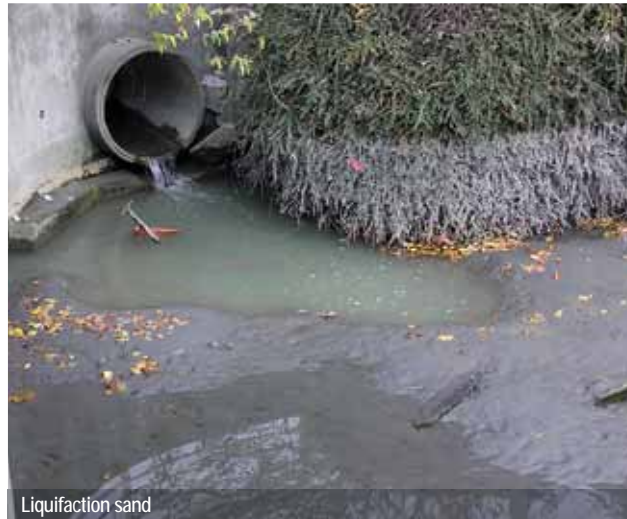
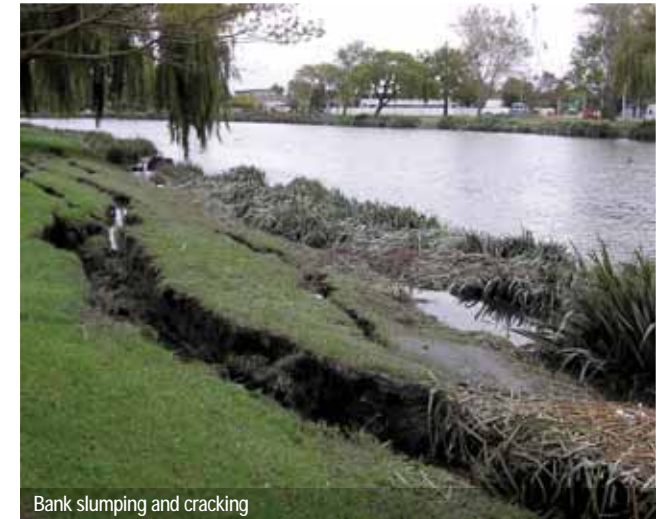
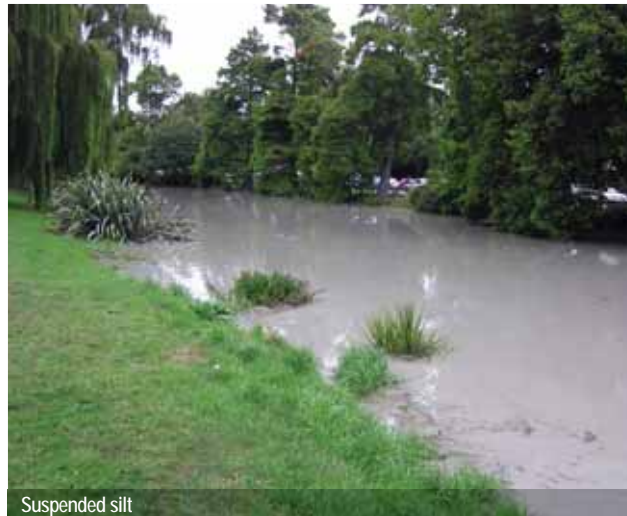
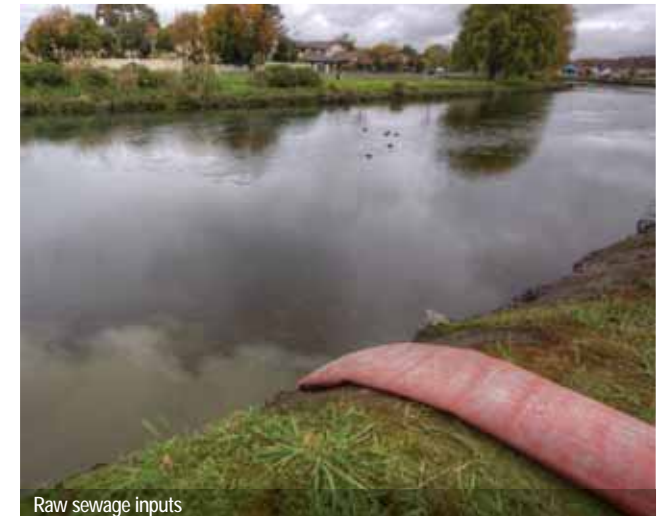
FIGURE 1  
Some of the physical effects of the earthquake on the Avon River that may have affected aquatic life.

The devastation wrought by the 22nd February 2011 earthquake extended to Christchurch's waterways. Large amounts of sediment were released that smothered the aquatic plants and riverbed which is habitat for many aquatic animals (Fig. 1). In places the banks slumped and the riverbed was uplifted altering physical habitat characteristics of the river (e.g., depth, water velocities, and channel width). Numerous broken wastewater pipes discharged untreated sewage to the river (Fig. 1). Such organic material input can result in a spike in oxygen-demanding bacterial activity that can deplete dissolved oxygen levels and in extreme situations kill aquatic life.

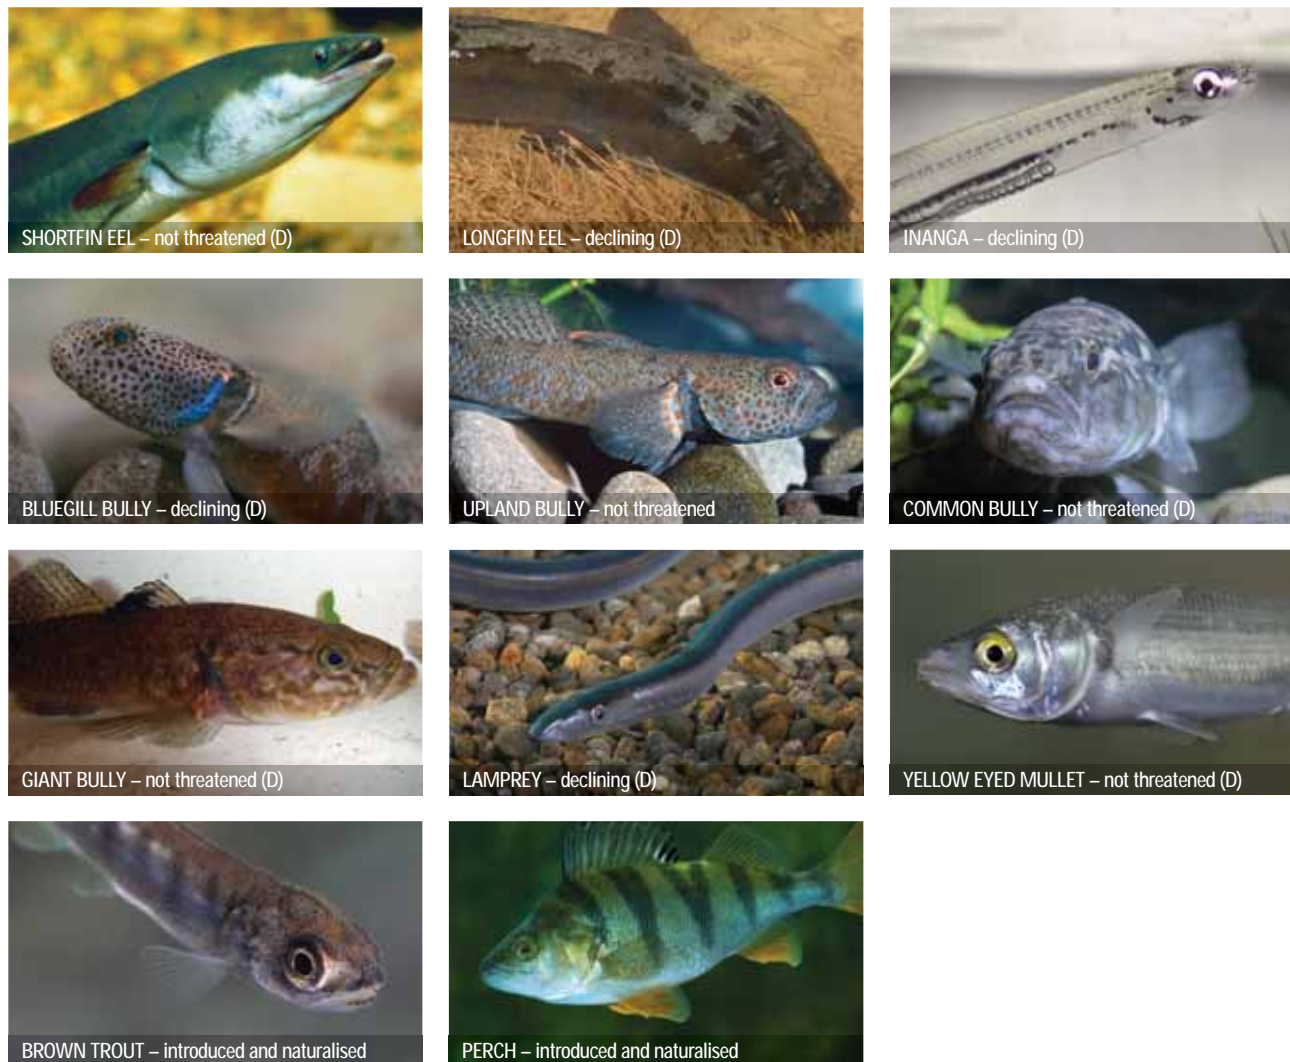
FIGURE 2  
At least 11 freshwater fish species have been recorded from the Avon River upstream of Fitzgerald Ave (derived from New Zealand Freshwater Fish Database and personal observations). Two are introduced with the remaining nine species being native. The threat classifications of Allibone et al. (2010) are given as are the diadromy status of each species (D=diadromous; species migrate between freshwater and the sea at some stage in their lifecycles).

At least 16 freshwater fish species have been recorded from the Avon River catchment with 11 species upstream of the Fitzgerald Ave bridge (Fig. 2). Two are introduced with the remaining nine species being native. The majority of the fish species recorded are diadromous meaning they migrate between fresh and salt water at some stage in their lifecycles. Yellow-eyed mullet is an estuarine species that commonly penetrates far upstream beyond the tidally influenced lower section of the river. Most fish species are rarely seen as they are nocturnal and cryptic and some species are not encountered often even in surveys (e.g., perch, lamprey). The most common fish observed off the City's bridges are brown trout, eels, and inanga. Large schools of yellow-eyed mullet can also be seen if you are in the right place at the right time.

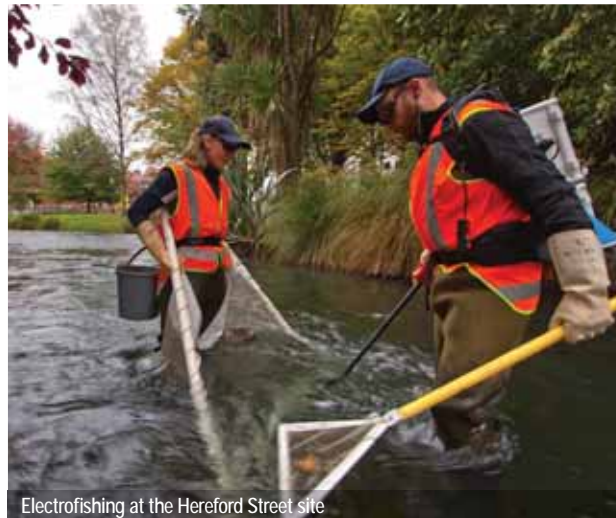
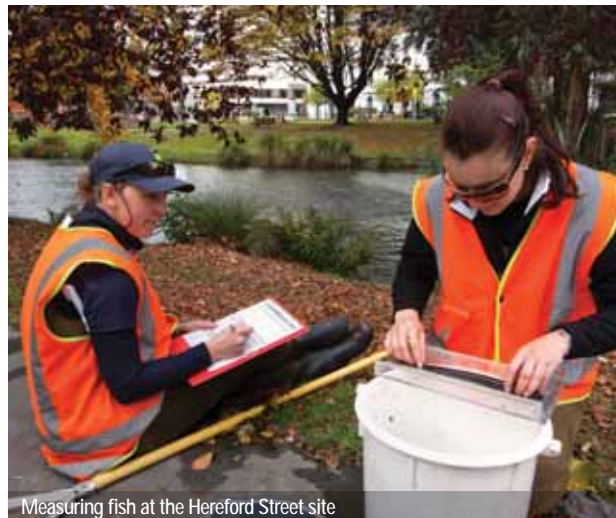
FIGURE 3

Sewage overflow locations (circles) and sites in the Avon River catchment sampled for fish on 19–21 April, 2011 (squares). Sewage overflows from the pumping stations PS2/1, PS3/1, and PS4/1 ceased in mid to late March. The overflow adjacent to Fitzgerald Ave still continues to discharge sewage (as of 21 May, 2011).

EOS Ecology and Aquatic Ecology have fish data from a number of locations in the Avon River catchment collected before the earthquake (i.e., McMurtrie & Taylor, 2003; McMurtrie *et al.*, 2007; McMurtrie, 2009). Six sites were selected, and resampled on the 19–21 April 2011 to enable a pre and post earthquake comparison of fish communities (Fig. 3). Sites were selected along an upstream-downstream gradient from no earthquake effects (Wairarapa Stream & Fendalton Rd), to possible sand/silt inputs (Carlton Mill & Hereford St), to known sewage and sand/silt inputs (Kilmore St & Fitzgerald Ave). Ideally we would have included sites further downstream of Fitzgerald Ave, where there were more sewage and sand/silt inputs. However, the Avon River is too deep for electrofishing downstream of Fitzgerald Ave and as such there is very limited pre-earthquake quantitative fish community data from this section.

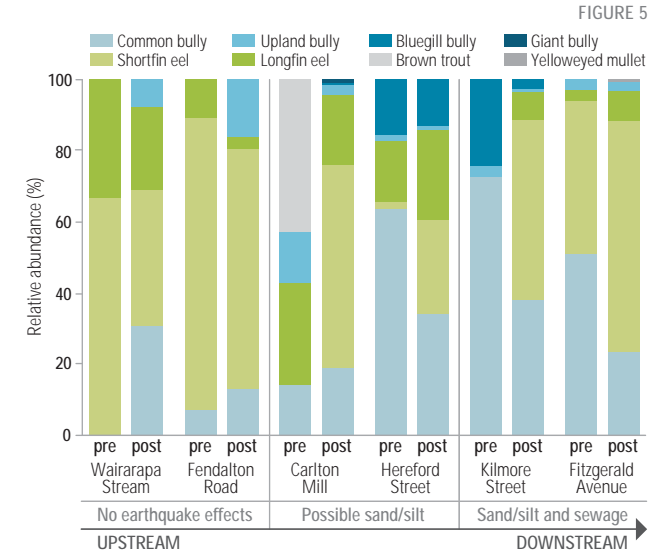
FIGURE 5  
The relative abundance of the eight fish species captured in the Avon River at each site before and after the 22 February 2011 earthquake.

Before the earthquake there was a distinct difference in the relative abundance of fish species along the Avon River with sites upstream of Hagley Park being dominated by shortfin eel and those sites in the CBD dominated by common bully (Fig. 5). After the earthquake there was no such obvious upstream-downstream difference, with all sites having more similar communities. This reflected a general increase in shortfin eel abundance and decrease in common bully abundance at the four downstream (e.g., possibly earthquake affected) sites after the February earthquake.

Bluegill bullies were found at two CBD sites before the earthquake but were found at a third site after the earthquake (Fig. 5). While their abundance at the Hereford St site was similar over time, their abundance dropped at the Kilmore St site following the earthquake. Brown trout were only captured on one occasion before the earthquake (at the Carlton Mill site) but electrofishing often misses fast moving trout so they were likely present at other sites also.

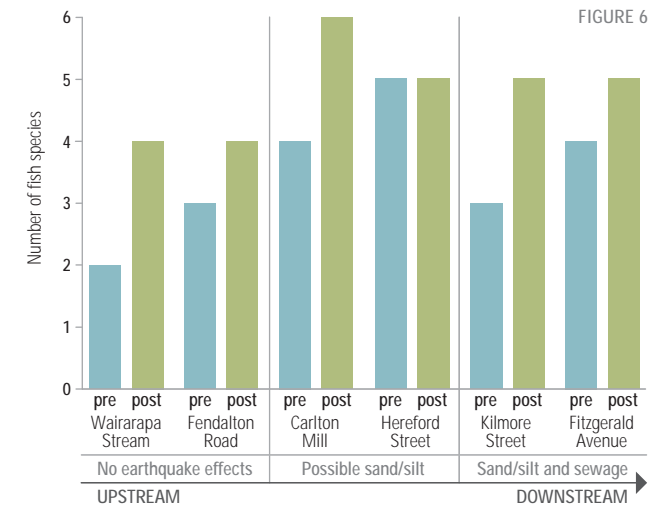
FIGURE 6  
The number of fish species captured at each site along the Avon River before and after the 22 February 2011 earthquake.

The number of fish species captured ranged from two (Wairarapa Stm before the earthquake) to six (Carlton Mill after the earthquake) (Fig. 6). There were either the same numbers or more fish species caught at sites during the post-earthquake surveys (Fig. 6).

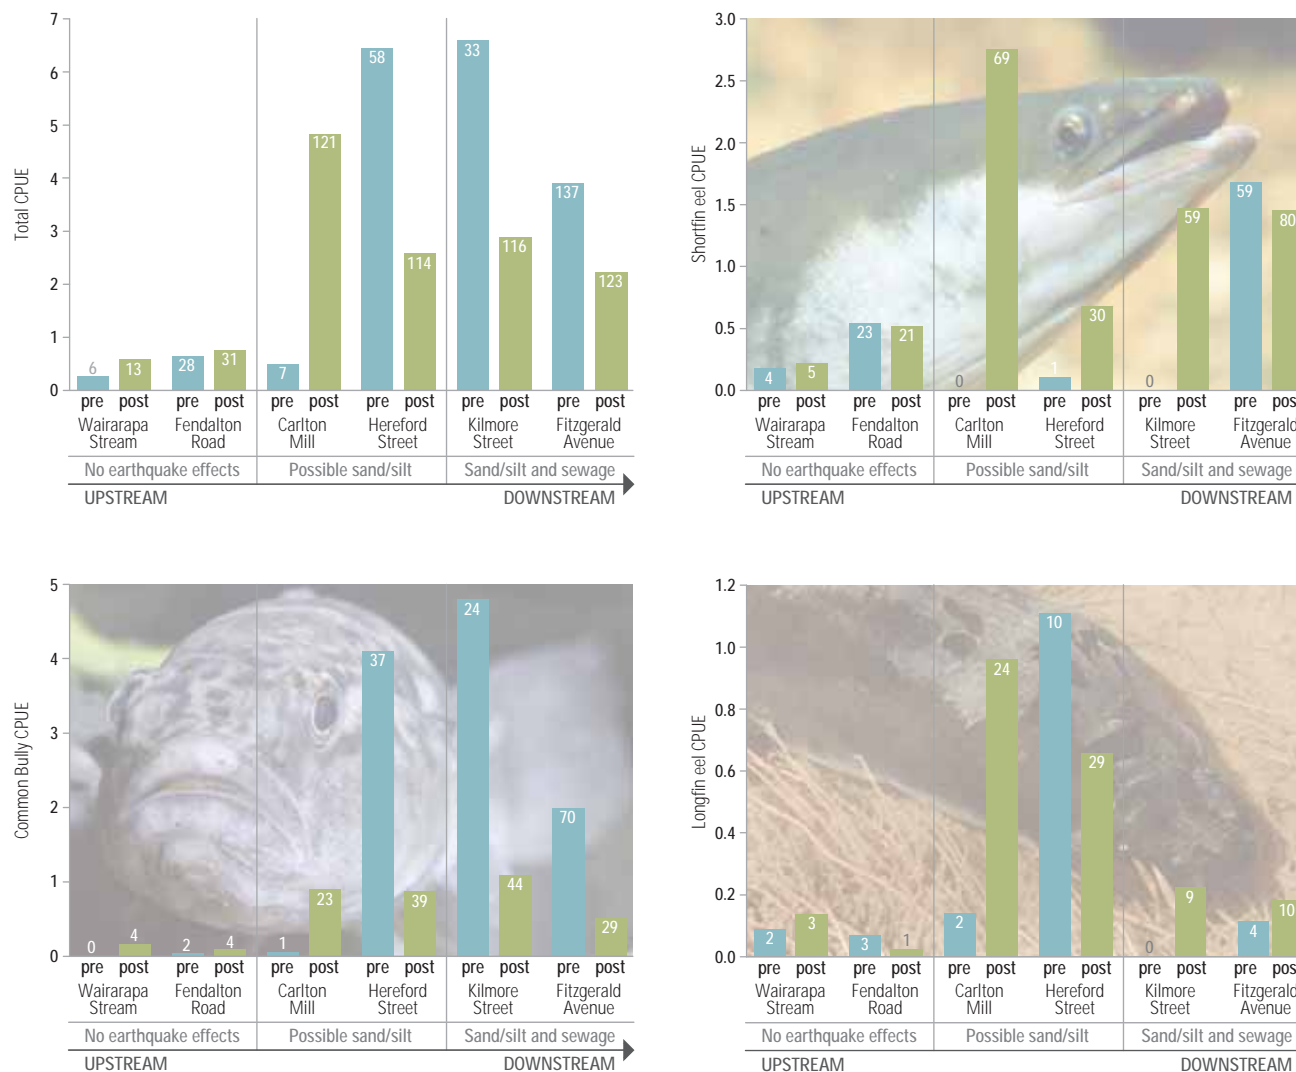
**FIGURE 7**  
The catch per unit effort (CPUE) at sites along the Avon River before and after the 22 February 2011 earthquake for all the fish captured, and the three most common species. A higher CPUE means more fish were caught for the same amount of effort (time).

The total CPUE was lower at the three CBD sites (Hereford St, Kilmore St, and Fitzgerald Ave) after the earthquake (Fig. 7); sites possibly affected by sand/silt or sand/silt and sewage. It was similar before and after the earthquake at the two sites upstream of Hagley Park that were not affected by the earthquake (Wairarapa Stm and Fendalton Rd), and much higher at the Carlton Mill site (possible sand/silt effects) after the earthquake (Fig. 7). At the Hereford St and Kilmore St sites, many more fish were captured post-earthquake, however fewer were being caught per unit effort (time). At the Fitzgerald Ave site a similar number of fish were captured before and after the earthquake but they took more effort (time) to catch in the post-earthquake survey (Fig. 7).

Much of the CPUE pattern seen for the total catch was driven by the CPUE of common bully (the most common species captured at the three CBD sites before the earthquake) and shortfin eel (the most common species captured at the three CBD sites after the earthquake) (Fig. 7). The increased total CPUE post-earthquake at Carlton Mill was most likely because only spot-fishing was done in the pre-earthquake survey (Fig. 7). The CPUE for both eel species tended to be quite variable between sites and sampling occasions (Fig. 7).
