Dunbar, Days & Henderson Waterways

Aquatic Ecology Technical Report
Prepared for Christchurch City Council

21 December 2016

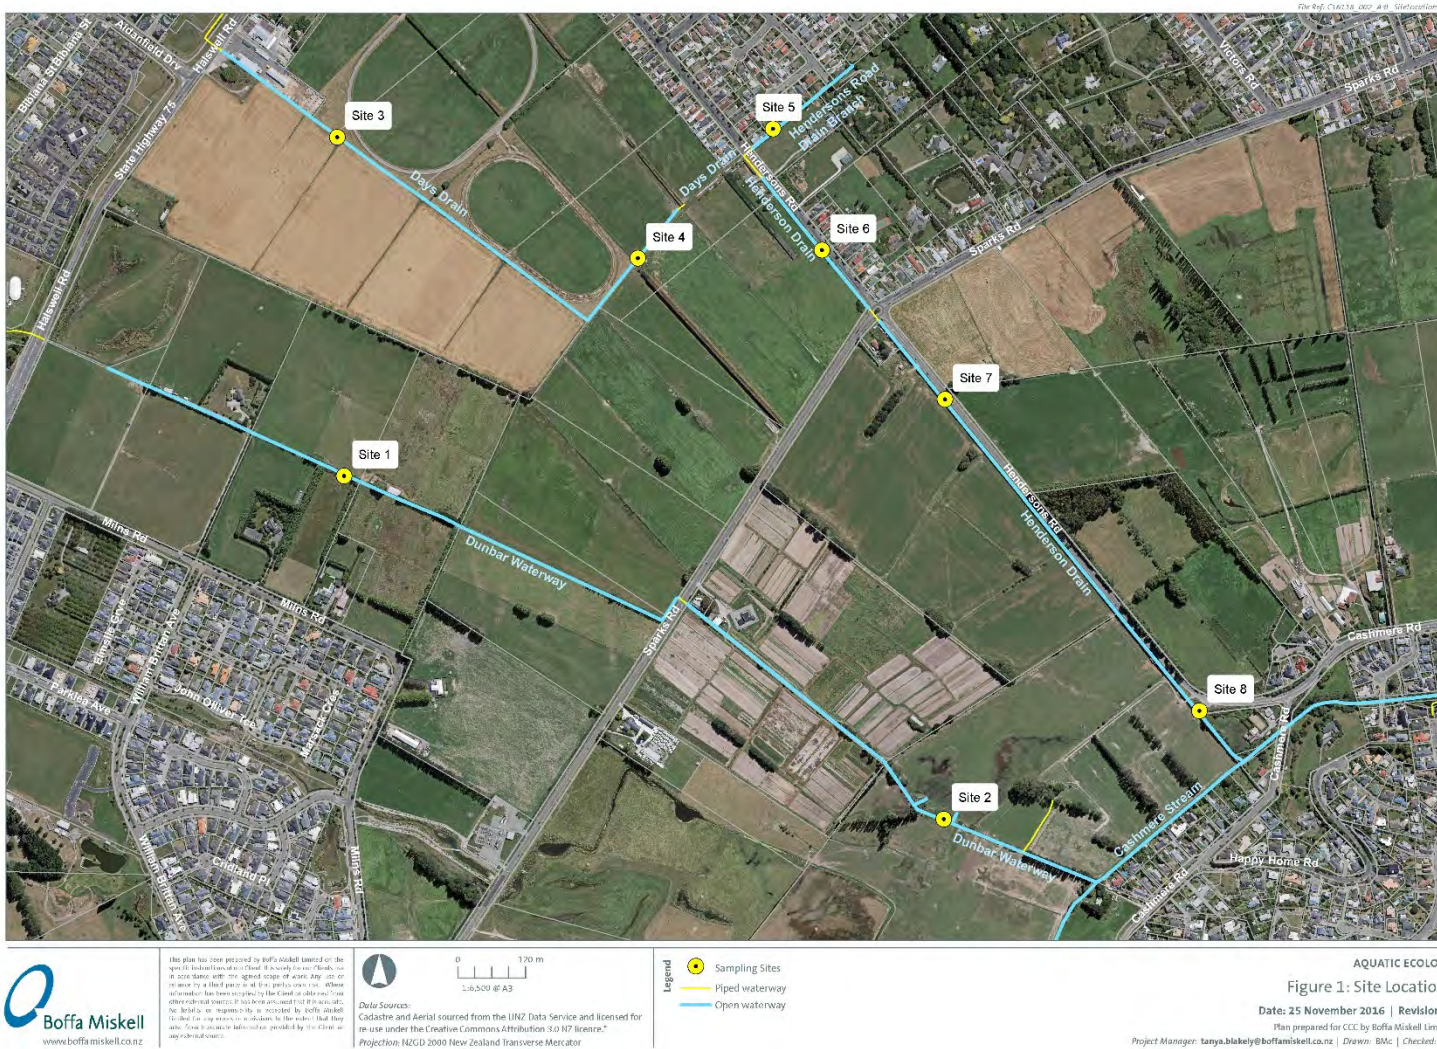
Figure 1. Locations of the eight sites in Dunbar, Days, Hendersons Road Branch, and Henderson Waterways, surveyed in October and November 2016.

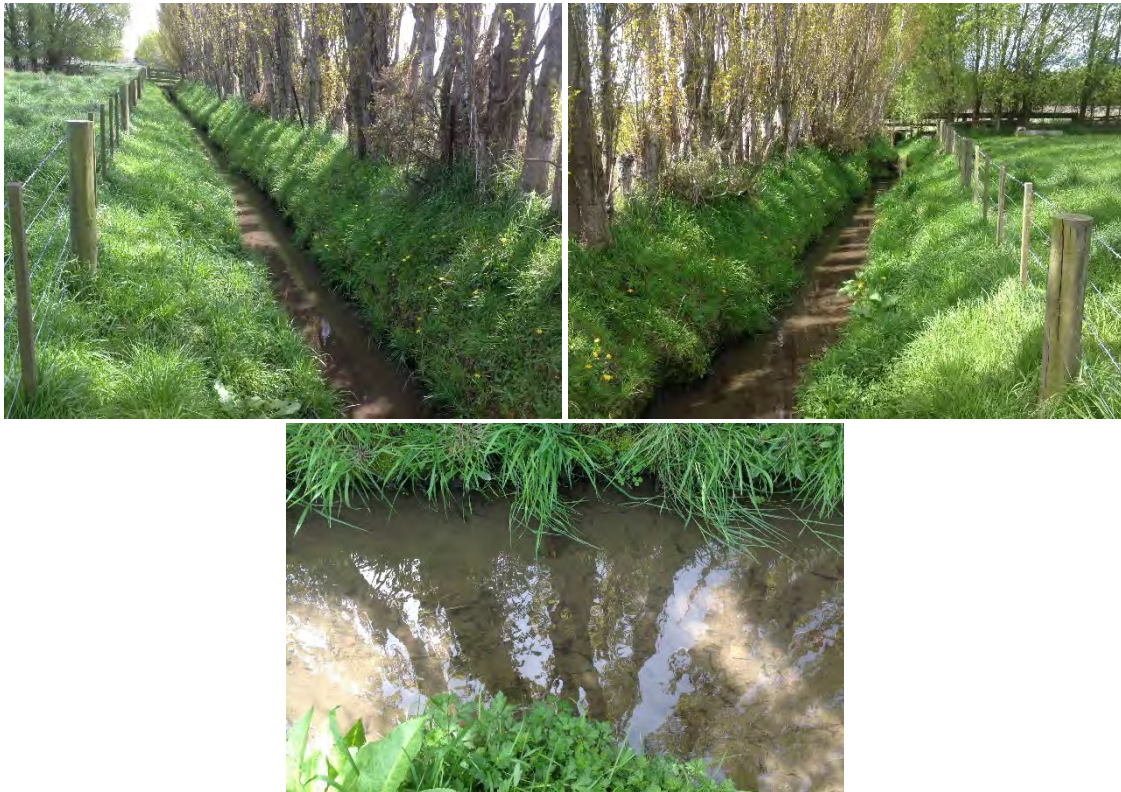
Undercut banks and overhanging vegetation were largely absent at the site. Canopy cover was generally low at the site (Table 3), however, rank grass and a poplar shelterbelt (on the true left bank) provided in-stream shading at times of the day. Macrophyte and algal growth was limited at the site (Photo 1), presumably, in part, as a result of the shading provided by the shelterbelt.

Photo 1. Site 1: Dunbar Waterway – upstream, located approximately 600 m downstream of Halswell Road, looking upstream (top left) and downstream (top right), looking into the channel (bottom).

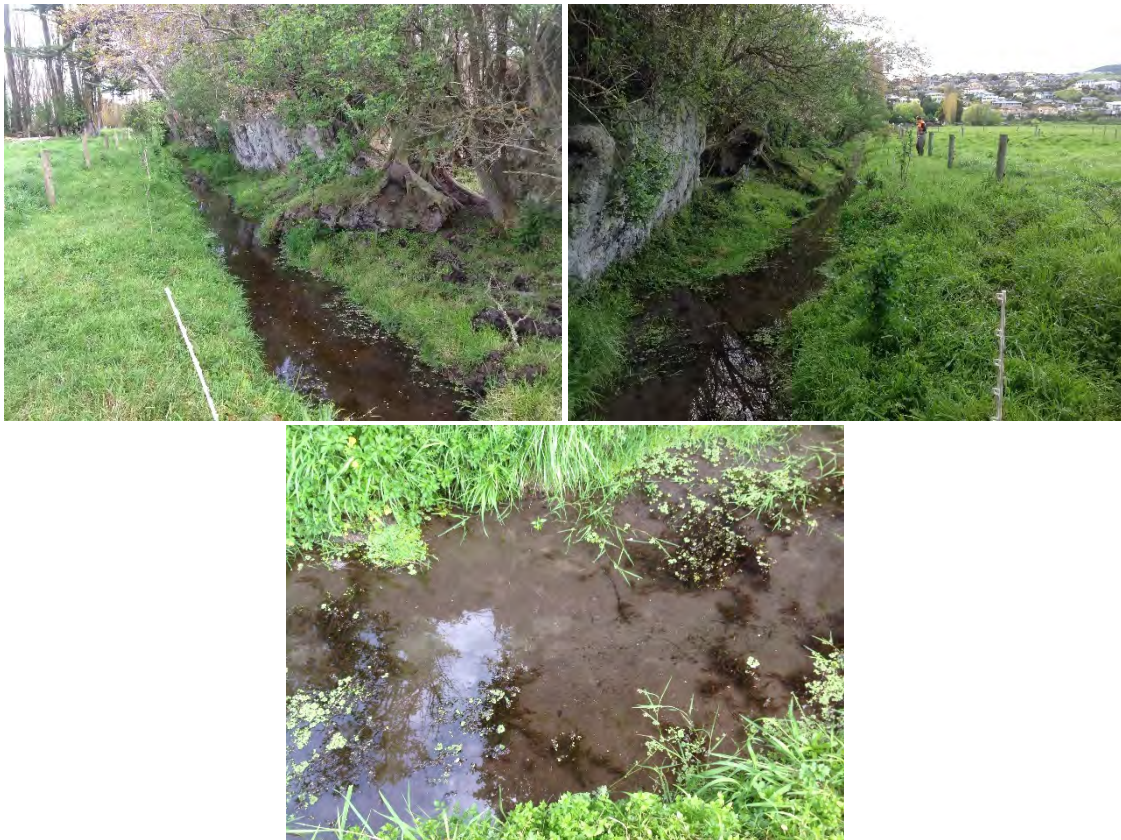
Although the channel of Dunbar Waterway was natural earth (rather than lined), it was very straight and channelized, and appeared to be regularly maintained for drainage (e.g. macrophyte removal).

Photo 2. Site 2: Dunbar Waterway – upstream, located approximately 300 m upstream of the confluence with Cashmere Stream, looking upstream (top left) and downstream (top right), looking into the channel (bottom).

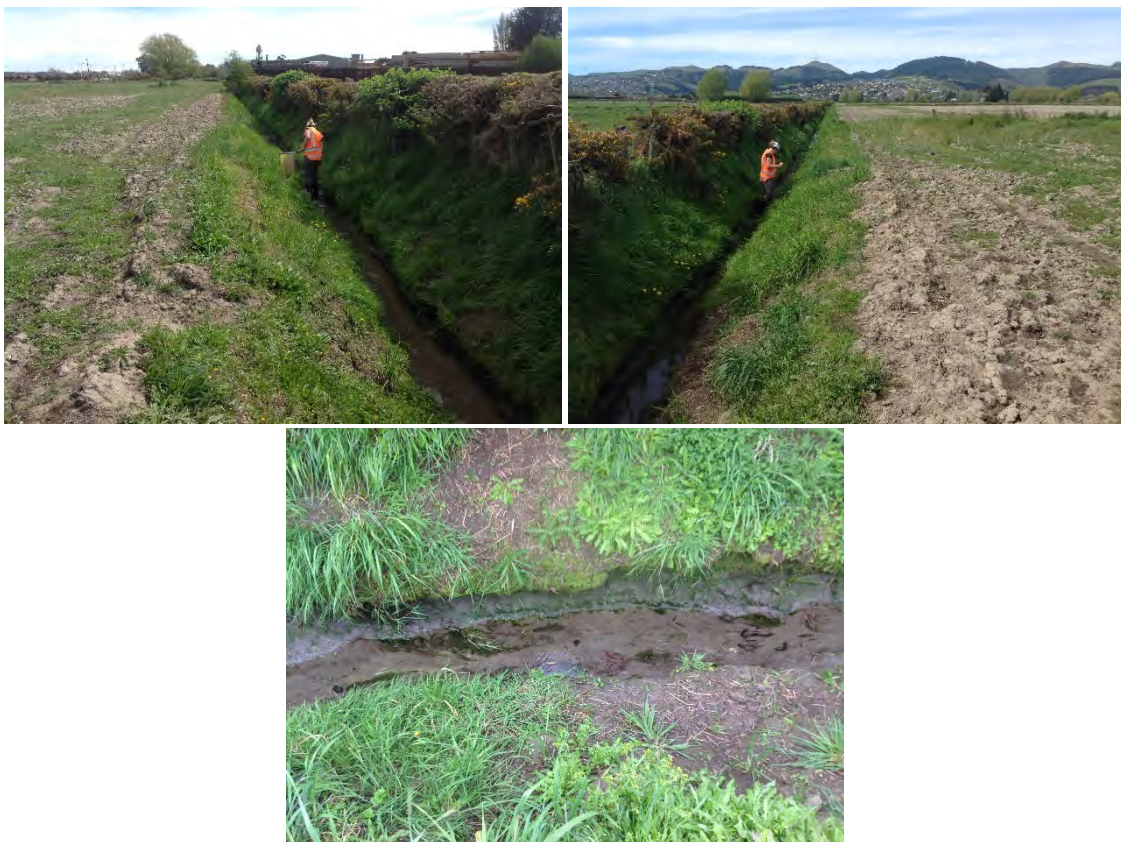
The stream bed was dominated by fine substrates (Substrate Index of 3.0), with an average of 13 cm of soft sediment covering the bed. Undercut banks and overhanging vegetation was largely absent and with a paucity of in-stream habitat present to support aquatic fauna.

Photo 3. Site 3: Days Waterway – upstream, located approximately 250 m downstream of Halswell Road, looking upstream (top left) and downstream (top right), looking into the channel (bottom).

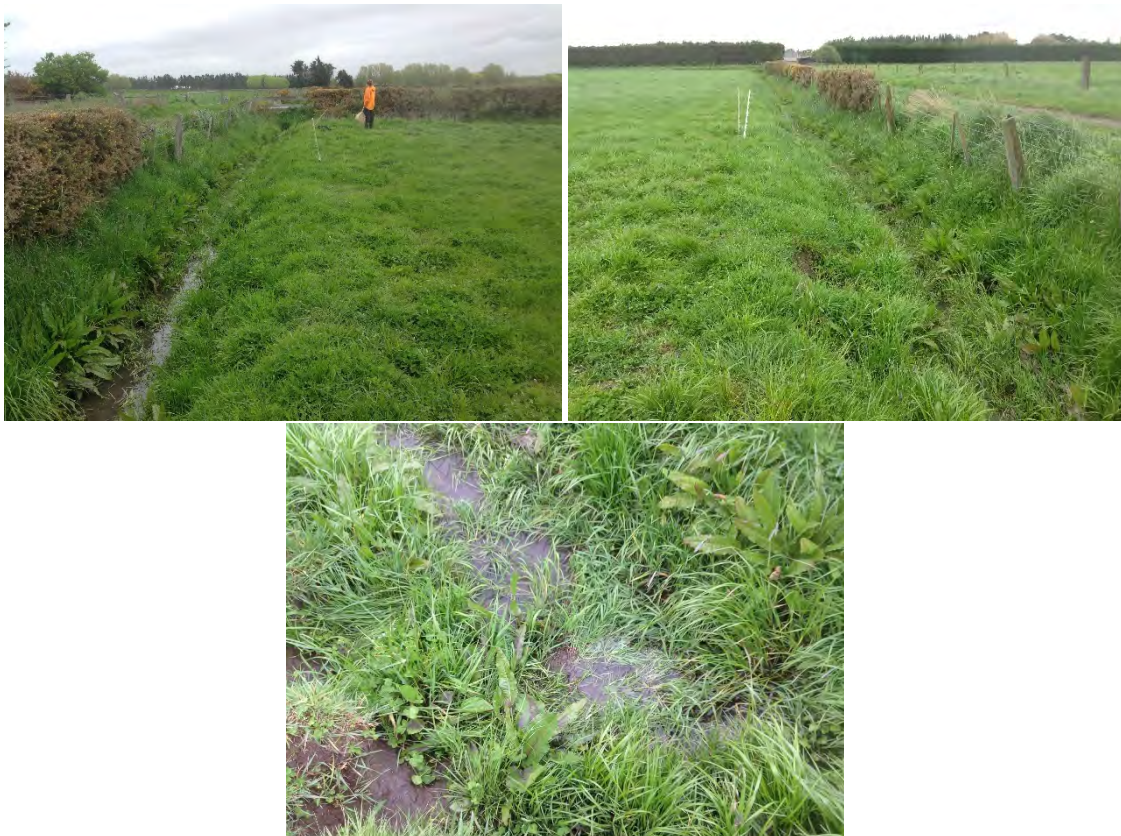
Undercut banks and overhanging vegetation were largely absent at the site, and little shading due to the lack of canopy cover (Table 3; Photo 4).

Photo 4. Site 4: Days Waterway – downstream, located approximately 250 m upstream of its confluence with Henderson Waterway, looking upstream (top left) and downstream (top right), looking into the channel (bottom).

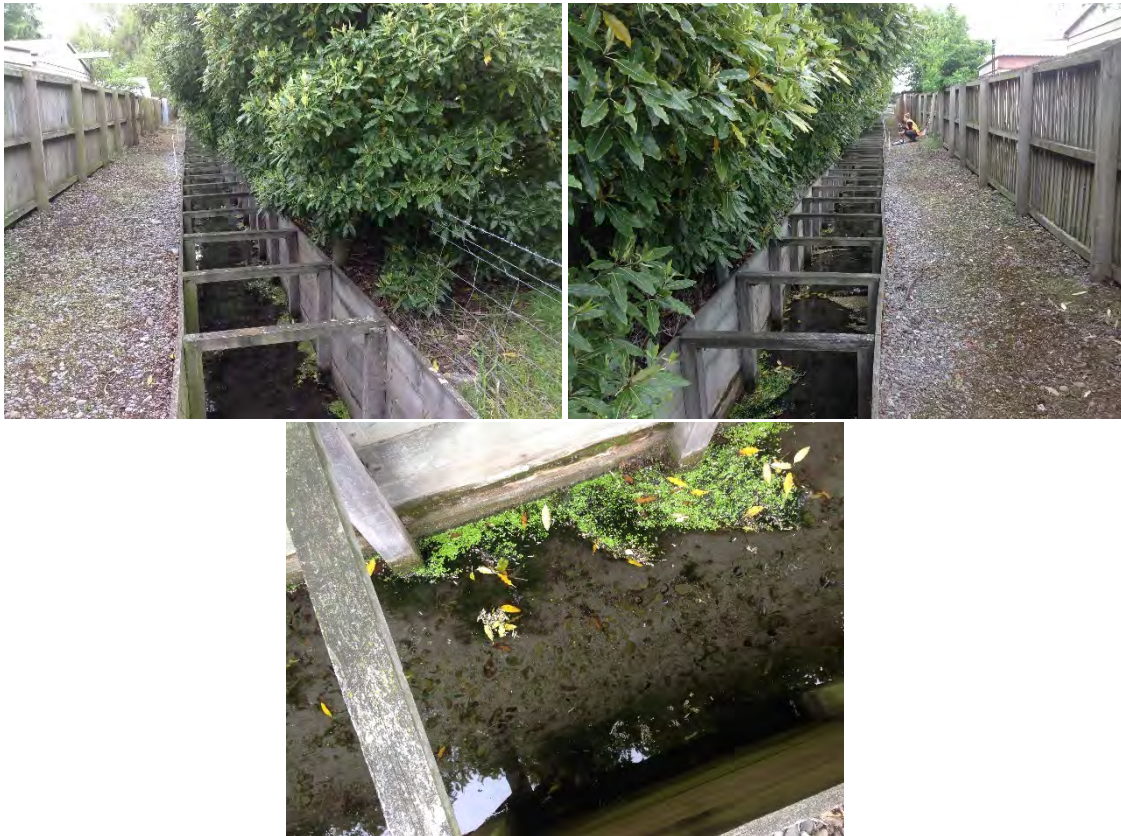
Undercut banks and overhanging vegetation was absent from this site, as the waterway was confined to the timber-lined channel. However, gaps between the horizontal palings of the timber walls did provide some habitat for freshwater fishes, especially bullies and juvenile eels.

Photo 5. Site 5: Hendersons Road Branch Drain, located approximately 70 m upstream of the confluence of Days Waterway and Hendersons Road Branch Drain, looking upstream (top left) and downstream (top right), looking into the channel (bottom).

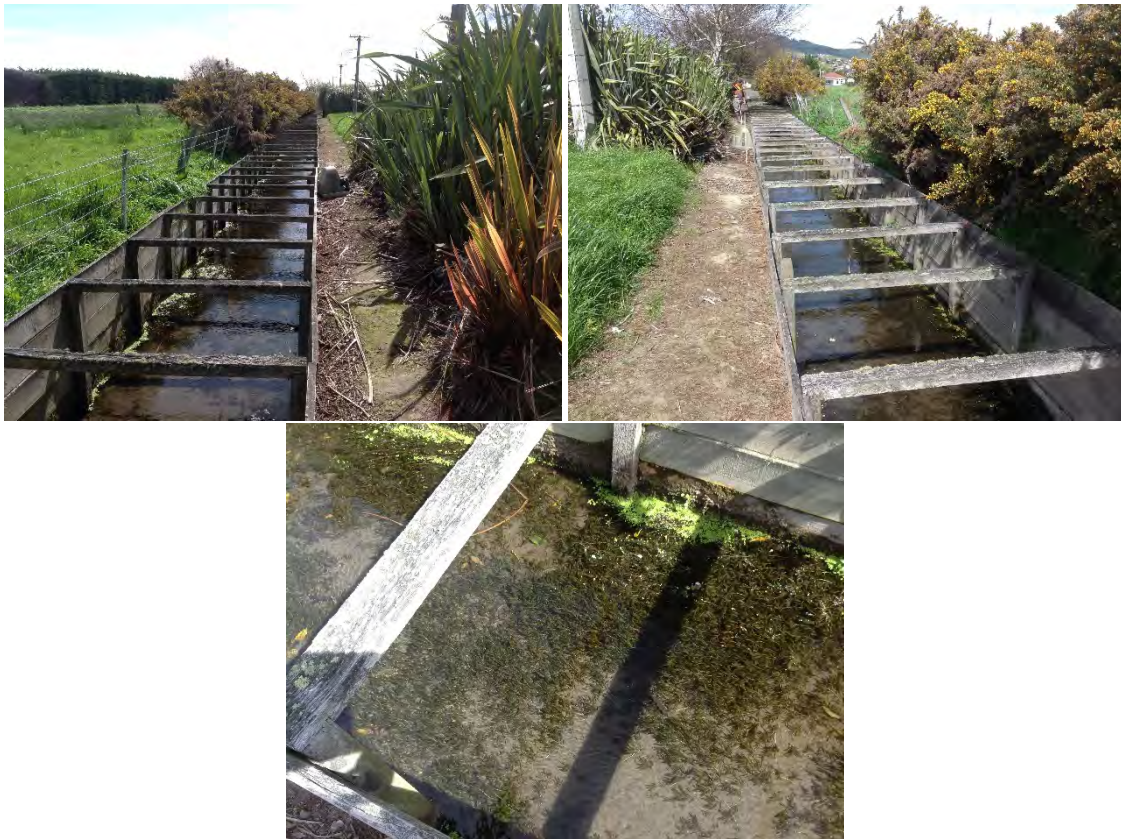
Macrophytes, dominated by the exotic curly pondweed (*Potamogeton crispus*), were abundant, with total cover approaching 50% at this site.

Photo 6. Site 6: Henderson Waterway - upstream, located approximately 70 m upstream of its confluence with Henderson Waterway, looking upstream (top left) and downstream (top right), looking into the channel (bottom).

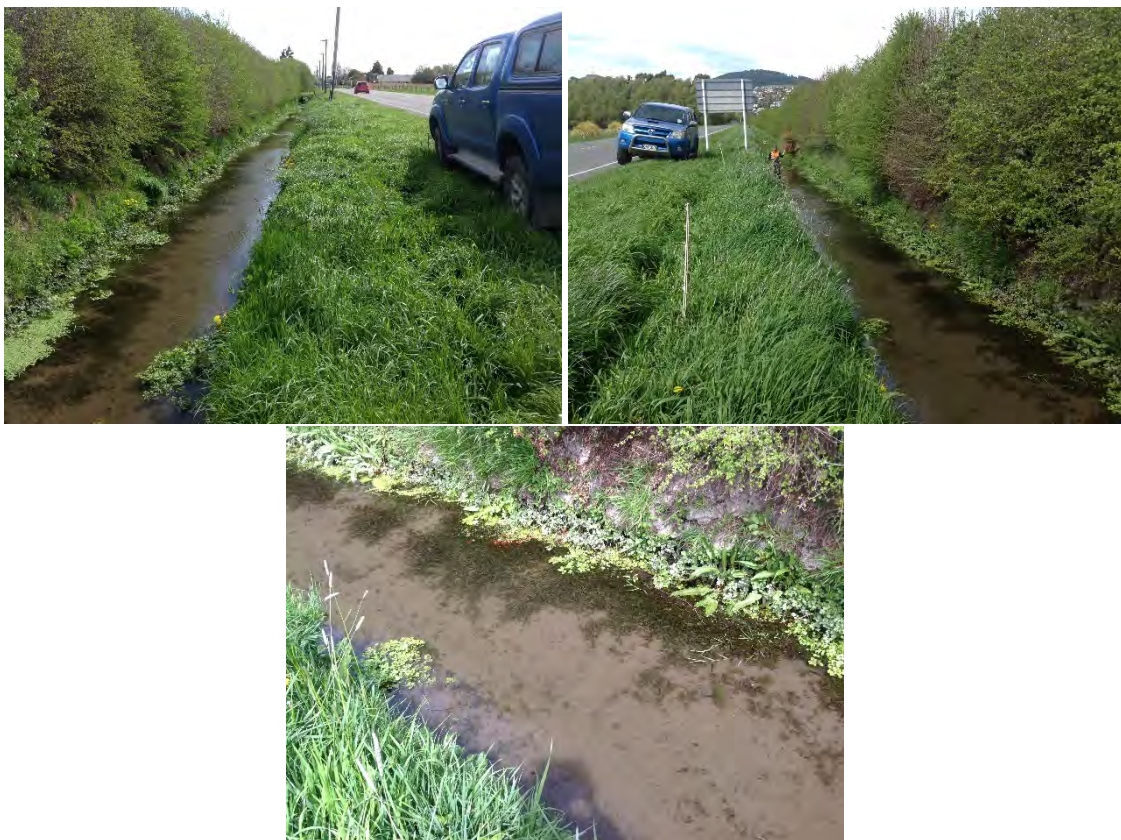
When the site was revisited in November to survey the fish community, macrophyte and filamentous algal cover was estimated as greater than 80% cover. Other than macrophytes, there was a paucity of cover or in-stream habitat for aquatic fauna.

Photo 7. Site 7: Henderson Waterway - mid, located approximately 350 m downstream of Site 6, looking upstream (top left) and downstream (top right), looking into the channel (bottom).

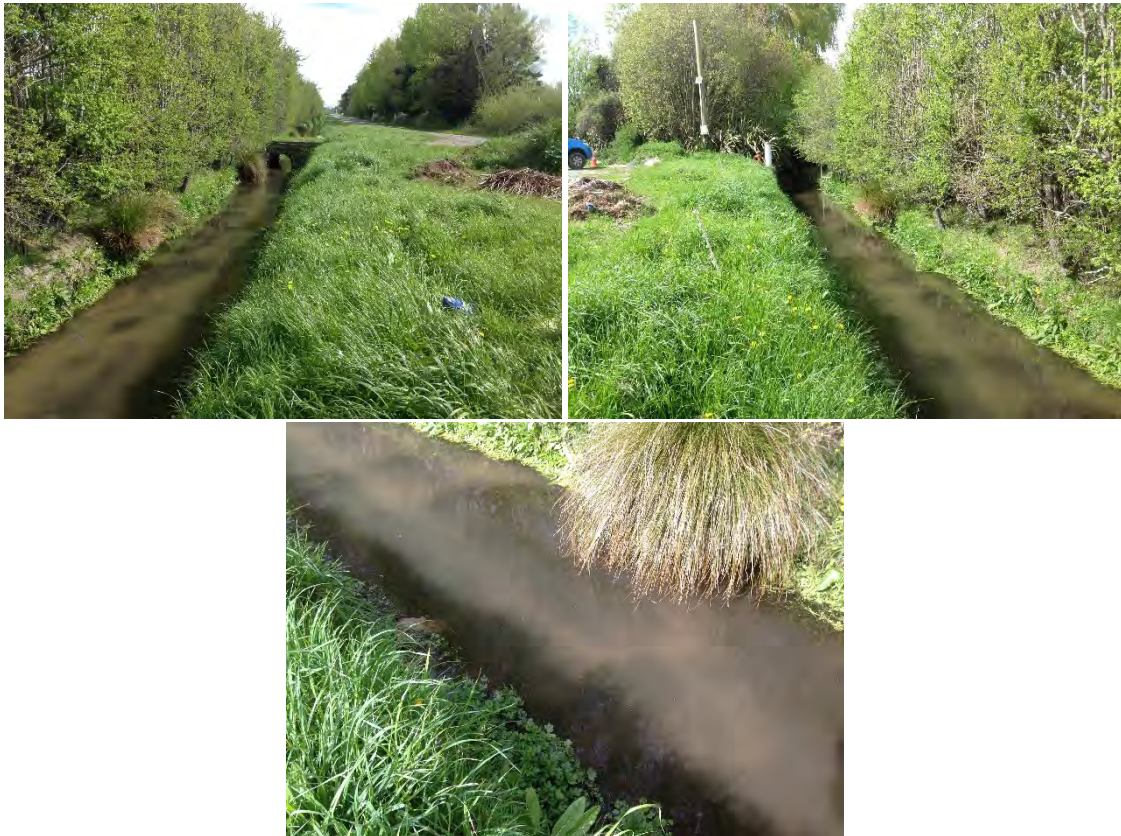
Macrophytes, dominated by curly pondweed, were very abundant in October 2016, with total cover exceeding Canterbury's Land and Water Regional Plan recommended guideline of a maximum total cover of 50% at site 8. Macrophyte cover had noticeably increased when the site was revisited for the fish survey in November 2016.

Photo 8. Site 8: Henderson Waterway - upstream, located approximately 700 m downstream of Site 7 and 120 m upstream of its confluence with Cashmere Stream, looking upstream (top left) and downstream (top right), looking into the channel (bottom).

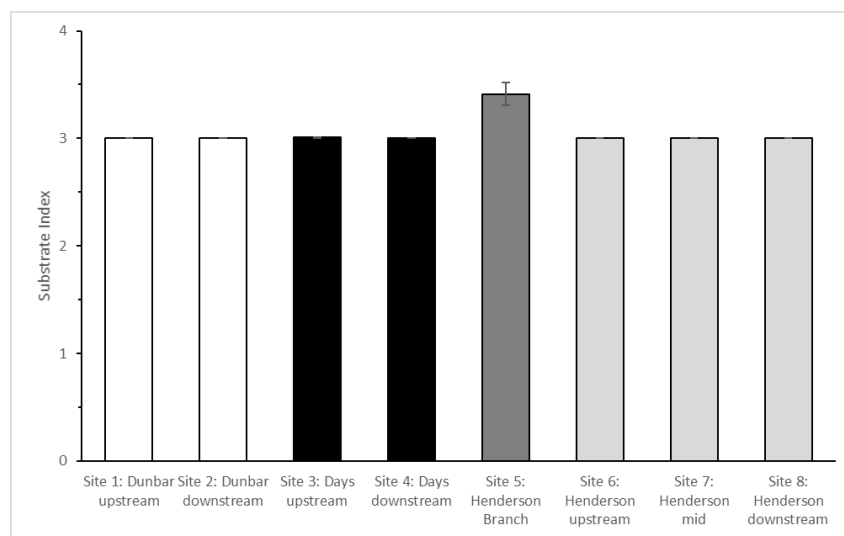
Figure 8. Mean ($\pm 1SE$) substrate index calculated from substrate composition measures recorded at five locations along each of three transects at the eight sites surveyed within the three waterways. The two Dunbar Waterway sites are shown in white bars, Days Waterway sites are shown in black bars, the Henderson Road Drain Branch Waterway site is shown in dark grey bar, and the three sites along Henderson Waterway are shown in light grey bars.

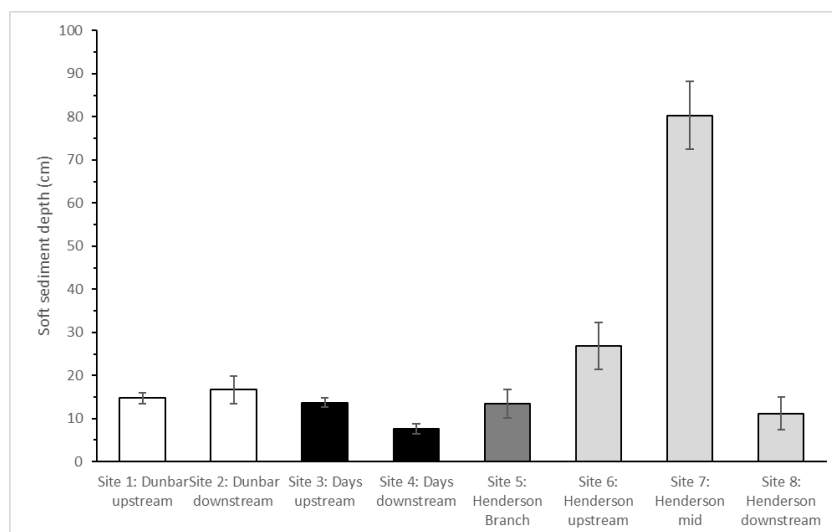
Figure 10. Mean ($\pm 1SE$) soft sediment depth recorded at five locations along each of three transects at the eight sites surveyed within the three waterways. The two Dunbar Waterway sites are shown in white bars, Days Waterway sites are shown in black bars, the Henderson Road Drain Branch Waterway site is shown in dark grey bar, and the three sites along Henderson Waterway are shown in light grey bars.

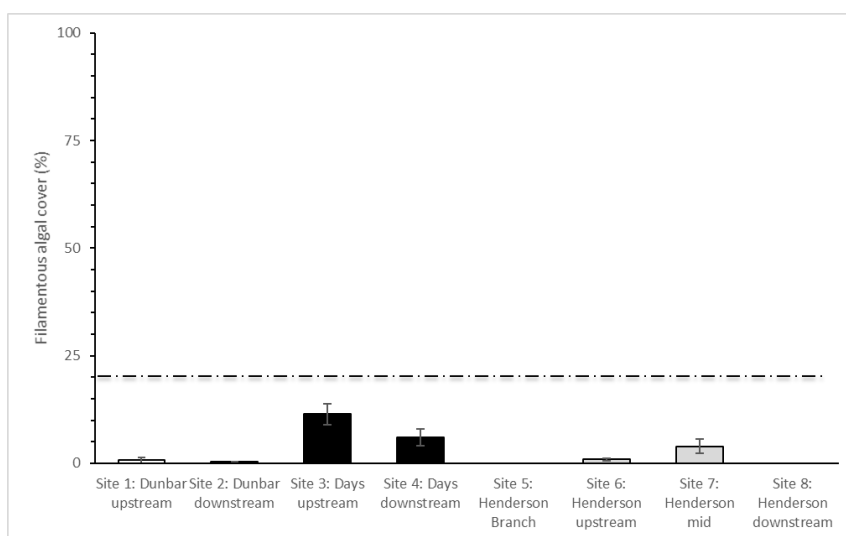
Figure 12. Mean (± 1 SE) filamentous algal (long, >20 mm) cover recorded at five locations along each of three transects at the eight sites surveyed within the three waterways. The two Dunbar Waterway sites are shown in white bars, Days Waterway sites are shown in black bars, the Henderson Road Drain Branch Waterway site is shown in dark grey bar, and the three sites along Henderson Waterway are shown in light grey bars. The dashed lines indicate the maximum cover of long (> 20 mm) filamentous algae recommended for Banks Peninsula waterways by the LWRP.

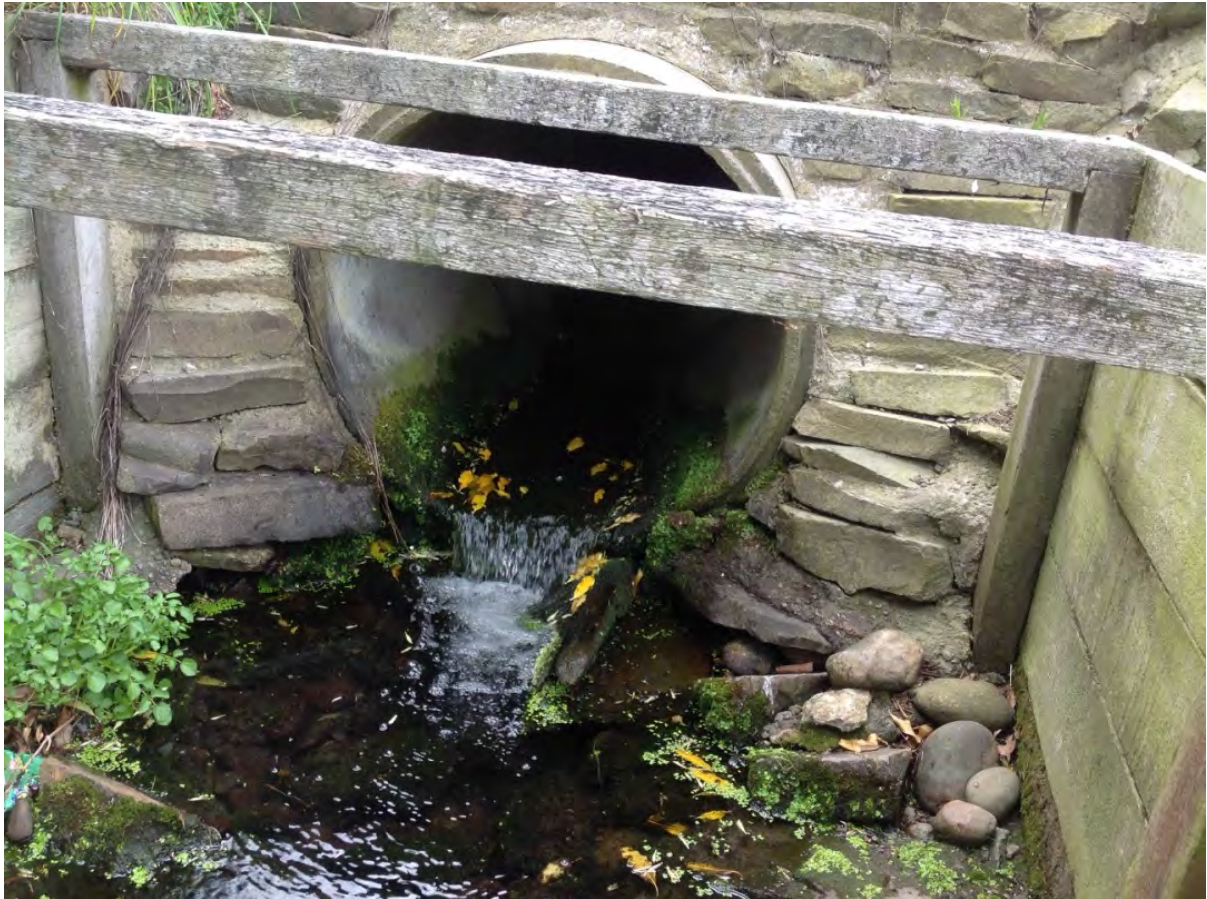
A1 was located approximately 150 m upstream of Site 6, at the upper most end of the waterway. Here the culvert was perched during baseflow conditions, and would likely present an obstacle to most migratory fish species, and potentially to kēkēwai. Poor climbing species, such as inanga will almost certainly be unable to navigate through this culvert, and a number of inanga were observed in the pool immediately downstream of this structure.

A1: Perched culvert under driveway, Henderson Waterway, 150 m upstream of Site 6; Inanga observed in pool below culvert.

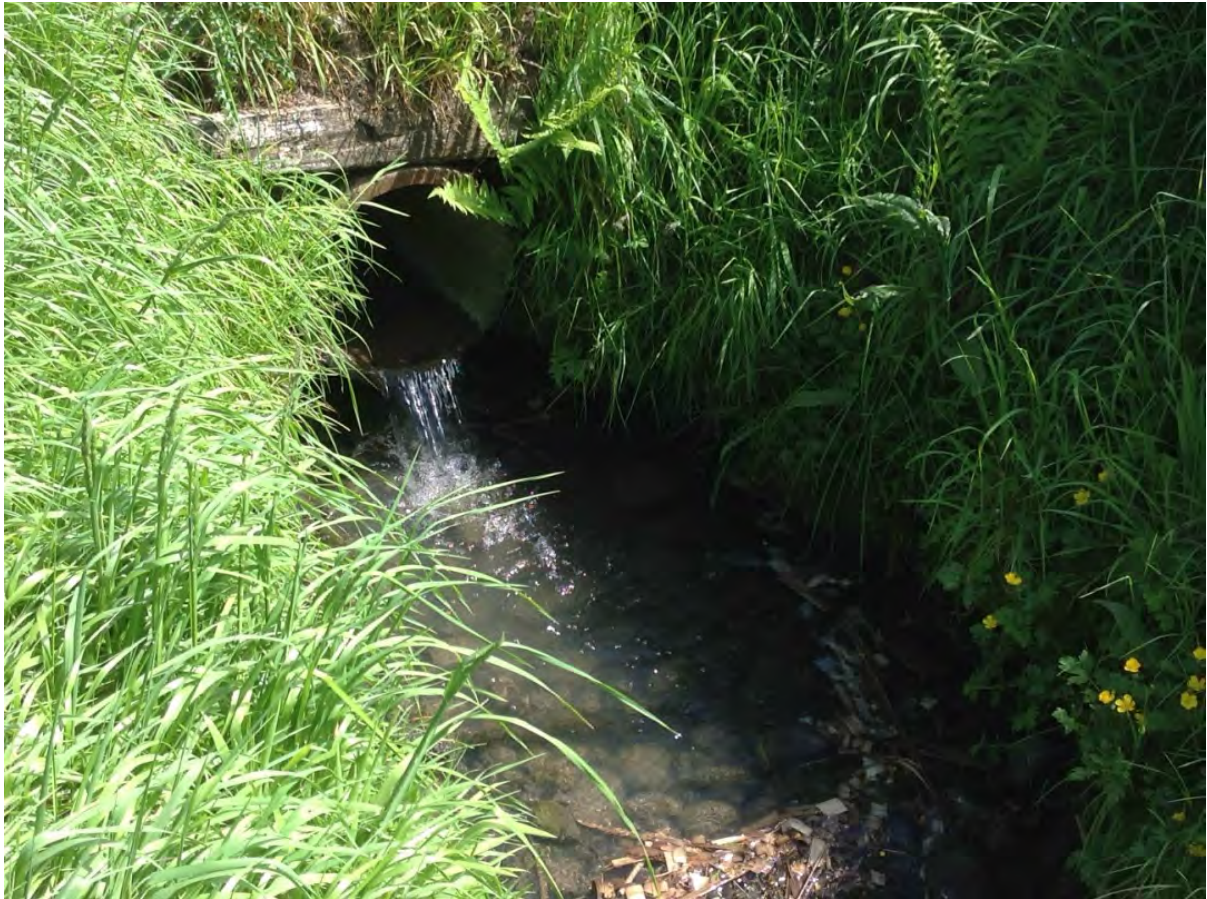
Three perched culverts were found along Dunbar Waterway (A2, A3, and A4; Appendix 2).

A2: Perched culvert along Dunbar waterway.

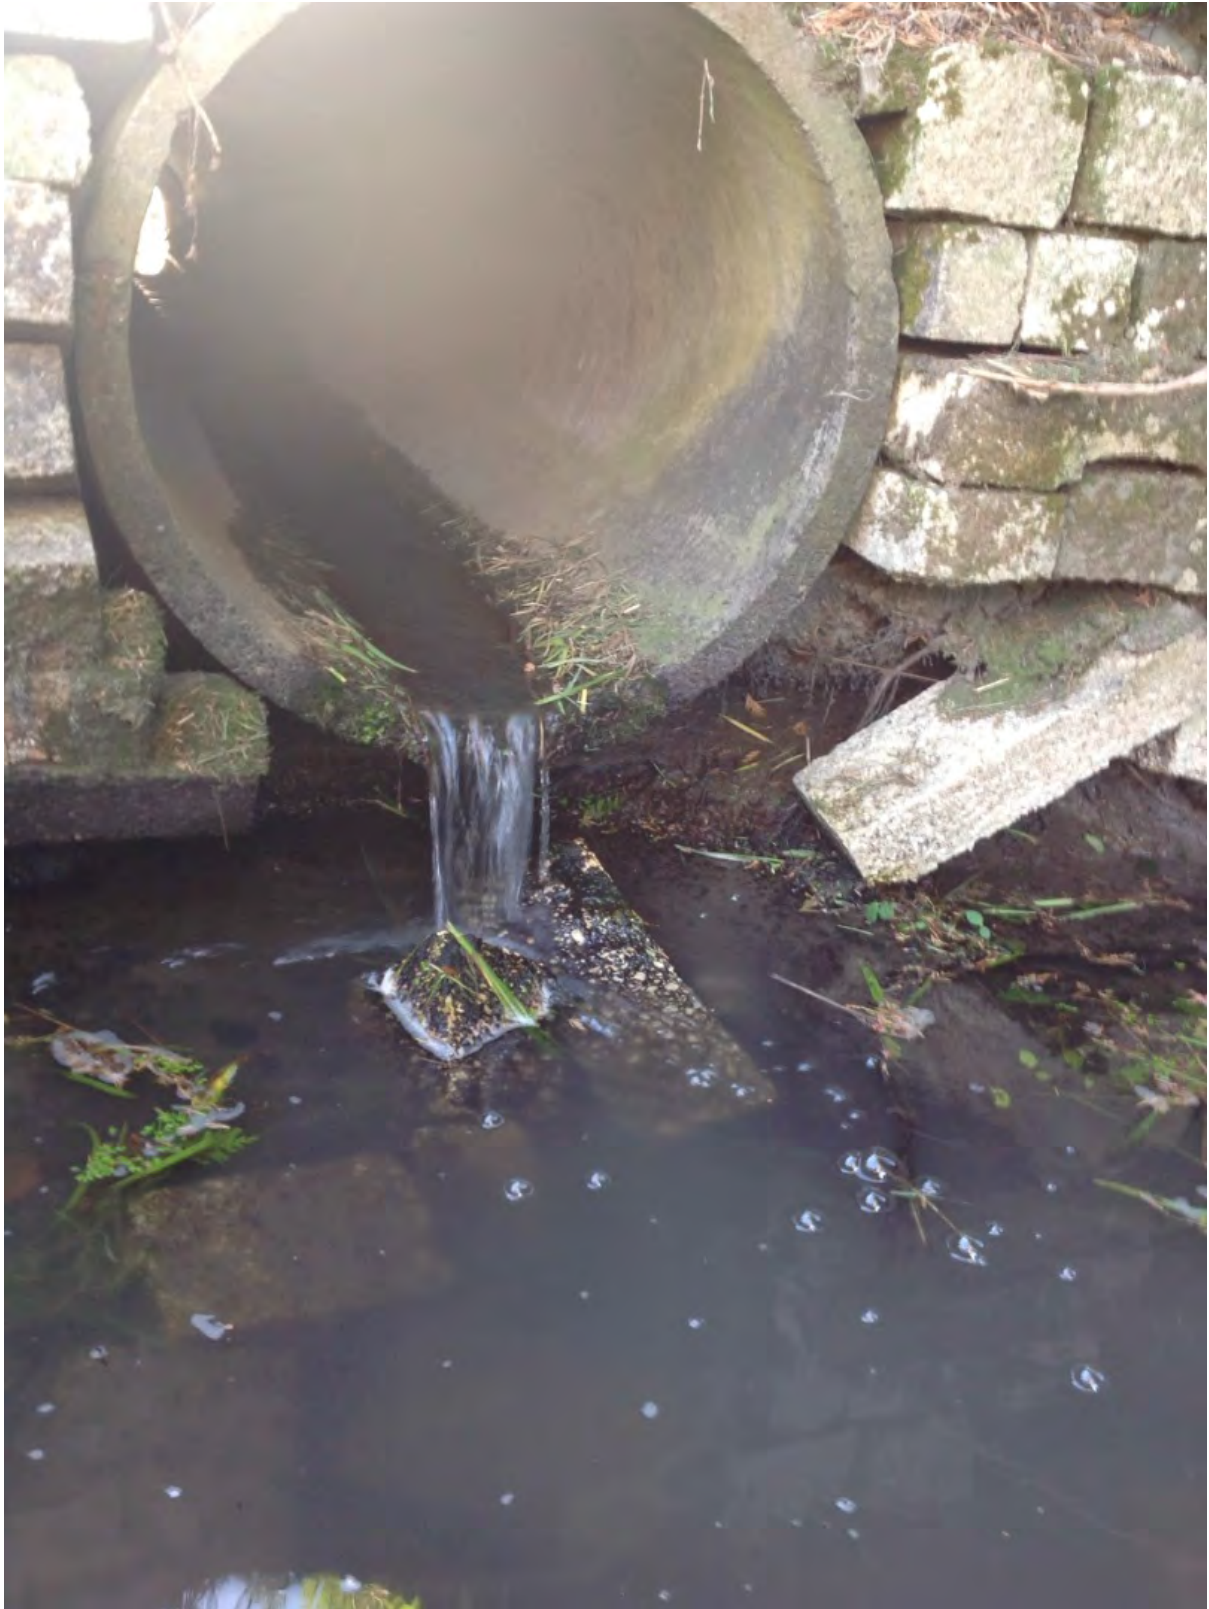
A3: Perched culvert along Dunbar Waterway, at Sparks Road, upstream of Site 2.

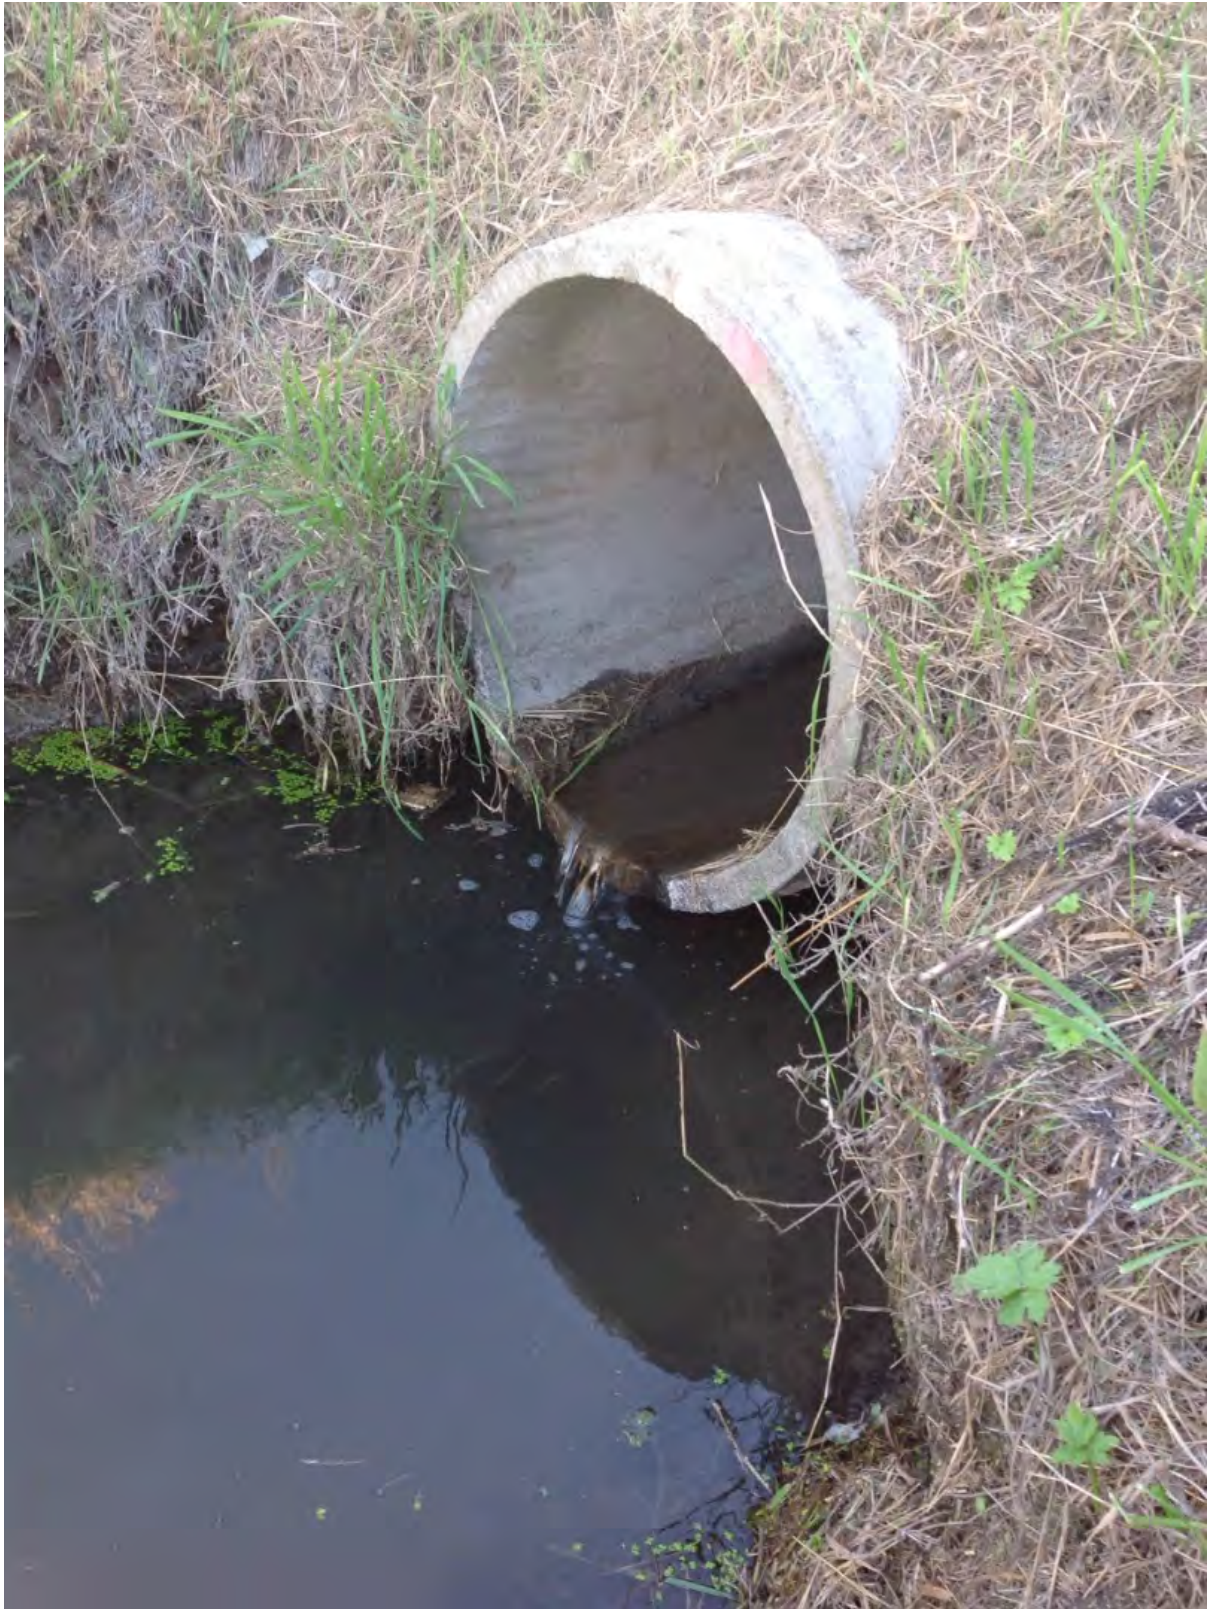
A4: Perched culvert along Dunbar Waterway, downstream of Sparks Road, upstream of Site 2.

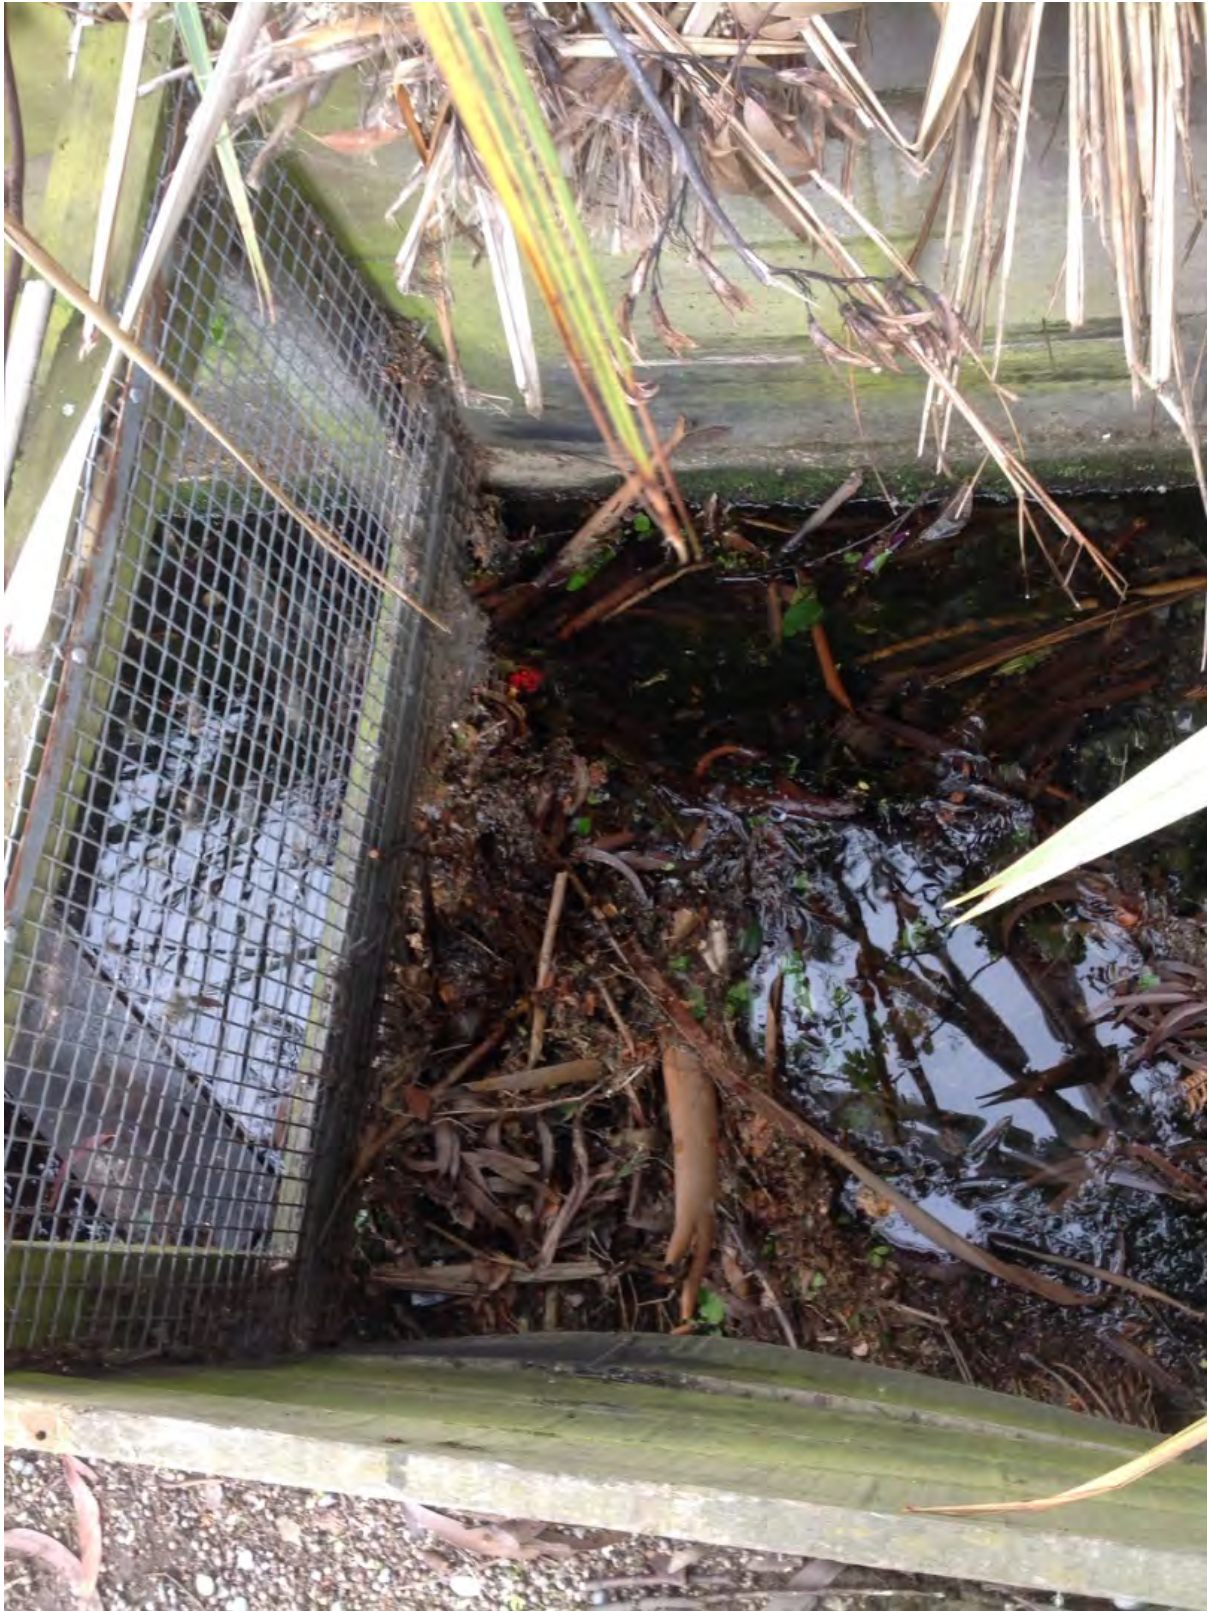
Two potential barriers to fish (and other aquatic fauna) passage were noted along Hendersons Road Branch Waterway (P1, P2; Appendix 2).

P1: Debris gate does not reach below water level, but could be a barrier to fish passage when debris builds up.

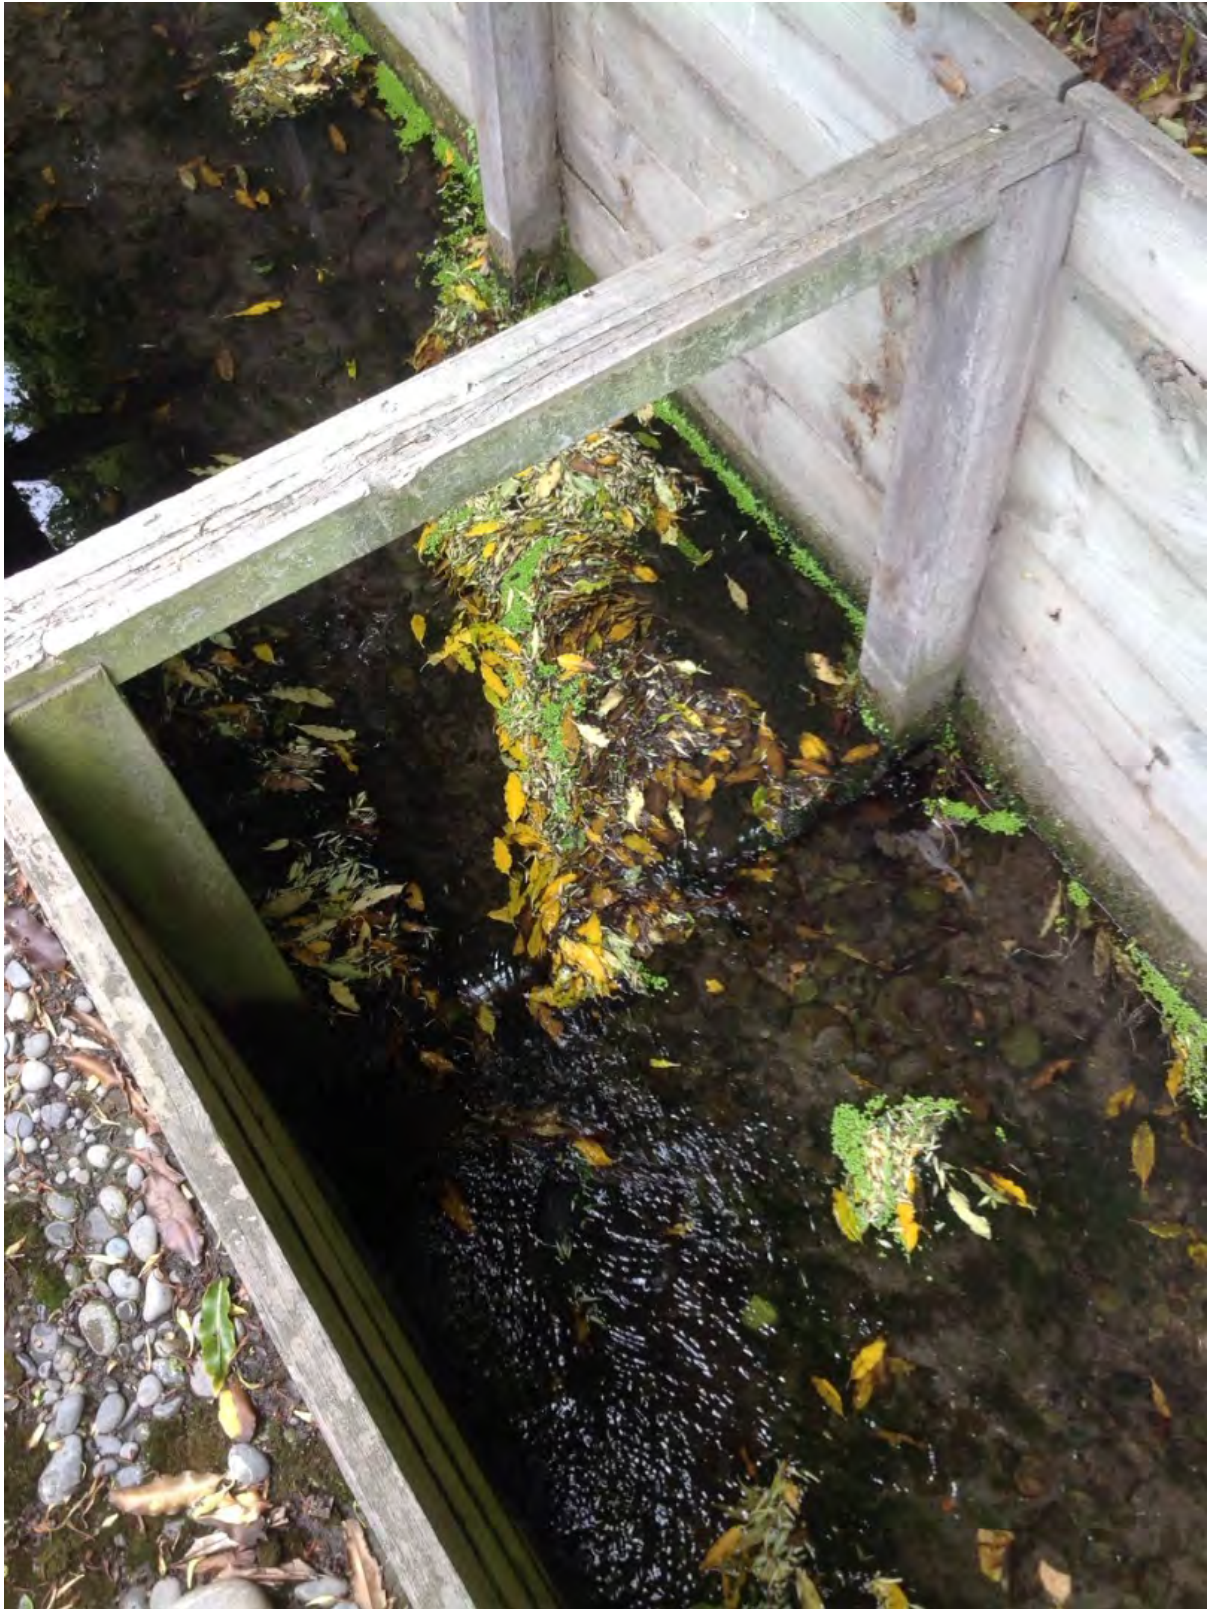
The second potential barrier to in-stream movement (migration) was located at / near Site 2. Timber cross beams lined the stream bed, supporting the timber-lined channel. These had the potential to become perched, and impassable to some species, particularly during low flow conditions (P2; Appendix 2).

P2: Timber cross beam may be a barrier to fish passage at times of low flow; Hendersons Road Branch Drain, approximately 20 m downstream of Site 5.
