Dunbar, Days & Henderson Waterways

Aquatic Ecology Technical Report
Prepared for Christchurch City Council

21 December 2016

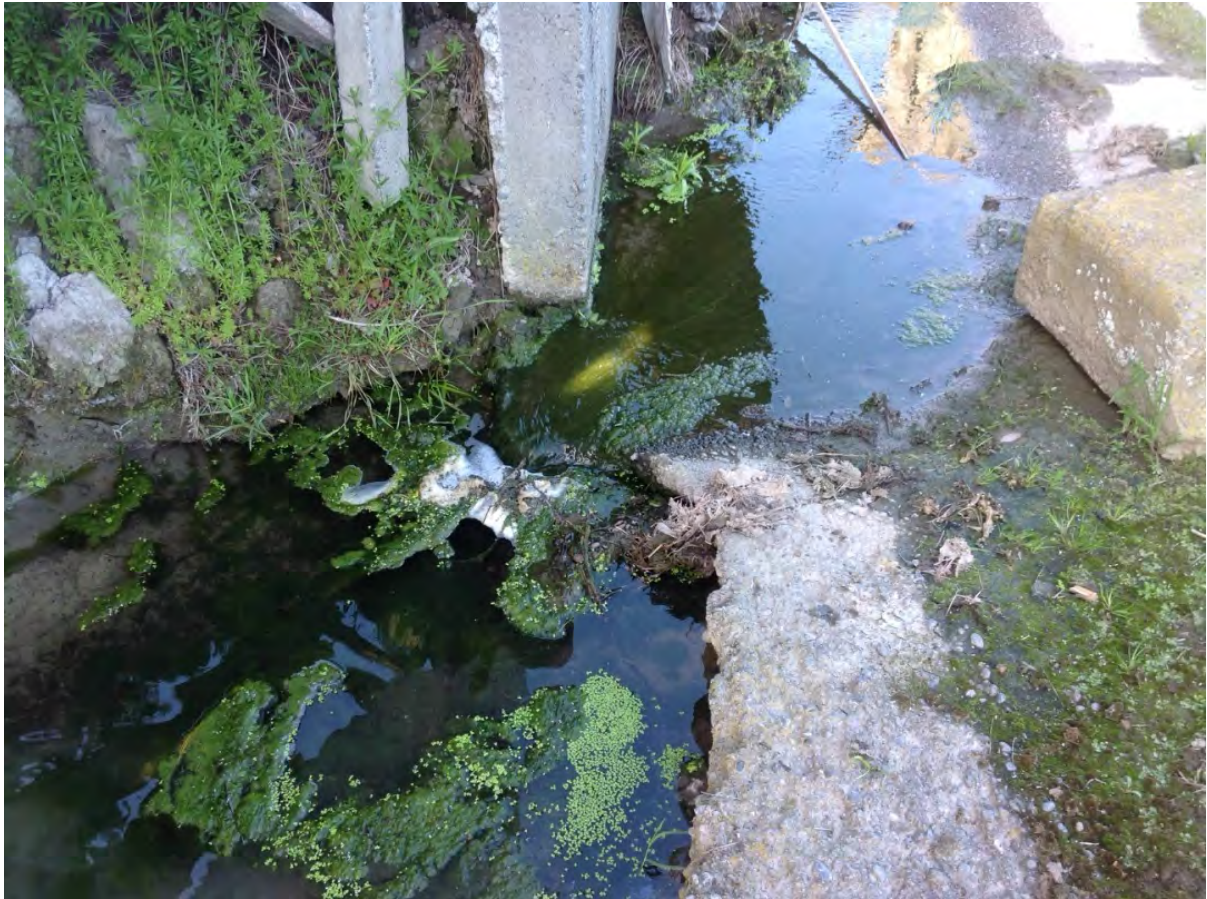
A potential barrier to fish (and other aquatic fauna) passage was found approximately 150 m downstream of Site 4 (P3; Appendix 2). The concrete lining along the bottom of the channel has eroded underneath, and may be perched and impassable for some aquatic fauna, particularly during low flow conditions.

P3: Perched concrete sill, which may be a barrier to fish passage during periods of low flow, downstream of Site 4 in Days Waterway.

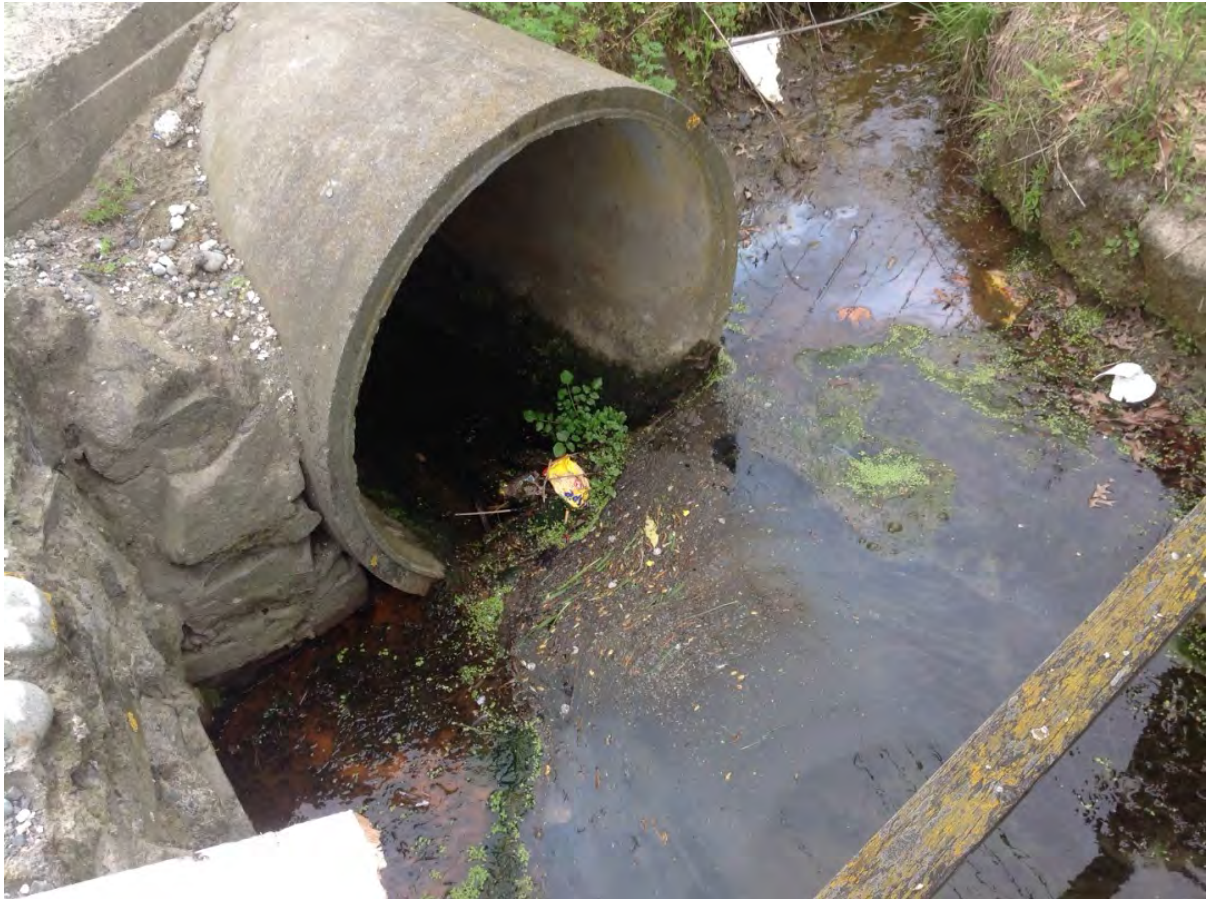
P4, the culvert under Sparks Road and particularly the upstream end, was noted as a potential barrier during low flow conditions and as a result of blockages by debris and litter (Appendix 2).

P4: Road culvert, upstream of Sparks Road, may collect woody debris and litter, which may be a barrier to fish passage.

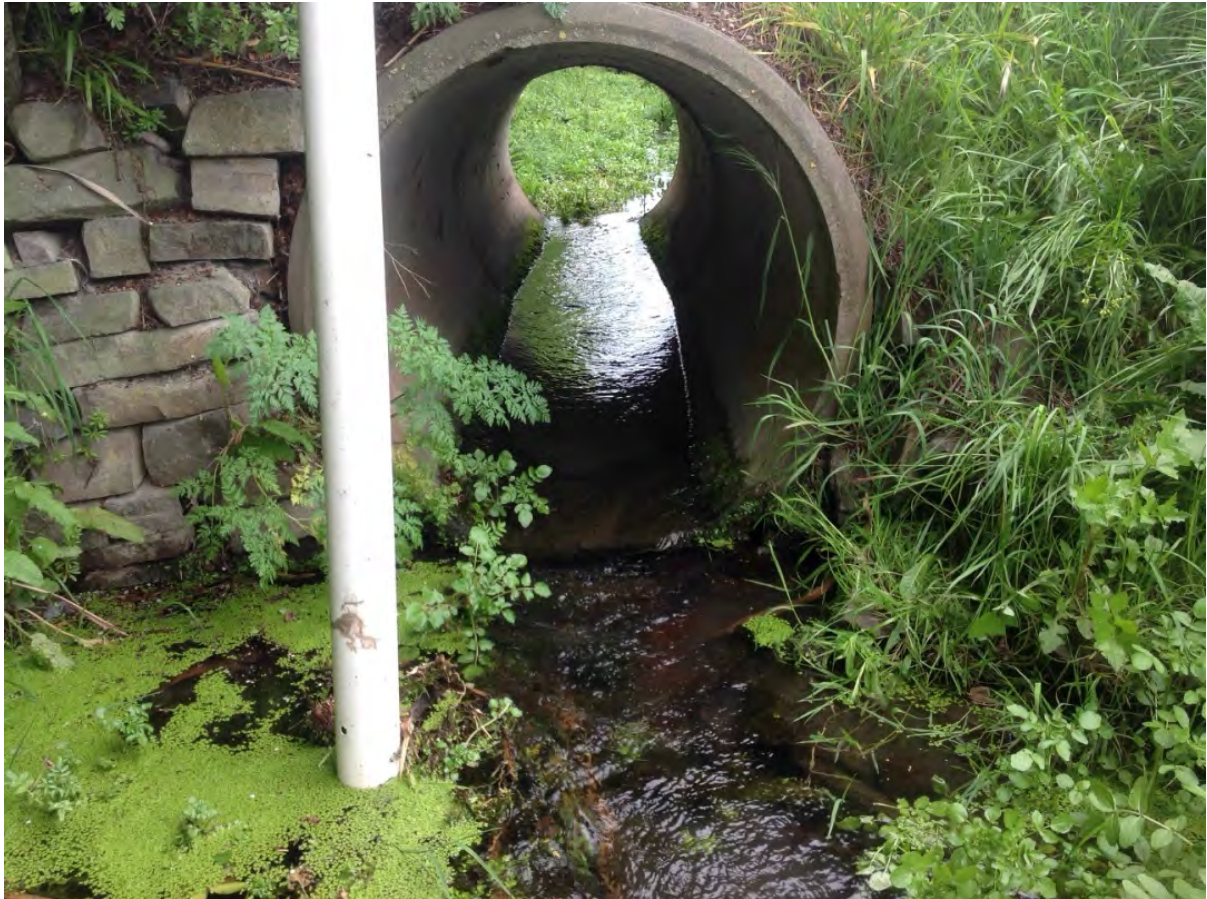
P5 was a culvert under a farm crossing of Henderson Waterway, just upstream of Site 7. This was noted as having the potential to be perched during low flows, and may also be impassable to some fish species during high flows (due to velocity barrier within the culvert) (Appendix 2).

P5: Culvert on lower Henderson Waterway, has potential to be a barrier in both high and low flows.
