# Number One Drain Aquatic Ecology Survey

August 2016

Prepared for:  
Christchurch City Council

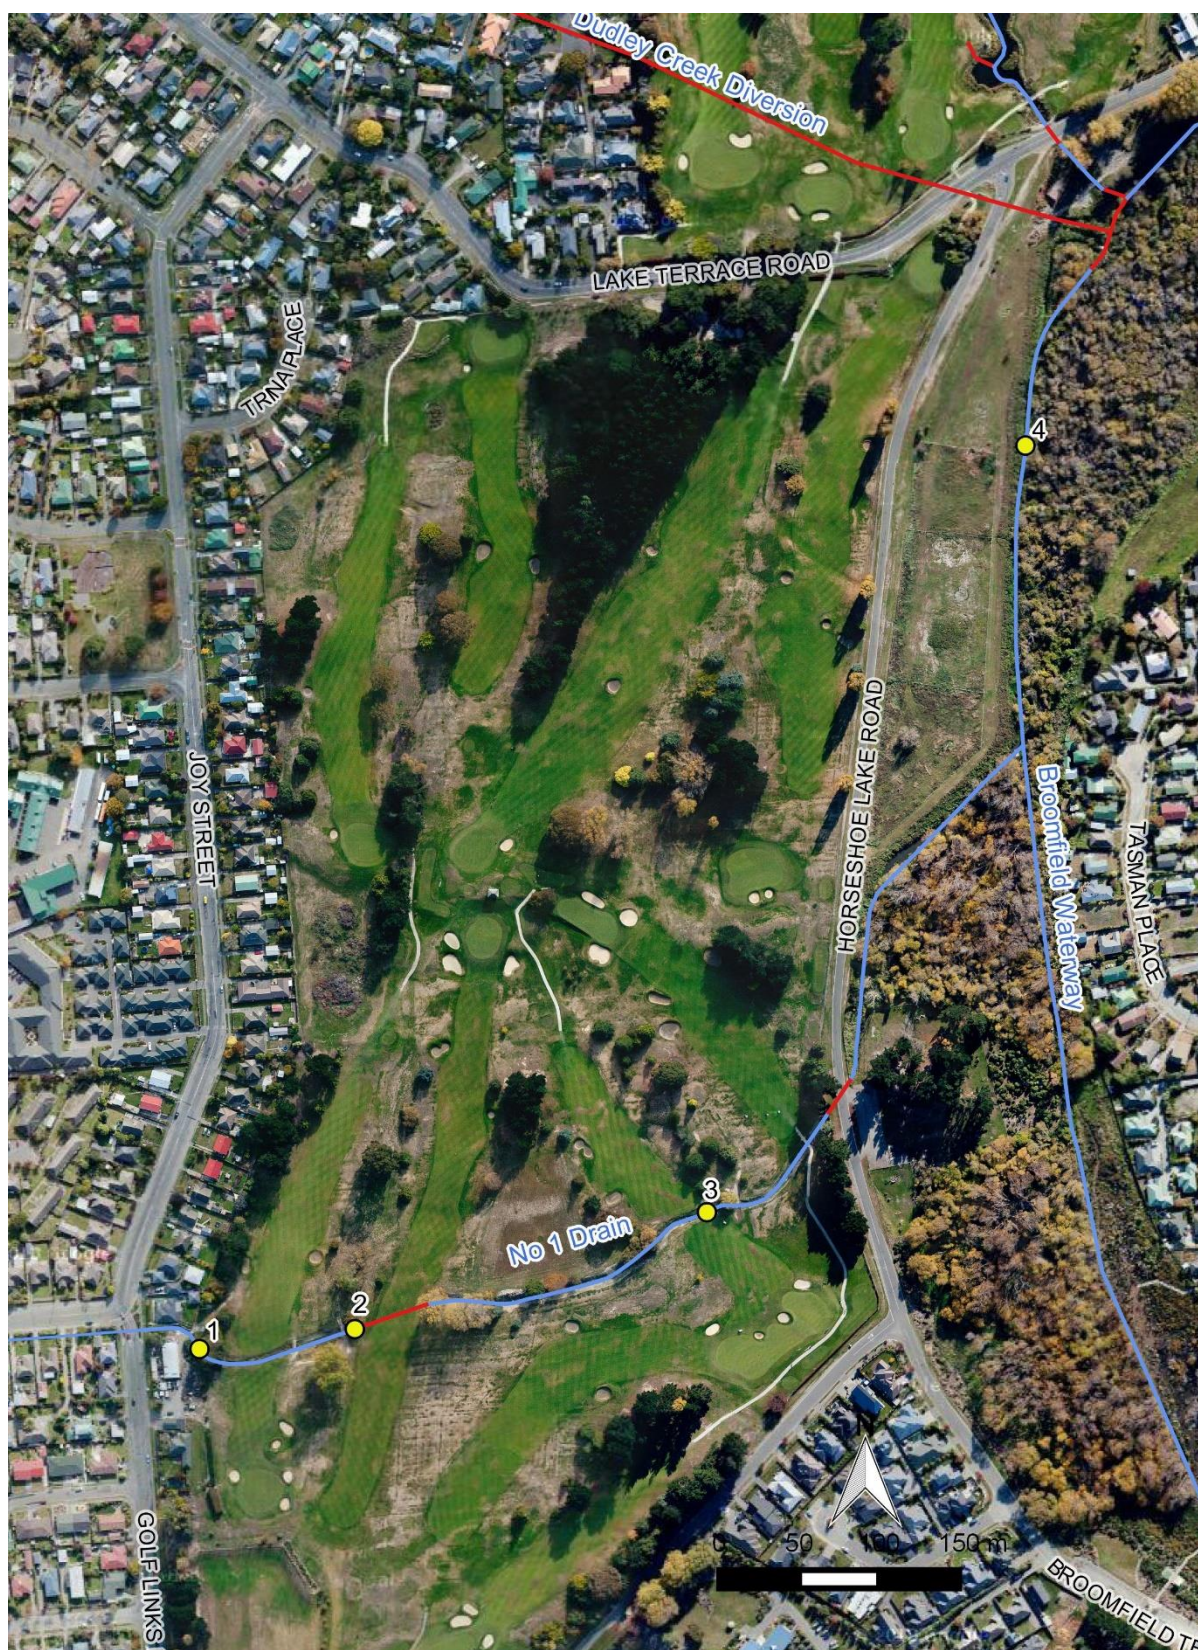
Figure 1: No. 1 Drain and ecology sampling sites (numbered yellow circles). Blue lines indicate open waterways, while red lines typically indicate piped or culverted sections. Satellite Imagery from Google.

Four ecology sampling locations were chosen in consultation with CCC (Figure 1, Table 1). Sites 1 and 4 were located upstream and downstream of the proposed waterway restoration, respectively, and were selected as control sites, while Sites 2 and 3 were within the restoration area and were treatment sites. Sites 1, 2 and 3 were all located on No. 1 Drain, while Site 4 was located further downstream on Broomfield Waterway because the section of No. 1 Drain immediately downstream of Horseshoe Lake Road was too sluggish and overgrown with aquatic macrophytes to serve as a good comparison for the upper sites.

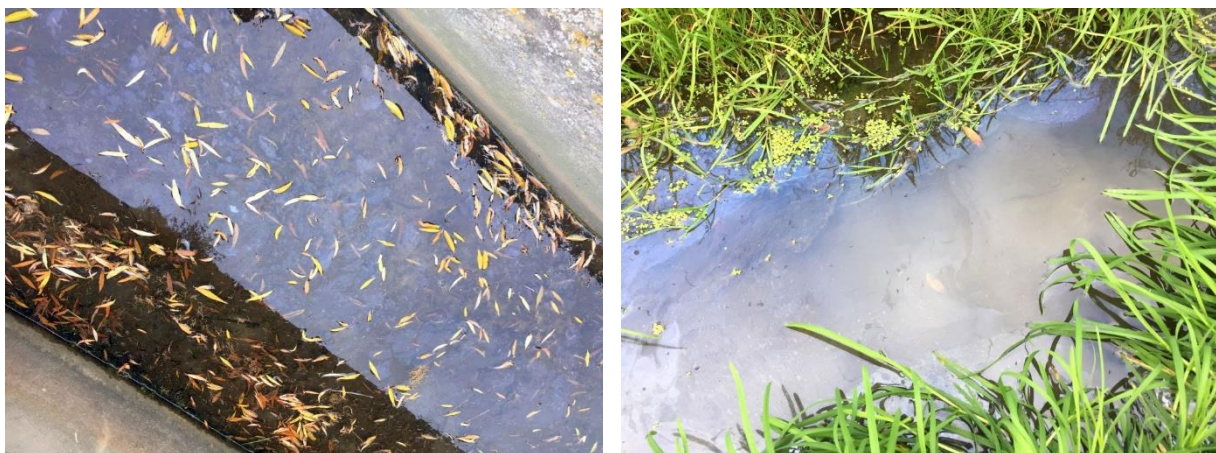
An oily sheen was observed on the water surface throughout much of Sites 3 and 4 (Figure 2). Oily sheens can be associated with natural seepage from wetland soils containing low DO, but can also be caused by other factors, such as hydrocarbon spills or landfill leachate. The sheen is most likely from wetland seepage, as there are no historic landfills under the sampling sites, the sheen occurred both within and downstream of the golf course, and No. 1 Drain is within an area characterised by heavier soils that was covered in extensive wetland prior to land drainage.

Figure 2: Oily sheens on the water at Site 3 (left) and Site 4 (right).

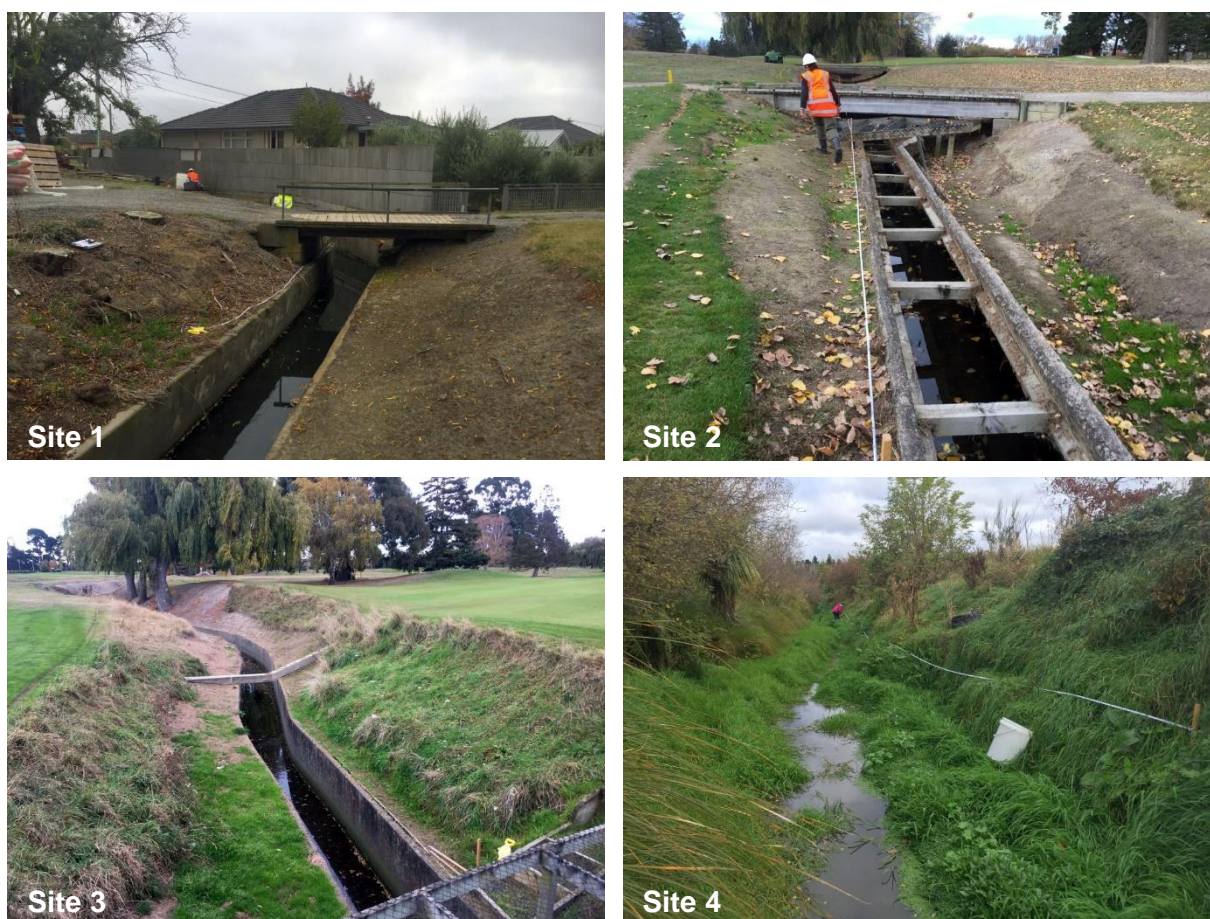
No. 1 Drain within the golf course is narrow, straight, concrete-lined and has near-vertical walls (Figure 3). At Site 2, the top of the south bank was leaning over the channel, due to earthquake damage, and wooden bracing was in place to stop the bank from completely toppling over (Figure 3). There was a significant difference in lower bank angle amongst sites ( $P < 0.001$ ), with mean bank angles of 88 to 99 degrees for Sites 1 to 3, and a mean of 21 degrees at Site 4. Bank heights also differed significantly amongst sites ( $P < 0.001$ ), with Sites 1 to 3 having uniform bank heights of 1.1 m, while Site 4 bank height was on average 0.4 m and was more variable. Bank undercuts were absent from all sites, due to the concrete walls at Sites 1 to 3 and the relatively low bank angles at Site 4.

Figure 3: Representative photographs of the four ecology sampling sites.

- **Natural banks.** The existing concrete channel with vertical walls should be replaced with more natural construction materials (e.g., rock or geotextile bags) with the banks battered back to limit erosion. Natural banks provide habitat for riparian plants and animals, and allow macrophytes to take root, which in turn provide habitat and cover for fish and invertebrates.

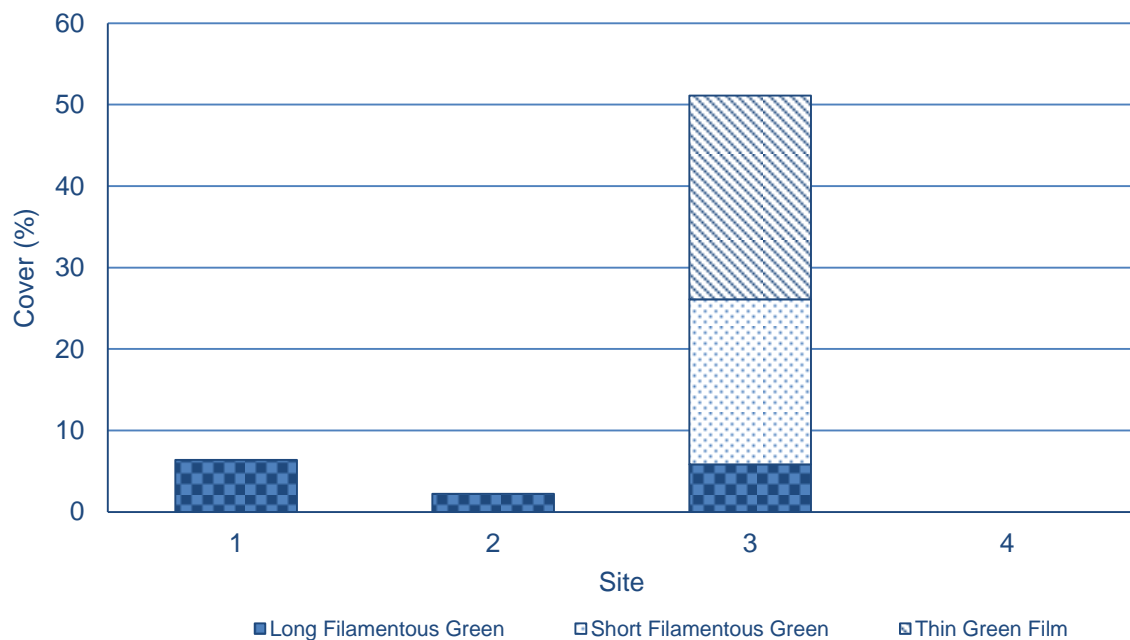
Periphyton cover was sparse at Sites 1, 2, and 4, while Site 3 had moderate coverage with thin green films and short green filamentous algae (Figure 6). Bed coverage with long green filamentous algae was <10% at all sites, and well below the LWRP freshwater outcome of 30% bed cover (Figure 5, Table 4). No periphyton was observed at Site 4, presumably due to the dominance of macrophytes and soft sediments.

Figure 6: Cover and composition of major periphyton groups.

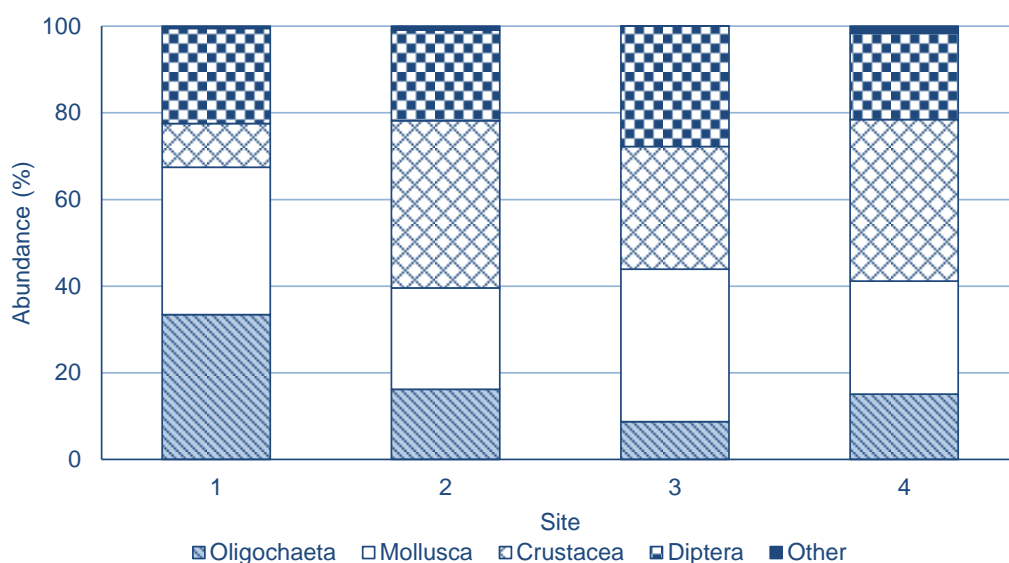
A total of 29 invertebrate taxa were recorded across the four sites and the invertebrate community was numerically dominated by pollution-tolerant taxa at all sites. The five most abundant taxa across all sites were ostracod crustaceans (27% of total abundance) the blood-worm *Chironomus zealandicus* (21%), oligochaete worms (17%), the common mudsnail *Potamopyrgus antiposarum* (13%), and sphaeriid molluscs (11%). Other common but less abundant taxa included *Gyraulus* snails, cladocerans, copepods, and chironomid midge larvae (Figure 7). Overall, invertebrate community composition was similar to that recorded previously from other drains in the area (Taylor & McMurtrie 2003, James 2012, Boffa Miskell 2014).

Figure 7: Relative abundance of major invertebrate taxa at each site.

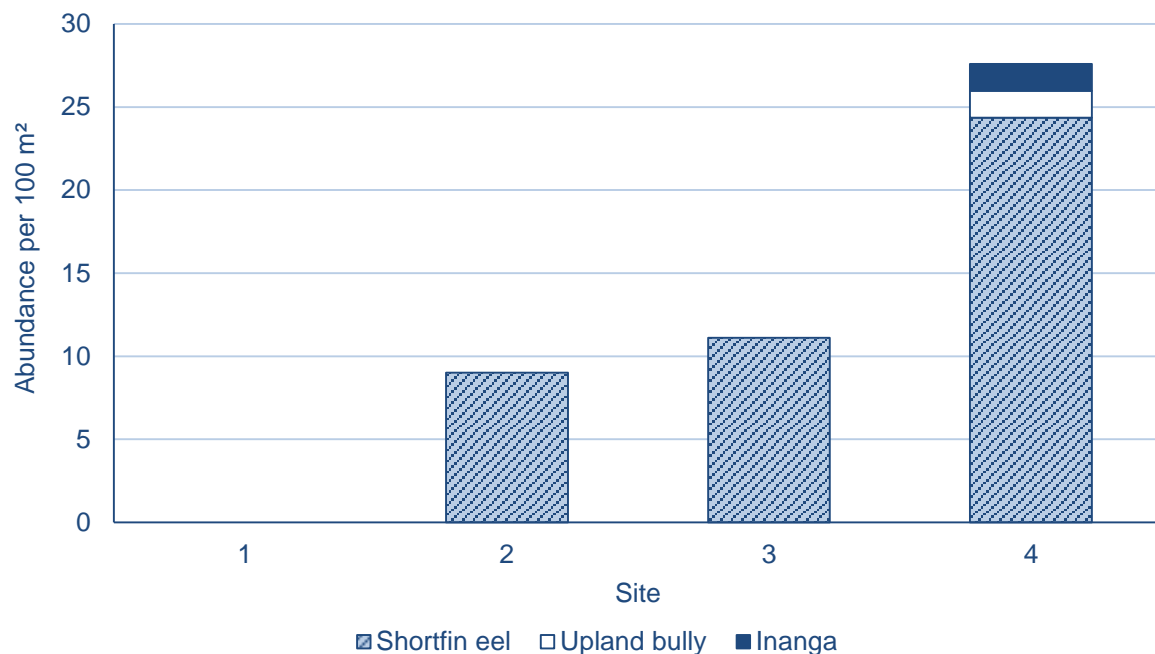
Fish diversity was low overall, with only three species caught: shortfin eel (*Anguilla australis*), inanga (*Galaxias maculatus*), and upland bully (*Gobiomorphus breviceps*). No fish were caught at Site 1, although a single large eel was observed prior to fishing. Only shortfin eel were caught at Sites 2 and 3, but an adult inanga was observed at Site 3 (Table 5). Eel abundance at Site 4 was double that at Sites 2 and 3 (Figure 10). Shortfin eel are a common native species that are also important mahinga kai. Upland bullies are common native species, while native inanga are of conservation interest because they are classified as At Risk – Declining, and their juveniles comprise the annual whitebait catch that is of cultural and recreational value.

Figure 10: Fish species and abundance at the four sampling sites.

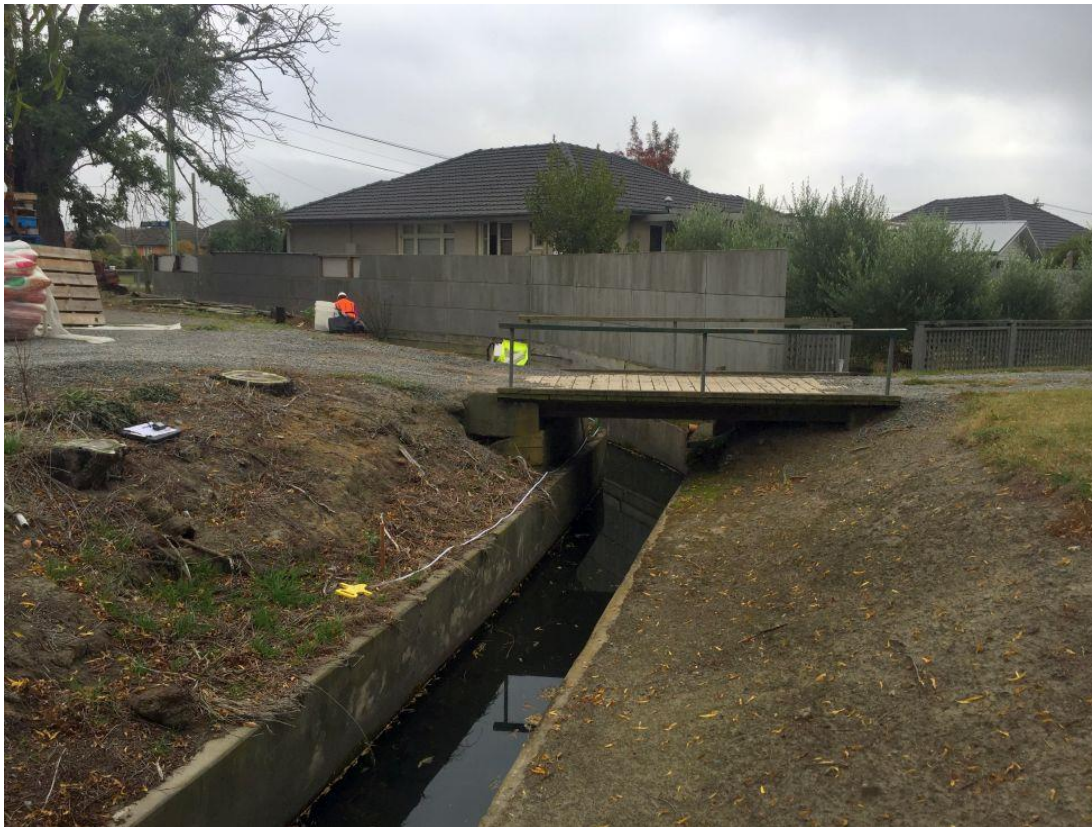
*Figure 1: Site 1, view upstream from the bottom of the reach.*

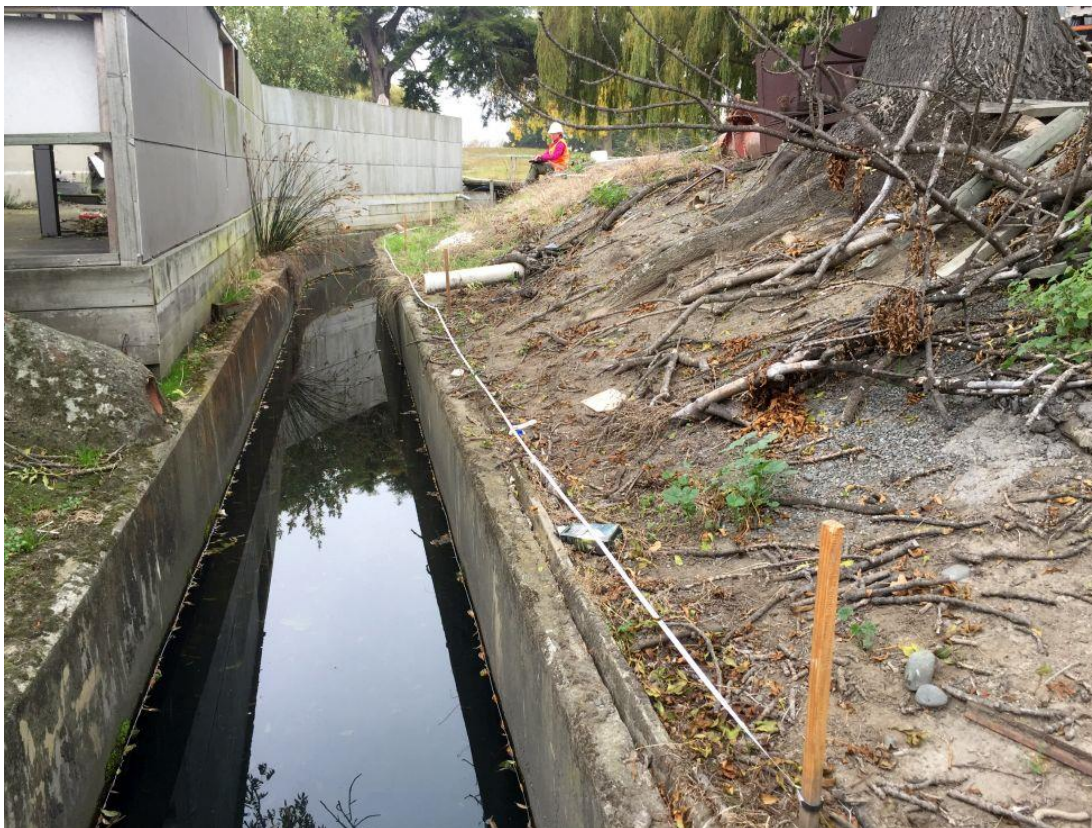
*Figure 2: Site 1, view downstream from the top of the reach.*

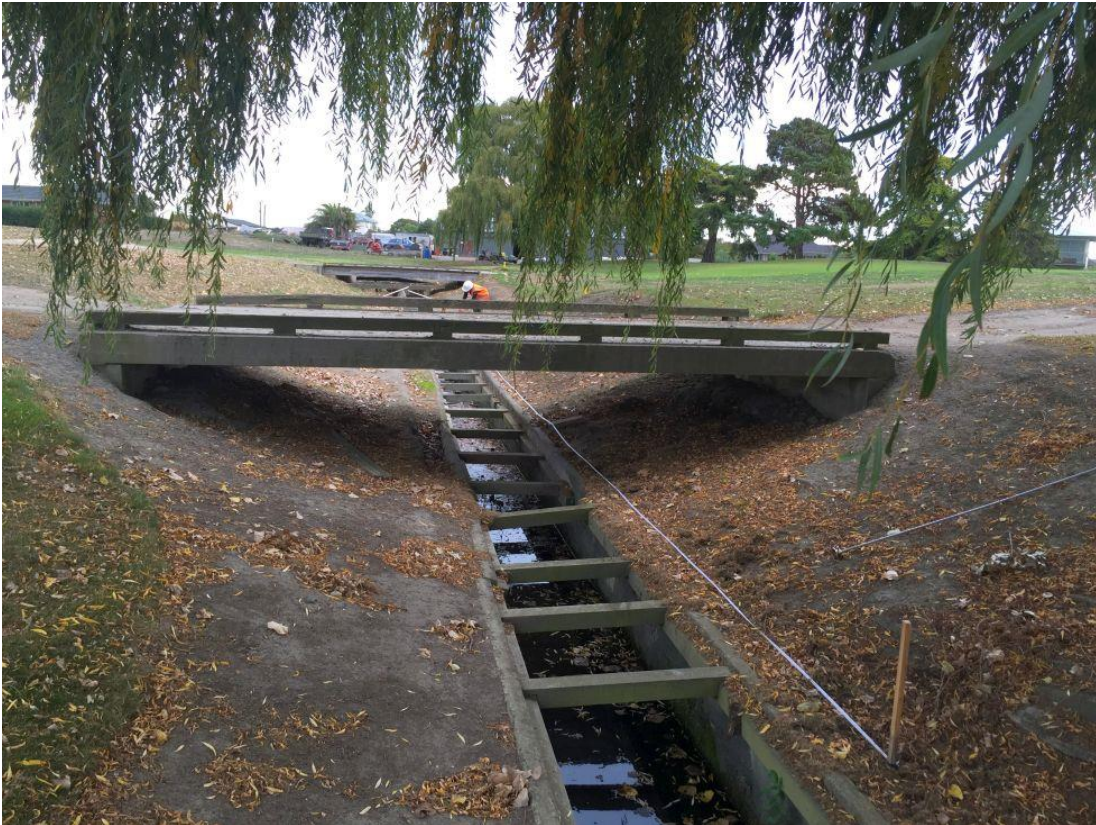
Figure 3: Site 2, view upstream from the bottom of the reach.

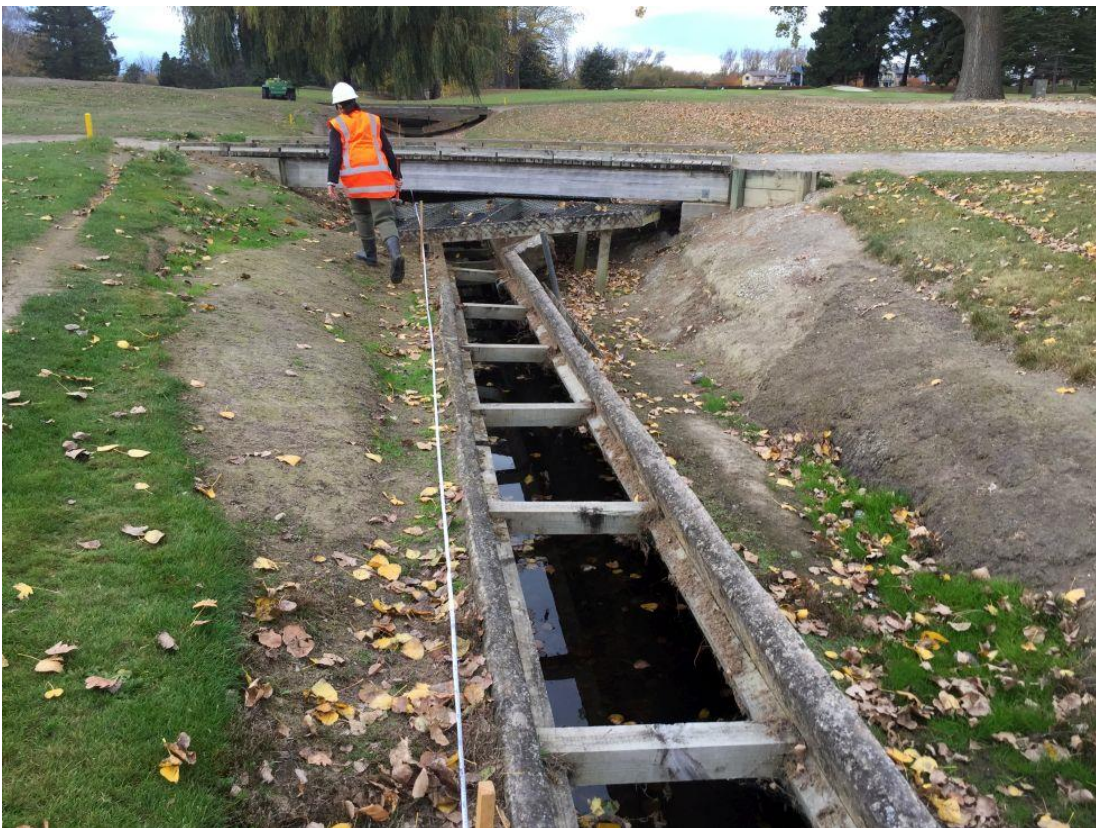
Figure 4: Site 2, view downstream from the top of the reach.

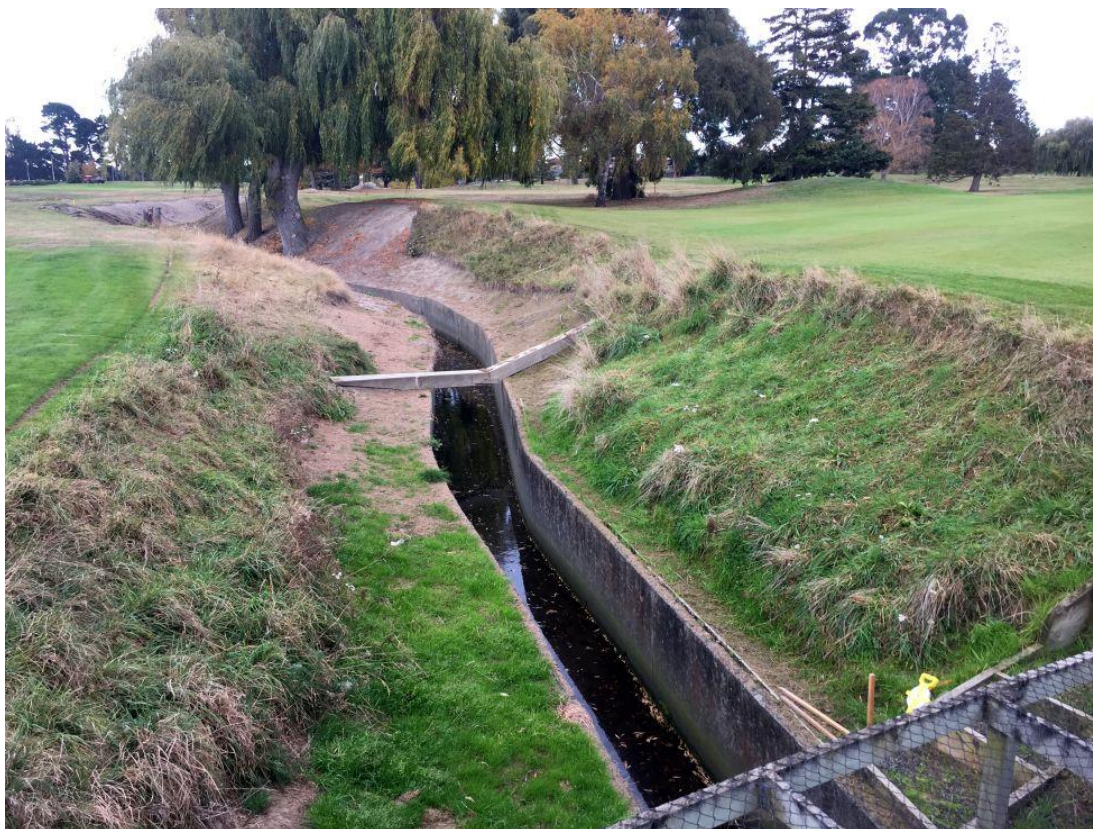
*Figure 5: Site 3, view upstream from the bottom of the reach.*

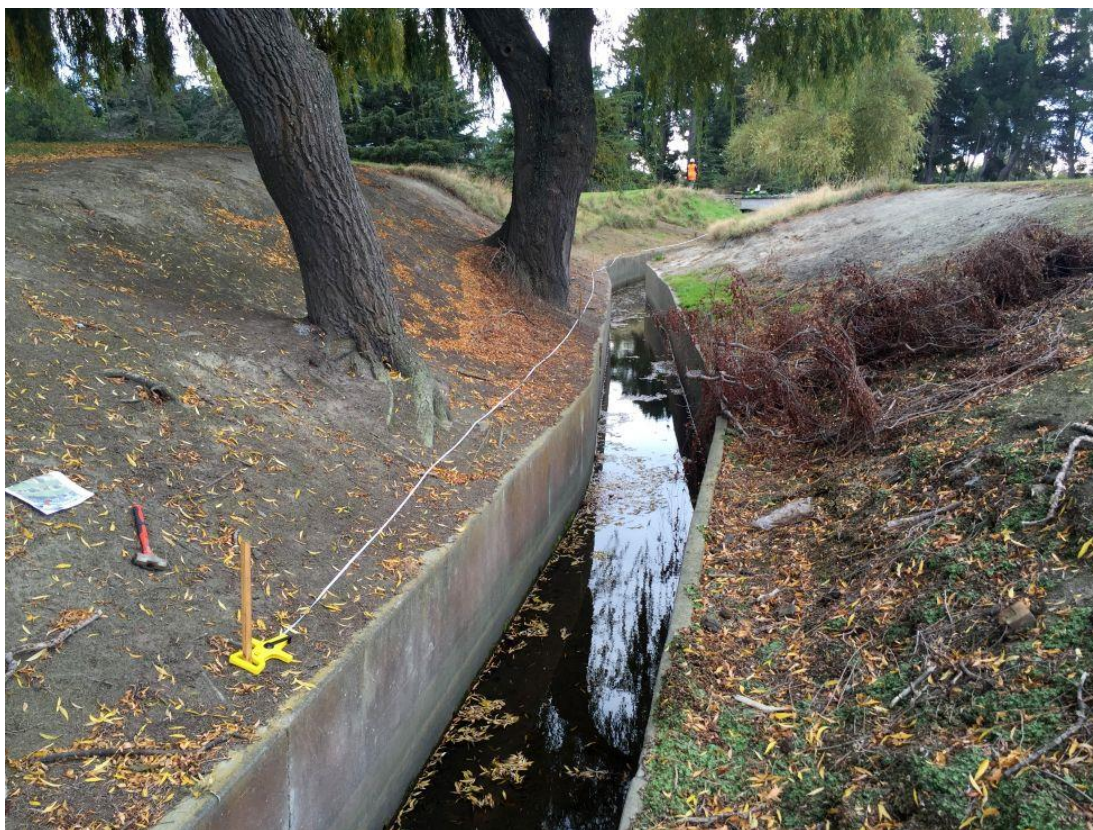
*Figure 6: Site 3, view downstream from the top of the reach.*

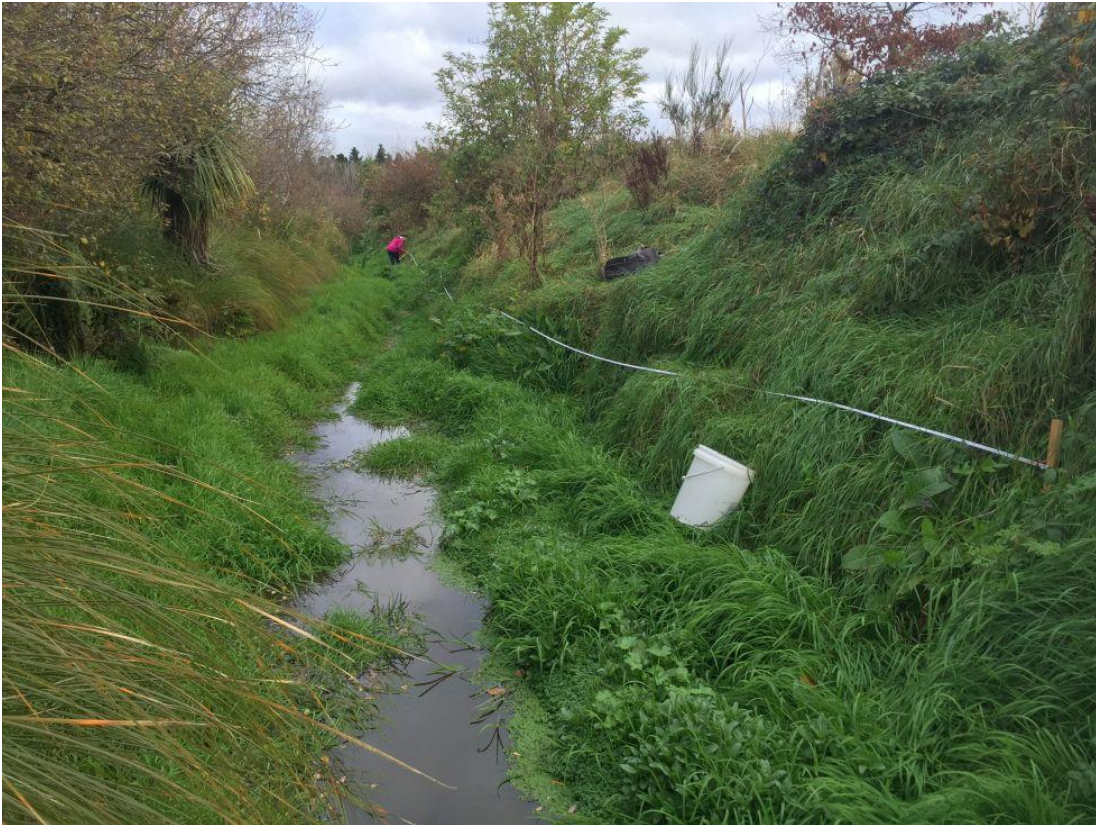
*Figure 7: Site 4, view upstream from the bottom of the reach.*

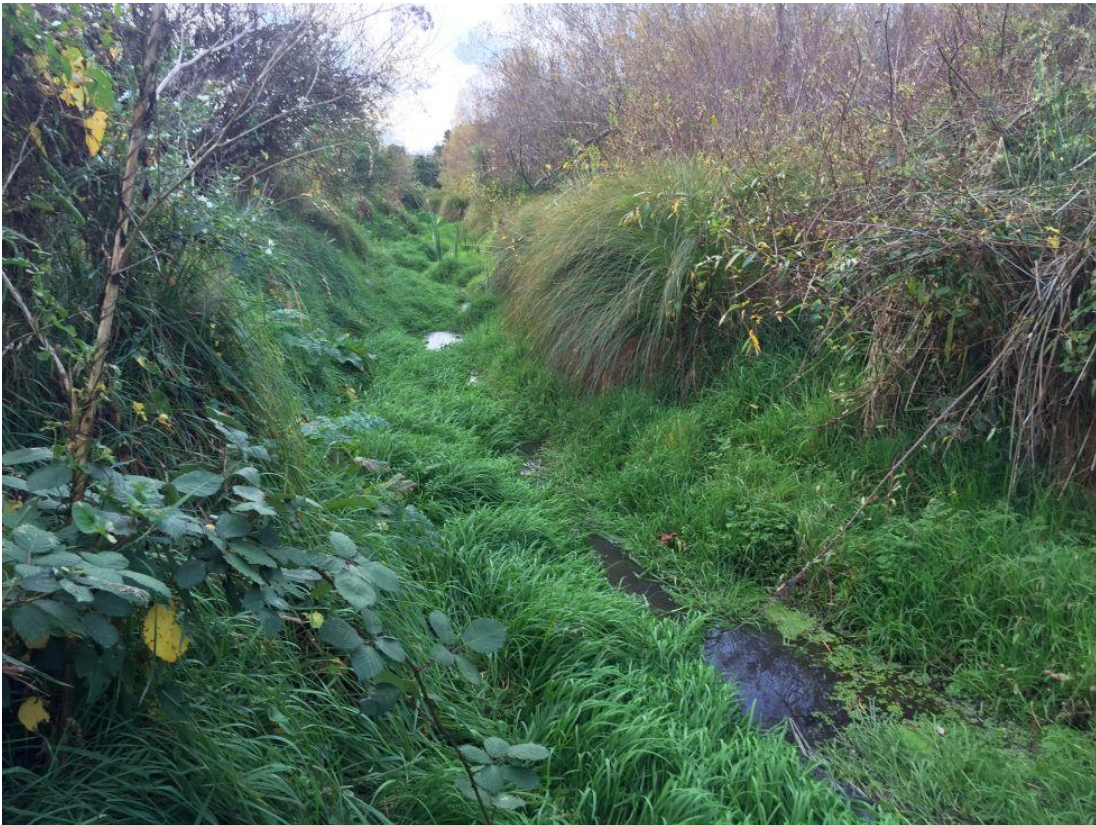
*Figure 8: Site 4, view downstream from the top of the reach.*
