1.8 Boundary treatments

1.8.1 Brick Wall

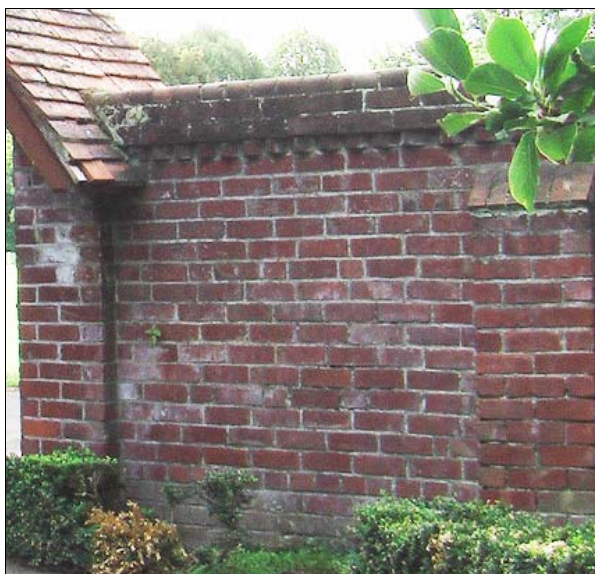
Figure 1.27. Boundary wall showing biological growth and initial stages of plant colonisation on brick surface. Source: L. Beaumont, 2012

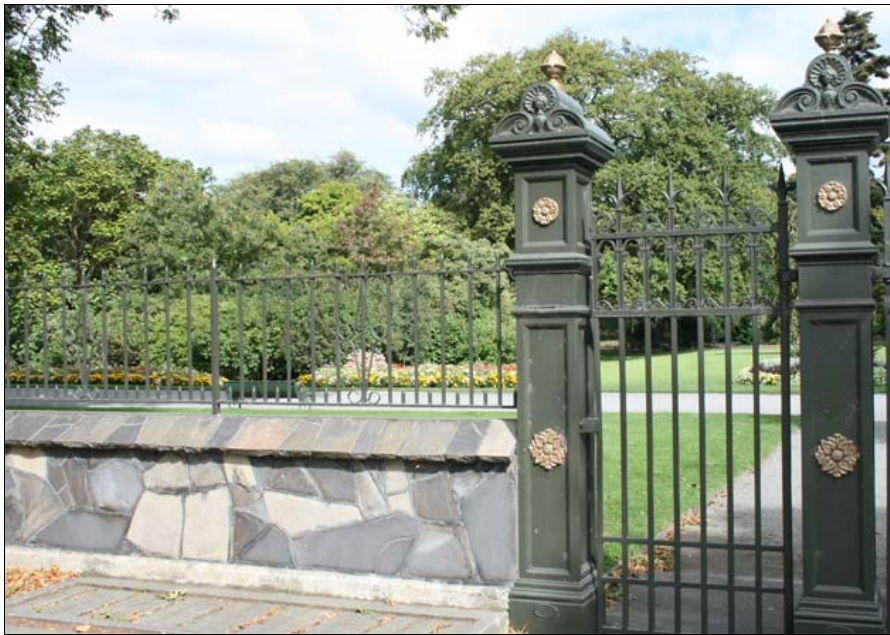
<p>Figure 1.28. Portion of the Rolleston Avenue wall. Source: L. Beaumont, 2012</p>	
<p>History: In 1960 the 90-year-old Rolleston Avenue holly hedge was described as being in very bad repair and unable to fulfil its role in keeping out unauthorised persons. To address this security issue, and replace the hedge with an alternative that was more in keeping with the dignity of the three main entrances, the then Assistant Curator, Lawrie Metcalf, recommended the construction of a stone wall. This, he suggested, would be a way of marking the approaching centenary of the Botanic Gardens.⁷⁸</p> <p>Plans for a stone and wrought iron fence were drawn up in early 1962 by Edgar Taylor, Christchurch City Council's Landscape Architect. Taylor's design respected the three existing, long-established, egress points and incorporated the Gardens' three heritage gates and pillars and the west wing wall into his overall scheme.</p>

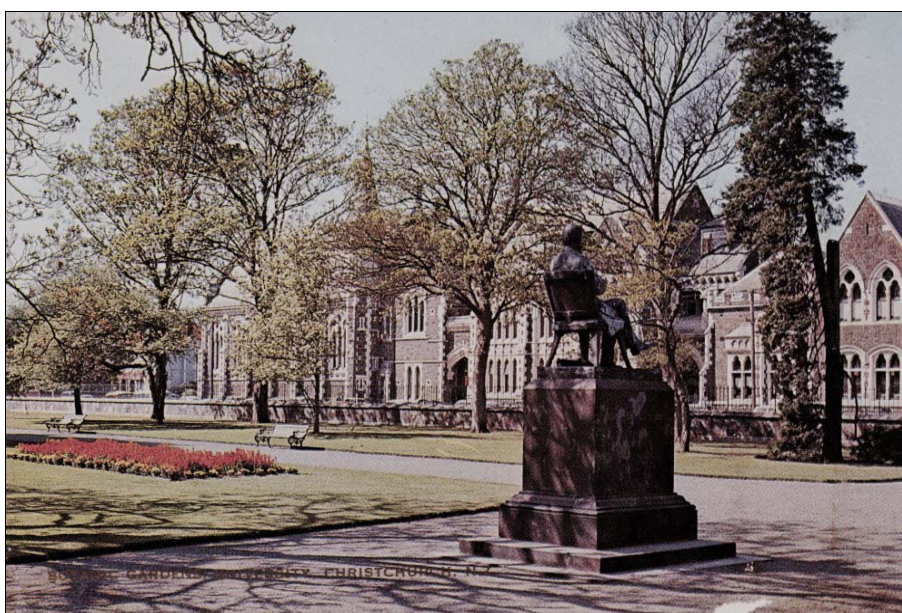
Figure 1.29. Postcard view of the Rolleston Avenue wall with the Arts Centre backdrop ca.1963.
Source: Sir George Grey Special Collections, 996-571, APL

Materially, Taylor took his cue from the surrounding buildings, and reflected one of the ornamental elements from the carriage gates in simplified form in the wrought iron work. Council minutes at the time described his design as *“harmonising with and conforming to the architectural qualities of the adjacent buildings and providing a pleasing link in the unification of associated effects.”*

As well as providing the design for the wall Taylor is also understood to have selected the stone for its construction and supervised its erection. Considering this to be a notable culmination to his 21 years service with the Council.⁷⁹ Erection of the wall was carried out by Council tradesmen and a stonemason was employed to undertake the stonework.

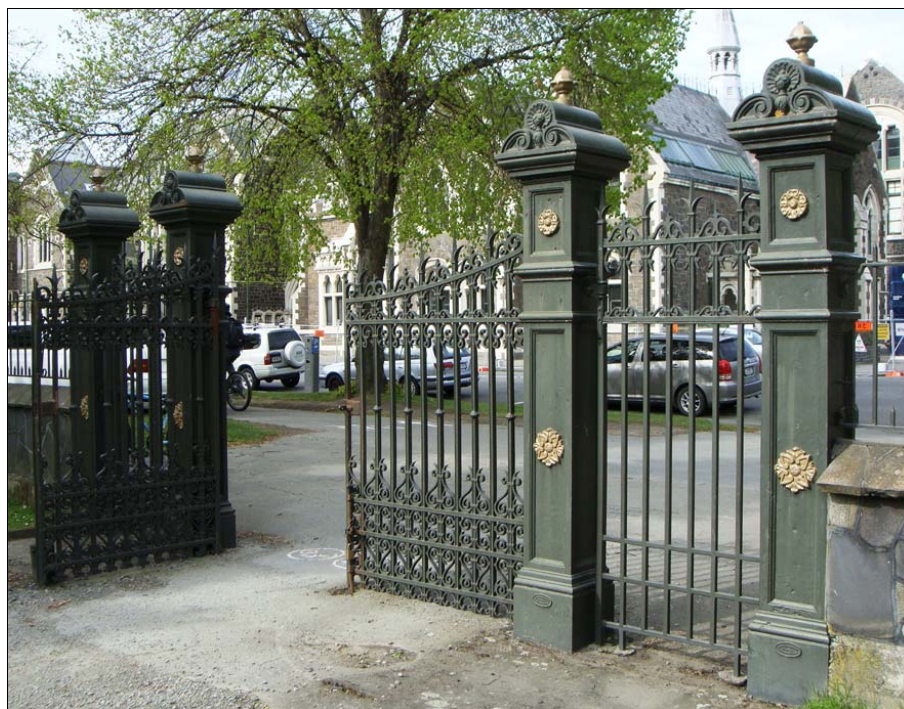
Figure 1.31. Hereford Street Gates, Rolleston Avenue showing altered foot gate.
See figure 1.32 for comparison.
Source: DPAL, 2012

At some point after the construction of the Rolleston Avenue wall and the publication of *A Garden Century* in 1963, the foot gates at the Hereford Street entrance were either partially re-fabricated (the lower two-thirds of the gate) or replaced with a new simplified version of the original gate. (Refer figures 1.31 and 1.35.)

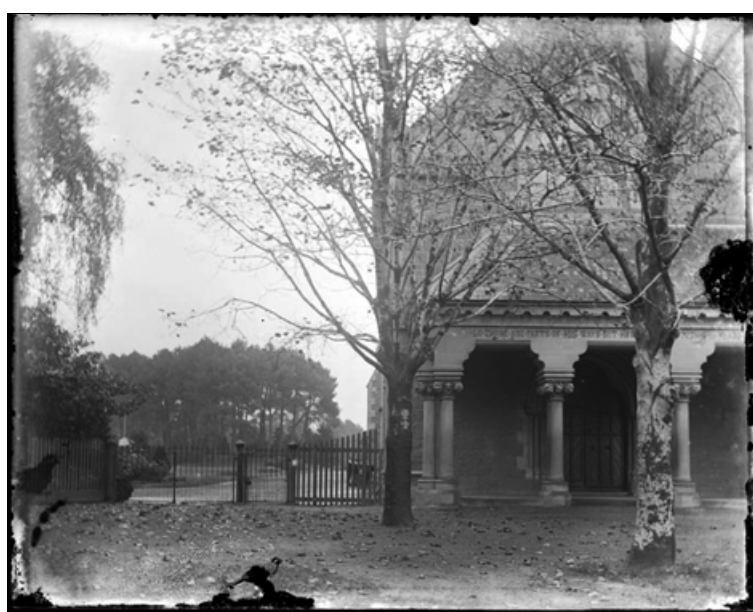
Figure 1.32. Early entrance into the Domain, note timber pailing fence, n.d.
Source: Photo 26332/1667/B7/012, MBL

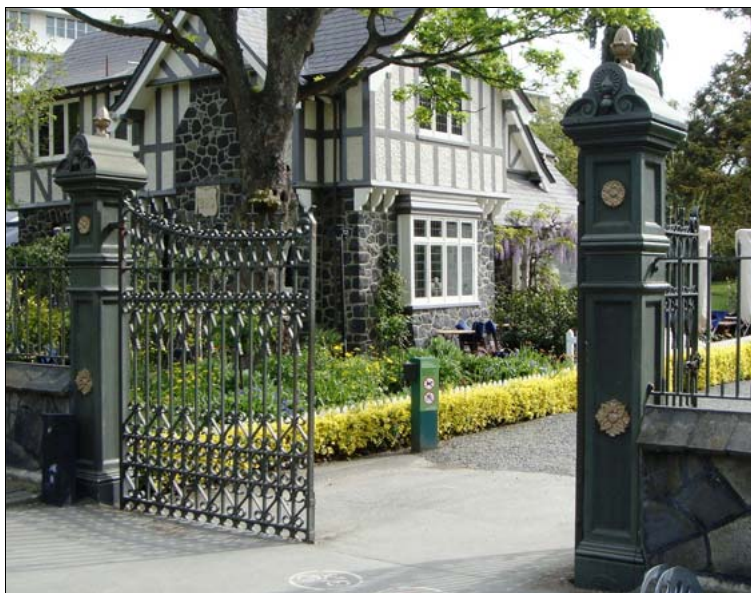
Figure 1.33. Curator's House Gates, Rolleston Avenue.
Source: DPAL, 2012

By January 1912 new gates and pillars had been erected at both the Museum entrance and at the Curator's House entrance. These gates were funded by money raised through the Domain fêtes. Both are extant. These were an important and carefully considered new acquisition by the Domain Board who were noted to have spent some two hours discussing the various designs that had been submitted. The gates were made by the Christchurch firm of Cooper and Duncan and are noted to be of a similar style to the Anderson gates and gate pillars but are differently ornamented.

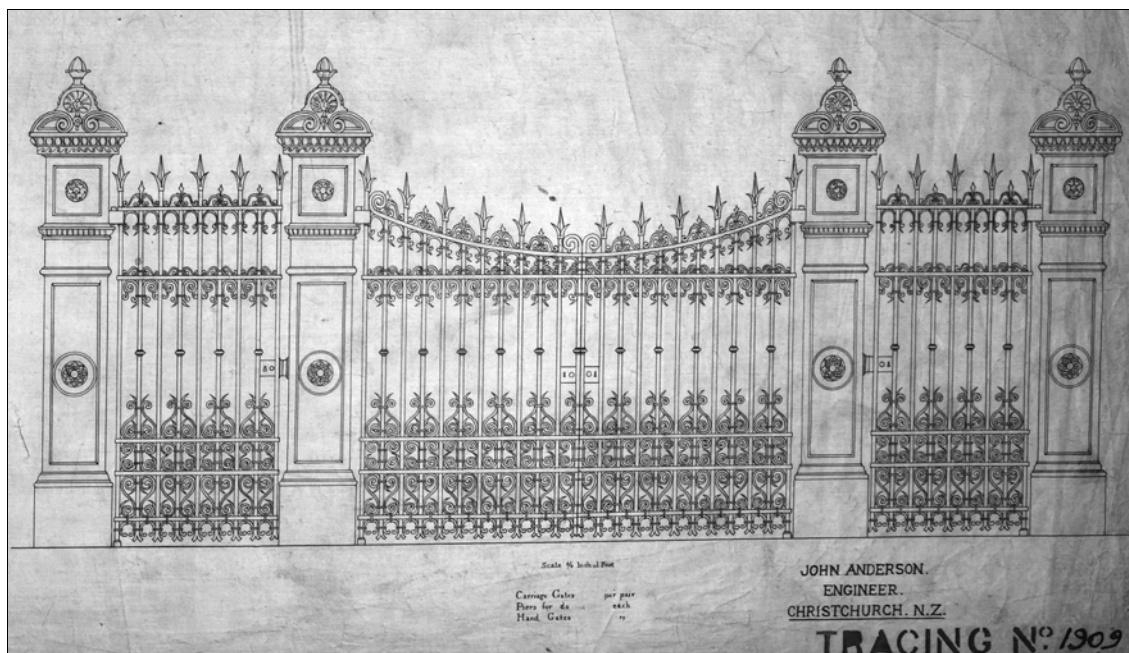
Figure 1.34. John Anderson Pattern 16, Tracing No. 1909, undated.
Source: J Anderson, Carriage Gate plans, Ref 2513, CMDRC

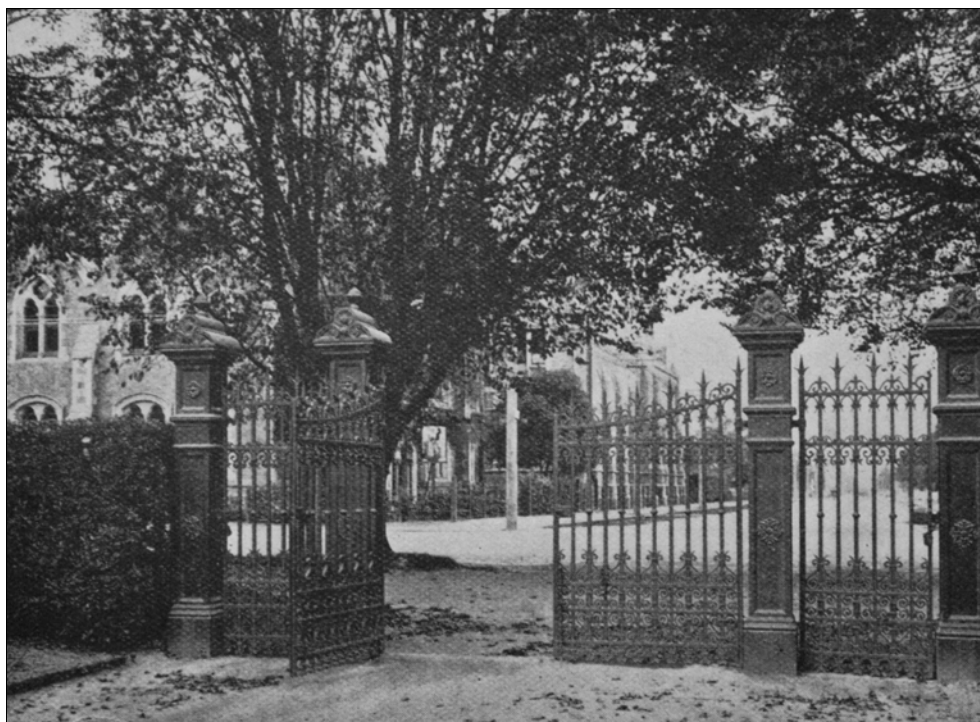
Figure 1.35. Centre Gates showing original foot gates either side of the carriage gates ca.1910.
Source: *Auckland Weekly Press*, 1910

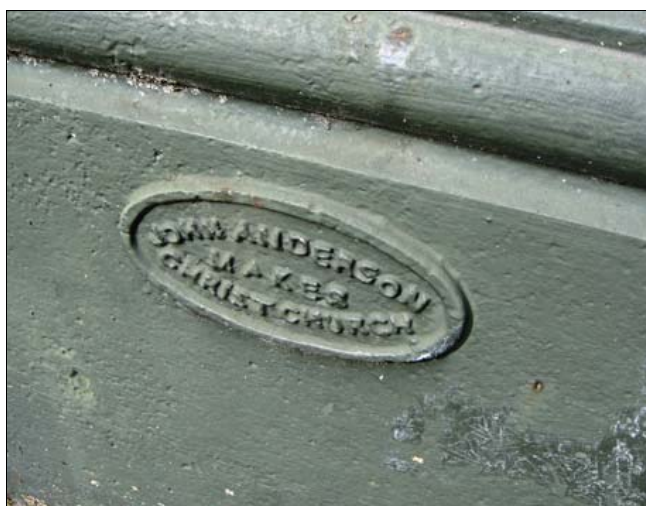
- The Hereford Street Gates and pillars represents the work of the Canterbury Foundry, the city's first foundry, and are notably marked with an early foundry insignia of this business. The Museum and Curator's House Gates similarly represent the work of an early Canterbury foundry, Duncan and Cooper, and are also marked with the insignia of this foundry.

Figure 1.36. Rolleston Avenue pillar foundry insignia opposite Hereford Street showing John Anderson insignia
Source: DPAL, 2012

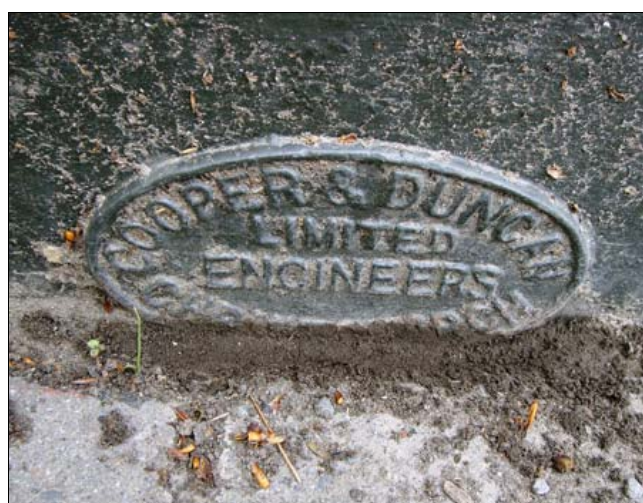
Figure 1.37. Rolleston Avenue pillar foundry insignia at the Museum entrance.
Source: DPAL, 2012

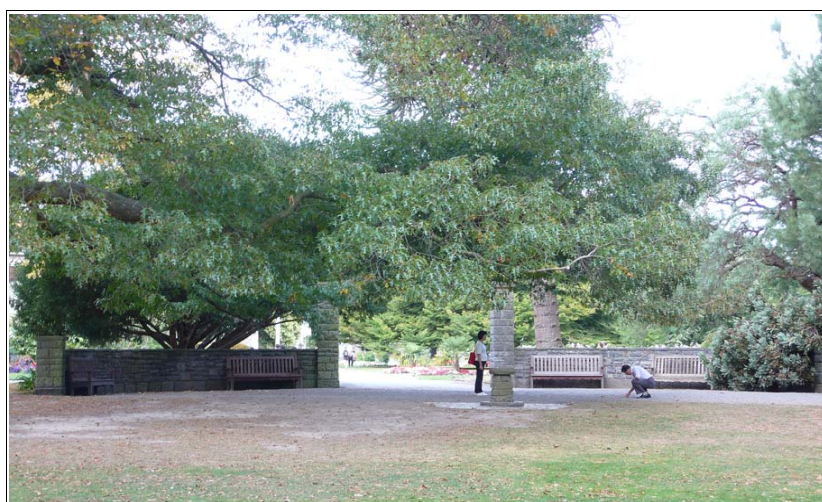
Evidence of minor cracking of the moulded pier caps, particularly on the southern entrance pier. This pier has also sustained damage to the corner areas of the cap. Possibly the consequence of branch fall? Plant growth is evident on the memorial and this has caused deterioration and stone displacement. A structure investigation is required to confirm the integrity of the memorial post earthquake.

Figure 1.39. View of the Eveleyn Couzins Memorial Gateway, 2011. Source: L. Beaumont

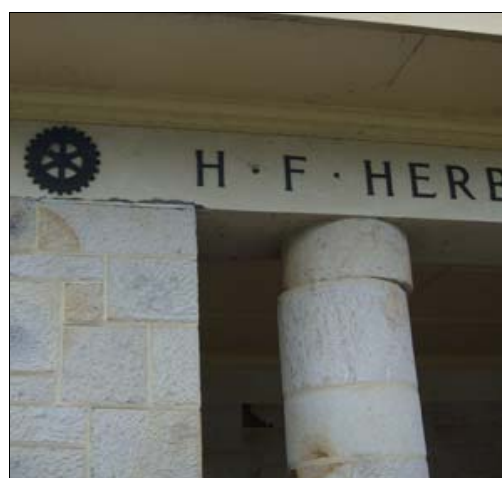
Figure 1.41. Displaced drum columns and cracking.
Source: Dave Pearson, July 2012

The Pavilion is currently closed awaiting an engineering review.

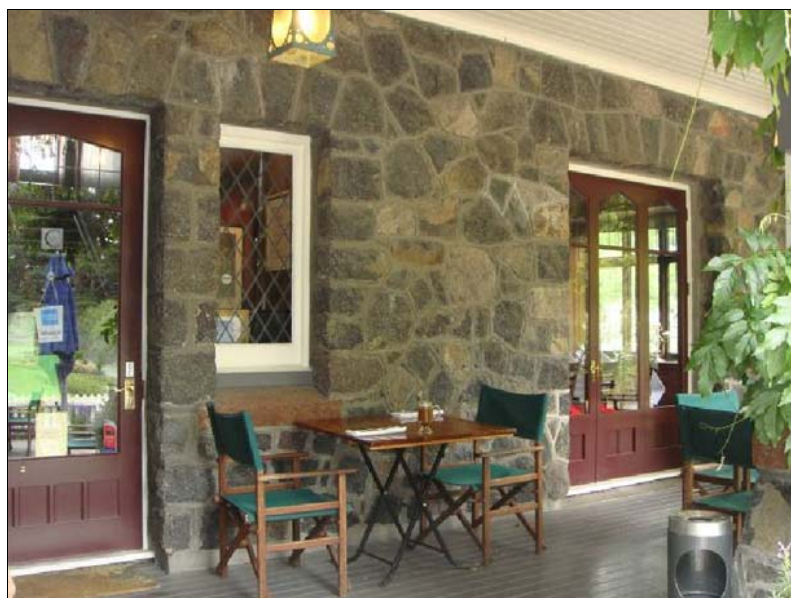
The northern façade has a front verandah on the ground floor. Concrete steps lead up to the verandah. The interior is accessed by a front door on the verandah. The front door is glazed with some timber panelling on the lower section of the door. Next to this on the verandah is a single window with diamond patterned leadlight. Double glazed doors mimicking the front door with the Tudor arch and panelling below feature on the western side of the verandah.

Figure 1.45. Front verandah on northern elevation.
Source: DPAL

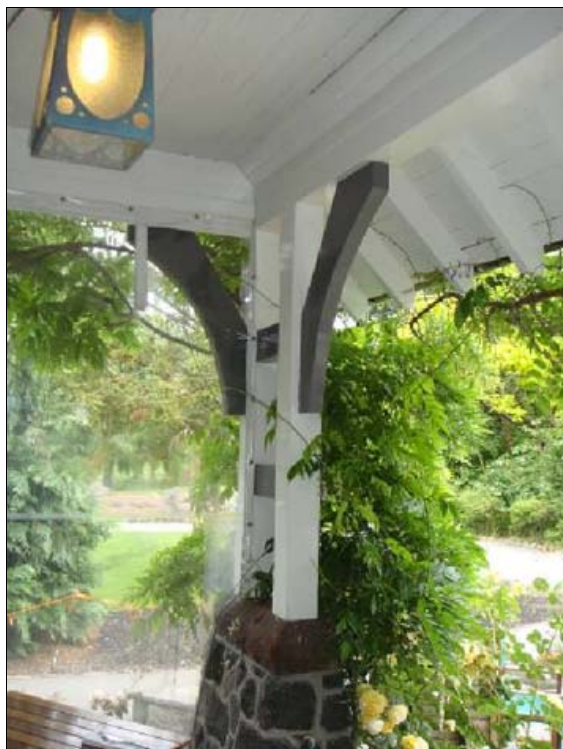
Figure 1.46. Verandah posts.
Source: DPAL

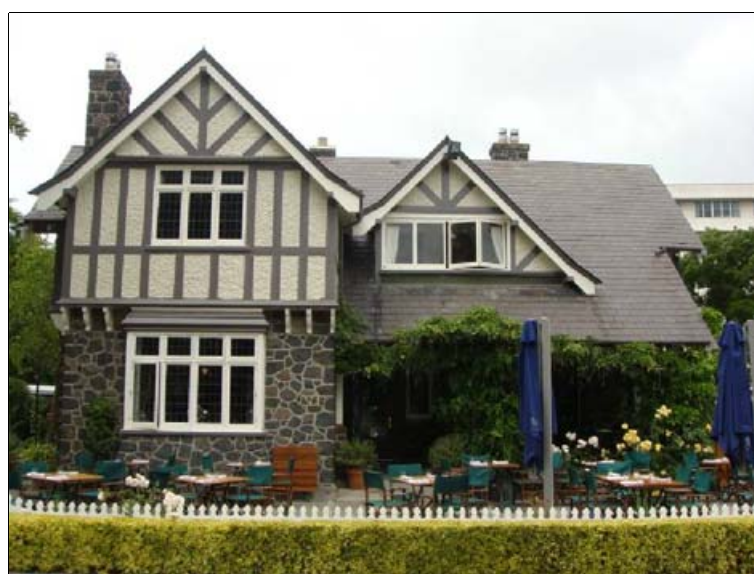
Next to the verandah the house extends out beneath a separate gable creating an L shape on the northern elevation. On the ground floor there is a square shaped window bay consisting of four casement windows with fanlights. All glazing is patterned with leadlight squares. Below the windows the stone bay splays out towards the ground.

Figure 1.47. L-shaped northern elevation with gabled dormer above the verandah.
Source: DPAL

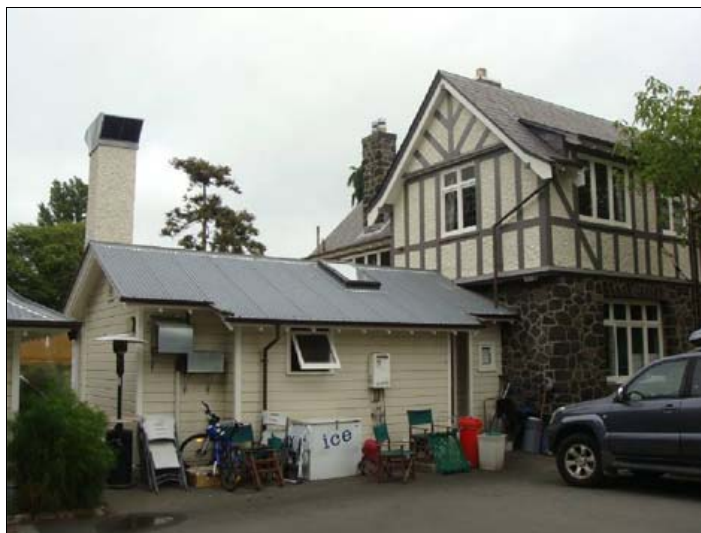
Figure 1.49. Extension on southern side of eastern elevation. Source: DPAL

Attached to the eastern elevation is a rectangular timber extension that has exposed rafters beneath the corrugated steel roof mimicking this bungalow feature on the main house.

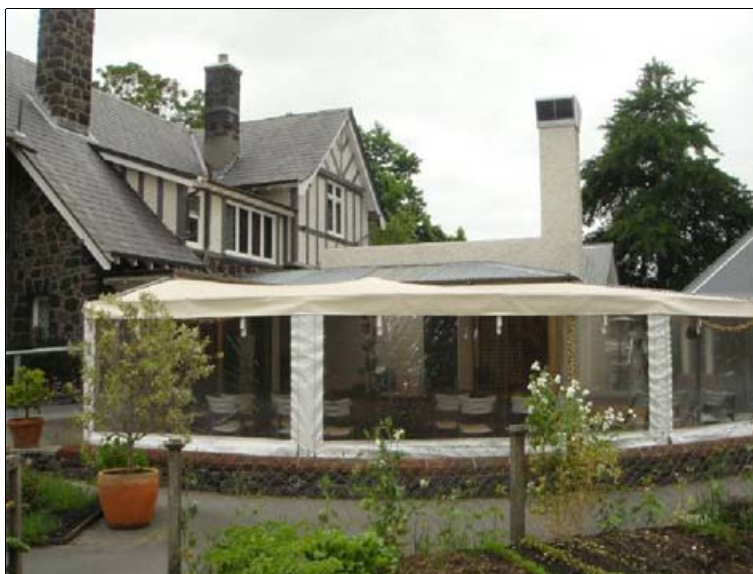
Figure 1.50. Looking towards the southern side of the house from the west.
Source: DPAL

The south elevation at the rear of the house has an extended bay similar to the front elevation. On this extended bay a set of two casement windows with fanlights feature in the upper floor. The same patterned battens over the rough casted finish surrounds the window. Attached to this bay area is the single storey timber addition. A rough cast clad flat roofed extension has been added to the side of the timber addition with a tall chimney on the southern end.

On the ground floor a Tudor shaped entry is situated below the dormer. Two double hung sash windows are positioned on the wall in between this door and another on the western side of the elevation. A flat roof extends out beyond the main roof line.

The south elevation now has a courtyard area protected by removable plastic café blinds below an awning.

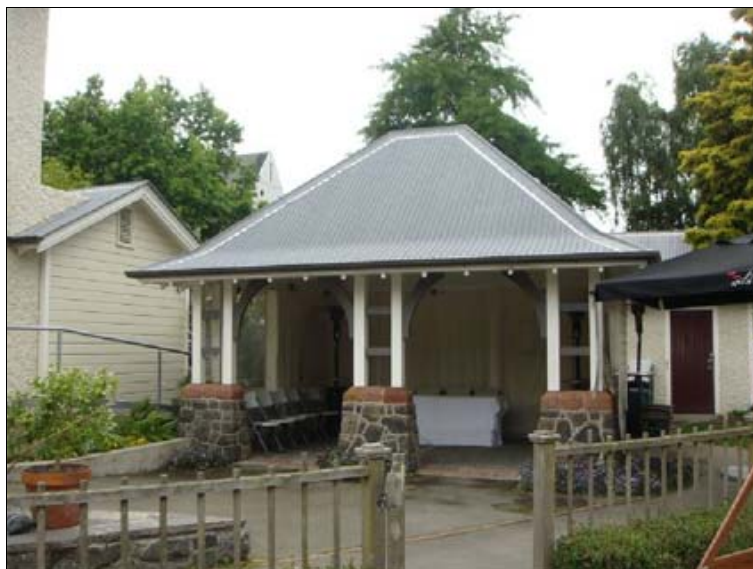
Figure 1.51. Small Curator's House Pavilion.
Source: DPAL

On the southern side of the house there are other buildings such as the small pavilion shown above designed with features that mimic the verandah of the main house. Beside this is another rectangular rough cast clad building.

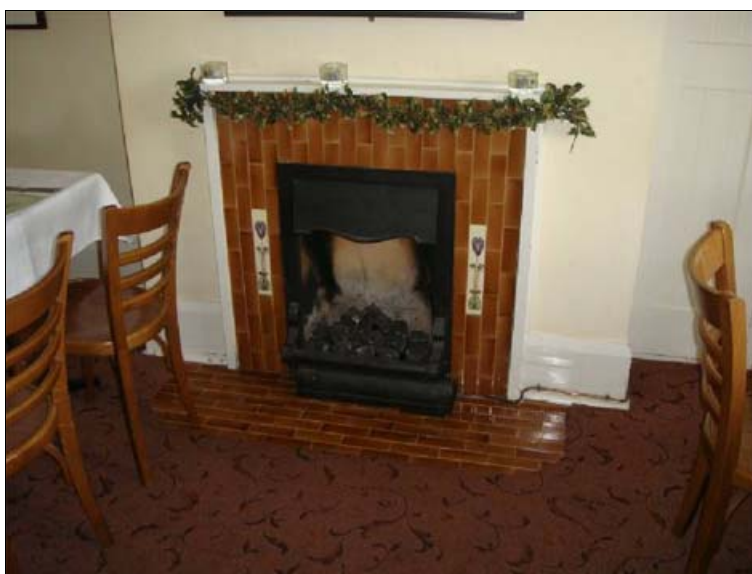
The fireplace and hearth is tiled with an Art Nouveau pattern in F6. The fireplace has been converted to gas.

Figure 1.54 Tiled fireplace in F6.

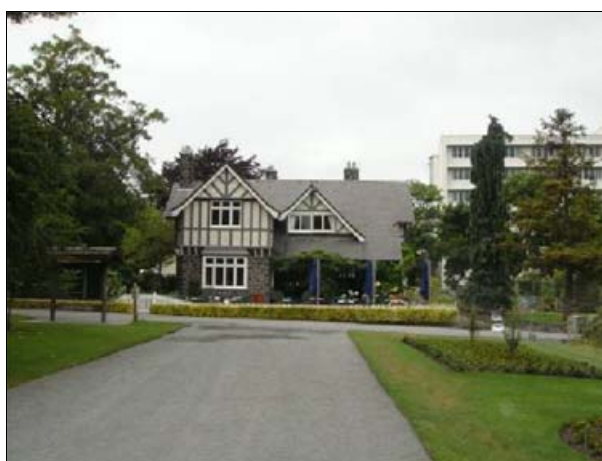
Roof: The gabled roof is sheathed in slate tiles apart from the new kitchen addition at the rear which is clad in corrugated steel.

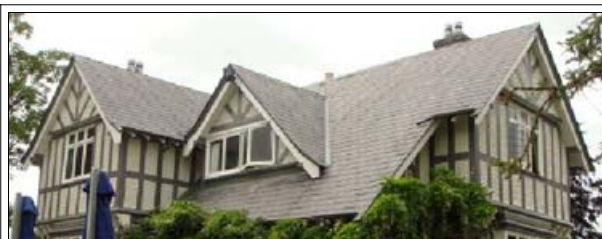
North Elevation: The northern side is the front of the house containing the verandah and front entry. Apart from alterations made to the dormer windows, the front door and windows on the verandah, this façade is very original.

Concrete foundation base (OF)
Original window bay with leadlight(OF)
First floor casement windows with leadlight (OF)
Sumner red stone capping and sills (OF)
Halswell stone angles and quoins (OF)
Random rubble cladding (OF)
Rough cast cladding (OF)
Timber battens (OF)
Moulded brackets below first floor (OF)
Casement window on verandah with leadlight (OF)
Verandah posts and brackets (OF)
Sarking beneath verandah roof (OF)
Exposed rafters below verandah eaves (OF)
Decorative barge boards (OF)

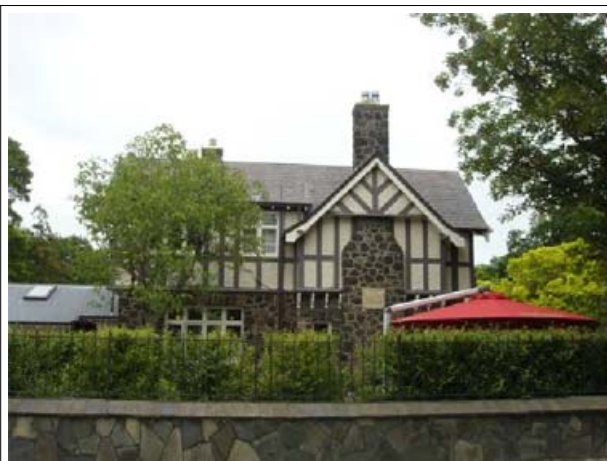
East Elevation: The east elevation faces Rolleston Avenue with a garden between the house and a rock wall beside the street path.

Concrete foundation base (OF)
 Chimney breast with limestone plaque (OF)
 Casement windows both floors with leadlight (OF)
 Sumner red stone capping and sills (OF)
 Halswell stone angles and quoins (OF)
 Random rubble cladding (OF)
 Rough cast cladding (OF)
 Timber battens (OF)
 Moulded brackets below first floor (OF)
 Exposed rafters (OF)
 Decorative barge boards (OF)

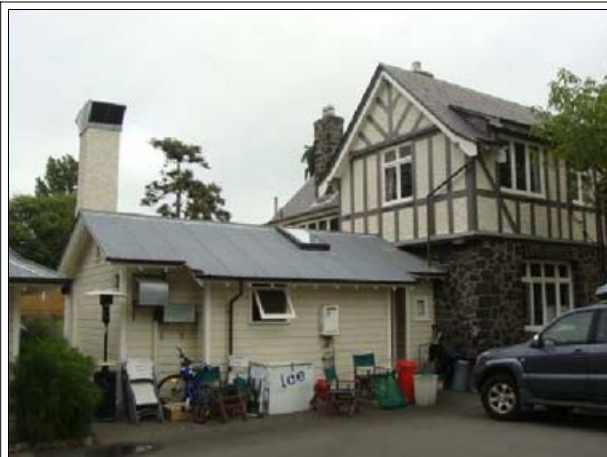
East Elevation: Modifications to this elevation have altered its appearance. However the original house is still apparent beyond the added kitchen. A small pavilion or summer house has been added on this side as well as a storage room.

Concrete foundation base (OF)
 Casement windows first floor with leadlight (OF)
 Halswell stone angles and quoins (OF)
 Random rubble cladding (OF)
 Rough cast cladding (OF)
 Timber battens (OF)
 Eaves brackets below dormer (OF)
 Exposed rafters(OF)
 Decorative barge boards (OF)

Back door added (RF)
 Windows on ground floor(RF)
 New deck and pergola (RF)

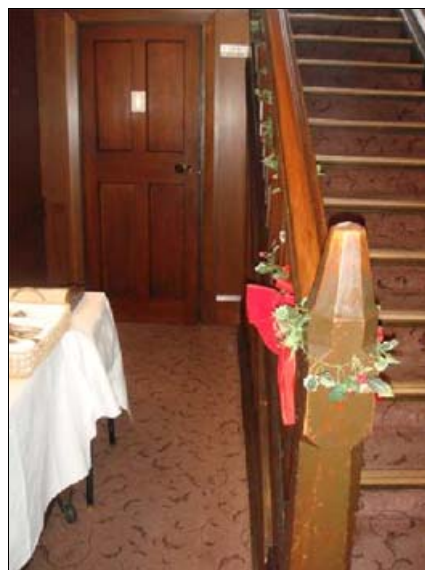
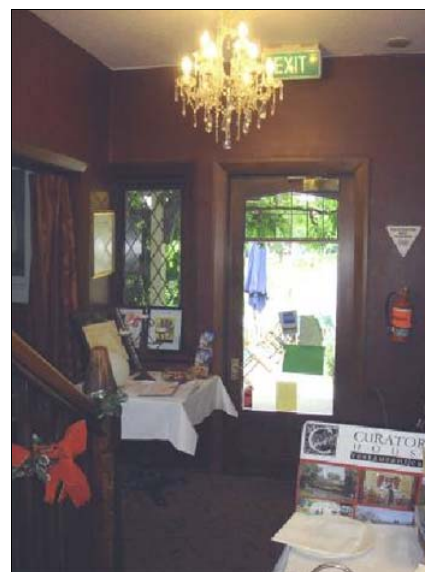
Former Kitchen (G2): Significant alterations have taken place in this room which was once the kitchen. It is now a bar area for the restaurant.

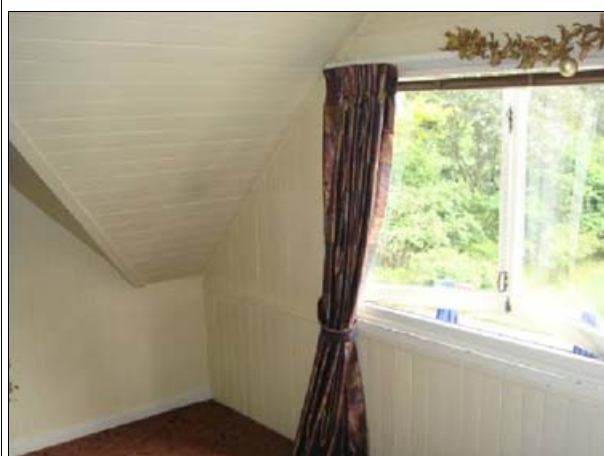
Former Laundry Now the women's toilets, this room was reconfigured to accommodate toilet cubicles.

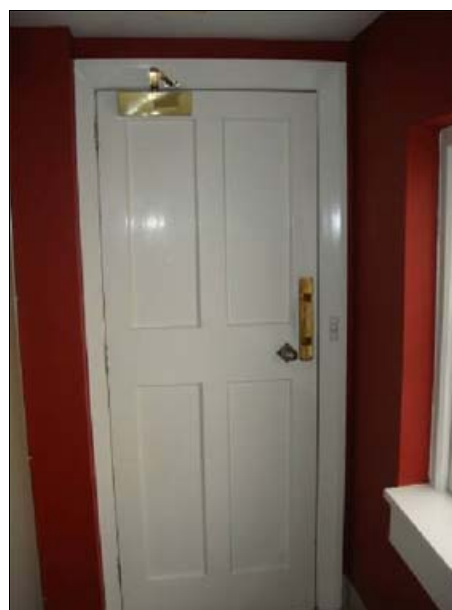
Former Bathroom (F2): On the eastern side of the hall this room is now an office.

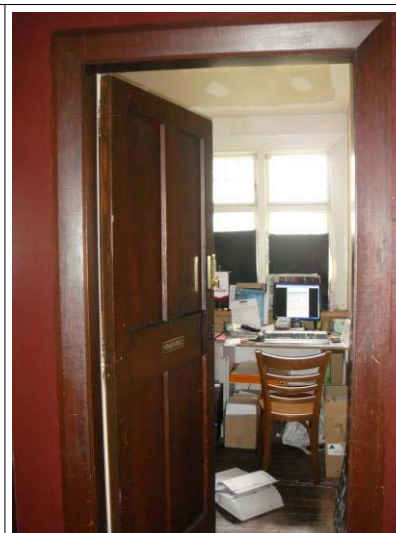
First Floor Hall (F4):

There have been few alterations to the hall apart from expanded openings.

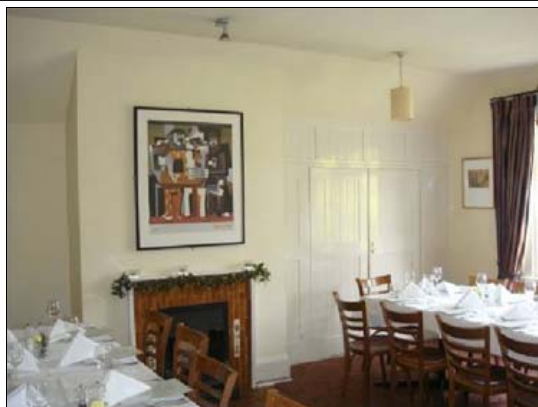
Former Bedroom (F3): On the eastern side of the hall this room is now another dining area of the restaurant.

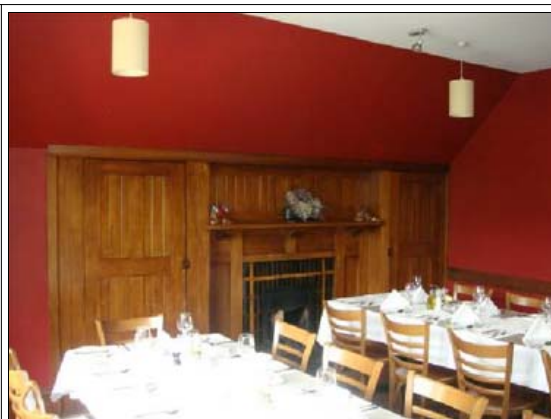
Former Bedroom (F1): On the eastern side of the hall this room is now another dining area of the restaurant.

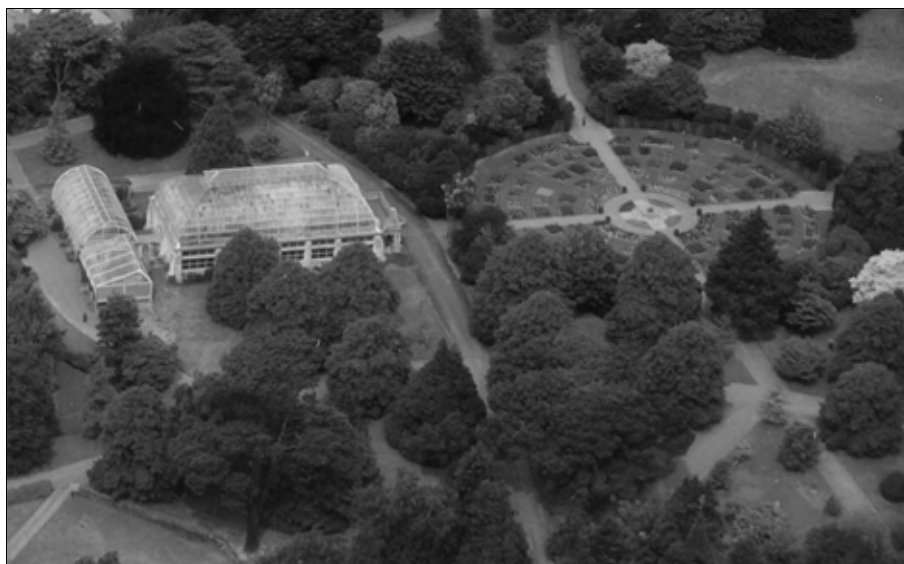
Figure 1.58. Aerial view of the Rosary, Cuningham House and new Show Houses in 1962. Apart from the replacement of the central pool with the Stevenson sundial and an increase in tree density the relationship between the building and setting remains the same today.

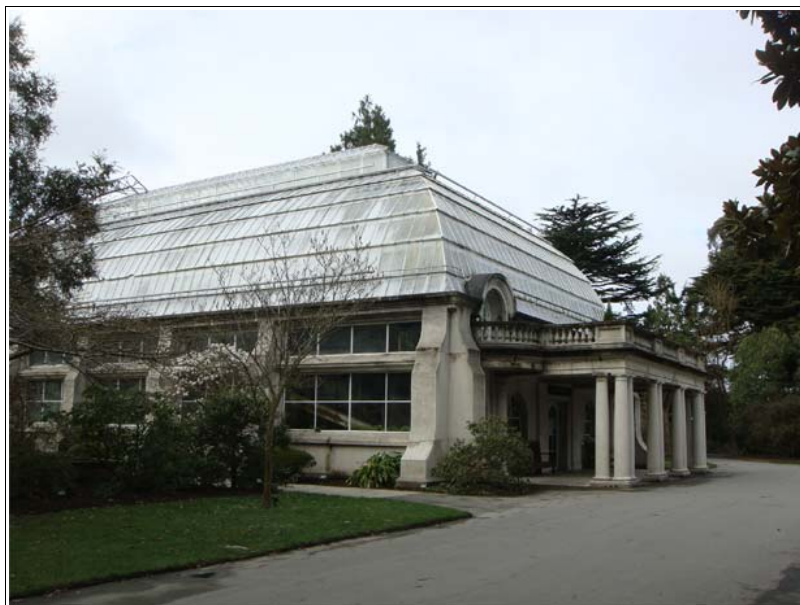
Figure 1.59. Cuninghame House Winter Garden looking towards the front entrance, 2012. The large concrete buttresses can be seen on the side of the building. Source: DPAL

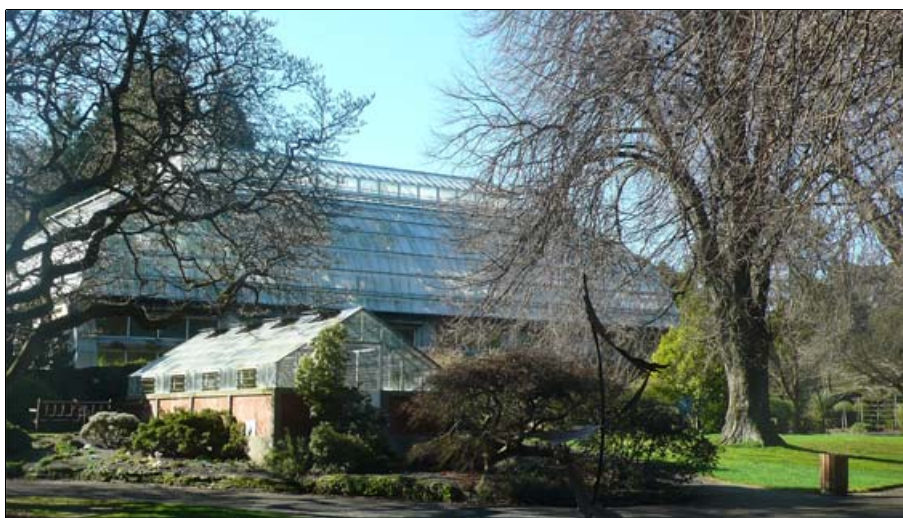
Figure 1.60. West elevation of Cuninghame House, Foweraker House in foreground
Source: L. Beaumont 2010

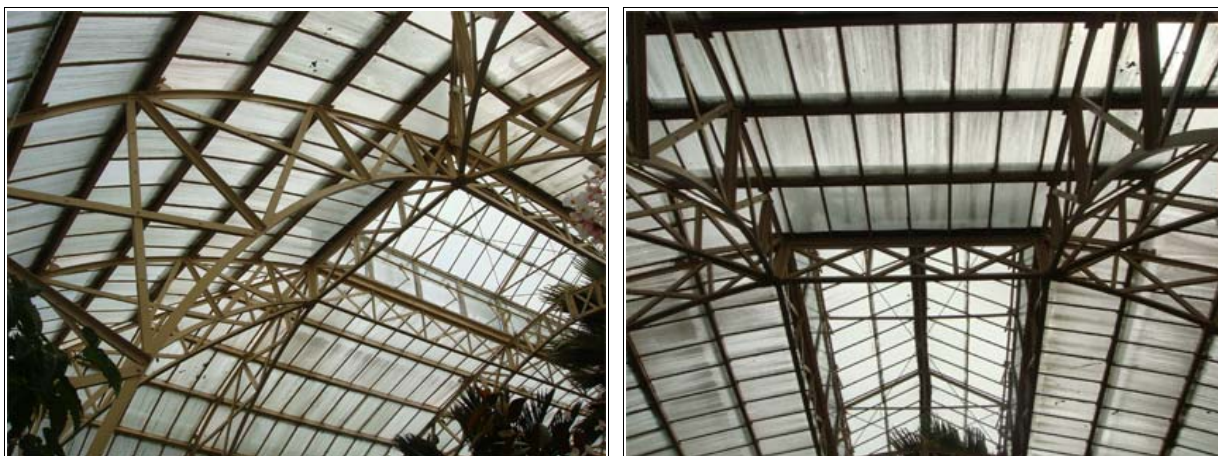
Figure 1.63. The roof structure with large steel trusses and the steel purlins.

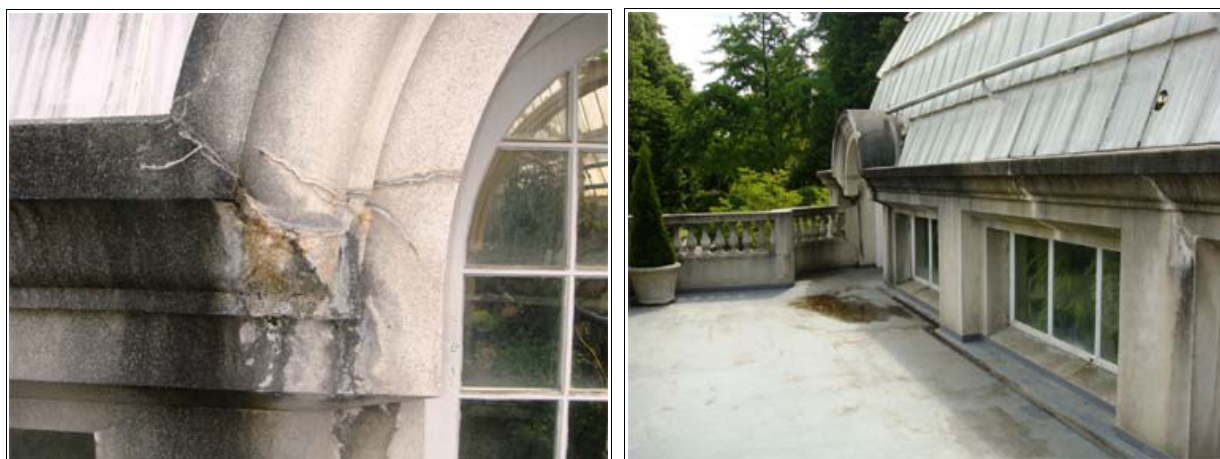
Figure 1.64. Cracks in the plaster and signs of efflorescence and spalling beneath the arch and along the cornice beneath the roofline. Source: DPAL

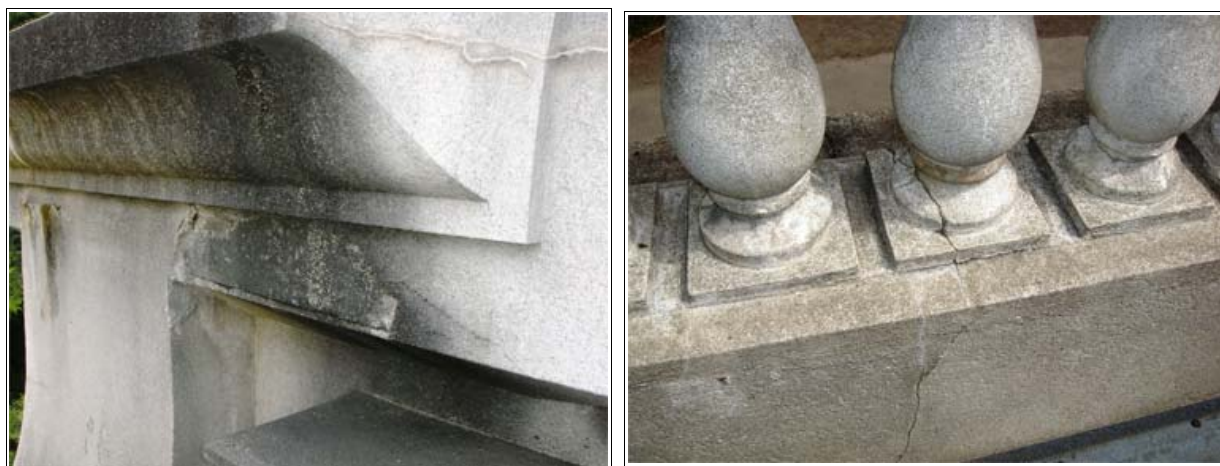
Figure 1.65. Plaster spalling (left) and cracks in the balustrade (right).
Source: DPAL

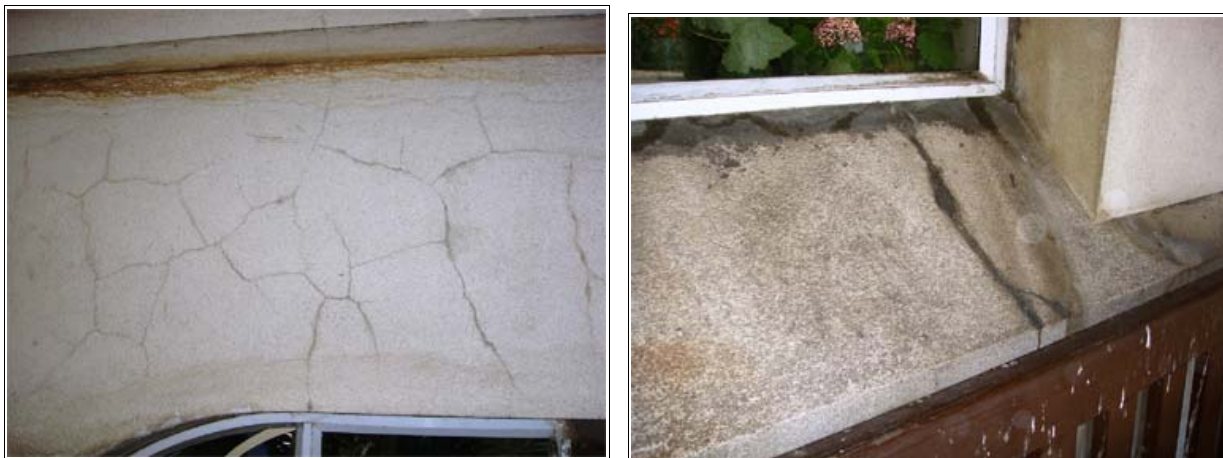
Figure 1.66. Crazing of the plaster work on ground floor verandah wall (left) and cracks in the window sill (right).

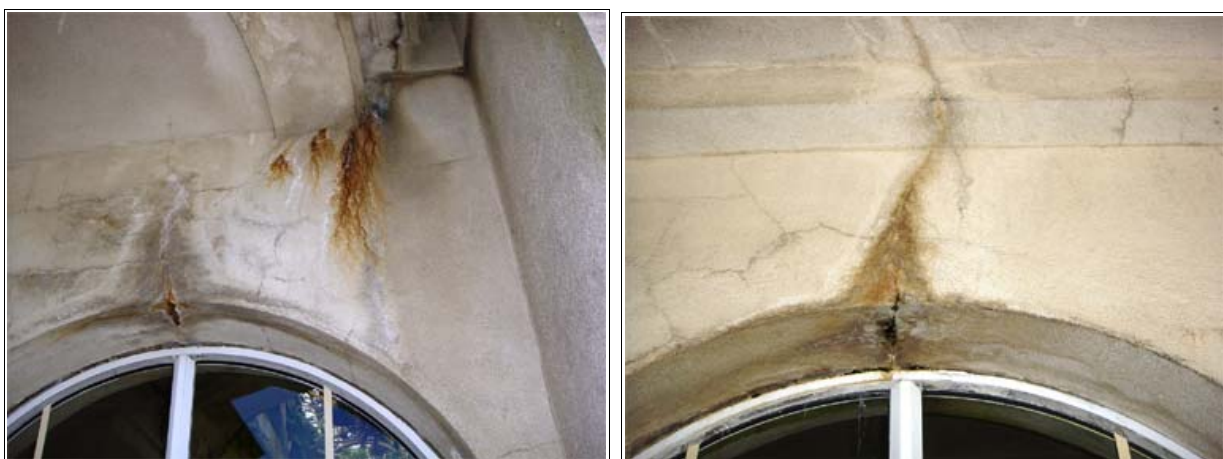
Figure 1.67. Cracks and signs efflorescence and rust stains above windows on the ground floor portico.

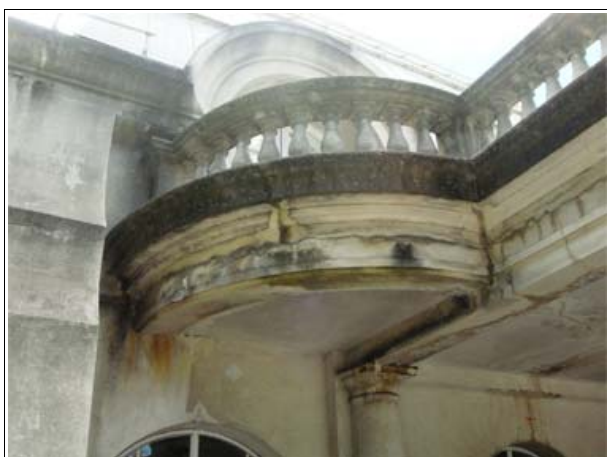
Figure 1.68. Evidence of cracking and moisture on the spandrel of the balcony.

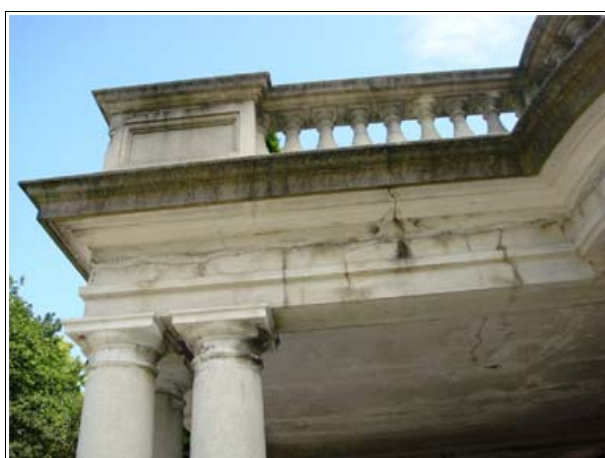
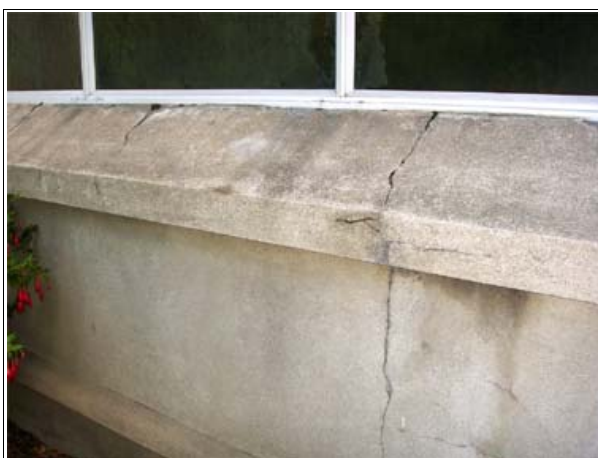
Figure 1.69. Cracks in the plaster spandrel (left) and in the windows sills extending down the wall (right).
