memorandum

TO Christchurch City Council FROM [REDACTED]
DATE 17/03/2023
RE Living Earth Odour Monitoring: 13th February 2023 to 26th February 2023 Summary

1.0 Background

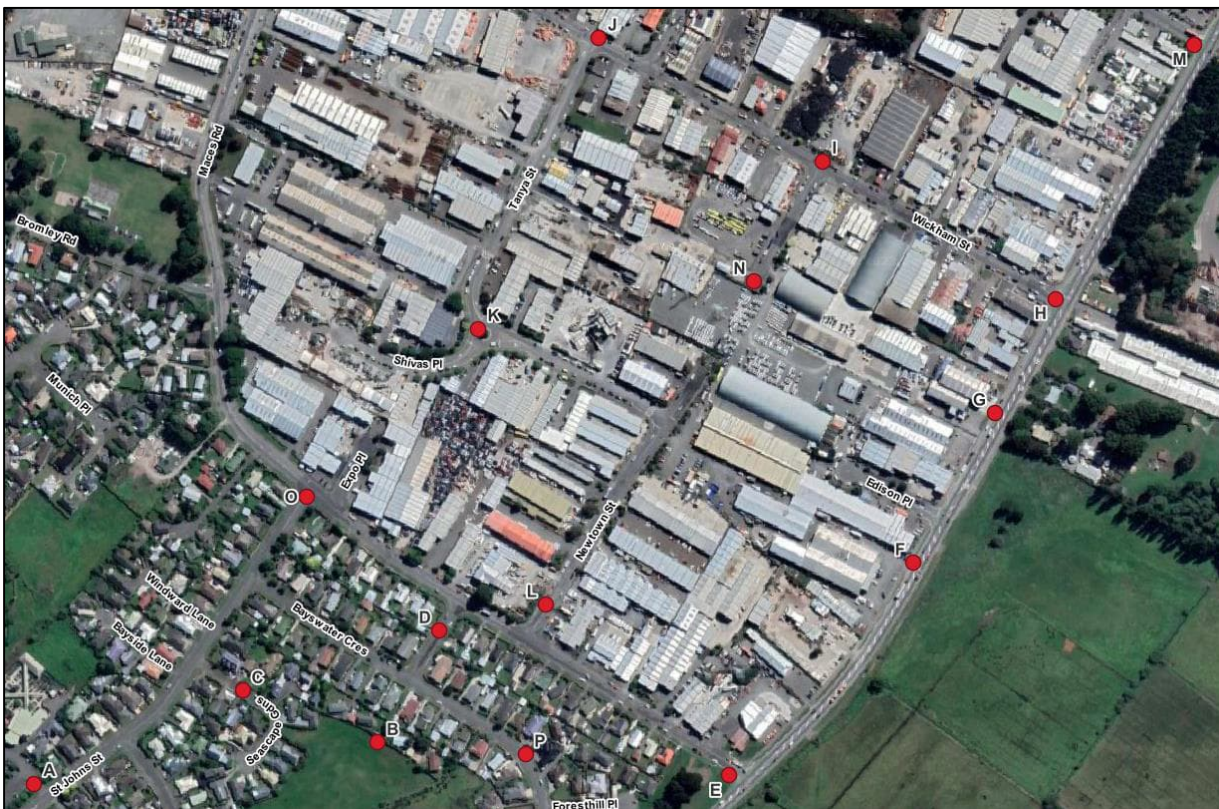
Figure 1: Odour Observation Locations

Sites H and M are immediately downwind of the site, located along Dyers Road with sites G and F. Sites I, J, K, and N are located in the heavy industrial zone. Sites A, C, B, D, and P are located in the residential zone around Bayswater Reserve. Sites E, L, and O are located roughly along the residential-industrial boundary. In assessments, Sites E and O are used to represent the closest (to the LE Site) downwind edge of the residential zone. Site L is located in the general industrial zone - Site D is used as the closest (to the LE Site) downwind residential monitoring point in this area.

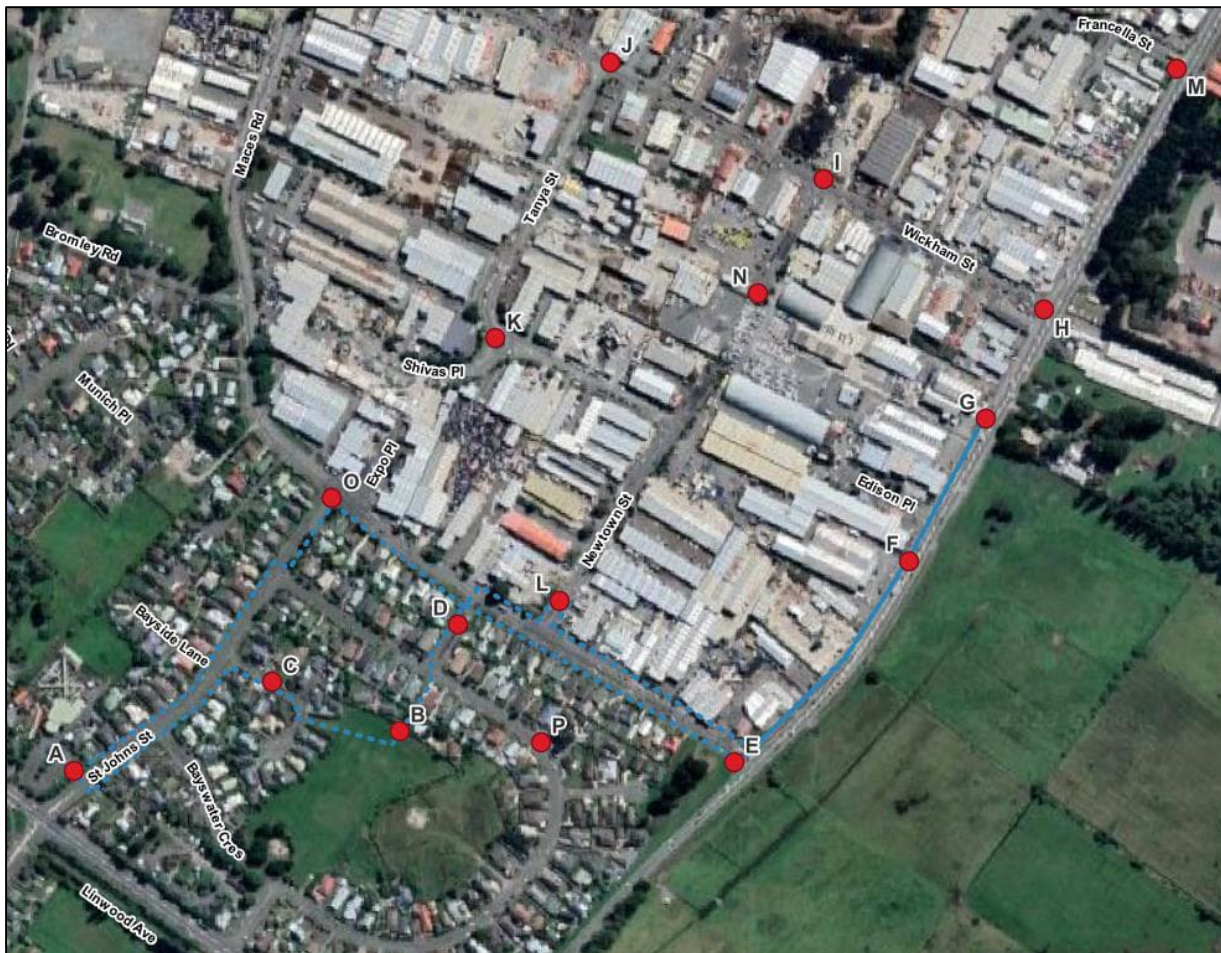
Figure 2: 18th February Odour Scout Route

[REDACTED] was the PDP odour scout. The scout was present for approximately one hour. The temperature was 21.5 °C with windspeeds ranging from 5.7 m/s to 6.1 m/s as a 10-minute average. The wind was predominately coming from an E direction. The scout started and finished at Site A. Broadly, the scout worked upwind towards the site, first through the residential zone, then the industrial zone along Dyers Rd. The odour scout route (blue dashed line) and key scouting locations are shown in **Figure 2**.

Odour levels were varied across the course of the scout. Distinct (3) compost odours were not detected in the residential zone. A single 10 second observation of weak (2) compost odour was detected at Site O and Site C. PDP does not consider the odour detected in the residential zone was offensive or objectionable.

Distinct (3) compost odours were detected in the industrial zone. PDP does not consider the odour detected in the industrial zone was offensive or objectionable.

The character of the compost odour matched PDP's experience with the odour generated by the outdoor material, namely the unscreened compost, oversize stockpiles and screened fines. The odour did not match PDP's experience with the odour from the processing hall or associated biofilter.

An unusual burnt/faecal odour was present in the vicinity of Site D at 11:58. That odour character was not present closer to the downwind boundary of the LE site. As such, it is unlikely to have originated from the LE site. The specific source of this odour was not determined.

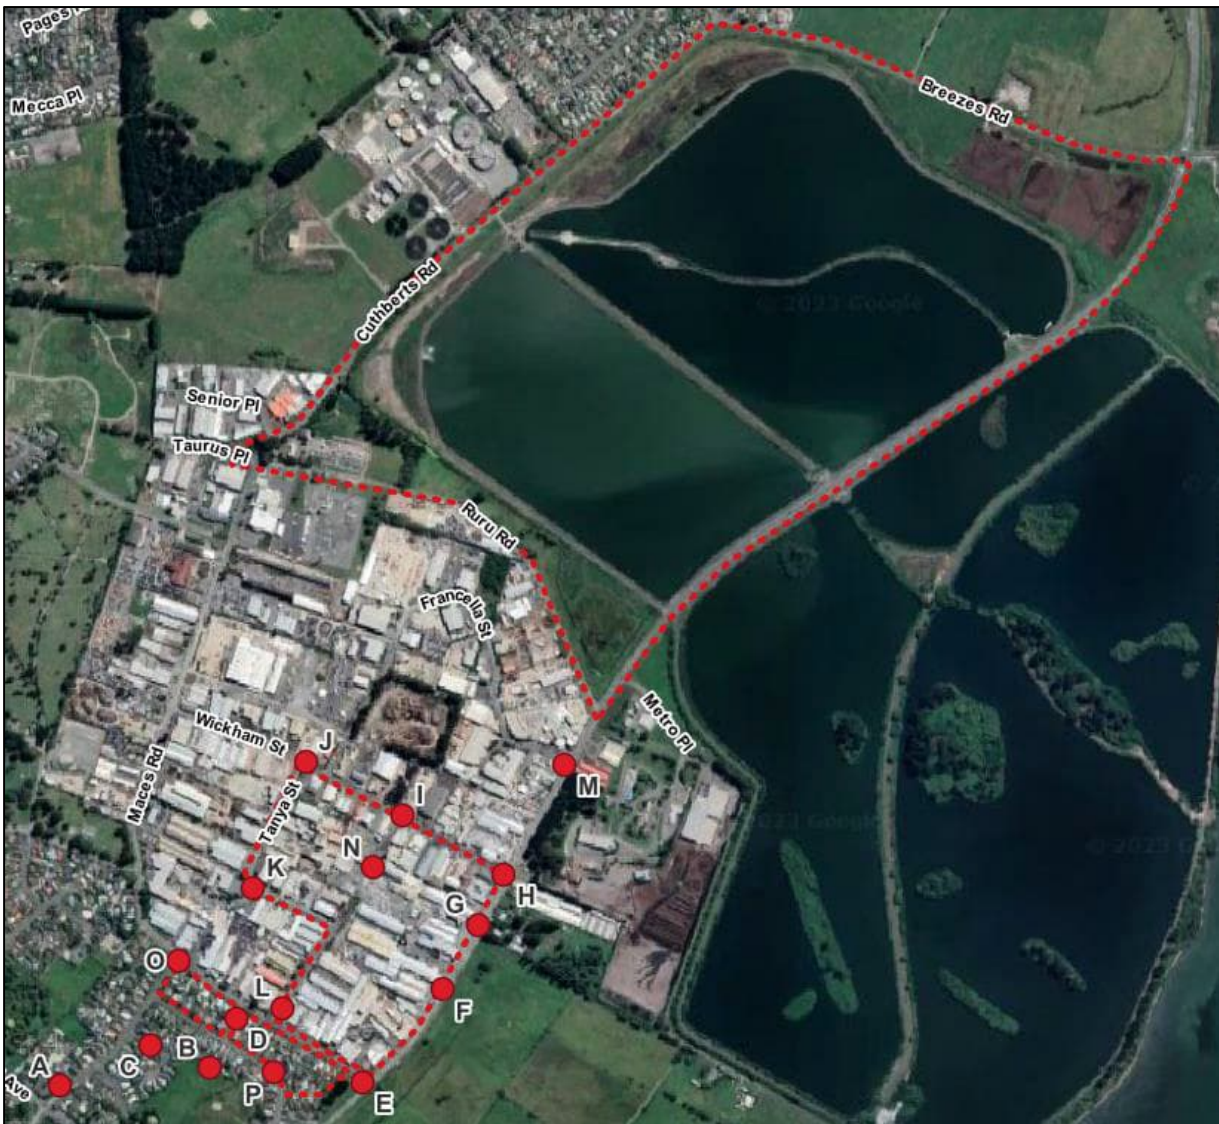
Figure 3: 20th February Odour Scout Route

[REDACTED] were present as PDP odour scouts. The scouts were present for approximately one hour. The temperature was 18 °C with windspeeds ranging from 5.4 m/s to 6.1 m/s as a 10-minute average. The wind was predominately coming from an E to ESE direction. The scouts started and finished at Site D. Broadly, the scouts walked a loop of the north end of the residential zone along Bayswater Cres and Maces Rd, then followed a loop through the industrial zone until the plume was encountered. The odour scout route (red dots) and key scouting locations are shown in **Figure 3**. A second loop was driven along Ruru Rd, Cuthberts Rd, Breezes Rd and Dyers Rd, stopping periodically to identify any compost odours present due to the material being spread near the wastewater ponds.

When scouting downwind of the plant, compost odours were detected close to the LE site and in the industrial zone. Compost odours were not detected along Maces Rd at the residential/industrial boundary

or further into the residential zone. PDP does not consider the odour detected was offensive or objectionable.

The character of the compost odour matched PDP's experience with the odour generated by the outdoor material, namely the unscreened compost, oversize stockpiles and screened fines. The odour did not match PDP's experience with the odour from the processing hall or associated biofilter.

When scouting around the wastewater ponds, intermittent weak (2) to distinct (3) compost odour was detected just south of the Breezes Rd roundabout. This odour was not detected south of the wastewater ponds. Material had been spread on the paddocks immediately east of Dyers Road, and this appeared to be the source of the odour. The character of the odour was that of compost, but more earthy than that observed downwind of Living Earth.

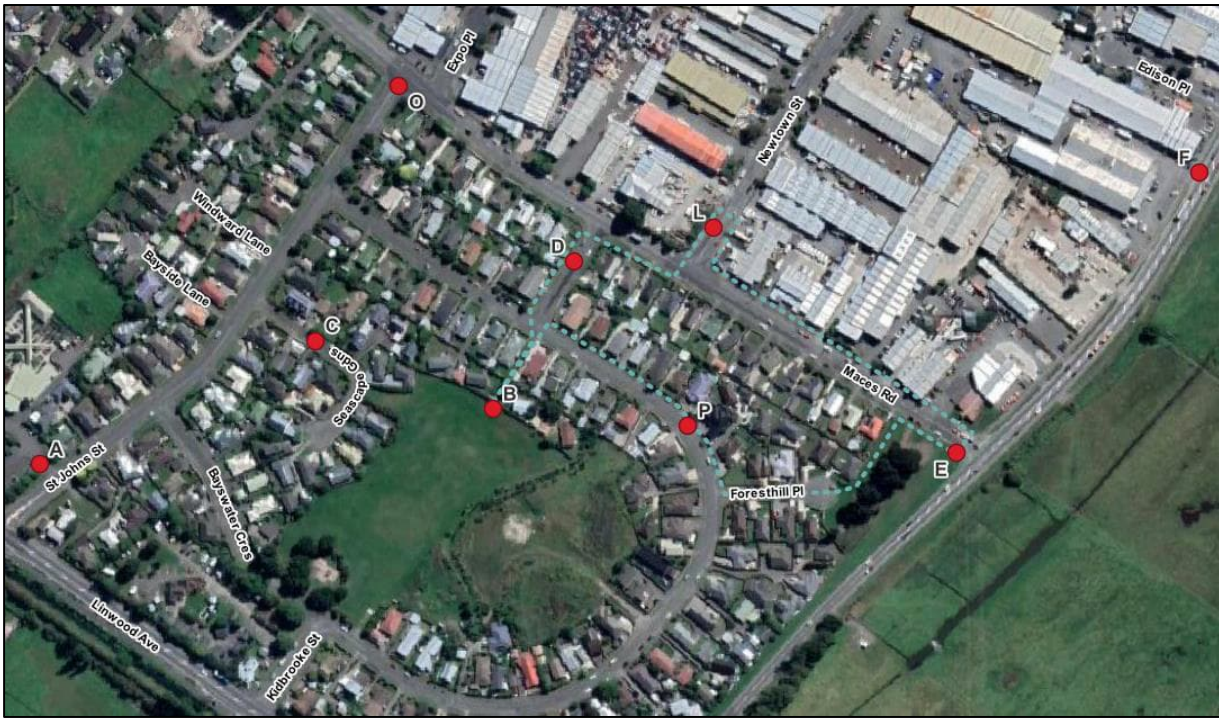
Figure 4: 21st February Odour Scout Route

██████████ was the PDP odour scout. The scout was present for approximately one hour. The temperature was 17 °C with windspeeds ranging from 4.2 m/s to 4.7 m/s as a 10-minute average from an E direction. The scout started and finished at Site E. Broadly, the scout walked a loop of the north end of the residential zone along Bayswater Cres and Maces Rd. The odour scout route (teal dots) and key scouting locations are shown in **Figure 4**.

When scouting downwind of the plant, distinct (3) compost odours were detected in the industrial zone.

Distinct (3) compost odours were not detected along Maces Rd at the residential/industrial boundary or further into the residential zone. Intermittent weak (2) compost odours were detected. PDP does not consider the odour detected was offensive or objectionable.

The character of the compost odour matched PDP's experience with the odour generated by the outdoor material, namely the unscreened compost, oversize stockpiles and screened fines. The odour did not match PDP's experience with the odour from the processing hall or associated biofilter.

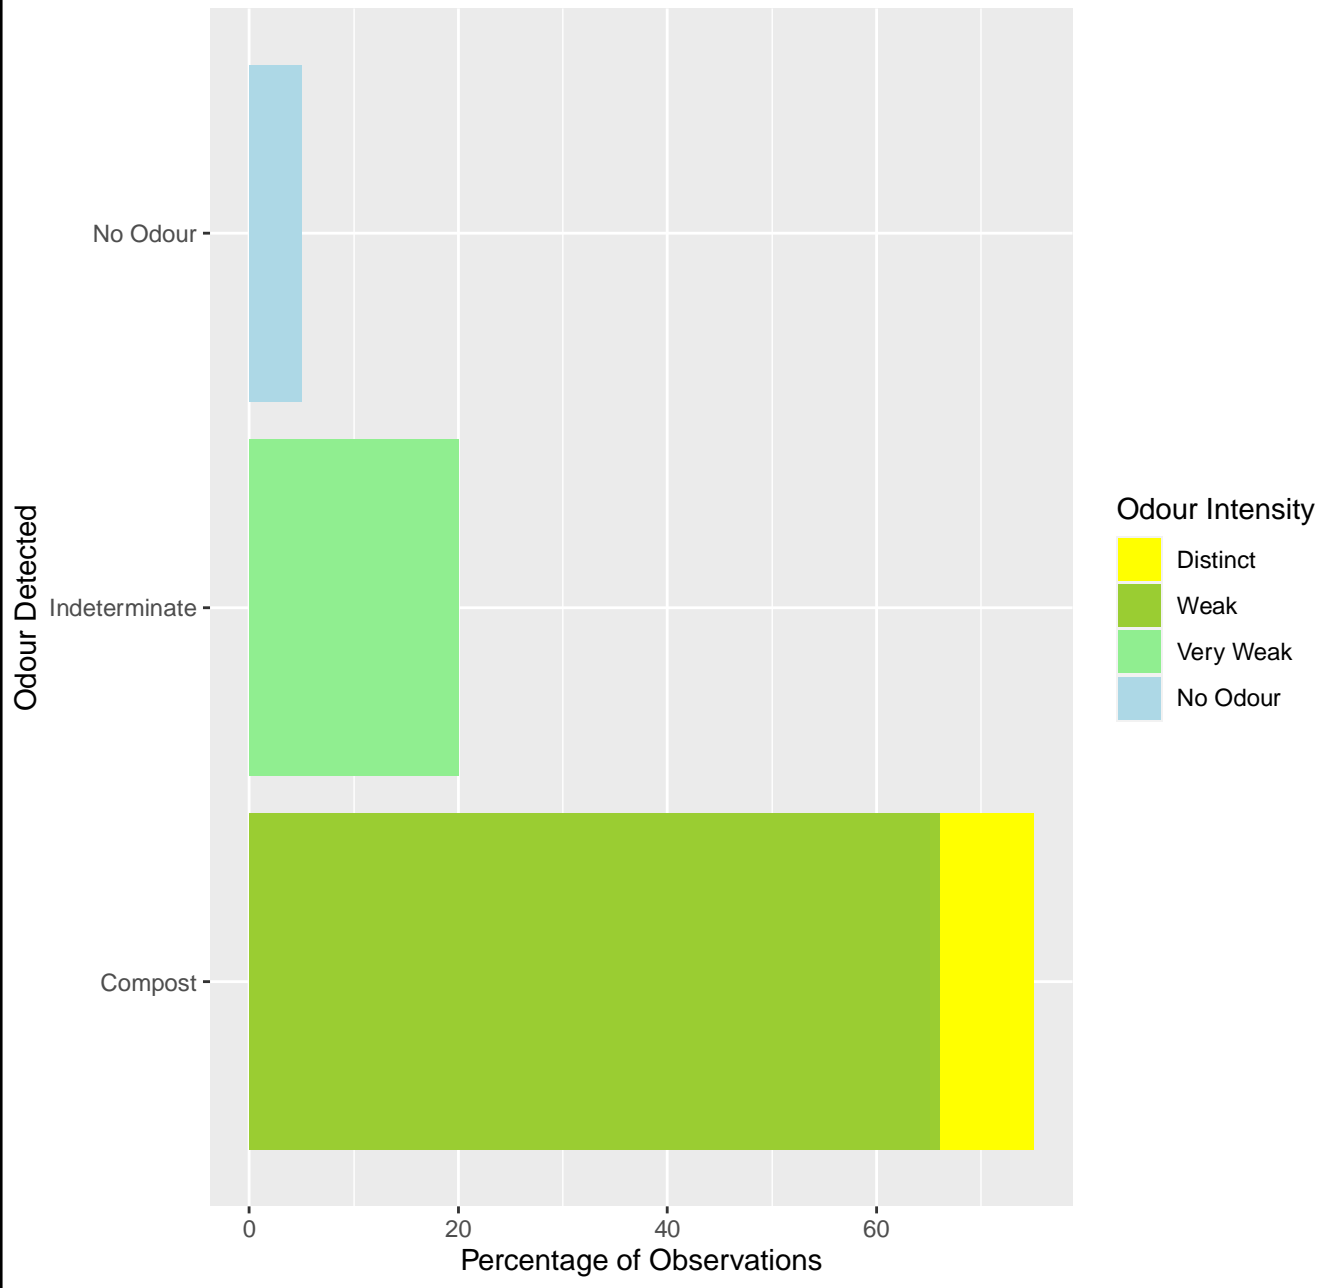
Breezes Rd Roundabout : Summary of Odours Detected at Site

H to D		Nothing of note detected.
Compost Spreading Scout		
Ruru Rd		No compost odour detected.
Cuthberts Rd		No compost odour detected.
Breezes Rd		No compost odour detected.
South of Breezes Rd Roundabout on Dyers Rd	15:19	FIDOL assessment completed. No odour was present 5% of the time. Very weak (1) odours of an indeterminate character were present 20% of the time. Weak (2) compost odour was present 66% of the time. Distinct (3) compost odour was present 9% of the time. Odour assessed as not offensive or objectionable.
Dyers Rd		Intermittent weak (2) to distinct (3) compost odour detected near the Breezes Rd roundabout.

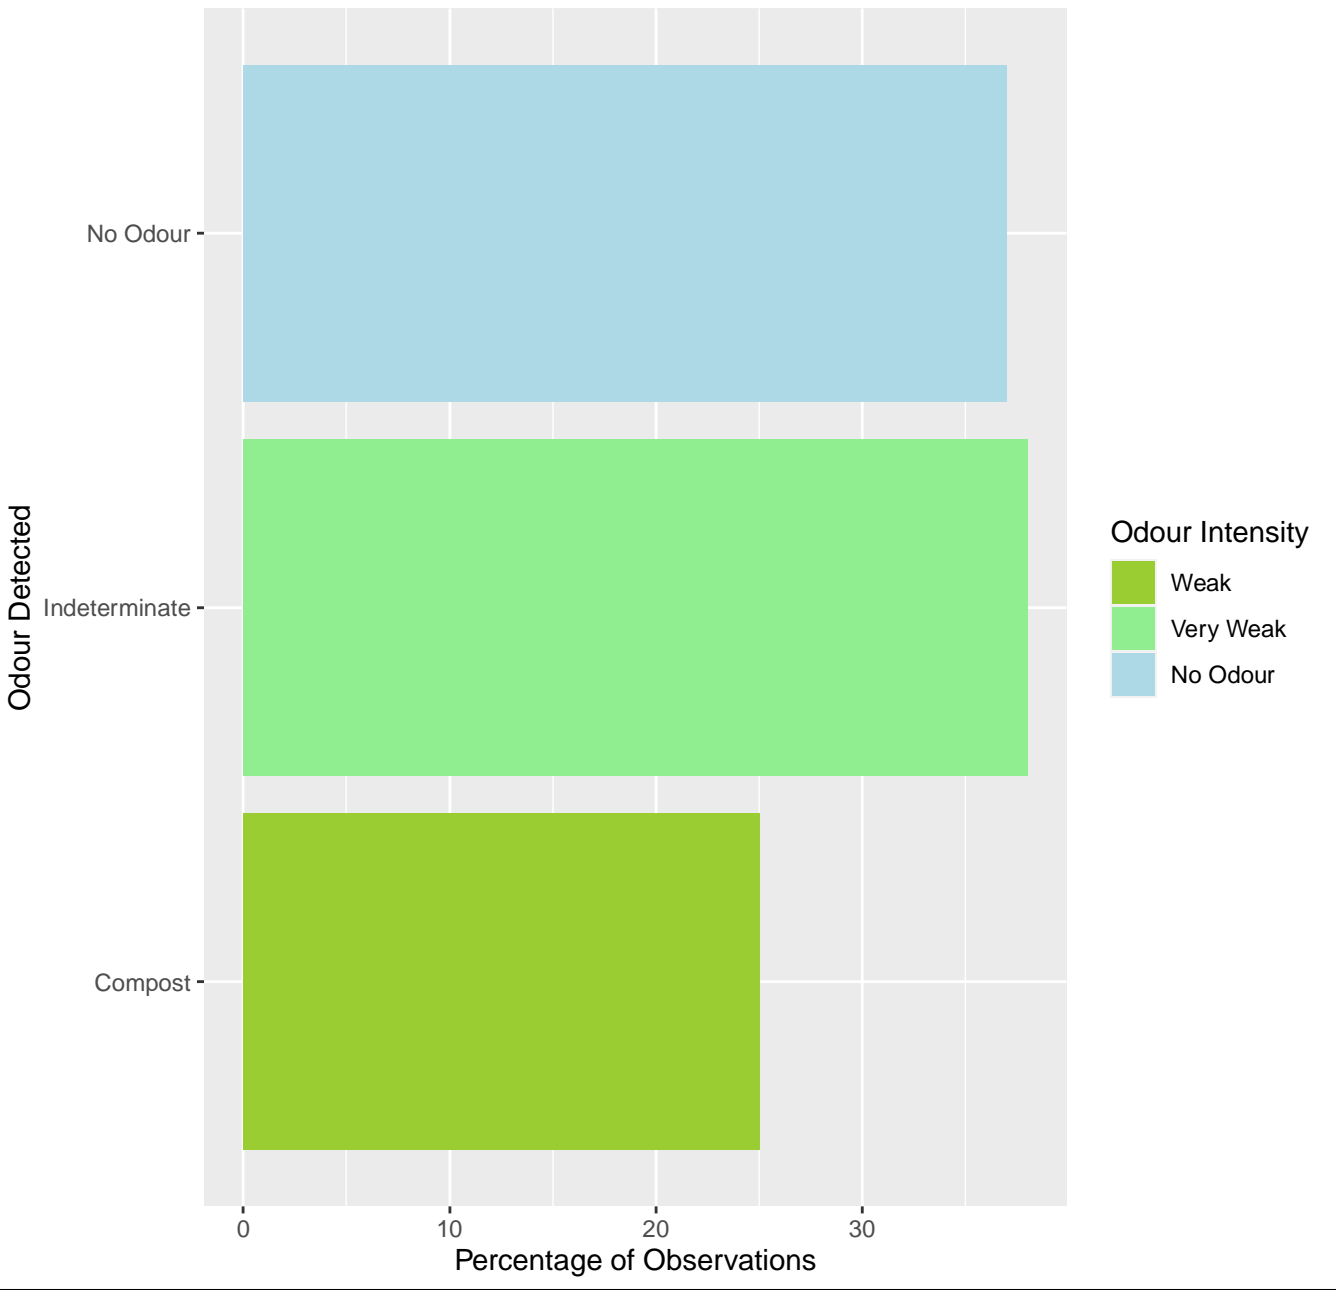
Site D : Summary of Odours Detected at Site

Site	Time	Observations
D	16:19	FIDOL assessment completed. No odour was present 37% of the time. Very weak (1) odours of an indeterminate character were present 38% of the time. Weak (2) compost odour was present 25% of the time. Odour assessed as not offensive or objectionable.
D to B	16:28	No odour detected.
B	16:28	FIDOL assessment completed. No odour was present 85% of the time. Very weak (1) odours of an indeterminate character were present 15% of the time. Odour assessed as not offensive or objectionable.
B to P	16:38	No odour detected.
P	16:39	FIDOL assessment completed. No odour was present 100% of the time. Odour assessed as not offensive or objectionable.

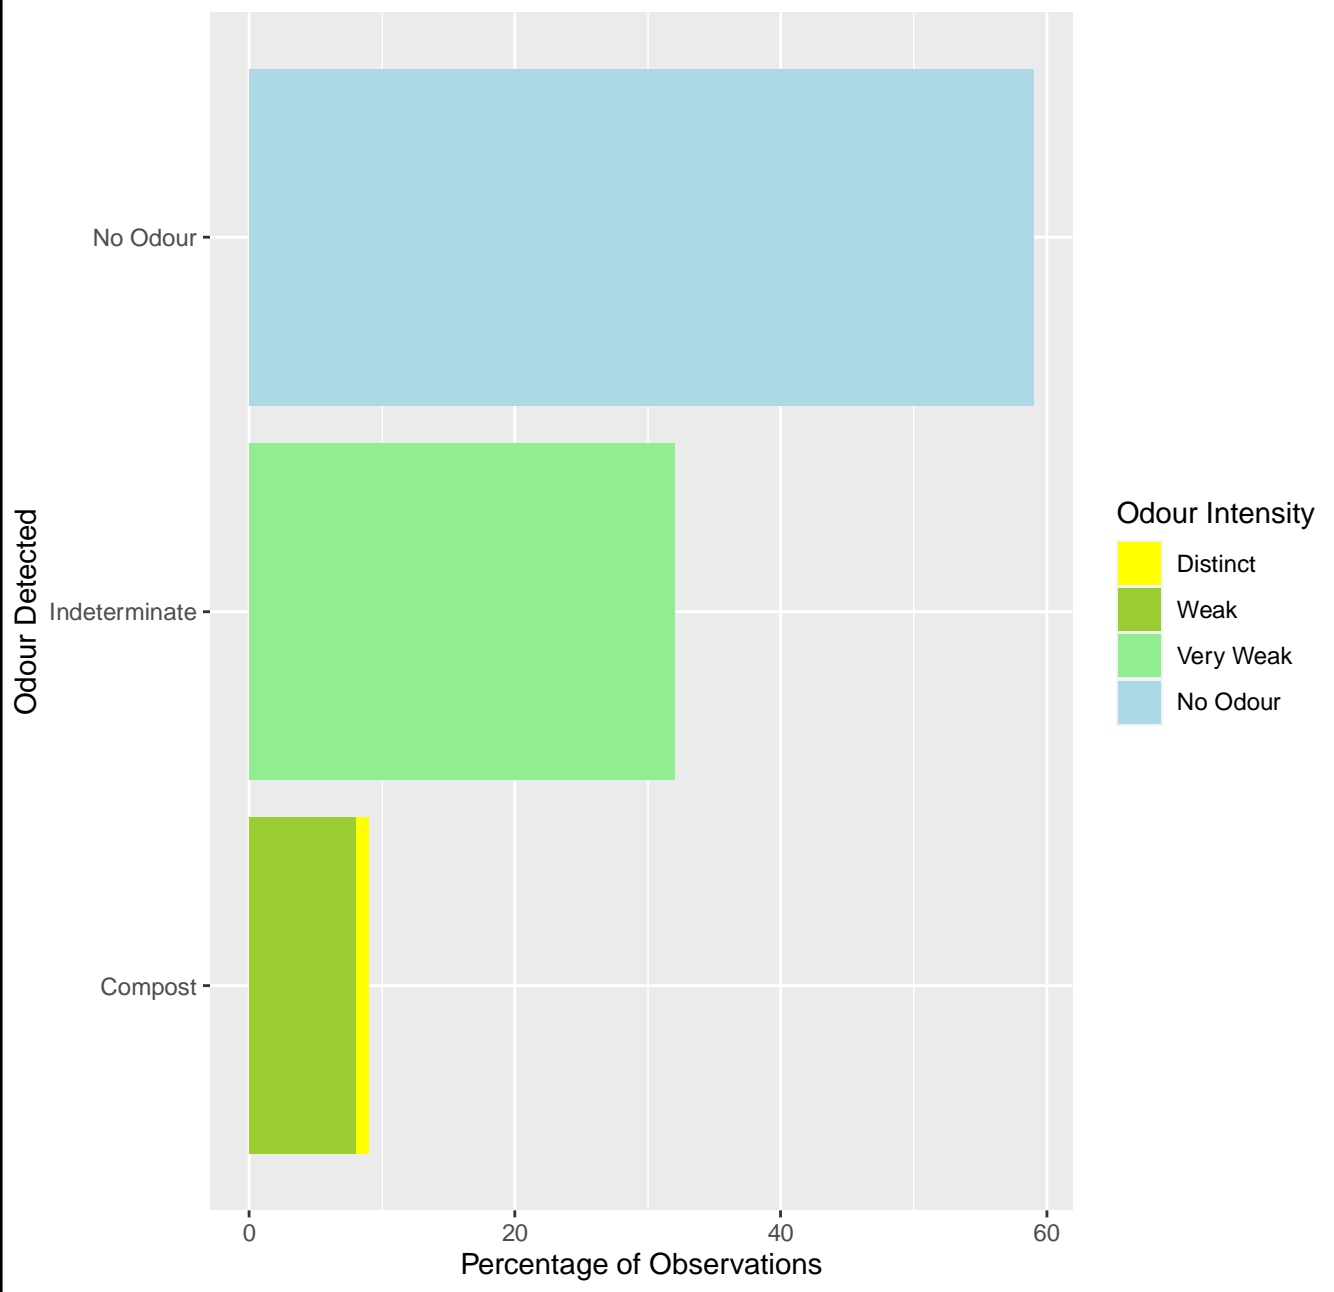
Site K : Summary of Odours Detected at Site

Site	Time	Observations
D	13:45	No odour detected.
O		No odour detected.
D	13:54	No odour detected.
P	13:56	No odour detected.
E	14:01	No odour detected.
L	14:05	Intermittent weak (2) solvent odour detected.
L to K		Intermittent weak (2) compost odour detected.
K	14:13	FIDOL assessment completed. No odour was present 59% of the time. Very weak (1) odours of an indeterminate character were present 32% of the time. Weak (2) compost odour was present 8% of the time. Distinct (3) compost odour was present 1% of the time. Odour assessed as not offensive or objectionable.
K to I		Intermittent weak (2) compost odour detected.
I to H	14:33	Intermittent weak (2) to distinct (3) compost odour detected.
H	14:36	FIDOL assessment completed. No odour was present 19% of the time. Very weak (1) odours of an indeterminate character were present 33% of the time. Weak (2) compost odour was present 43% of the time. Distinct (3) compost odour was present 6% of the time. Odour assessed as not offensive or objectionable.
