# memorandum

TO Christchurch City Council FROM [REDACTED]  
DATE 13/04/2023  
RE Living Earth Odour Monitoring: 13<sup>th</sup> March 2023 to 26<sup>th</sup> March 2023 Summary

## 1.0 Background

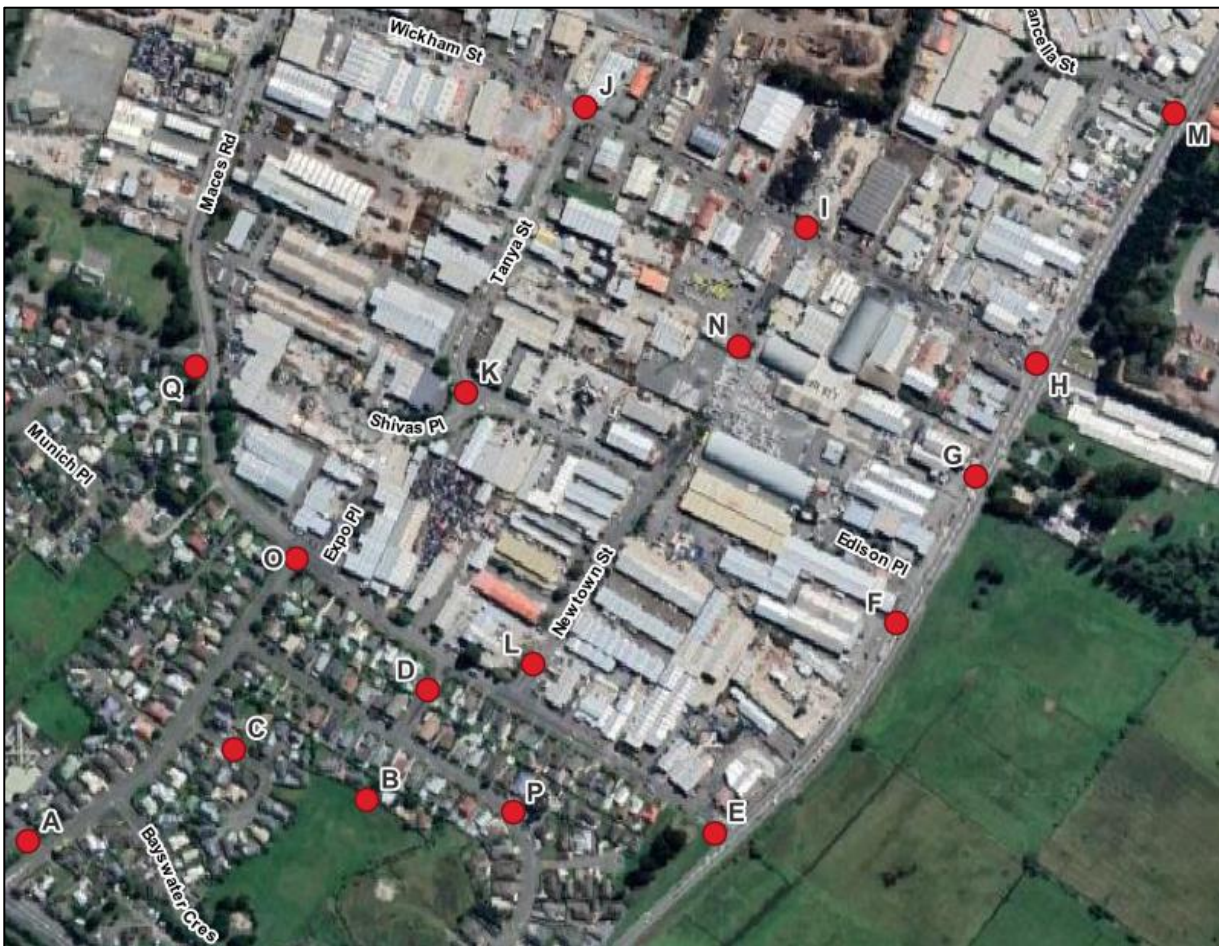
**Figure 1: Odour Observation Locations**

Sites H and M are immediately downwind of the site, located along Dyers Road with sites G and F. Sites I, J, K, and N are located in the heavy industrial zone. Sites A, C, B, D, and P are located in the residential zone around Bayswater Reserve. Sites E, L, O and Q are located roughly along the residential-industrial boundary. In assessments, Sites E, O, and Q are used to represent the closest (to the LE Site) downwind edge of the residential zone. Site L is located in the general industrial zone - Site D is used as the closest (to the LE Site) downwind residential monitoring point in this area.

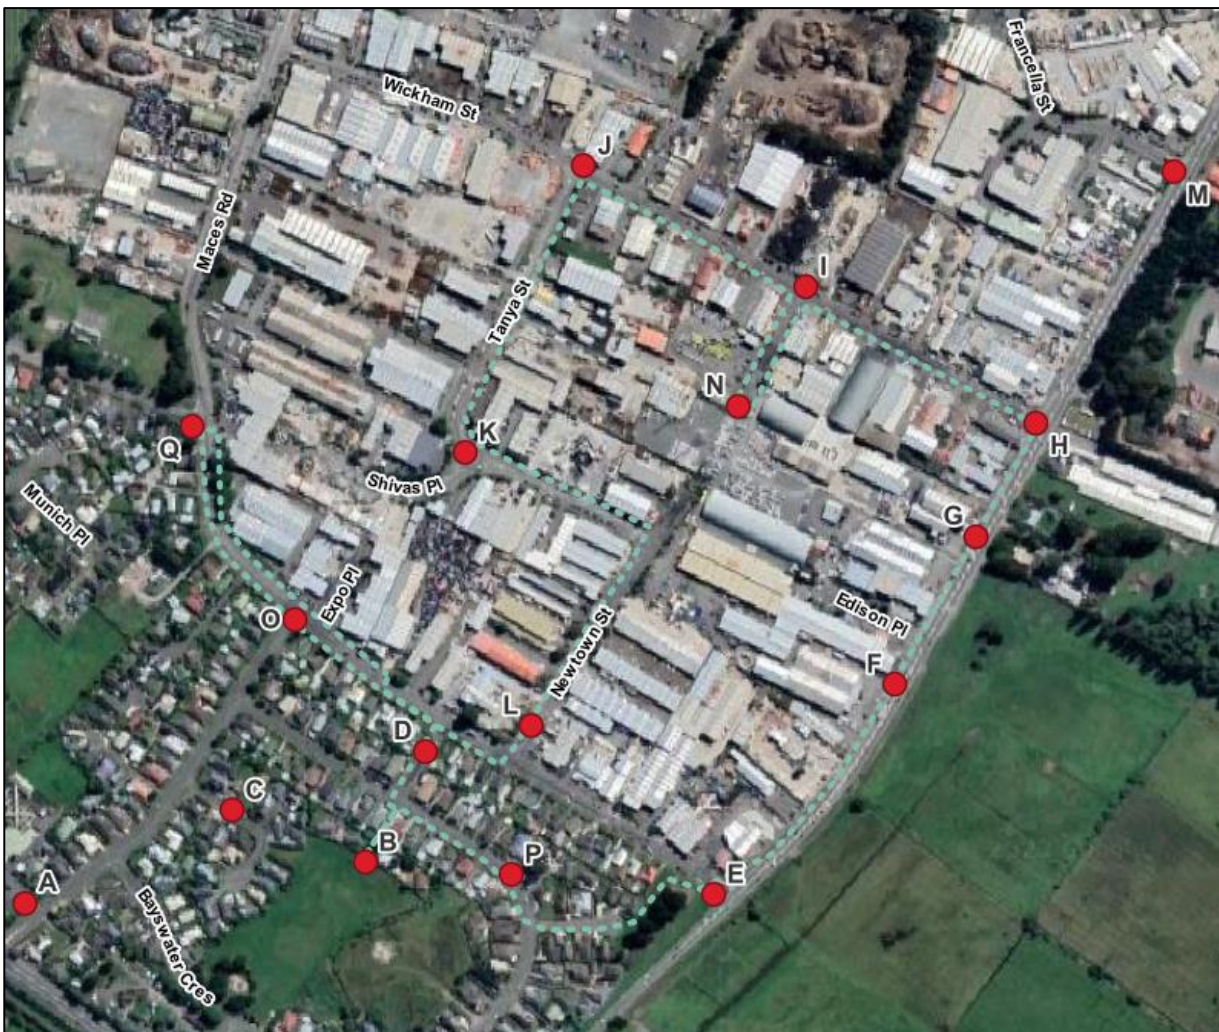
Figure 2: 15<sup>th</sup> March 2023 - Odour Scout Route

██████████ was the PDP odour scout. The scout was present for approximately 1 hour. The weather was clear, with a temperature of 18 °C and an easterly wind ranging from 7.8 m/s to 8.6 m/s as a 10-minute average. The scout started at Site D (Woburn Street) and finished at Site Q (Bromley Road). The object was to undertake odour monitoring across a full cross-section of the area downwind of the LE Site. The odour scout route (green dots) and key scouting locations are shown in **Figure 2**.

Intermittent, weak (2) compost odour was detected at Sites Q and E. This intermittent odour was not offensive or objectionable.

Distinct (3) compost odour was detected in the industrial zone along Dyers Rd, closest to the LE site. Being in a heavy industrial zone, this odour was not offensive or objectionable for the location.

The character of the compost odour matched PDP’s experience with the odour generated by the outdoor material, namely the unscreened compost, oversize stockpiles and screened fines. The odour did not match PDP’s experience with the odour from the processing hall or associated biofilter.

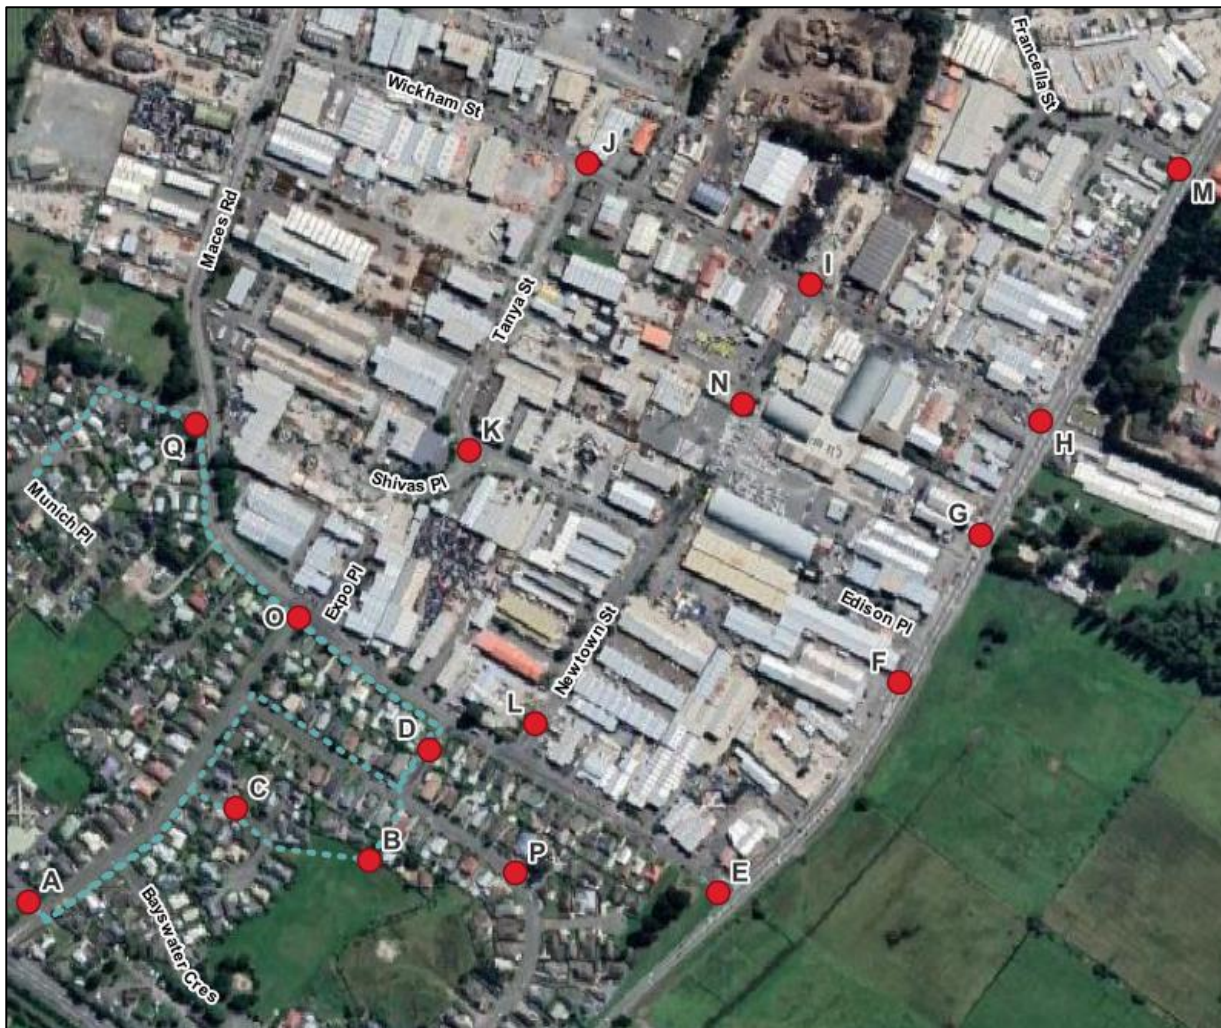
Figure 3: 16<sup>th</sup> March 2023 - Odour Scout Route

██████████ was the PDP odour scout. The scout was present for approximately 1 hour. The temperature was 20 °C with windspeeds ranging from 2.8 m/s to 3.9 m/s as a 10-minute average from an E to SE direction. The scout started and finished at Site A. The scout worked a loop through the residential zone following detected odour. The odour scout route (teal dots) and key scouting locations are shown in Figure 3.

Weak (2) rubbish and compost odours, both with a negative hedonic tone were present at Site Q during the FIDOL assessment. Intermittent, weak (2) compost odour was detected at Sites E, O, and on Munich Place. This intermittent odour was not offensive or objectionable.

The character of the compost odour matched PDP's experience with the odour generated by the outdoor material, namely the unscreened compost, oversize stockpiles and screened fines. The odour did not match PDP's experience with the odour from the processing hall or associated biofilter.

The rubbish odour had a municipal waste character. This was similar to the character odour observed immediately downwind of the EcoDrop during previous site visits. However, it is also similar to odours observed near municipal rubbish bins. The specific source was not determined. The rubbish odours were not detectable on Munich Place.

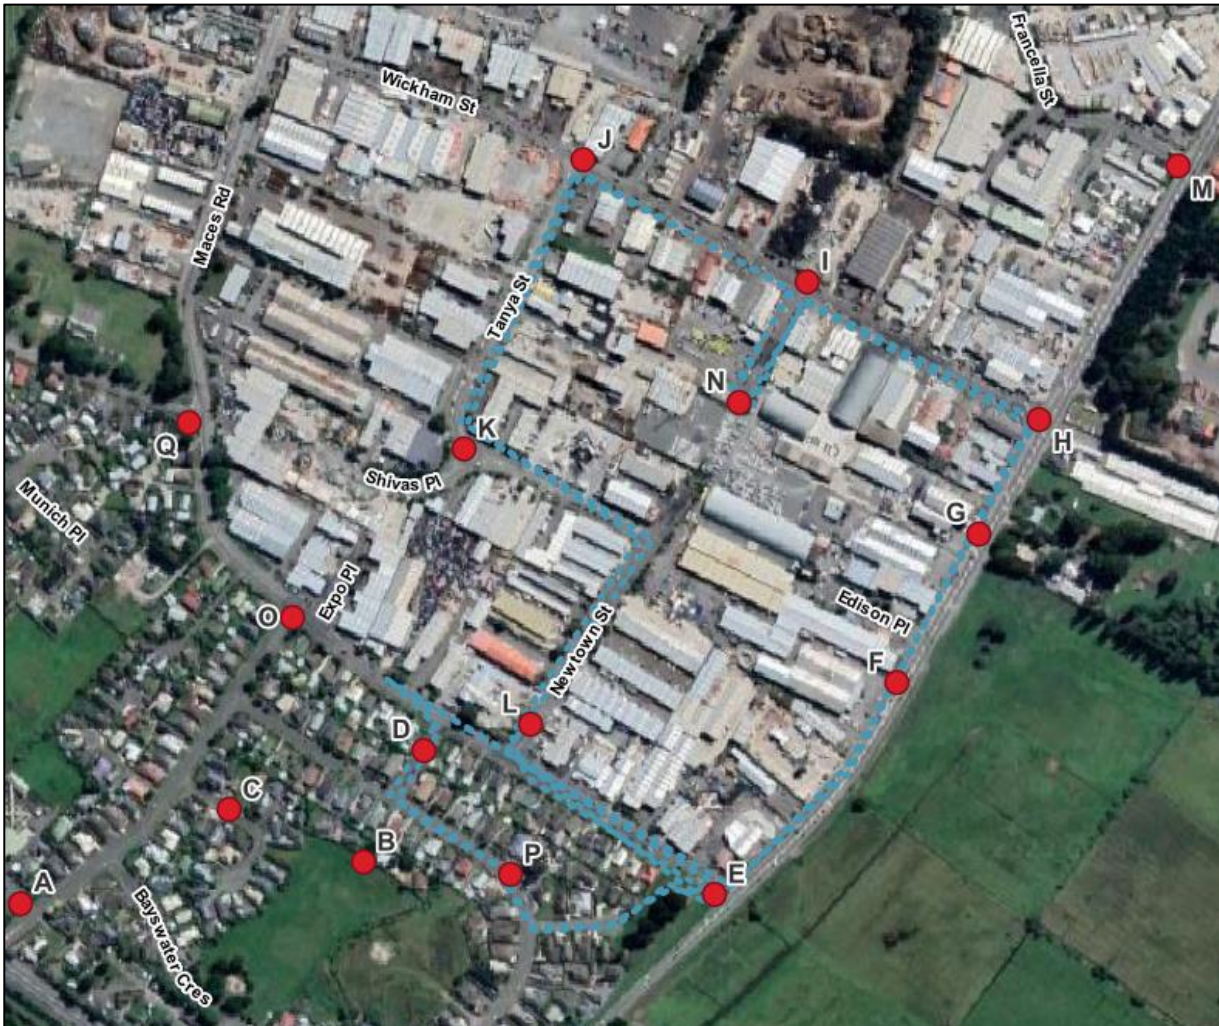
Figure 4: 17<sup>th</sup> March 2023 - Odour Scout Route

██████████ was the PDP odour scout. The scout was present for approximately one hour. The temperature was 23 °C with windspeeds ranging from 6.0 m/s to 6.6 m/s as a 10-minute average. The wind was predominately coming from an WNW direction. The forecast on the day was for a NE shift in the afternoon. Ground conditions on the afternoon were from a more W direction than expected. The scout started and finished at Site D. The odour scout route (blue dots) and key scouting locations are shown in Figure 4.

No compost odours were detected during the scout. This was due to the wind conditions having a NW component instead of the forecast NE direction.

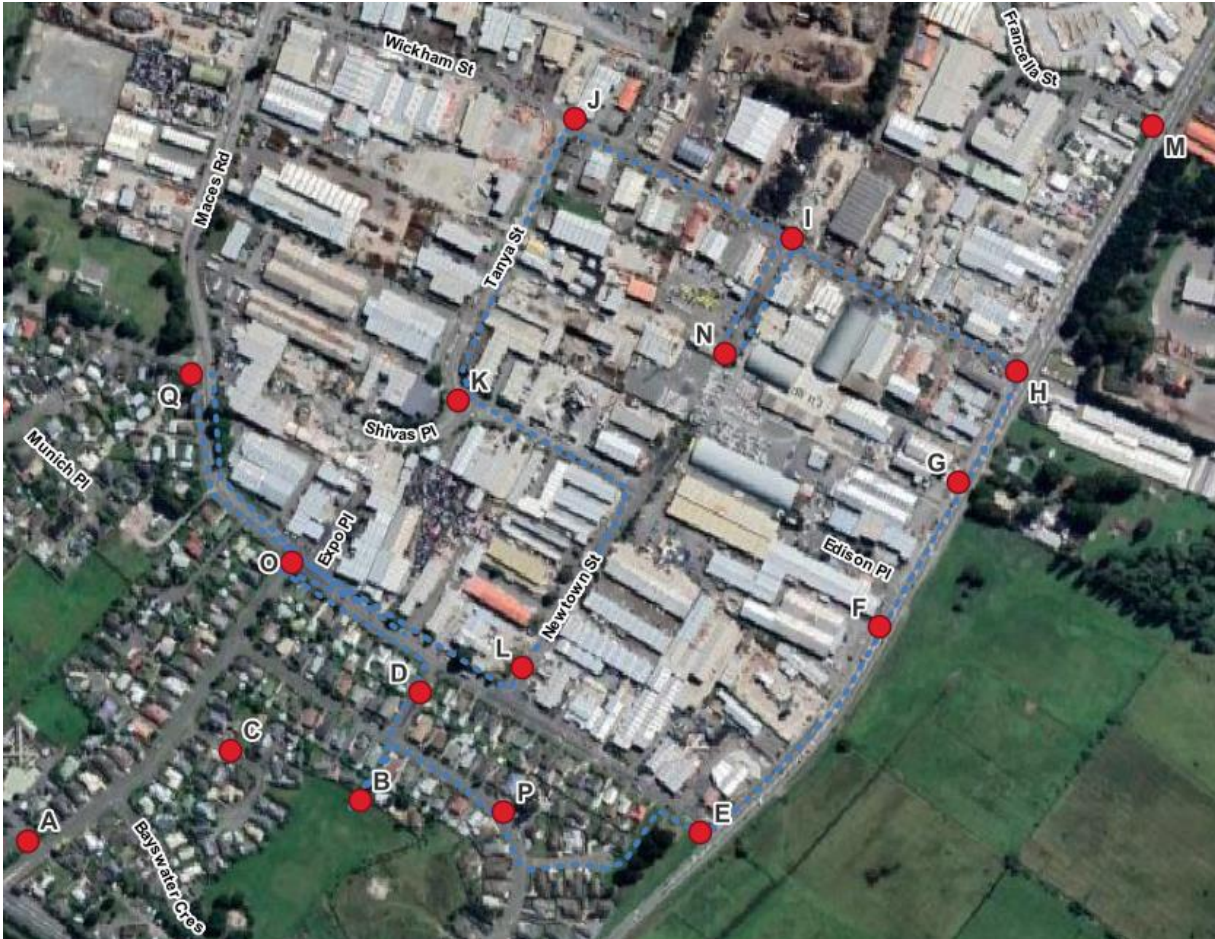
**Figure 5: 24<sup>th</sup> March 2023 - Odour Scout Route**

██████ was the PDP odour scout. The scout was present for approximately two hours. The temperature was 16 °C with windspeeds ranging from 6.6 m/s to 7.5 m/s as a 10-minute average from an ENE to E direction. The scout completed a loop through the industrial and residential areas, starting and finishing near Site O. The odour scout route (blue dots) and key scouting locations are shown in **Figure 5**.

Intermittent, weak (2) compost odour was detected at Sites O, D, B, and Q. This intermittent odour was not offensive or objectionable.

Distinct (3) compost odour was detected in the industrial zone along Dyers Rd, closest to the LE site. Being in a heavy industrial zone, this odour was not offensive or objectionable for the location.

The character of the compost odour matched PDP's experience with the odour generated by the outdoor material, namely the unscreened compost, oversize stockpiles and screened fines. The odour did not match PDP's experience with the odour from the processing hall or associated biofilter.
