memorandum

TO Christchurch City Council FROM [REDACTED]
DATE 15/03/2023
RE Living Earth Odour Monitoring: 1st March NONC Review

This memorandum provides PDP's summary and review of the NONC, and details of observations of off-site odour scouting undertaken by PDP staff on the 1st of March 2023.

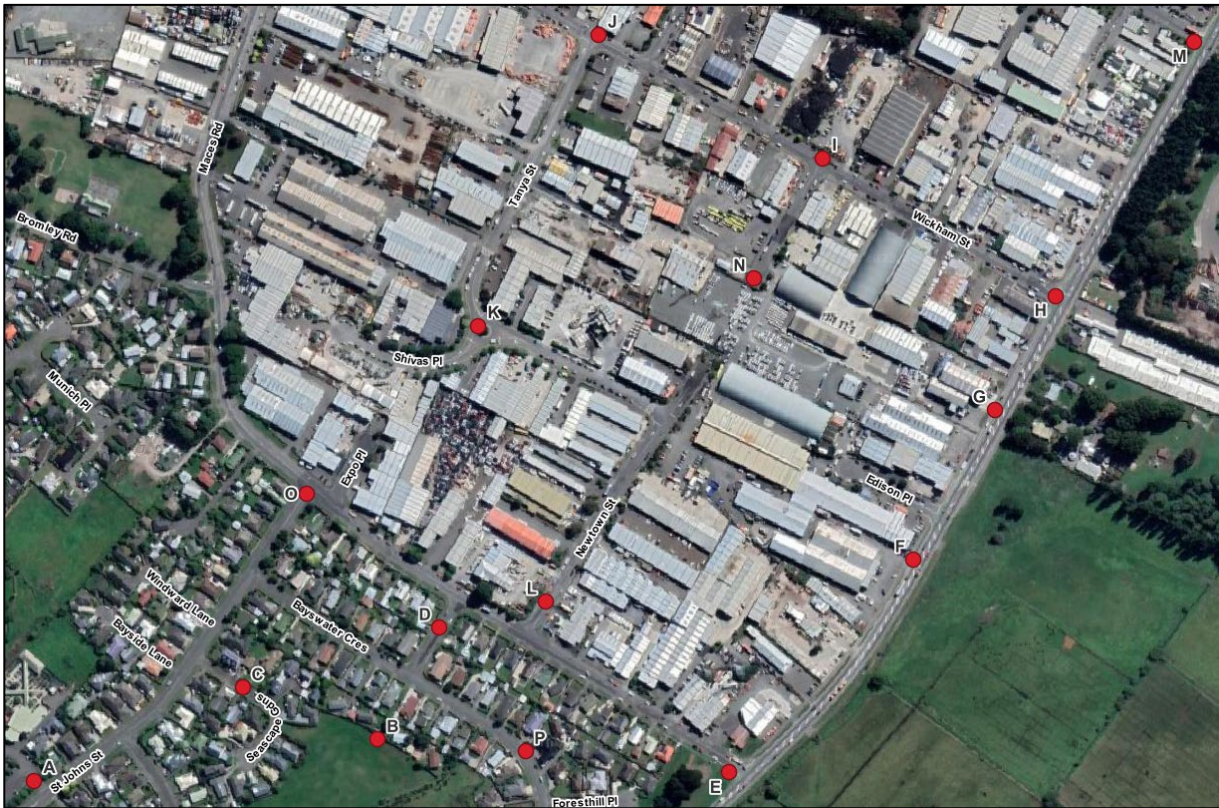
Figure 1: Odour Observation Locations

During an assessment, scouts walk at a comfortable pace through the area downwind of the LE Site, making note of odours detected. PDP has defined a series of observation points in the area where the scout makes more detailed observations, these are shown in **Figure 1**. The exact route and observation points visited in an assessment depend on the meteorological conditions (wind speed and direction) and the odour (if any) detected by the scout on the route.

Sites H and M are immediately downwind of the site, located along Dyers Road with sites G and F. Sites I, J, K, and N are located in the heavy industrial zone. Sites A, C, B, D, and P are located in the residential zone around Bayswater Reserve. Sites E, L, and O are located roughly along the residential-industrial boundary. In assessments, Sites E and O are used to represent the closest (to the LE Site) downwind edge of the residential zone. Site L is located in the general industrial zone - Site D is used as the closest (to the LE Site) downwind residential monitoring point in this area.

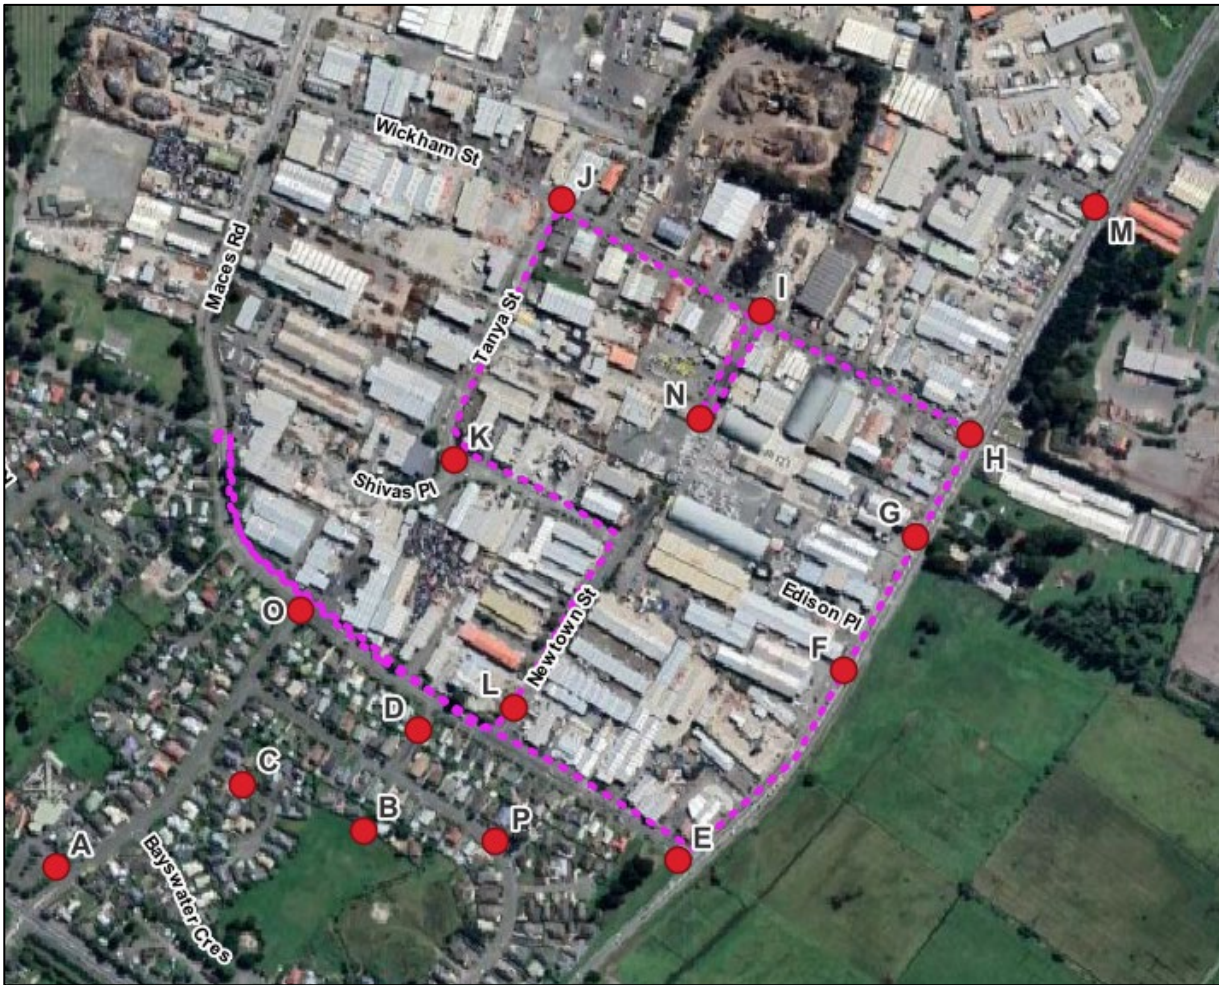
Figure 2: 1st March Odour Scout Route

The weather was clear, with a temperature of 18 °C and an easterly wind ranging from 6.7 m/s to 7.3 m/s as a 10-minute average. [REDACTED] was the PDP odour scout. The scout started at Site L (Woburn Street) and finished at Bromley Road. Broadly, the object was to collect a full cross-section of the area downwind of the LE Site. The odour scout route (purple dots) and key scouting locations are shown in Figure 2.

Results from the odour scout are shown below. Entries within Table 4 that are highlighted blue denote locations within a residential zone and purple denotes locations within an industrial zone.

Except for the area around the corner of Maces Rd and Bromley Rd, compost odour was not detected in the residential zone. Intermittent, weak (2) compost odour was detected around the corner of Maces Rd and Bromley Rd. This intermittent odour was not offensive or objectionable.

Distinct (3) compost odour was detected through the industrial zone, typically with a frequency below 10%. The highest frequency of distinct (3) compost odour was found at Site G. Being in a heavy industrial zone, this odour was not offensive or objectionable for the location.

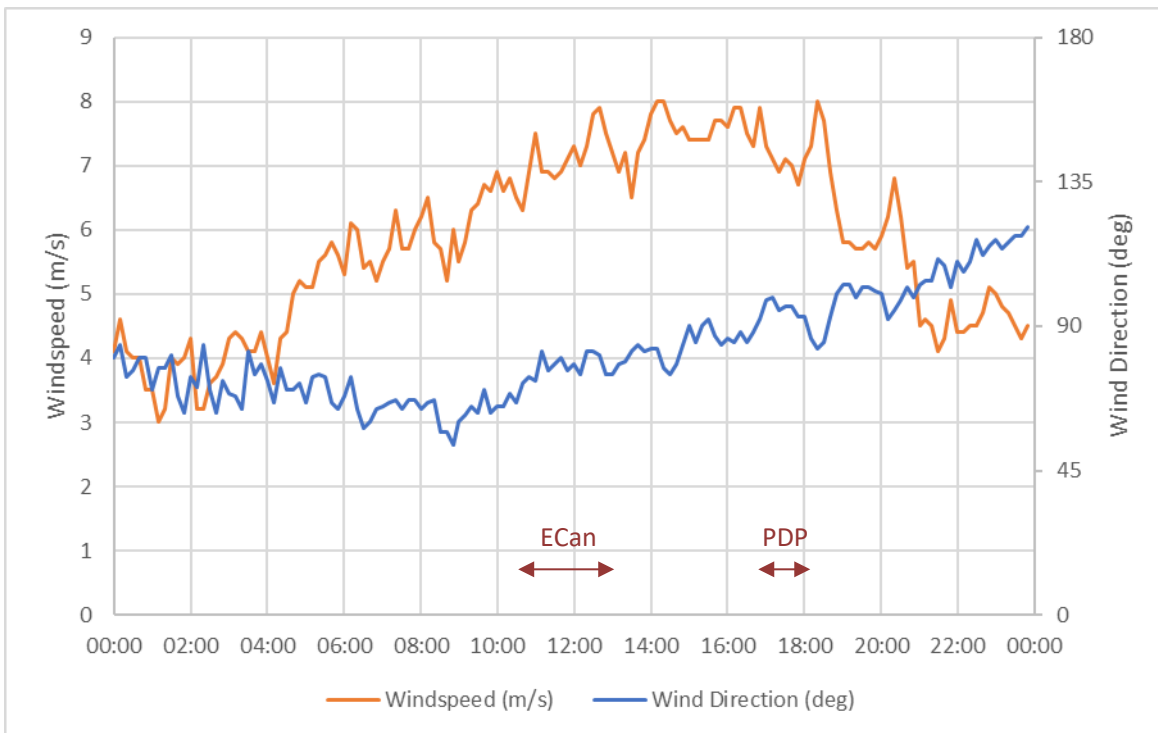
Figure 3: 1st March 2023 - Bromley EWS Meteorology

The meteorology, as measured at NIWA’s Bromley EWS (on a 10-minute basis) for the day of the 1st March 2023 is presented in **Figure 3**.

Windspeeds were fairly consistent over the course of the day:

- ∴ Ranging between 5.5 m/s and 8 m/s during daylight hours, and
- ∴ Approximately 4 m/s in the early morning and late evening.

The wind started from an ENE direction (approx. 70°) and gradually shifted towards ESE over the course of the day.

While ECan were present in the Bromley area, conditions were approx. 7 m/s ENE winds.

While PDP were present in the Bromley area, conditions were approx. 7.5 m/s E winds.

The meteorology on the day (during the period of the complaints) was 7 to 8 m/s. During the period ECan were onsite, wind directions were ENE. During the period PDP were onsite, wind directions were E.

The shift in wind direction from ENE to E will have pushed the odour plume through the industrial area when PDP were on-site as opposed as towards Woburn St when ECan were present.

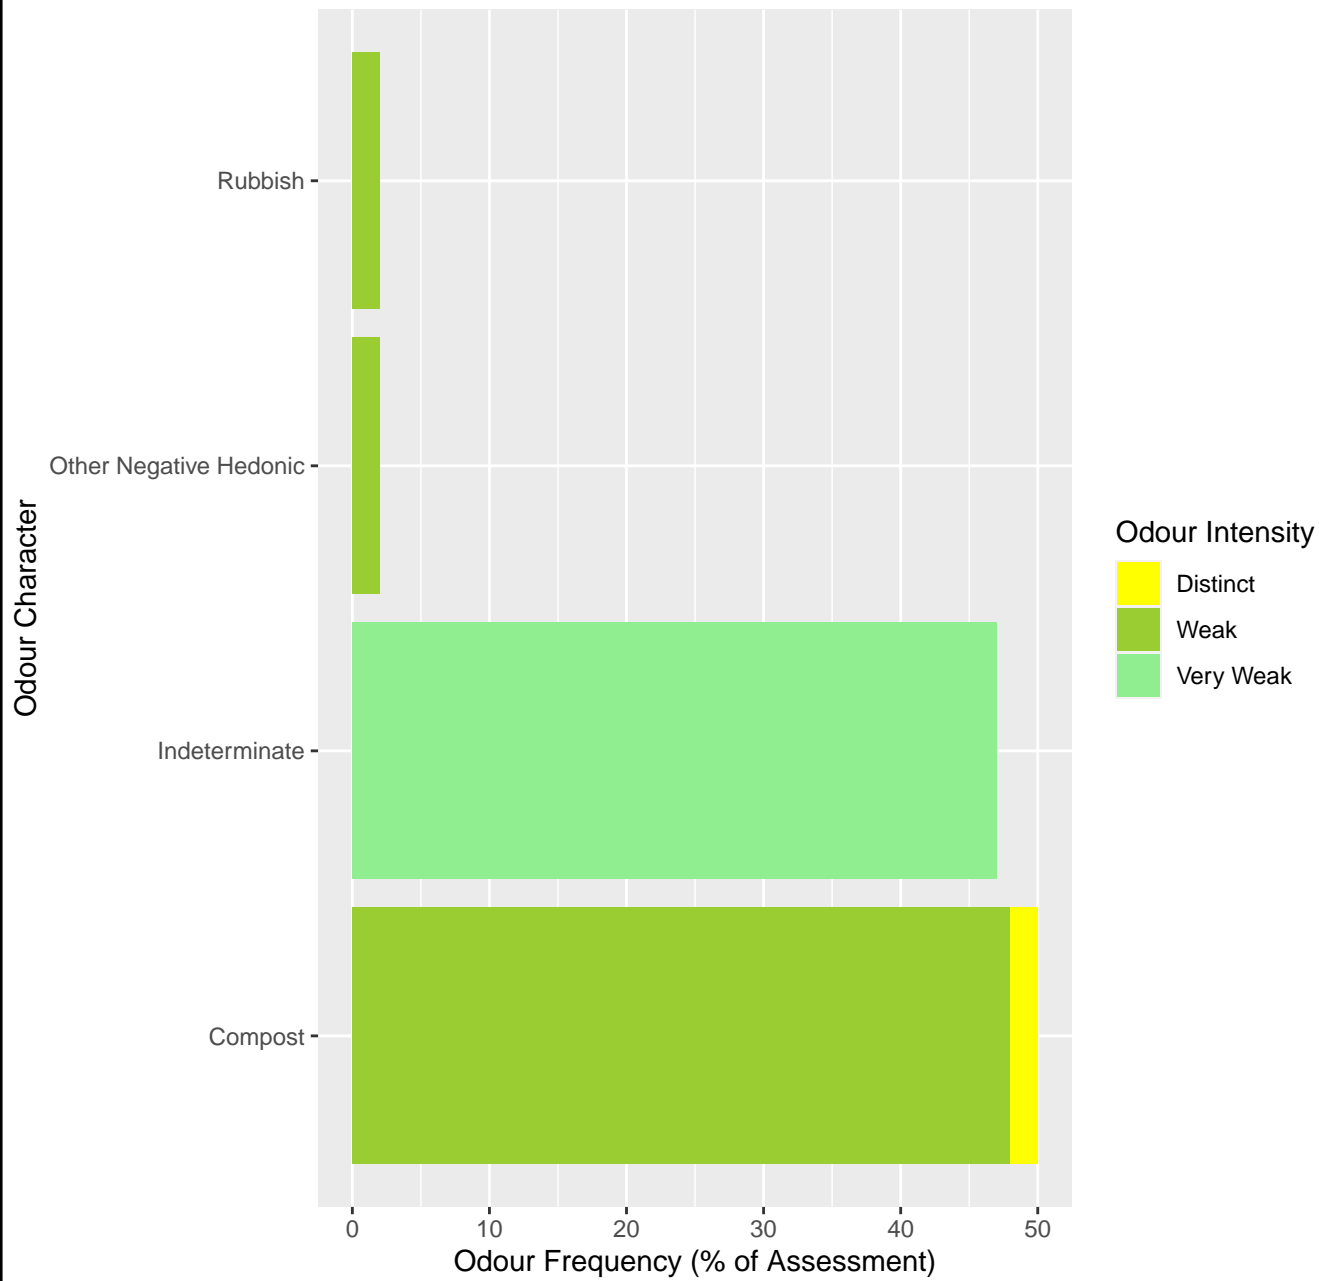
Site H: Odours Observed 2023-03-01 17:12:00

Site	Time	Observations
H	17:12	FIDOL assessment completed. Very weak (1) odours of an indeterminate character were present 47% of the time. Weak (2) compost odour was present 48% of the time. Weak (2) rubbish odour was present 2% of the time. Weak (2) cigarette smoke odour was present 2% of the time. Distinct (3) compost odour was present 2% of the time. Odour assessed as not offensive or objectionable.
H to I		No odour (0) to weak compost odour (2) detected.
I	17:29	FIDOL assessment completed. No odour was present 32% of the time. Very weak (1) odours of an indeterminate character were present 28% of the time. Weak (2) compost odour was present 37% of the time. Distinct (3) compost odour was present 3% of the time. Odour assessed as not offensive or objectionable.
I to N		Localised distinct (3) solvent odour detected.
N to I		Localised distinct (3) solvent odour detected.
I to J		No odour (0) to weak compost odour (2) detected.

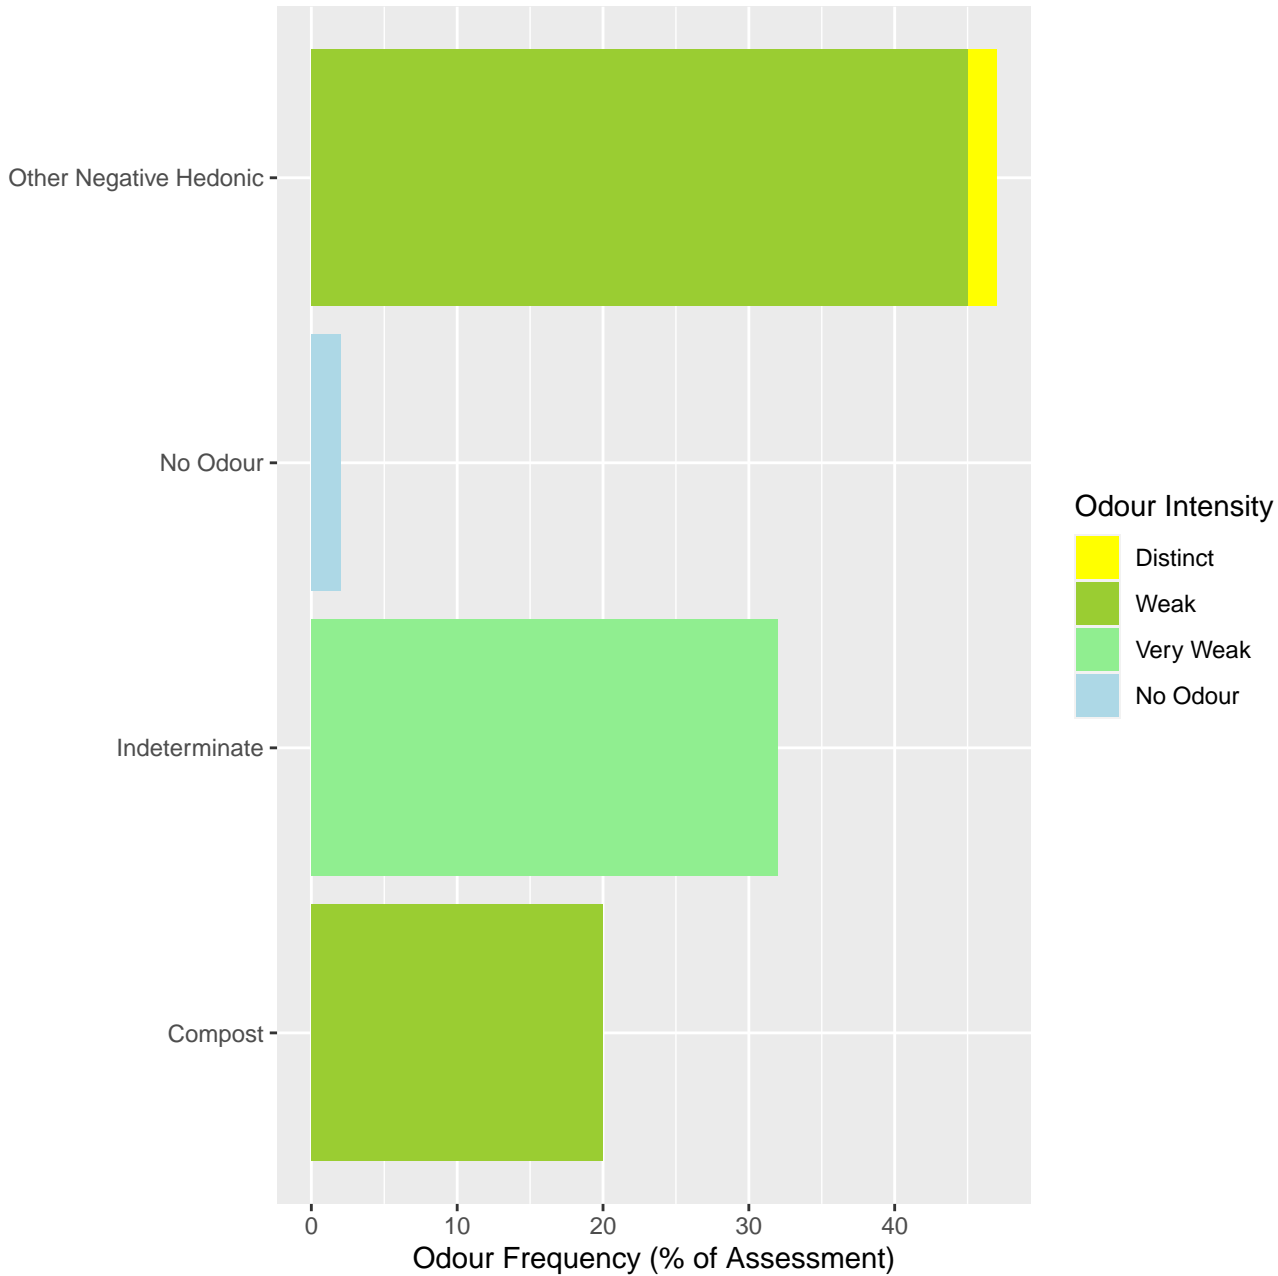
Site K: Odours Observed 2023-03-01 17:43:00

J to K		No odour (0) to weak compost odour (2) detected.
K	17:43	FIDOL assessment completed. No odour was present 2% of the time. Very weak (1) odours of an indeterminate character were present 32% of the time. Weak (2) compost odour was present 20% of the time. Weak (2) odour of a negative hedonic tone resembling soil or manure was present 45% of the time. Distinct (3) odour of a negative hedonic tone resembling soil or manure was present 2% of the time. Odour assessed as not offensive or objectionable.
K to L		No odour (0) to weak compost odour (2) detected.
L to D		No odour detected.
D to Bromley Rd		No odour (0) to weak compost odour (2) detected.
Corner of Maces Rd & Bromley Rd	18:02	FIDOL assessment completed. No odour was present 78% of the time. Very weak (1) odours of an indeterminate character were present 8% of the time. Weak (2) compost odour was present 13% of the time. Odour assessed as not offensive or objectionable.

At Site K, the weak (2) to distinct (3) soil/manure smell encountered was unfamiliar to the scout and did not match the character of odours observed from the LE site previously. It was not observed along Dyers Rd or at Site N so may reflect another odour source in the industrial zone.
