memorandum

TO Christchurch City Council FROM [REDACTED]
DATE 22 December 2023
RE Living Earth Odour Monitoring: 11th November 2023 to 8th December 2023
Summary

Living Earth Limited (Living Earth) operates an organics processing plant and composting facility located at 40 Metro Place, Bromley, Christchurch (the LE Site). Living Earth's air discharges are subject to the conditions attached to air discharge consent CRC080301.1 ("the consent") from Canterbury Regional Council (CRC) to discharge contaminants (odour and dust) to air.

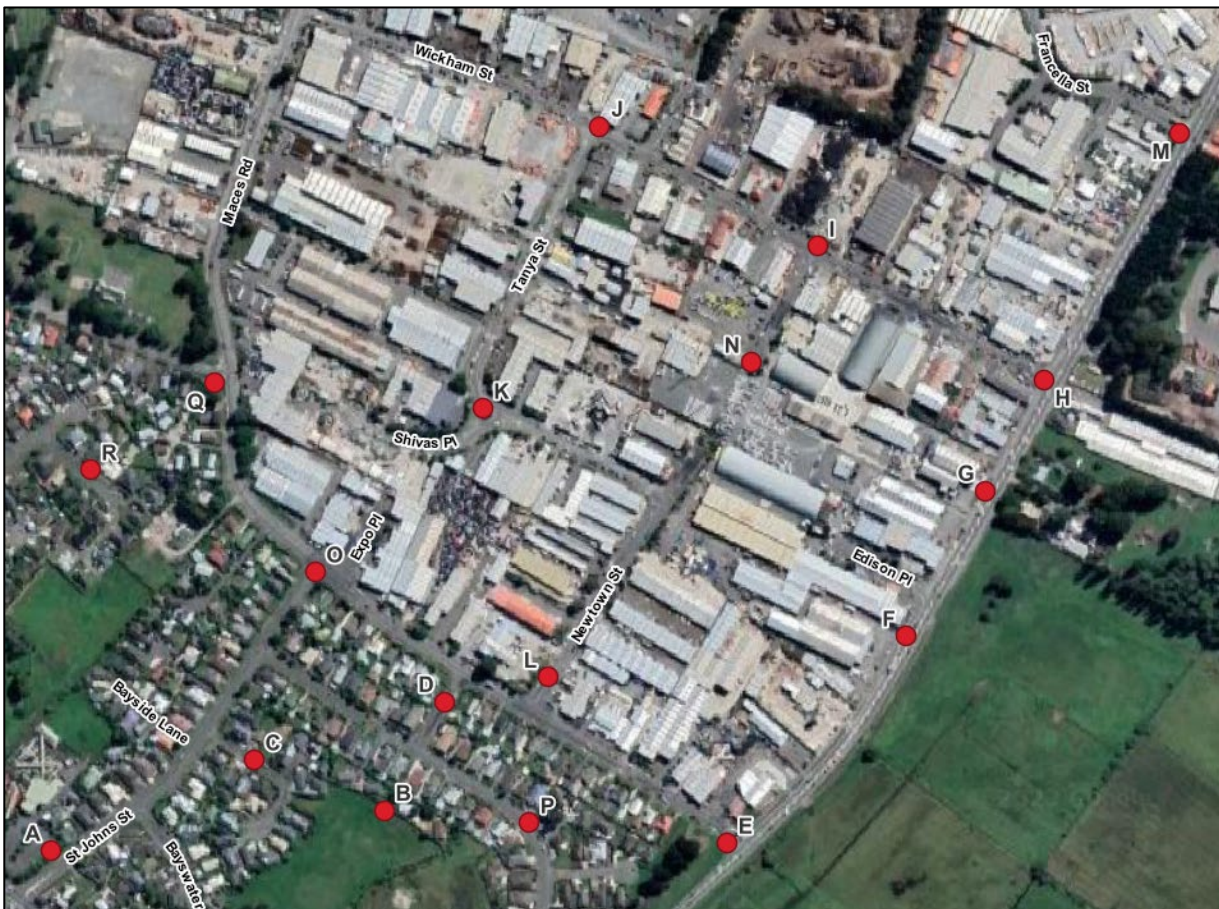
Figure 1: Odour Observation Locations

Sites H and M are immediately downwind of the site, located along Dyers Road with sites G and F. Sites I, J, K, and N are located in the heavy industrial zone. Sites A, C, B, D, P, and R are located in the residential zone around Bayswater Reserve. Sites E, L, O, and Q are located roughly along the residential-industrial boundary. In assessments, Sites E, O, D and Q are in the residential zone, while Site L is in the general industrial zone.

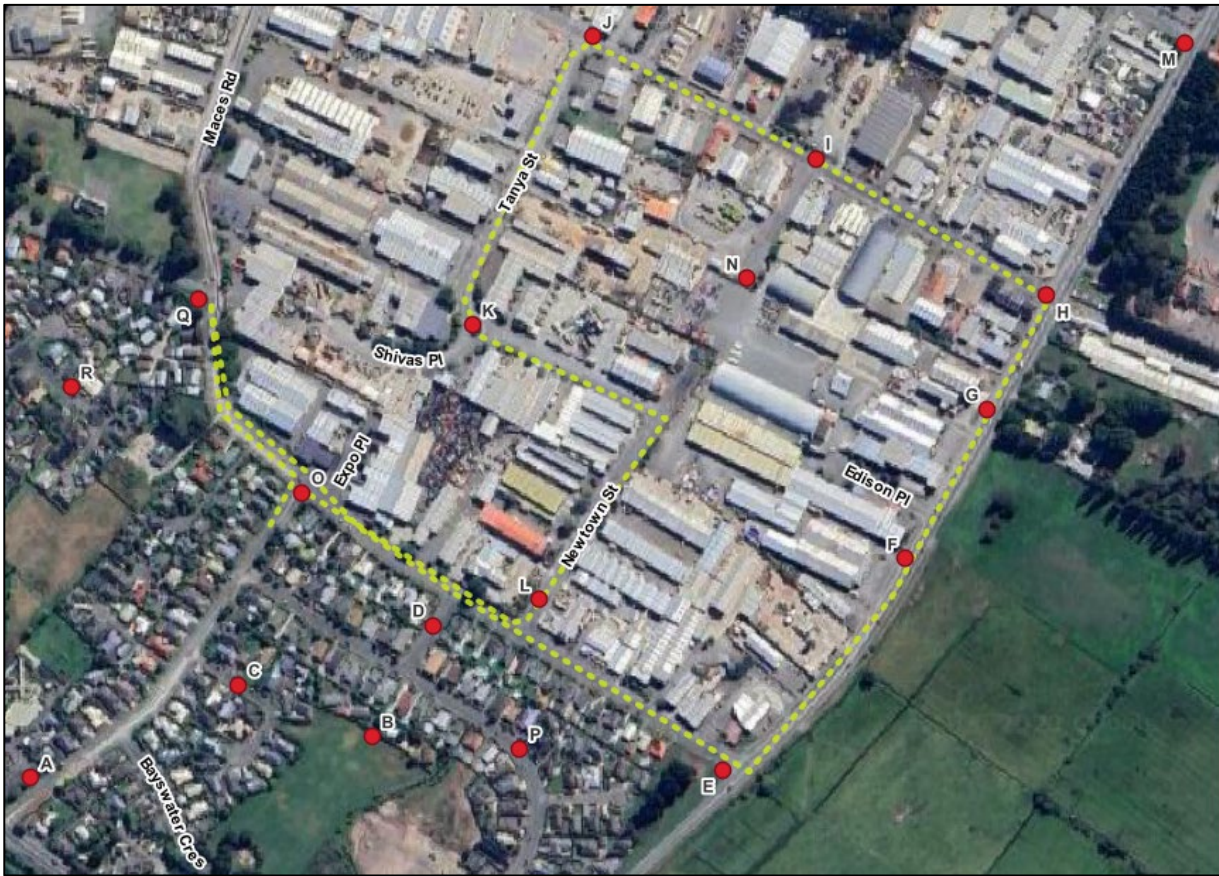
Figure 2: 22nd November 2023 - Odour Scout Route

██████████ were the PDP odour scouts. The scouts were present for approximately 1 hour. The weather was clear, with an average temperature of 18 °C, and easterly winds ranging from 7.6 to 7.9 m/s as a 10-minute average. The scouts started at Site C, then walked a loop, finishing back at Site C. The objective was to undertake odour monitoring in the area downwind of the LE Site. The odour scout route (yellow dots) and key scouting locations are shown in **Figure 2**.

Intermittent weak compost odour was detected in the residential area, at Site D. This odour was not assessed to be offensive or objectionable. The odour detected in the industrial area was not considered offensive or objectionable for an industrial area.

The character of the compost odour matched PDP’s experience with the odour generated by the outdoor material, namely the unscreened compost, oversize stockpiles and screened fines. The odour did not match PDP’s experience with the odour from the processing hall or associated biofilter.

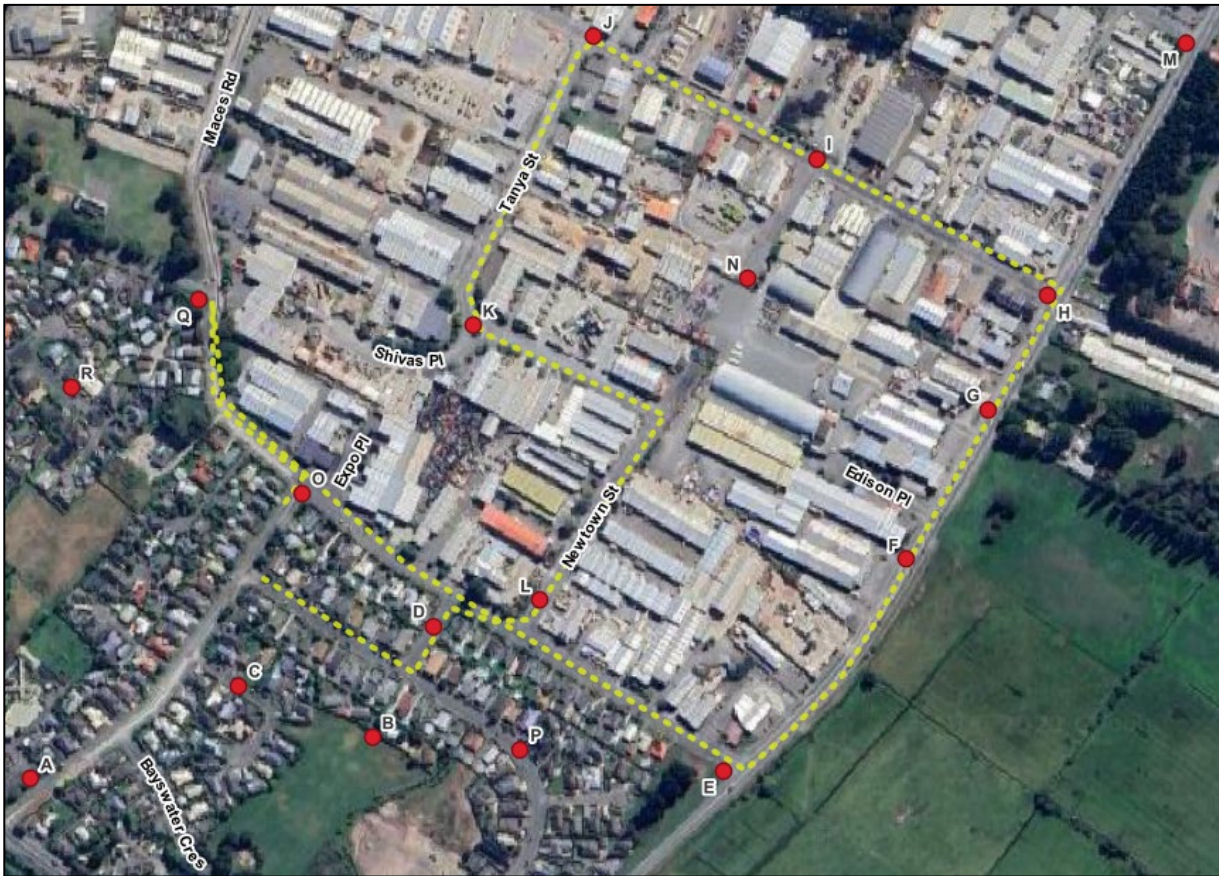
Figure 3: 27th November 2023 - Odour Scout Route

██████████ was the odour scout. The scout was present for approximately 1 hour. The weather was clear, with an average temperature of 16 °C and easterly winds ranging from 6.6 to 7.4 m/s as a 10-minute average. The scout started at Site O, before walking the boundary of the residential zone, from Site Q to Site E. The scout then walked a loop around the industrial zone, before ending at Site O. The objective was to take odour observations downwind of the LE Site. The odour scout route (yellow dots) and key scouting locations are shown in **Figure 3**.

No compost odour was detected in the residential area.

The compost odour detected in the industrial area was not considered offensive or objectionable for an industrial area.

The character of the compost odour matched PDP’s experience with the odour generated by the outdoor material, namely the unscreened compost, oversized stockpiles and screened fines. The odour did not match PDP’s experience with the odour from the processing hall or associated biofilter.

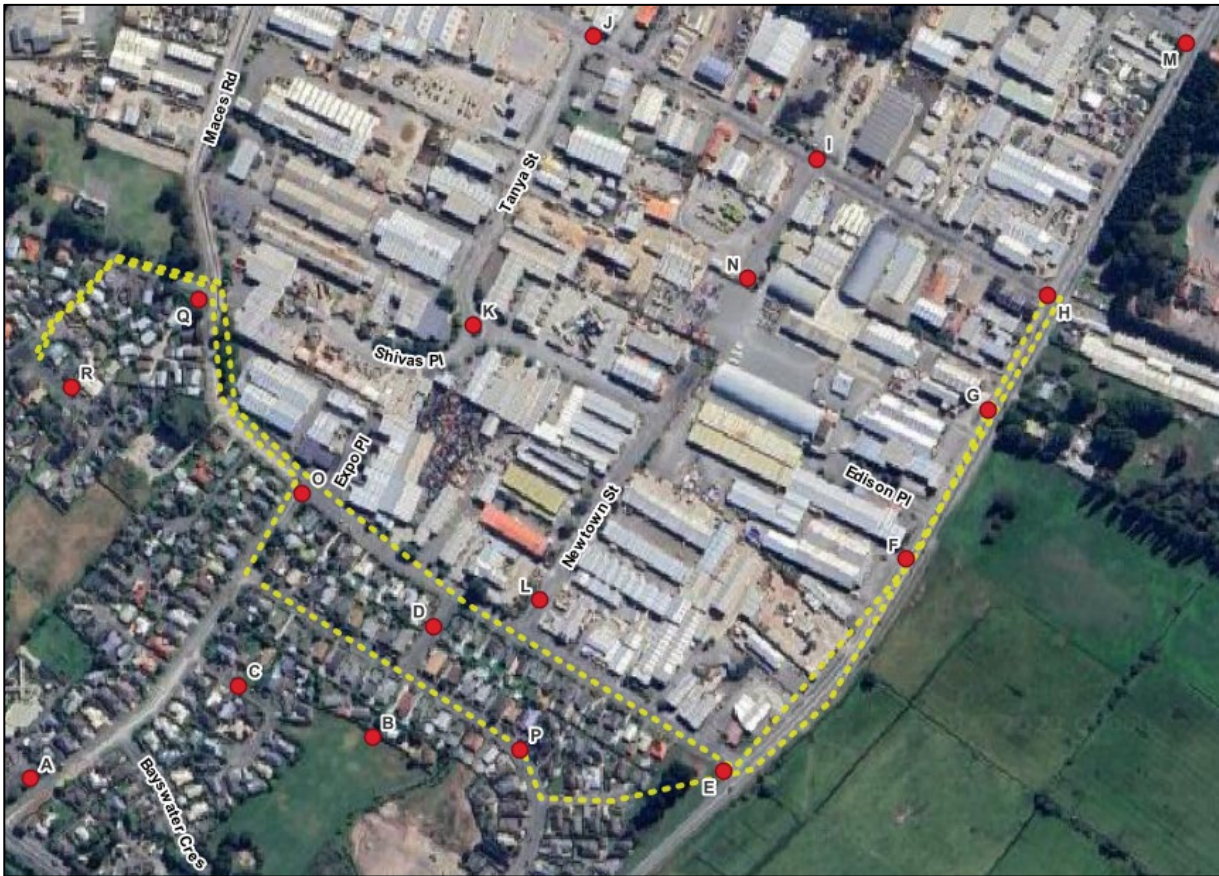
Figure 4: 4th December 2023 - Odour Scout Route

██████████ were the odour scouts. The scouts were present for approximately 45 minutes. The weather was clear, with an average temperature of 16 °C and east-north-easterly to west-north-westerly winds ranging from 0.4 to 1.5 m/s as a 10-minute average. The scouts started at Site O, before walking the boundary of the residential zone, from Site Q to Site E. The scouts then walked up Dyers Road toward the LE site, before returning and ending at Site O. The objective was to take odour observations downwind of the LE Site. The odour scout route (yellow dots) and key scouting locations are shown in **Figure 4**.

No compost odour was detected in the residential or industrial areas.

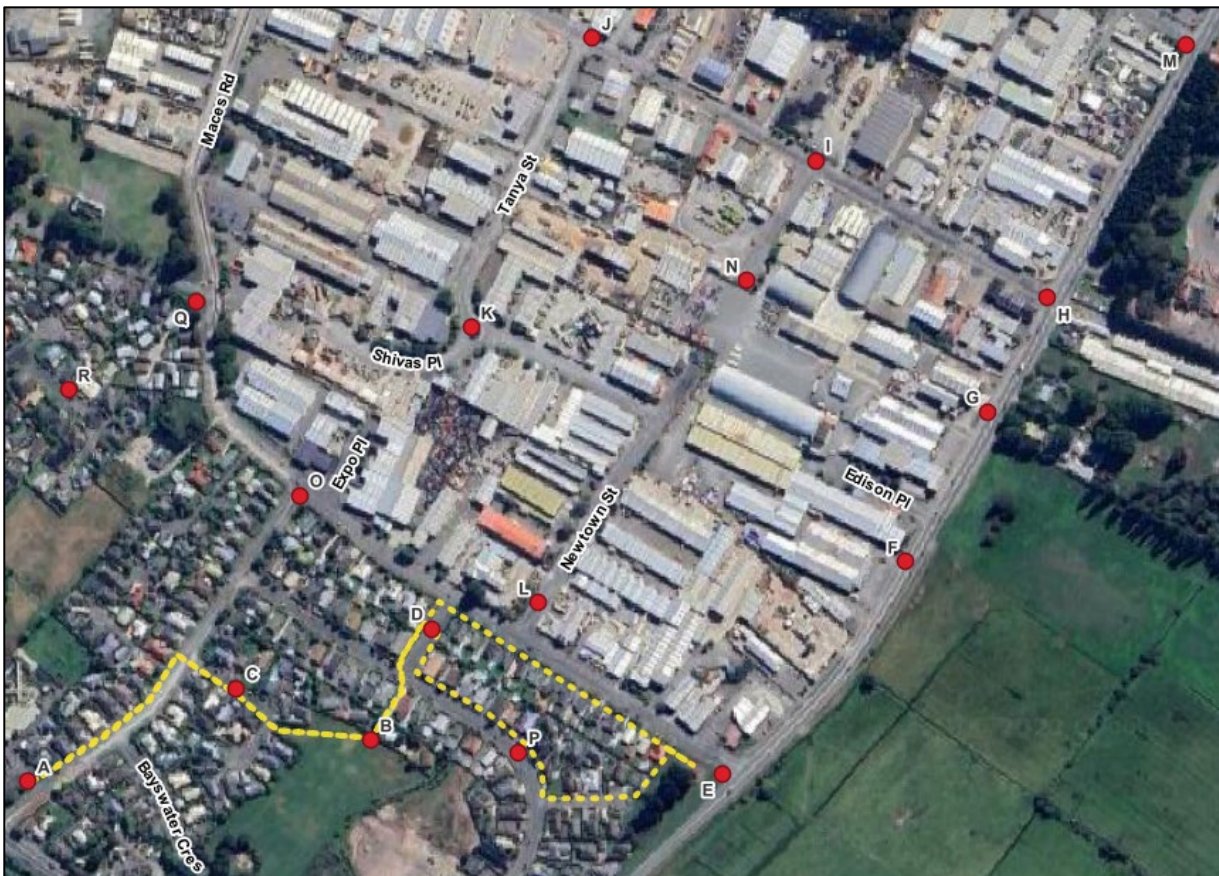
Figure 5: 5th December 2023 – Odour Scout Route

██████████ were the odour scouts. The scouts were present for approximately 1 hour. The weather was overcast and drizzling, with an average temperature of 13 °C and north-easterly winds ranging from 8.9 to 9.7 m/s as a 10-minute average. The scouts started at Site A, before walking a loop through the residential zone via Site E. The objective was to take odour observations downwind of the LE Site. The odour scout route (yellow dots) and key scouting locations are shown in **Figure 5**.

The odour at Site E was variable, with observations of distinct (3) compost odour dispersed among observations of weak (2) compost odour, very weak (1) indeterminate odour, and no odour (0). This odour was assessed to be offensive or objectionable, primarily due to the occurrence of higher strength distinct (3) odours. The location of the Site E odour observations was at the corner of Foresthill Park adjacent to 3 Maces Road, slightly north-west of the location marker for Site E shown in Figure 5, so the odour experienced by the odour scouts would be very similar to the odour experienced at the residences near the corner of Maces Road and Dyers Road.

Meteorological conditions were stable during the day of the 5th of December, with wind directions remaining between 50° and 70°, and windspeeds from 8 to 10 m/s. Therefore, the odour would likely have been similar throughout the day.

The scouts attempted to establish the extent of the offensive odour within the residential zone. Distinct (3) odour was only observed in the vicinity of the Maces Road and Dyers Road intersection. The scouts walked along Bayswater Crescent and Woburn Steet prior to, and after the observations at Site E. Intermittent weak (2) compost odour was present at times along these streets, but distinct (3) odour was

not observed. This odour was not offensive or objectionable. As such, the area observed to be affected by the offensive or objectionable odour during the scout was limited to houses north of Bayswater Crescent, close to the Maces Road and Dyers Road intersection.

Compost odour was not detected in Bayswater Reserve or in Seascape Gardens.

The character of the compost odour matched PDP’s experience with the odour generated by the outdoor material, namely the unscreened compost, oversize stockpiles and screened fines. The odour did not match PDP’s experience with the odour from the processing hall or associated biofilter.

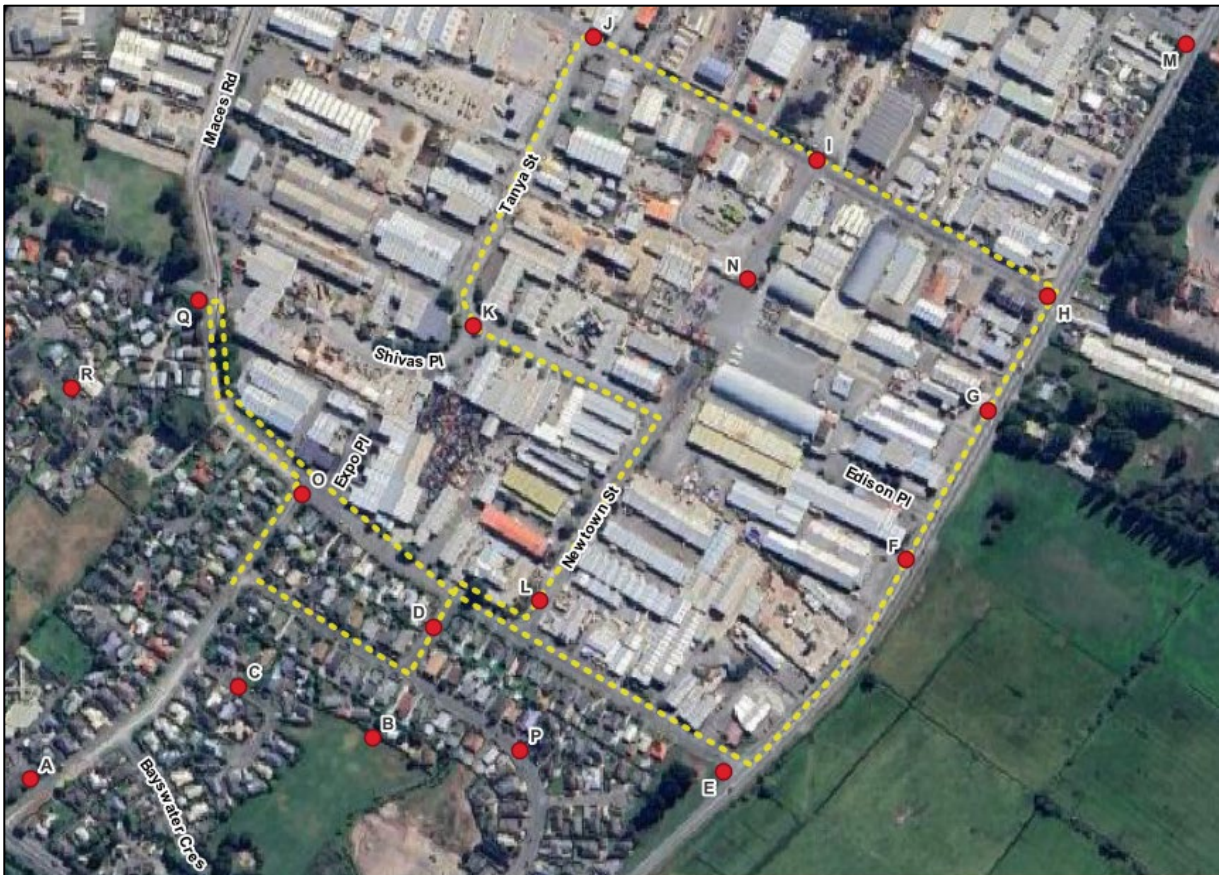
Figure 6: 6th December 2023 - Odour Scout Route

██████████ were the odour scouts. The scouts were present for approximately 1 hour. The weather was overcast and drizzling, with an average temperature of 18 °C and easterly winds ranging from 7 to 7.3 m/s as a 10-minute average. The scouts started at Site O, before walking the boundary of the residential zone, from Site Q to Site E. The scouts then walked a loop around the industrial zone, before ending at Site O. The objective was to take odour observations downwind of the LE Site. The odour scout route (yellow dots) and key scouting locations are shown in **Figure 6**.

Compost odour was detected in the residential area at sites D and O. This odour was assessed to not be offensive or objectionable. The compost odour detected in the industrial area was not considered offensive or objectionable for an industrial area.

The character of the compost odour matched PDP's experience with the odour generated by the outdoor material, namely the unscreened compost, oversize stockpiles and screened fines. The odour did not match PDP's experience with the odour from the processing hall or associated biofilter.

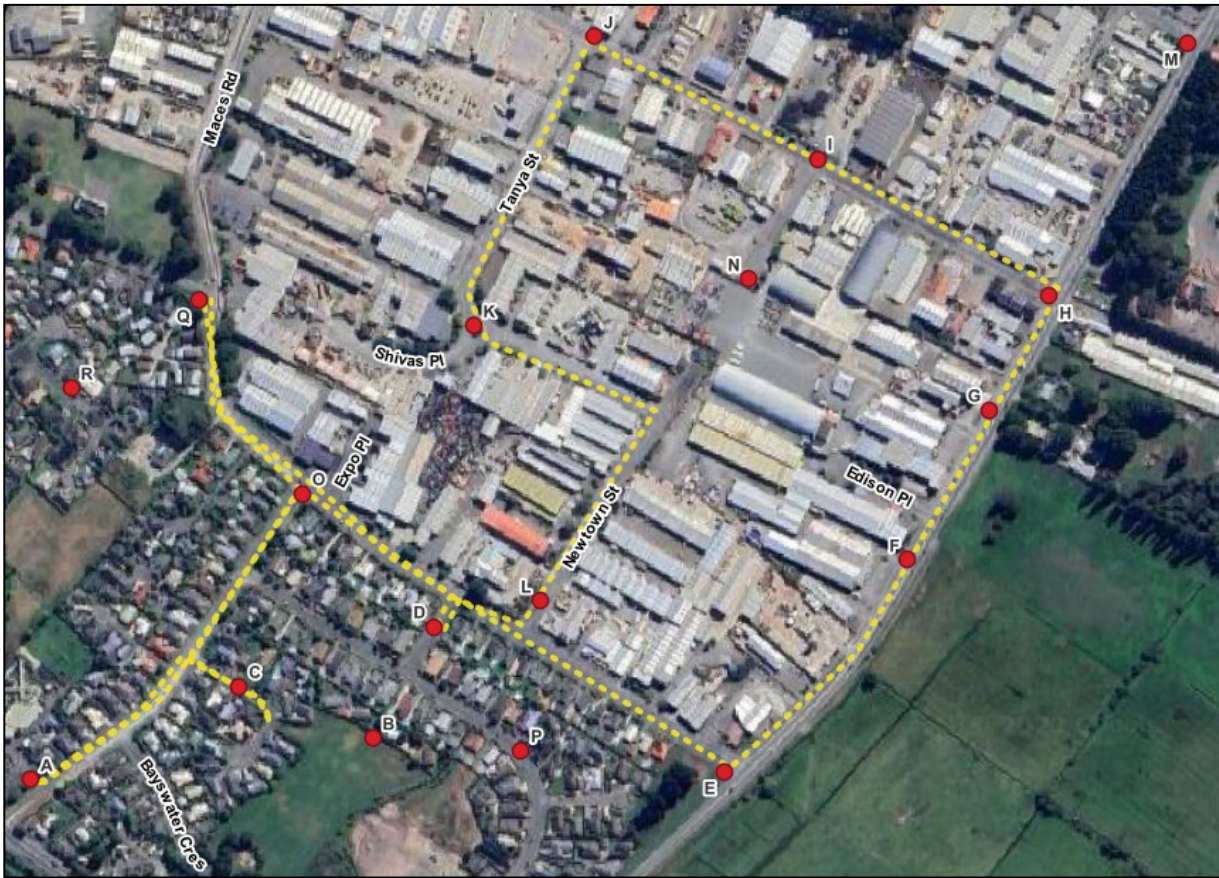
Figure 7: 8th December 2023 - Odour Scout Route

██████████ was the PDP odour scout. The scout was present for approximately 1.5 hours. The weather was clear, with an average temperature of 18 °C, and east-north-easterly to easterly winds ranging from 5.3 to 6.3 m/s as a 10-minute average. The scout started at Site C, then walked a loop, finishing back at Site C. The objective was to undertake odour monitoring in the area downwind of the LE Site. The odour scout route (yellow dots) and key scouting locations are shown in **Figure 7**.

Compost odour was detected in the residential area at sites C, D, E, and O. This odour was assessed to not be offensive or objectionable. The compost odour detected in the industrial area was not considered offensive or objectionable for an industrial area.

The character of the compost odour matched PDP's experience with the odour generated by the outdoor material, namely the unscreened compost, oversize stockpiles and screened fines. The odour did not match PDP's experience with the odour from the processing hall or associated biofilter.
