memorandum

TO Christchurch City Council FROM [REDACTED]
DATE 28 July 2023
RE Living Earth Odour Monitoring: 22nd May 2023 to 18th June 2023 Summary

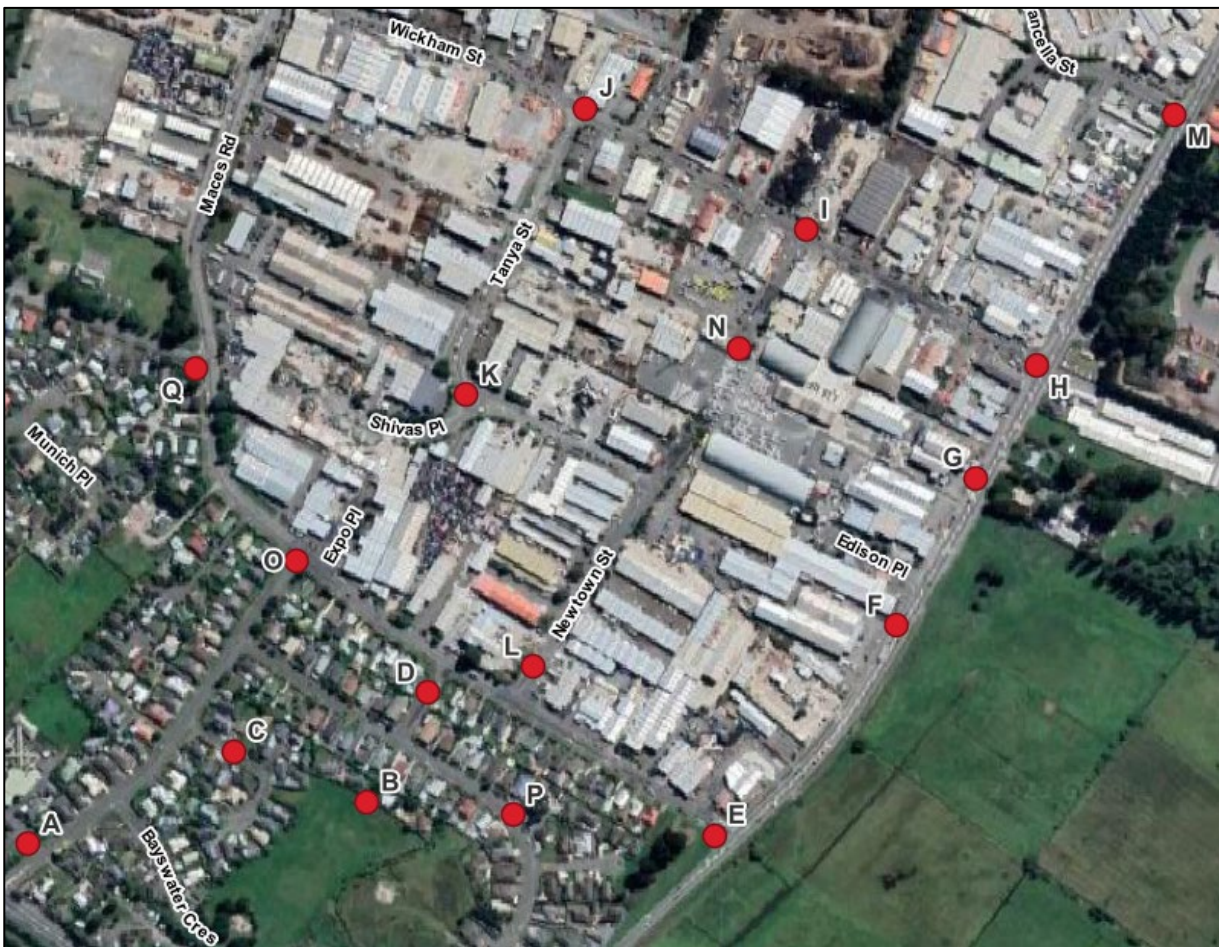
Figure 1: Odour Observation Locations

Sites H and M are immediately downwind of the site, located along Dyers Road with sites G and F. Sites I, J, K, and N are located in the heavy industrial zone. Sites A, C, B, D, and P are located in the residential zone around Bayswater Reserve. Sites E, L, O and Q are located roughly along the residential-industrial boundary. In assessments, Sites E, O, and Q are used to represent the closest (to the LE Site) downwind edge of the residential zone. Site L is located in the general industrial zone - Site D is used as the closest (to the LE Site) downwind residential monitoring point in this area.

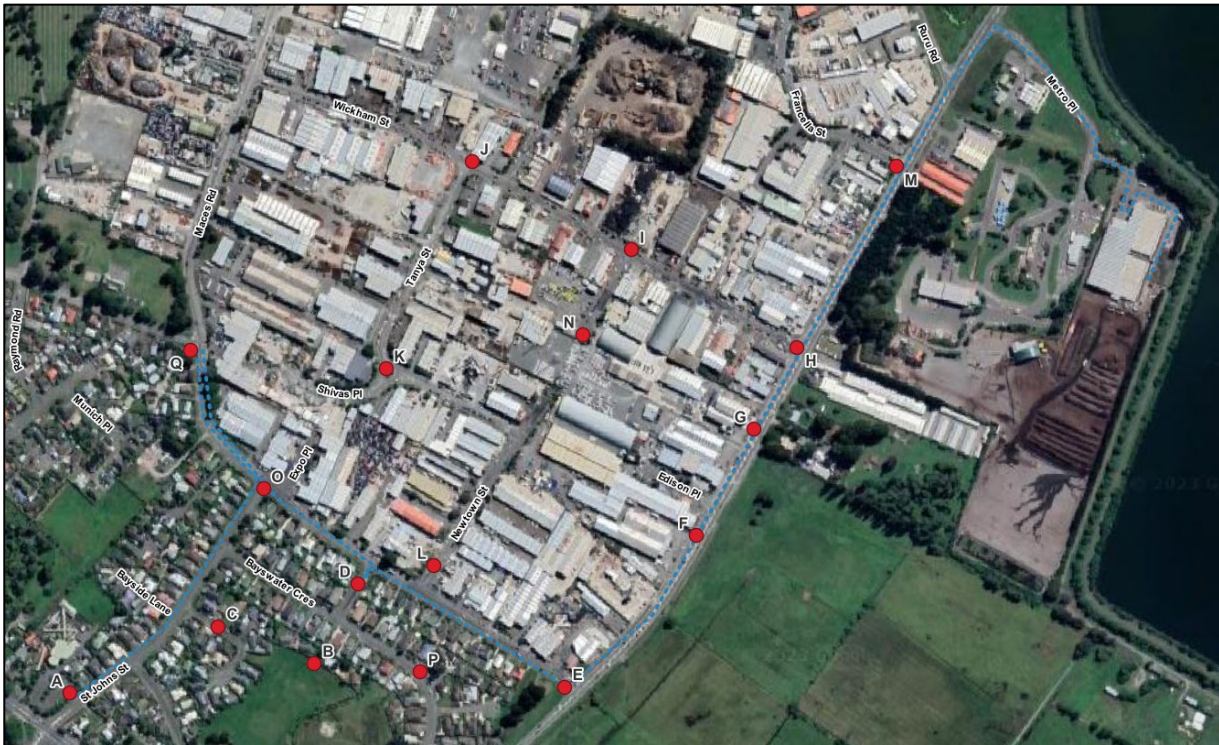
Figure 2: 25th May 2023 - Odour Scout Route

██████ was the PDP odour scout. The scout was present for approximately 1 hour. The weather was clear, with an average temperature of 14 °C and east to east-south-easterly winds ranging from 3.5 m/s to 4.3 m/s as a 10-minute average. The scout started at Site A and finished at the LE site. The objective was to undertake odour monitoring in the area downwind of the LE Site. The odour scout route (blue dots) and key scouting locations are shown in **Figure 2**. The odour scout drove between Sites A and Q, between Sites Q and O, and between Site D and the LE site.

Maintenance works were occurring on the biofilter during the odour scout. The odour produced due to this disruption was detected at Site O. The odour detected in the residential area was not considered offensive or objectionable.

The character of the compost odour did not match PDP’s experience with the odour generated by the outdoor material. The odour at Site Q was sharper, sweeter, and grassier than normal. At Site O, the odour was more clearly different, with an acidic, grassy, sharp, and fermented character. This character matched the scout’s on-site observations at the biofilter on the day. The odour did not match PDP’s previous observations of the character of the biofilter under normal operating conditions.

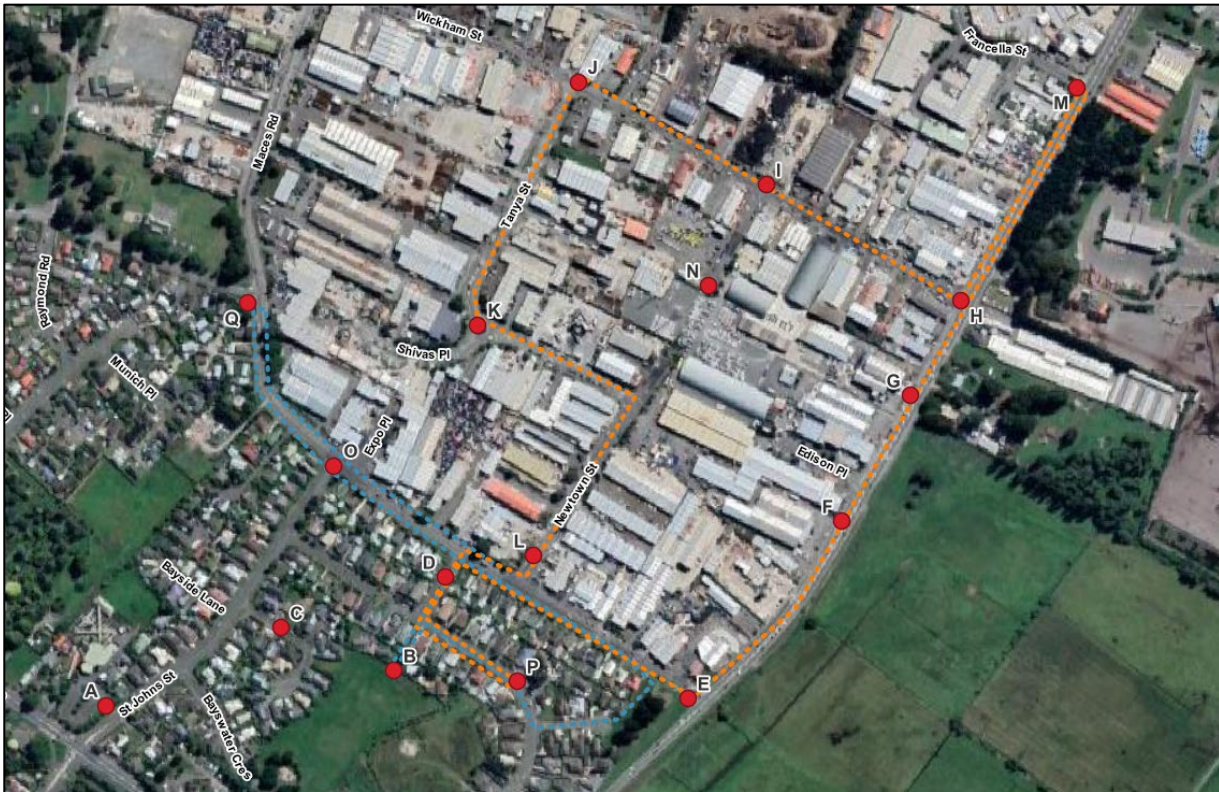
Figure 3: 1st June 2023 - Odour Scout Route

██████████ were the PDP odour scouts. The scouts were present for approximately 1 hour. The weather was clear, with an average temperature of 16 °C and north-easterly to east-south-easterly winds ranging from 2.2 m/s to 2.9 m/s as a 10-minute average. The scouts started near site L and finished near Site E. The objective was to undertake odour monitoring in the area downwind of the LE Site. The first odour scout’s route (blue dots), second odour scout’s route (orange dots) and key scouting locations are shown in **Figure 3**.

A wind shift occurred over the course of the odour scout. The wind was initially east-south-easterly, with odour detected at Site J. Over the course of the scout, the wind shifted to a north-easterly direction, becoming detected at Site E.

The 'upset biofilter' odour detected at Site E was offensive and objectionable.

The 'upset biofilter' odour detected matched PDP's experience with the odour from the biofilter while maintenance works were occurring, as detected on 25th May 2023.

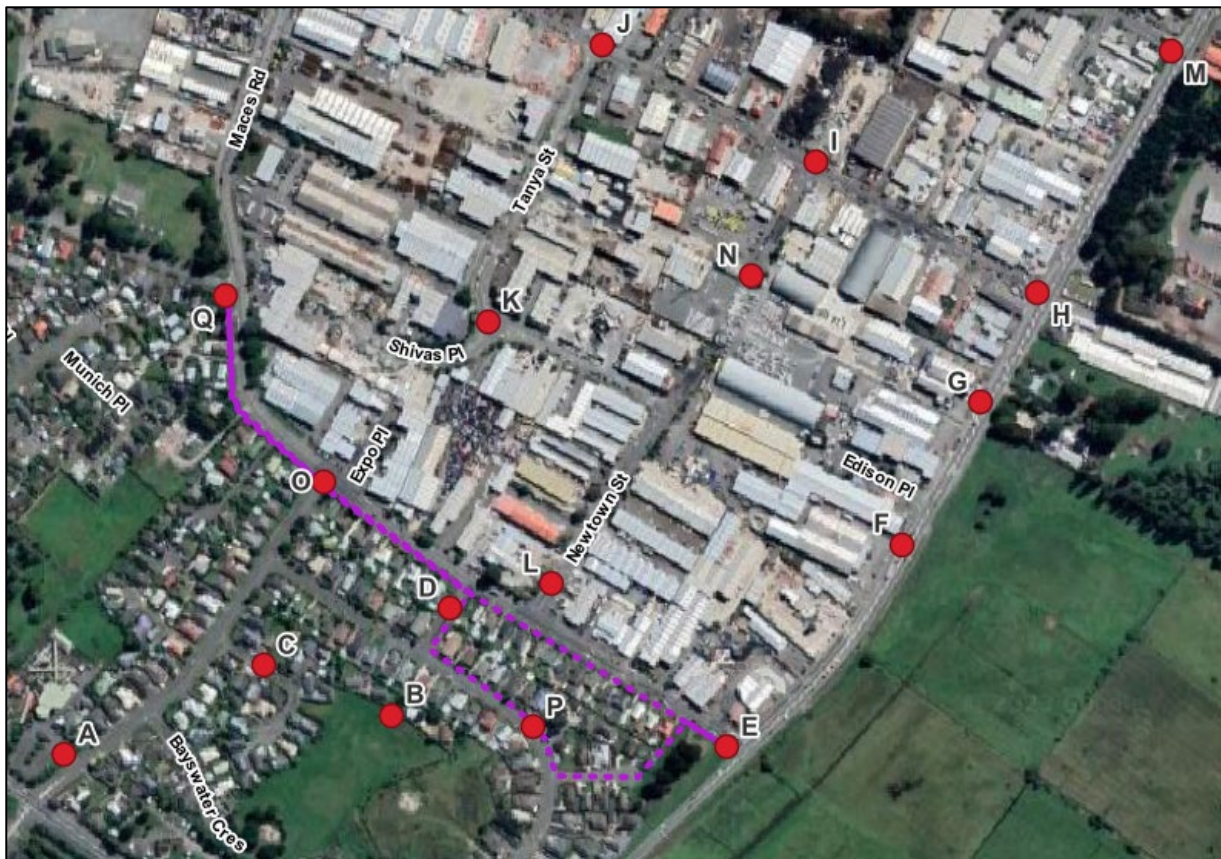
Figure 4: 9th June 2023 - Odour Scout Route

██████ was the PDP odour scout. The scout was present for approximately 30 minutes. The weather was overcast, with a temperature of 9 °C and north-easterly winds with a windspeed of 2.1 m/s as a 10-minute average. The scout started and finished at Site O. The objective was to undertake odour monitoring in the area downwind of the LE Site. The odour scout route (purple dots) and key scouting locations are shown in **Figure 4**.

Weak (2), intermittent compost odour was detected at several locations in the residential areas and was not offensive or objectionable. A number of other industrial odours were also detected along Maces Rd.

The character of the compost odour matched PDP's experience with the odour generated by the outdoor material, namely the unscreened compost, oversize stockpiles and screened fines. The odour did not match PDP's experience with the odour from the processing hall or associated biofilter.

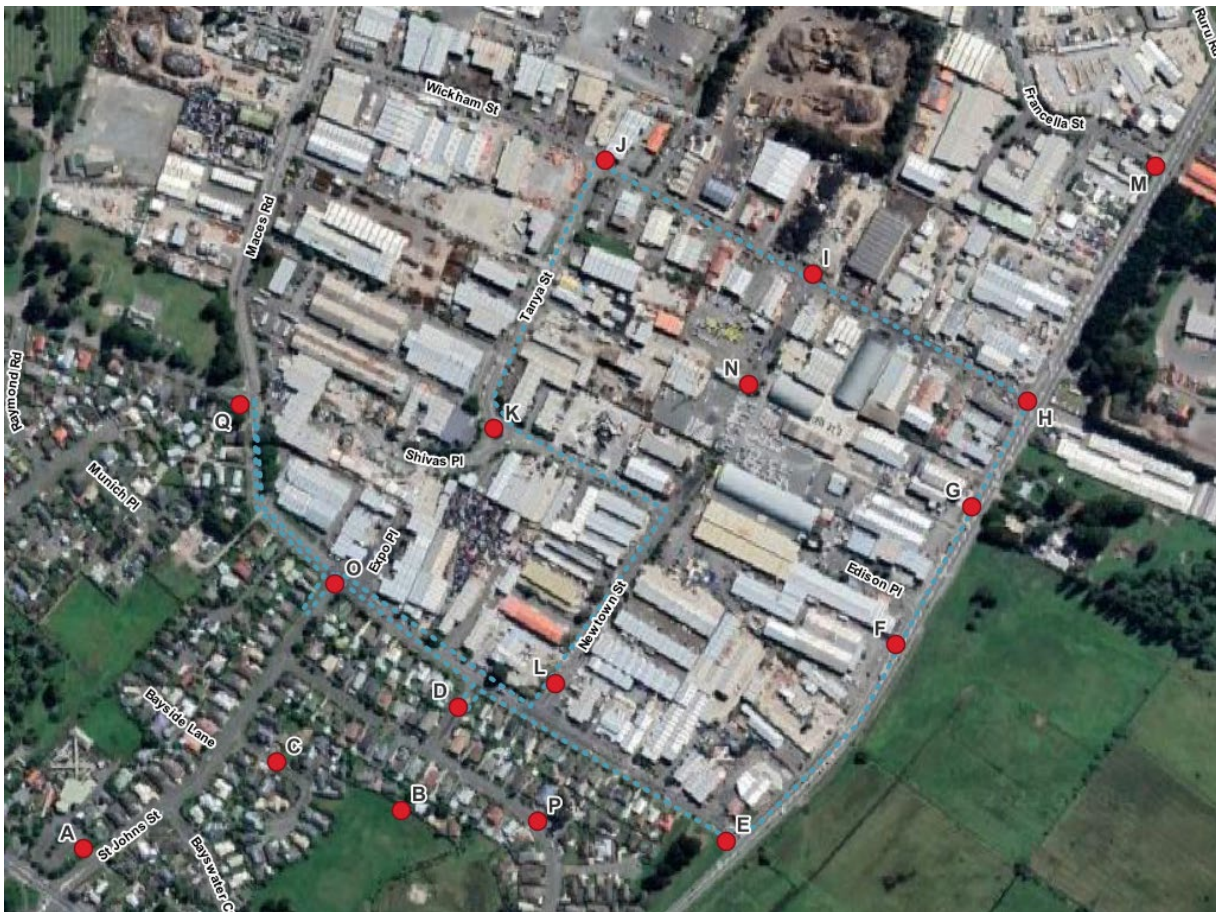
Figure 5: 15th June 2023 - Odour Scout Route

██████████ was the PDP odour scout. The scout was present for approximately 1 hour. The weather was clear, with an average temperature of 12 °C and east-northeast winds ranging from 5.3 m/s to 6.8 m/s as a 10-minute average. The scout started and finished near Site O. The objective was to undertake odour monitoring in the area downwind of the LE Site. The odour scout route (blue dots) and key scouting locations are shown in **Figure 5**.

Intermittent weak (2) compost odour was detected at Sites O and D. This odour was not offensive or objectionable.

Distinct (3) compost odour was detected in the industrial zone along Dyers Rd, close to the LE site. Being in a heavy industrial zone, this odour was not offensive or objectionable for the location.

The character of the compost odour matched PDP's experience with the odour generated by the outdoor material, namely the unscreened compost, oversize stockpiles and screened fines. The odour did not match PDP's experience with the odour from the processing hall or associated biofilter.

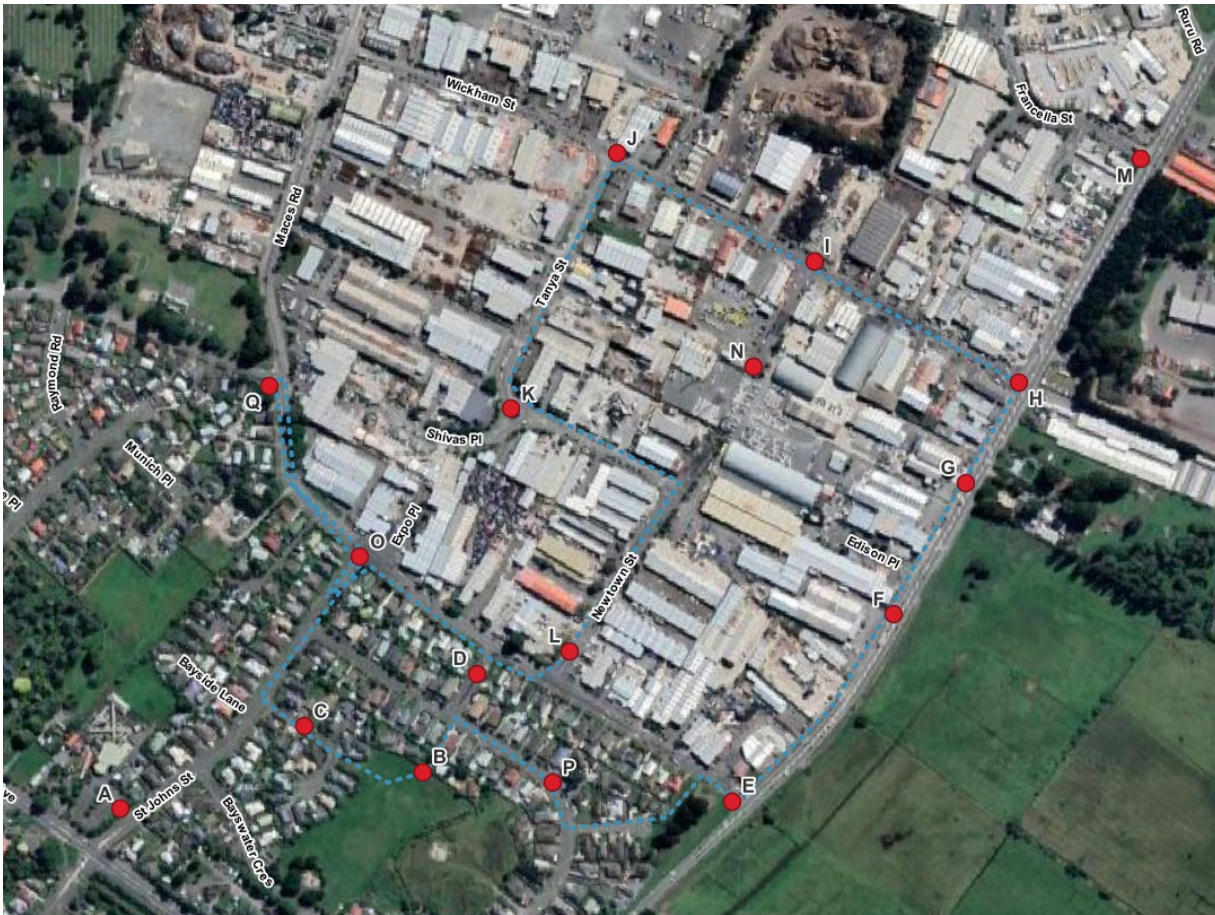
Figure 6: 16th June 2023 - Odour Scout Route

██████████ was the PDP odour scout. The scout was present for approximately 1 hour. The weather was clear, with an average temperature of 12 °C and east-northeasterly to easterly winds ranging from 6.1 m/s to 6.9 m/s as a 10-minute average. The scout started and finished near site O. The objective was to undertake odour monitoring in the area downwind of the LE Site. The odour scout route (blue dots) and key scouting locations are shown in **Figure 6**.

Intermittent, weak (2) compost odour was detected at and around Site O, and between sites B and P. This odour was not offensive or objectionable. Continuous distinct compost odour was detected from F to H. This odour was not offensive or objectionable for an industrial area.

The character of the compost odour matched PDP's experience with the odour generated by the outdoor material, namely the unscreened compost, oversize stockpiles and screened fines. The odour did not match PDP's experience with the odour from the processing hall or associated biofilter.
