TO Christchurch City Council FROM [REDACTED]
DATE 3 October 2023
RE Living Earth Odour Monitoring: 19th August 2023 to 15th September 2023 Summary

1.0 Background

This letter provides a summary of PDP's observations of off-site odour scouting for the period between the 19th of August 2023 and the 15th of September 2023.

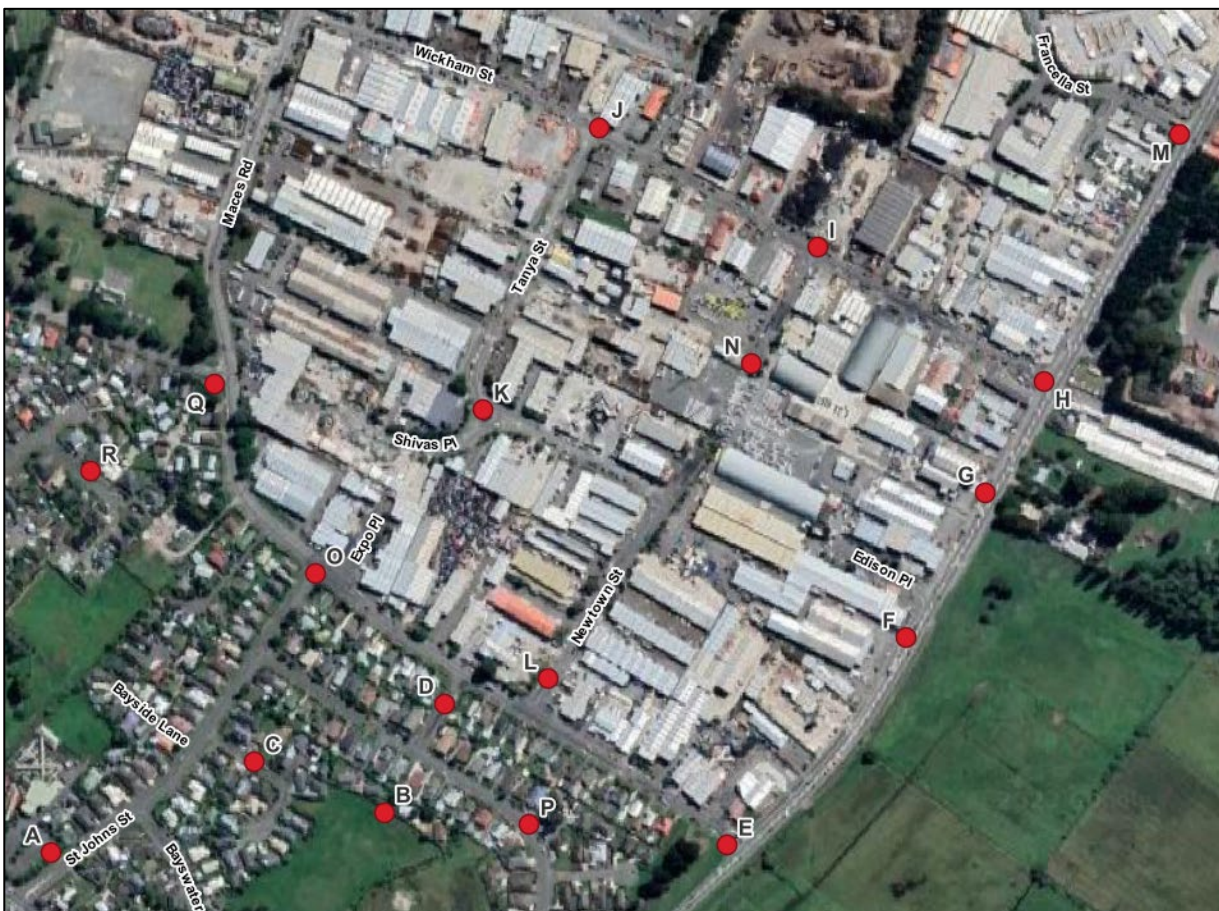
Figure 1: Odour Observation Locations

Sites H and M are immediately downwind of the site, located along Dyers Road with sites G and F. Sites I, J, K, and N are located in the heavy industrial zone. Sites A, C, B, D, R, and P are located in the residential zone around Bayswater Reserve. Site R (Munich Place) has been added to collect data further into the residential zone in easterly conditions. Sites E, L, O, D and Q are located roughly along the residential-industrial boundary. In assessments, Sites E, O, D and Q are in the residential zone, while Site L is in the general industrial zone.

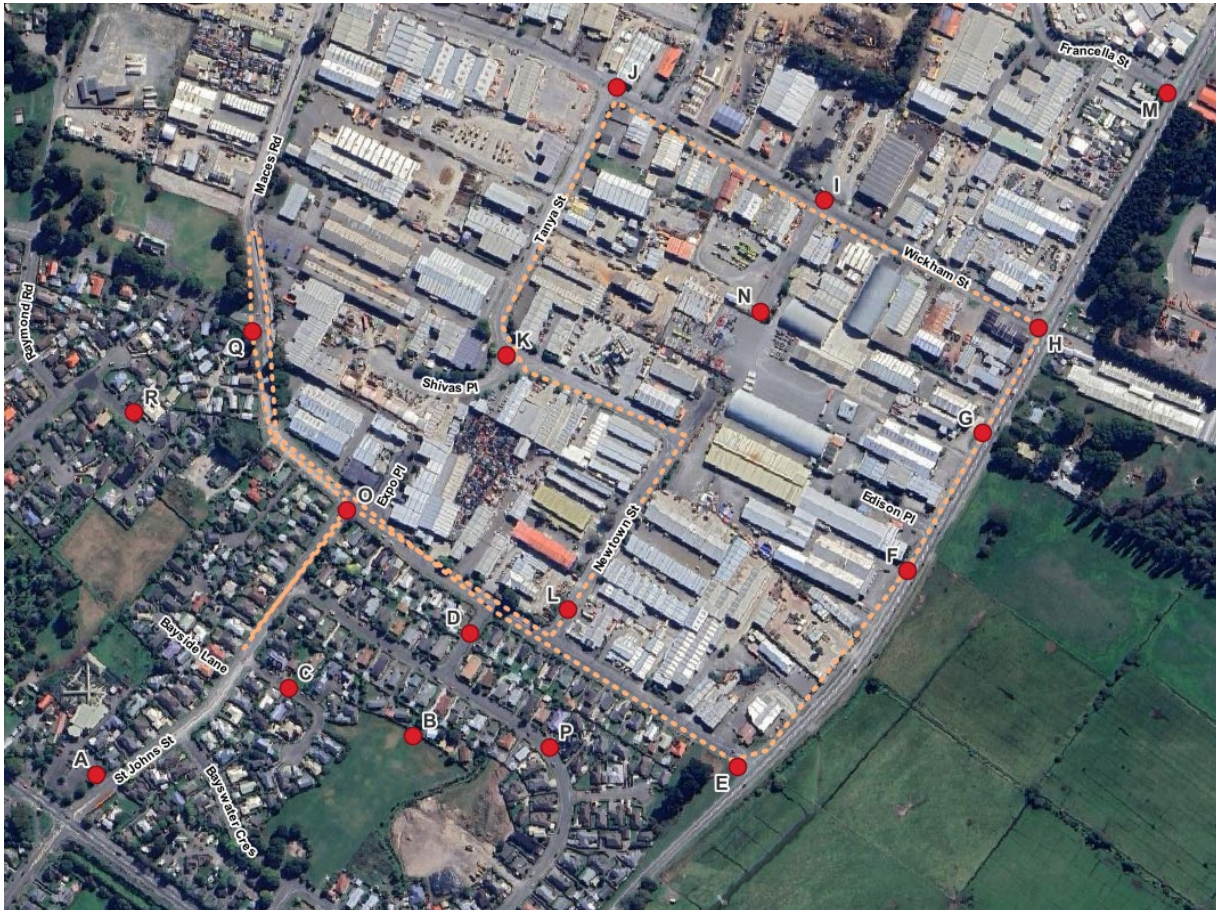
Figure 2: 22nd August 2023 - Odour Scout Route

_____ were the PDP odour scouts. The scouts were present for approximately 1 hour. The weather was clear, with an average temperature of 10 °C and east-north-easterly winds ranging from 4.1 m/s to 4.5 m/s as a 10-minute average. The scouts started at Site C, then walked to Site O and walked a loop, finishing back at Site O. The objective was to undertake odour monitoring in the area downwind of the LE Site. The odour scout route (orange dots) and key scouting locations are shown in **Figure 2**.

Intermittent weak (2) compost odour was detected between Site D and E in the residential area. This odour was not considered offensive or objectionable.

The odour detected in the industrial area was not considered offensive or objectionable for an industrial area.

The character of the compost odour matched PDP's experience with the odour generated by the outdoor material, namely the unscreened compost, oversize stockpiles and screened fines. The odour did not match PDP's experience with the odour from the processing hall or associated biofilter.

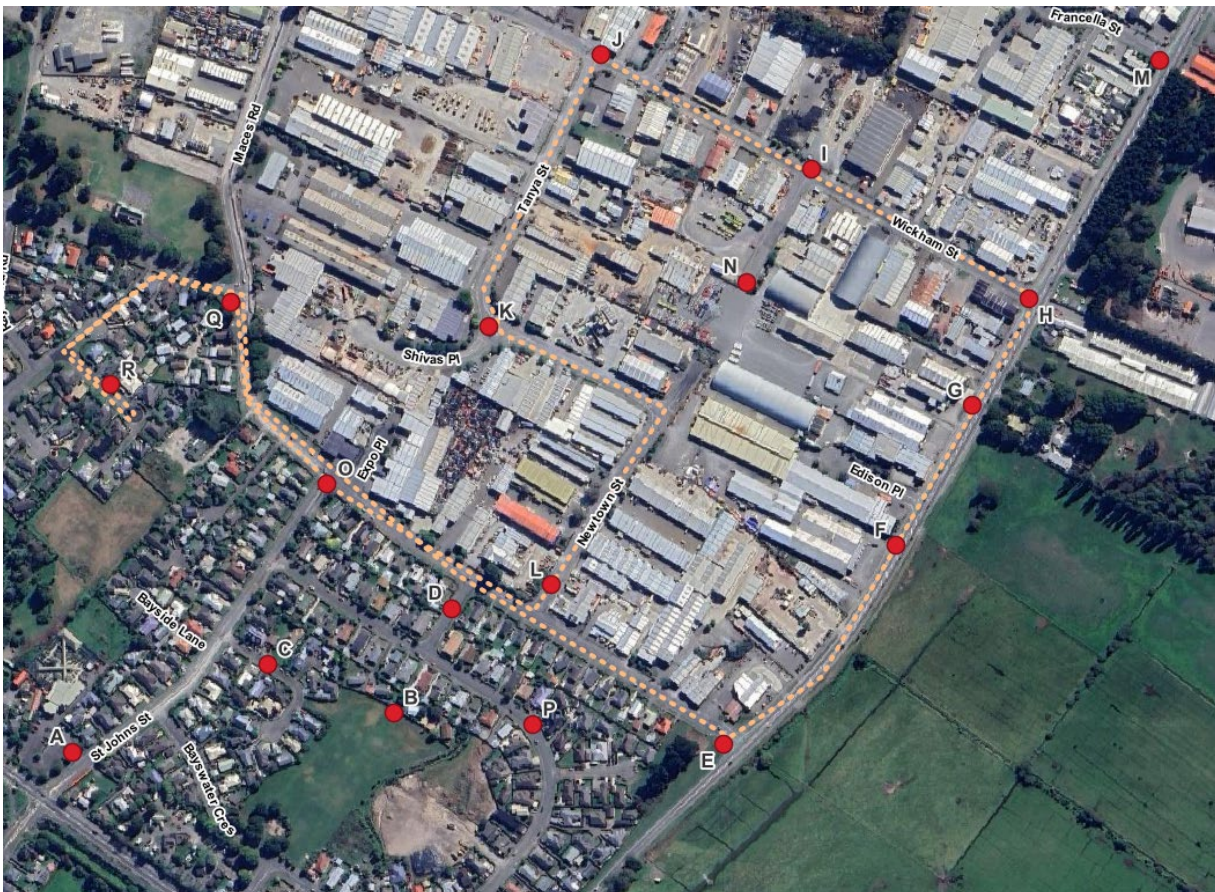
Figure 3: 23rd August 2023 - Odour Scout Route

██████████ was the PDP odour scout. The scout was present for approximately 1 hour. The weather was clear, with an average temperature of 10 °C and easterly winds ranging from 4.4 m/s to 4.8 m/s as a 10-minute average. The scout started and finished at Site R. The objective was to undertake odour monitoring in the area downwind of the LE Site. The odour scout route (orange dots) and key scouting locations are shown in **Figure 3**.

No compost odour was detected in the residential area.

The odour detected in the industrial area was not considered offensive or objectionable for an industrial area.

The character of the compost odour matched PDP’s experience with the odour generated by the outdoor material, namely the unscreened compost, oversize stockpiles and screened fines. The odour did not match PDP’s experience with the odour from the processing hall or associated biofilter.

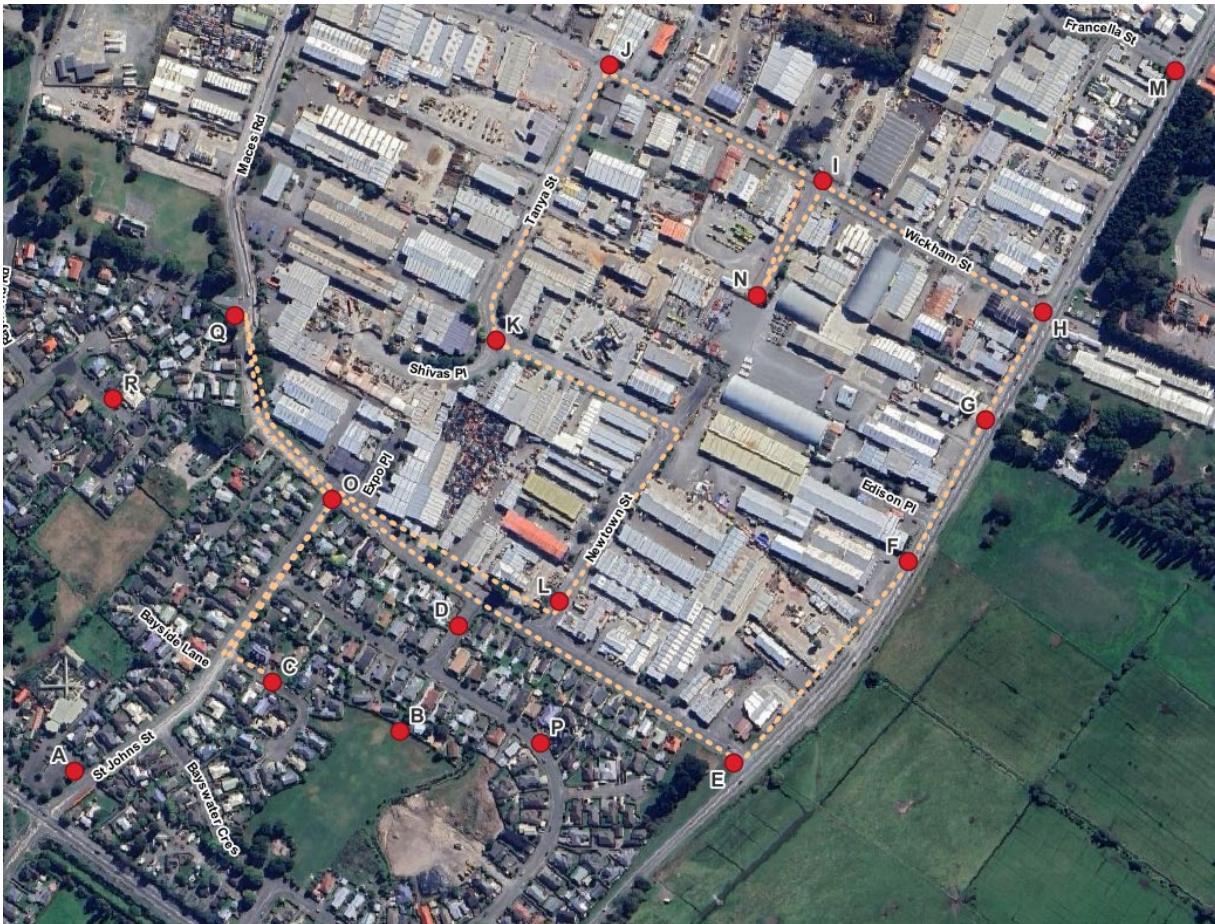
Figure 4: 25th August 2023 - Odour Scout Route

██████████ were the PDP odour scouts. The scouts were present for approximately 1 hour. The weather was clear, with an average temperature of 11 °C and easterly winds ranging from 4.3 m/s to 4.7 m/s as a 10-minute average. The scouts started and finished near Site C. The objective was to undertake odour monitoring in the area downwind of the LE Site. The odour scout route (orange dots) and key scouting locations are shown in **Figure 4**.

Intermittent weak (2) compost odour was detected at Site Q. This odour was not offensive or objectionable.

Distinct (3) compost odour was detected in the industrial zone along Dyers Rd, close to the LE site. Being in a heavy industrial zone, this odour was not offensive or objectionable for the location.

The character of the compost odour matched PDP's experience with the odour generated by the outdoor material, namely the unscreened compost, oversize stockpiles and screened fines. The odour did not match PDP's experience with the odour from the processing hall or associated biofilter.

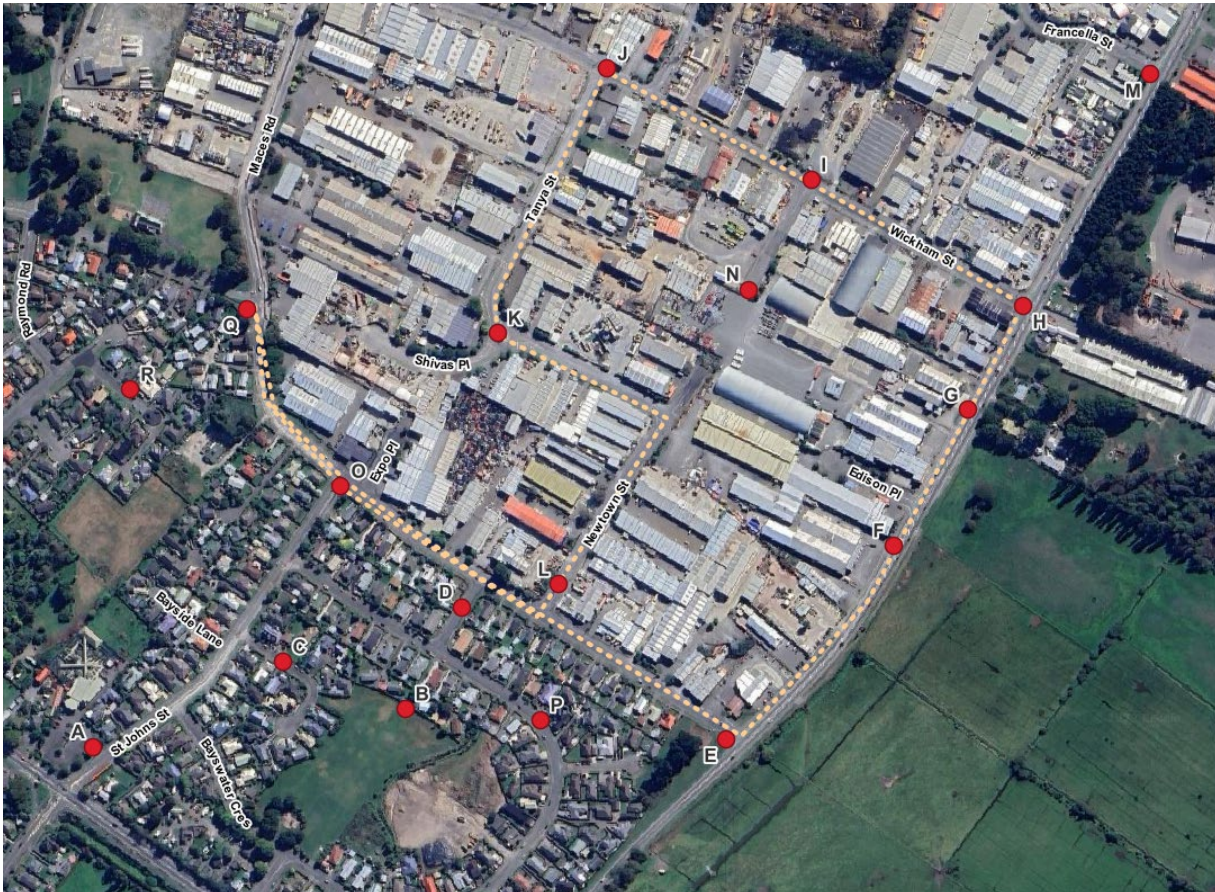
Figure 5: 30th August 2023 - Odour Scout Route

██████████ was the PDP odour scout. The scout was present for approximately 1 hour. The weather was clear, with an average temperature of 12°C and east-north-easterly winds ranging from 4.2 m/s to 4.6m/s as a 10-minute average. The scout started and finished near Site O, first walking the boundary of the residential area, and then walking a loop within the industrial zone. The objective was to undertake odour monitoring in the area downwind of the LE Site. The odour scout route (orange dots) and key scouting locations are shown in **Figure 5**.

No objectionable or offensive compost odour was detected in the residential zone.

Distinct (3) compost odour was detected in the industrial zone along Dyers Rd, close to the LE site, and weak (2) compost odour was detected from Sites I to J, in the industrial zone. Being in a heavy industrial zone, this odour was not offensive or objectionable for the location.

The character of the compost odour matched PDP's experience with the odour generated by the outdoor material, namely the unscreened compost, oversize stockpiles and screened fines. The odour did not match PDP's experience with the odour from the processing hall or associated biofilter.

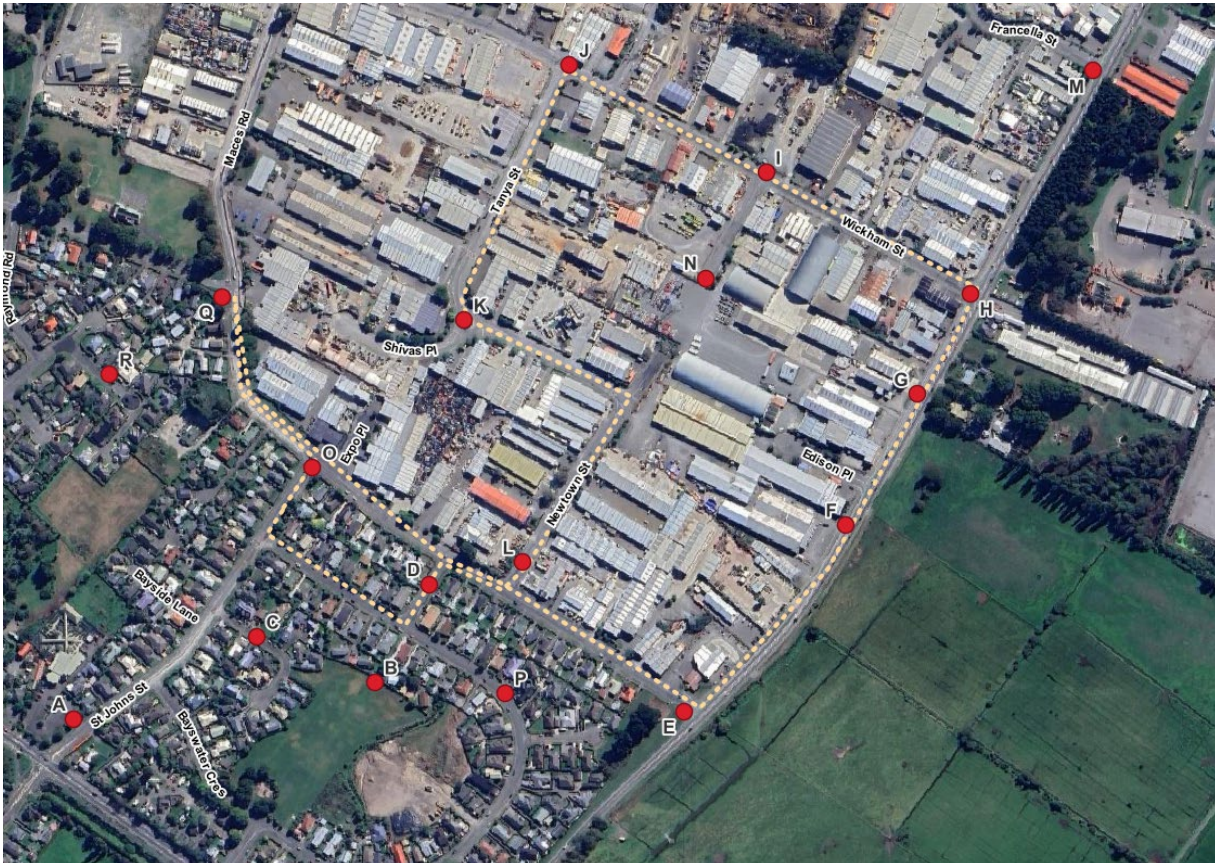
Figure 6: 1st September 2023 - Odour Scout Route

[REDACTED] was the PDP odour scout. The scout was present for approximately 40 minutes. The weather was clear, with an average temperature of 17°C and easterly winds ranging from 2.1 m/s to 2.5 m/s as a 10-minute average. The scout started and finished near Site O, first walking the boundary of the residential area, and then walking a loop within the industrial zone. The objective was to undertake odour monitoring in the area downwind of the LE Site. The odour scout route (orange dots) and key scouting locations are shown in **Figure 6**.

No objectionable or offensive compost odour was detected in the residential zone.

Weak (2) compost odour was detected from Sites G to H, in the industrial zone. Being in a heavy industrial zone, this odour was not offensive or objectionable for the location.

The character of the compost odour matched PDP's experience with the odour generated by the outdoor material, namely the unscreened compost, oversize stockpiles and screened fines. The odour did not match PDP's experience with the odour from the processing hall or associated biofilter.

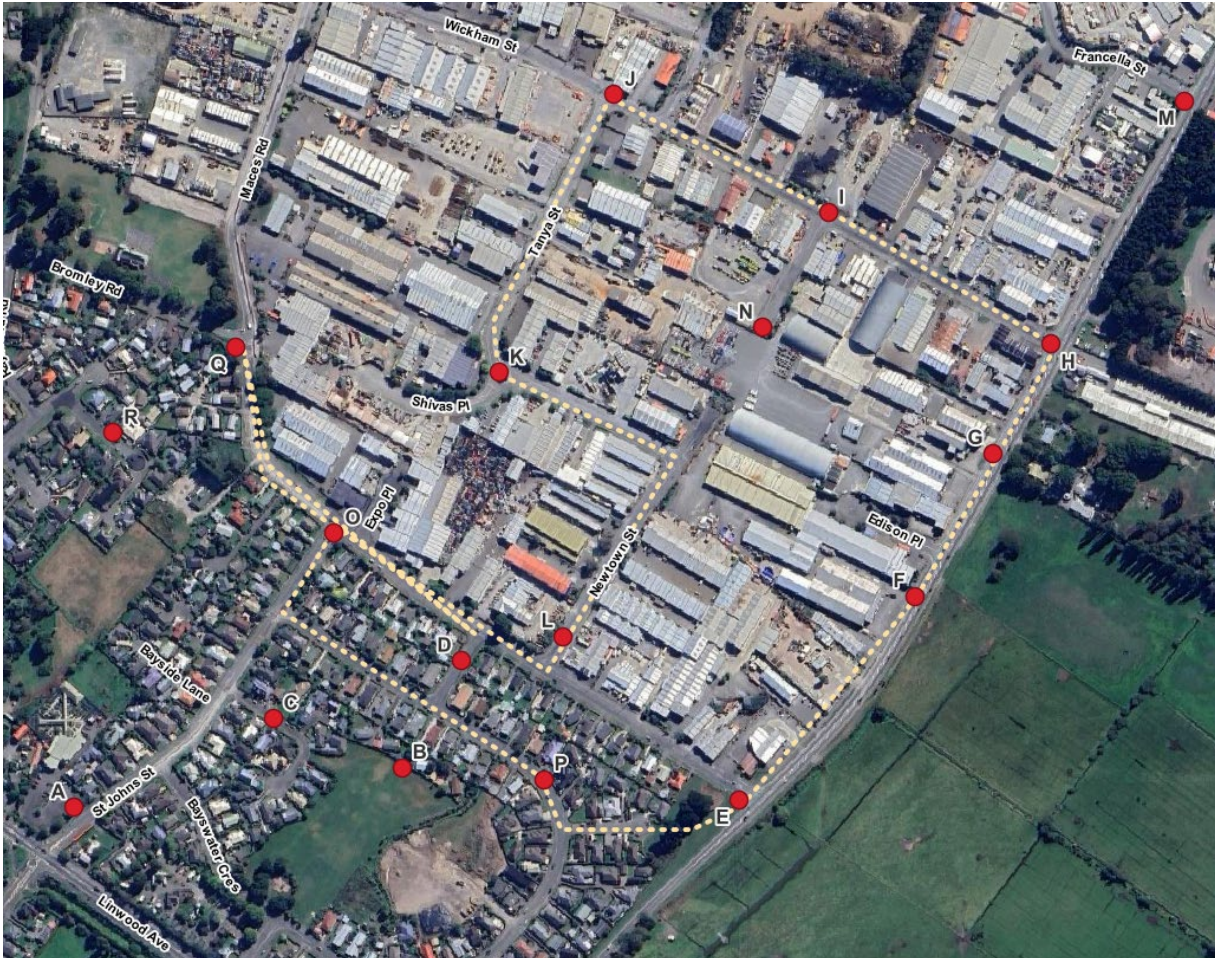
Figure 7: 4th September 2023 - Odour Scout Route

██████ was the PDP odour scout. The scout was present for approximately 1 hour. The weather was clear, with an average temperature of 11°C and easterly winds ranging from 6.6 m/s to 7 m/s as a 10-minute average. The scout started and finished near Site O, first walking the boundary of the residential area, and then walking a loop within the industrial zone before walking back through part of the residential area. The objective was to undertake odour monitoring in the area downwind of the LE Site. The odour scout route (orange dots) and key scouting locations are shown in Figure 7.

No objectionable or offensive compost odour was detected in the residential zone.

Weak (2) compost odour was detected along Dyers Road, in the industrial zone. Being in a heavy industrial zone, this odour was not offensive or objectionable for the location.

The character of the compost odour matched PDP's experience with the odour generated by the outdoor material, namely the unscreened compost, oversize stockpiles and screened fines. The odour did not match PDP's experience with the odour from the processing hall or associated biofilter.

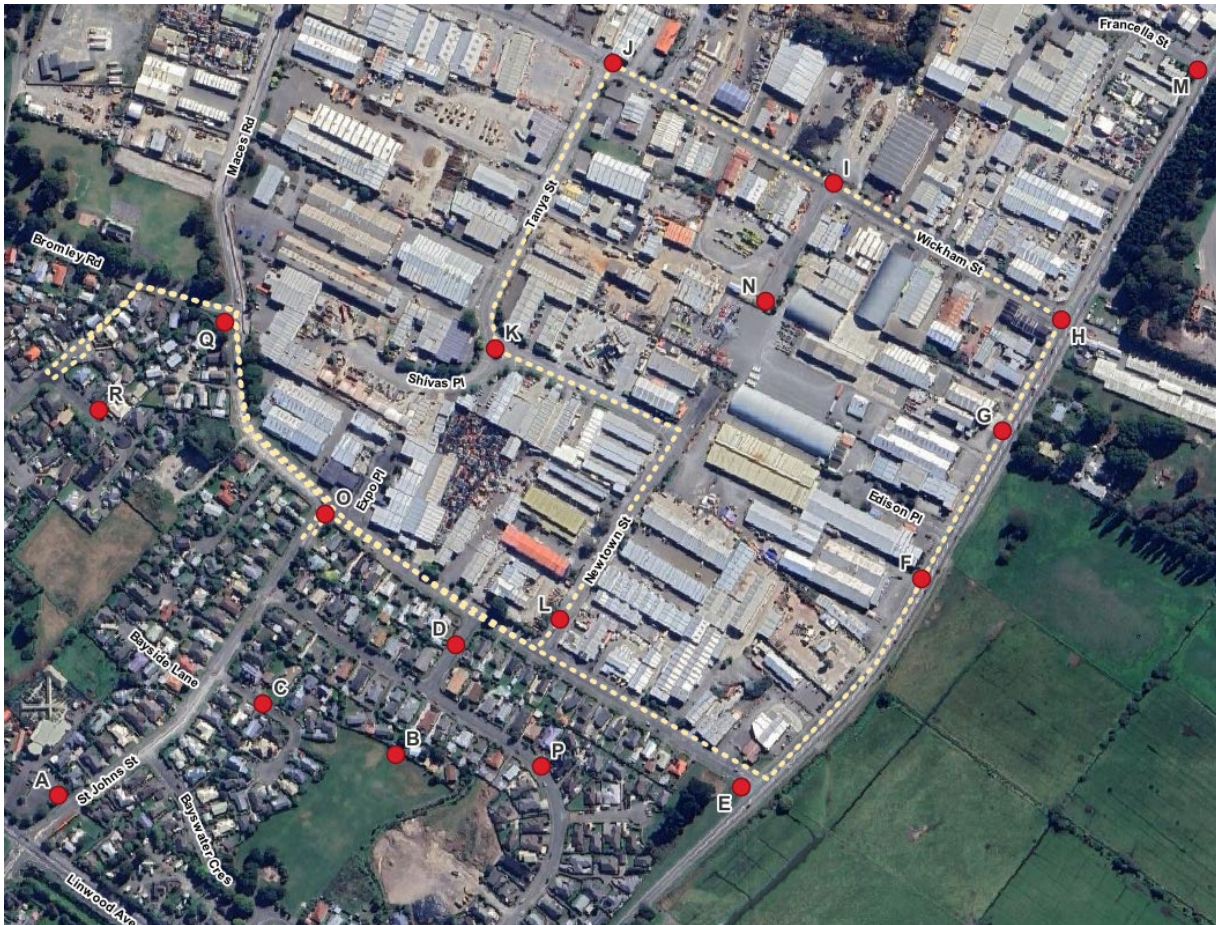
Figure 8: 13th September 2023 - Odour Scout Route

[REDACTED] was the PDP odour scout. The scout was present for approximately 1 hour. The weather was clear, with an average temperature of 13°C and easterly winds ranging from 5.2 m/s to 6.5 m/s as a 10-minute average. The scout started and finished near Site O, first walking the boundary of the residential area, and then walking a loop within the industrial zone before walking back through part of the residential area. The objective was to undertake odour monitoring in the area downwind of the LE Site. The odour scout route (orange dots) and key scouting locations are shown in Figure 8.

No objectionable or offensive compost odour was detected in the residential zone.

Weak (2) compost odour was detected along Dyers Road, close to the Living Earth facility in the industrial zone. Being in a heavy industrial zone, this odour was not offensive or objectionable for the location.

The character of the compost odour matched PDP's experience with the odour generated by the outdoor material, namely the unscreened compost, oversize stockpiles and screened fines. The odour did not match PDP's experience with the odour from the processing hall or associated biofilter.
