Project Number 20488.000.001

Bromley Black Staining and Mould Investigation

Bromley and New Brighton, Christchurch,

Christchurch City Council

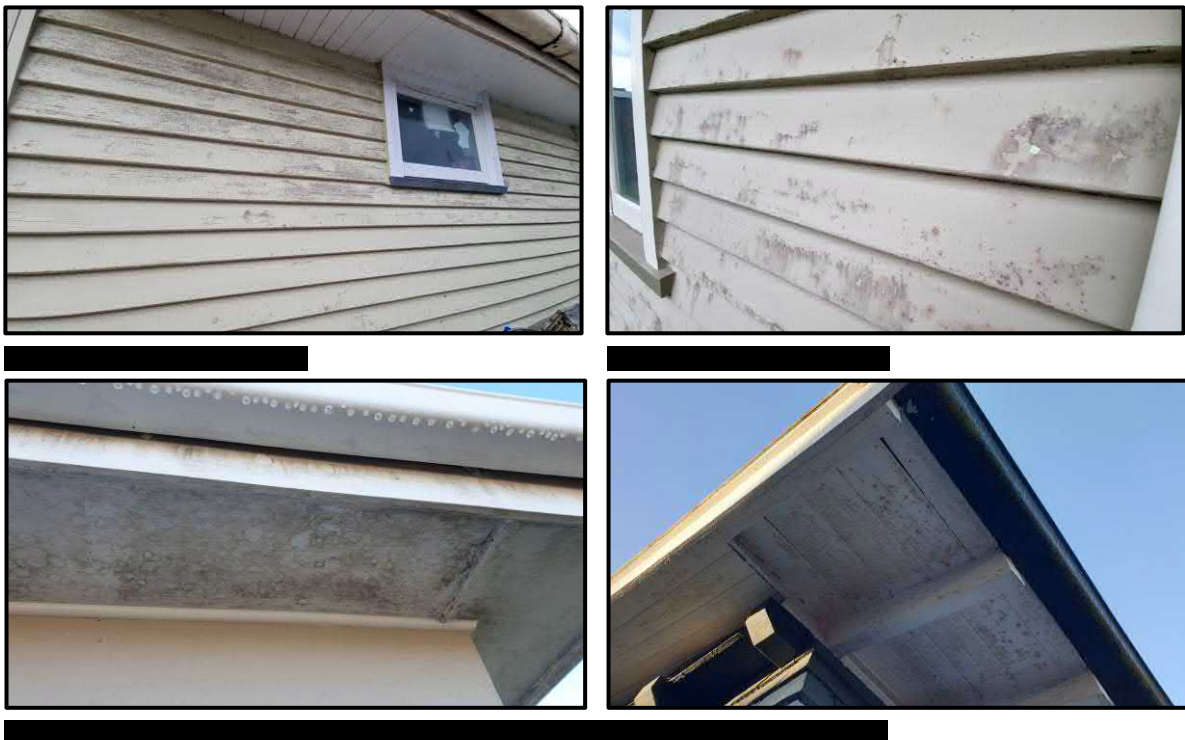
Figure 2: Black Staining

Grey / black staining was observed at all test locations in varying concentrations. Surfaces impacted included exterior walls, trim materials around doors and windows, and soffits on the underside of rooflines. Building materials impacted consisted predominantly of painted timber and cement-based weatherboards, see photos 1-8.

Laboratory and XRF paint analysis reported all surfaces with black staining to be coated in lead-based paint. Concentrations of lead in the paints ranged from 128 to 68,000 mg/kg. Five properties tested positive and three tested negative for the likely presence of a chemical reaction between lead-based paints and hydrogen sulphide gas exposure.

Field testing results indicate lead-based paints are / were likely exposed to hydrogen sulphide gas and is potentially the cause of some black staining being observed. Ongoing monitoring should be completed to ensure hydrogen sulphide levels are below concentrations that would be a risk to human health.

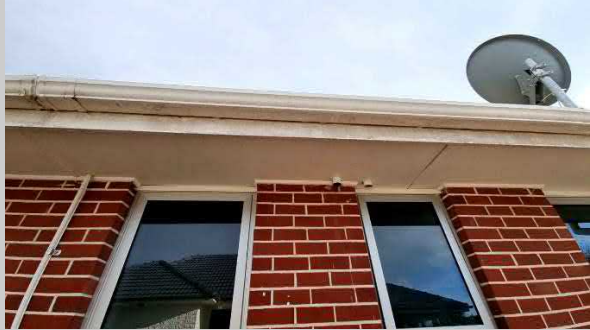
Exterior		Soffits													
Site Observations															
Black staining was observed on underside of soffits.															
Surface Tape Samples Laboratory Analysis															
Sample ID	Location		Mould Detected		Potential Toxic Mould		Potential Allergen		Active Growth						
46021/2	Exterior Soffit		None Detected		None identified		Unlikely		None						
Outdoor Air Spore Trap Sample Laboratory Analysis															
Slide Sample ID	Cladosporium	Penicillium / aspergillus type	Stachybotrys	Chaetomium	Alternaria / Ulocladium	Pithomyces	Drechslera / Bipolaris	Epicoccum	Curvularia	Fusarium	Basidiomycete	Hyphal Fragments	Other Spore Types	Spore Total / m ³	
46021/1	53	27	0	0	0	0	0	0	0	40	700	27	5367	6214

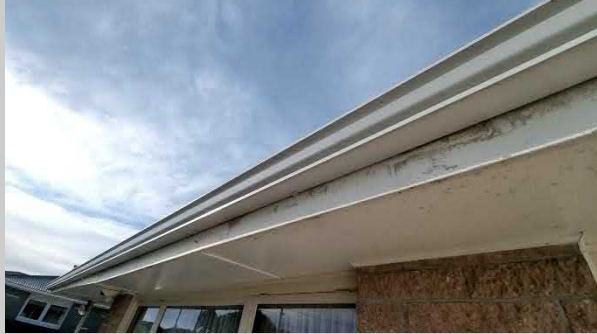
Exterior		Soffits													
Site Observations															
Black staining was observed on underside of soffits and trim around windows.															
Surface Tape Samples Laboratory Analysis															
Sample ID	Location		Mould Detected		Potential Toxic Mould		Potential Allergen		Active Growth						
46022/2	Exterior Soffit		None Detected		None identified		Unlikely		None						
Outdoor Air Spore Trap Sample Laboratory Analysis															
Slide Sample ID	Cladosporium	Penicillium / aspergillus type	Stachybotrys	Chaetomium	Alternaria / Ulocladium	Pithomyces	Drechslera / Bipolaris	Epicoccum	Curvularia	Fusarium	Basidiomycete	Hyphal Fragments	Other Spore Types	Spore Total / m ³	
46022/1	387	33	0	0	0	0	0	7	0	53	447	27	2867	3821

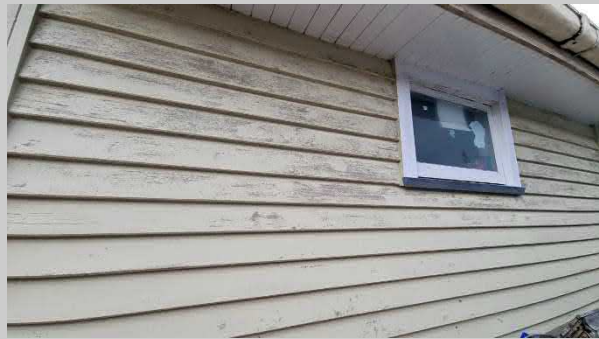
Exterior	Walls and Cladding	
Site Observations		
Black staining was observed on exterior walls / cladding and trim around windows.

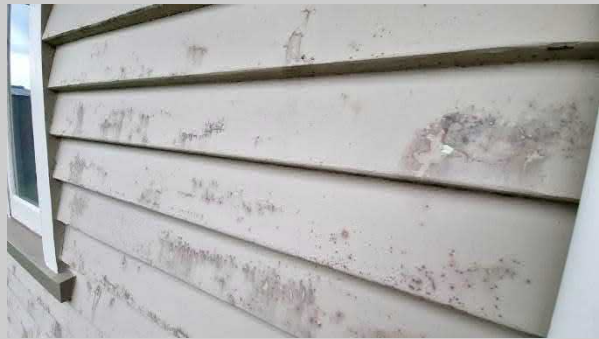
Exterior	Walls and Cladding	
Site Observations		
Black staining was observed on exterior walls / cladding and trim around windows.

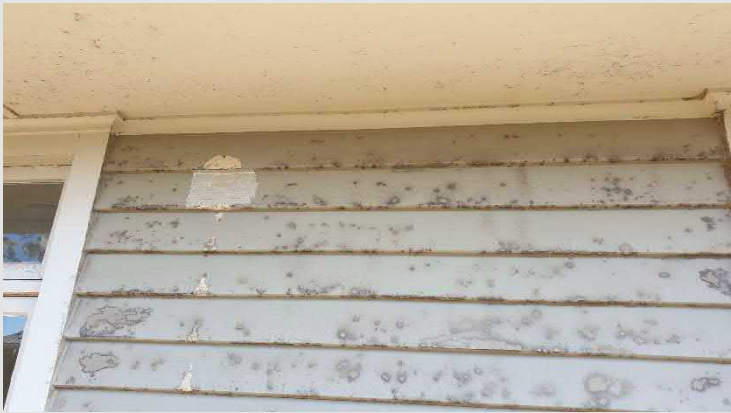
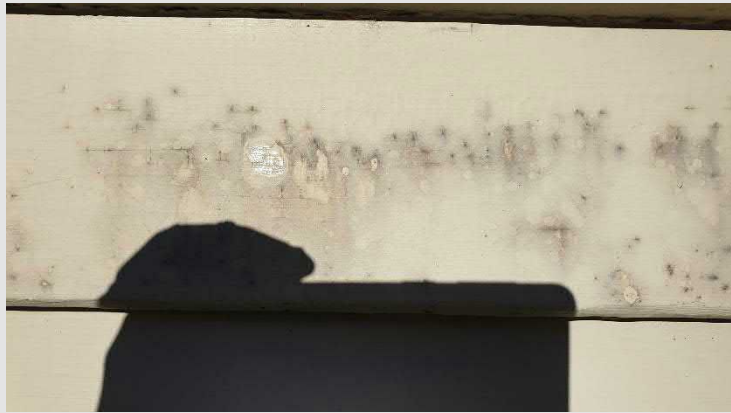
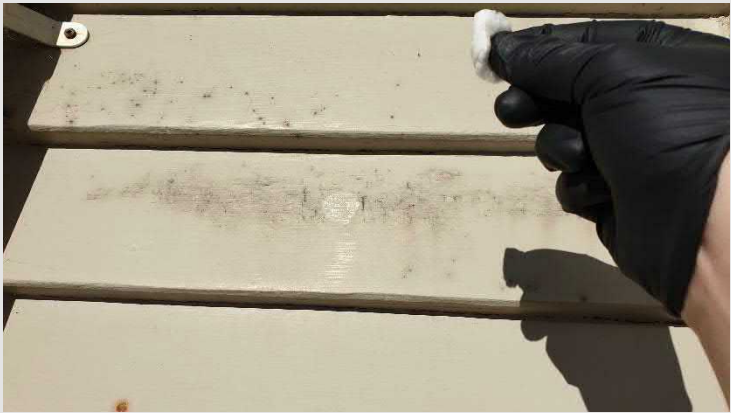
Property: Surface and Paint	Surface Staining Pre-Test	Hydrogen Peroxide Test	Bleach Test	Results
<p>Grey paint to walls</p>

<p>Staining removed under both tests; ring outline noted under Hydrogen Peroxide test.</p>
<p>White paint to soffits</p>

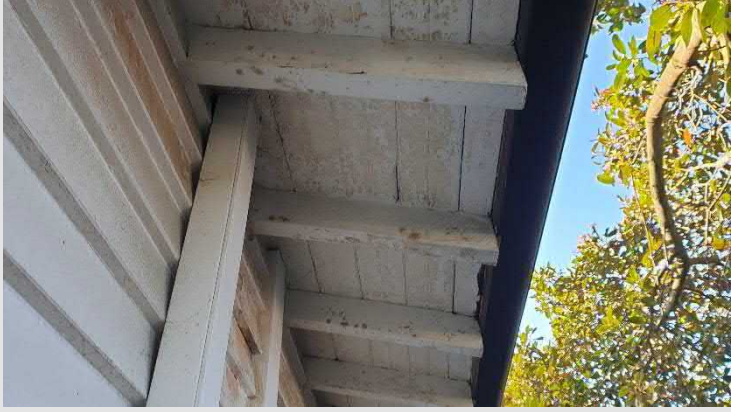
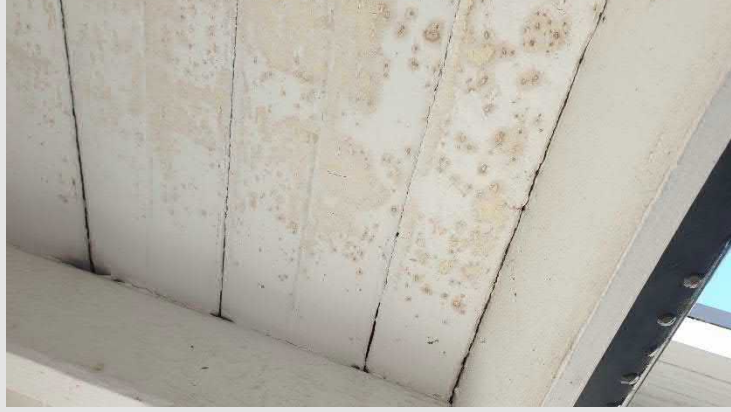
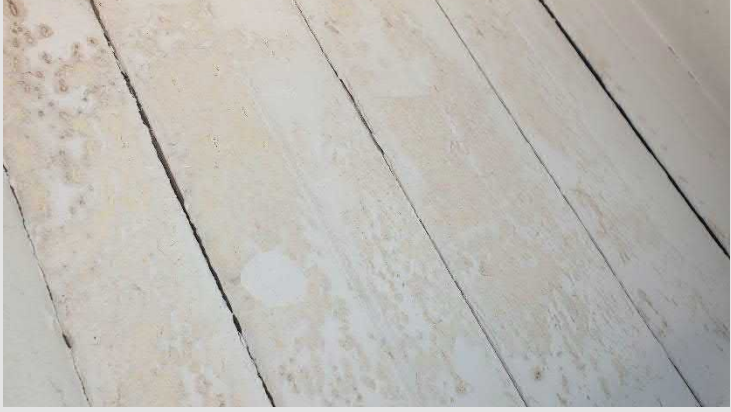
<p>Staining is clearly removed during bleach test, and only partially removed under Hydrogen Peroxide test.</p>
<p>White paint to soffits</p>

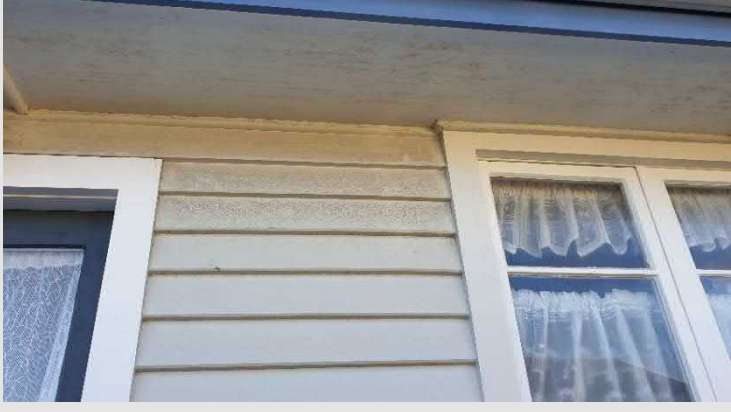
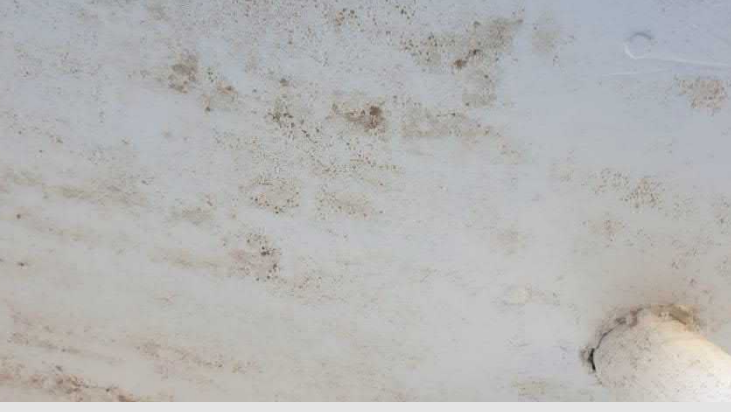
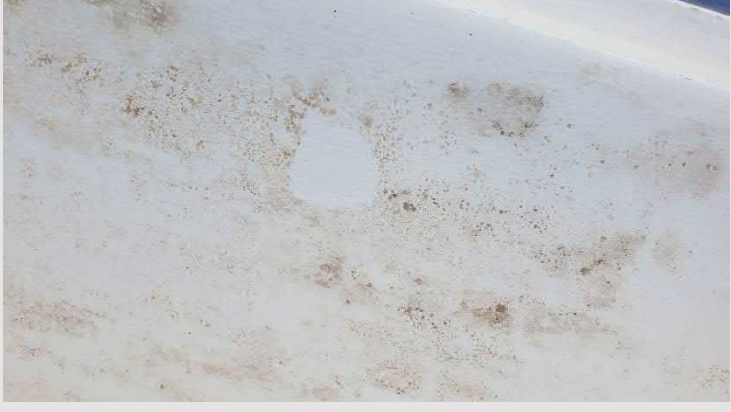
<p>Staining is clearly removed during bleach test, but no observable change during Hydrogen Peroxide test.</p>

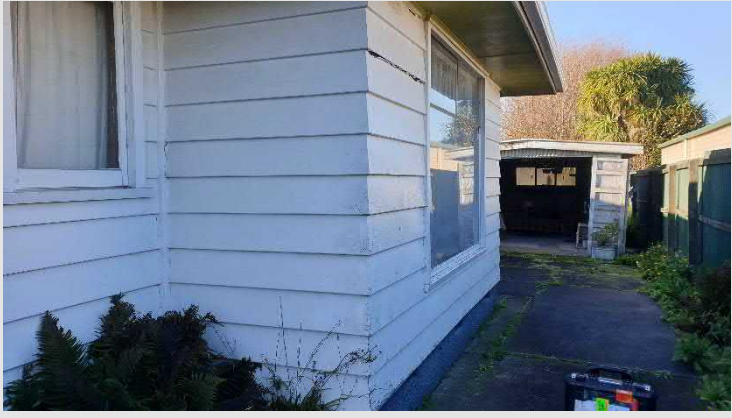
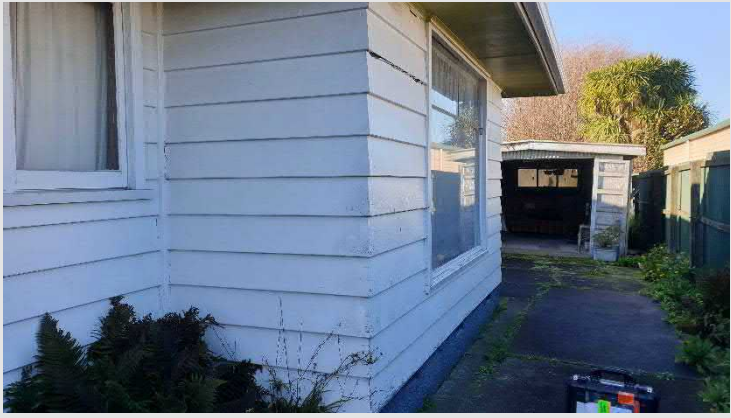
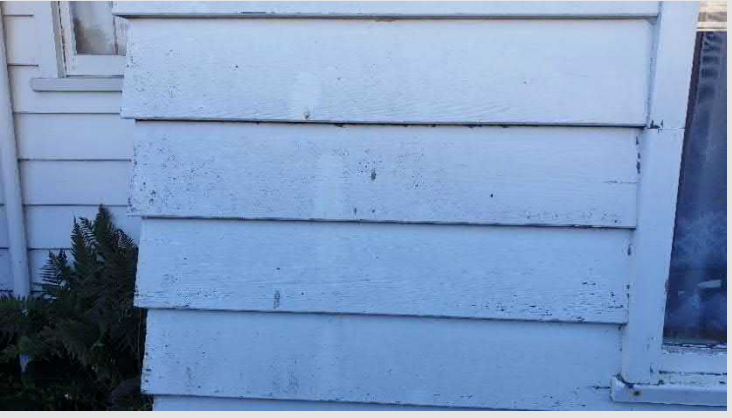
Property: Surface and Paint	Surface Staining Pre-Test	Hydrogen Peroxide Test	Bleach Test	Results
<p>White paint to walls</p>

<p>Staining is clearly removed during bleach test, and only partially removed under Hydrogen Peroxide test.</p>
<p>White paint to gable ends</p>

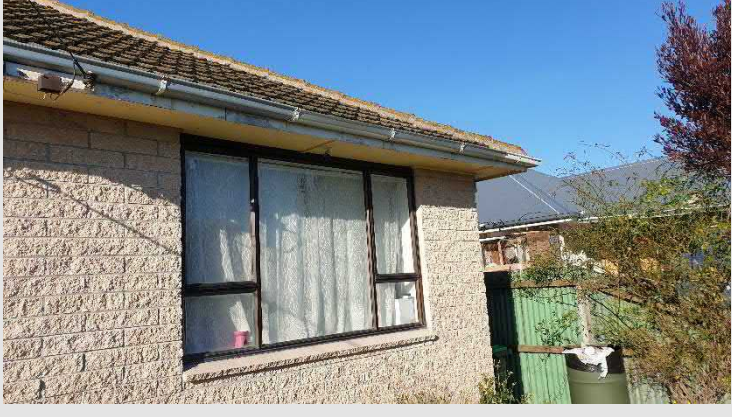
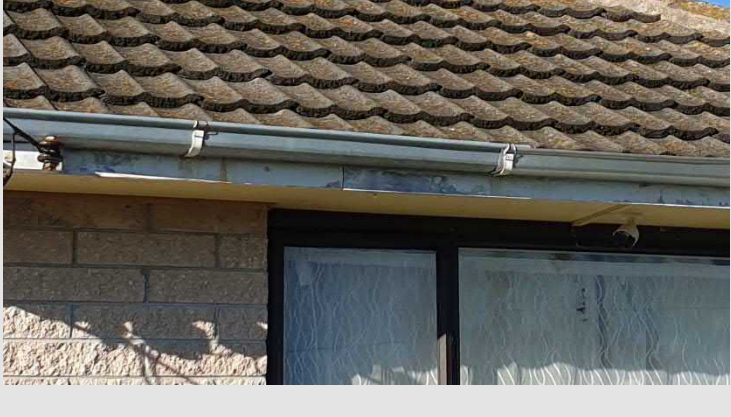
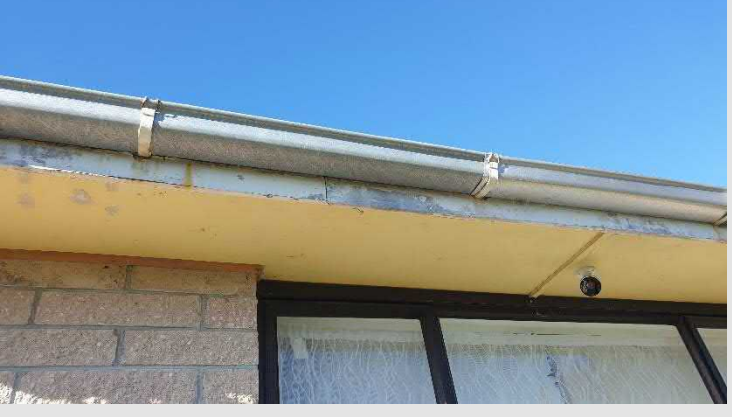
<p>Staining is clearly removed during bleach test, but no observable change during Hydrogen Peroxide test.</p>
<p>White paint to soffits</p>

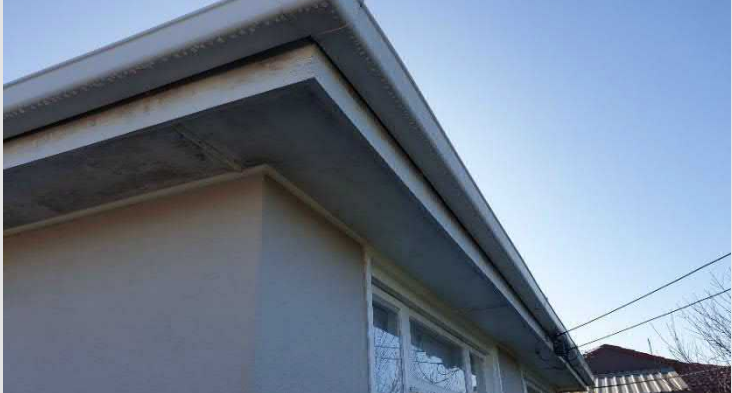
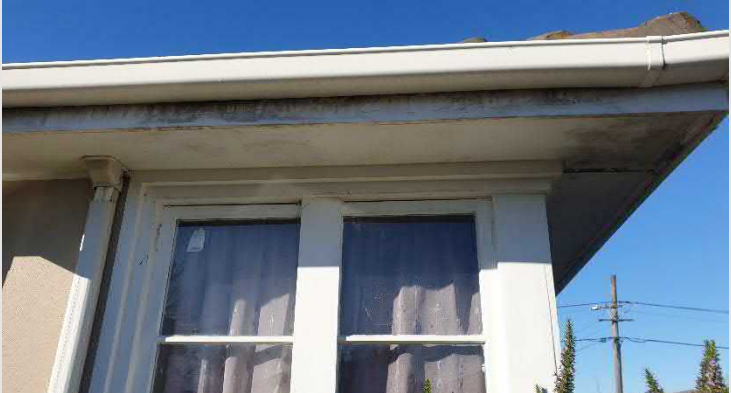
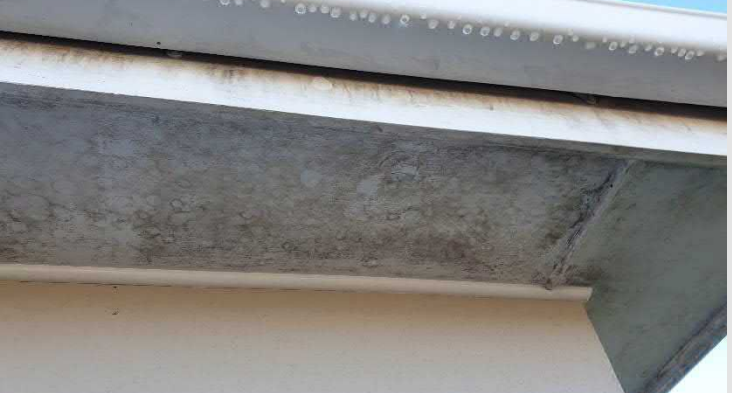
<p>Staining is clearly removed during bleach test, and partially removed under Hydrogen Peroxide test.</p>

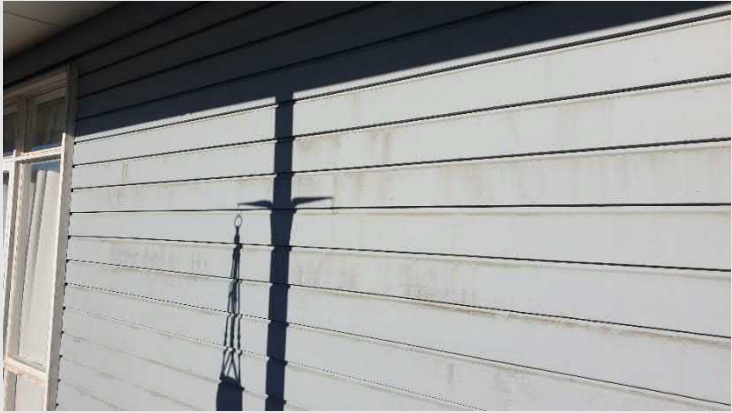
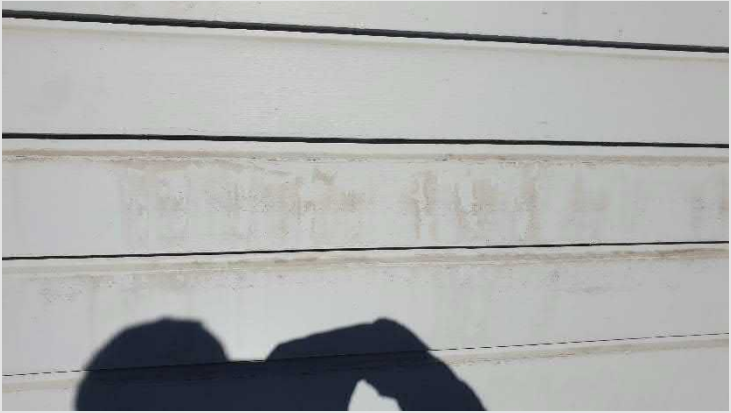
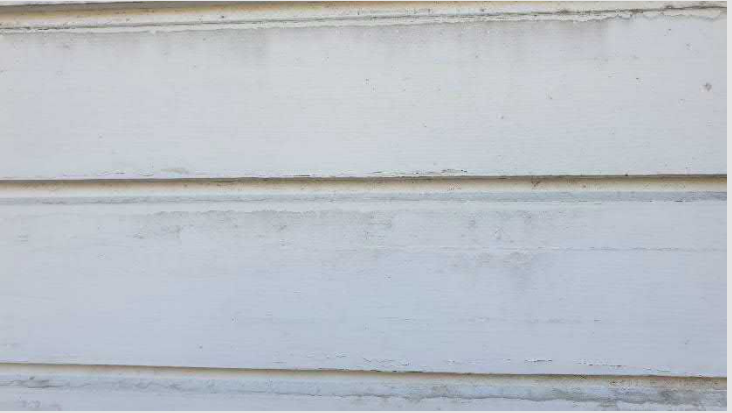
Property: Surface and Paint	Surface Staining Pre-Test	Hydrogen Peroxide Test	Bleach Test	Results
<p>█ Blue paint to walls</p>

<p>Staining is clearly and immediately removed under both bleach and Hydrogen Peroxide tests.</p>
<p>█ White paint to walls</p>

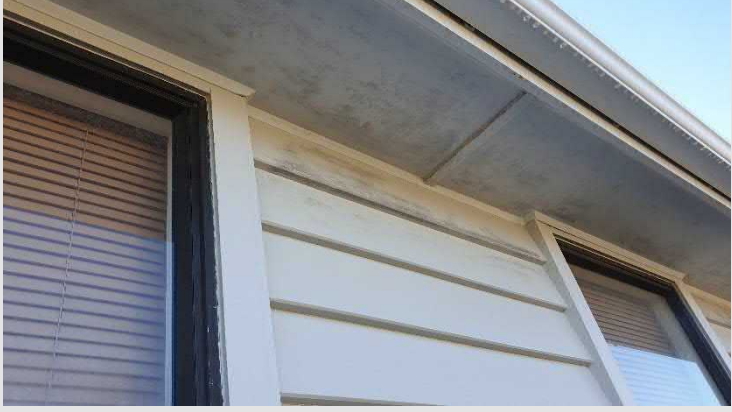
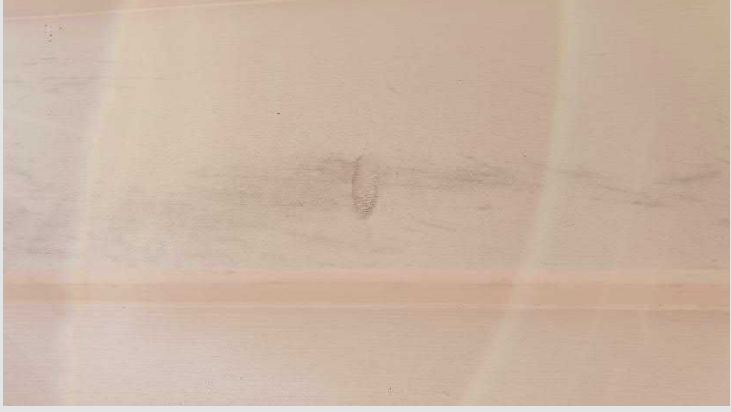
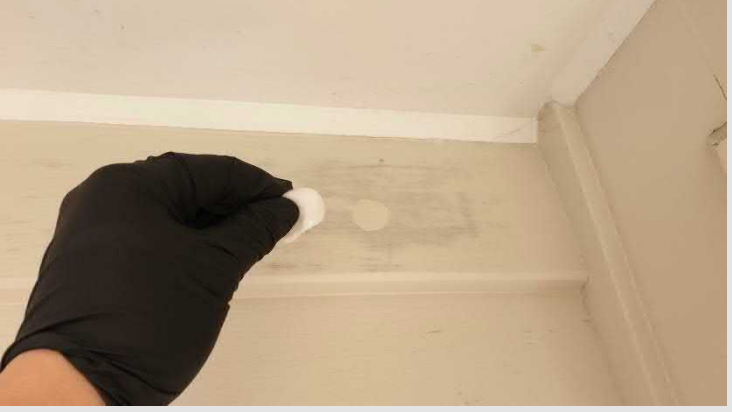
<p>Staining is clearly removed during bleach test, but no observable change during Hydrogen Peroxide test.</p>

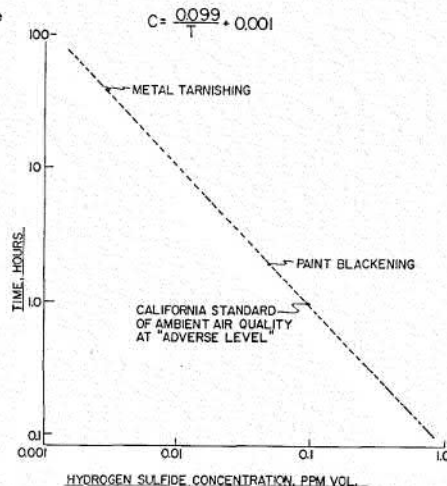
Fig. 1. Time vs. concentration for hydrogen sulfide effects.

- levels above 0.1 ppm for one hour are annoying to the general public,
- levels above 0.05 ppm for several hours darken paint under optimum conditions, and
- levels above 0.003 ppm for about 40 hours blacken sensitive metals such as silver or copper.

For hydrogen sulfide concentrations other than those noted in (a), (b), and (c), the time-concentration relationship shown in Fig. 1 may be used to determine the time factor.
