Naval Point Detailed Site Investigation

Client: Christchurch City Council

AECOM New Zealand Limited

Hazardous Materials Survey Report

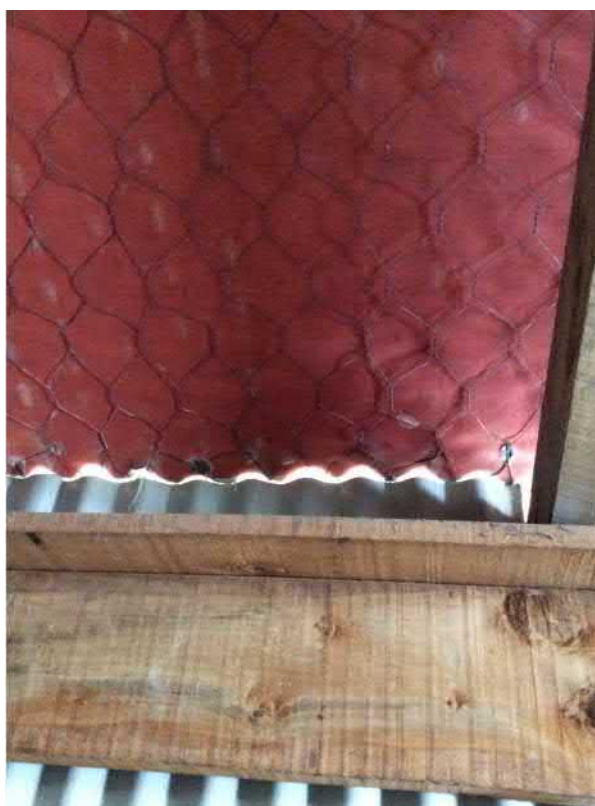
Photo No.	Date
2	04/11/2015
Room / Area	
Naval Point Rescue boat shed	
Location	
Southern wall	
Survey Reference	
Nprbs1	
Asbestos Type	
No Asbestos Detected	
Condition	
Broken, Layered	
Caption	
FCS

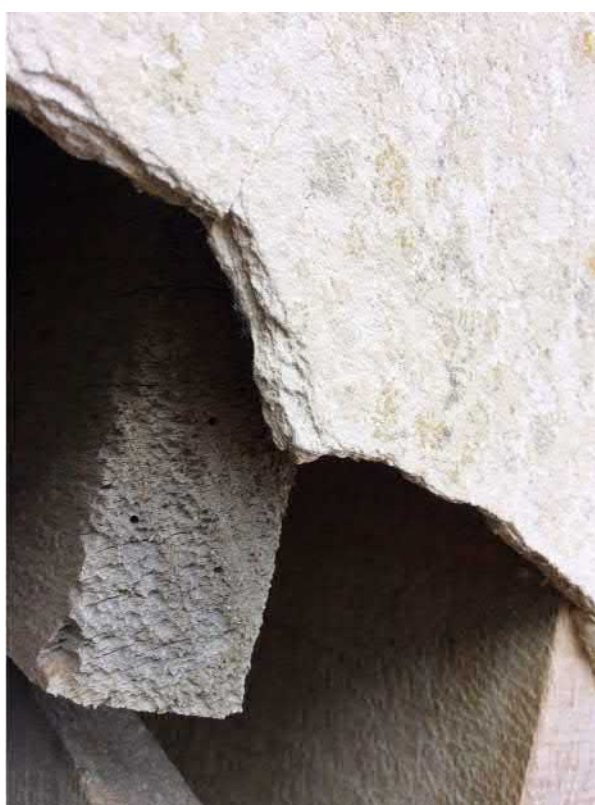
Photo No.	Date
3	04/11/2015
Room / Area	
Naval Point Rescue boat shed	
Location	
Southern wall	
Survey Reference	
Nprbs1	
Asbestos Type	
No ACM detected	
Condition	
Caption	
FCS panels on southern wall

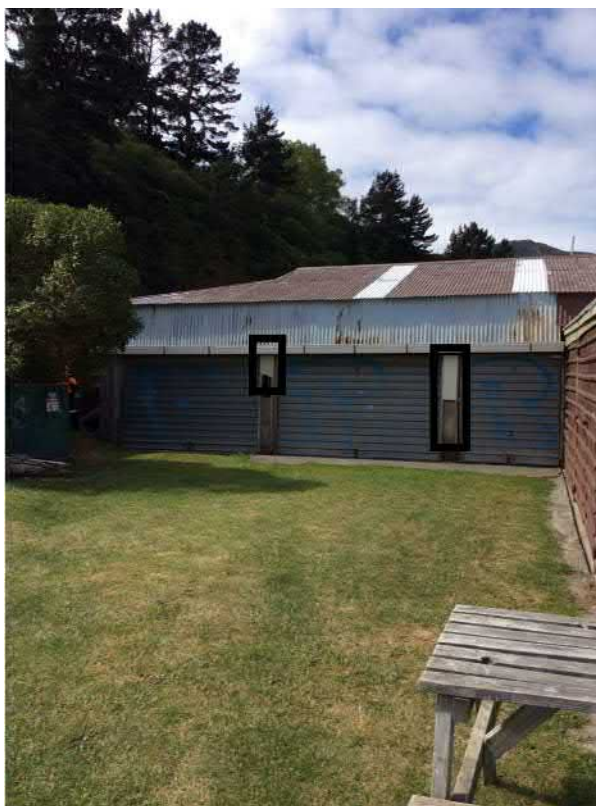
Photo No.	Date
4	04/11/2015
Room / Area	
Naval Point Rescue boat shed	
Location	
Northern wall	
Survey Reference	
Nprbs2	
Asbestos Type	
No ACM Detected	
Condition	
Newer looking FCS to FCS on Southern wall	
Caption	
FCS panels on northern wall.

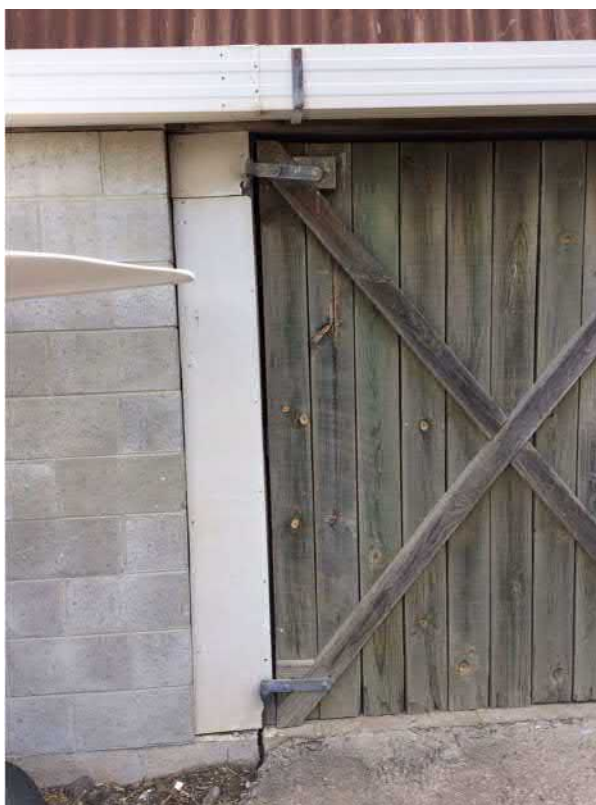
Photo No.	Date
5	04/11/2015
Room / Area	
Naval Point yacht club	
Location	
Exterior wall north.	
Survey Reference	
Npysl	
Asbestos Type	
No Asbestos Detected	
Condition/Comments	
Some minor damage to wall.	
Caption	
Later layered fibre cement sheeting on northern wall.

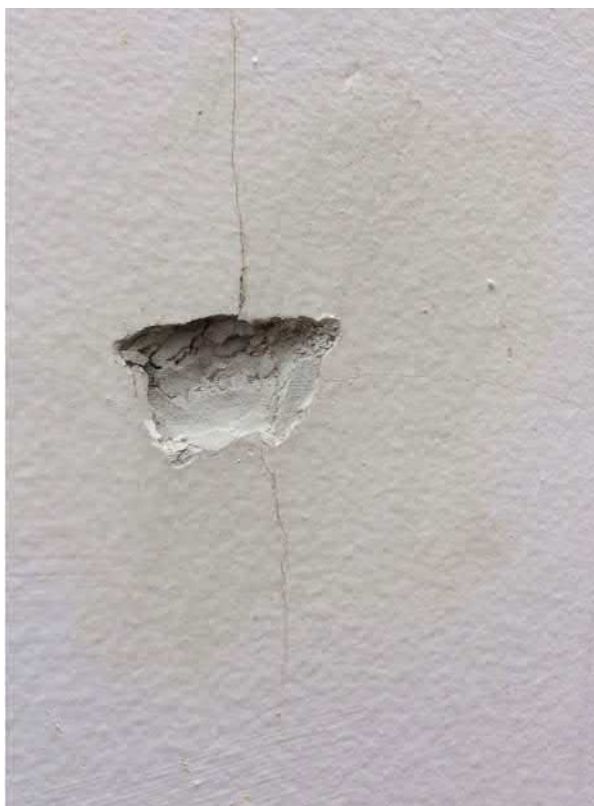
Photo No.	Date
6	04/11/2015
Room / Area	
Naval Point yacht club	
Location	
Exterior wall north.	
Survey Reference	
Npysl	
Asbestos Type	
No Asbestos Detected	
Condition/Comments	
Some minor damage to wall.	
Caption	
Later layered fibre cement sheeting on northern wall.

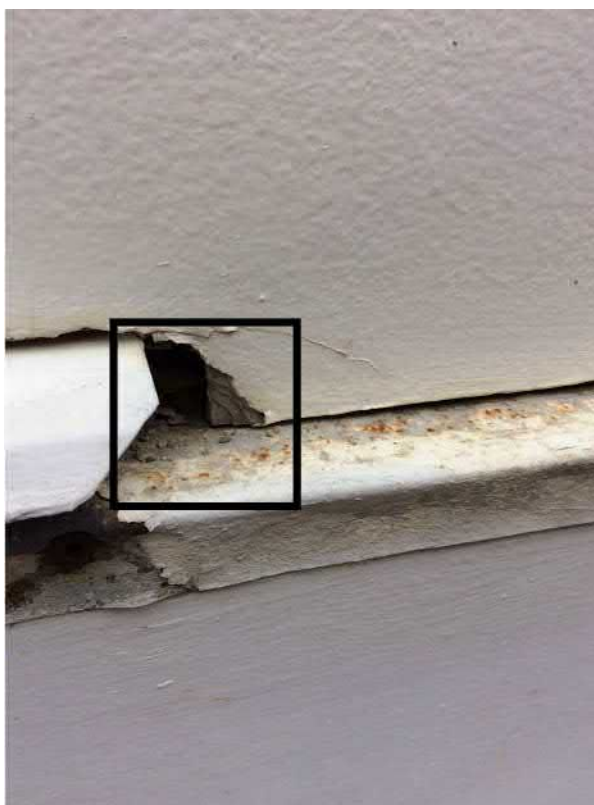
Photo No.	Date
7	04/11/2015
Room / Area	
Naval Point yacht club	
Location	
Exterior wall north.	
Survey Reference	
Npvc1	
Asbestos Type	
No Asbestos Detected	
Condition/Comments	
Some minor damage to wall.	
Caption	
Later layered fibre cement sheeting on northern wall.

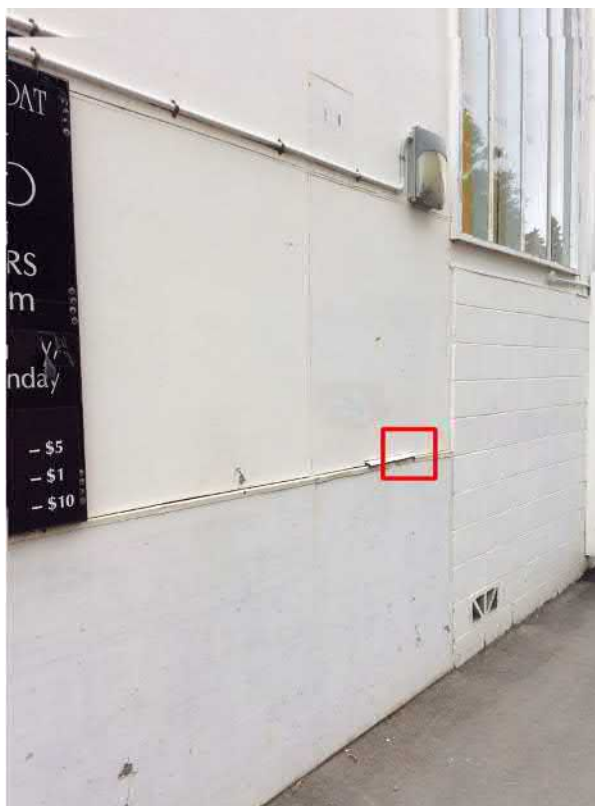
Photo No.	Date
8	04/11/2015
Room / Area	
Naval Point yacht club exterior walls.	
Location	
Exterior walls north and east.	
Survey Reference	
Npvc2	
Asbestos Type	
Chrysotile and Amosite	
Condition/Comments	
Some minor damage to parts of wall.	
Caption	
Original cladding on wall. Not layered like Npvc1 samples.

The Yacht Club contains asbestos fibre cement sheeting which was identified during the survey to be in a fair condition, as some areas were observed to be broken. It is recommended broken or damaged areas be encapsulated with an appropriate sealant to minimise risk of fibre release.

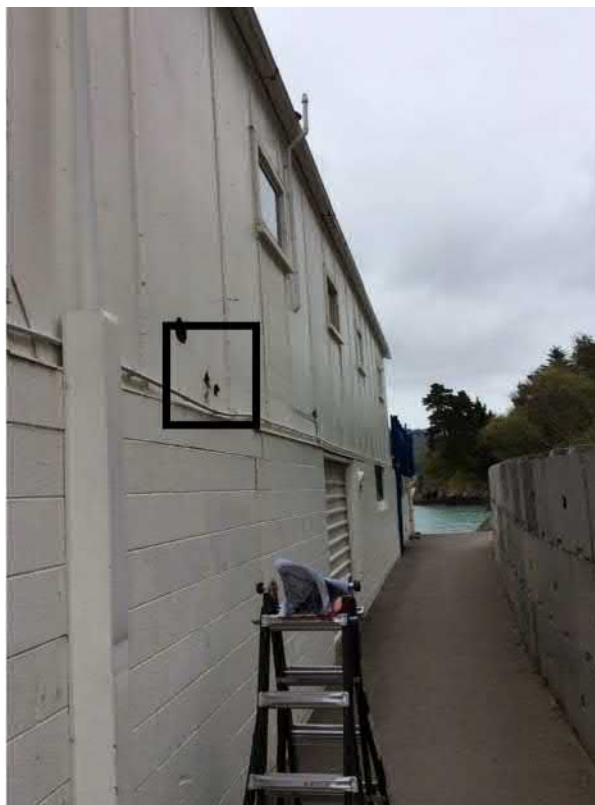
Photo No.	Date
9	04/11/2015
Room / Area	
Naval Point yacht club exterior walls.	
Location	
Exterior wall north and east.	
Survey Reference	
As per Npyc2	
Asbestos Type	
Inaccessible	
Condition/Comments	
Suspected ACM cladding, Inaccessible at the time of inspection.	
Caption	
NE gable 2nd floor. Suspected asbestos containing fibre cement

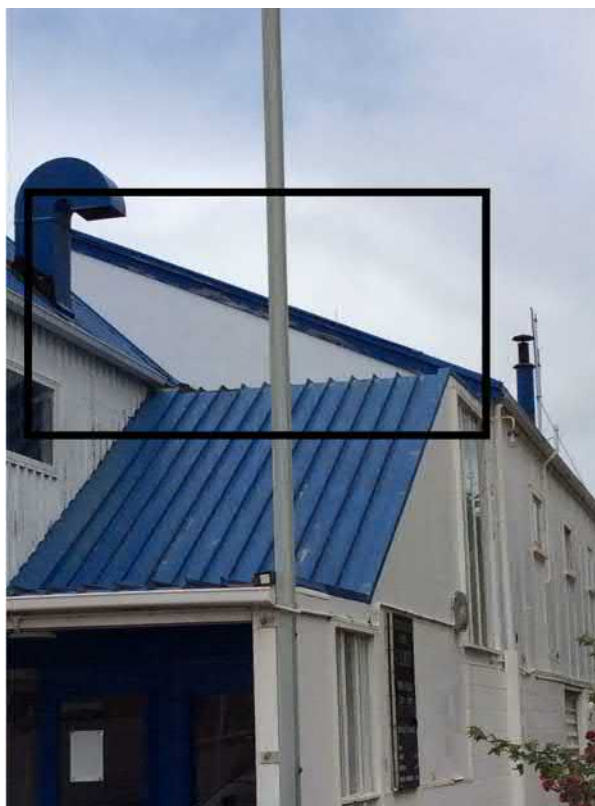
Photo No.	Date
10	04/11/2015
Room / Area	
Naval Point yacht club exterior walls.	
Location	
Exterior wall north and eastern soffit	
Survey Reference	
Npyc2	
Asbestos Type	
Chrysotile and Amosite	
Condition/Comments	
Broken in places.	
Caption	
Battens also as original cladding on wall. Not layered like Npyc1 samples.

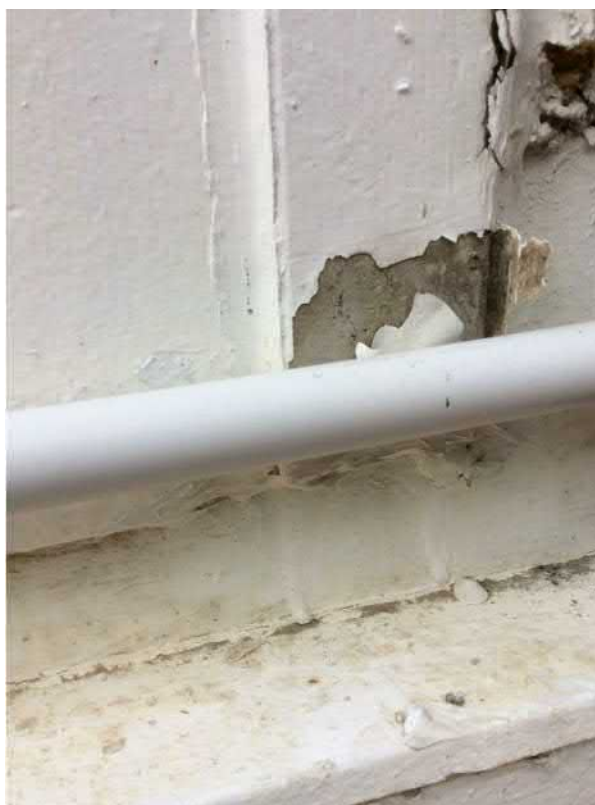
Photo No.	Date
11	04/11/2015
Room / Area	
Naval Point yacht club exterior walls.	
Location	
Exterior wall north and east.	
Survey Reference	
Npyc2	
Asbestos Type	
Chrysotile and Amosite	
Condition/Comments	
Broken in places.	
Caption	
Original cladding on wall. Not layered like Npyc1 samples.

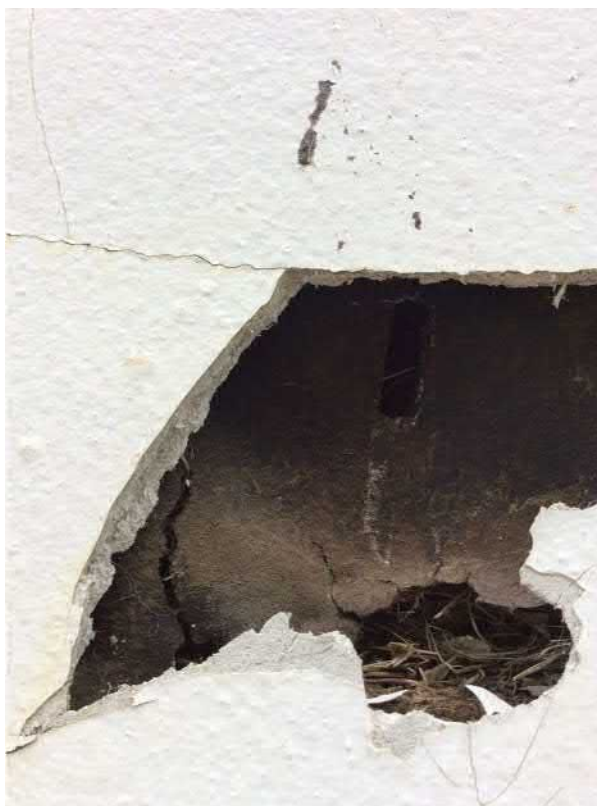
Photo No.	Date
12	04/11/2015
Room / Area	
Naval Point yacht club exterior walls.	
Location	
Exterior wall north and eastern soffit.	
Survey Reference	
Same as Npyc2	
Asbestos Type	
Chrysotile and Amosite	
Condition/Comments	
Soffits in good condition, it is assumed that the soffits are the same throughout the building.	
Caption	
Soffit as per original cladding on wall.

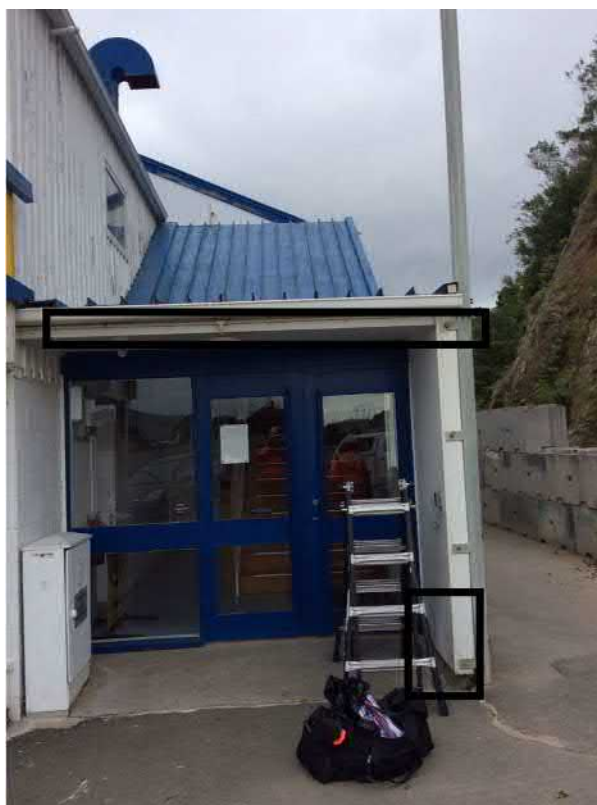
Photo No.	Date
13	04/11/2015
Room / Area	Naval Point yacht club exterior walls.
Location	Exterior wall north and east.
Survey Reference	Npyc2a
Asbestos Type	Chrysotile and Amosite
Condition/Comments	Unsealed in places.
Caption	Original cladding is asbestos containing.

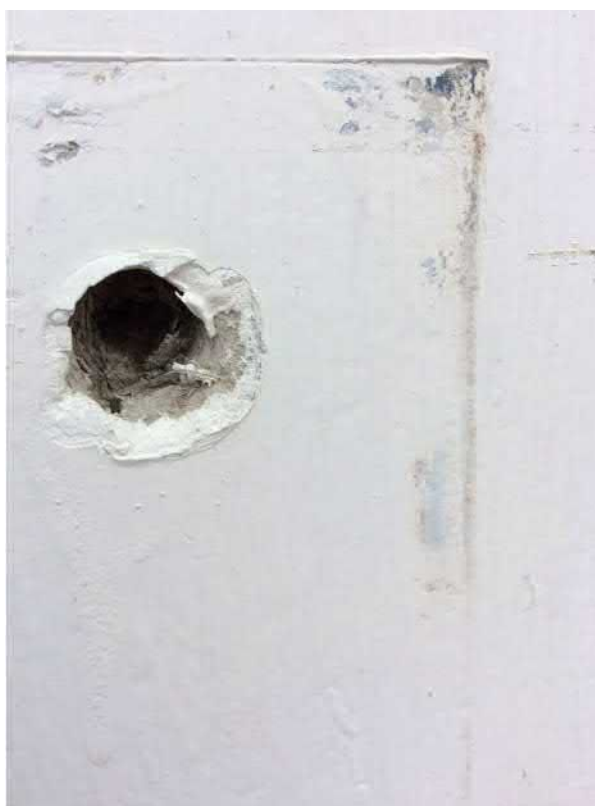
Photo No.	Date
14	04/11/2015
Room / Area	Naval Point yacht club exterior walls.
Location	Exterior wall north and east.
Survey Reference	Npyc2
Asbestos Type	Chrysotile and Amosite
Condition/Comments	Fibre cement sheeting is in good condition, wooden battens over wall cladding.
Caption	2nd floor wall as per original asbestos containing cement sheeting.

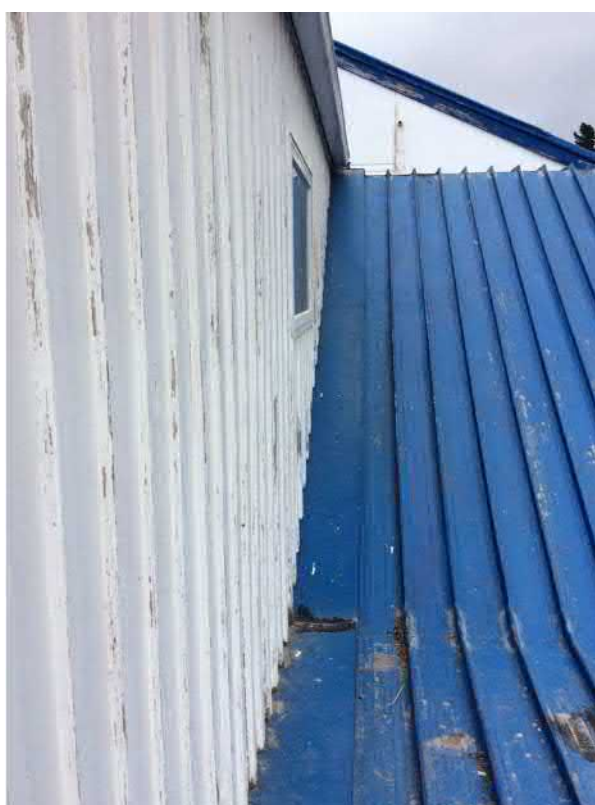
Photo No.	Date
15	04/11/2015
Room / Area	
Naval Point yacht club exterior walls.	
Location	
Exterior wall north and eastern soffit.	
Survey Reference	
Npyc2	
Asbestos Type	
Chrysotile and Amosite	
Condition/Comments	
Good.	
Caption	
Soffit on eastern entrance.

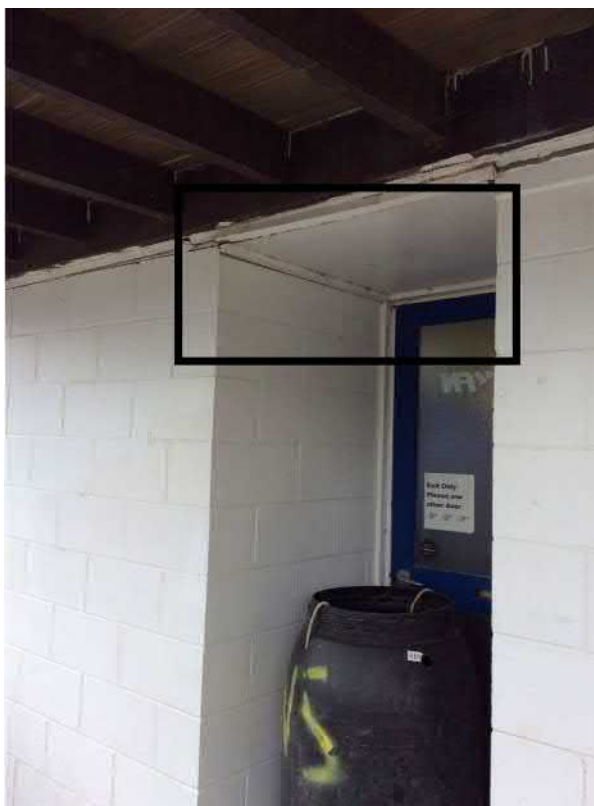
Photo No.	Date
16	04/11/2015
Room / Area	
Naval Point yacht club exterior walls.	
Location	
Exterior wall north and east.	
Survey Reference	
Npyc2	
Asbestos Type	
Chrysotile and Amosite	
Condition/Comments	
Fair Condition/Comments.	
Caption	
Some battens have been replaced with wood; most are original asbestos containing fibrous cement material.

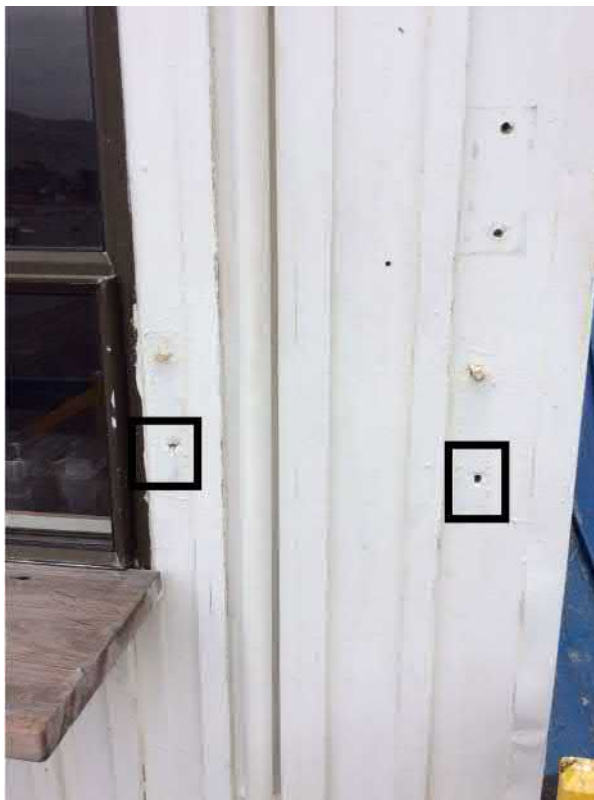
Photo No.	Date
17	04/11/2015
Room / Area	
Naval Point yacht club	
Location	
Exterior wall north; bituminous building paper.	
Survey Reference	
Npyc3	
Asbestos Type	
No asbestos detected	
Condition/Comments	
Exposed where cladding is broken.	
Caption	
Building paper sampled from where cladding is broken.

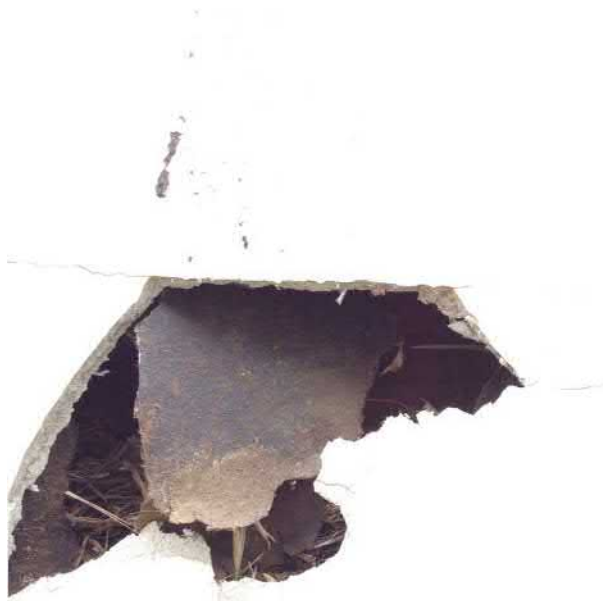
Photo No.	Date
18	04/11/2015
Room / Area	
Naval Point yacht club	
Location	
North wall glazing compound	
Survey Reference	
Npyc4	
Asbestos Type	
No asbestos detected	
Condition/Comments	
Fair.	
Caption	
Window Putty.

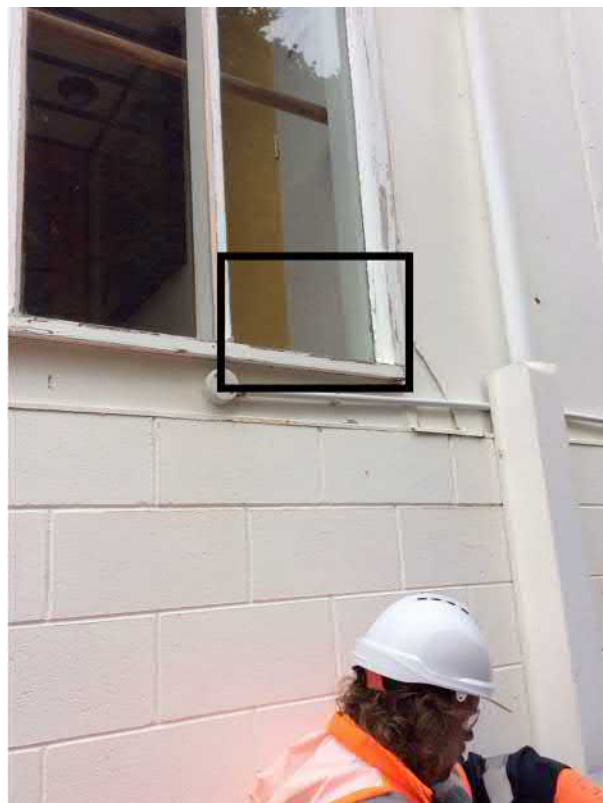
Photo No.	Date
19	04/11/2015
Room / Area	Naval Point yacht club
Location	North wall glazing compound
Survey Reference	Npyc4
Asbestos Type	No asbestos detected
Condition/Comments	Fair
Caption	Glazing compound.

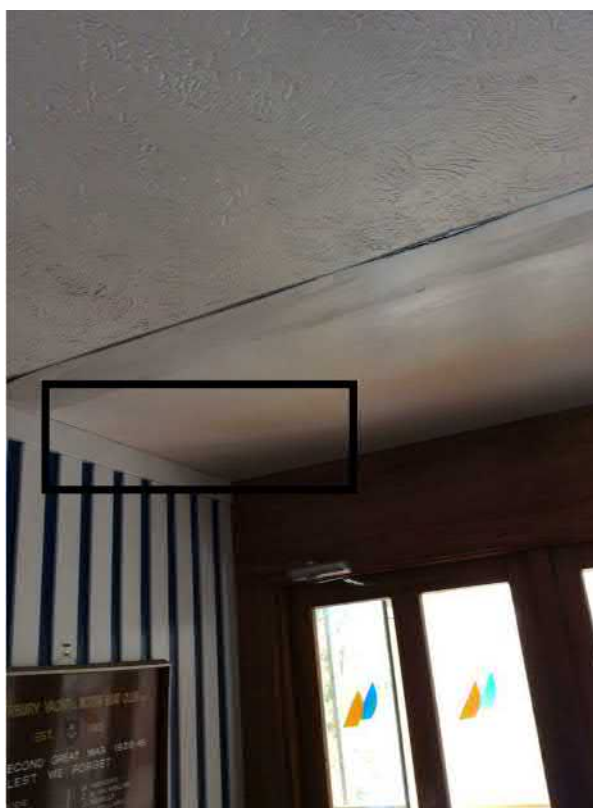
Photo No.	Date
24	04/11/2015
Room / Area	
Naval Point yacht club	
Location	
Upstairs hallway ceiling	
Survey Reference	
Npyc5	
Asbestos Type	
No asbestos detected	
Condition/Comments	
Good in places, poor in others.	
Caption	
No asbestos detected.

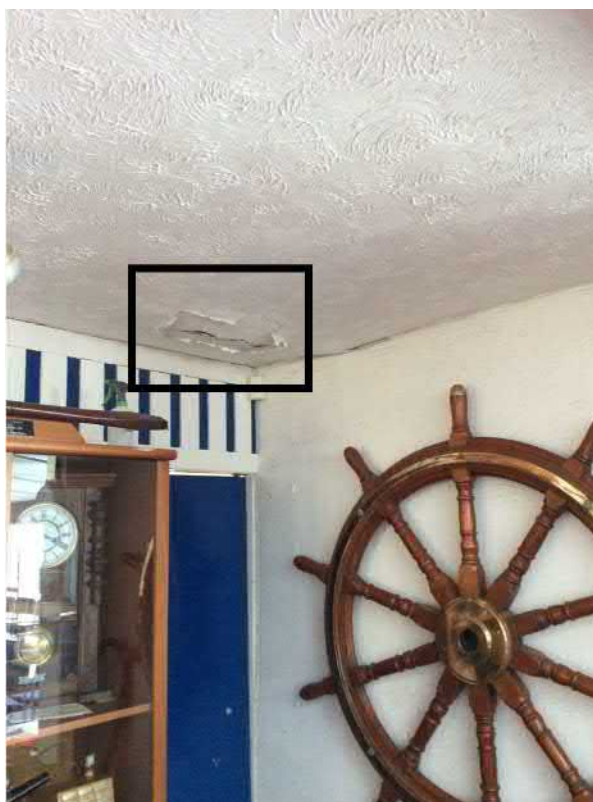
Photo No.	Date
25	04/11/2015
Room / Area	
Naval Point yacht club	
Location	
Upstairs hallway wall	
Survey Reference	
As per Npys5	
Asbestos Type	
No asbestos detected	
Condition/Comments	
Good.	
Caption	
Wall is similar material to ceiling and not suspected ACM.

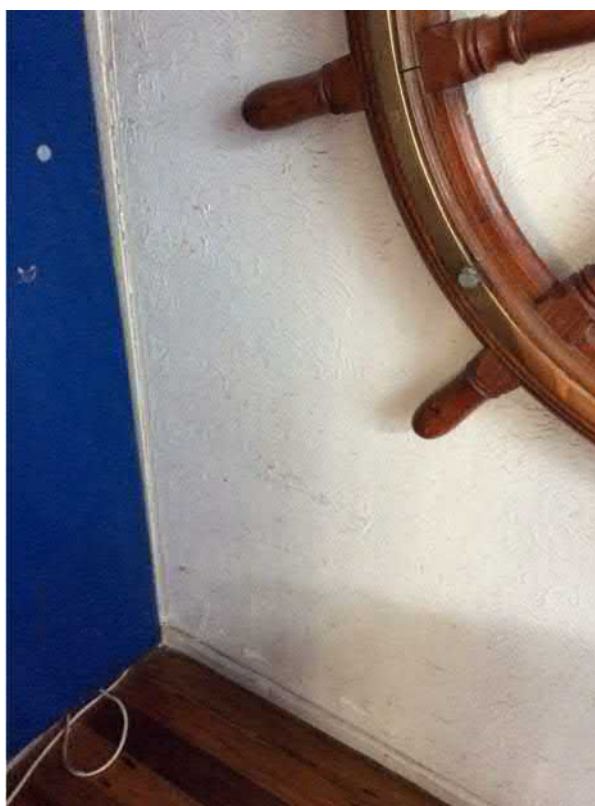
Photo No.	Date
26	04/11/2015
Room / Area	
Naval Point yacht club	
Location	
Upstairs hallway ceiling	
Survey Reference	
As per Npys5	
Asbestos Type	
No asbestos detected	
Condition/Comments	
Poor.	
Caption	
Textured Ceiling

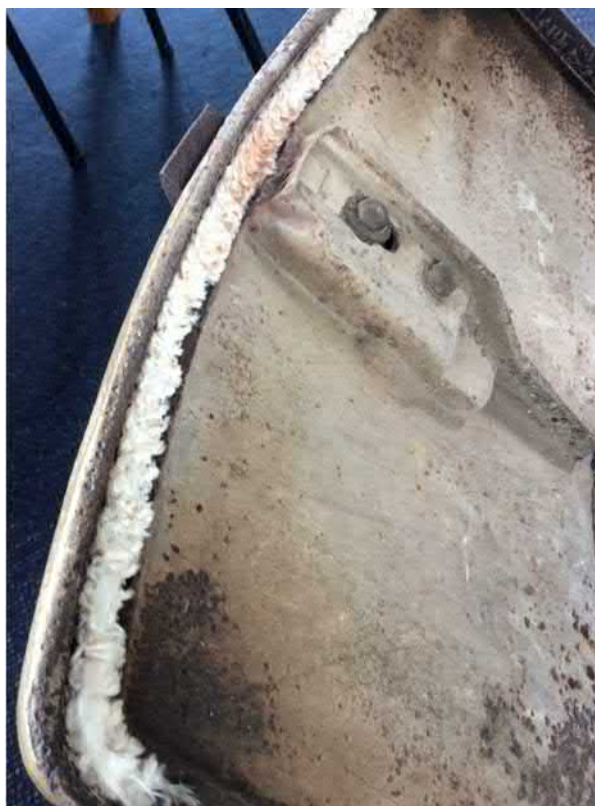
Photo No.	Date
30	04/11/2015
Room / Area	
Naval Point yacht club	
Location	
Upstairs function room	
Survey Reference	
Not sampled suspected asbestos containing.	
Asbestos Type	
Suspected Asbestos	
Condition/Comments	
Fair	
Caption	
Thermal bricks suspect ACM.

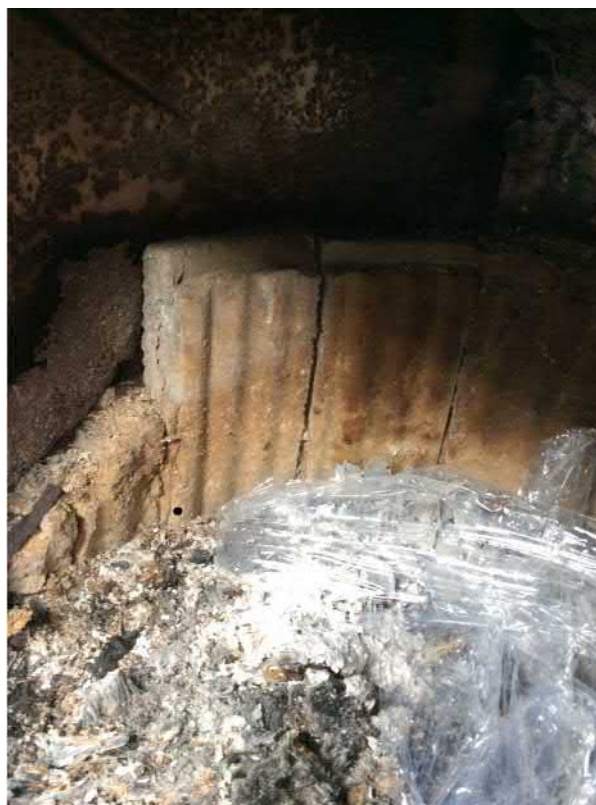
Photo No.	Date
31	04/11/2015
Room / Area	
Naval Point yacht club	
Location	
Upstairs function room	
Survey Reference	
Not sampled, components suspected to contain asbestos.	
Asbestos Type	
Inaccessible	
Condition/Comments	
Fair	
Caption	
Fireplace with suspected ACM components internally.

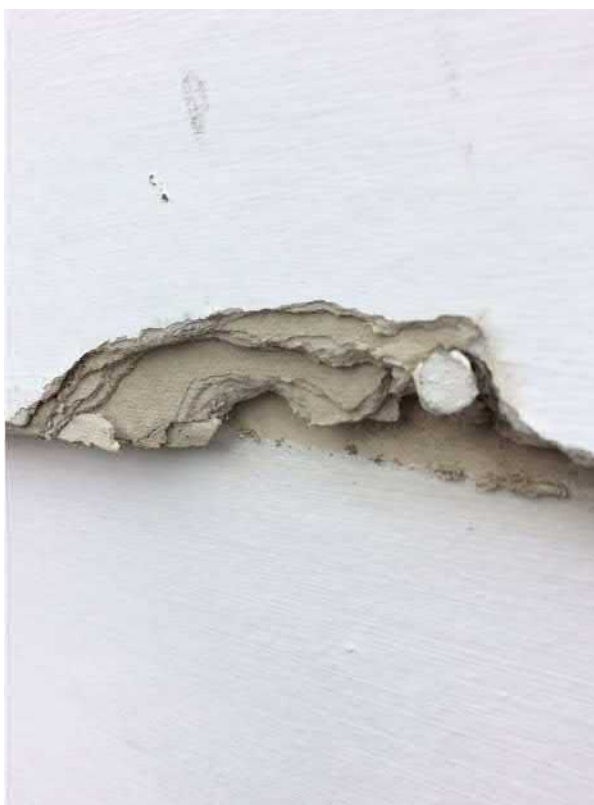
Photo No.	Date
33	04/11/2015
Room / Area	
Naval Point yacht club	
Location	
Building wall	
Survey Reference	
As per Npyc6	
Asbestos Type	
No asbestos detected	
Condition/Comments	
Good.	
Caption	
Cement sheet cladding.

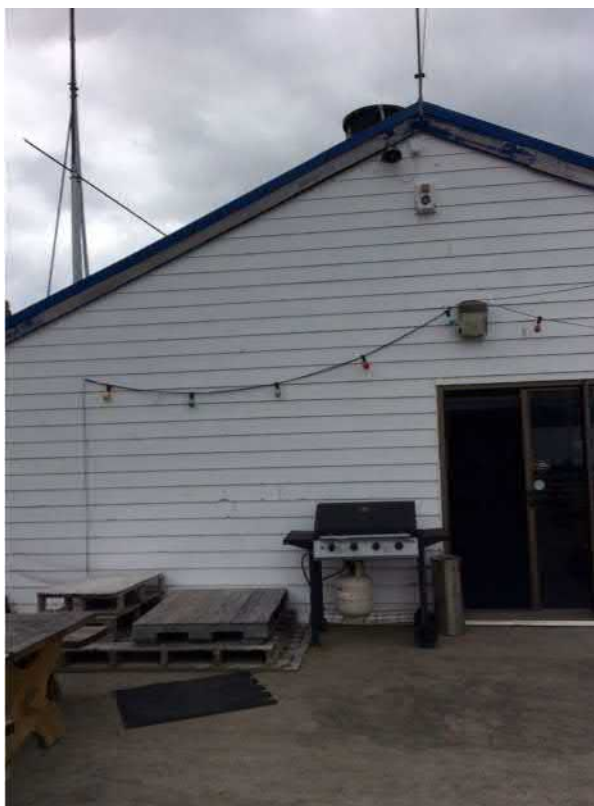
Photo No.	Date
34	04/11/2015
Room / Area	
Naval Point yacht club	
Location	
Library	
Survey Reference	
Npyc8	
Asbestos Type	
No asbestos detected	
Condition/Comments	
Good.	
Caption	
Gib board joint compound

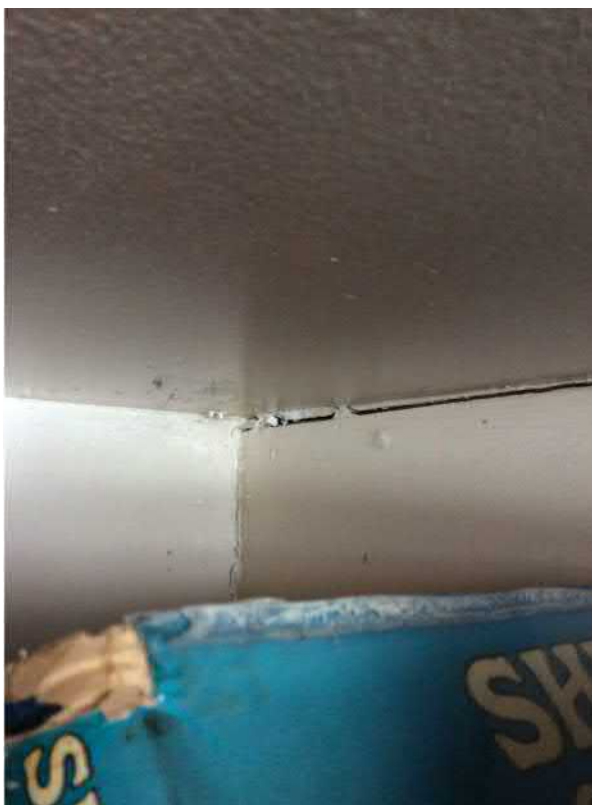
Photo No.	Date
35	04/11/2015
Room / Area	Naval Point yacht club
Location	Library
Survey Reference	Npvc8
Asbestos Type	No asbestos detected
Condition/Comments	Good.
Caption	Gib board joint compound

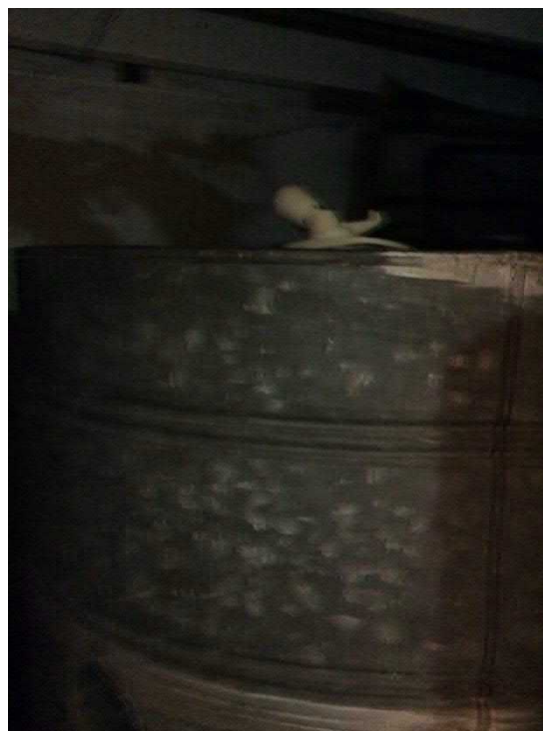
Photo No.	Date
39	11/11/2015
Room / Area	Naval point pavilion
Location	South wall soffit patch
Survey Reference	NPP-1a
Asbestos Type	No Asbestos detected
Condition/Comments	Good
Caption	FCM patch on soffit

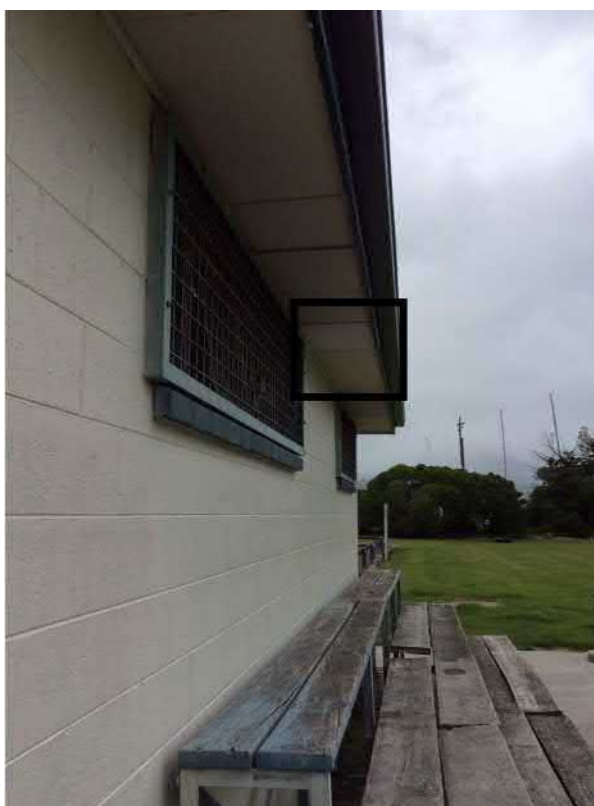
Photo No.	Date
40	11/11/2015
Room / Area	Naval point pavilion
Location	Soffit around whole building
Survey Reference	NPP-1
Asbestos Type	No Asbestos detected
Condition/Comments	Good
Caption	Original soffit around building

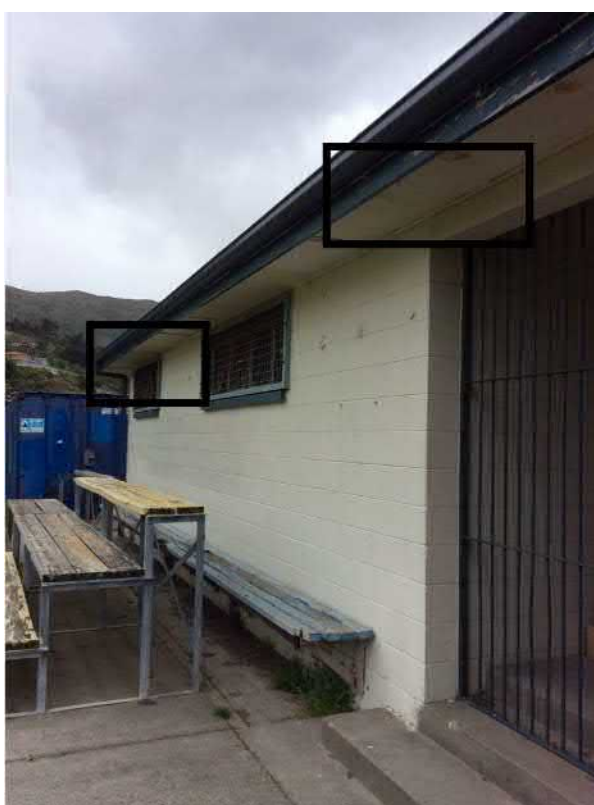
Photo No.	Date
41	11/11/2015
Room / Area	Naval point pavilion
Location	Window corkage on steel joinery
Survey Reference	NPP-2
Asbestos Type	No Asbestos detected
Condition/Comments	Good
Caption	Window Putty

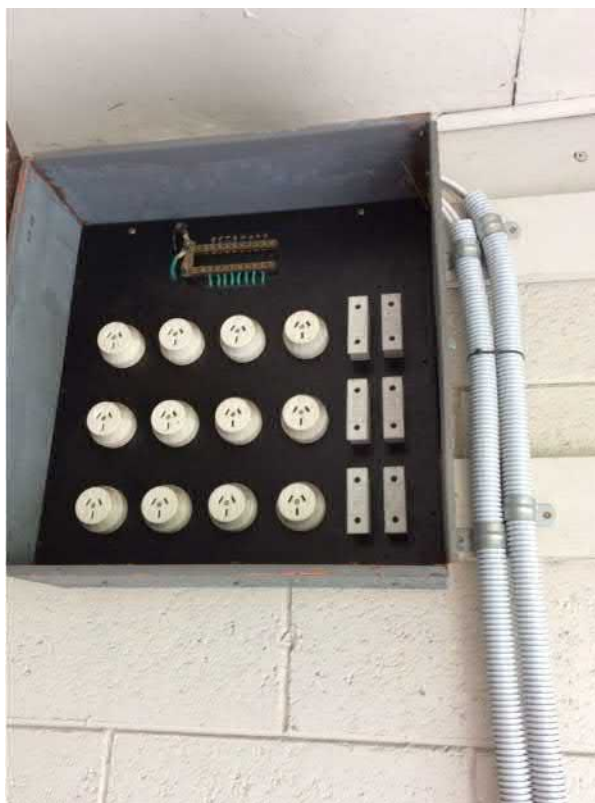
Photo No.	Date
43	11/11/2015
Room / Area	Naval point pavilion
Location	Eastern side changing rooms
Survey Reference	NPP-4
Asbestos Type	Asbestos- Visual
Condition/Comments	Good
Caption	Live backing board not sampled

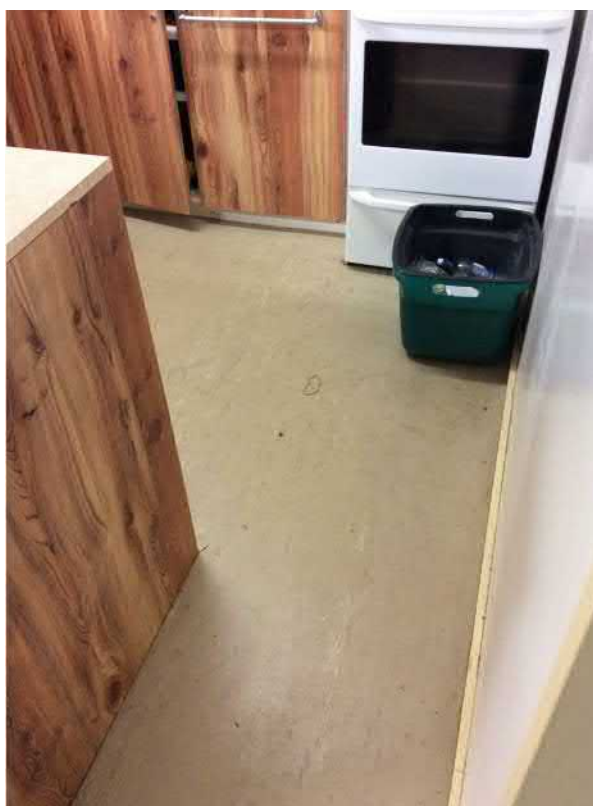
Photo No.	Date
48	17/11/2015
Room / Area	
Naval point coastguard	
Location	
Kitchen	
Survey Reference	
Npc-1	
Asbestos Type	
No Asbestos Detected	
Condition/Comments	
Poor in patches	
Caption	
vinyl

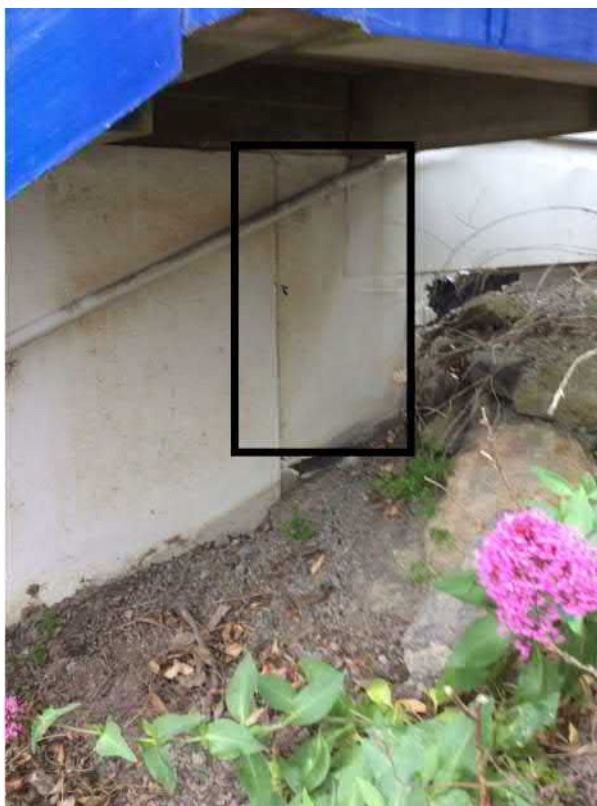
Photo No.	Date
53	17/11/2015
Room / Area	Naval point coastguard
Location	Under steps Ne side
Survey Reference	Npc6
Asbestos Type	No Asbestos Detected
Condition/Comments/Comment	Good Condition/Comments painted bituminous adhesive sealant.
Caption	Lower Section bituminous sealant.

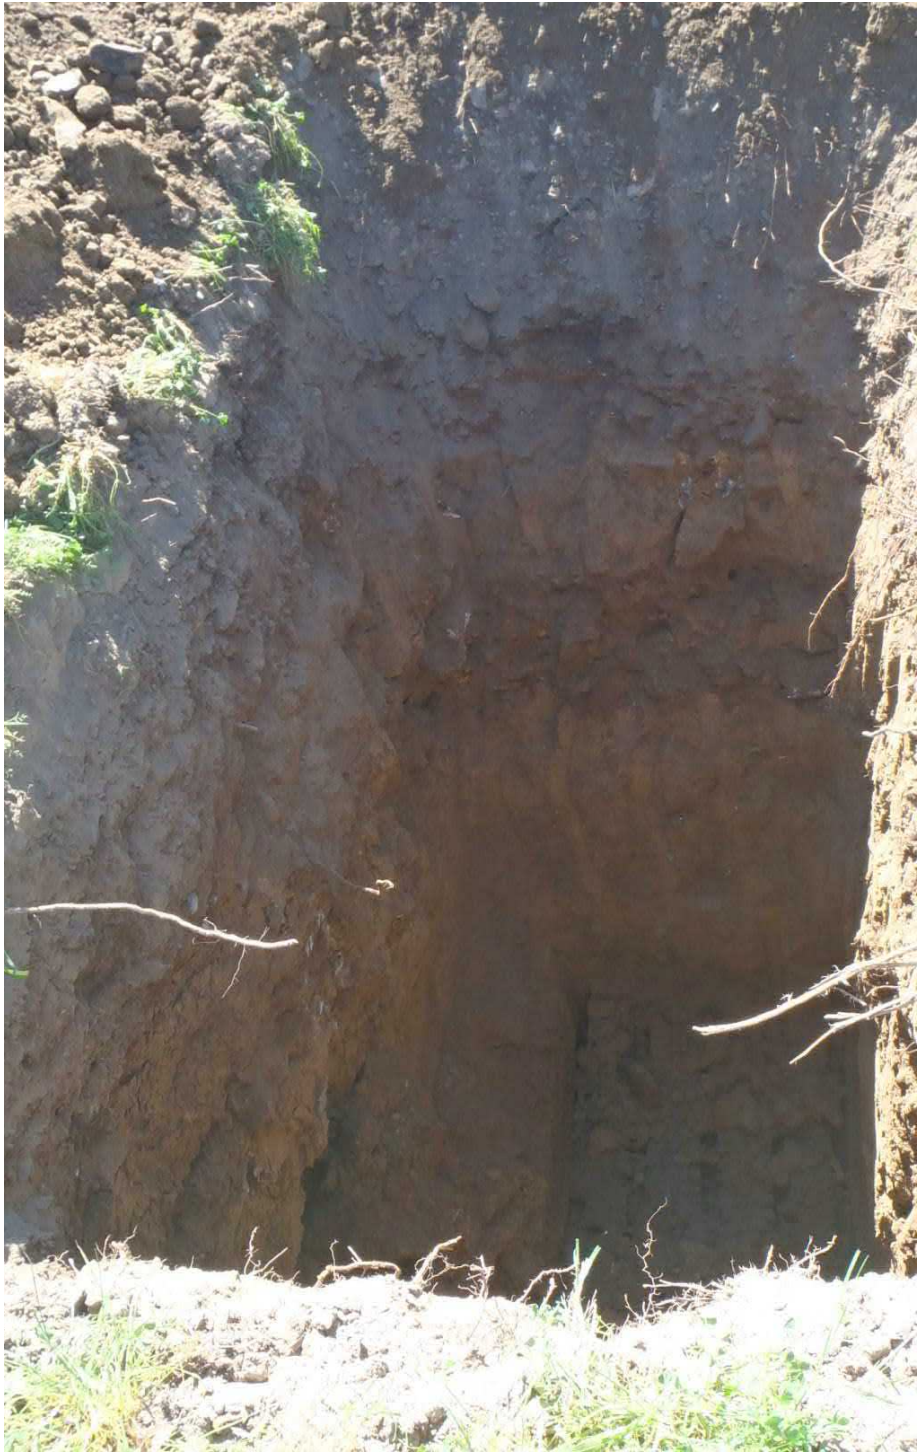
Photographic Log			
Client: Christchurch City Council		Site Location: Naval Point – Lyttleton	Project No.: 60444747
Photo. No.: 01	Date: 19/10/15

Test Pit ETP03

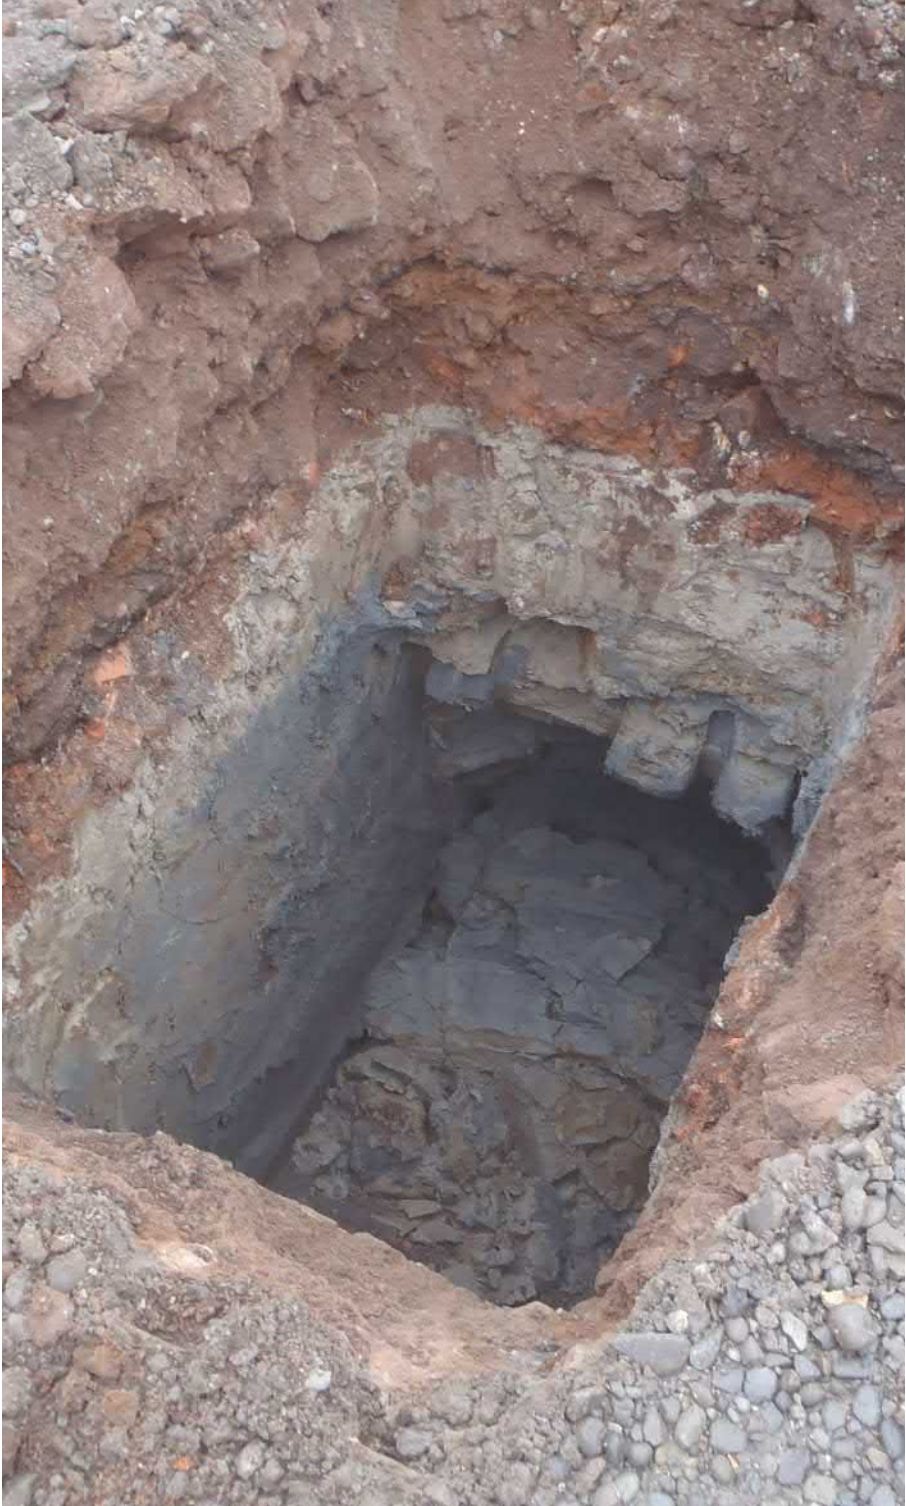
Photographic Log			
Client: Christchurch City Council		Site Location: Naval Point – Lyttleton	Project No.: 60444747
Photo. No.: 06	Date: 22/10/15

Test Pit ETP08

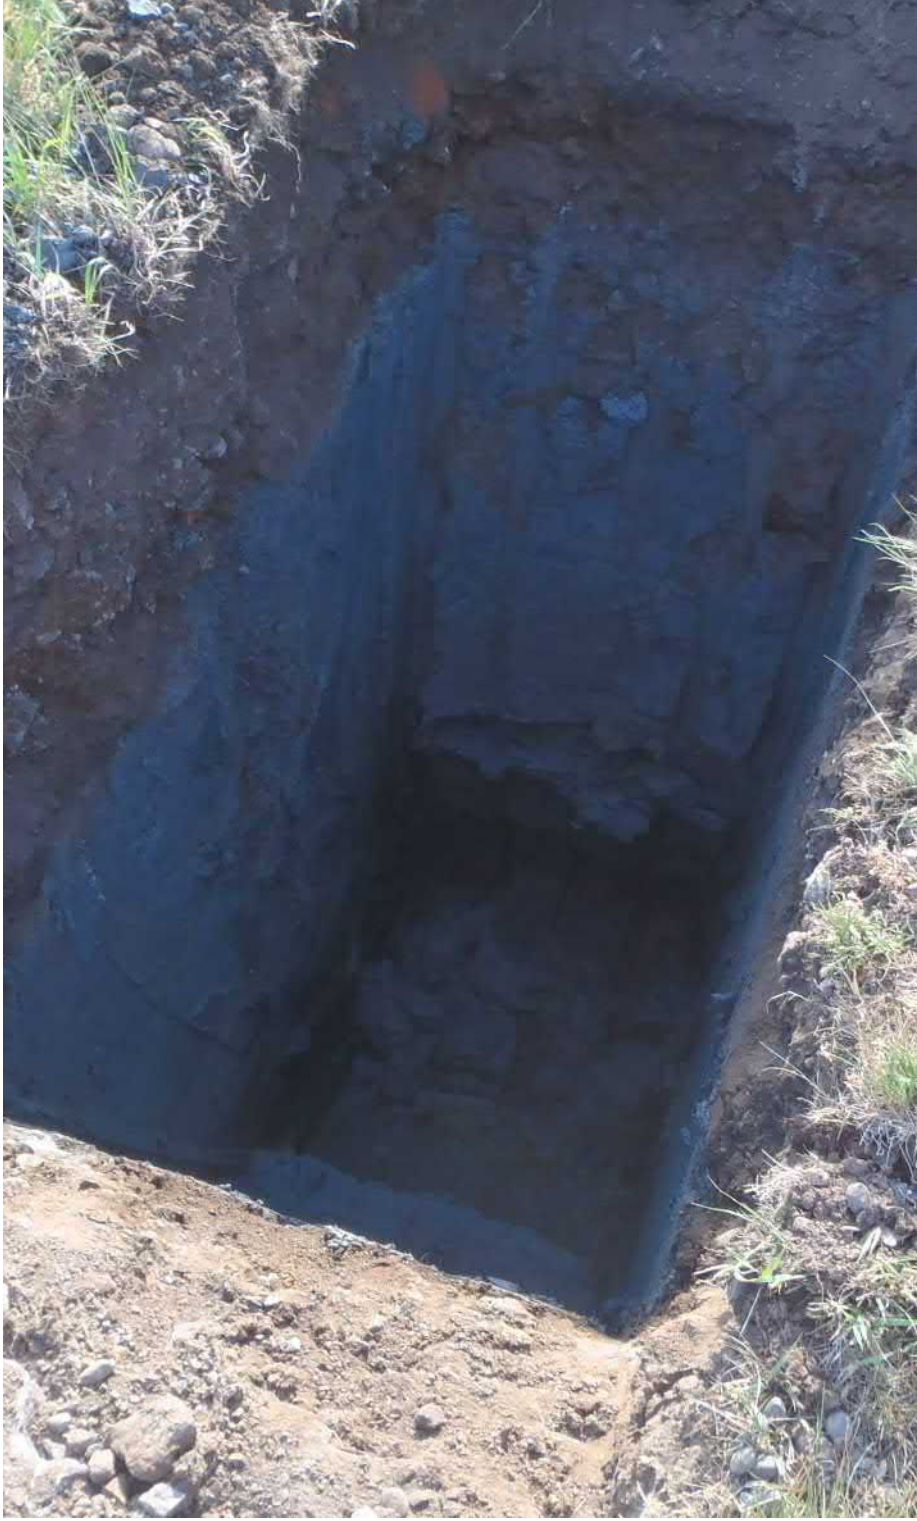
Photographic Log			
Client: Christchurch City Council		Site Location: Naval Point – Lyttleton	Project No.: 60444747
Photo. No.: 09	Date: 21/10/2015

Test Pit ETP13
