Naval Point Detailed Site Investigation

Client: Christchurch City Council

AECOM New Zealand Limited

Hazardous Materials Survey Report

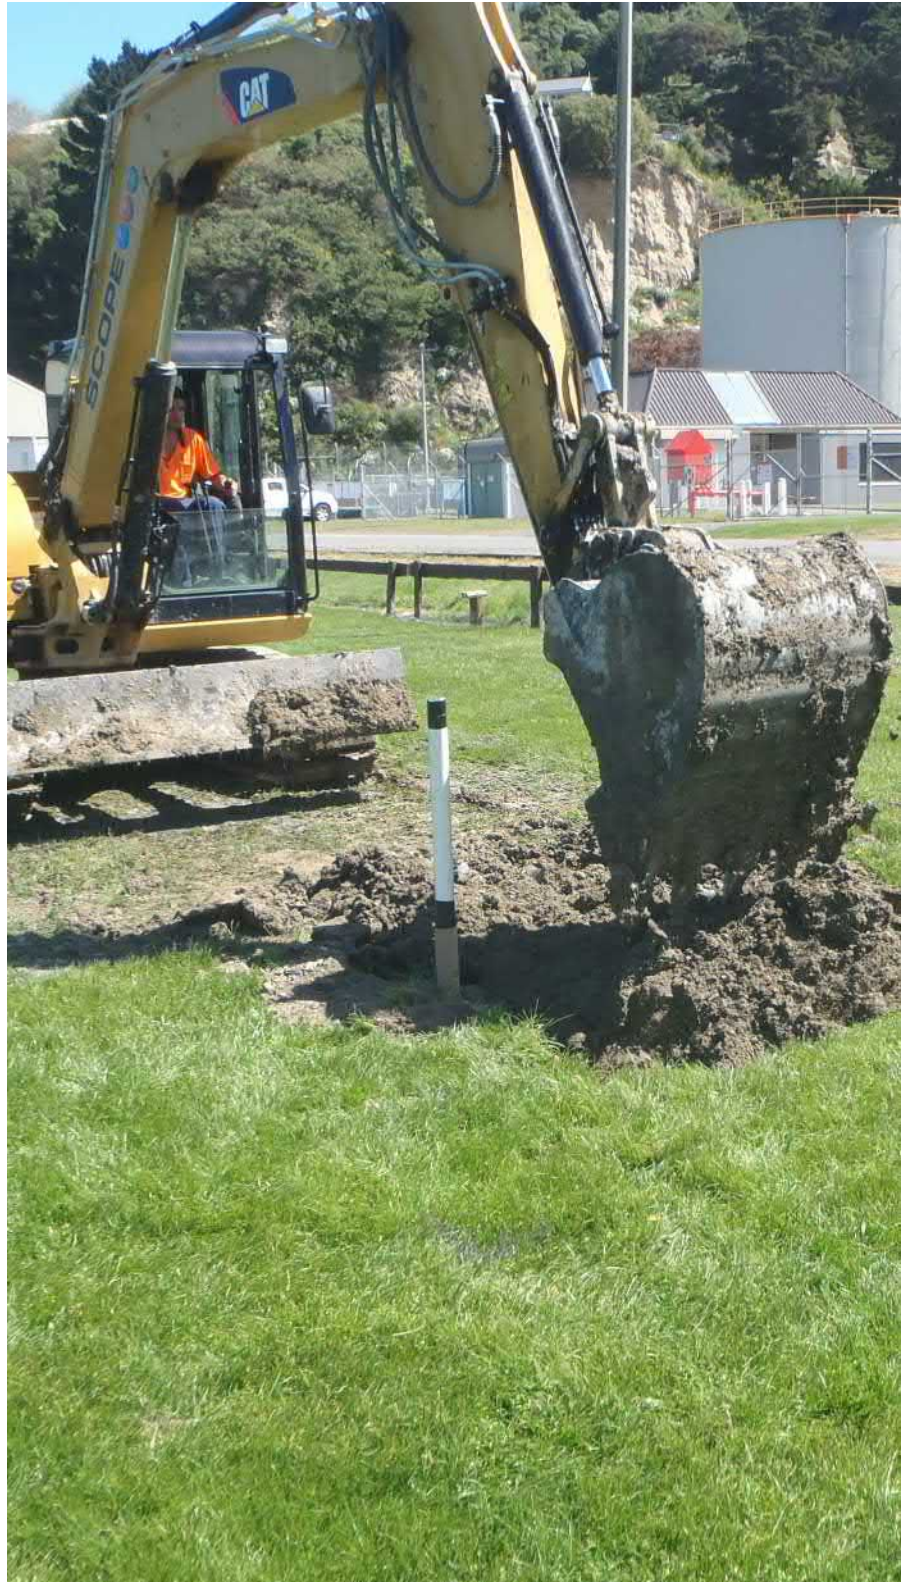
Date:
20/10/2015

Test Pit ETP15 with
groundwater well.

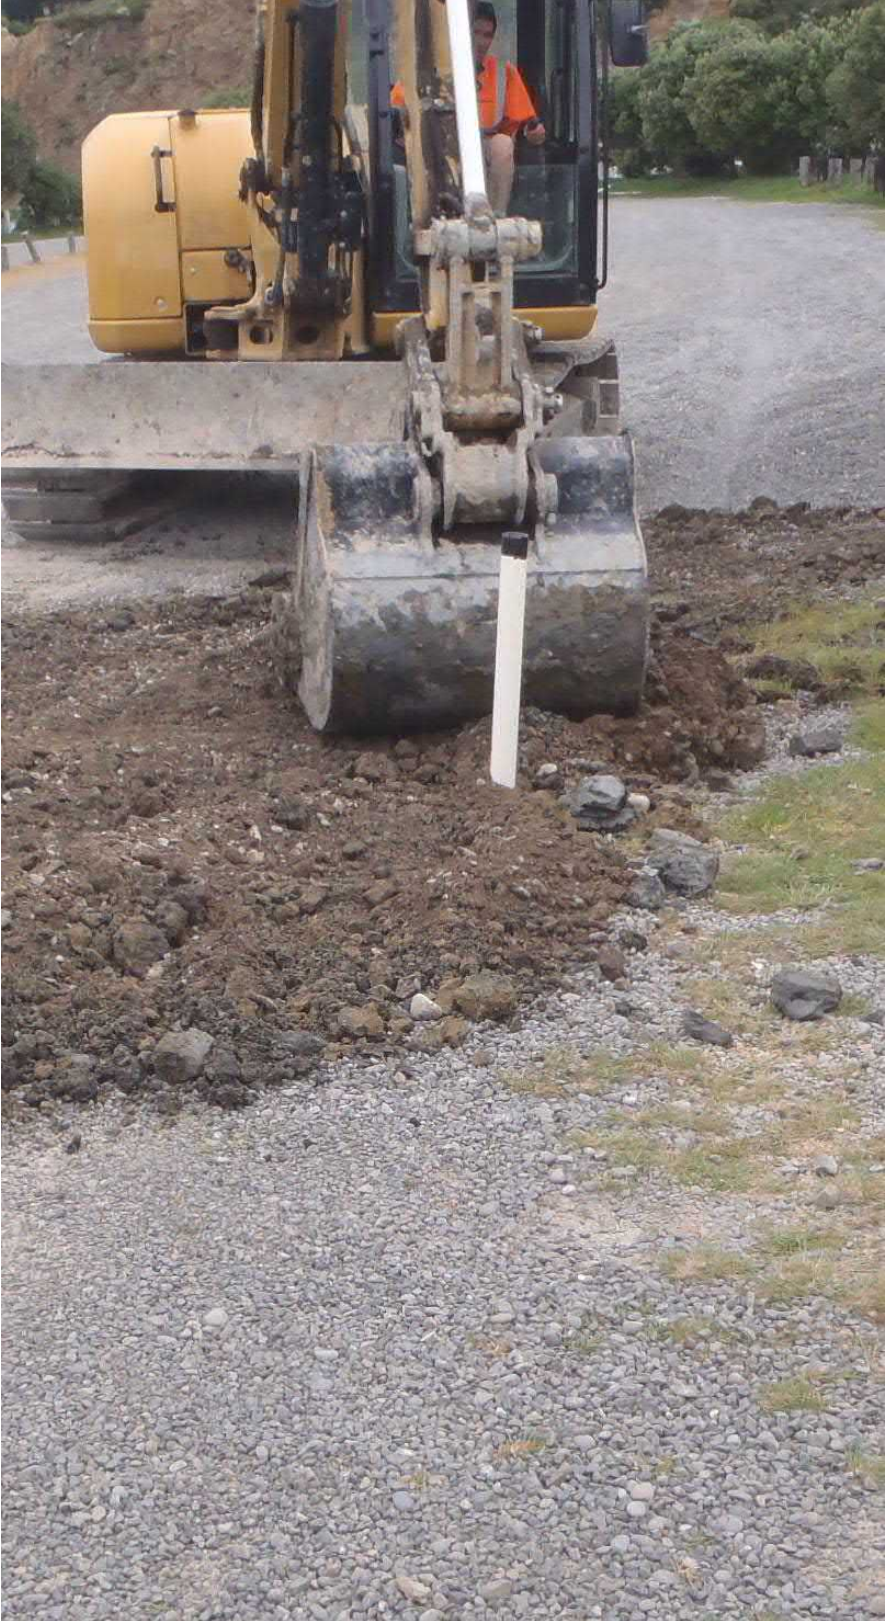
Photographic Log			
Client: Christchurch City Council		Site Location: Naval Point – Lyttleton	Project No.: 60444747
Photo. No.: 11	Date: 21/10/2015

Test Pit ETP18 with groundwater well.

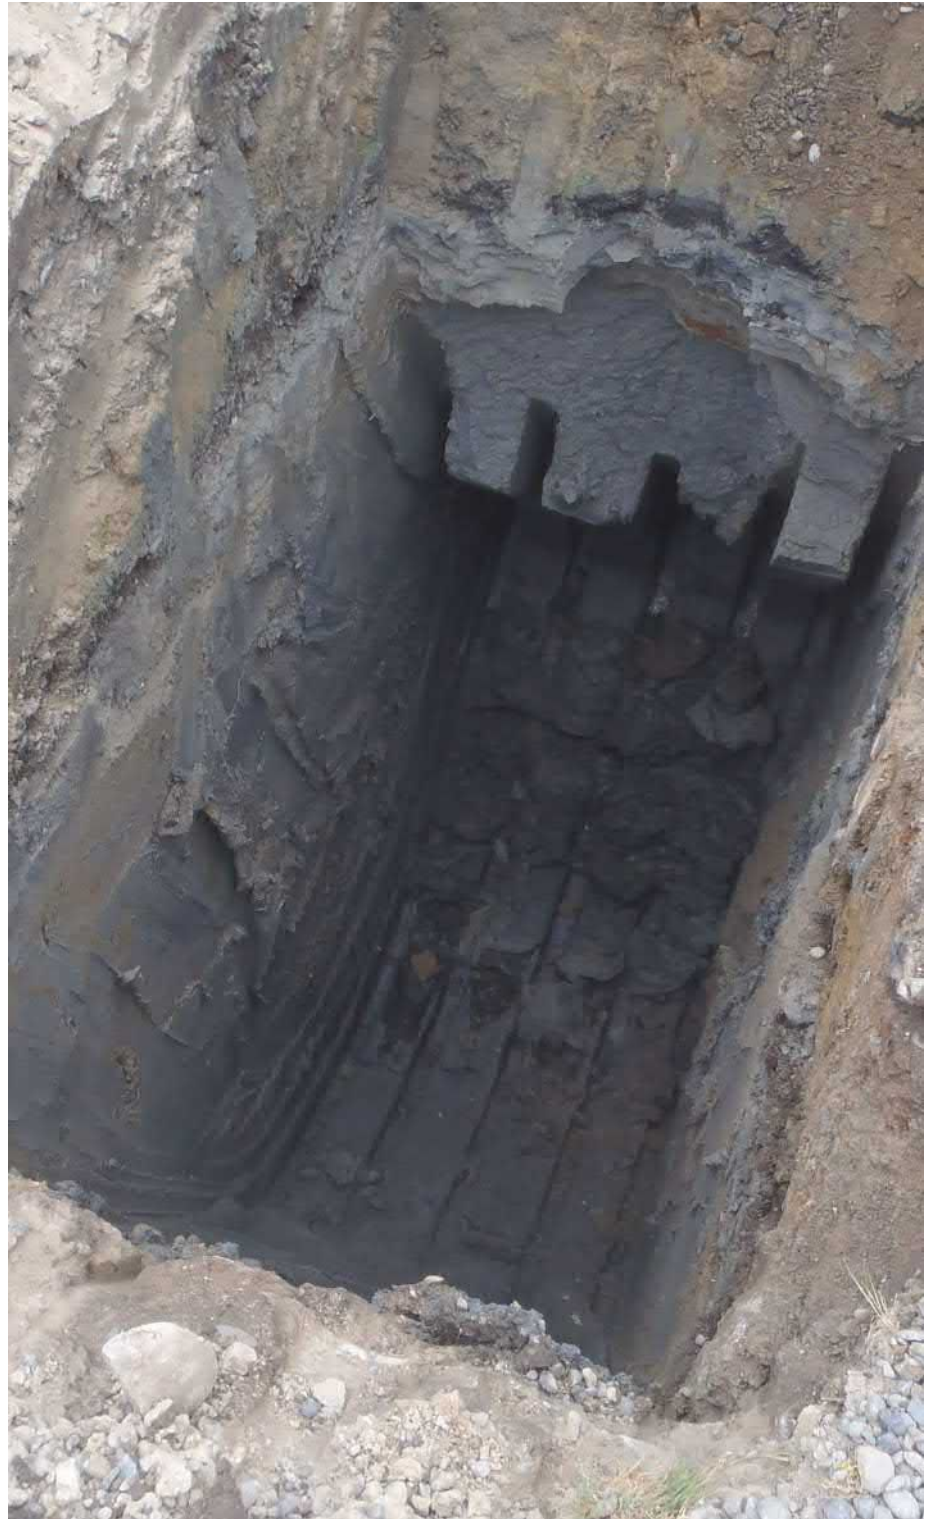
Photo. No.:
12 Date:
21/10/2015

Test Pit ETP20

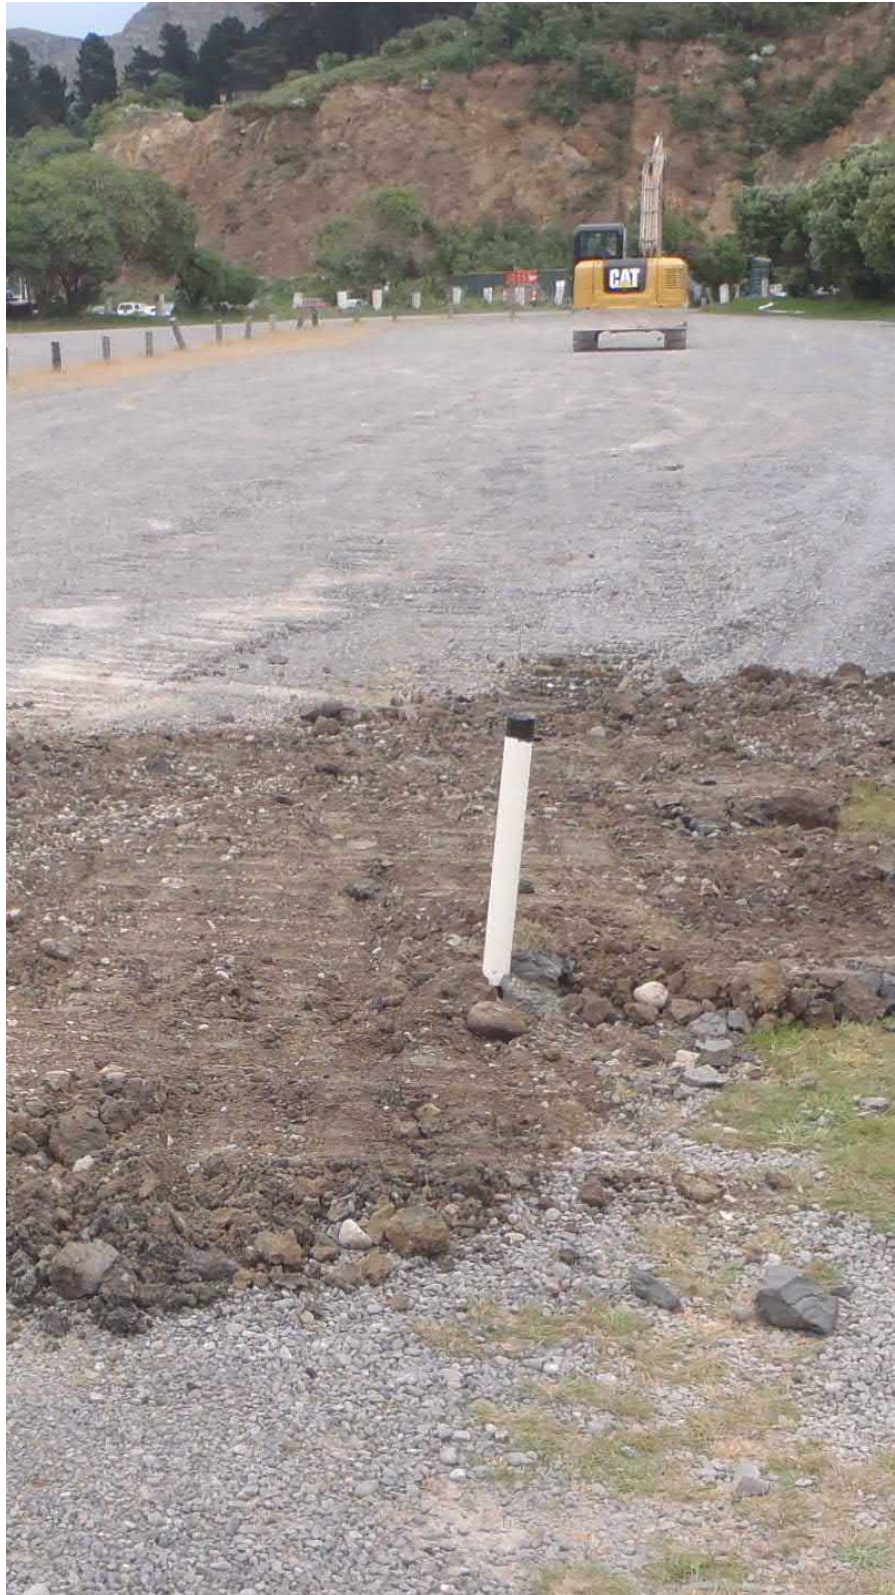
Photo. No.:
13 Date:
21/10/2015

Test Pit ETP20 with
groundwater well.

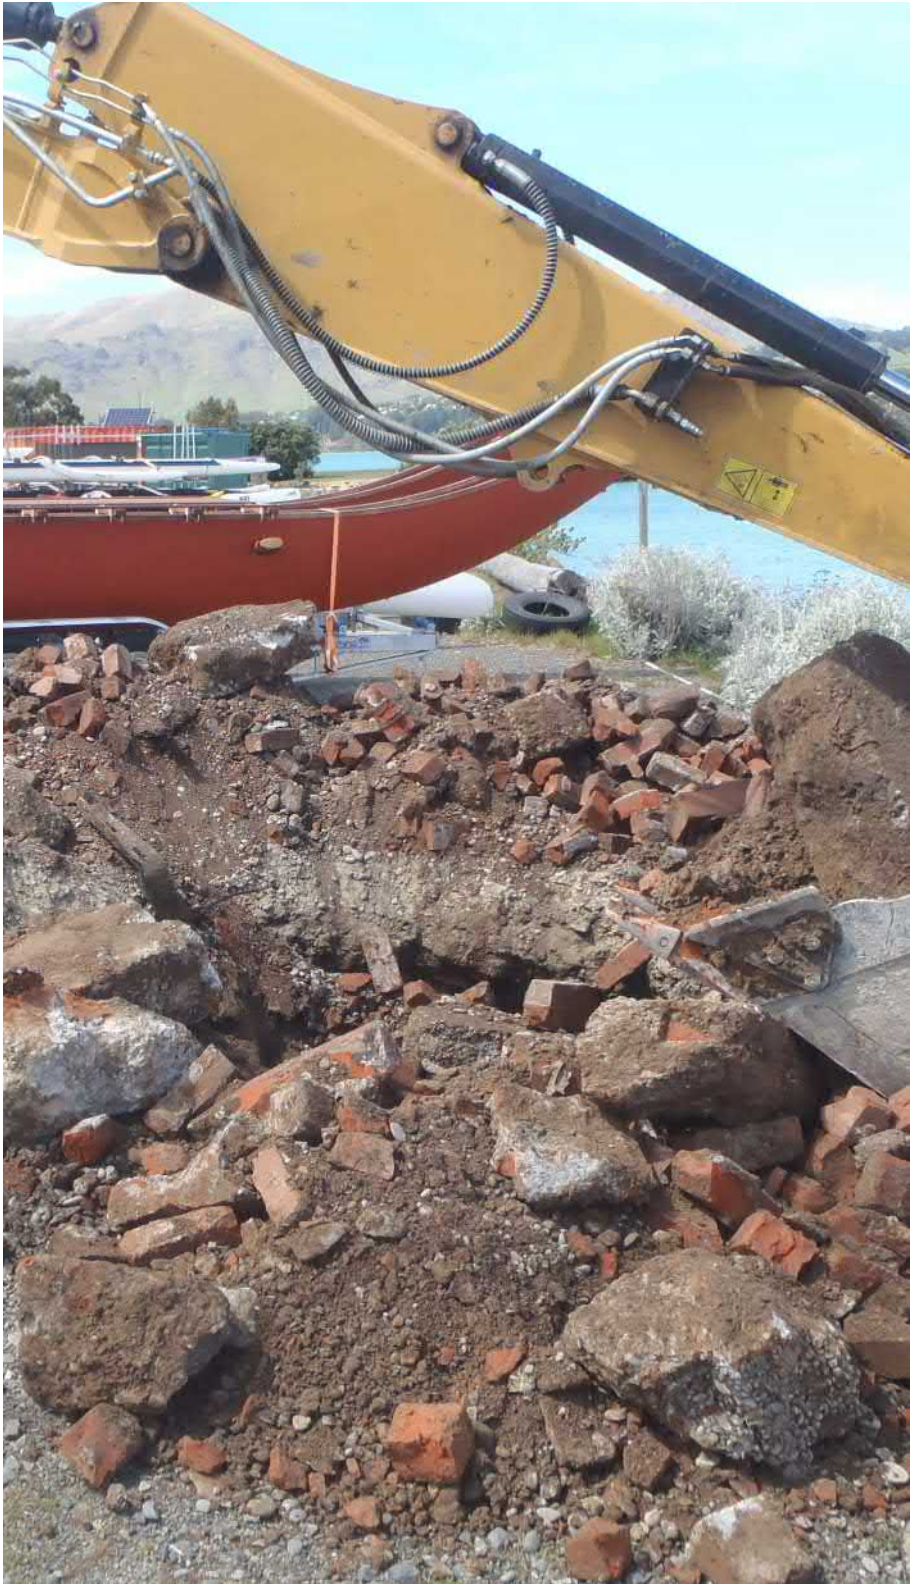
Photo. No.: 14	Date: 21/09/2015
-------------------	---------------------

Test Pit ETP21

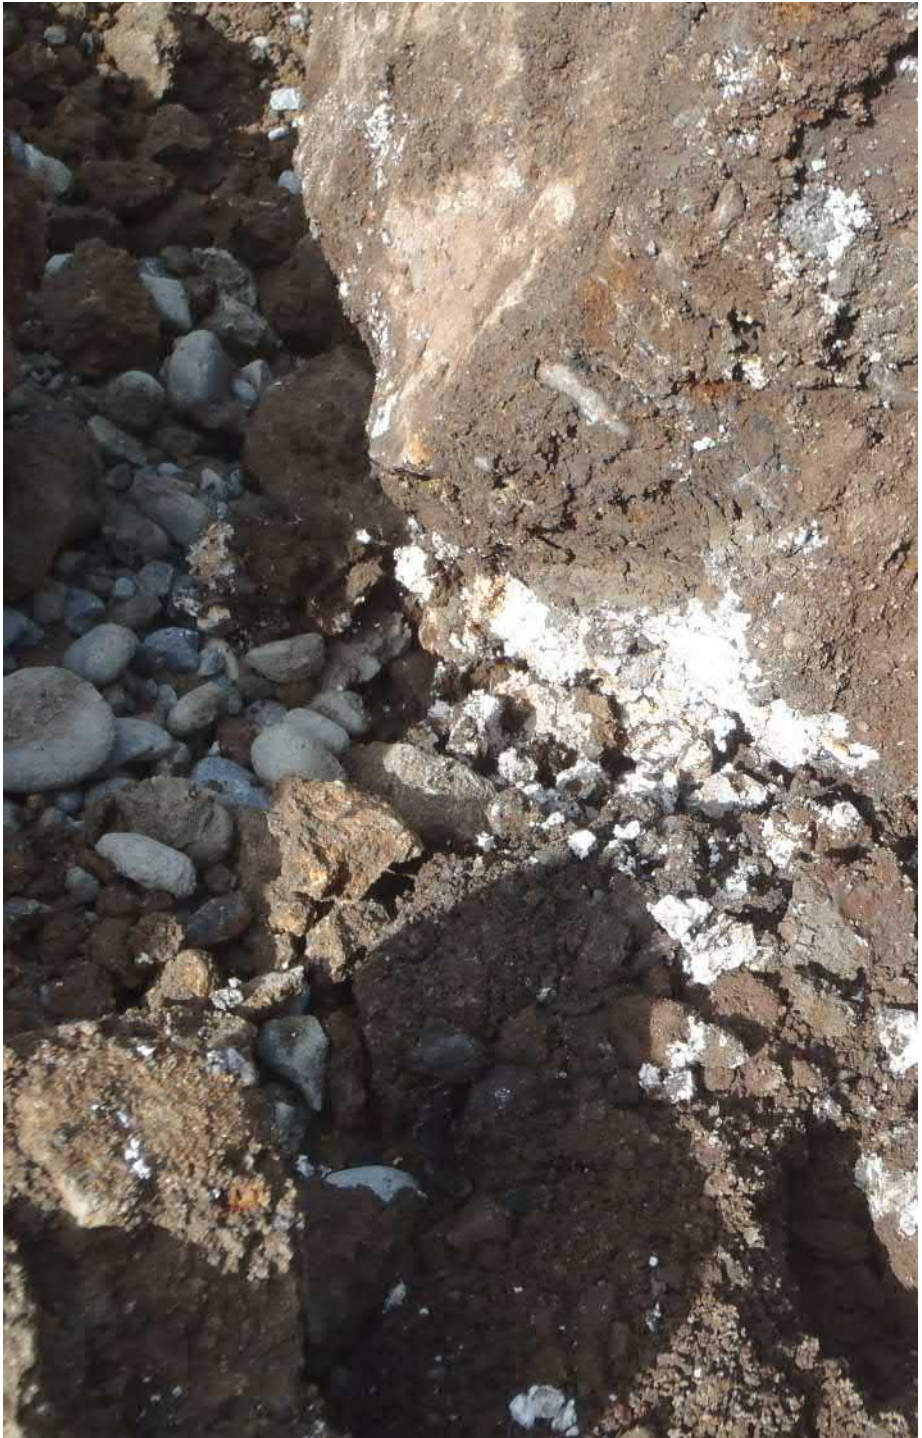
Photographic Log			
Client: Christchurch City Council		Site Location: Naval Point – Lyttleton	Project No.: 60444747
Photo. No.: 15	Date: 21/10/15

Test Pit ETP22
