CHRISTCHURCH CITY COUNCIL

SLOPE HAZARD SUSCEPTIBILITY  
ASSESSMENT

Akaroa Harbour Settlements

**March 2008**

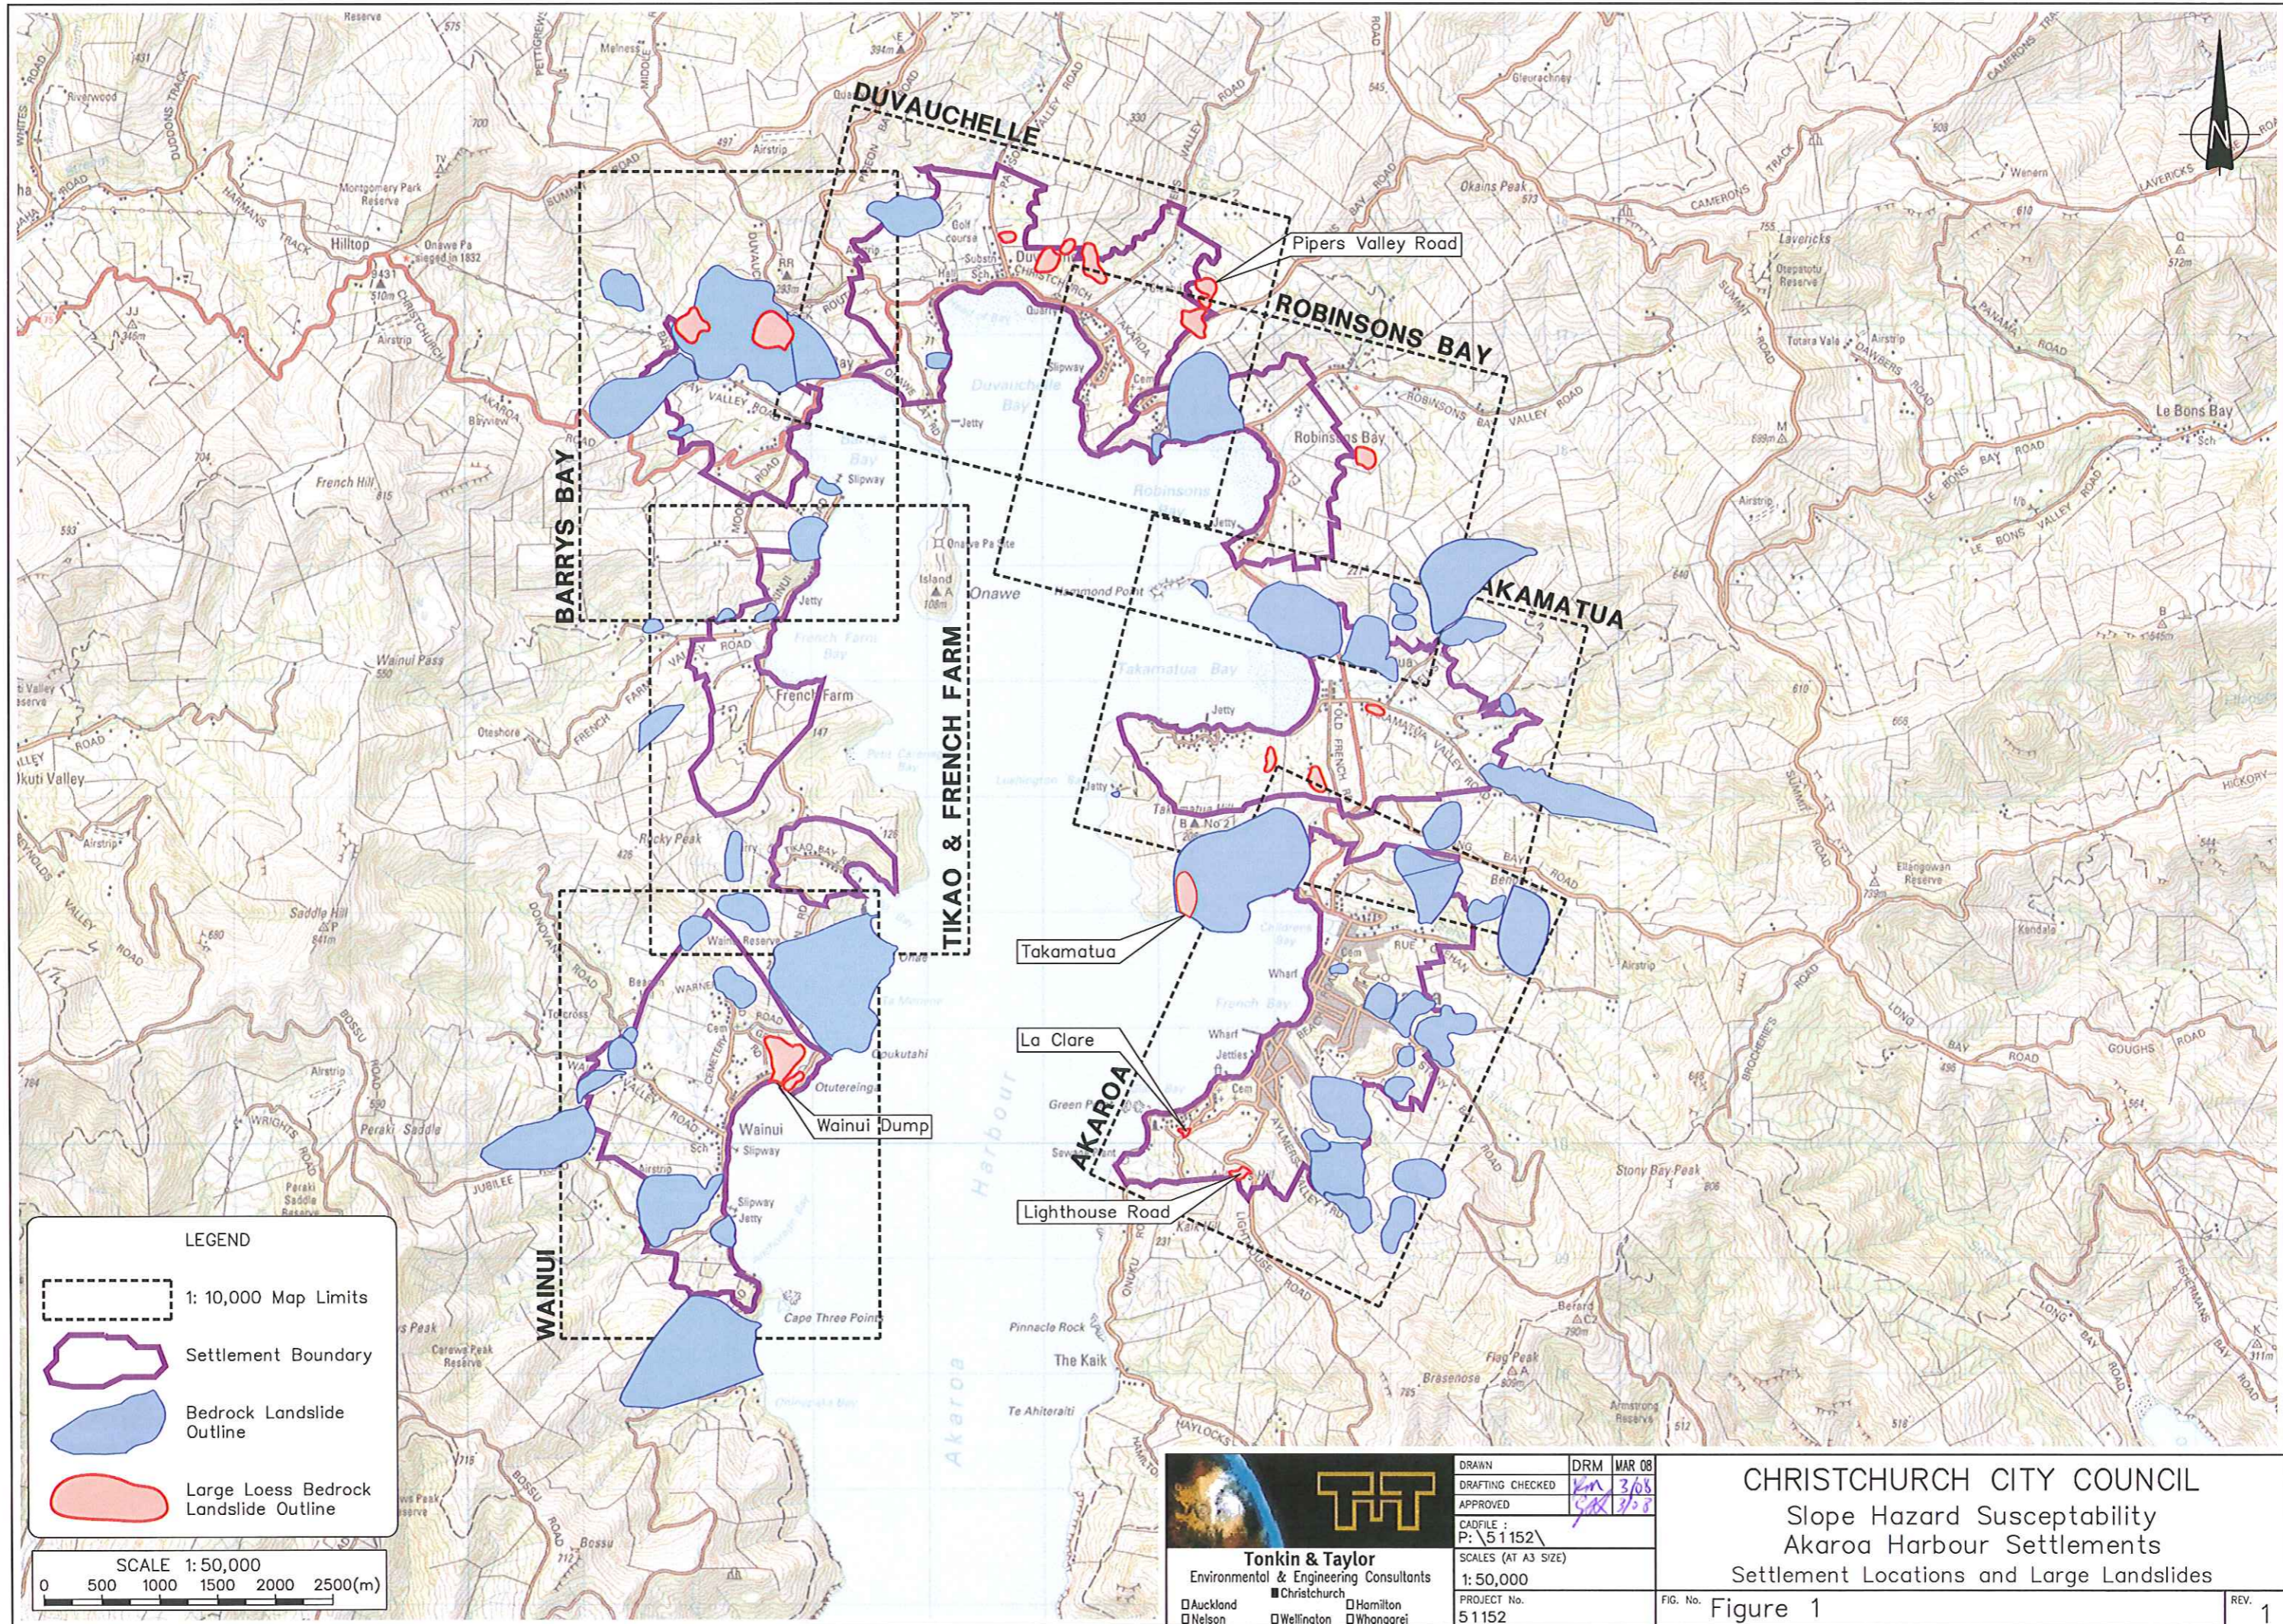
P:\51152\WorkingMaterial\CAD\Figures\Report\Figure 1.dwg, Figure 1, 28/03/2008 11:54:53 a.m., 1:1

Bedrock landslides (Figure 1, Appendix A and Figures C3 to C9, Appendix C) are large to very large failures that are inferred from air photo geomorphology. They occur predominantly on south and southwest facing slopes, forming steep faces and gentle benches that break up the otherwise 'smooth' valley and ridge slopes of the harbour. Depth to base of movement is inferred as 10 to >50m below ground level.

Bedrock landslides (Figure 1, Appendix A and Figures C3 to C9, Appendix C) are large to very large failures with a depth to base of movement inferred as 10 to >50m below ground level. The shape and distribution of the landslides suggest that they are ancient features, most likely formed during the initial erosion of the volcano, with subsequent periods of activity related to sea level changes, erosion and deposition cycles, and earthquakes.

Review of the available information indicates that the slope hazard susceptibility zoning requires significant input from detailed air photo interpretation. The air photo interpretations as shown in Figures 1 and 2 and Figures C3 to C9 (Appendix C) form the basis of the relative susceptibility zoning. The 1975 small landslides were used to count slope angle, slope aspect, slope position and slope length for input to susceptibility ranking/zoning. The breakdown of the assessment of 1975 small landslides is provided in tables in Appendix D.

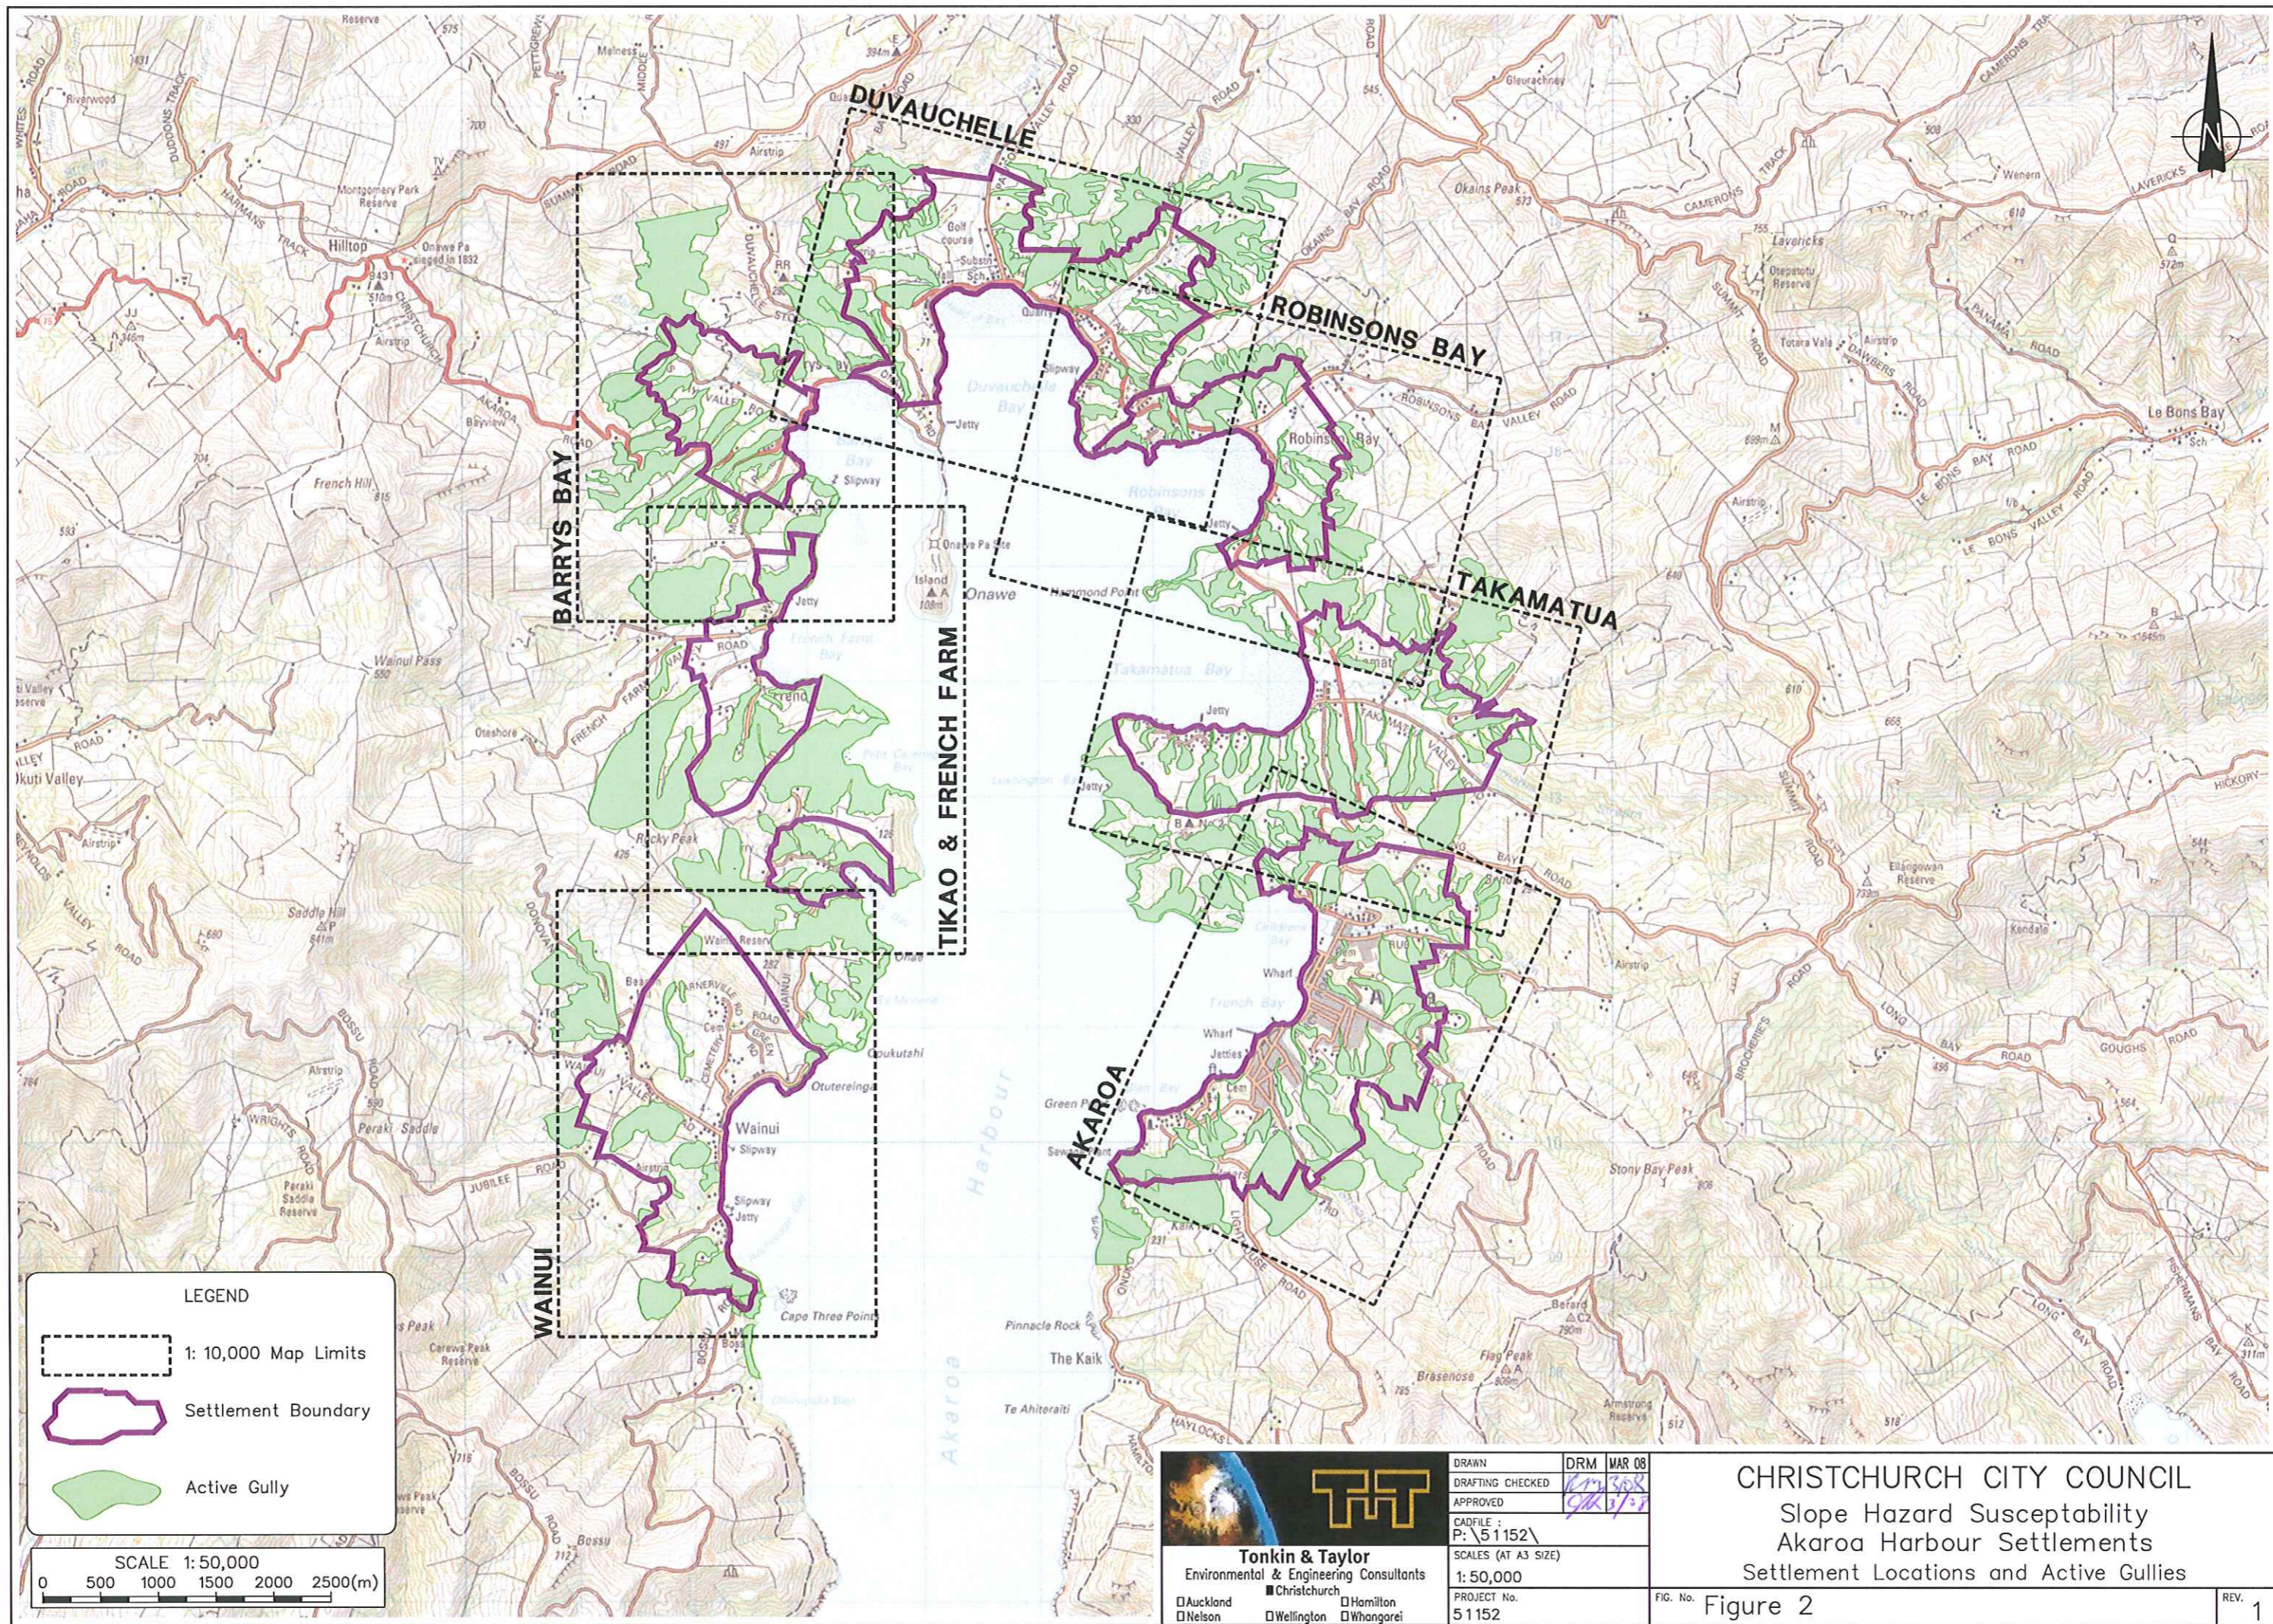
Figure 1 shows named large landslides that are known to have been recently active, and several inferred from air photo interpretation. Characteristics of these landslides are summarised in Appendix D. There may be more large landslides not recognised by this study, especially in the lobate heads of active gullies. The main defining characteristic would be episodic movement at depths from 5 to 15m (with other active gully instability occurring at <5m depth).

CCC has provided T&T with settlement boundaries in electronic format. The locations of the settlement boundaries are shown on Figure 1.

The Akaroa Harbour Basin Settlement land stability study covers a number of settlement areas totalling approximately 1900 ha. The study area comprises 8 settlement areas within Akaroa Harbour, as shown in Figure 1 (Appendix A). Generally the settlements are located in inlets and bays at the mouths of valleys adjacent to the coastline of Akaroa Harbour.

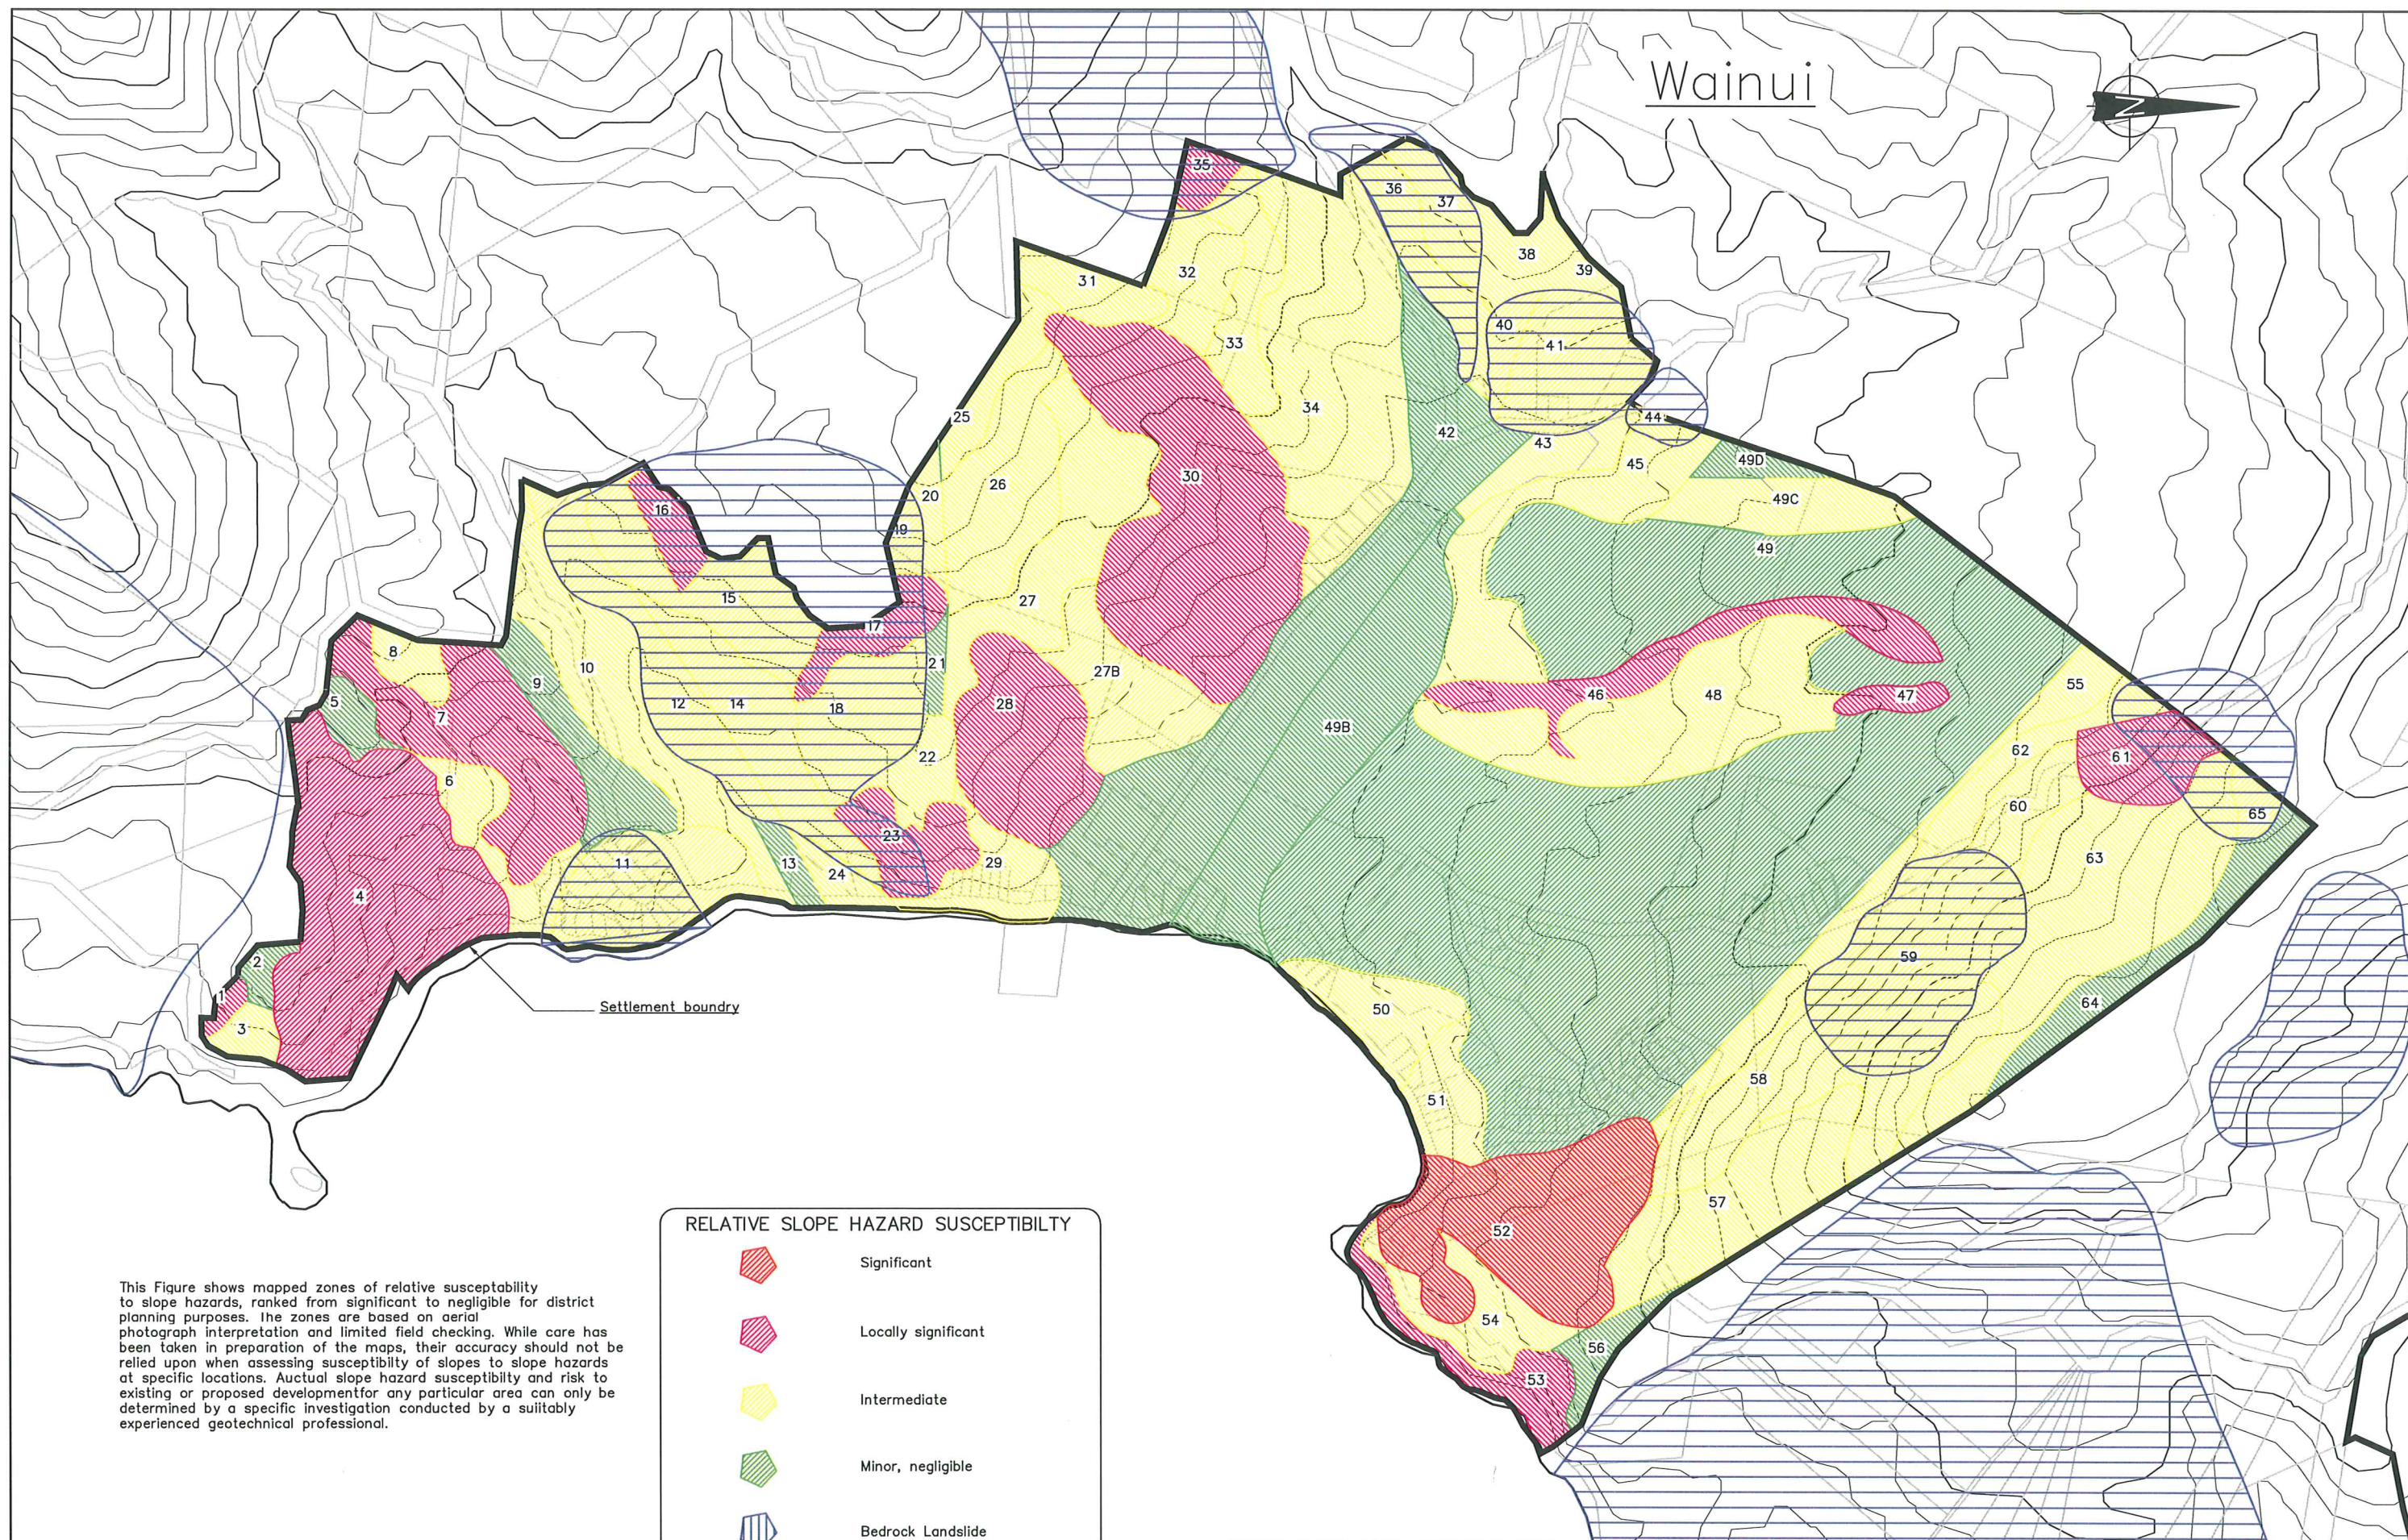
Wainui

This Figure shows mapped zones of relative susceptibility to slope hazards, ranked from significant to negligible for district planning purposes. The zones are based on aerial photograph interpretation and limited field checking. While care has been taken in preparation of the maps, their accuracy should not be relied upon when assessing susceptibility of slopes to slope hazards at specific locations. Actual slope hazard susceptibility and risk to existing or proposed development for any particular area can only be determined by a specific investigation conducted by a suitably experienced geotechnical professional.

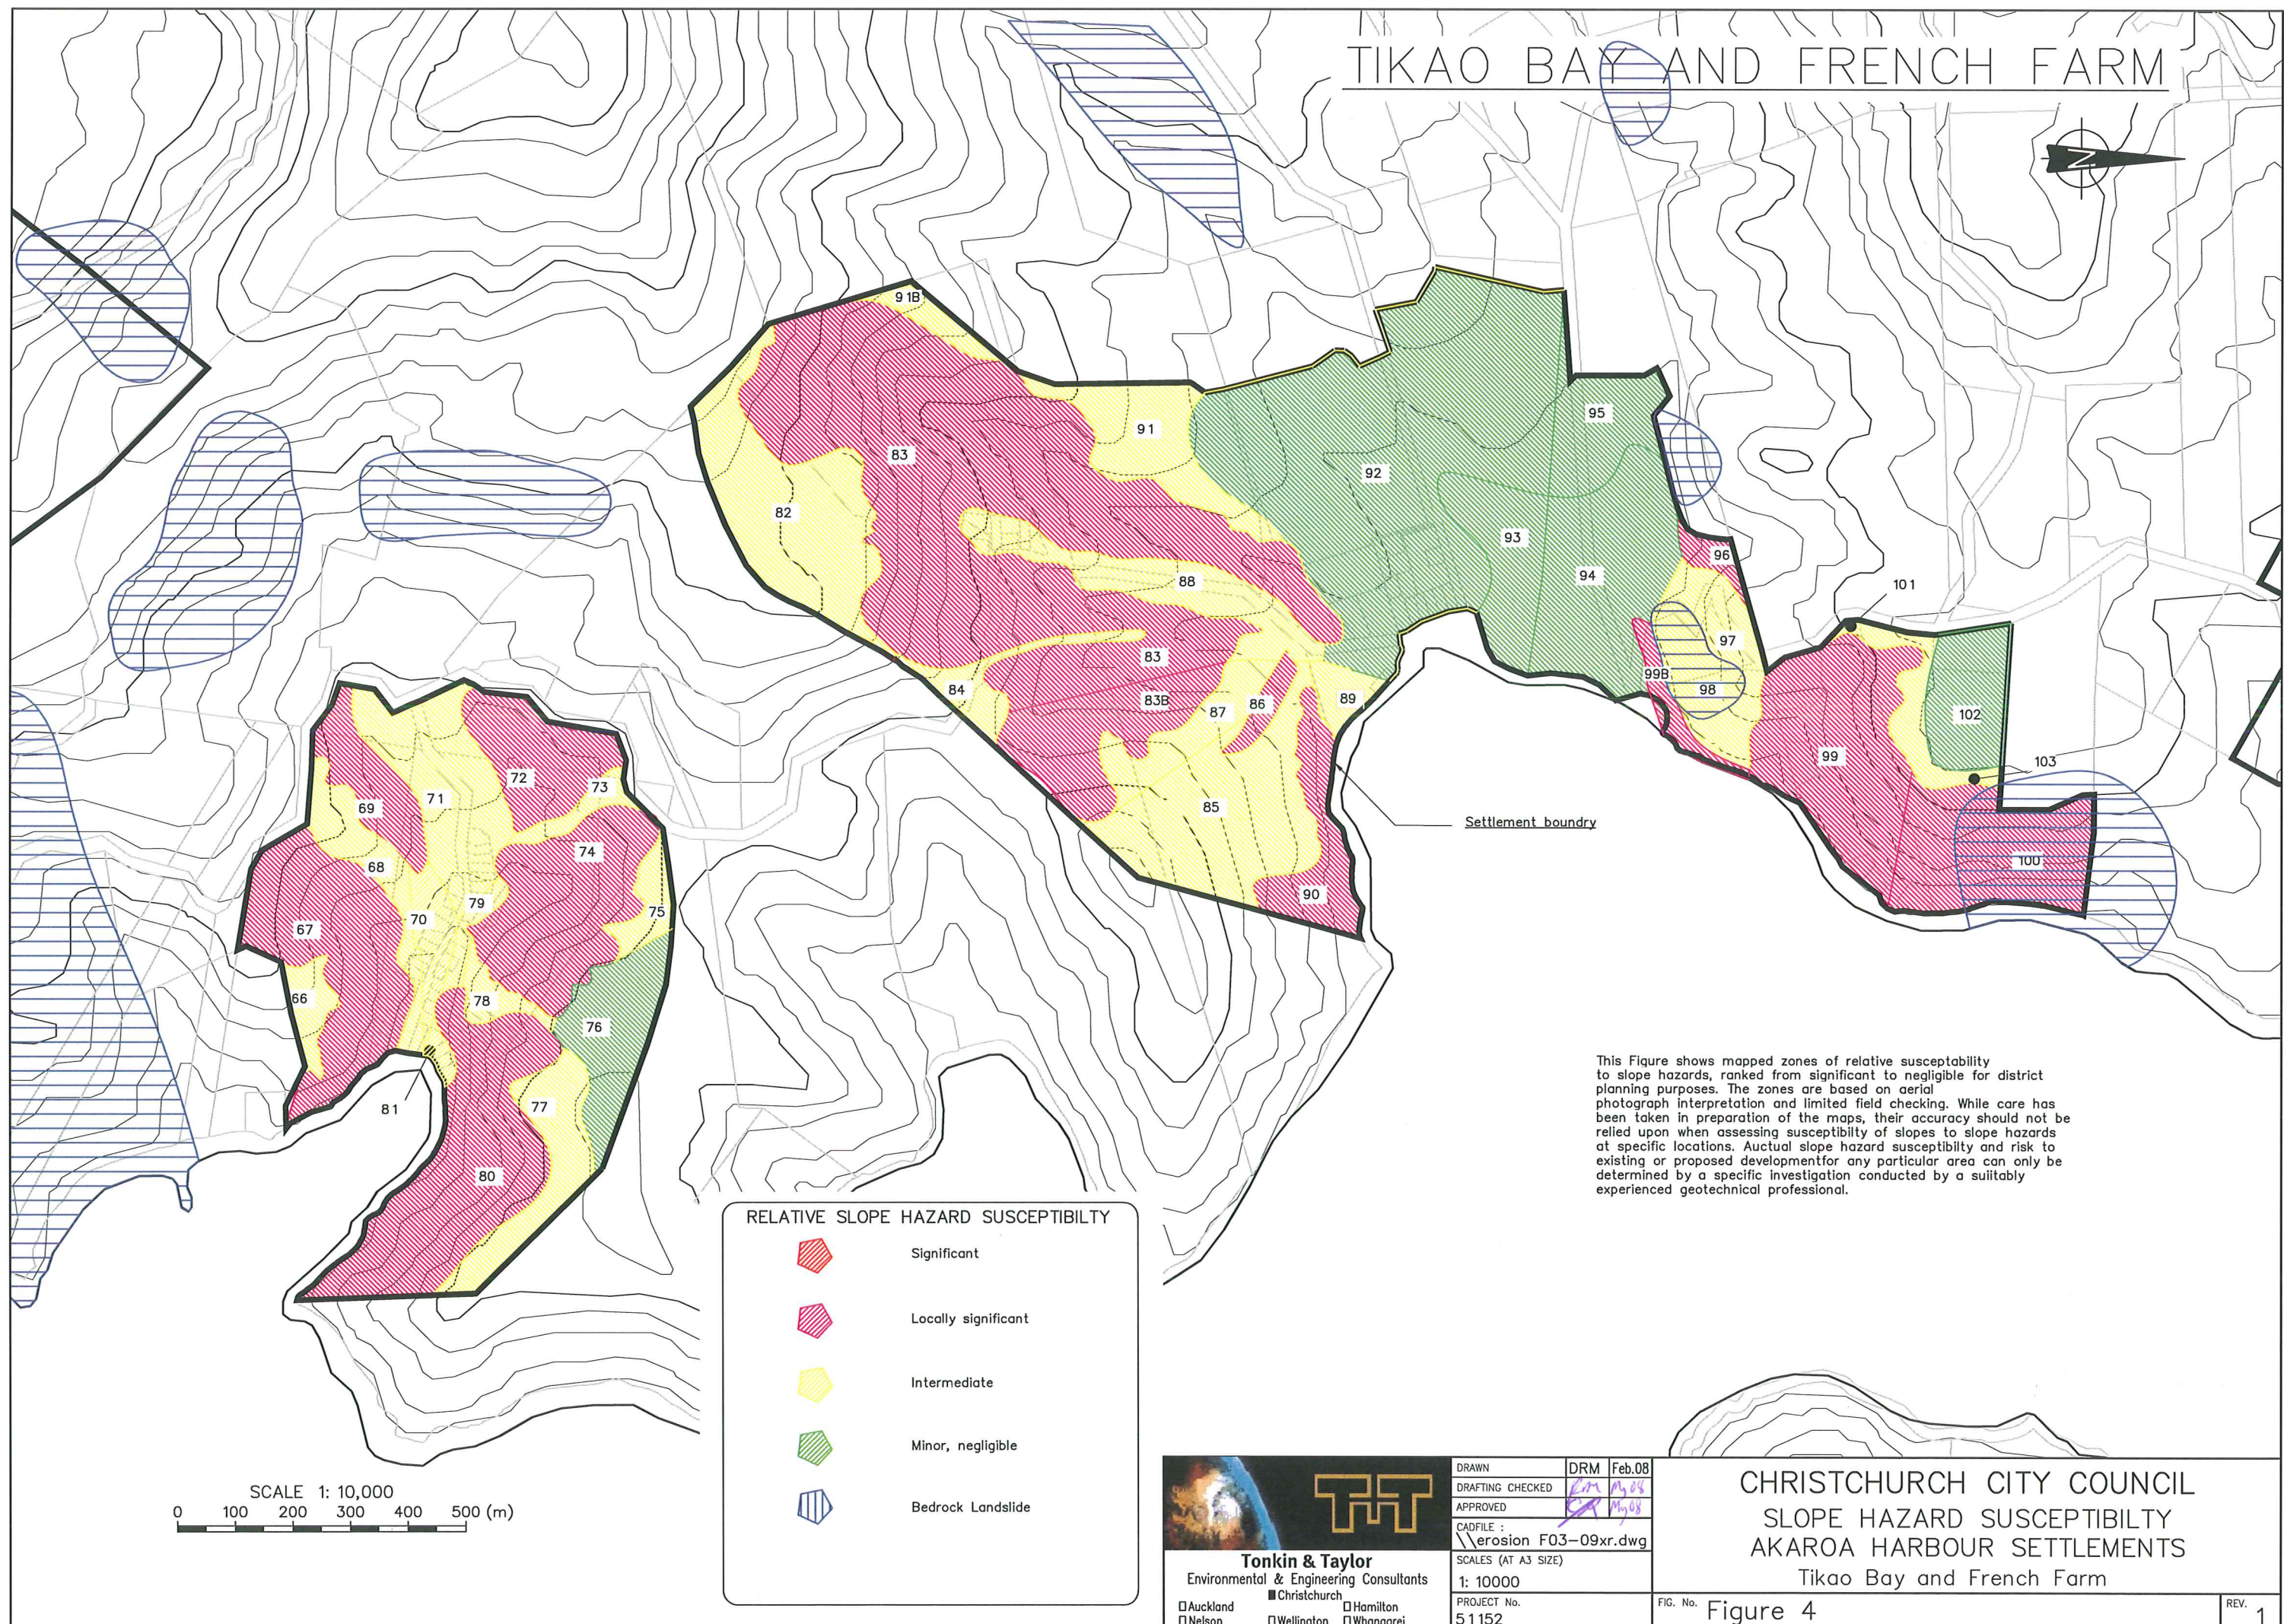
# TIKAO BAY AND FRENCH FARM

This Figure shows mapped zones of relative susceptibility to slope hazards, ranked from significant to negligible for district planning purposes. The zones are based on aerial photograph interpretation and limited field checking. While care has been taken in preparation of the maps, their accuracy should not be relied upon when assessing susceptibility of slopes to slope hazards at specific locations. Actual slope hazard susceptibility and risk to existing or proposed development for any particular area can only be determined by a specific investigation conducted by a suitably experienced geotechnical professional.

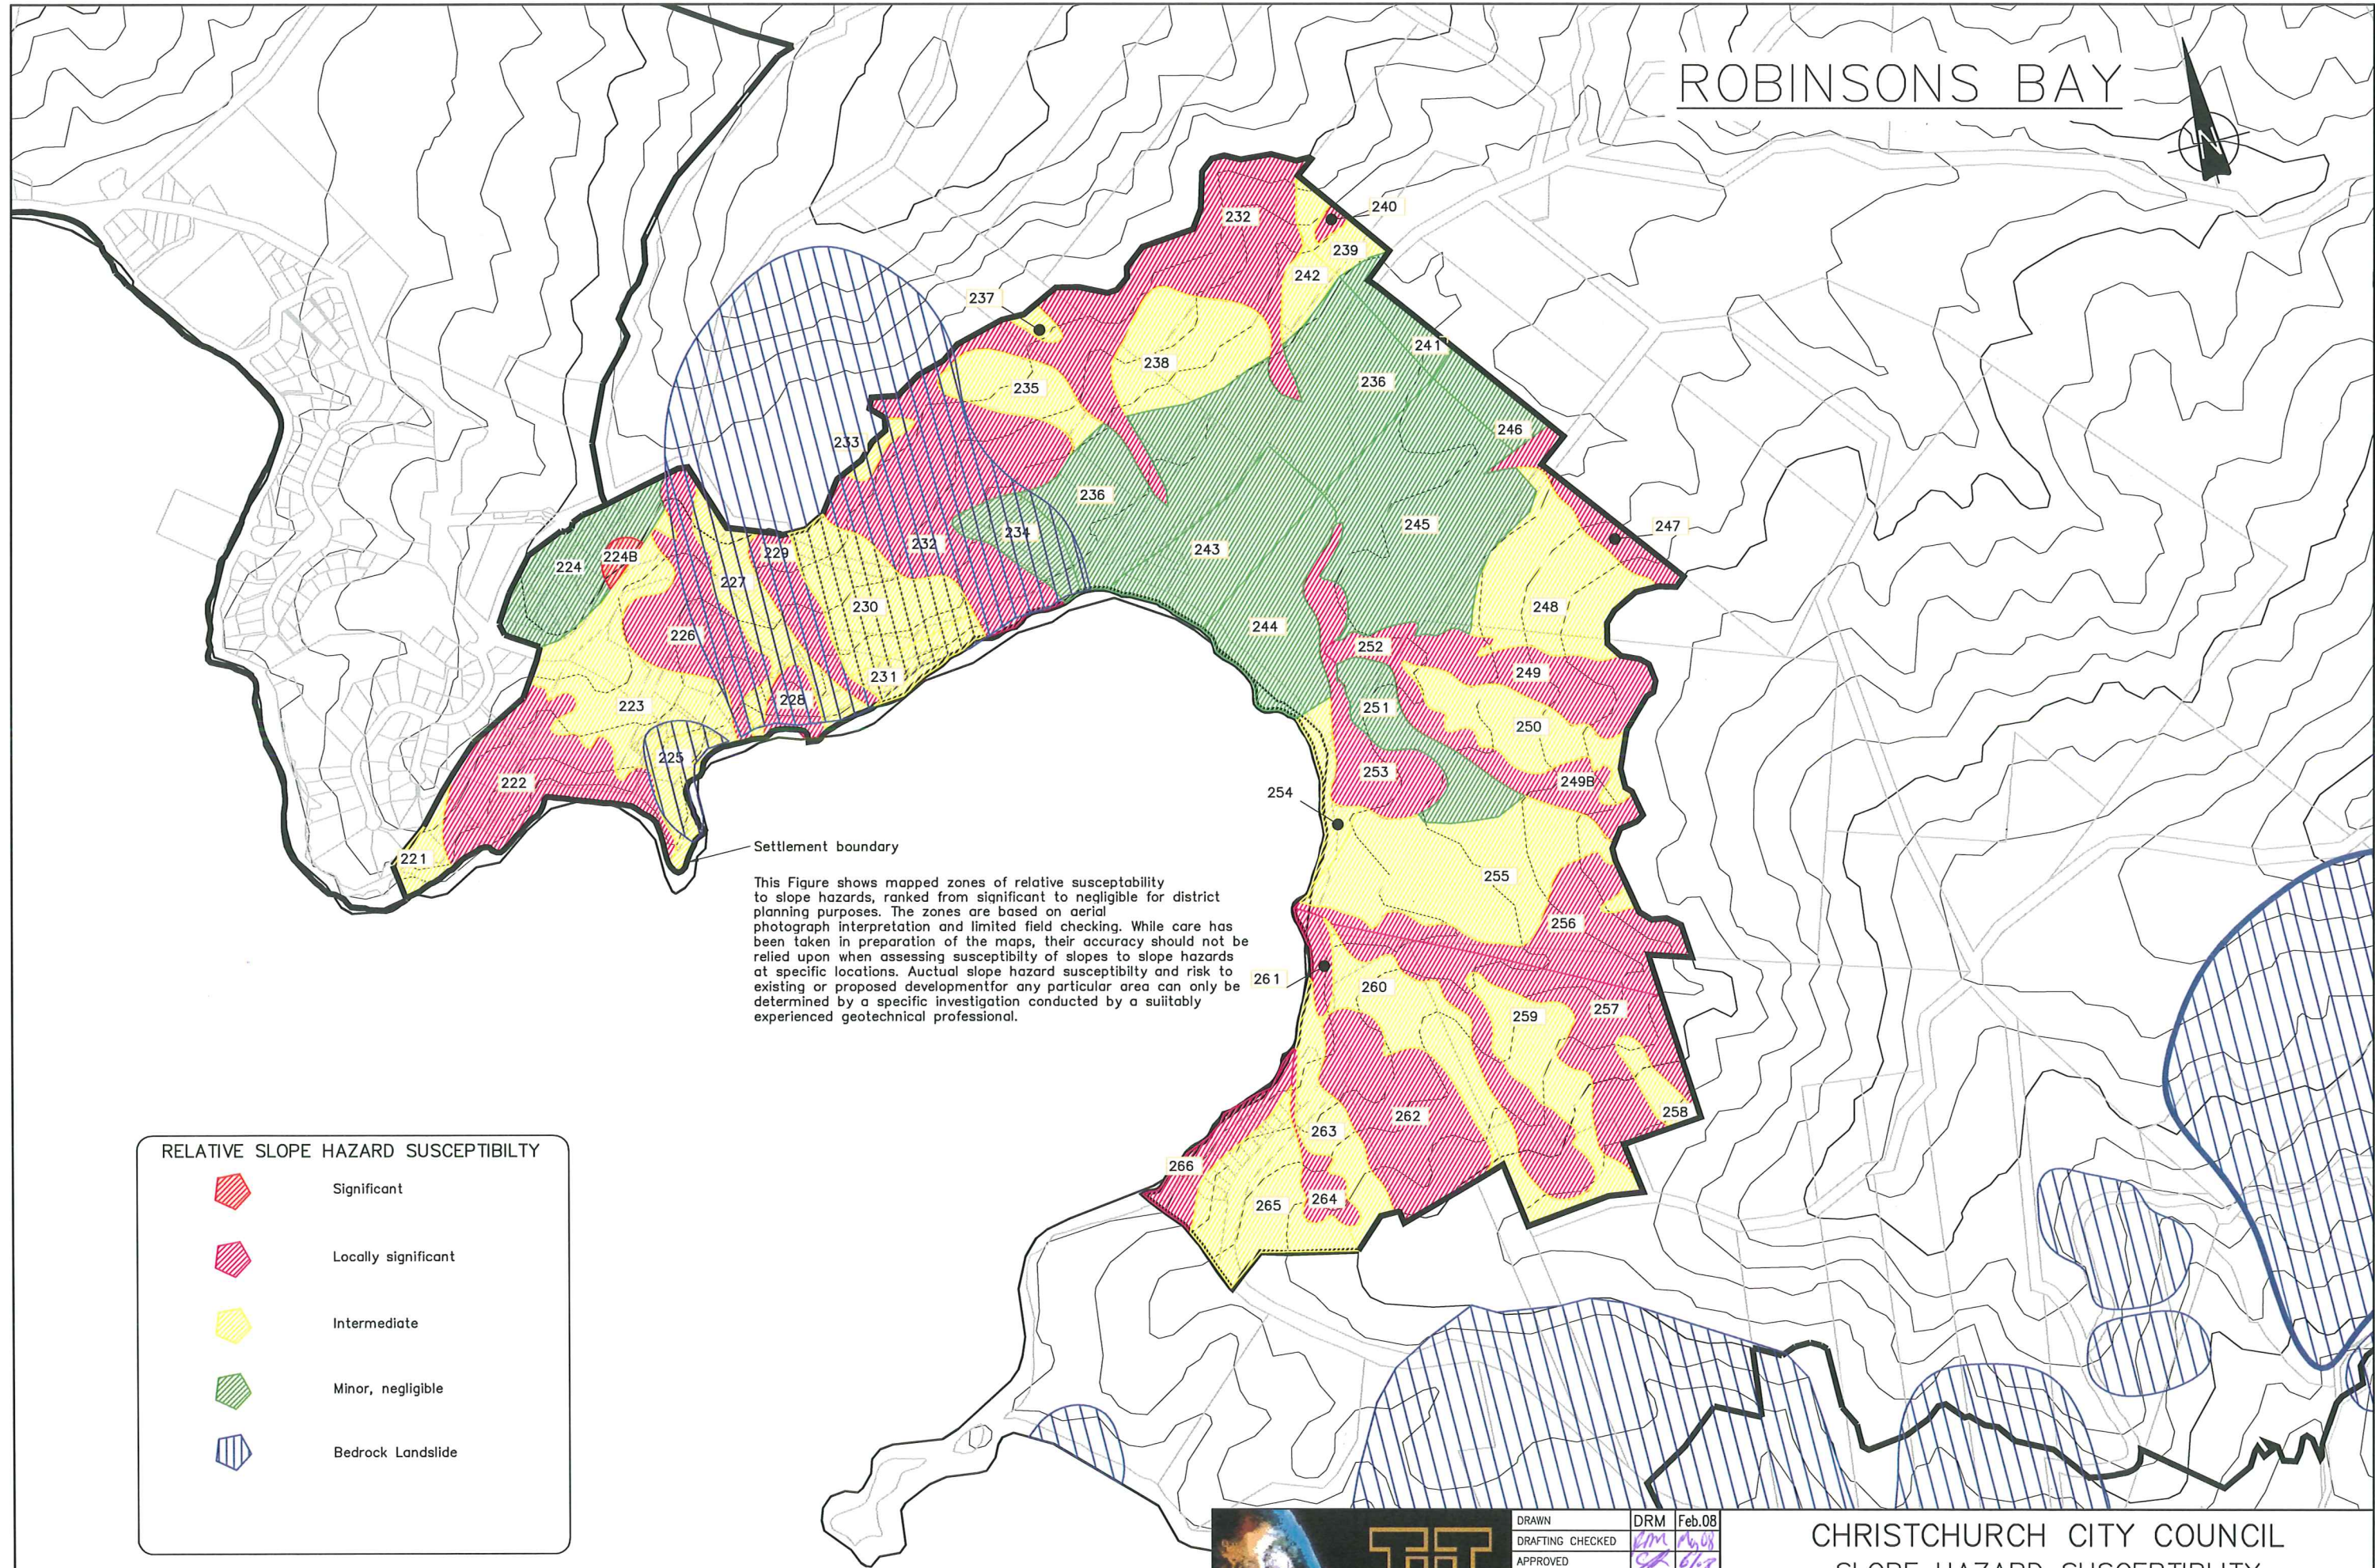
# ROBINSONS BAY

This Figure shows mapped zones of relative susceptibility to slope hazards, ranked from significant to negligible for district planning purposes. The zones are based on aerial photograph interpretation and limited field checking. While care has been taken in preparation of the maps, their accuracy should not be relied upon when assessing susceptibility of slopes to slope hazards at specific locations. Actual slope hazard susceptibility and risk to existing or proposed development for any particular area can only be determined by a specific investigation conducted by a suitably experienced geotechnical professional.
