CHRISTCHURCH CITY COUNCIL

SLOPE HAZARD SUSCEPTIBILITY  
ASSESSMENT

Akaroa Harbour Settlements

**March 2008**

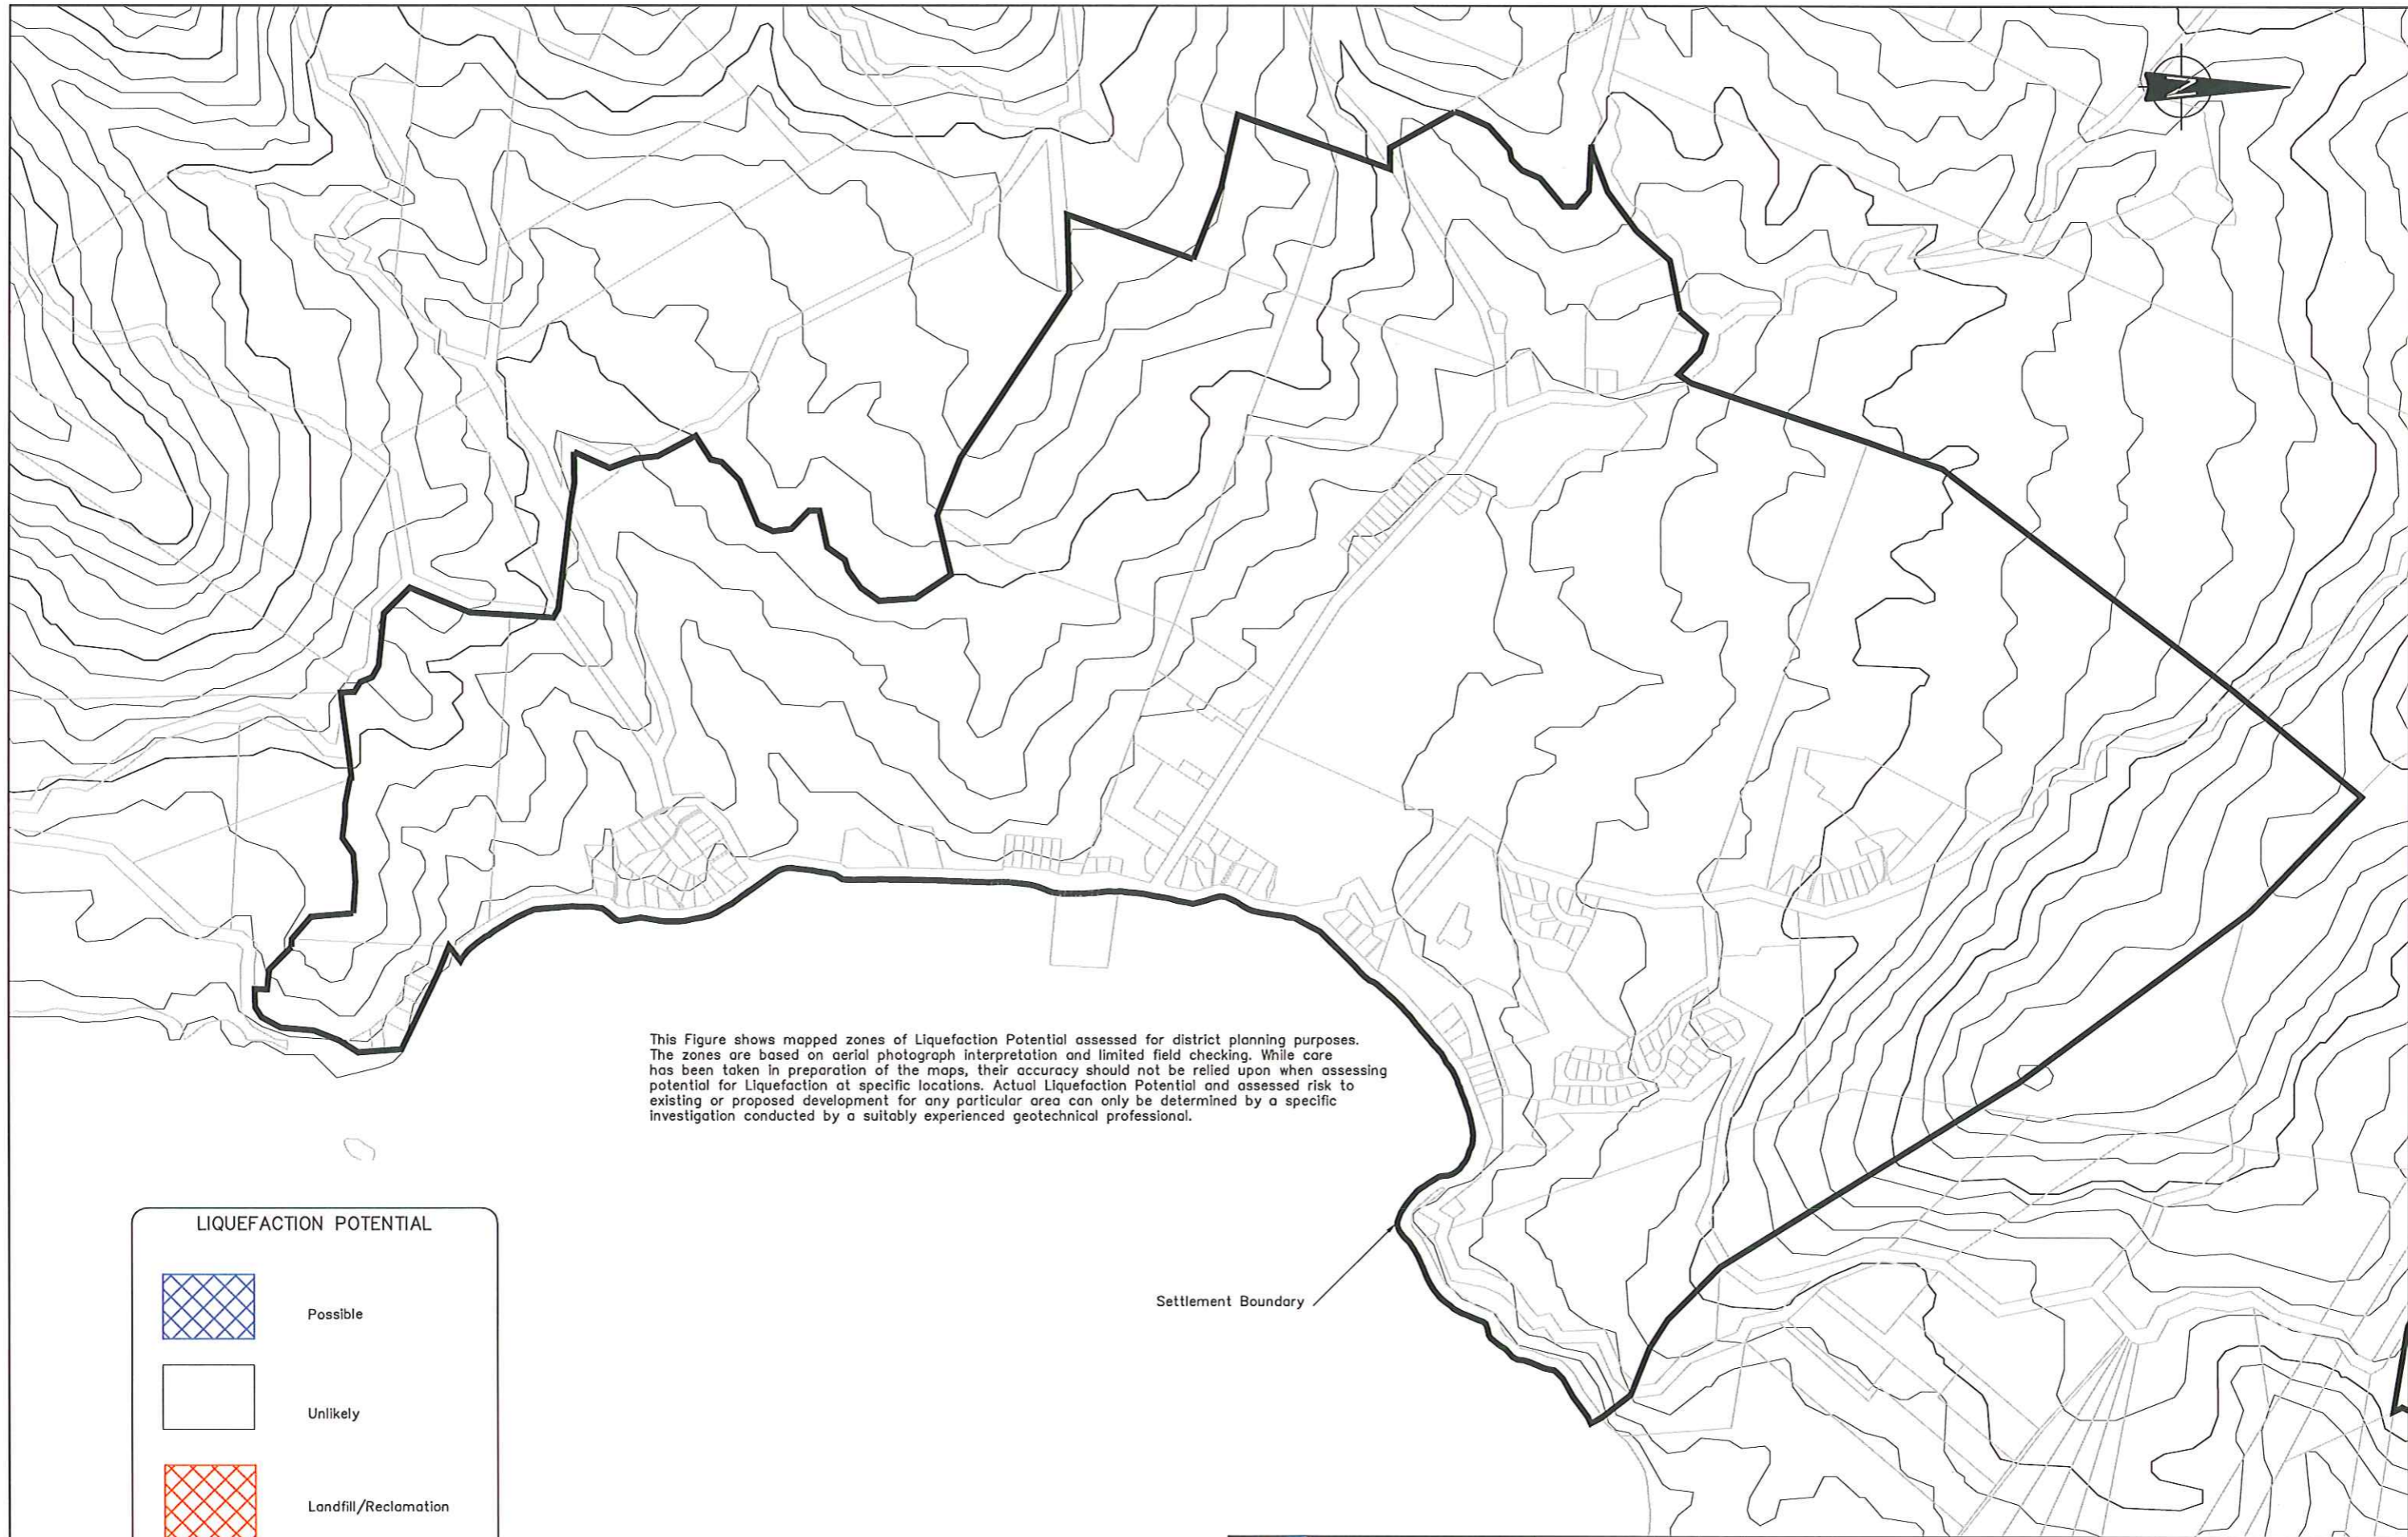
This Figure shows mapped zones of Liquefaction Potential assessed for district planning purposes. The zones are based on aerial photograph interpretation and limited field checking. While care has been taken in preparation of the maps, their accuracy should not be relied upon when assessing potential for Liquefaction at specific locations. Actual Liquefaction Potential and assessed risk to existing or proposed development for any particular area can only be determined by a specific investigation conducted by a suitably experienced geotechnical professional.

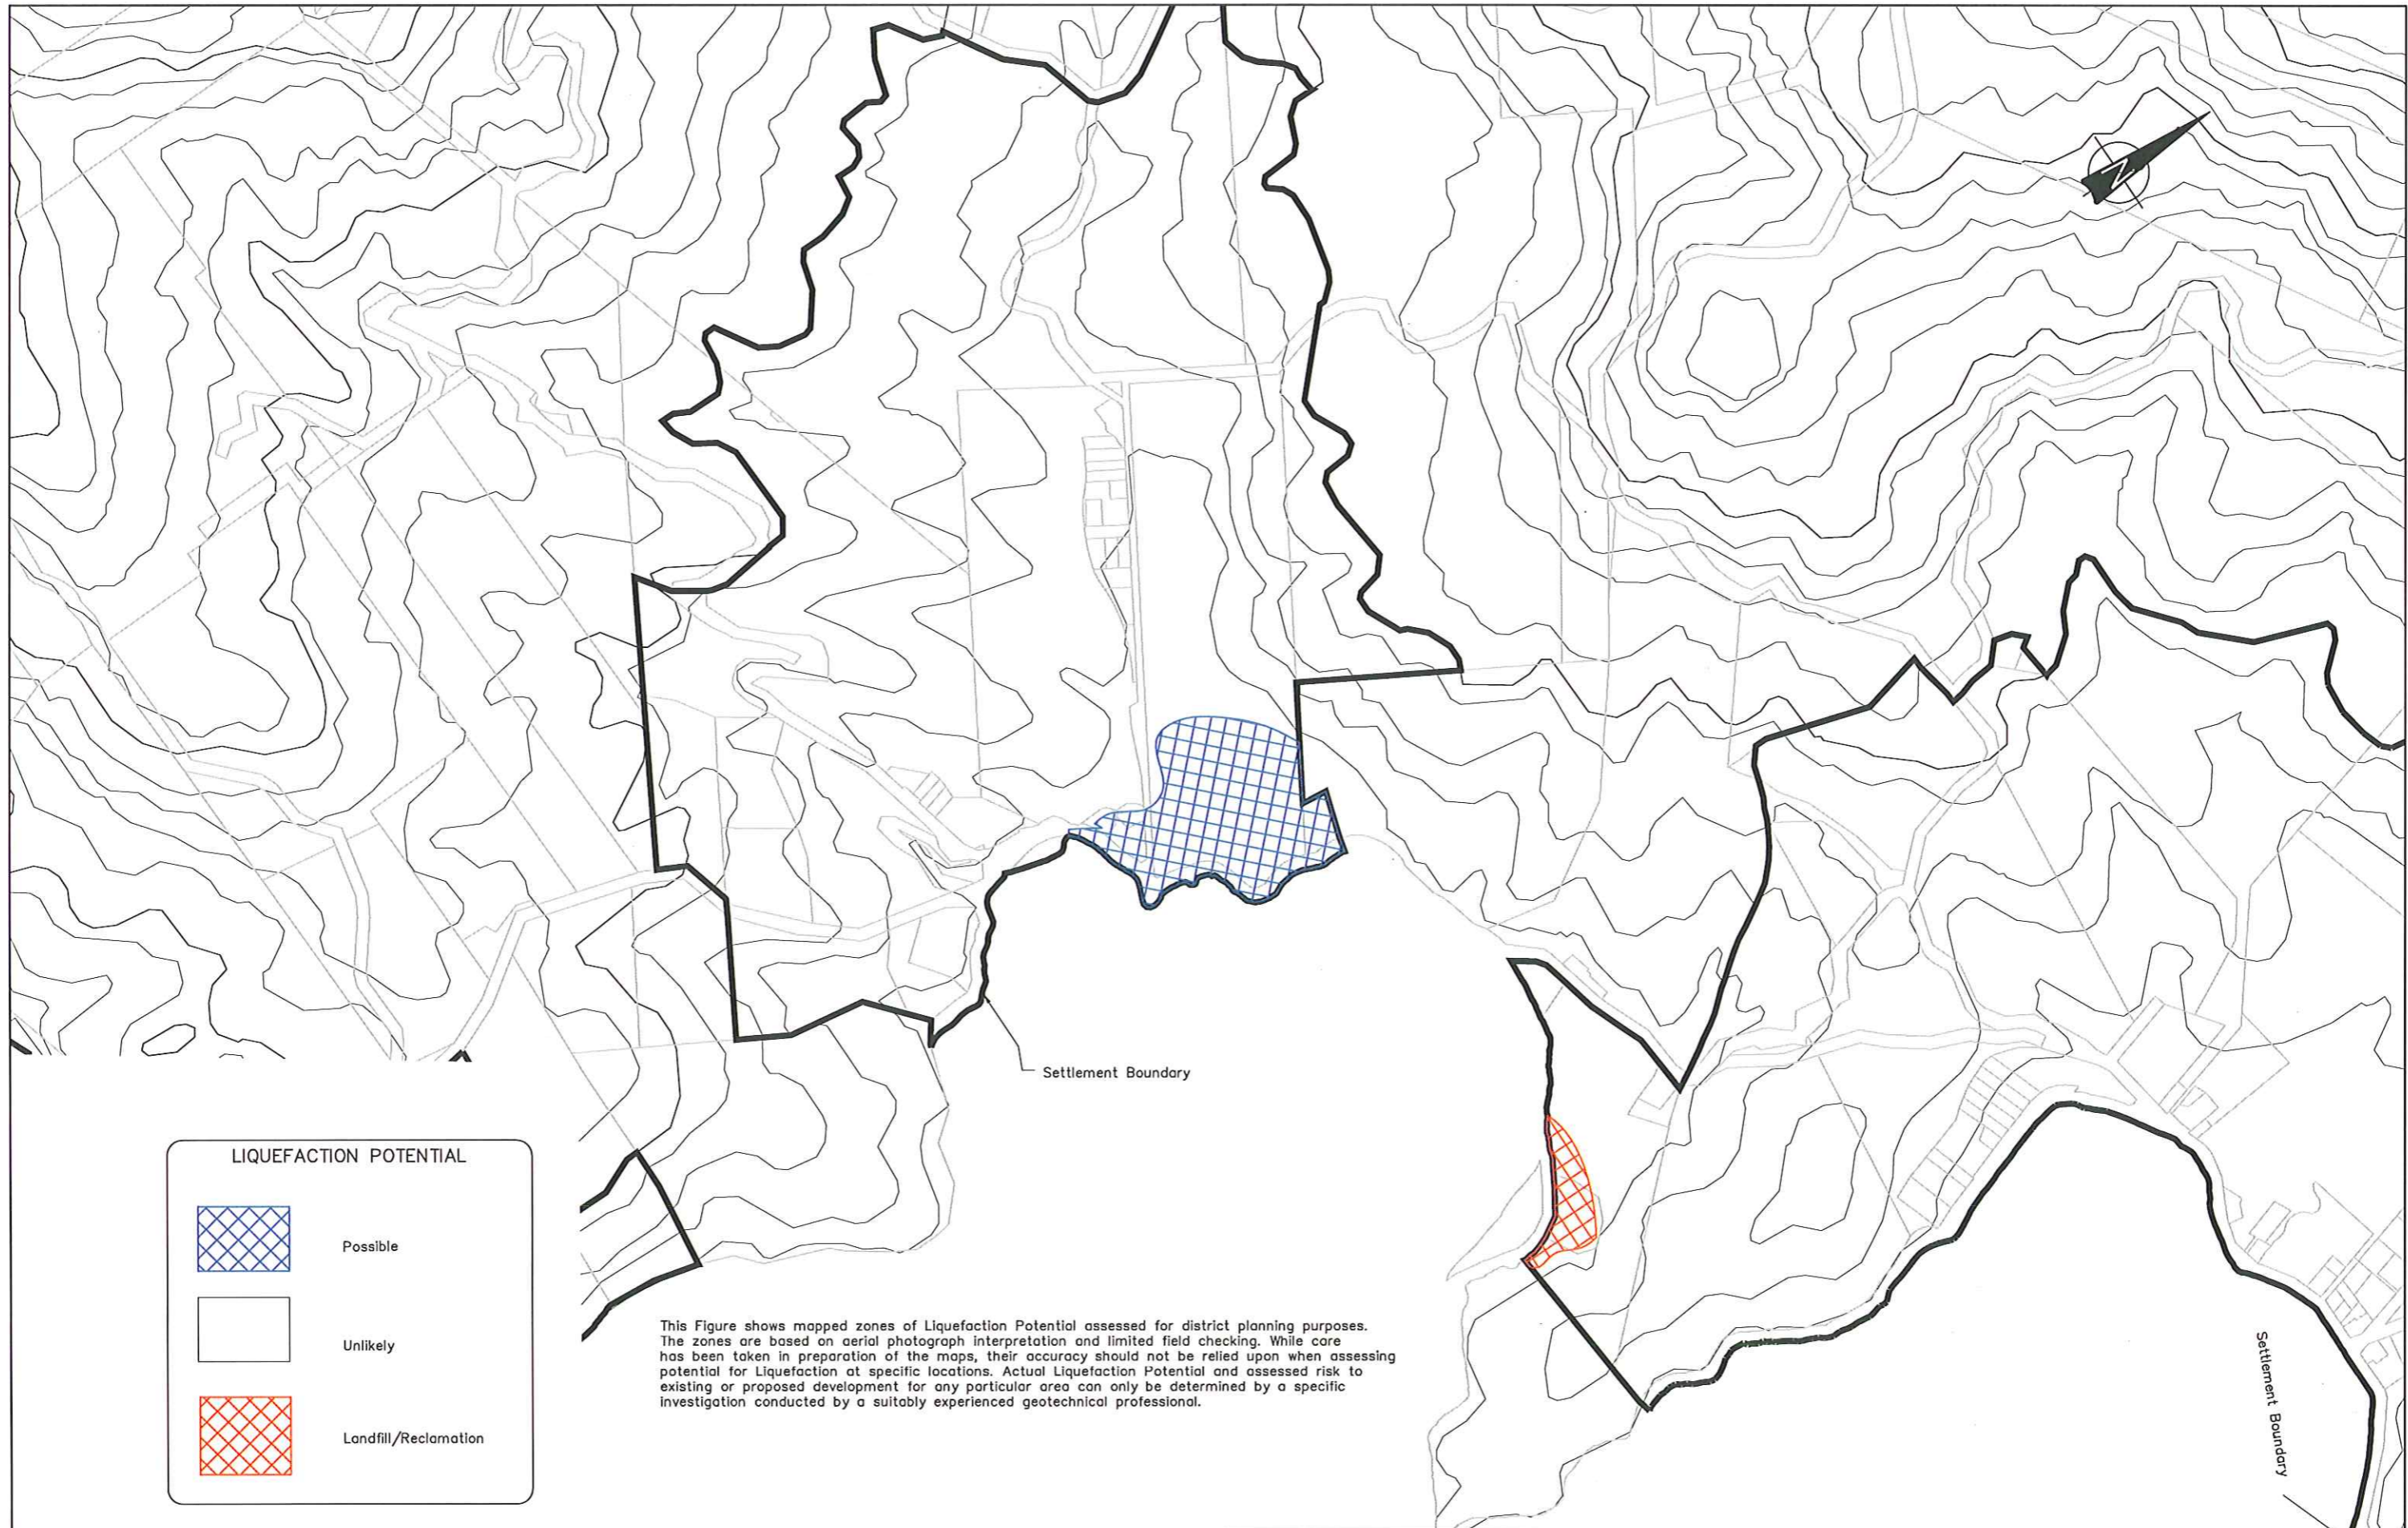
FIG. No. Figure 11

**LIQUEFACTION POTENTIAL**

Possible
	Unlikely
	Landfill/Reclamation

Liquefaction potential is based on our judgement and experience from elsewhere, in the absence of any useful site information. We have provided 2 zones for liquefaction potential shown in Figures 10 to 16 (Appendix A) as follows:

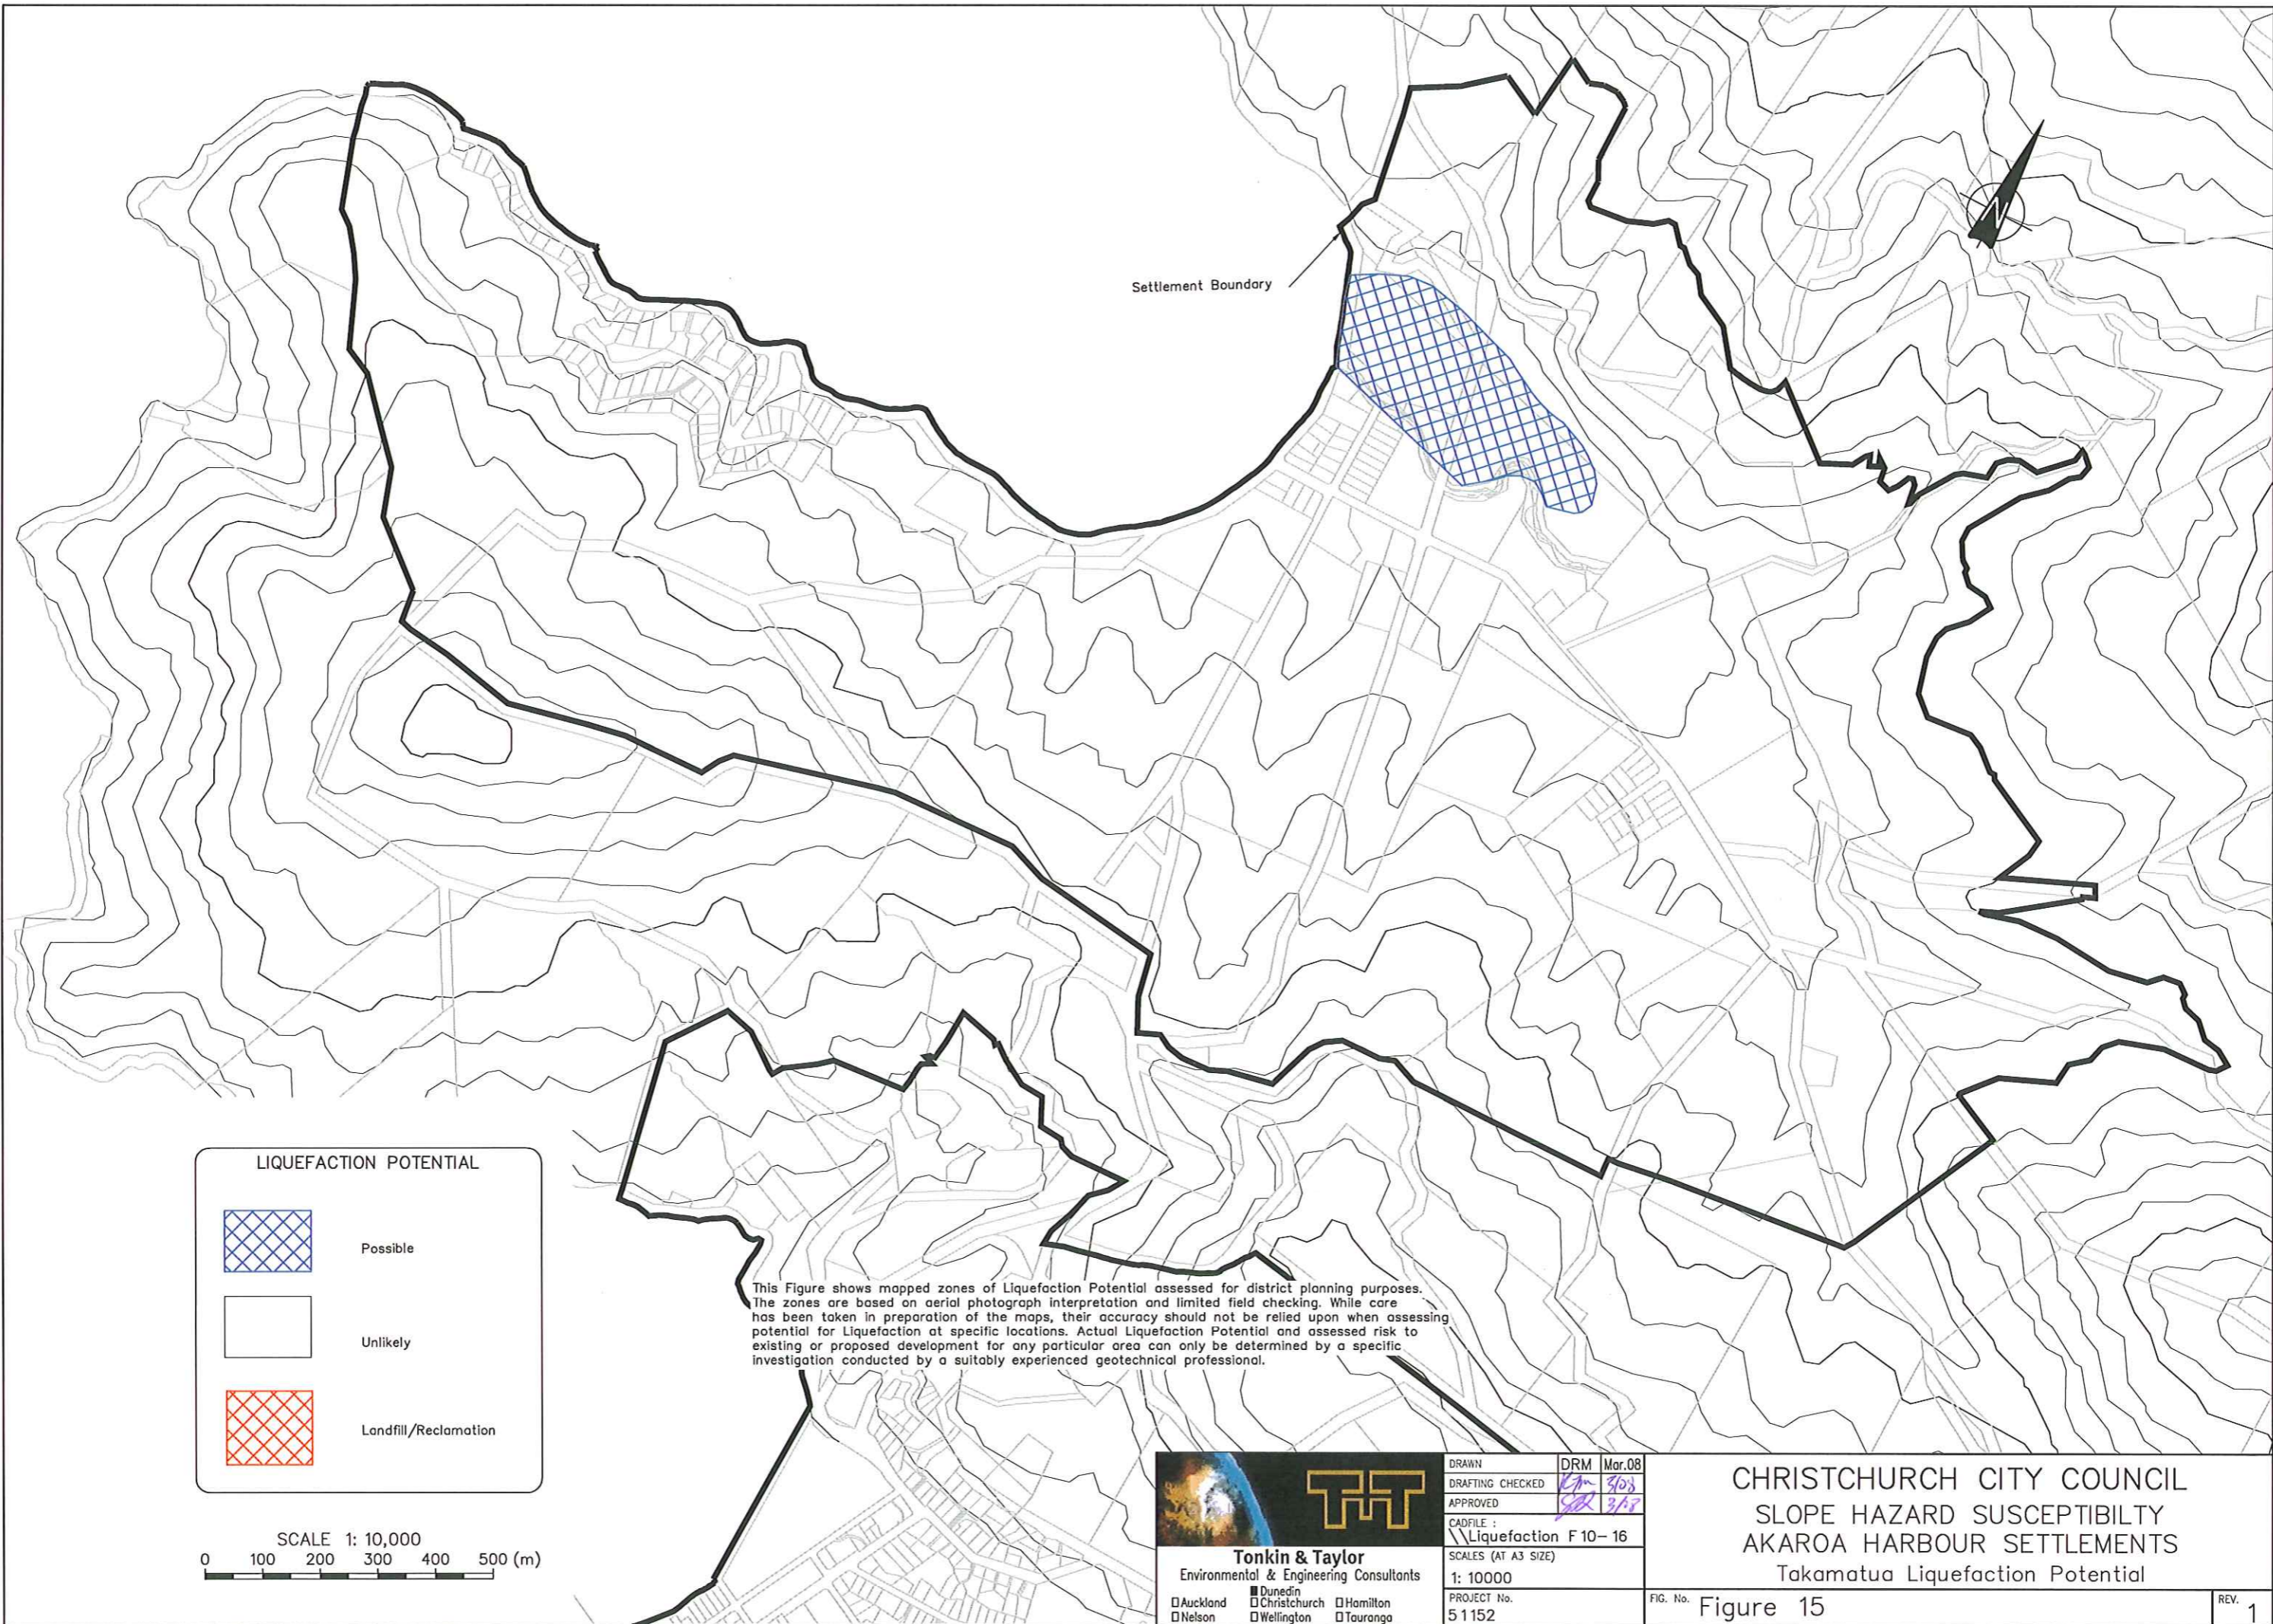
**CHRISTCHURCH CITY COUNCIL**  
 SLOPE HAZARD SUSCEPTIBLY  
 AKAROA HARBOUR SETTLEMENTS  
 Robinsons Bay Liquefaction Potential

**LIQUEFACTION POTENTIAL**

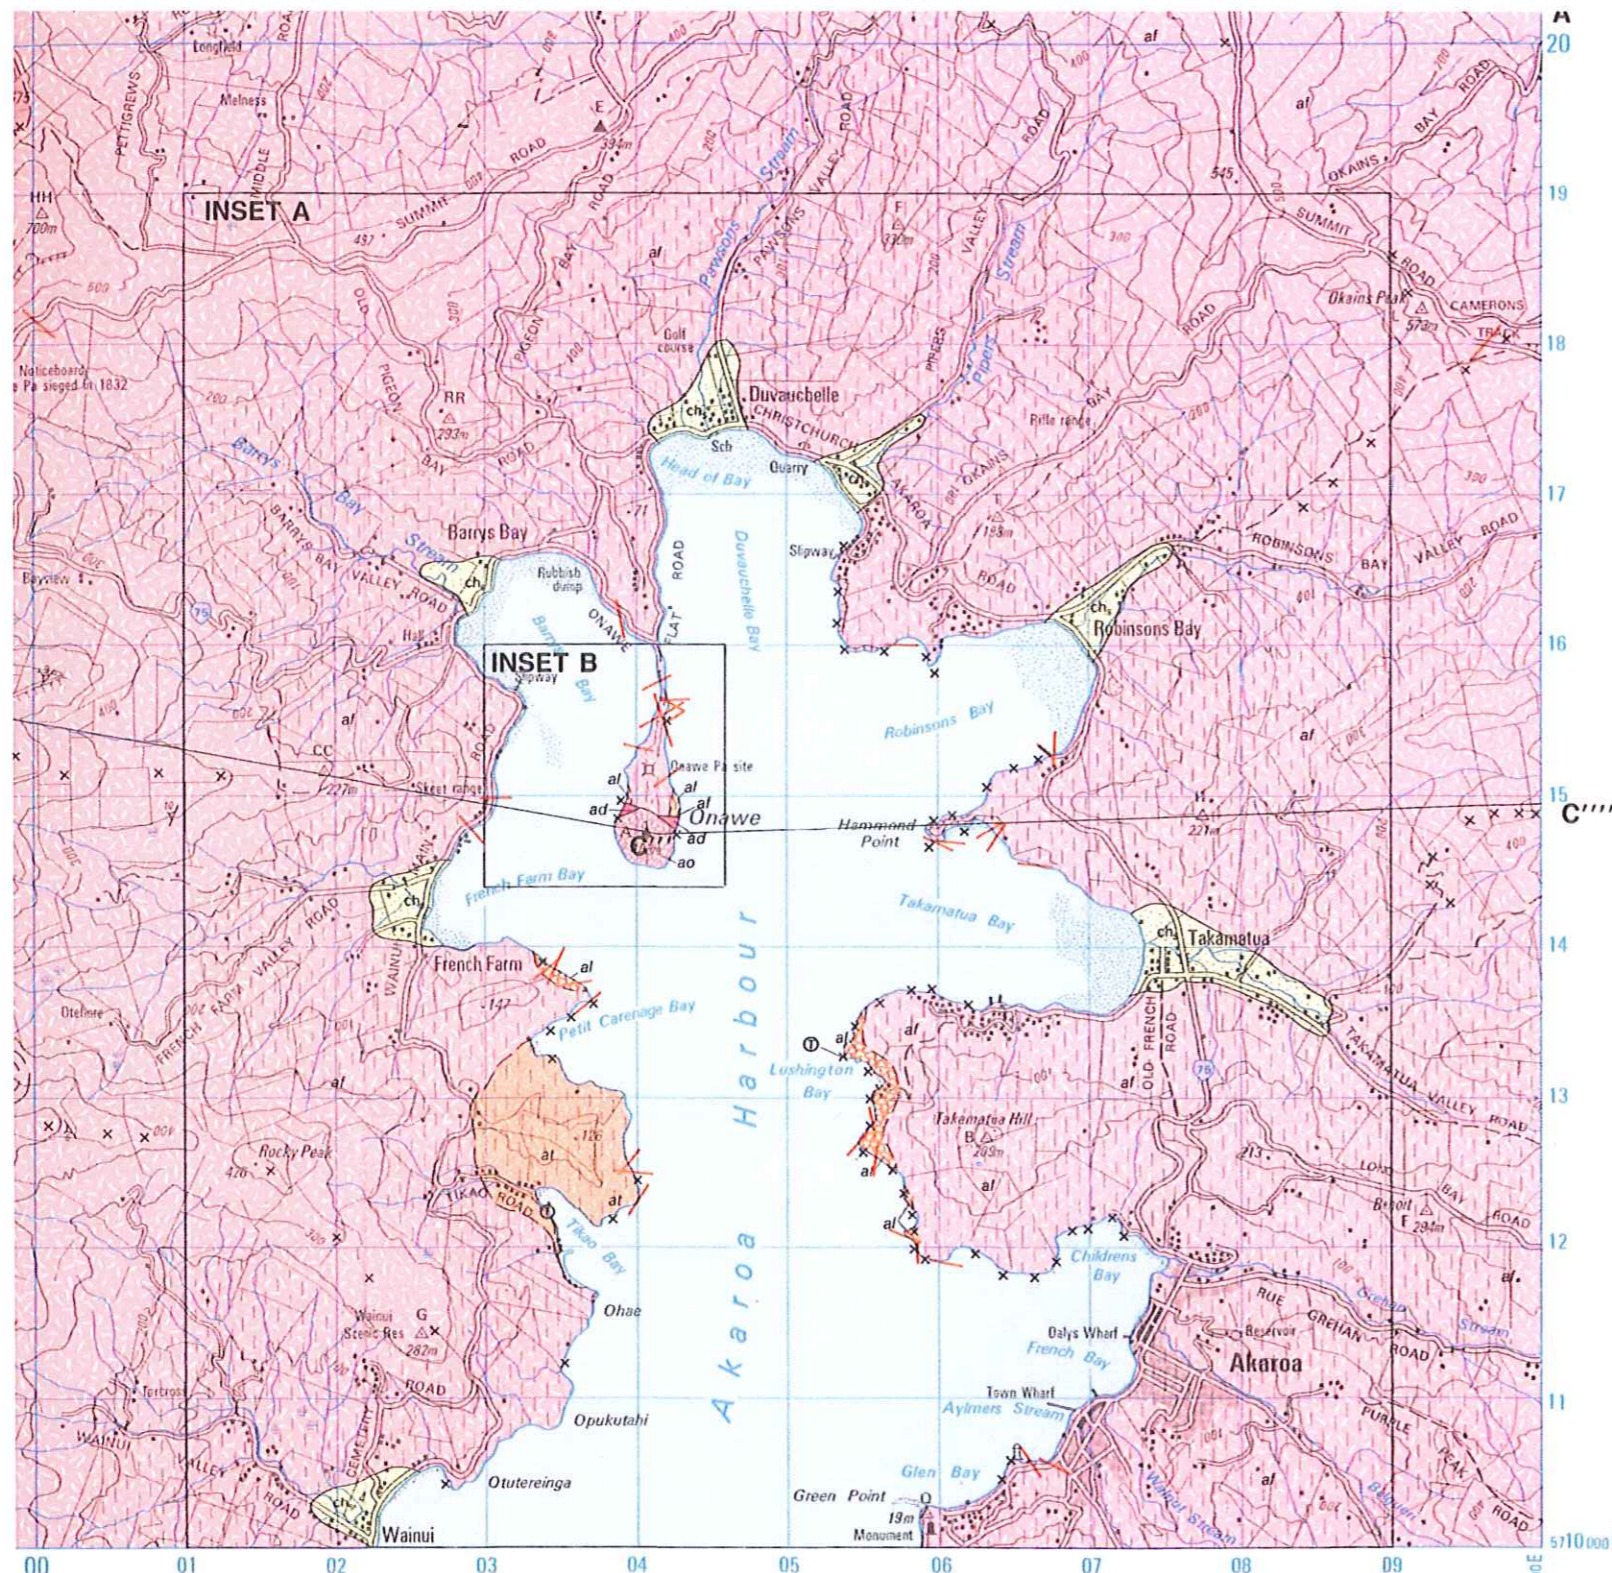
FIG. No. Figure C.1

Part of Geology of Akaroa West, Sheet N36AC  
N.Z. Geological Survey. 1990

Quaternary Age soil deposits including wind deposited silt (loess) blanket the inner slopes of the harbour and infill the valley floors (Figure C1, Appendix C) and head of the harbour (mudflats). Recent man made fill deposits comprising reclamation and waste disposal (municipal landfill) occur in Akaroa and Duvauchelle settlement areas (see Figures 13, 14, 16).

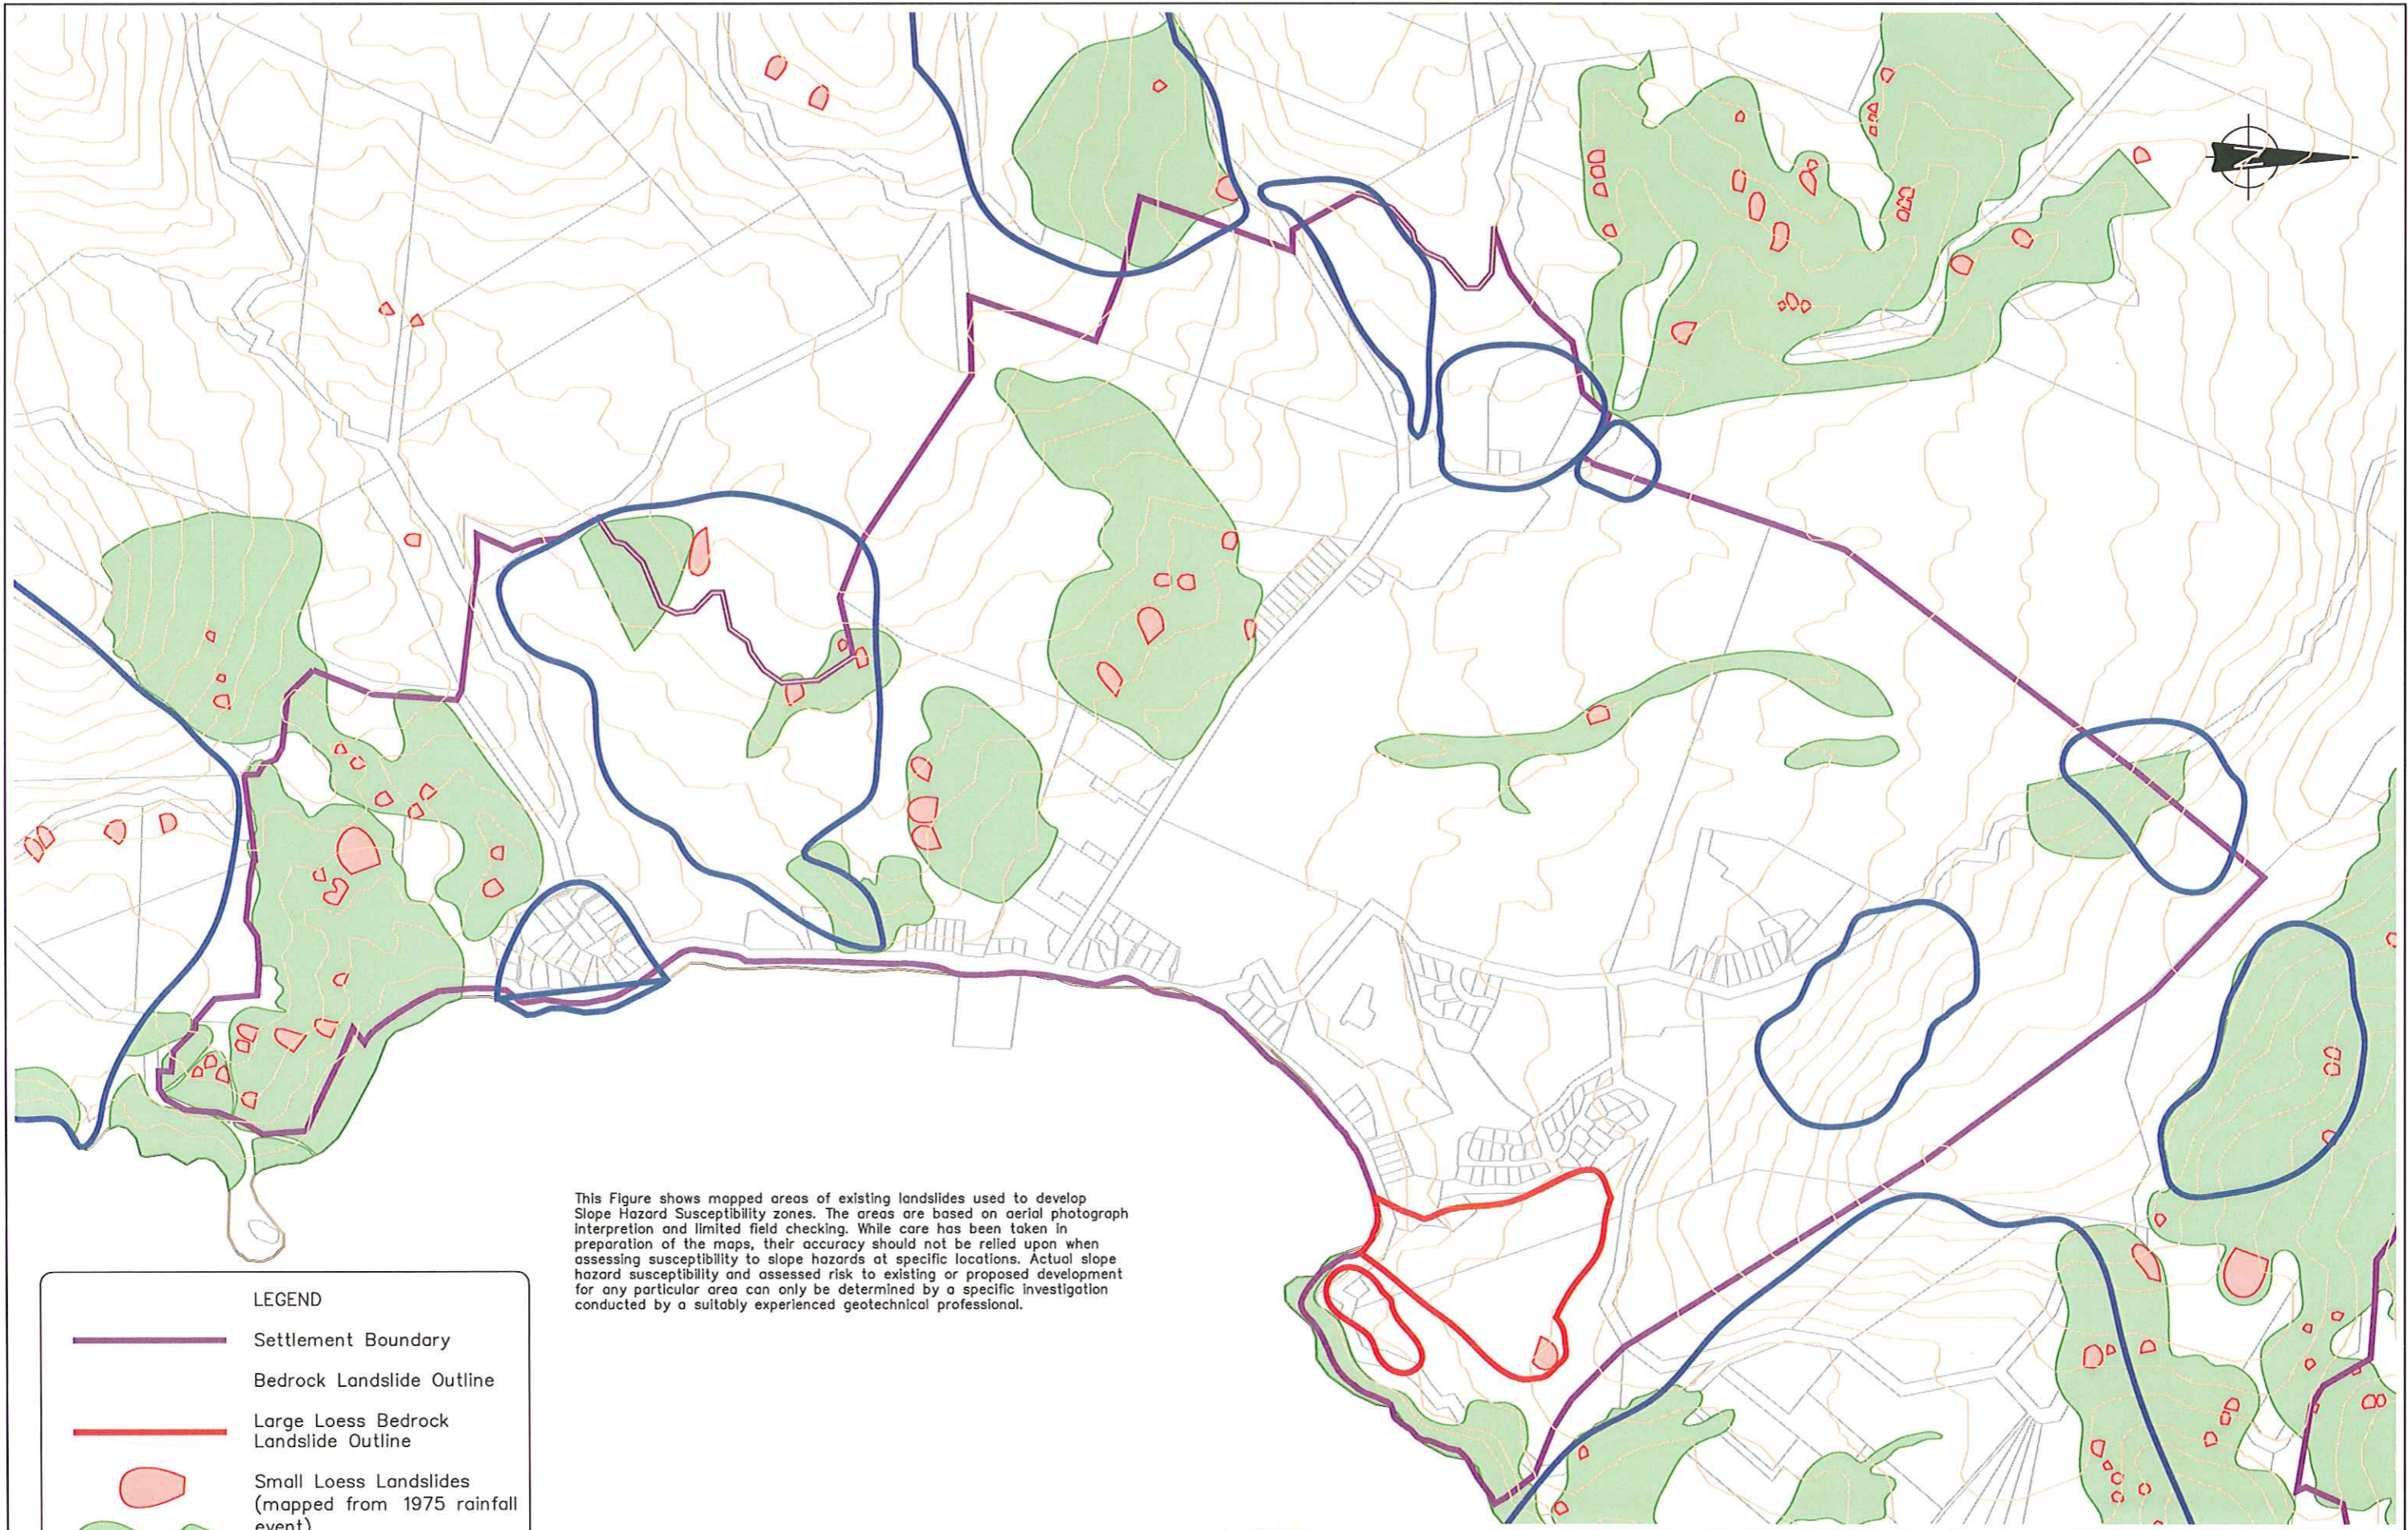
This Figure shows mapped areas of existing landslides used to develop Slope Hazard Susceptibility zones. The areas are based on aerial photograph interpretation and limited field checking. While care has been taken in preparation of the maps, their accuracy should not be relied upon when assessing susceptibility to slope hazards at specific locations. Actual slope hazard susceptibility and assessed risk to existing or proposed development for any particular area can only be determined by a specific investigation conducted by a suitably experienced geotechnical professional.

Bedrock landslides (Figure 1, Appendix A and Figures C3 to C9, Appendix C) are large to very large failures that are inferred from air photo geomorphology. They occur predominantly on south and southwest facing slopes, forming steep faces and gentle benches that break up the otherwise 'smooth' valley and ridge slopes of the harbour. Depth to base of movement is inferred as 10 to >50m below ground level.

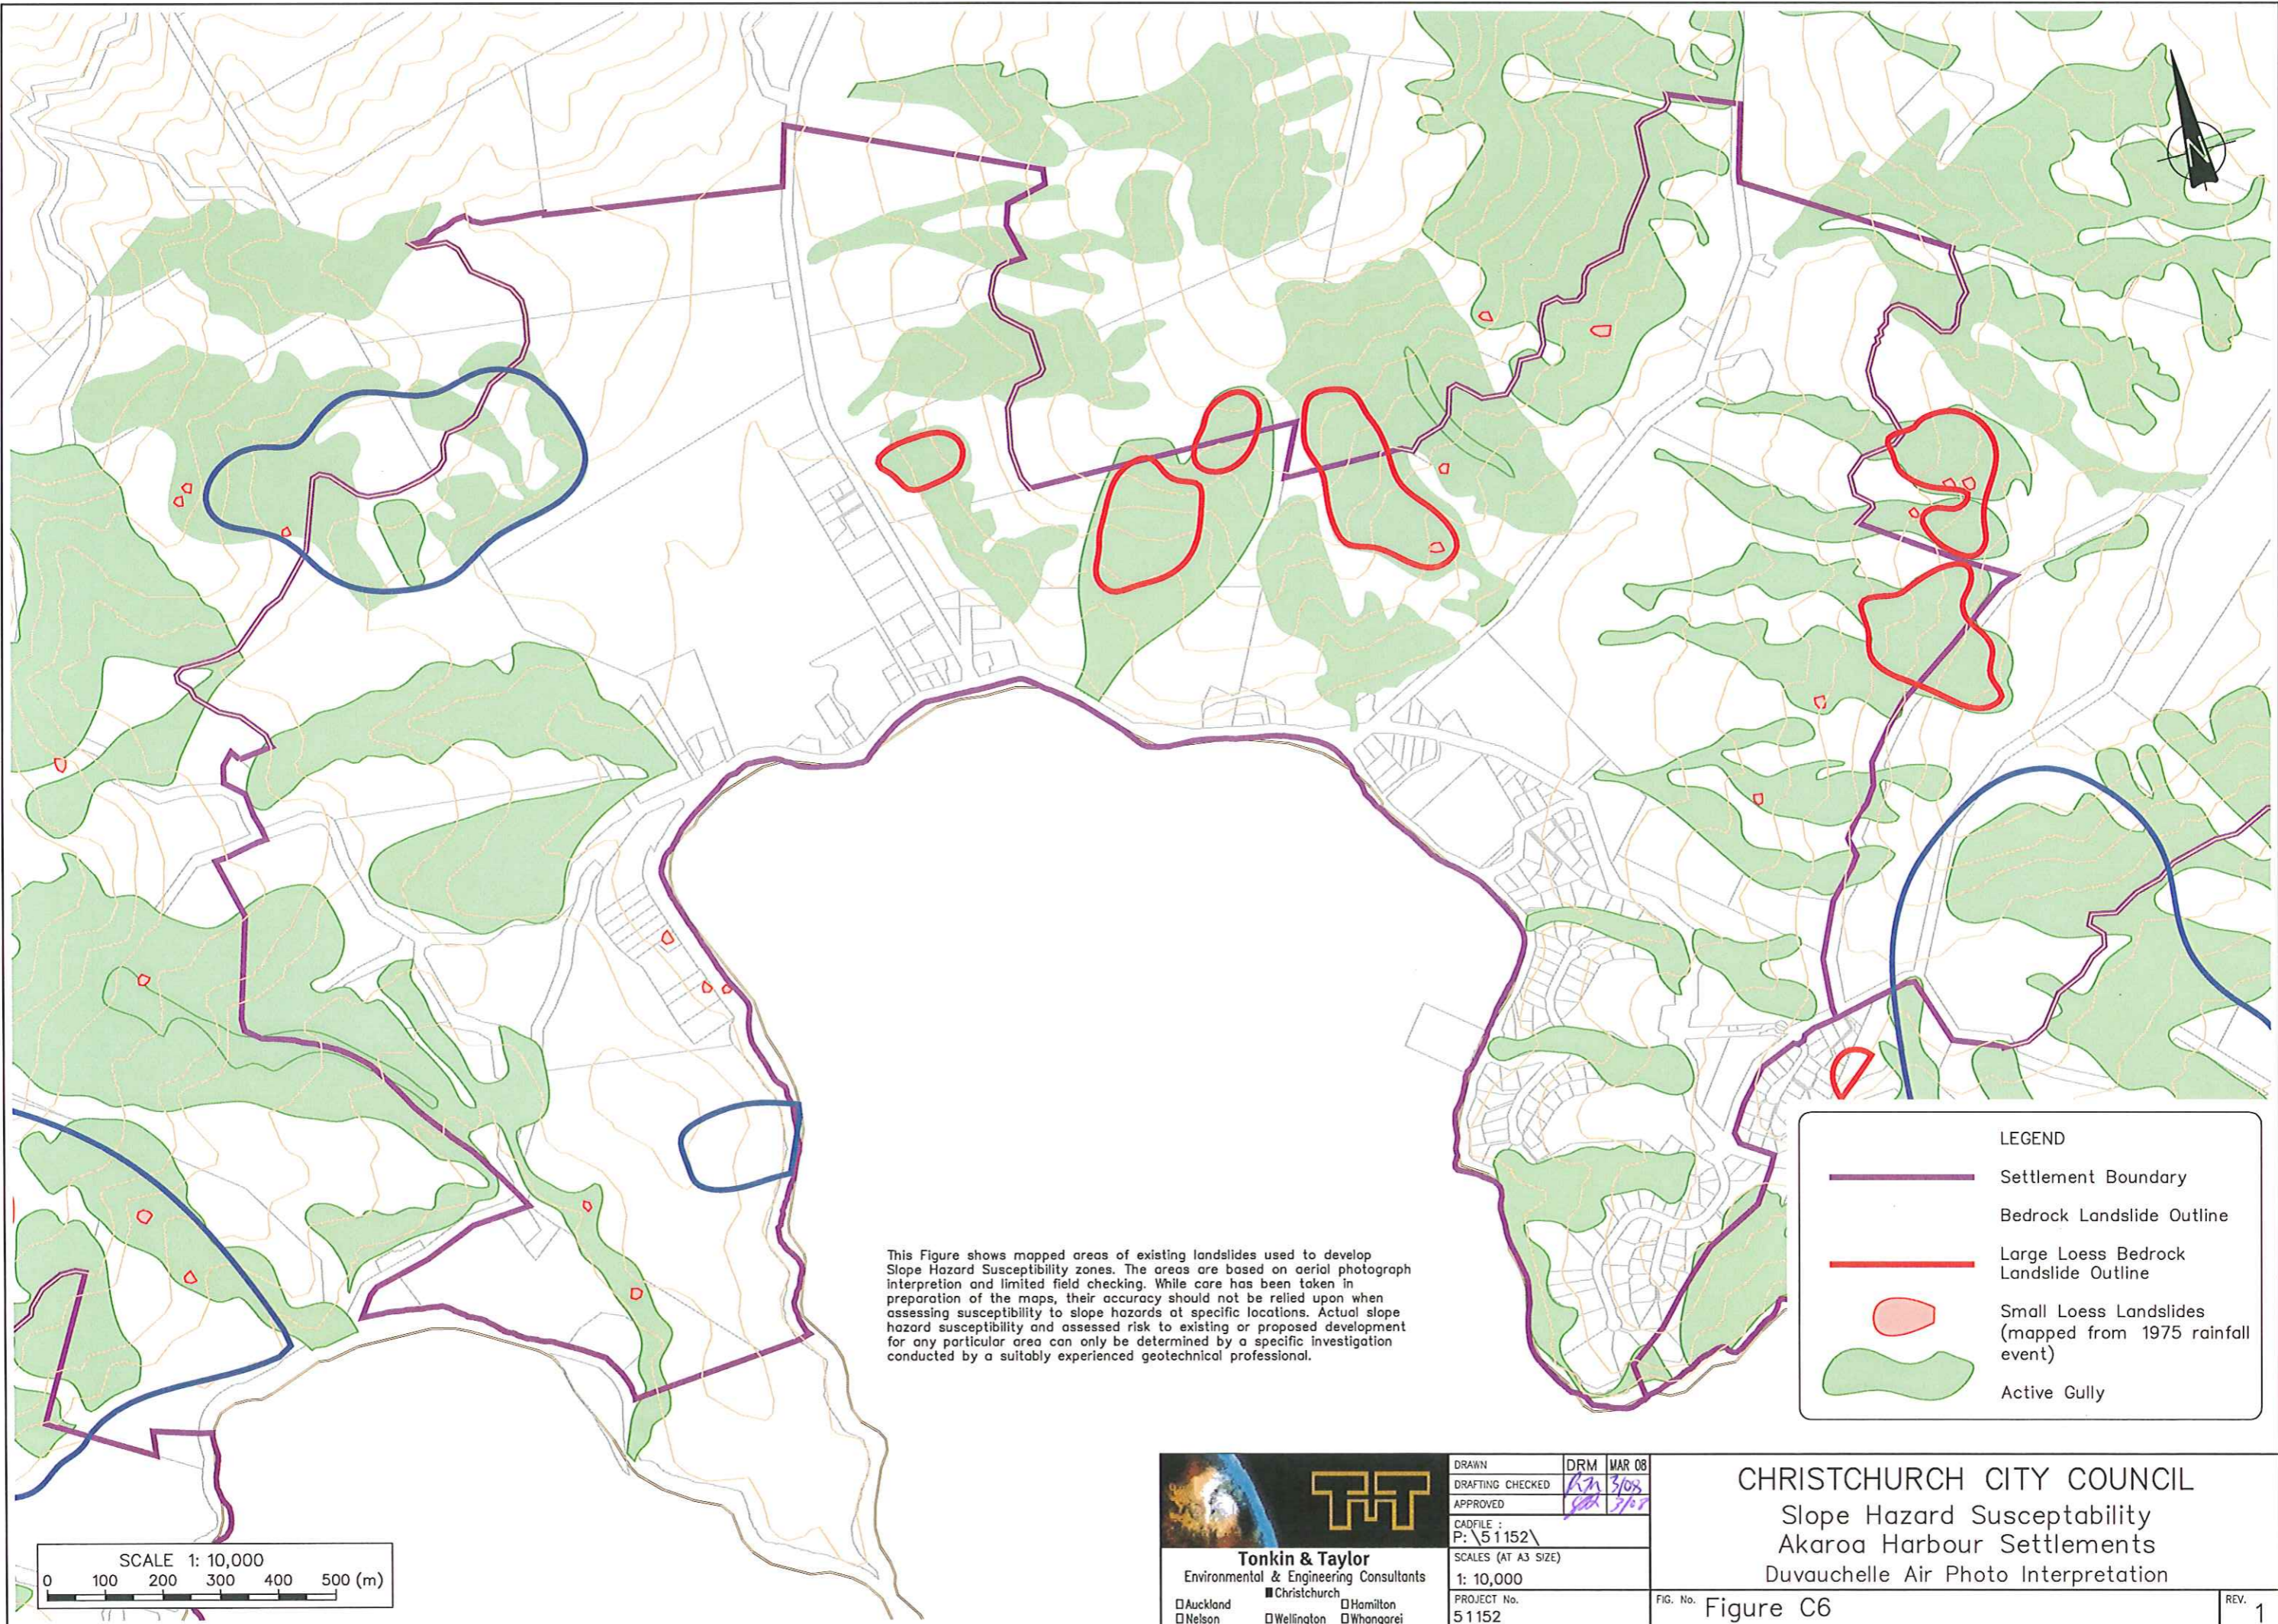
This Figure shows mapped areas of existing landslides used to develop Slope Hazard Susceptibility zones. The areas are based on aerial photograph interpretation and limited field checking. While care has been taken in preparation of the maps, their accuracy should not be relied upon when assessing susceptibility to slope hazards at specific locations. Actual slope hazard susceptibility and assessed risk to existing or proposed development for any particular area can only be determined by a specific investigation conducted by a suitably experienced geotechnical professional.
