CHRISTCHURCH CITY COUNCIL

SLOPE HAZARD SUSCEPTIBILITY  
ASSESSMENT

Akaroa Harbour Settlements

**March 2008**

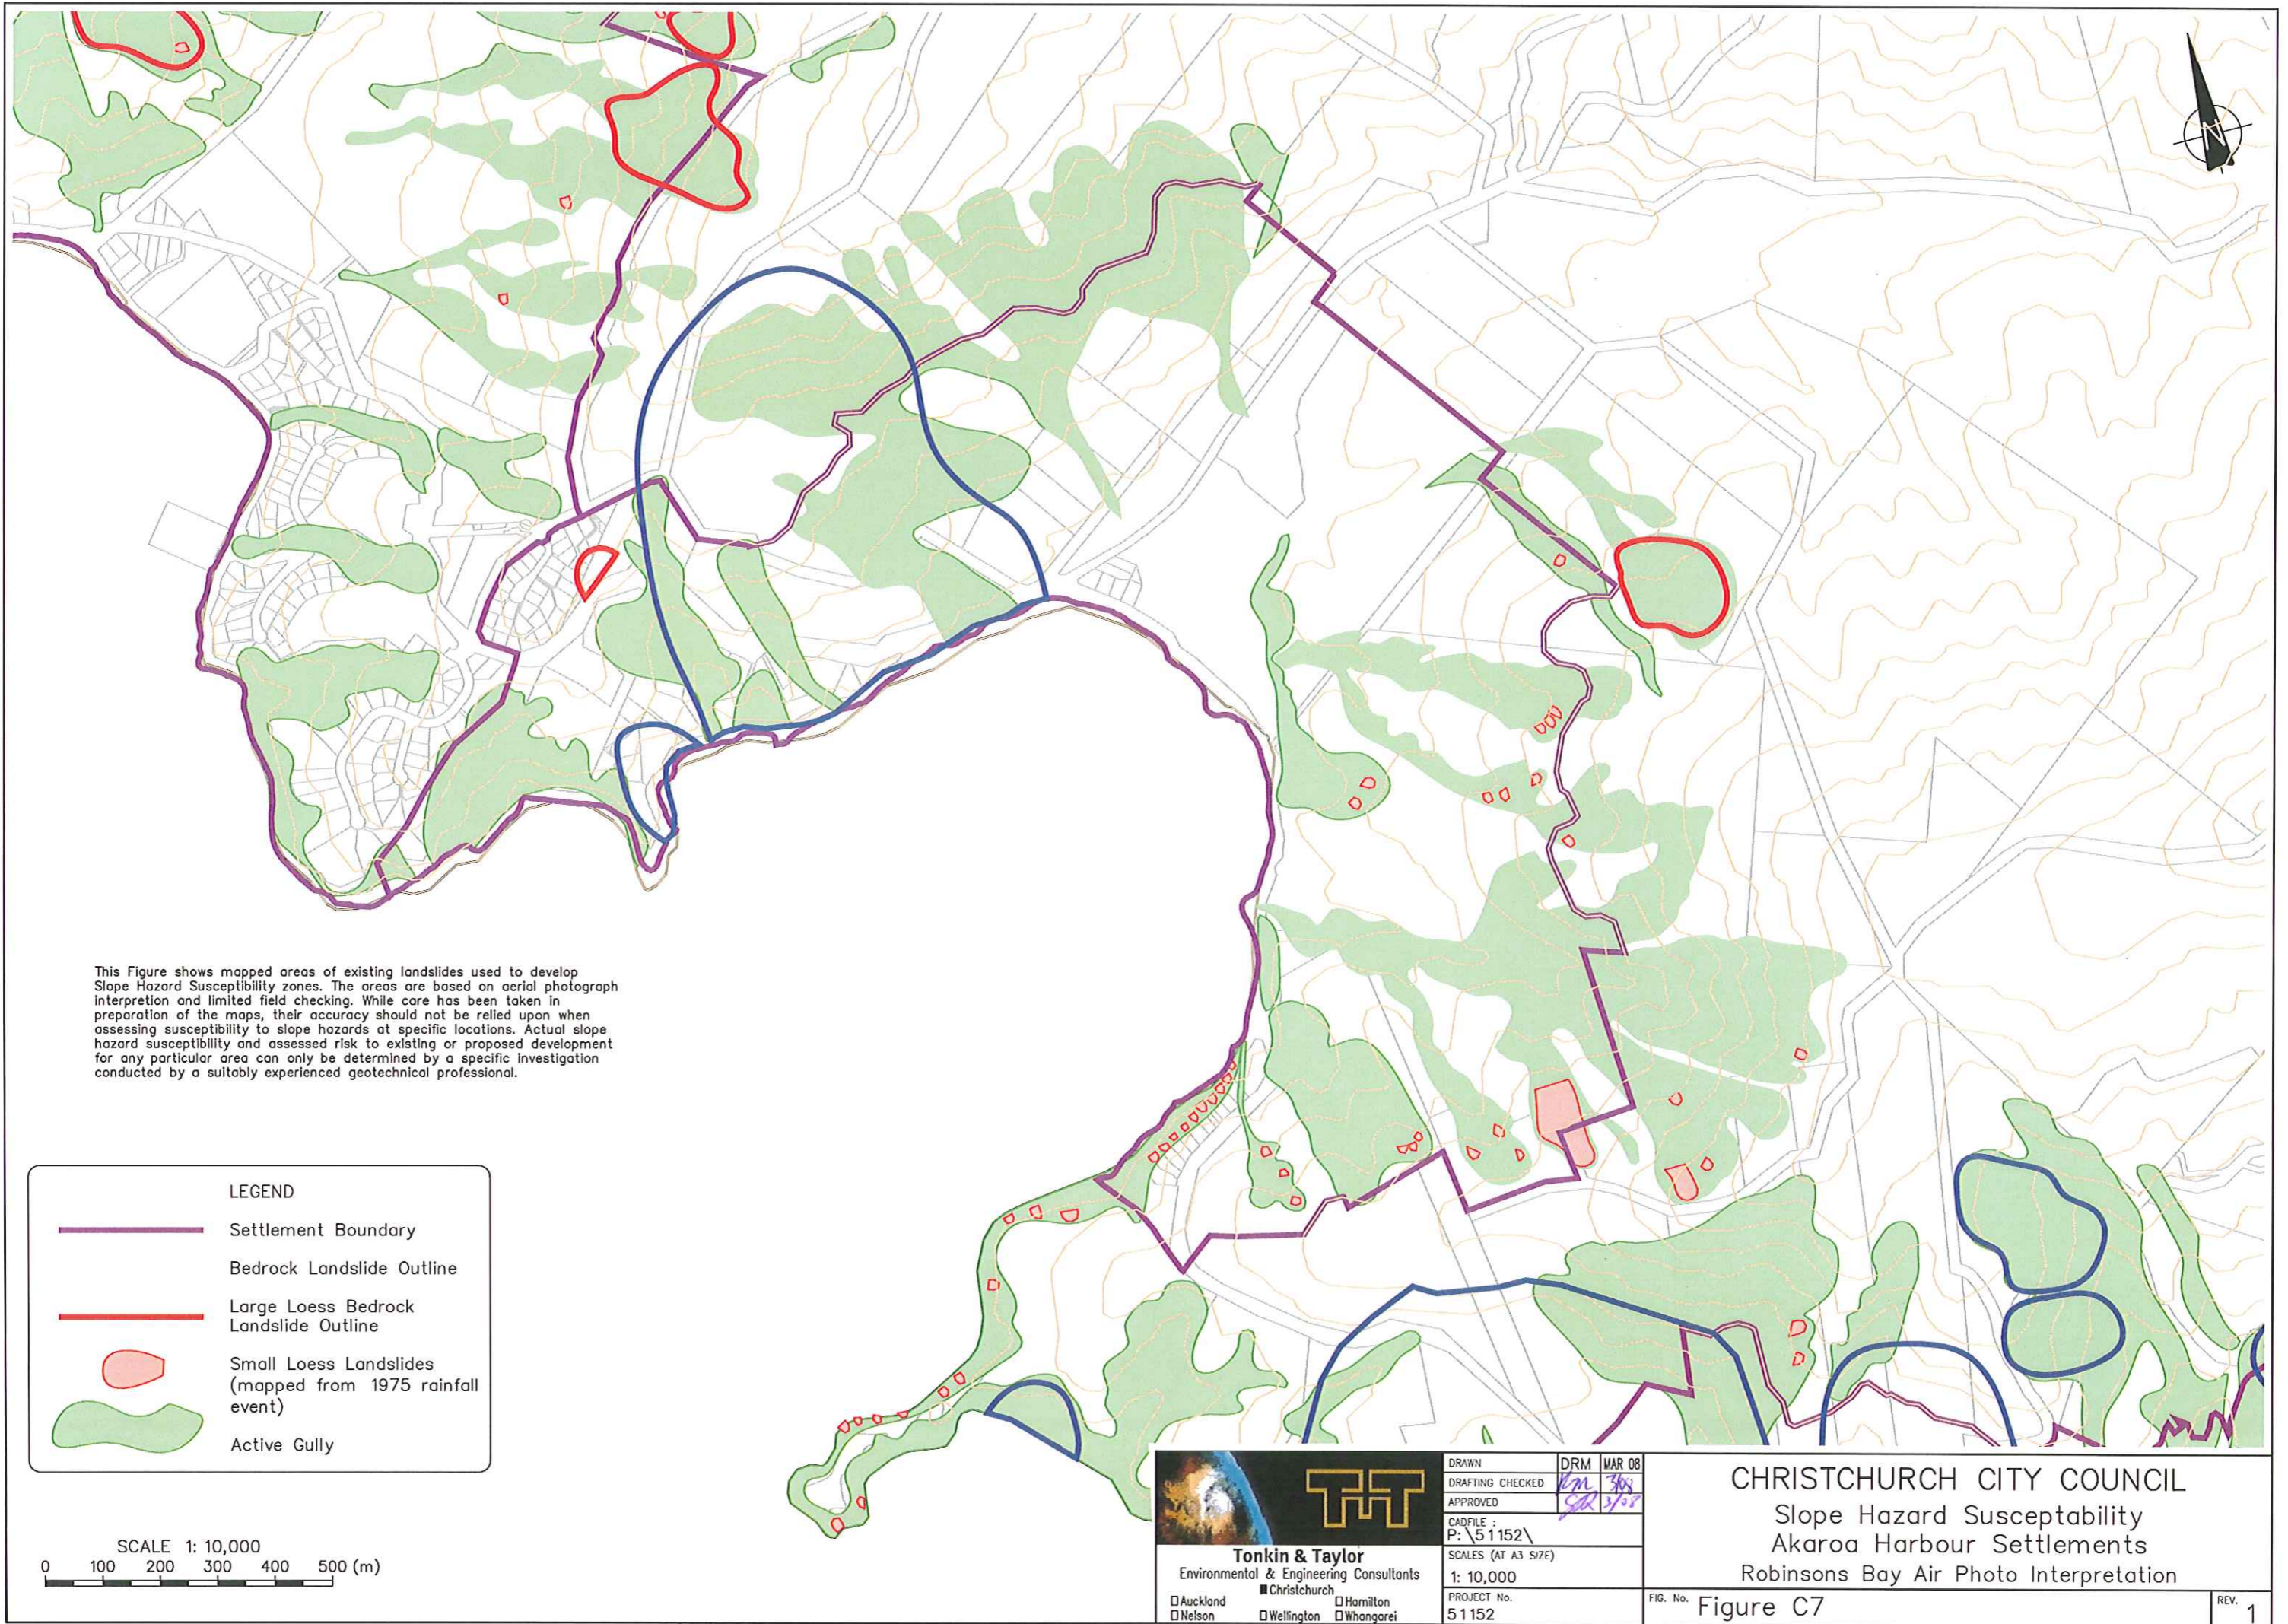
This Figure shows mapped areas of existing landslides used to develop Slope Hazard Susceptibility zones. The areas are based on aerial photograph interpretation and limited field checking. While care has been taken in preparation of the maps, their accuracy should not be relied upon when assessing susceptibility to slope hazards at specific locations. Actual slope hazard susceptibility and assessed risk to existing or proposed development for any particular area can only be determined by a specific investigation conducted by a suitably experienced geotechnical professional.

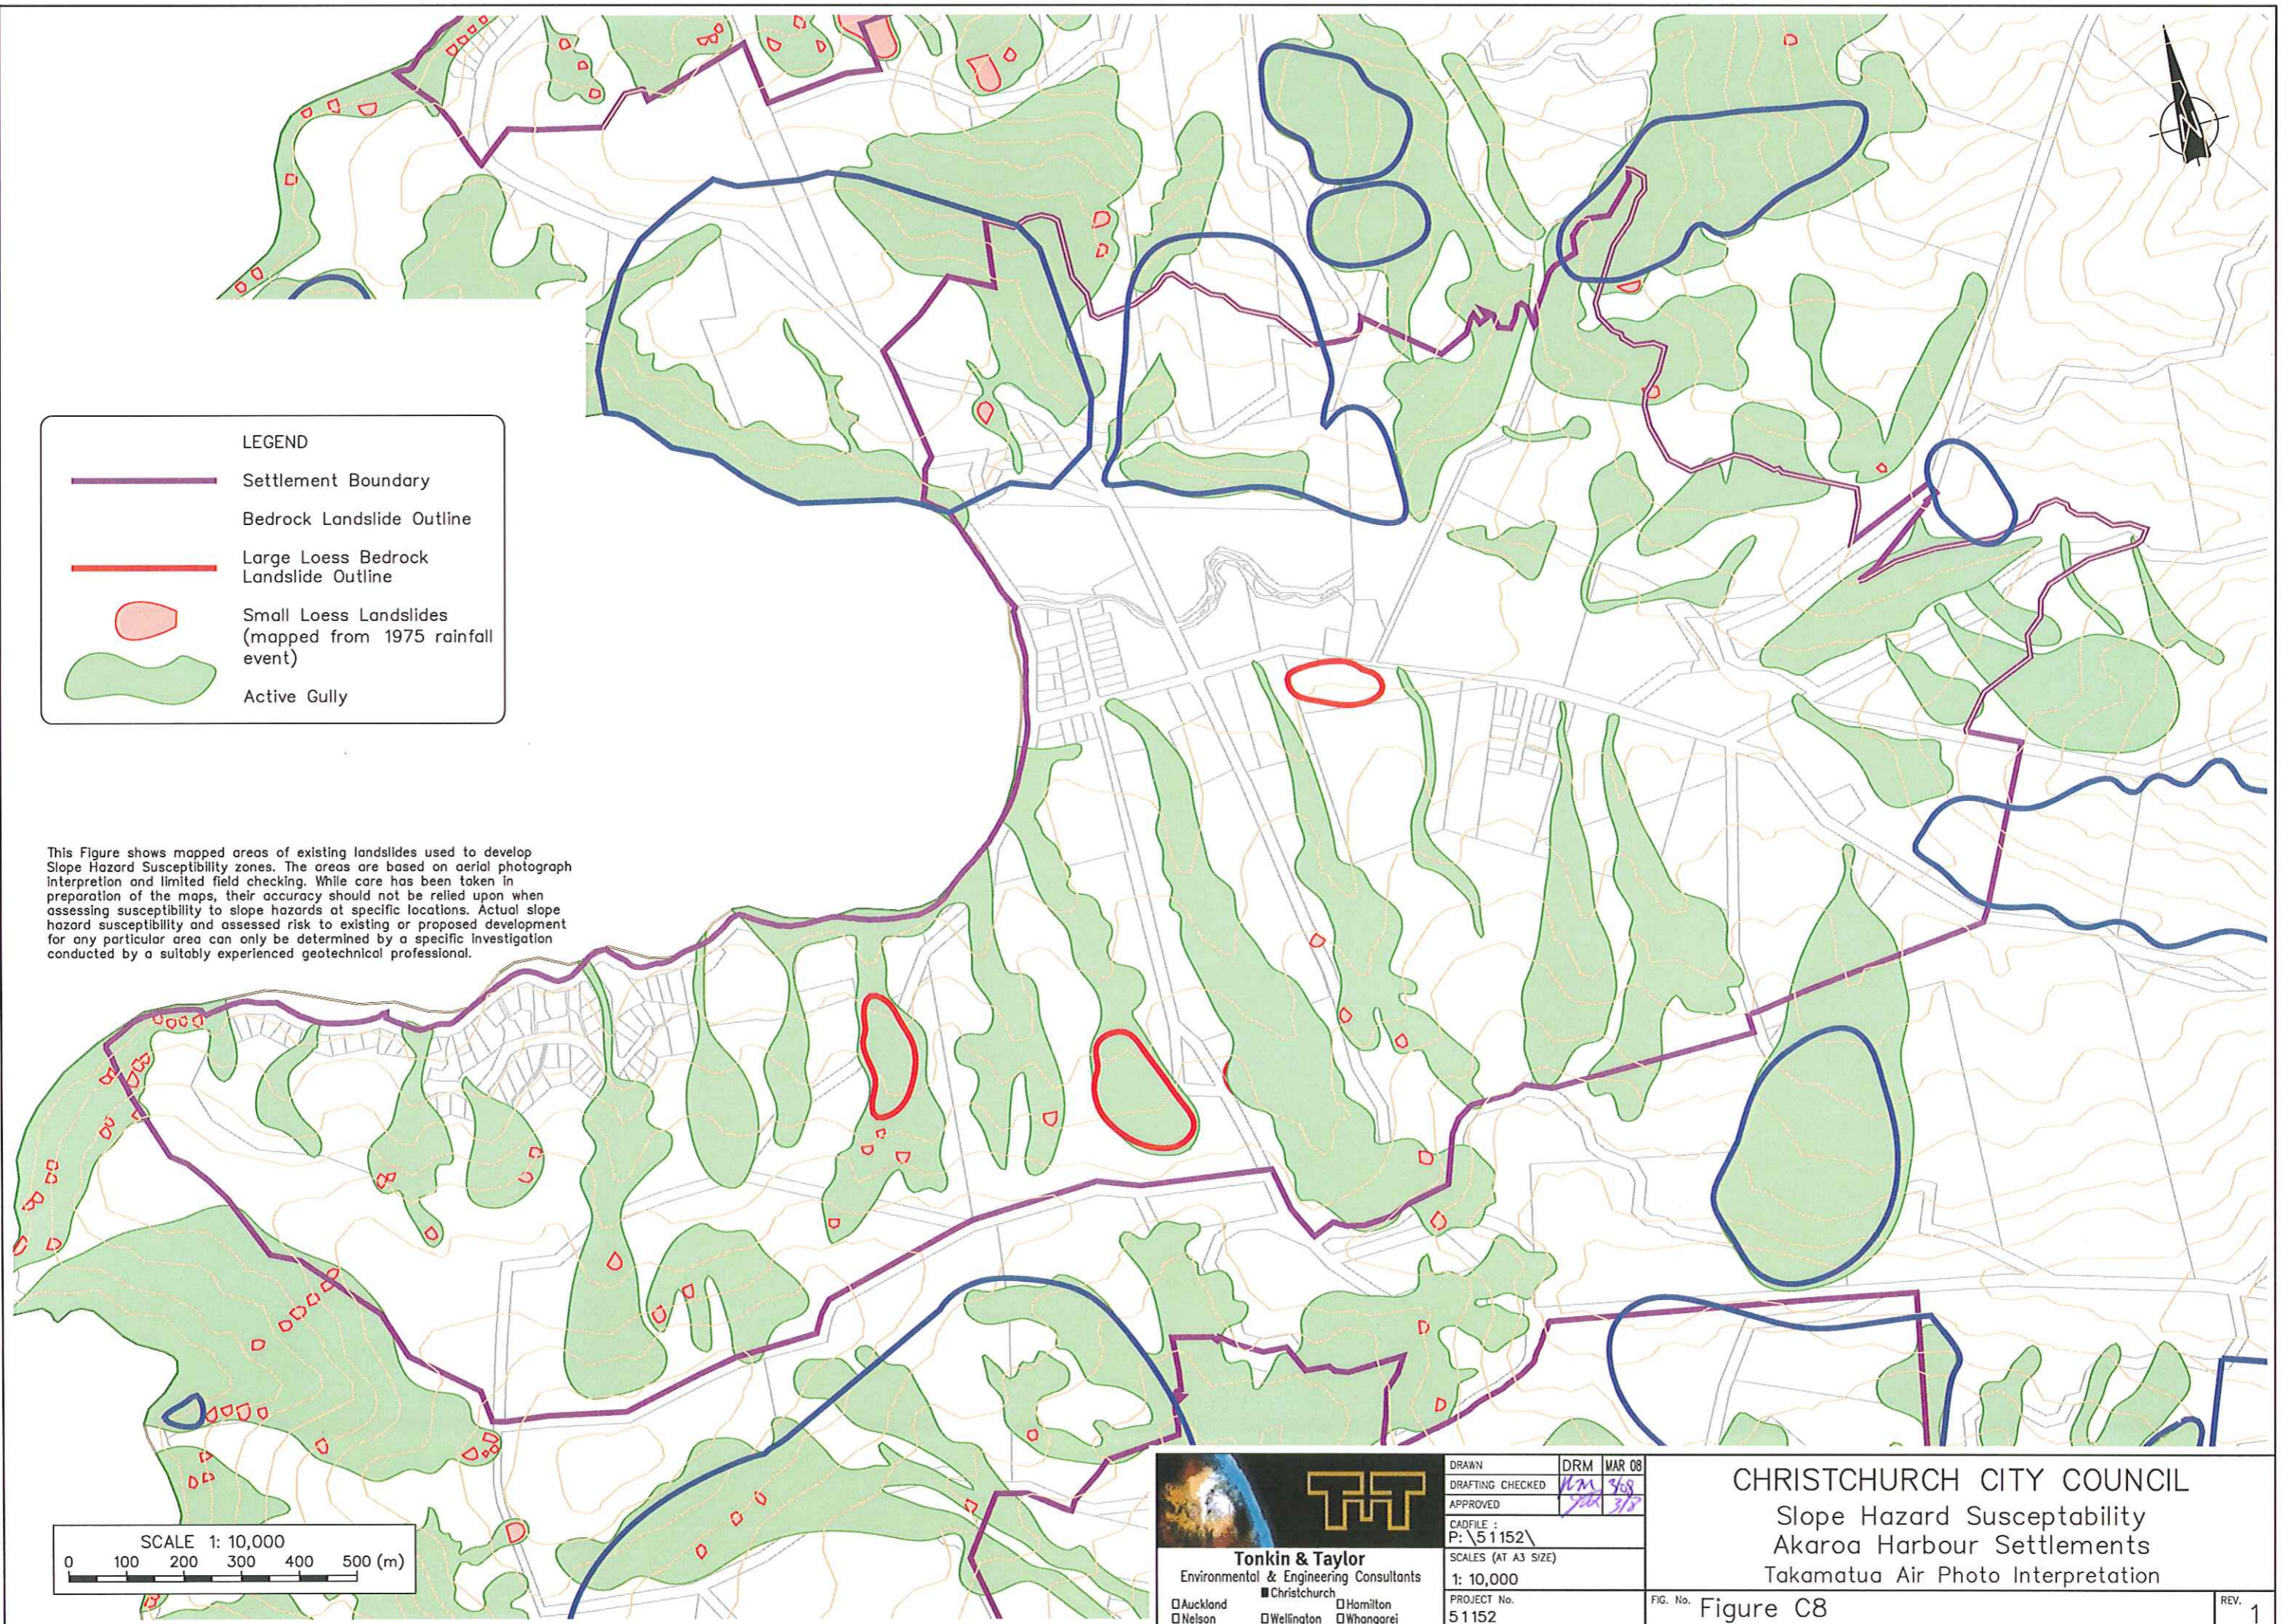
P:\151152\WorkingMaterial\CAD\Figures\Report\UPDATE of Figure C3-C9.dwg, Figure C8, 28/03/2008 9:10:19 a.m., 1:1

**CHRISTCHURCH CITY COUNCIL**  
Slope Hazard Susceptibility  
Akaroa Harbour Settlements  
Robinsons Bay Air Photo Interpretation

The air photo interpretations as shown in Figures 1 and 2 and Figures C3 to C9 (Appendix C) form the basis of the relative susceptibility zoning. The 1975 small landslides were used to count slope angle, slope aspect, slope position and slope length for input to susceptibility ranking/zoning. The breakdown of the assessment of 1975 small landslides is provided in tables in Appendix D. The results were checked and compared with similar assessments for large loess/bedrock landslides (tables Appendix D). The slope factors considered are described below.

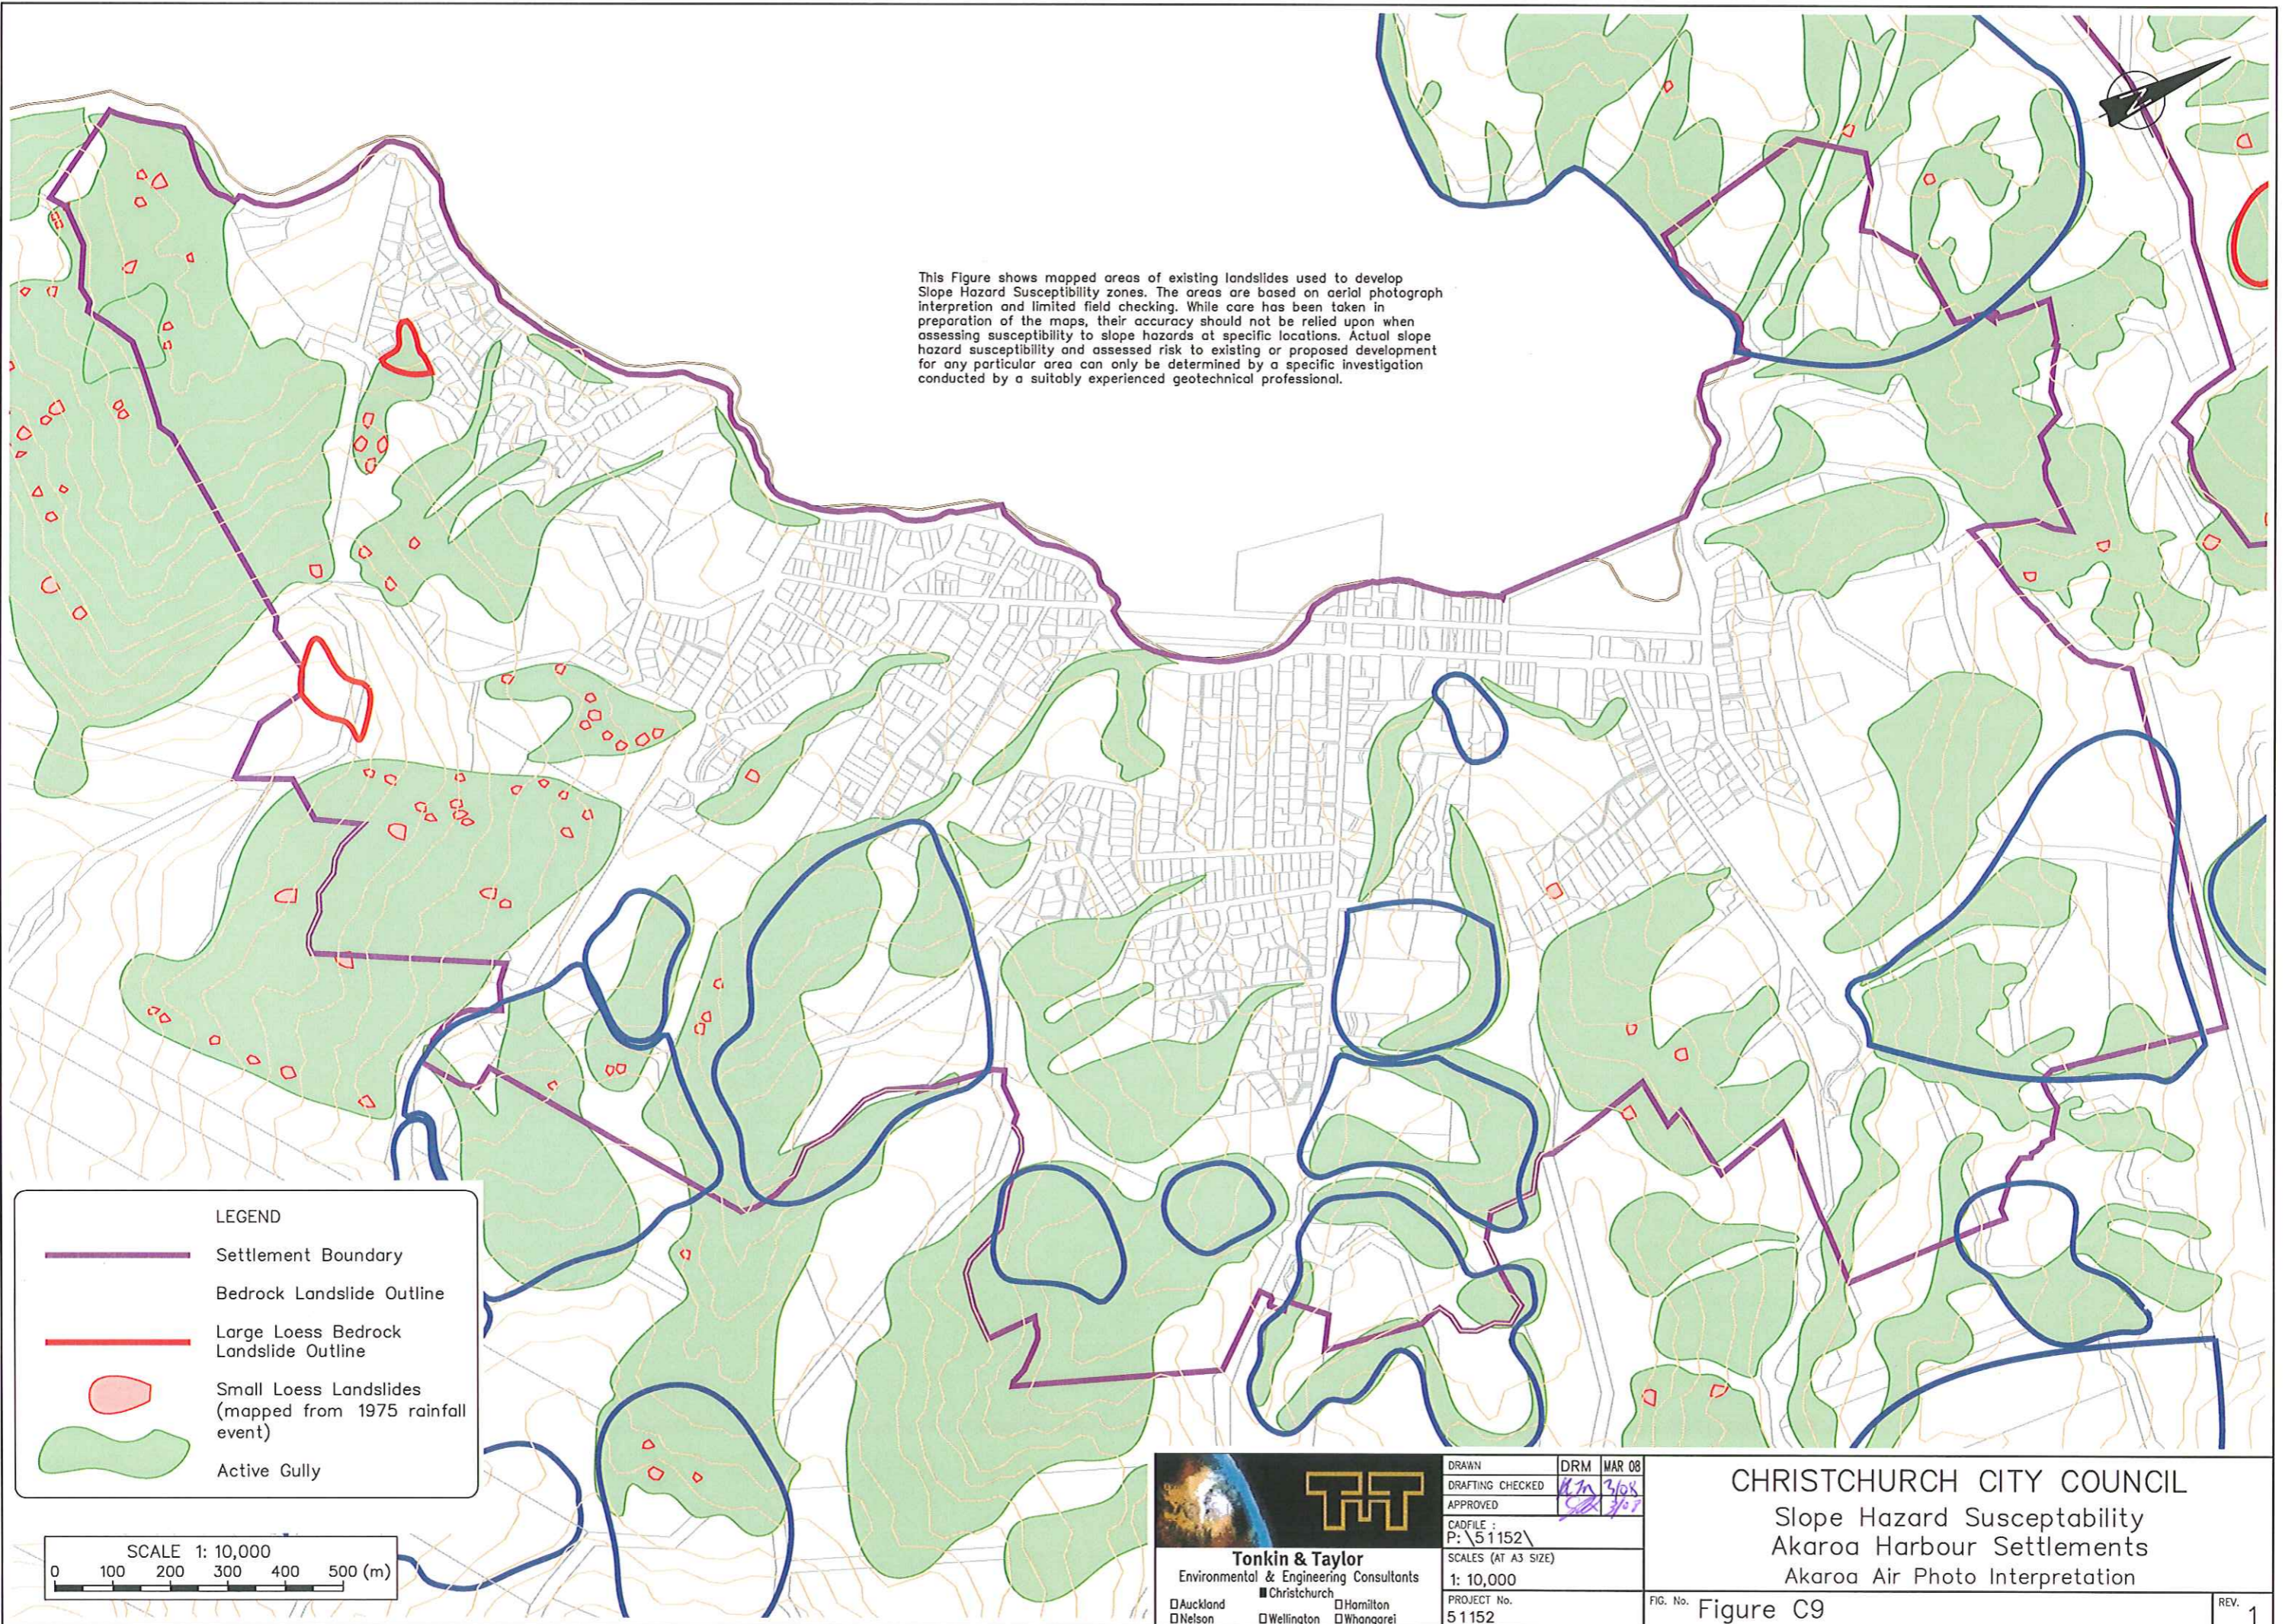
This Figure shows mapped areas of existing landslides used to develop Slope Hazard Susceptibility zones. The areas are based on aerial photograph interpretation and limited field checking. While care has been taken in preparation of the maps, their accuracy should not be relied upon when assessing susceptibility to slope hazards at specific locations. Actual slope hazard susceptibility and assessed risk to existing or proposed development for any particular area can only be determined by a specific investigation conducted by a suitably experienced geotechnical professional.

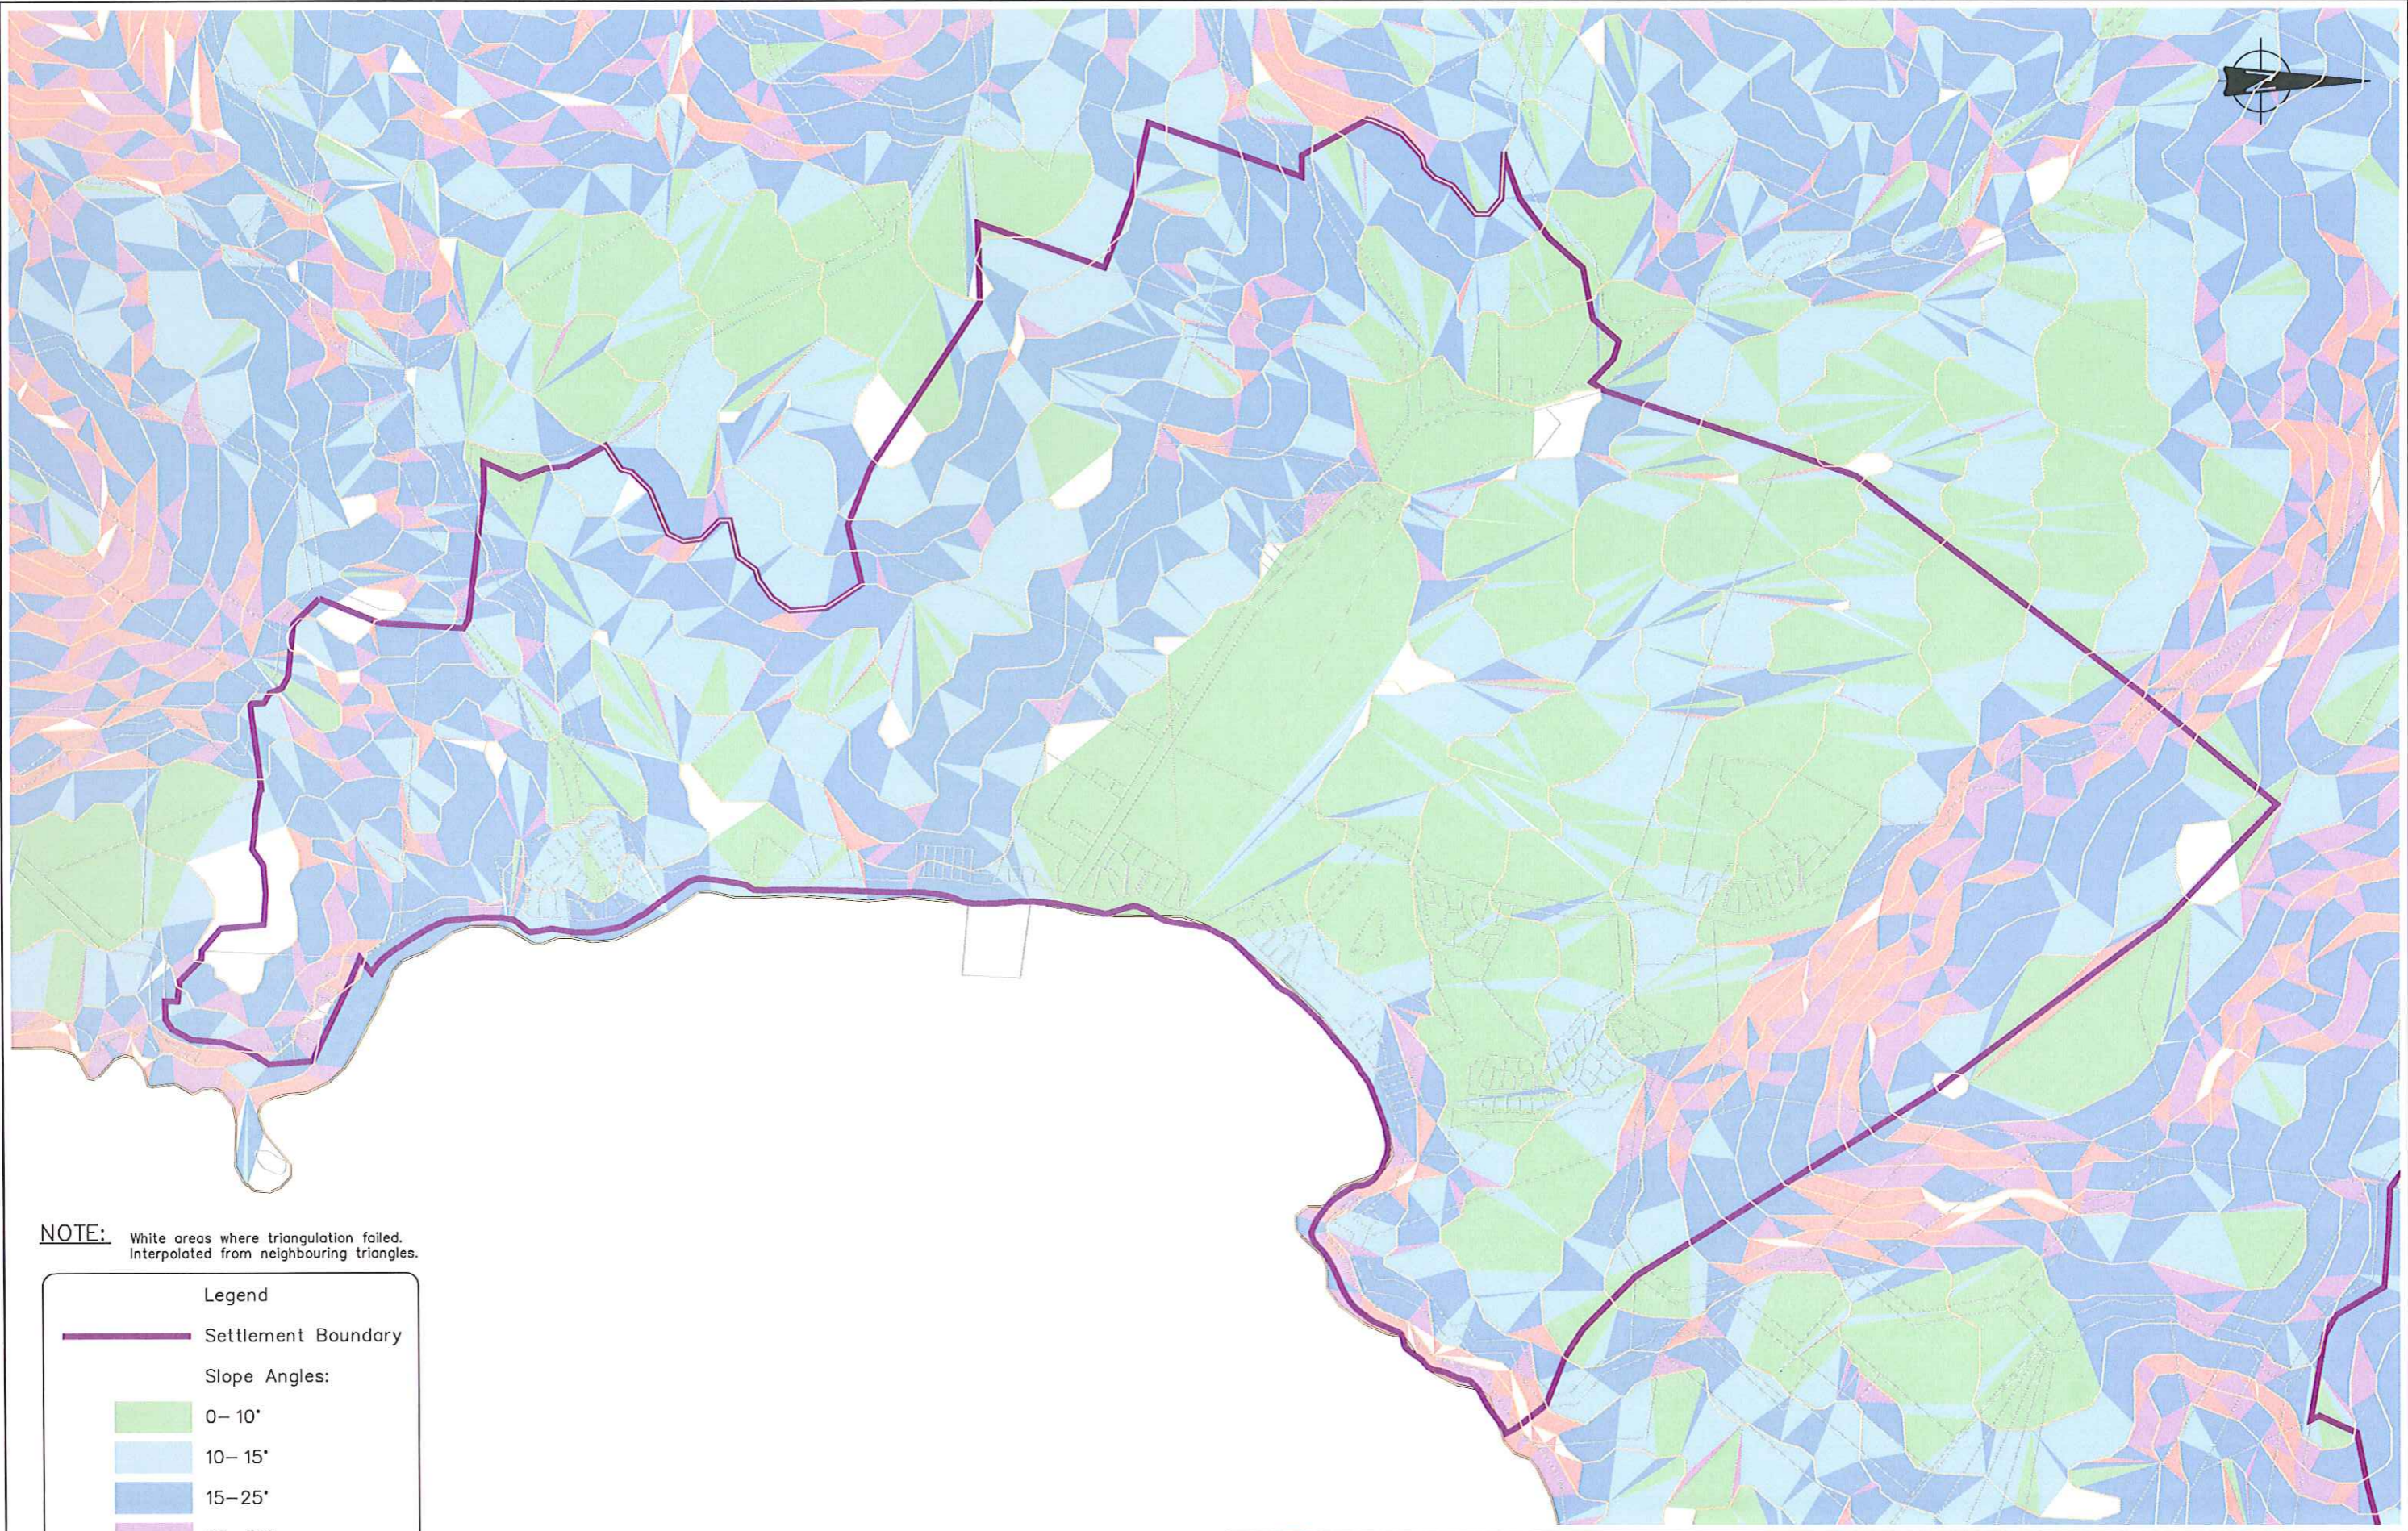
P:\51152\WorkingMaterial\CAD\Figures\Report\Figure C10-C16.dwg, Figure C10, 27/03/2008 2:13:41 p.m., 1:1

**NOTE:** White areas where triangulation failed. Interpolated from neighbouring triangles.

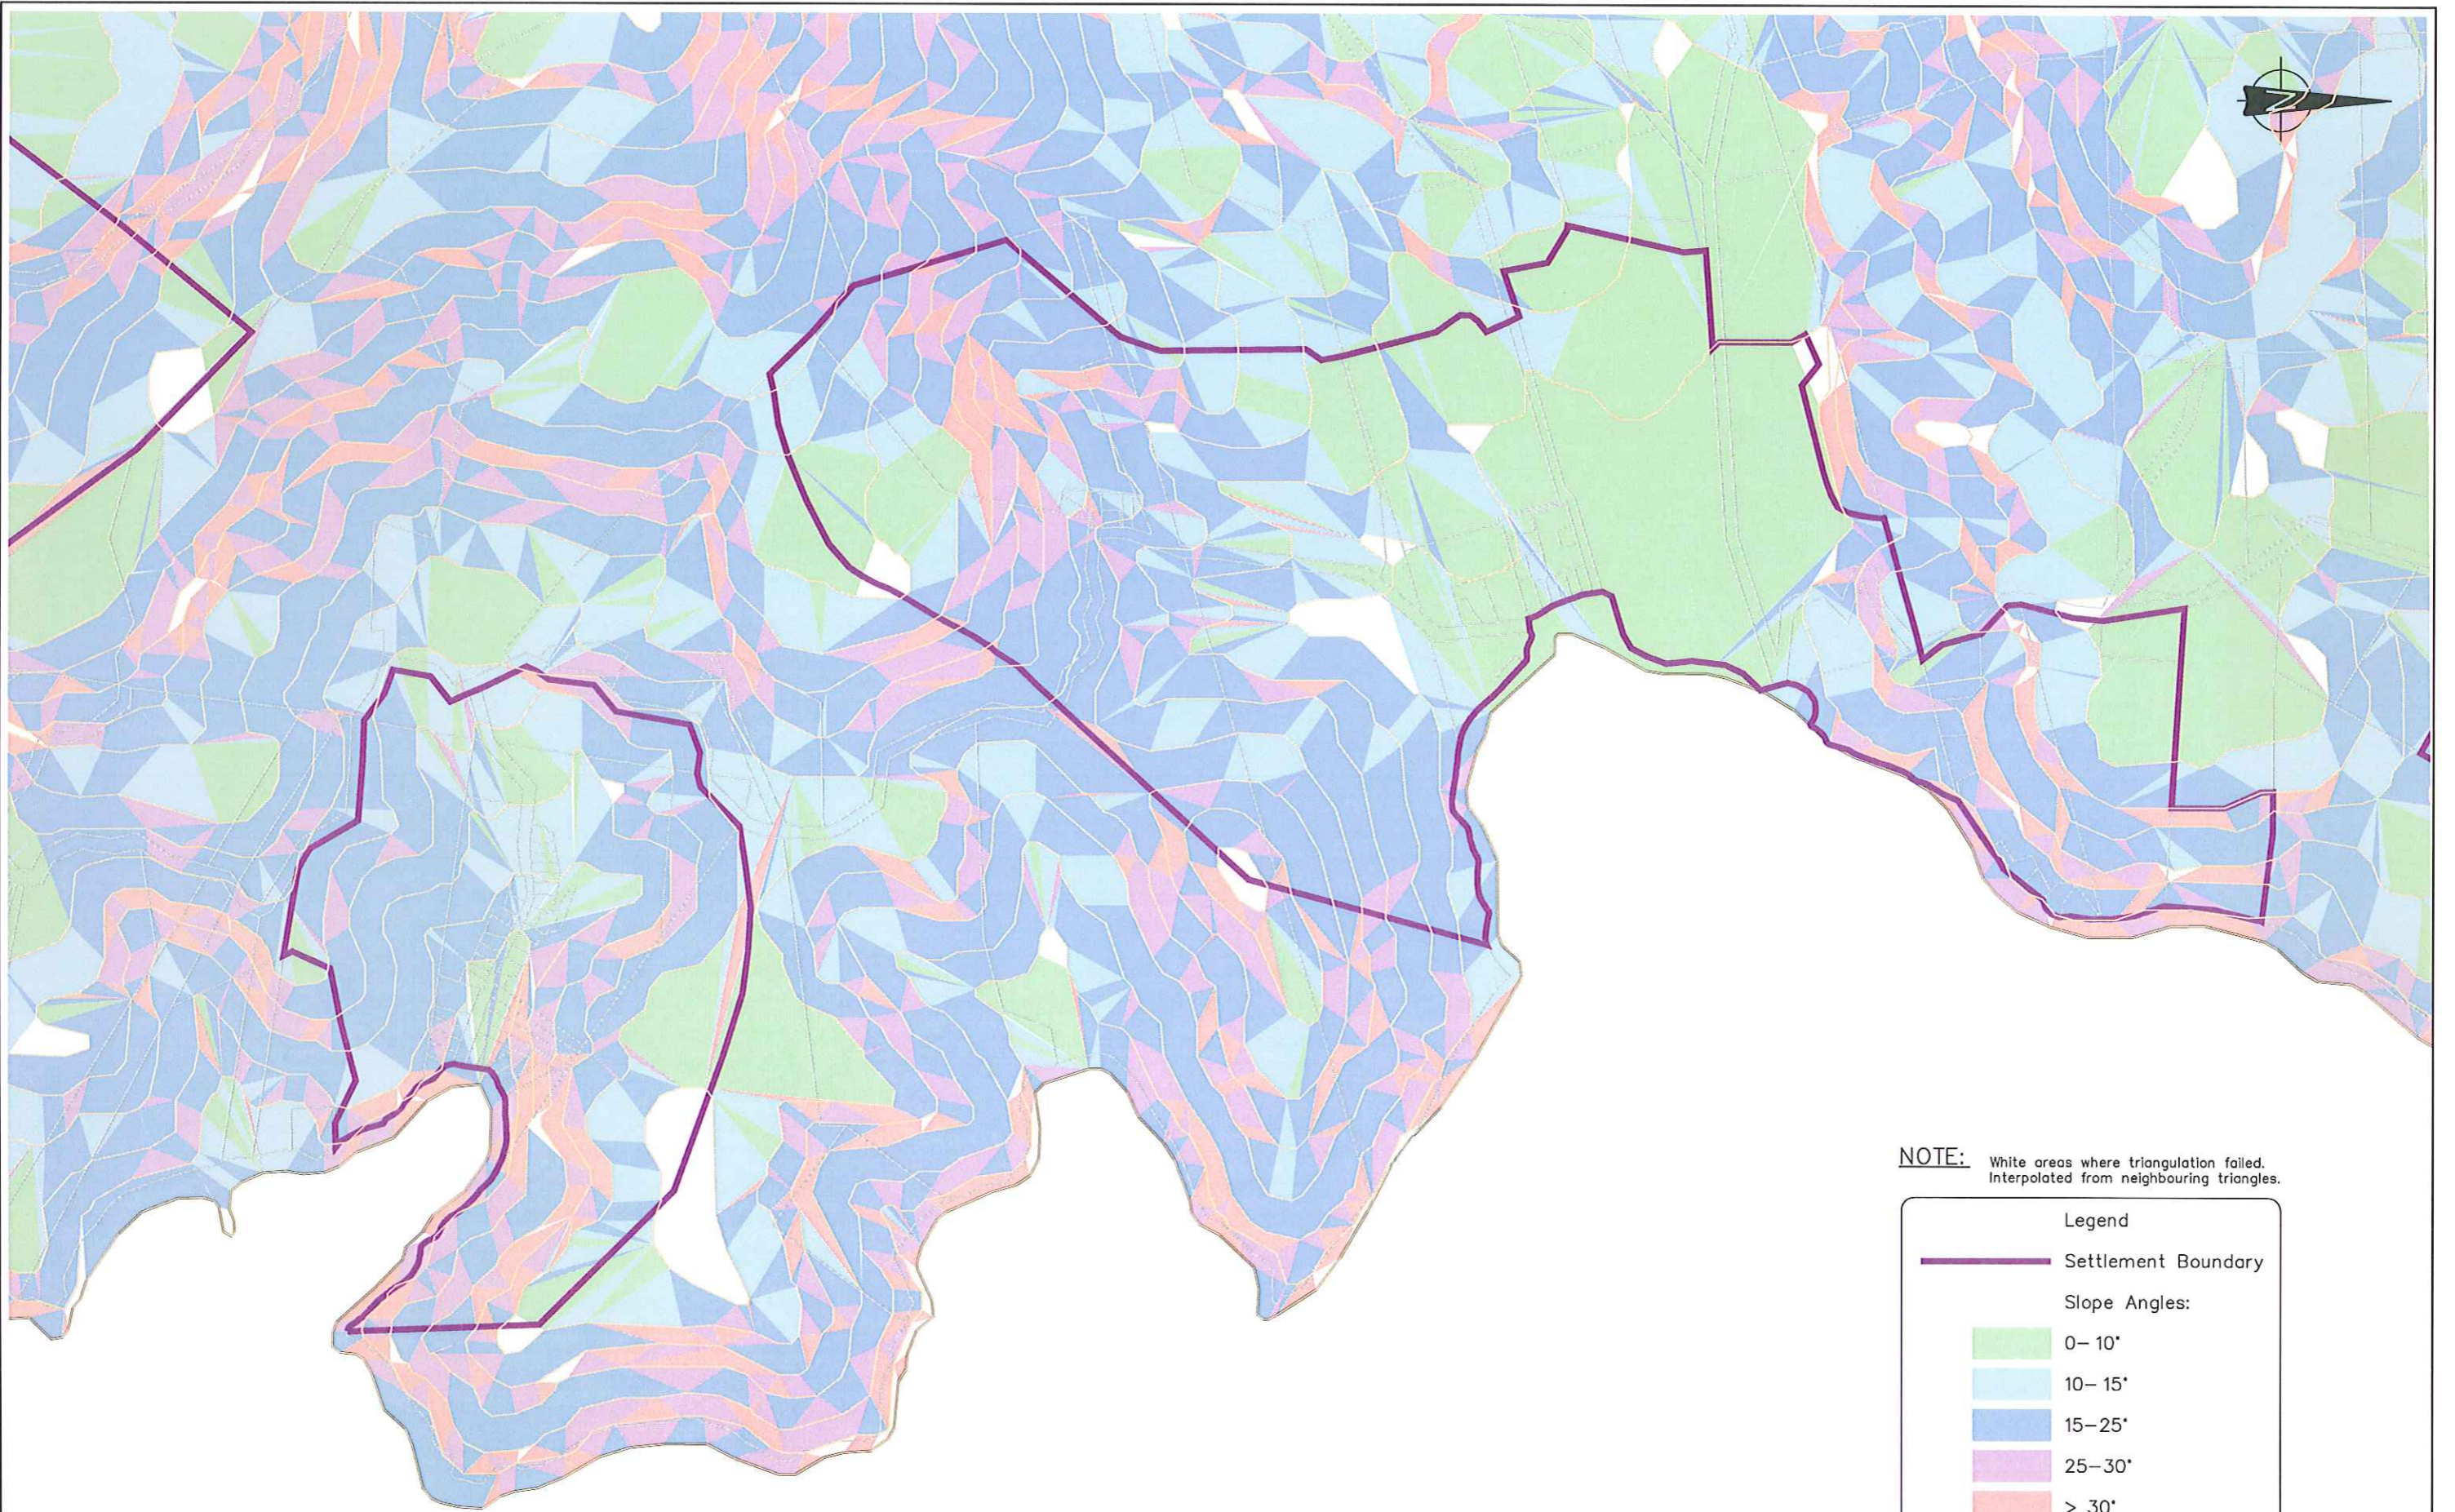
**NOTE:** White areas where triangulation failed.  
Interpolated from neighbouring triangles.

Legend	
	Settlement Boundary
Slope Angles:	
	0- 10°
	10- 15°
	15-25°
	25-30°
	> 30°

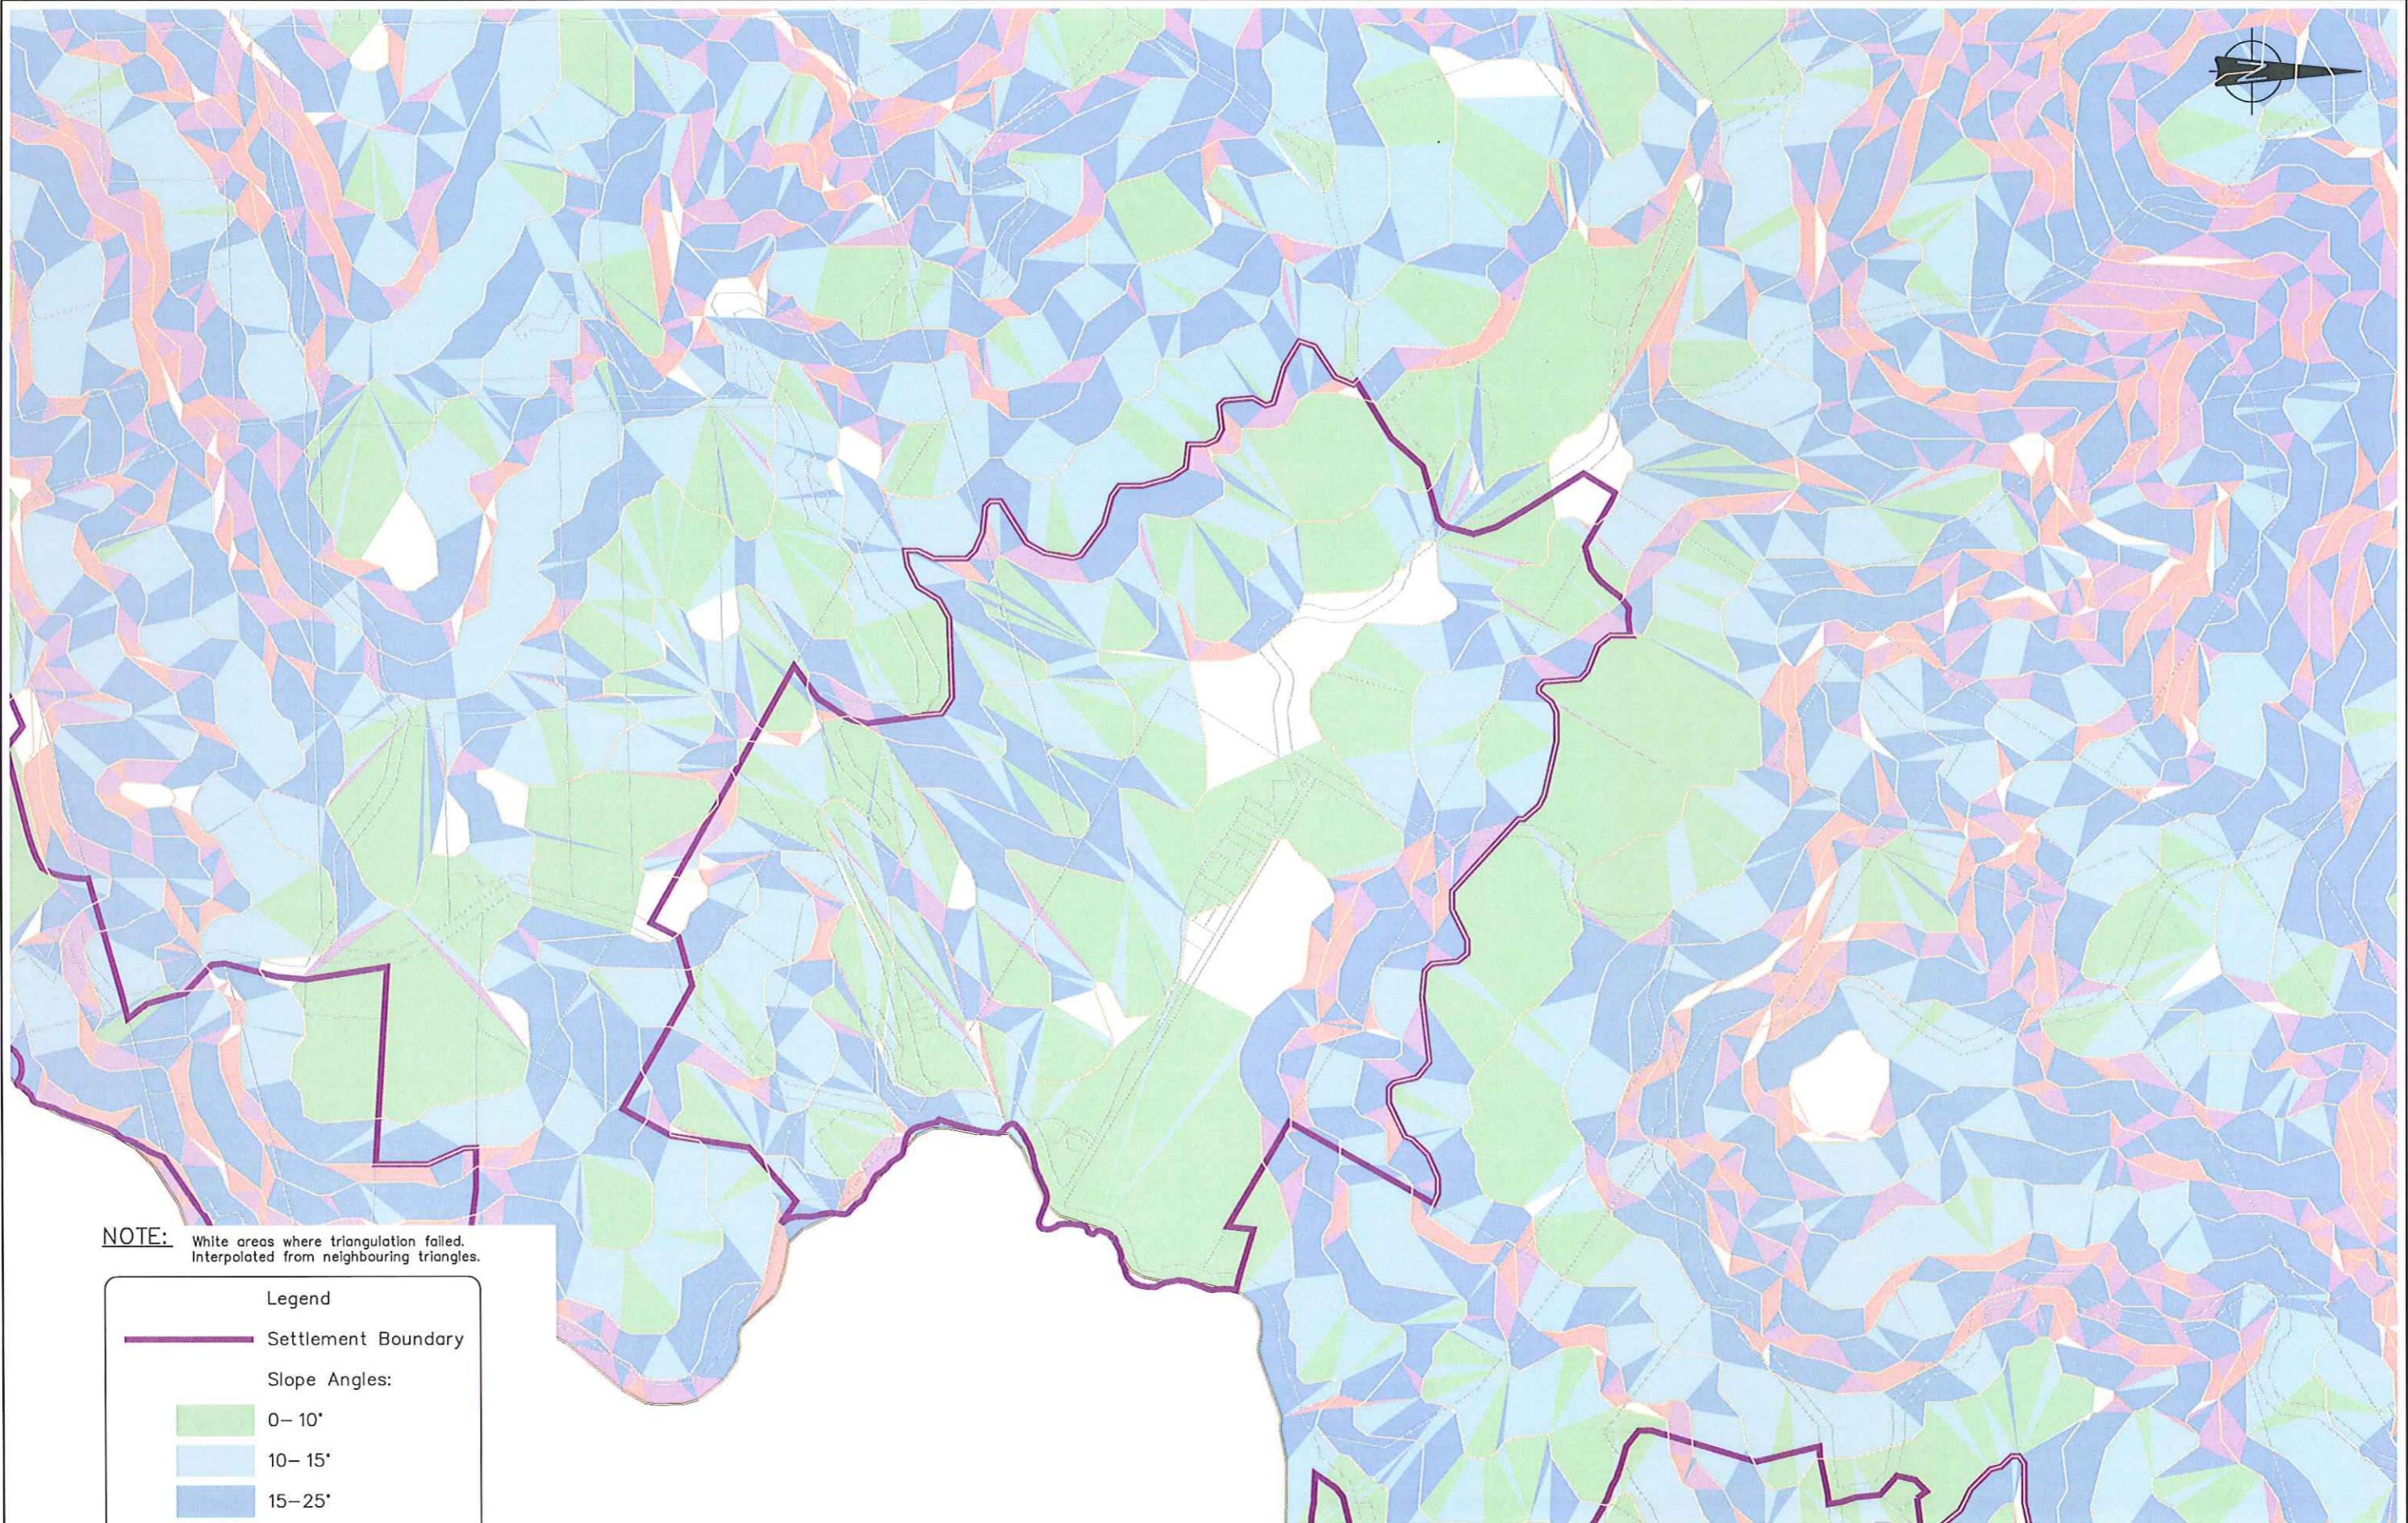
**CHRISTCHURCH CITY COUNCIL**  
Slope Hazard Susceptibility  
Akaroa Harbour Settlements  
Tikao French Farm Slope Angles (20m Contours)

**NOTE:** White areas where triangulation failed.  
Interpolated from neighbouring triangles.
