CHRISTCHURCH CITY COUNCIL

SLOPE HAZARD SUSCEPTIBILITY  
ASSESSMENT

Akaroa Harbour Settlements

**March 2008**

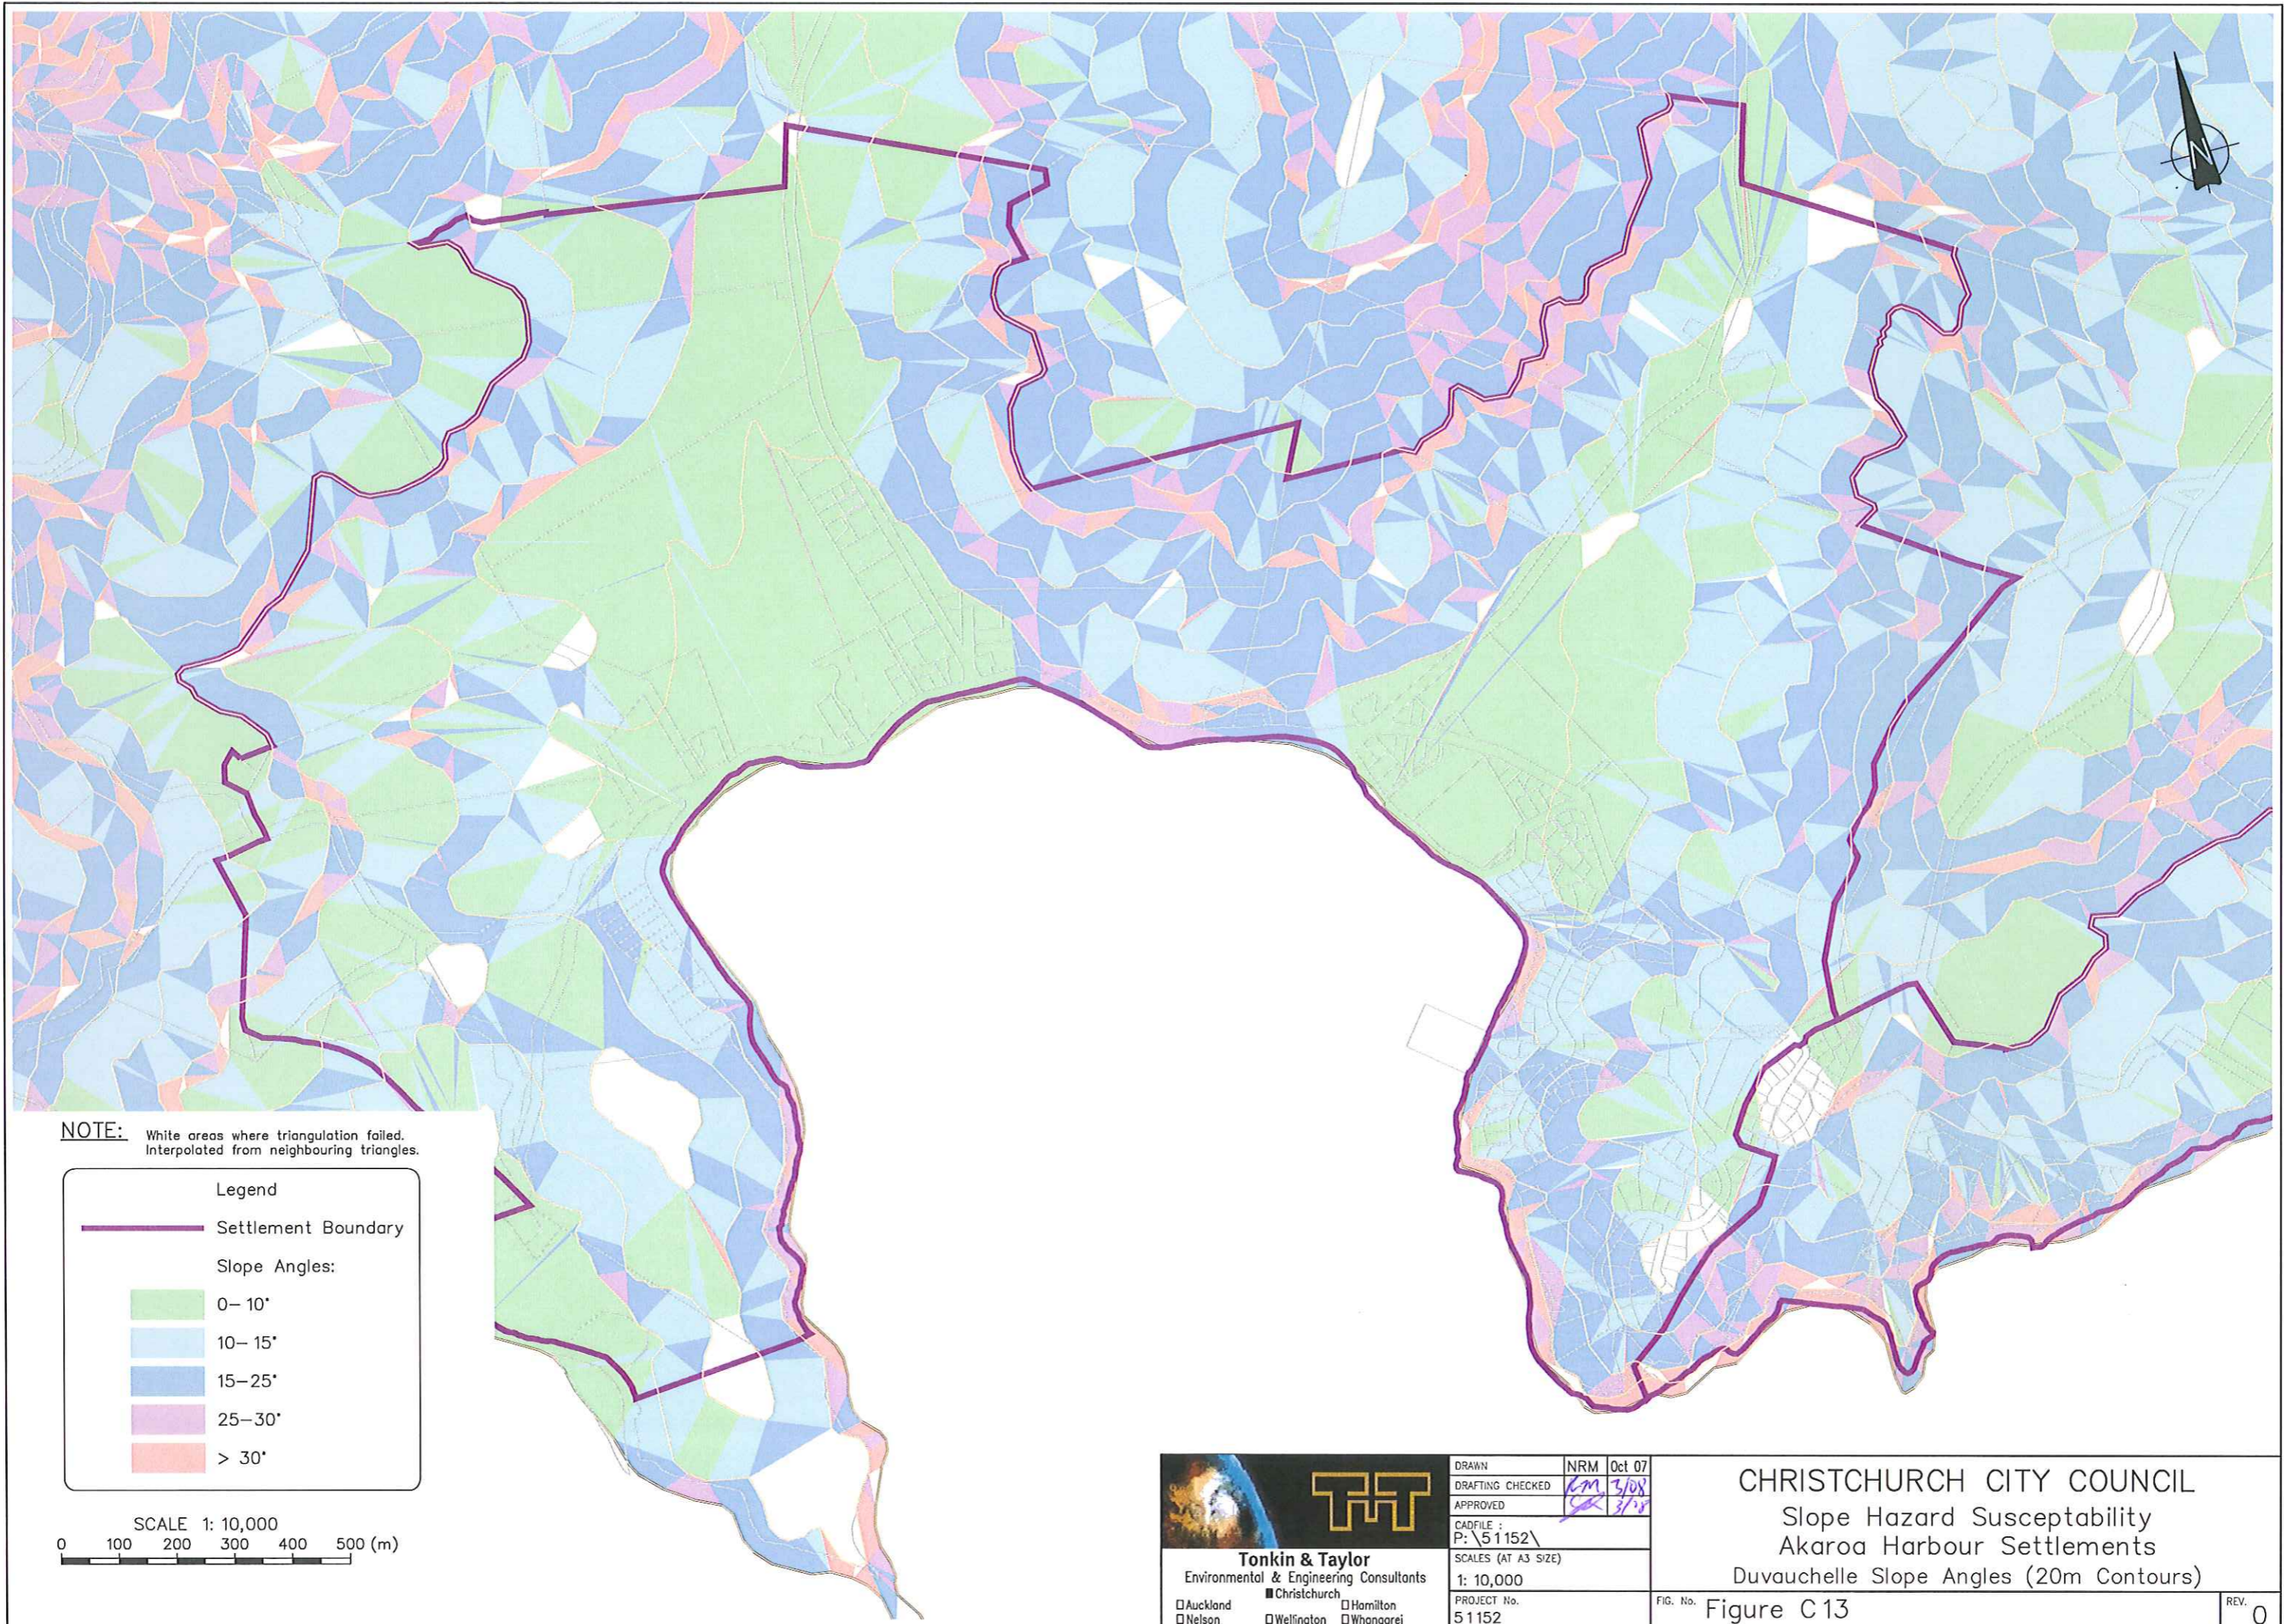
P:\51152\WorkingMaterial\CAD\Figures\Report\Figure C10-C16.dwg, Figure C13, 27/03/2008 2:27:55 p.m., 1:1

**CHRISTCHURCH CITY COUNCIL**  
Slope Hazard Susceptibility  
Akaroa Harbour Settlements  
Barrys Bay Slope Angles (20m Contours)

**NOTE:** White areas where triangulation failed.  
Interpolated from neighbouring triangles.

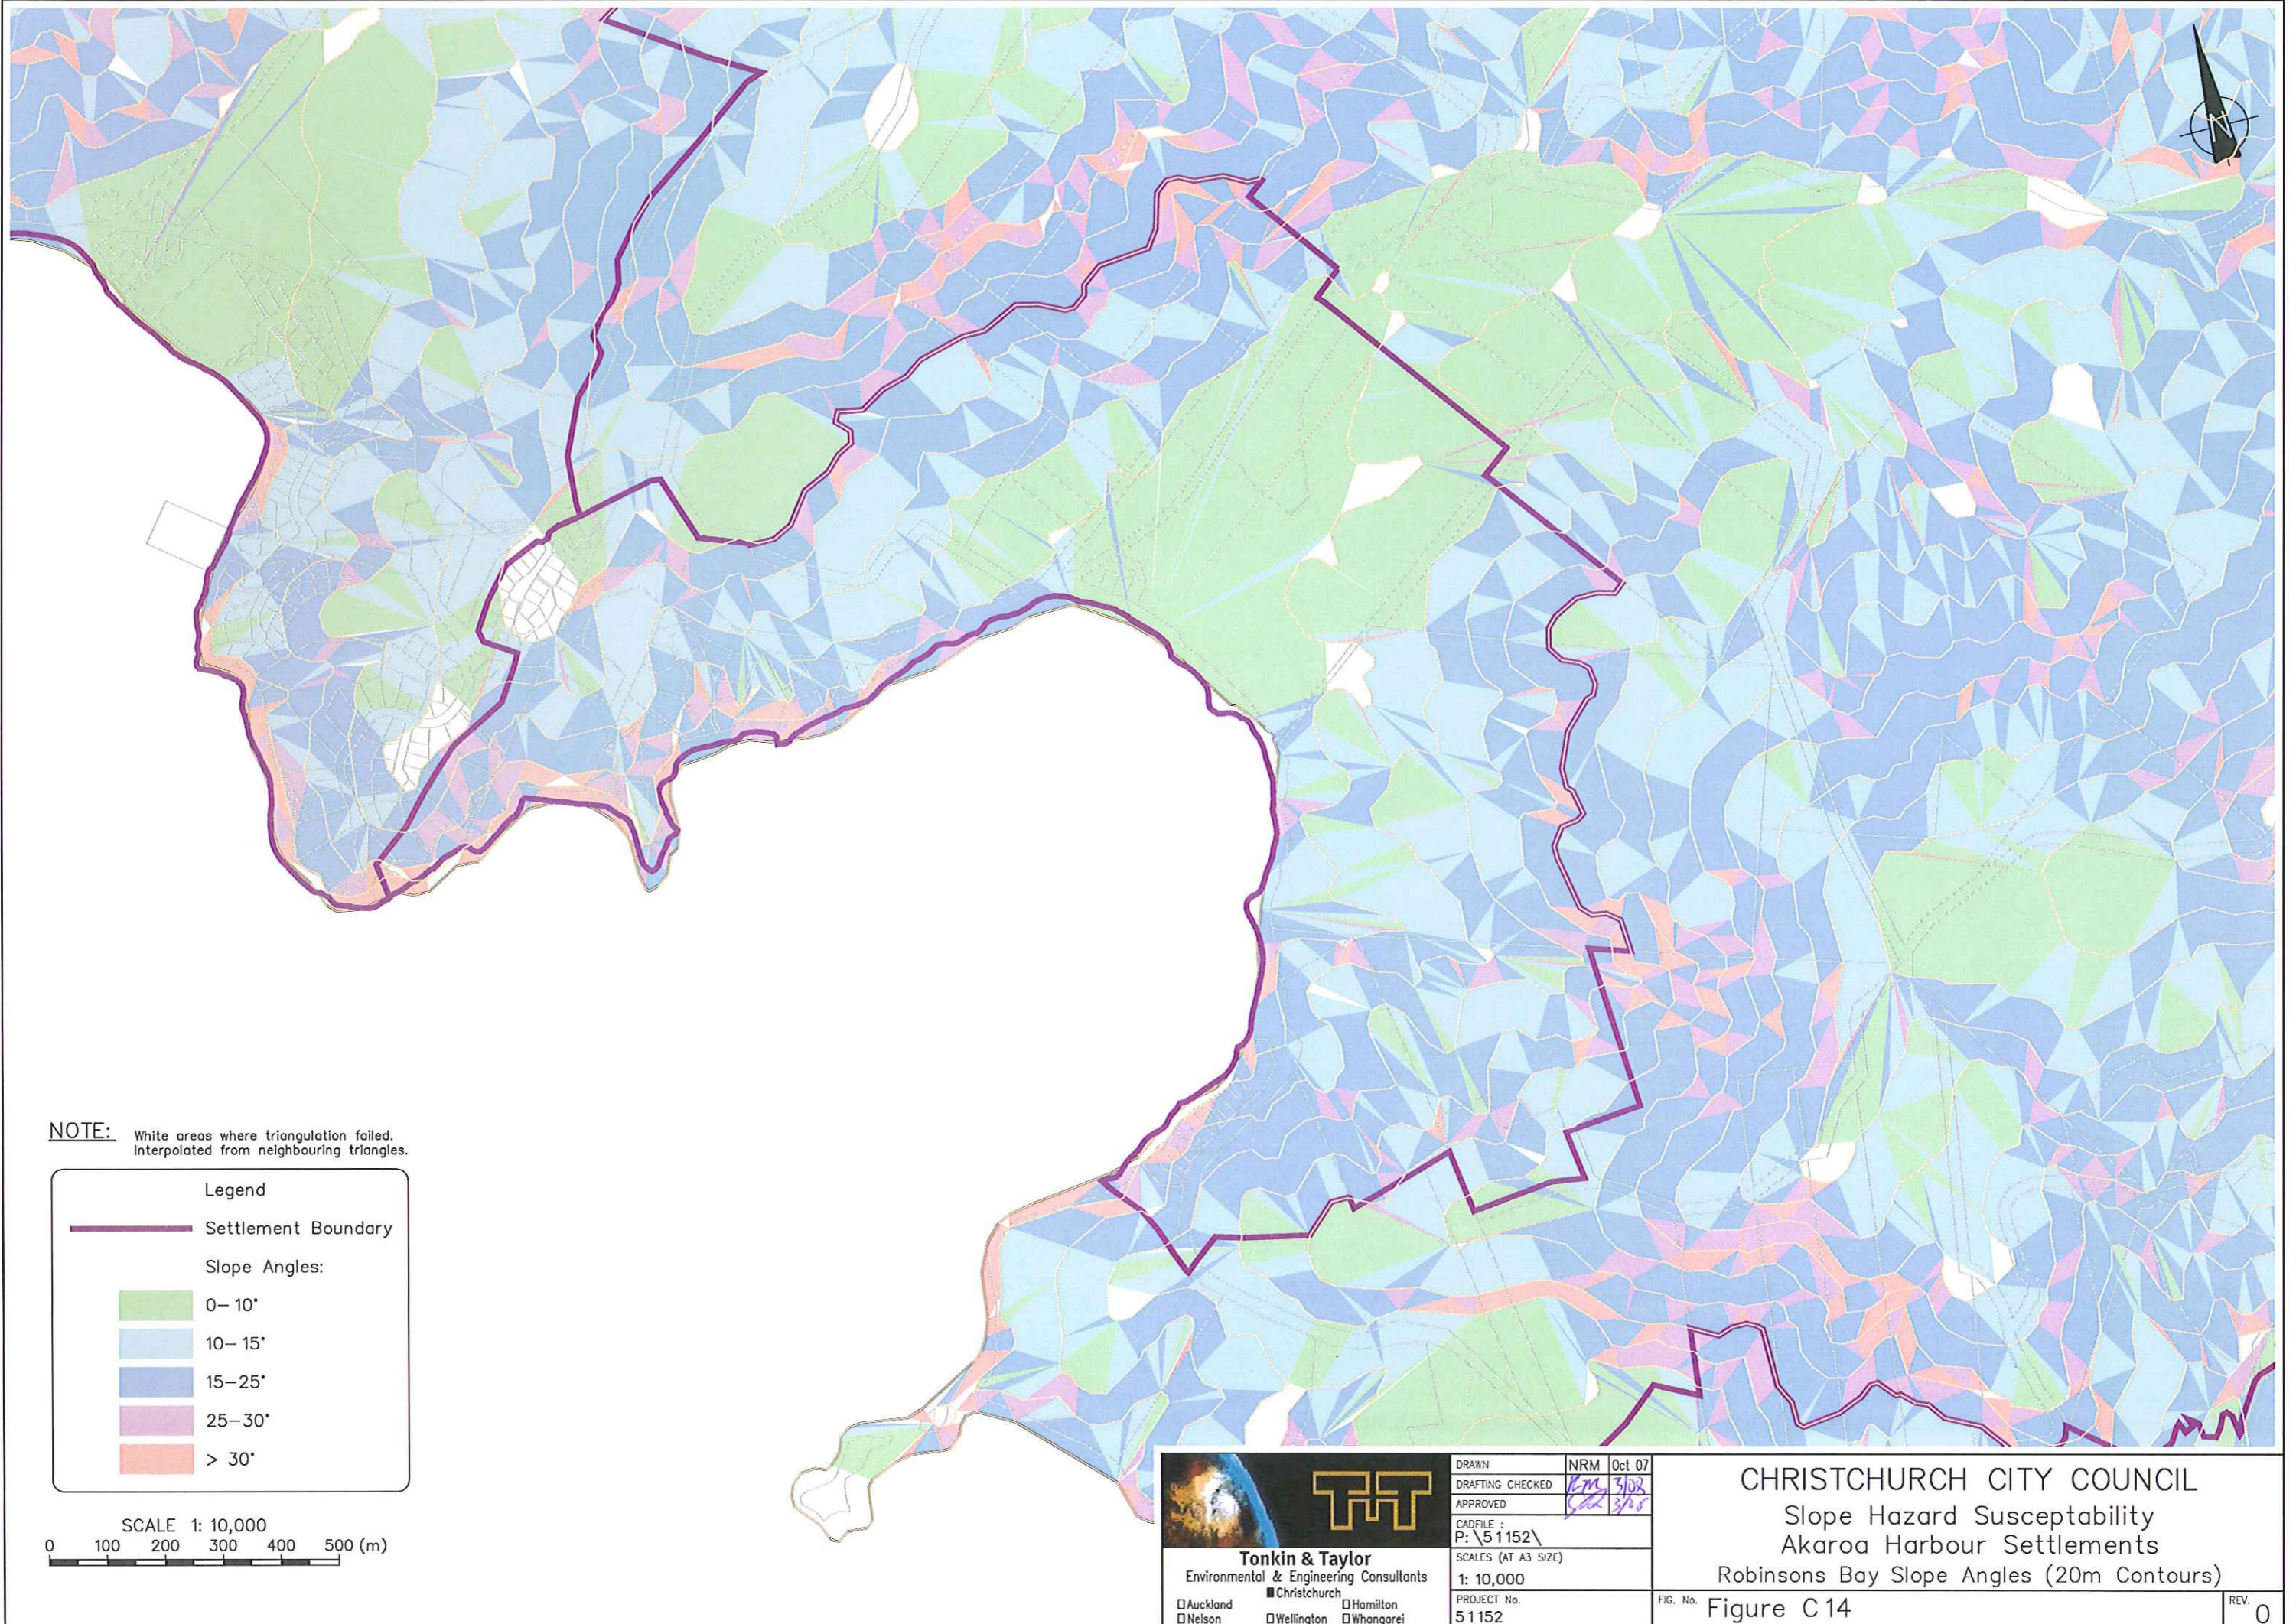
P:\51152\WorkingMaterial\CAD\Figures\Report\Figure C10-C16.dwg, Figure C14, 27/03/2008 2:40:21 p.m., 1:1

**NOTE:** White areas where triangulation failed. Interpolated from neighbouring triangles.

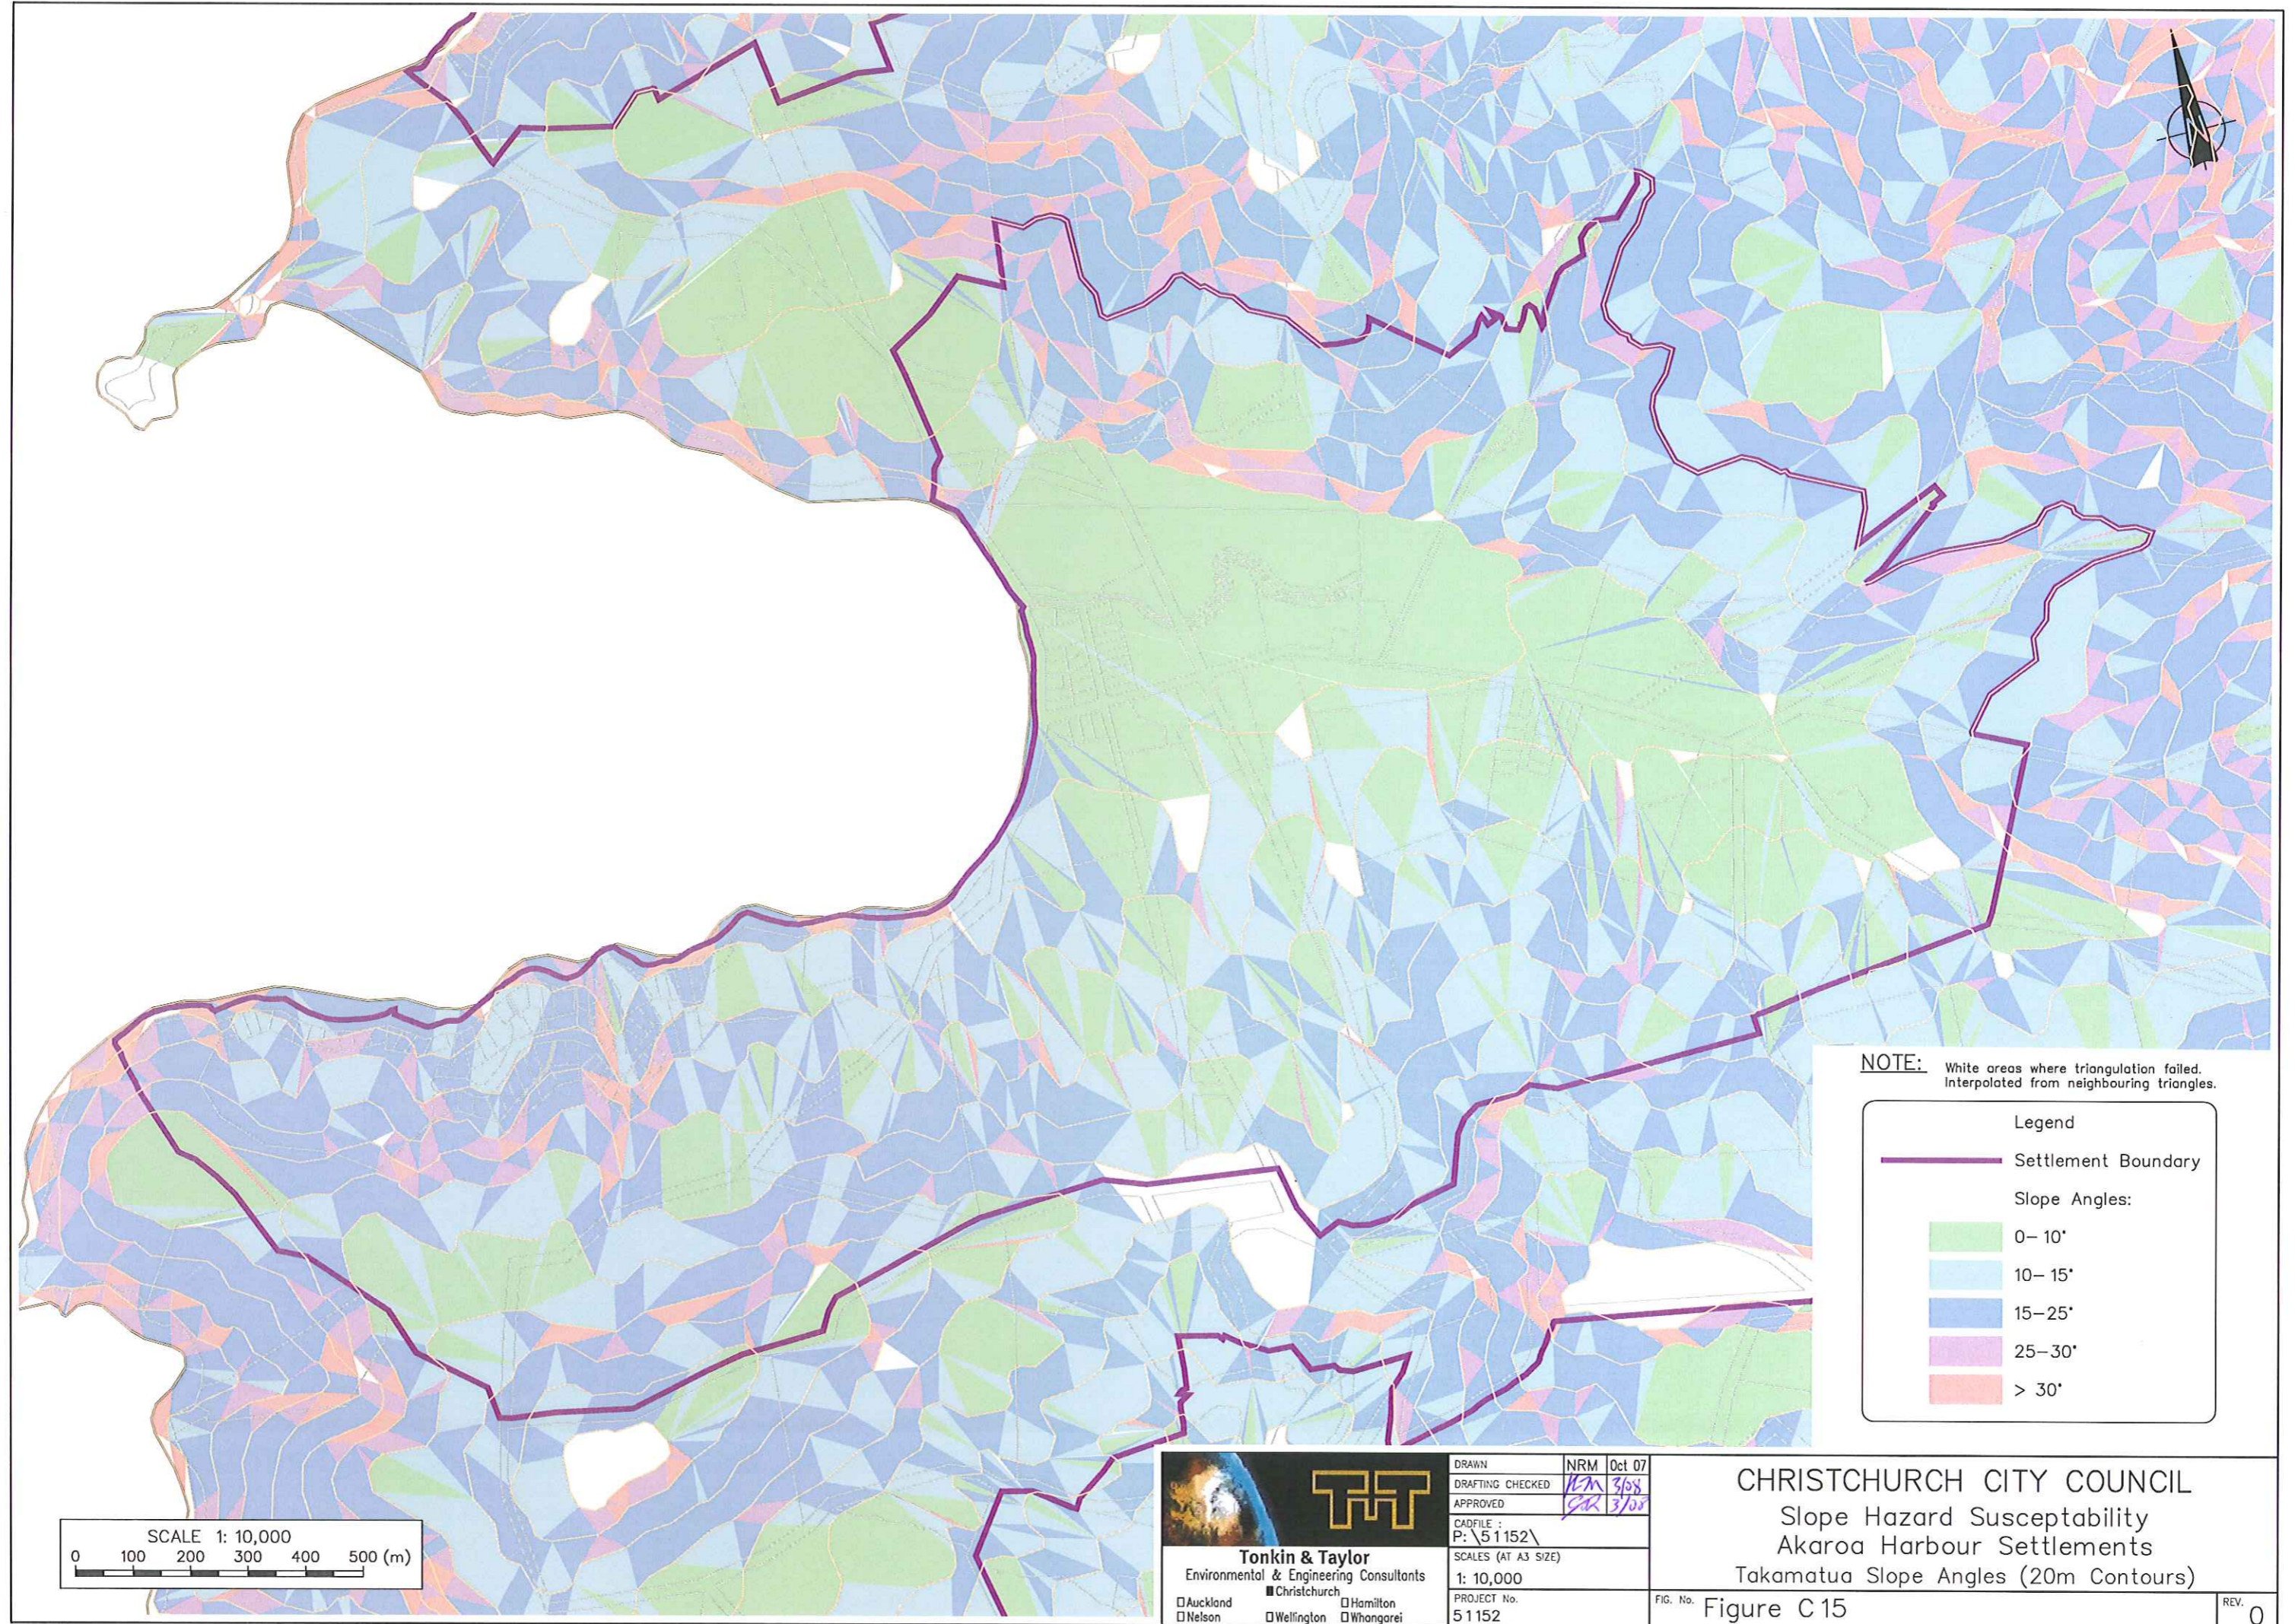
P:\51152\WorkingMaterial\CAD\Figures\Report\Figure C10-C16.dwg, Figure C15, 27/03/2008 2:52:49 p.m., 1:1

**NOTE:** White areas where triangulation failed. Interpolated from neighbouring triangles.

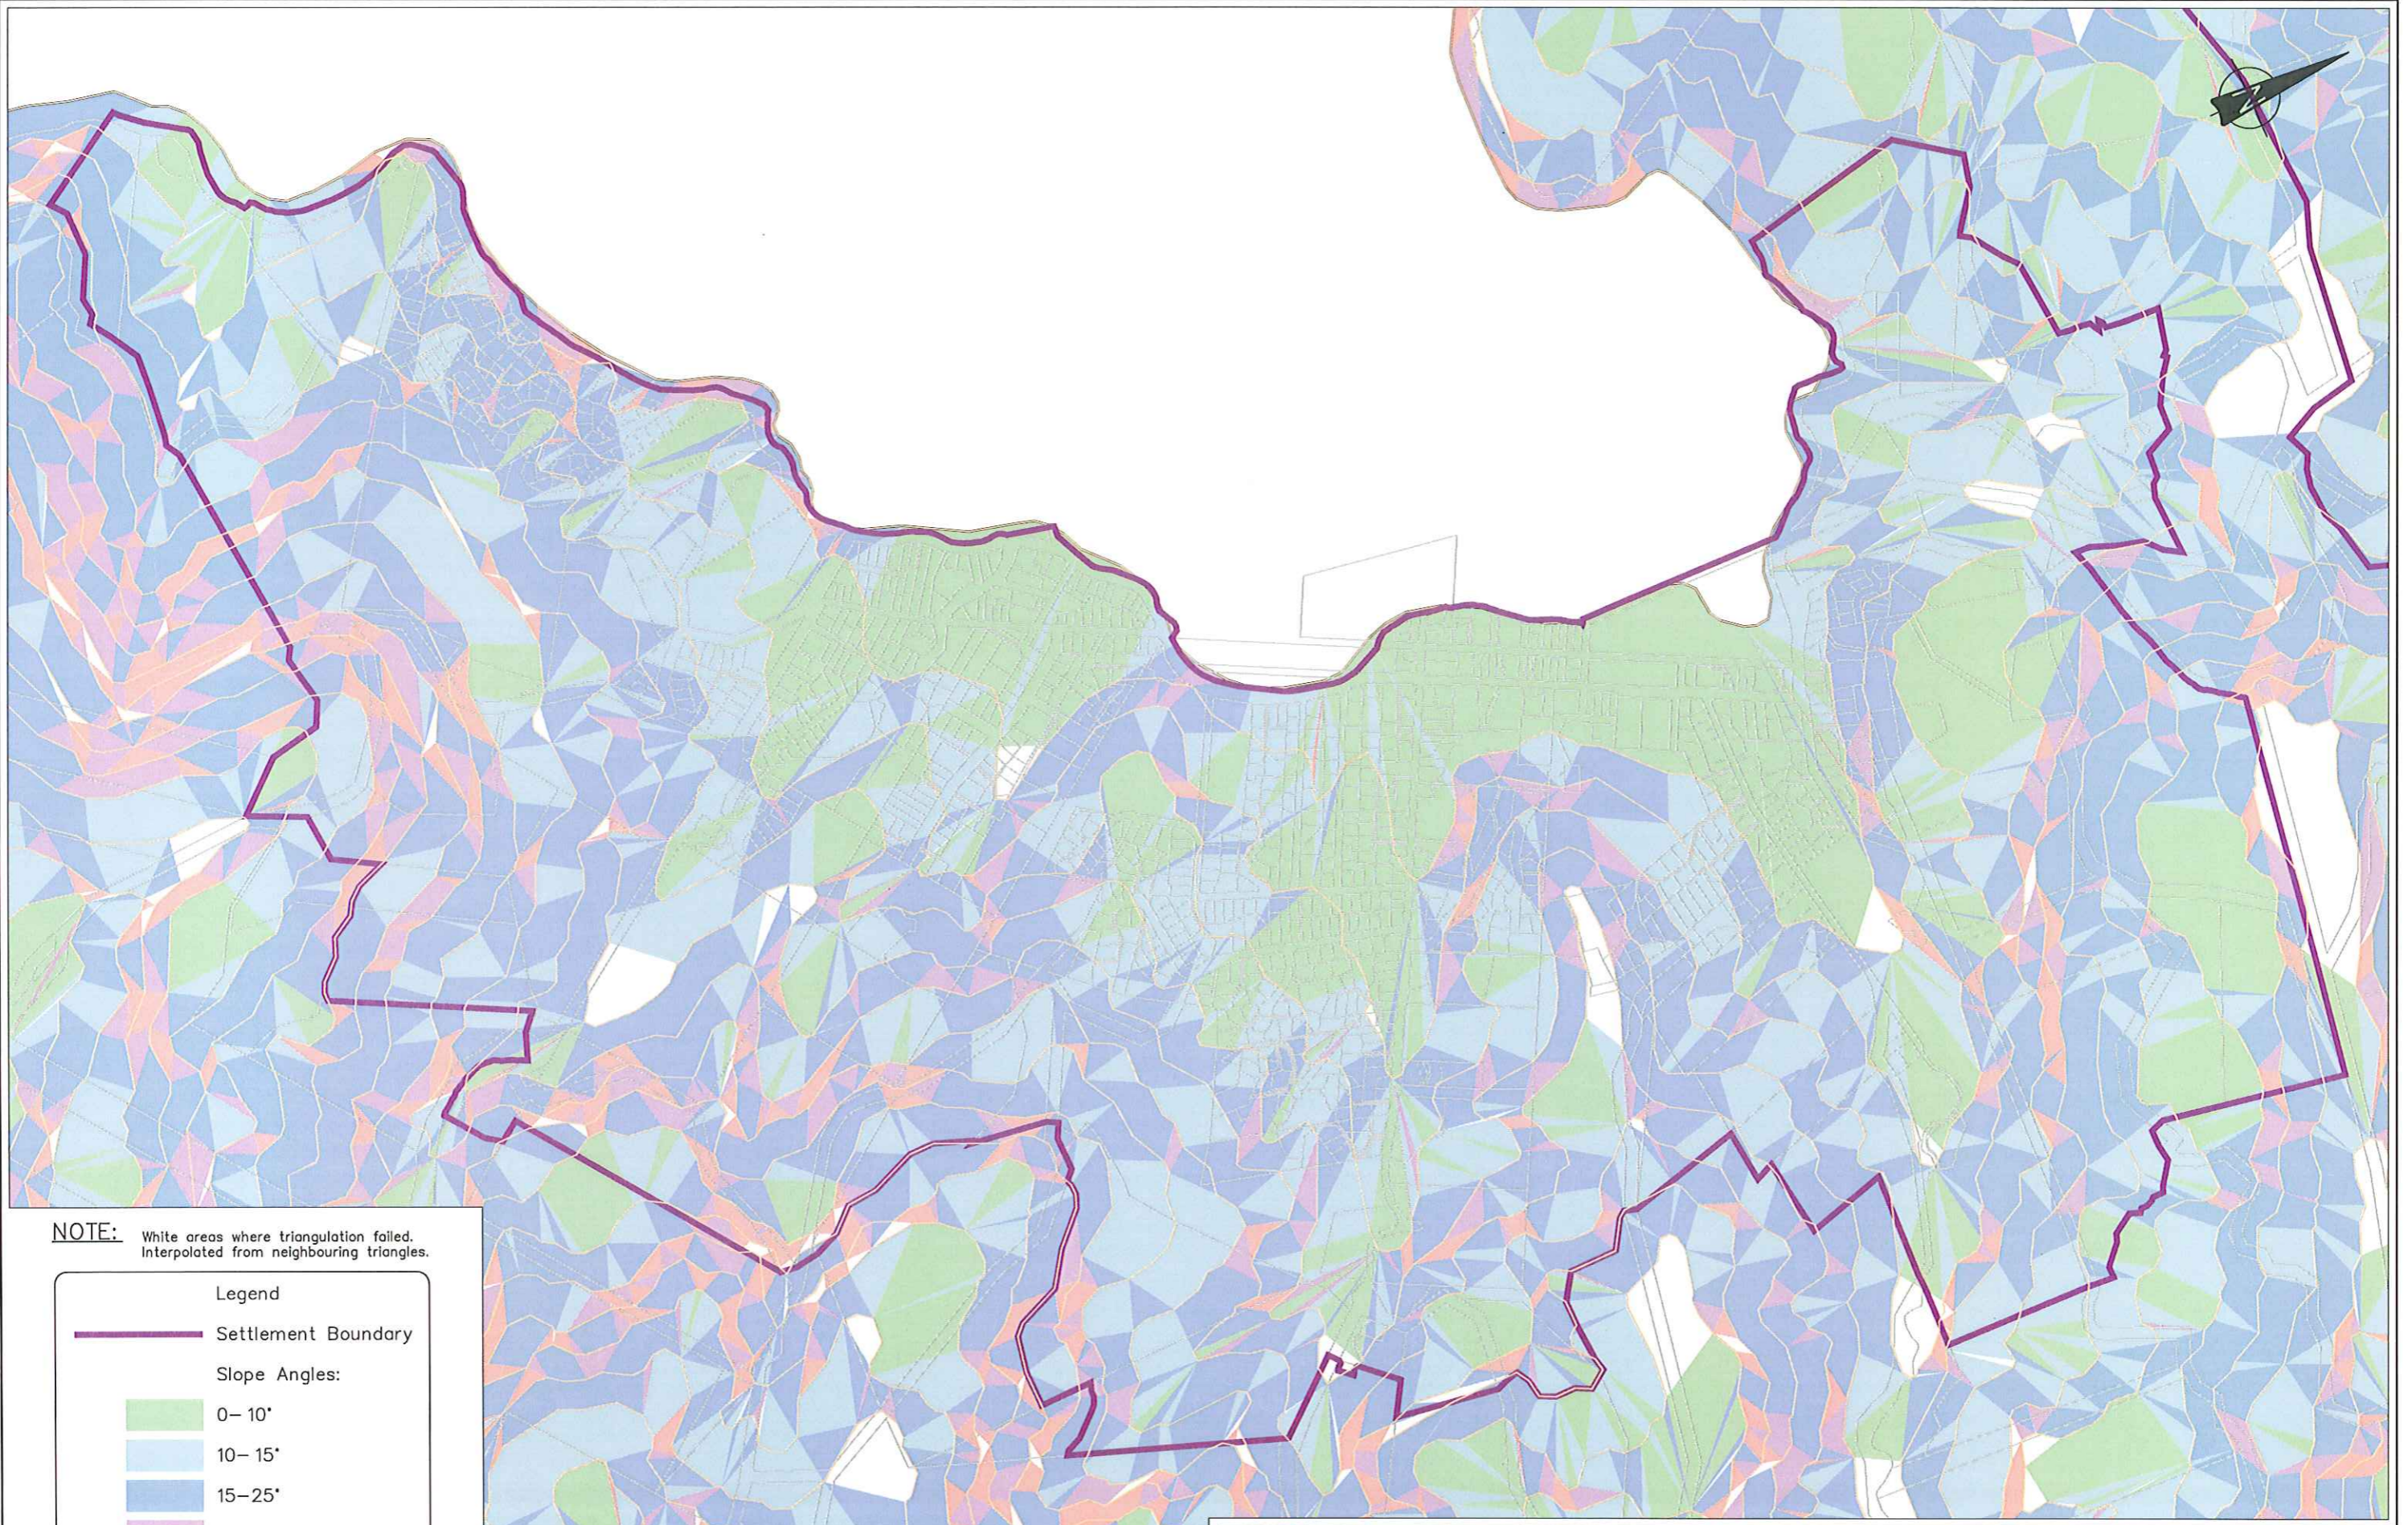
**CHRISTCHURCH CITY COUNCIL**  
Slope Hazard Susceptibility  
Akaroa Harbour Settlements  
Takamatua Slope Angles (20m Contours)

**NOTE:** White areas where triangulation failed.  
Interpolated from neighbouring triangles.

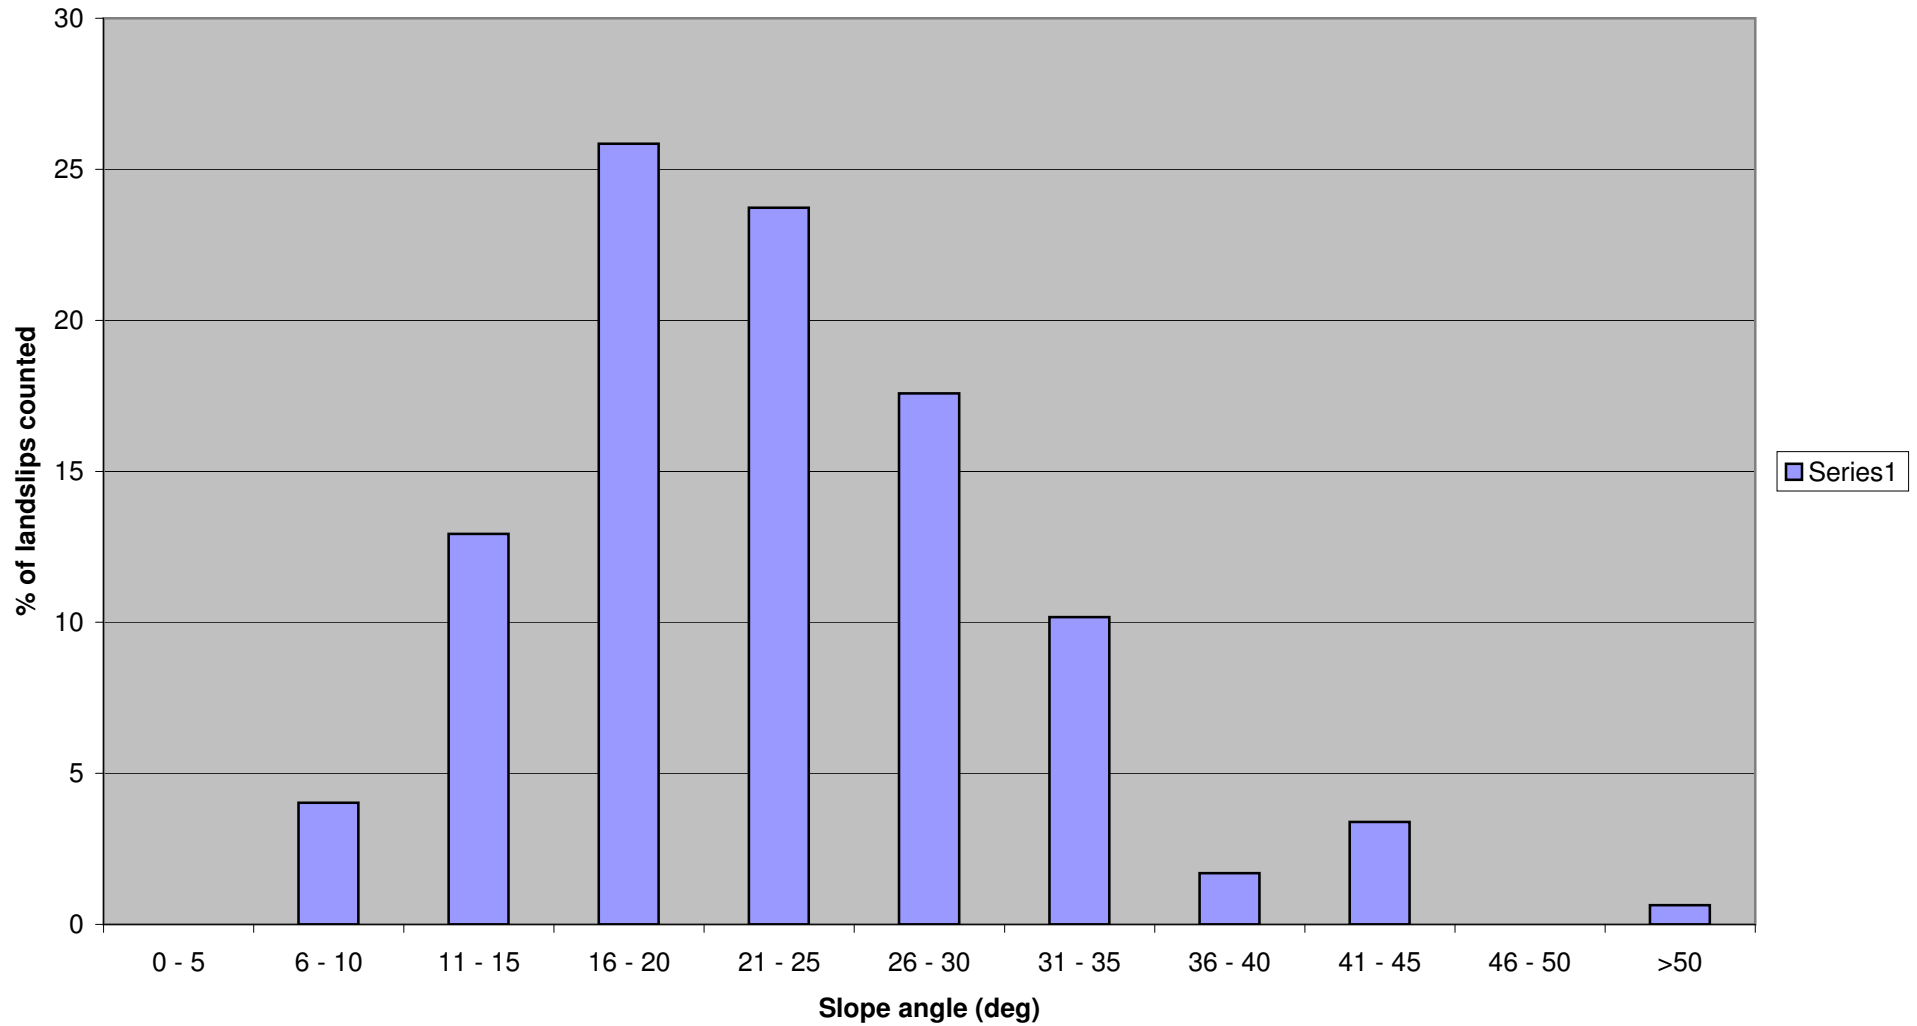
**% of small landslips by slope angle (20 m contour data)**

The 20 m contour data (See histogram chart in Appendix D) showed that 50% of the small scale landslides identified, occurred on slopes between 16 and 25°. An additional 28% of small scale landslides occurred on slopes between 26 and 35° and 13% of failures on slopes between 11 and 15°, accounting for 91% of failures in the 11 to 35° division.
