Appendix D: Observed Land Damage Map

CHRISTCHURCH CITY COUNCIL
 GEOLOGICAL INTERPRETATIVE REPORT
 CHRISTCHURCH CENTRAL CITY
 Observed Land Damage Map

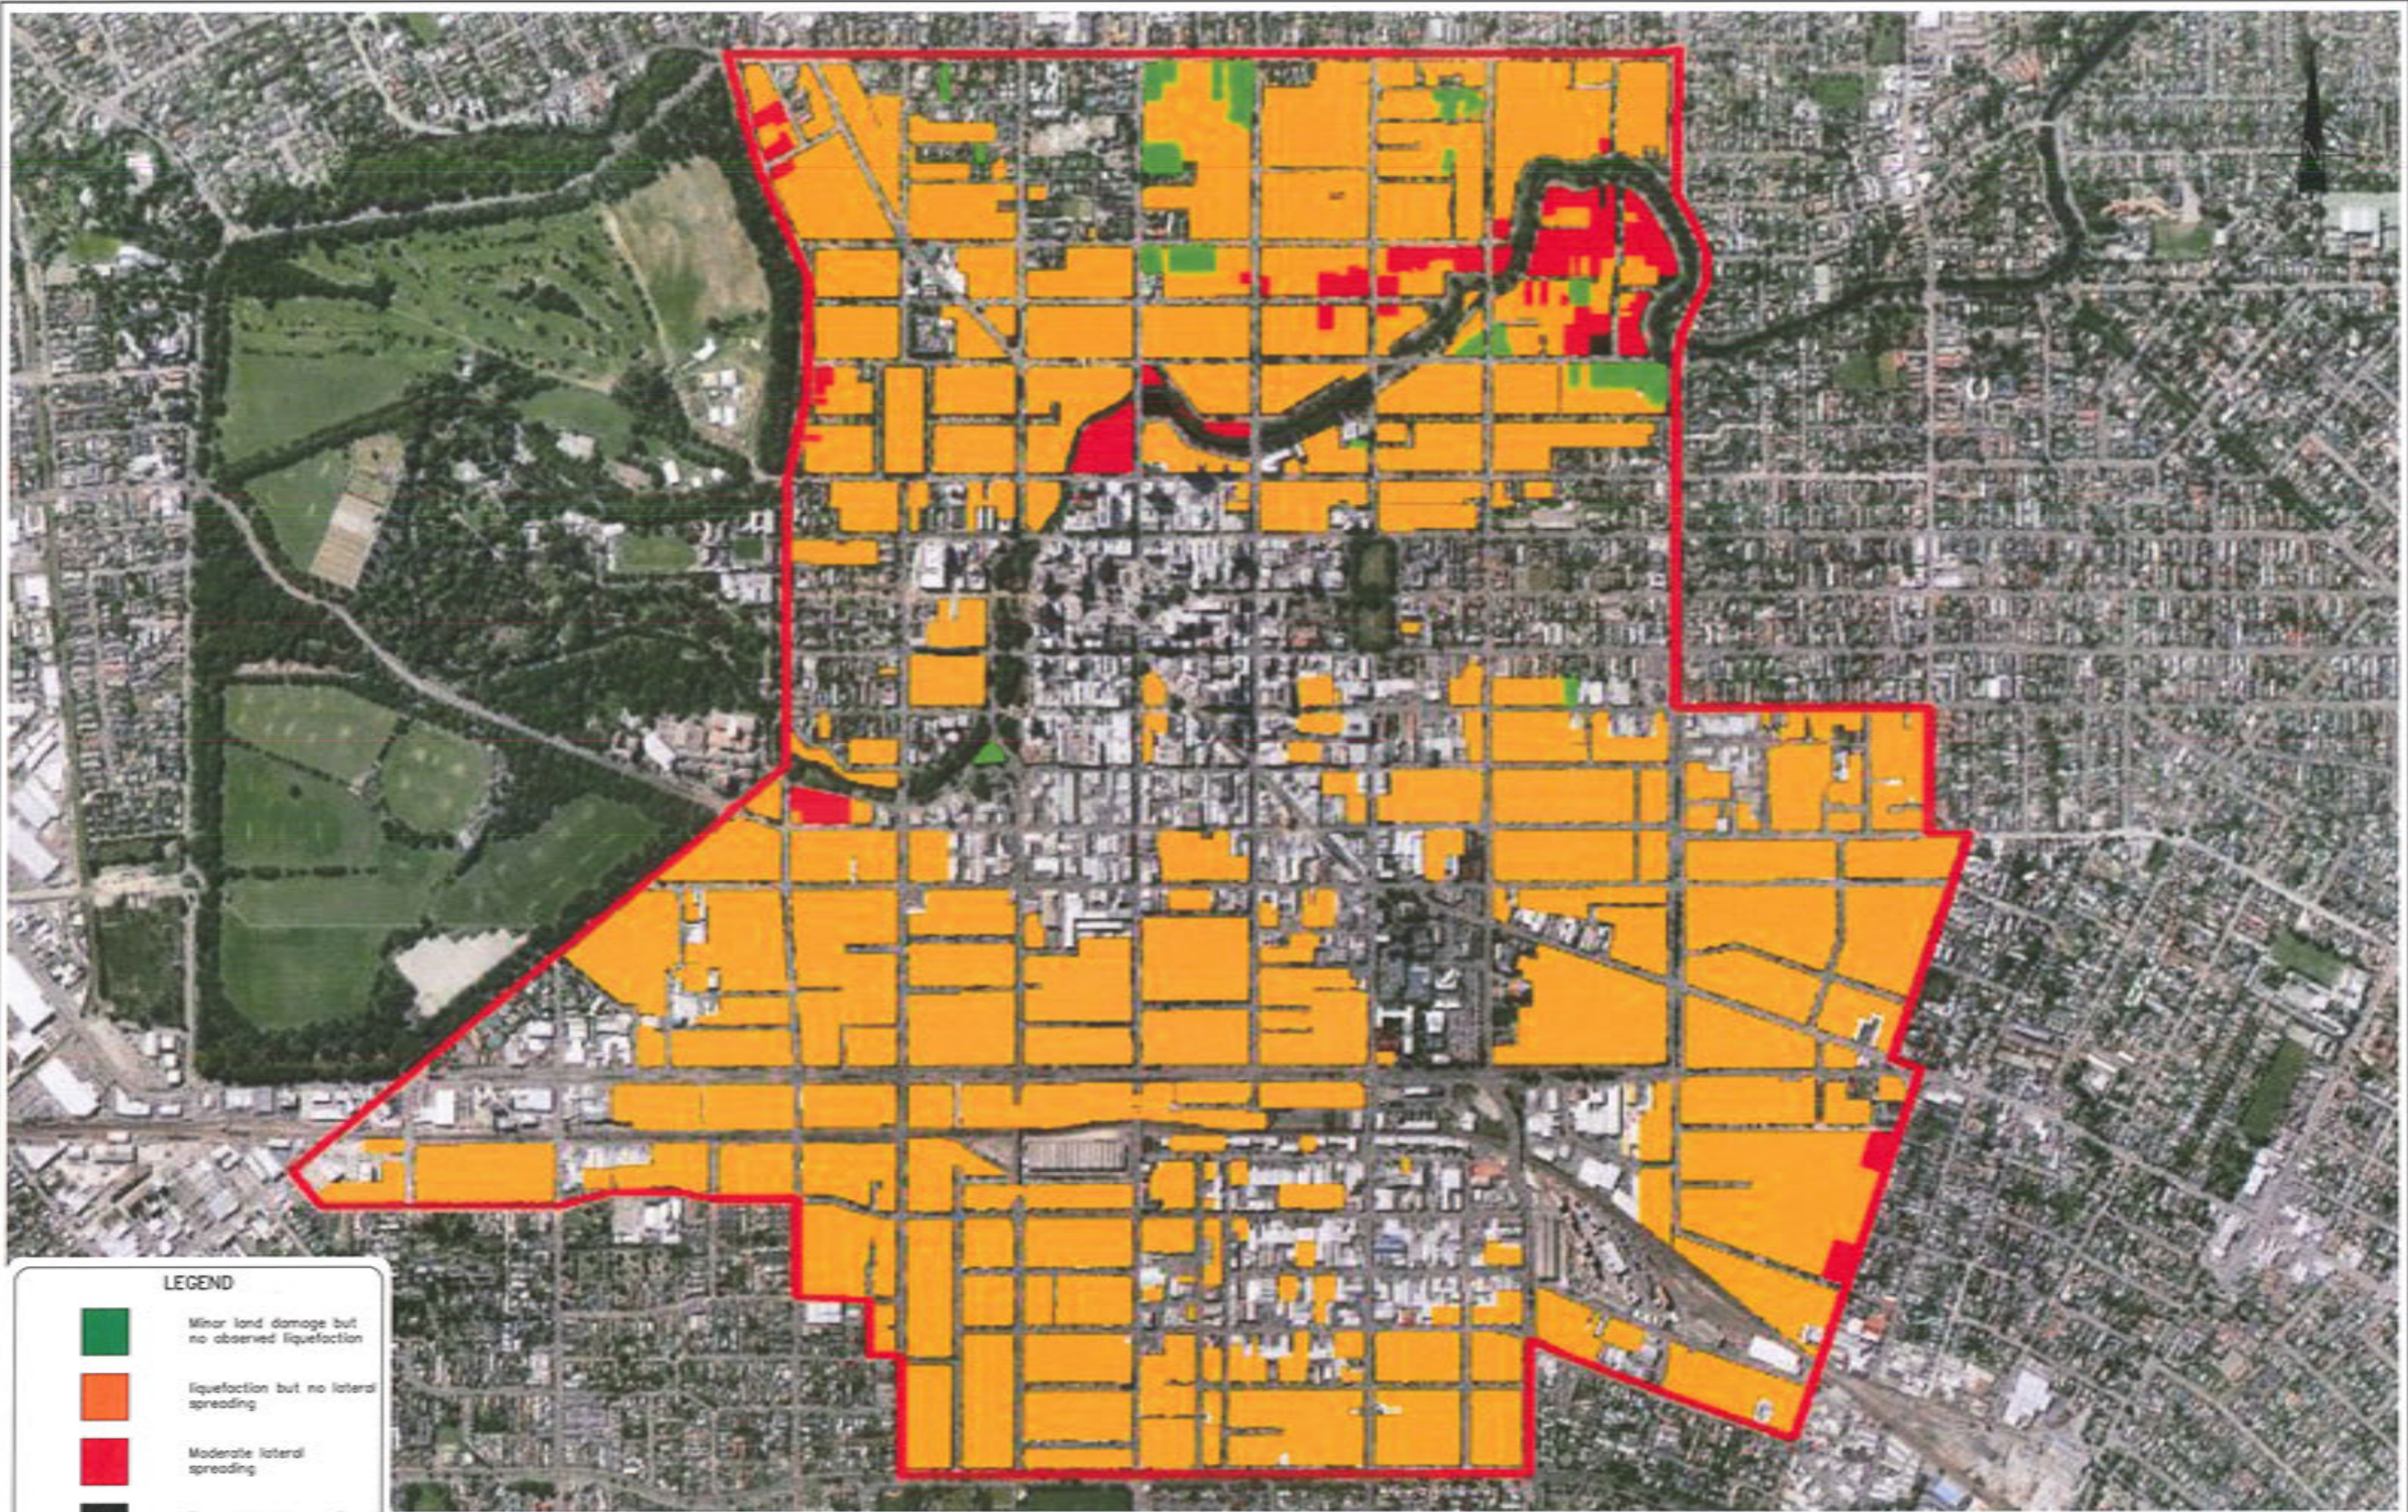
- Minor land damage but no observed liquefaction
- Liquefaction but no lateral spreading
- Moderate lateral spreading
- Severe lateral spreading

NOTES:
 1. Low resolution aerial photographs sourced from Google Earth (Copyright: 2009).
 2. The land damage assessment is based on preliminary inspections of individual properties undertaken by Tonkin & Taylor Ltd staff following the 22 February 2011 aftershock.
 3. The areas of damage are simplified for schematic purposes.
