## Kyle Park, Hornby

### Desktop Ground Contamination and Geotechnical Study

Prepared for  
Christchurch City Council

Prepared by  
Tonkin & Taylor Ltd

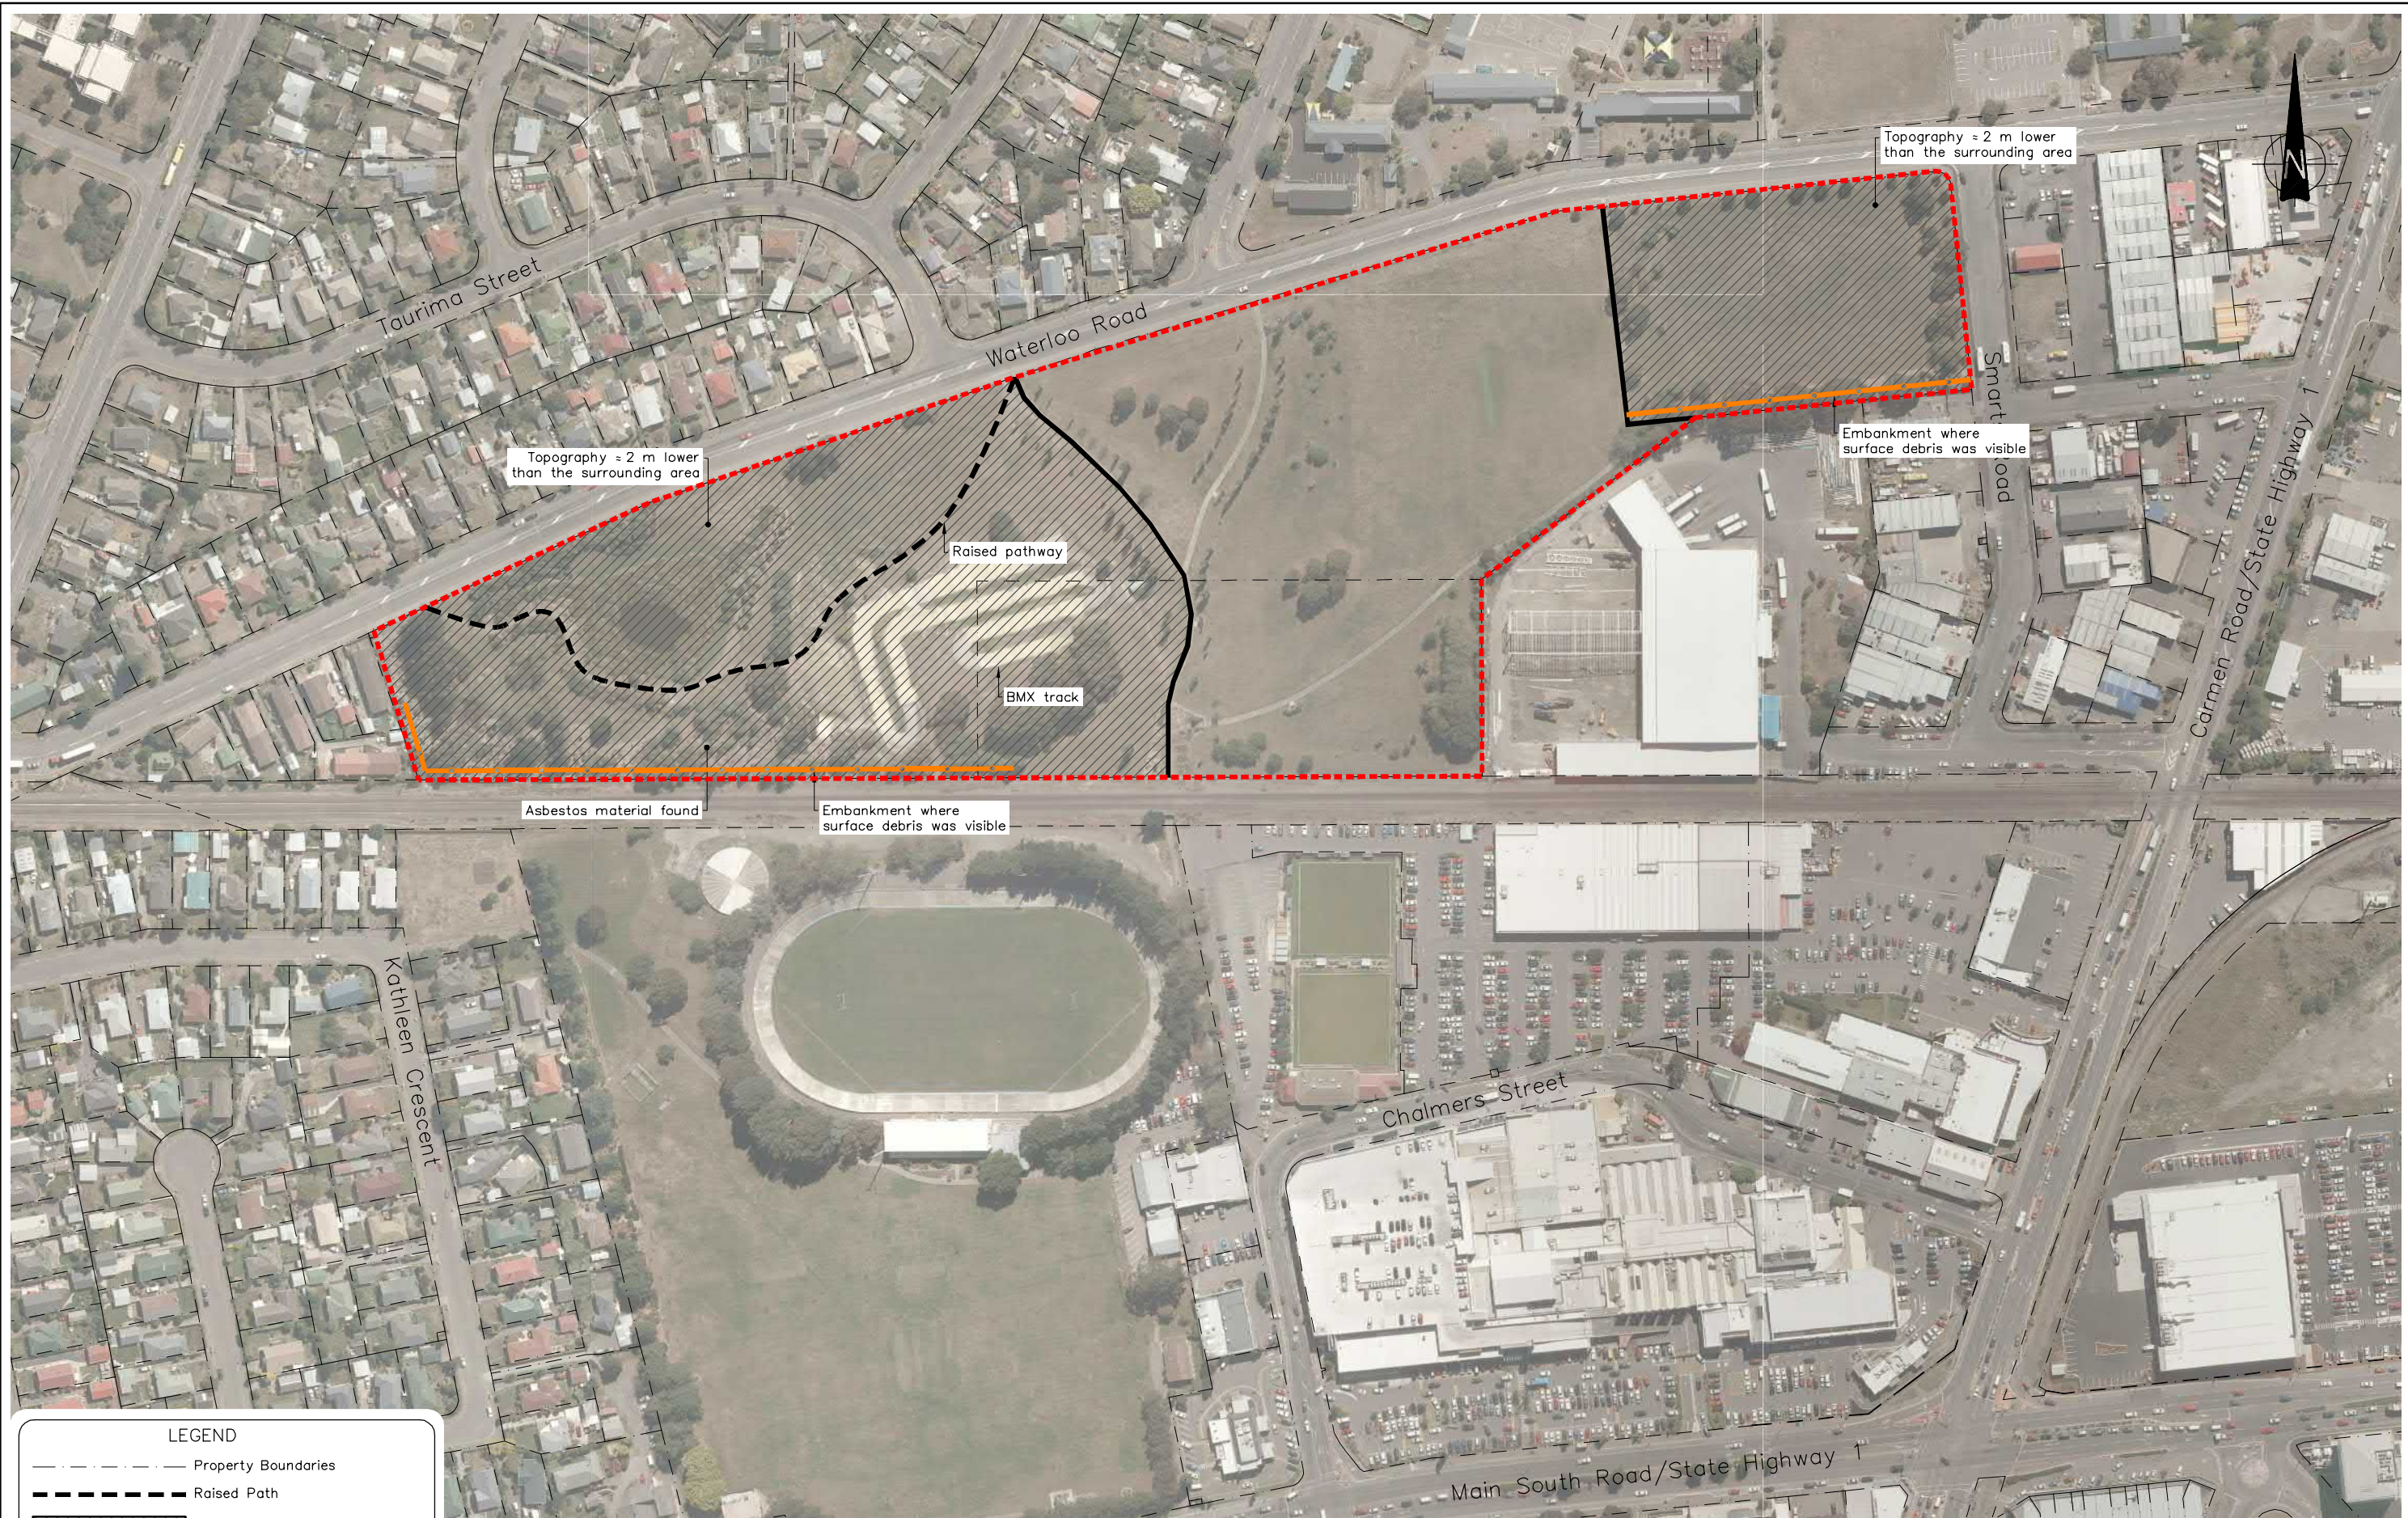
## **Appendix A: Site layout and photographs**

- Waste materials (such as concrete fragments, bricks, and glass) were observed along the embankment at the southeastern site boundary.
- Waste materials (such as concrete fragments, bricks, plastic, and glass) were observed along the embankment at the southwestern site boundary (Photograph 5). A fragment of friable fibreboard was found on the ground surface at this location (refer Figure A1 and Photographs 5-6, Appendix A). The fibreboard was tested for asbestos presence/absence at IANZ accredited laboratory. The results indicated that the fibreboard contained amosite, chrysotile and crocidolite (white, brown and blue) asbestos (refer to Appendix B for laboratory test results).

- It is not clear from our brief walkover whether the demolition materials observed at the southeast and southwest embankments were placed on top of the embankment (i.e. fly-tipped) or were exposed due to ground surface disturbance.

Surface debris	Asbestos.	During a site walkover, a piece of asbestos fibreboard was observed on an embankment at the northwestern site boundary. It was noted that the same embankment also had visible surface debris typically associated with demolition material (i.e. concrete and brick) on it.  As only a brief site walkover was undertaken, there is a potential for more asbestos containing materials to be present on-site.	Yes Activity I – land that has been subject to the intentional or accidental release of hazardous substance in sufficient quantity that it could be a risk to human health or the environment.

Given that the site is currently used as a recreational park then there is a potential for the friable asbestos, if present in further quantities, to be disturbed and for site users to be exposed to the disturbed and surficial asbestos material. As a specific assessment of the site for the presence of asbestos has not been completed, the extent and potential risk associated with further additional asbestos material (if present) on the site cannot be assessed. However, as a precautionary approach, T+T recommends that the embankment areas where building/demolition materials were observed are fenced to prevent public access as a matter of urgency.
