HORNBY LIBRARY, SERVICE CENTRE AND SW LEISURE CENTRE KYLE PARK

Landscape and Visual Assessment

Kyle Park Tree Survey

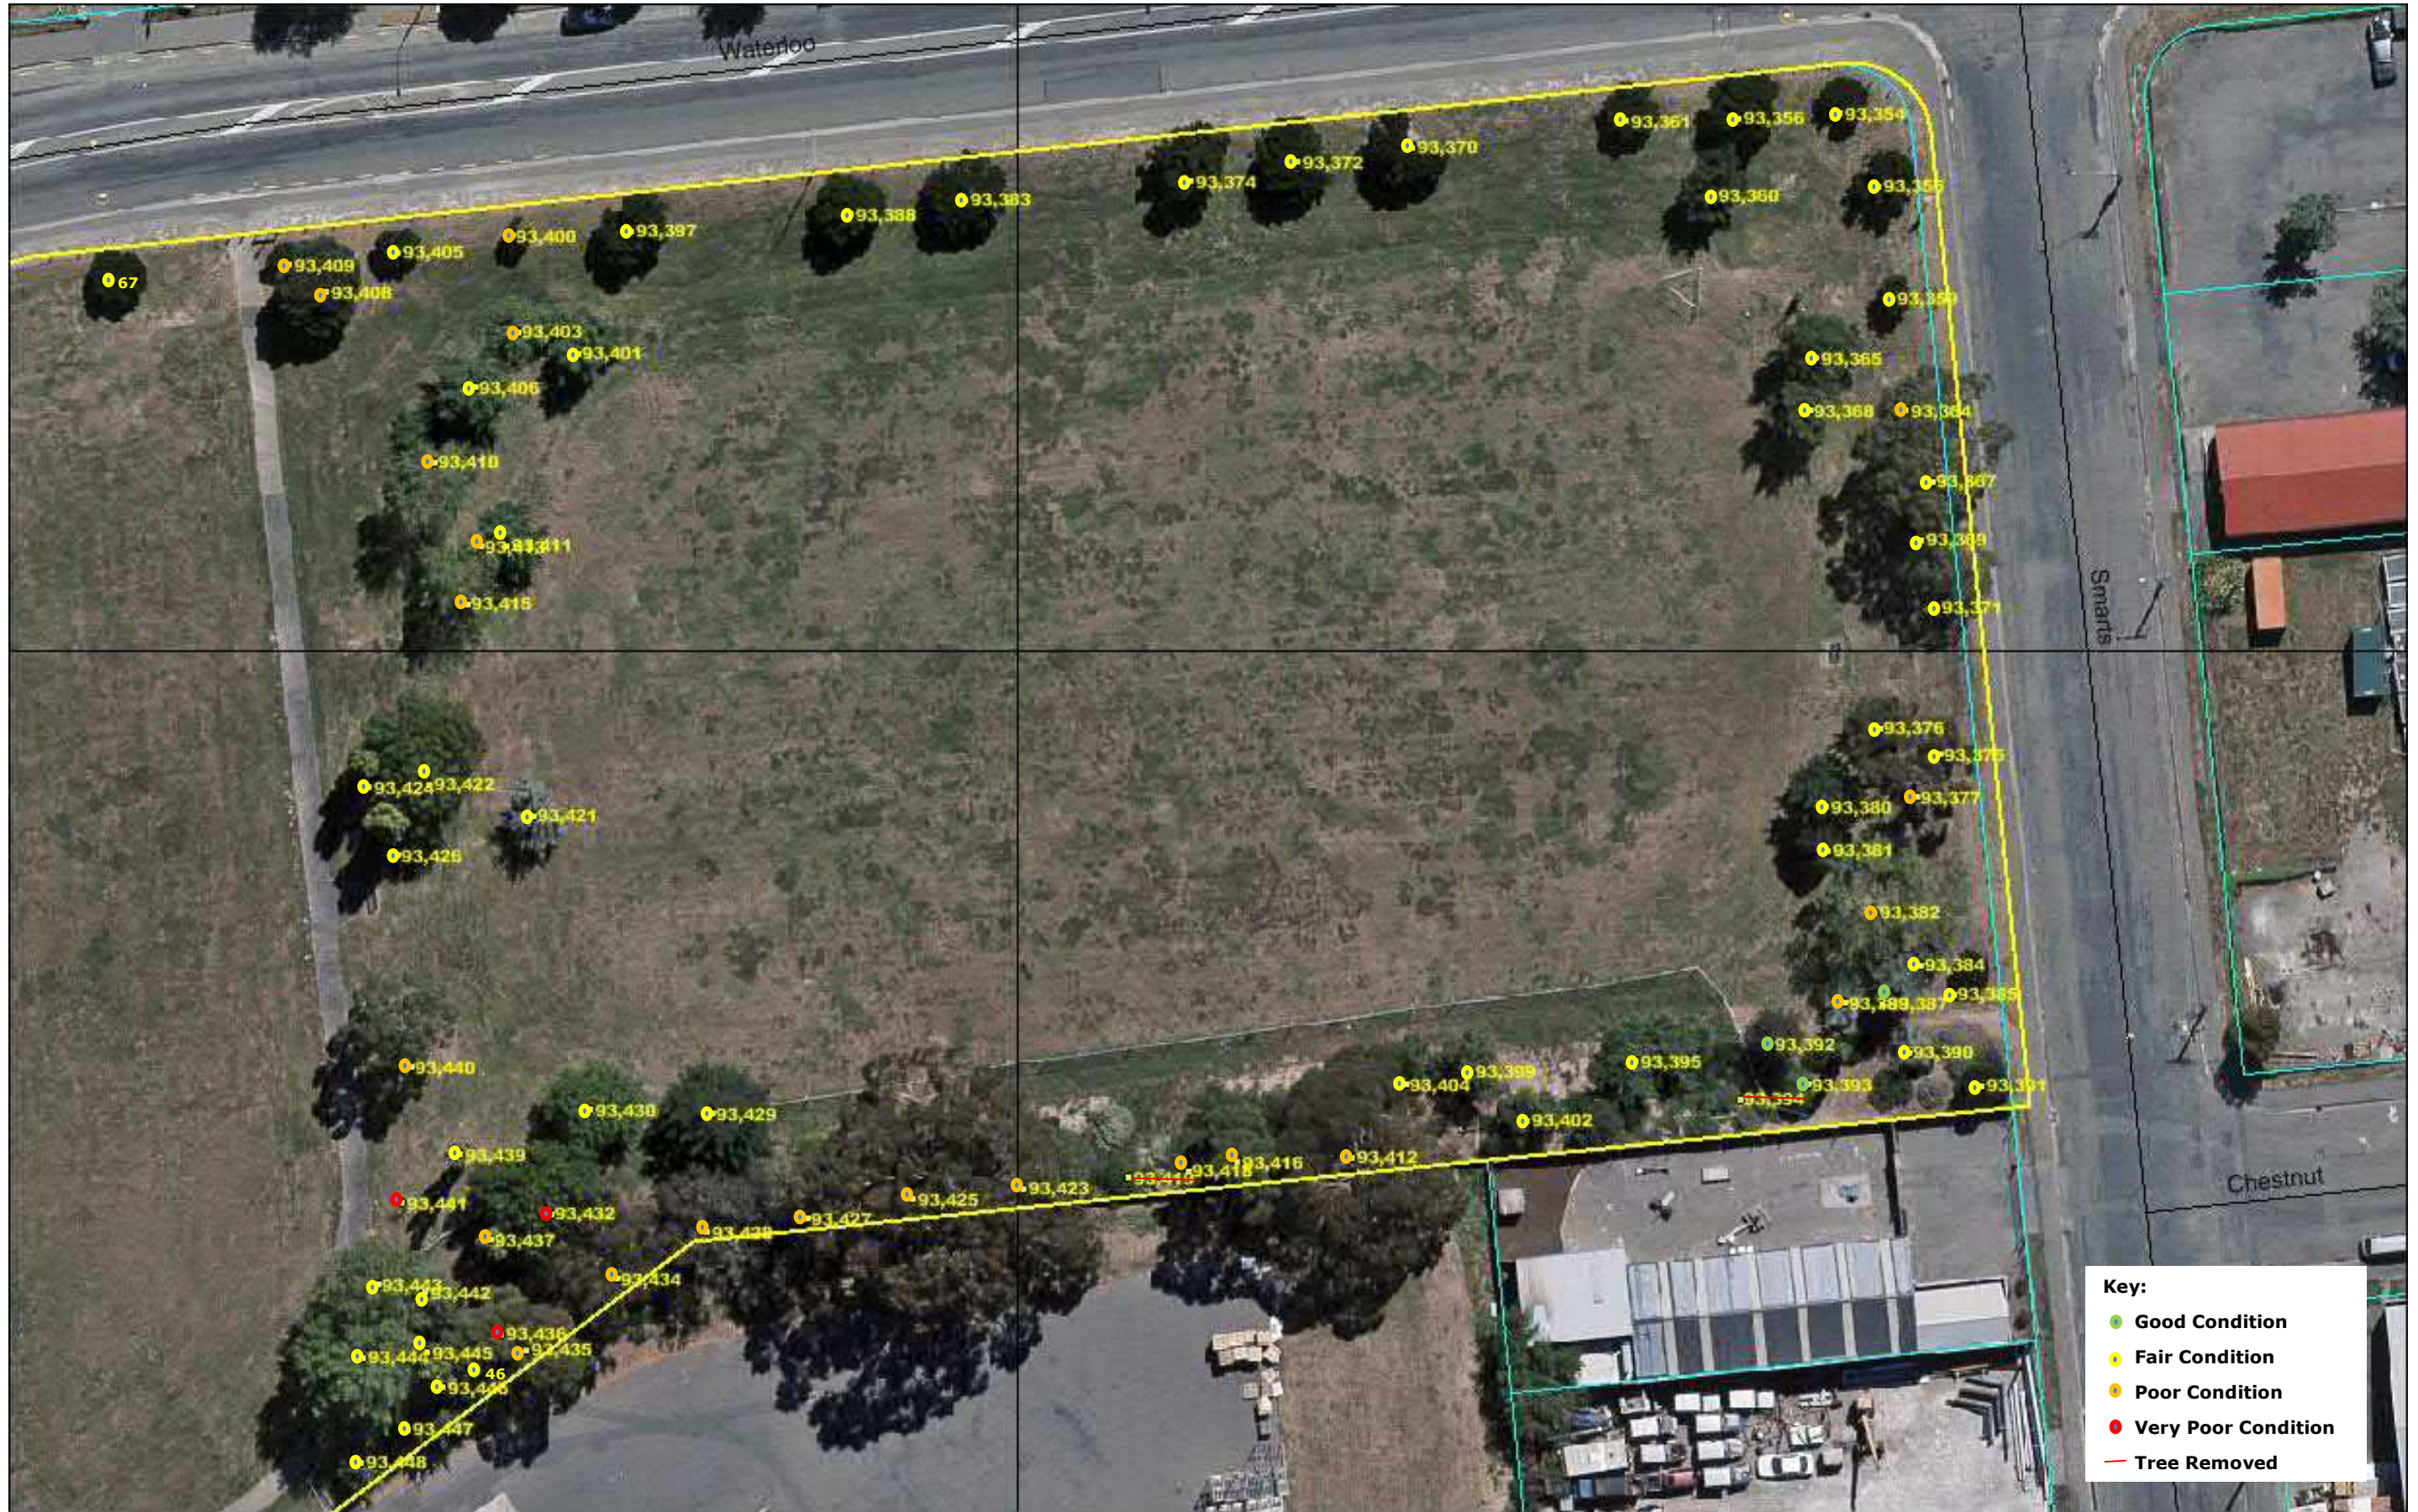
Tree Survey Map

- 3 trees were found to be in good condition;
- 49 trees in fair condition;
- 22 trees in poor condition; and,
- 3 trees in very poor condition.

The condition of the trees in poor and very poor condition related to a decline in tree health and/or structural integrity. Some of the trees in poor condition could be retained where maintenance pruning can improve the structural integrity of trees and where healthy growth is regenerating. The remaining trees in poor condition and the trees in very poor condition should be removed.

Tree maintenance is recommended within the survey area due to the structural condition of some trees.

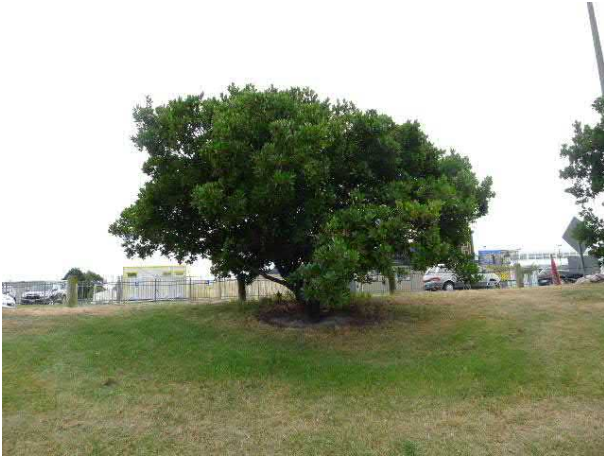
01 - 93361

Survey Number	Tree ID	Species	Common Name	Height	Canopy Spread	DBH	Tree Health	Tree Form	Overall Condition	Comments
1	93361	Arbutus unedo	Irish Strawberry Tree	3.0	5.0	0.30	2	3	3	Reasonably good foliage density, broken branch stub on southern side. Multiple stems near base, and canopy to near ground level.
2	93356	Arbutus unedo	Irish Strawberry Tree	5.0	7.0	0.35	2	3	3	Reasonably good foliage density, previous branch failures on western side. Multiple stems near base, and canopy to near ground level.
3	93360	Quercus cerris	Turkey Oak	6.0	7.0	0.2	2	3	3	Previous branch failures, and extensive decay.
4	93354	Arbutus unedo	Irish Strawberry Tree	4.0	5.0	0.3	2	3	3	Reasonably good foliage density, previous branch failures on the south-western side. Multiple stems near base, and canopy to near ground level.
5	93355	Arbutus unedo	Irish Strawberry Tree	5.0	6.0	0.45	2	3	3	Reasonably good foliage density. Multiple stems near base, and canopy to near ground level.

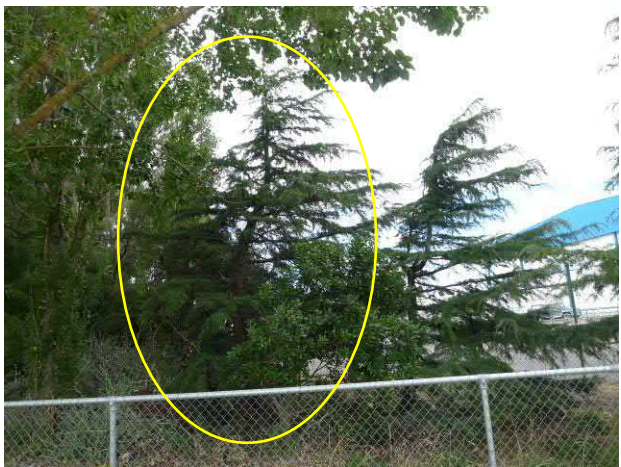
47 - 93445

46	46	Populus Italica nigra	Lombardy Poplar	8.0	2.0	0.1	3	3	3	Partial suppression, but fair condition overall.
47	93445	Populus Italica nigra	Lombardy Poplar	12.0	4.0	0.3	3	3	3	Sparse mid canopy. Basal wound on the western side, with possible decay. No significant structural defects.
48	93446	Cedrus deodara	Deodar Cedar	8.0	8.0	0.35	3	3	3	Slightly sparse lower canopy. Asymmetrical form due to suppression. No significant structural defects.
49	93447	Cedrus deodara	Deodar Cedar	5.5	4.0	0.18	3	3	3	Slightly sparse lower canopy. Asymmetrical form due to suppression. No significant structural defects.

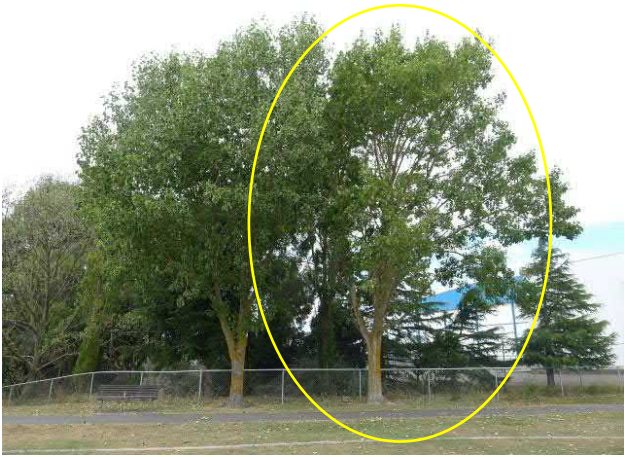
50 - 93448

Survey Number	Tree ID	Species	Common Name	Height	Canopy Spread	DBH	Tree Health	Tree Form	Overall Condition	Comments
50	93448	Cedrus deodara	Deodar Cedar	8.0	5.0	0.25	2	3	3	Some suppression on the north-western side of the canopy. No significant structural defects.
51	93444	Populus nigra	Black Poplar	14.5	11.0	0.45	3	3	3	Slightly sparse foliage density, currently less than 30% foliage density loss. Minor deadwood. Previous branch failures.
52	93443	Populus yunnanensis	Chinese Poplar	14.5	9.0	0.4	2	3	3	Reasonably good foliage density. Co-dominant from 2.0m with included unions.
53	93441	Cedrus Glauca atlantica	Blue Atlas Cedar	2.0	2.5	0.08	5	4	5	Small, stunted tree in very poor condition due to lack of live growth, a large bark wound at the trunk base, and multiple previous branch failures.
54	93439	Populus Italica nigra	Lombardy Poplar	13.0	2.0	0.18	3	3	3	Reasonably good foliage density, slight yellowing of leaves. No significant structural defects.

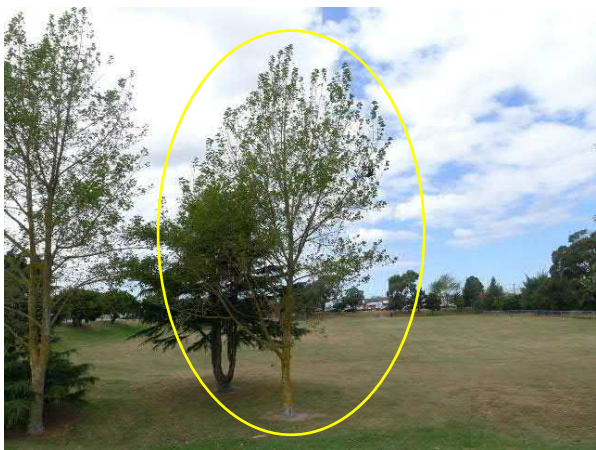
59 - 93422

Survey Number	Tree ID	Species	Common Name	Height	Canopy Spread	DBH	Tree Health	Tree Form	Overall Condition	Comments
59	93422	Populus yunnanensis	Chinese Poplar	11.0	12.0	0.35	3	3	3	Reasonably good foliage density slightly sparse crown, but less than 30% decline. Minor lateral suppression on the western side.
60	93415	Populus nigra	Black Poplar	10.0	11.0	0.25	4	4	4	Sparse crown, approximately 50% decline, and an old basal wound with decay.
61	93413	Populus nigra	Black Poplar	10.0	11.0	0.3	4	3	4	Sparse crown, approximately 50% decline.
62	93411	Cedrus atlantica	Atlas Cedar	7.0	7.0	0.25	2	3	3	Reasonably good foliage density. Multiple stems from ground level and multiple girdling roots. Slight lateral suppression from an adjacent tree, but no significant structural defects.
63	93410	Cedrus atlantica	Atlas Cedar	2.5	9.0	0.2	2	4	4	Reasonably good foliage density, crown to ground level. Central leader lost, and heavily suppressed under adjacent trees.

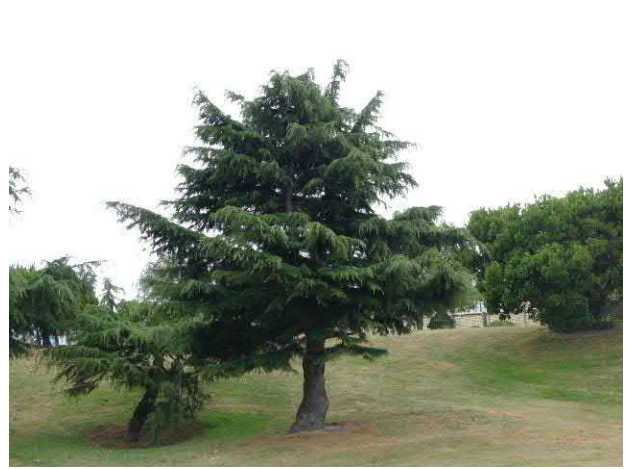
65 - 93403

64	93406	Cedrus atlantica	Atlas Cedar	7.0	10.0	0.35	2	3	3	Reasonably good foliage density. Multiple recent branch failures on the western side of the canopy.
65	93403	Cedrus atlantica	Atlas Cedar	3.5	5.0	0.2	3	4	4	Reasonably good foliage density. Central leader lost some time ago, and heavily suppressed by adjacent trees. Multiple previous branch failures.
66	93401	Cedrus atlantica	Atlas Cedar	6.0	8.0	0.4	2	3	3	Reasonably good foliage density. Asymmetrical form. No significant structural defects, but multiple branch failures in the lower crown.
67	67	Arbutus unedo	Irish Strawberry Tree	3.5	6.0	0.5	2	3	3	Reasonably good foliage density. Multiple stems from base, and canopy to near ground level. Broken branch stub on western side.

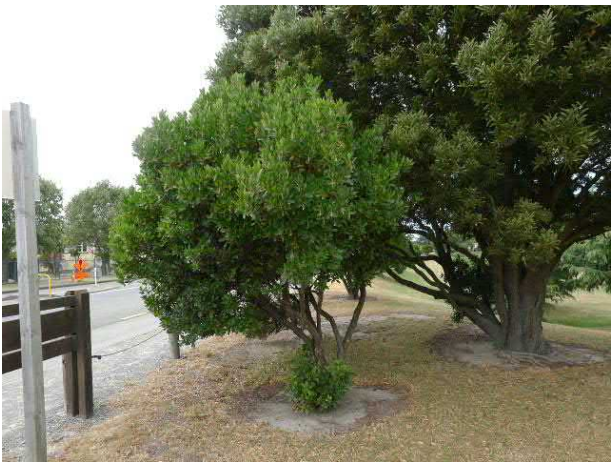
68 - 93408

Survey Number	Tree ID	Species	Common Name	Height	Canopy Spread	DBH	Tree Health	Tree Form	Overall Condition	Comments
68	93408	Acacia melanoxylon	Tasmanian Blackwood	8.0	8.0	0.6	3	4	4	Multiple stems from ground level, multiple included unions. Several delaminated branches.
69	93409	Arbutus unedo	Irish Strawberry Tree	3.0	3.0	0.2	3	4	4	Reasonably good foliage density. Multiple stems near base, and canopy to near ground level. Heavily suppressed by adjacent trees.
70	93405	Arbutus unedo	Irish Strawberry Tree	3.0	4.0	0.35	2	3	3	Reasonably good foliage density. Multiple stems near base, and canopy to near ground level.
71	93400	Arbutus unedo	Irish Strawberry Tree	2.5	4.0	0.25	2	4	4	Reasonably good foliage density. Multiple stems near base, and canopy to near ground level. Previous branch failures in the mid canopy.
72	93397	Arbutus unedo	Irish Strawberry Tree	4.0	7.0	0.4	2	3	3	Reasonably good foliage density. Multiple stems near base, and canopy to near ground level. Previous branch failures on the north-western side and mid canopy.
