Grand National Stand - Detailed Damage Evaluation

3D Response Spectrum, 3D Non-linear Pushover & Vertical
analysis

Client: Canterbury Jockey Club

27-Jan-2015

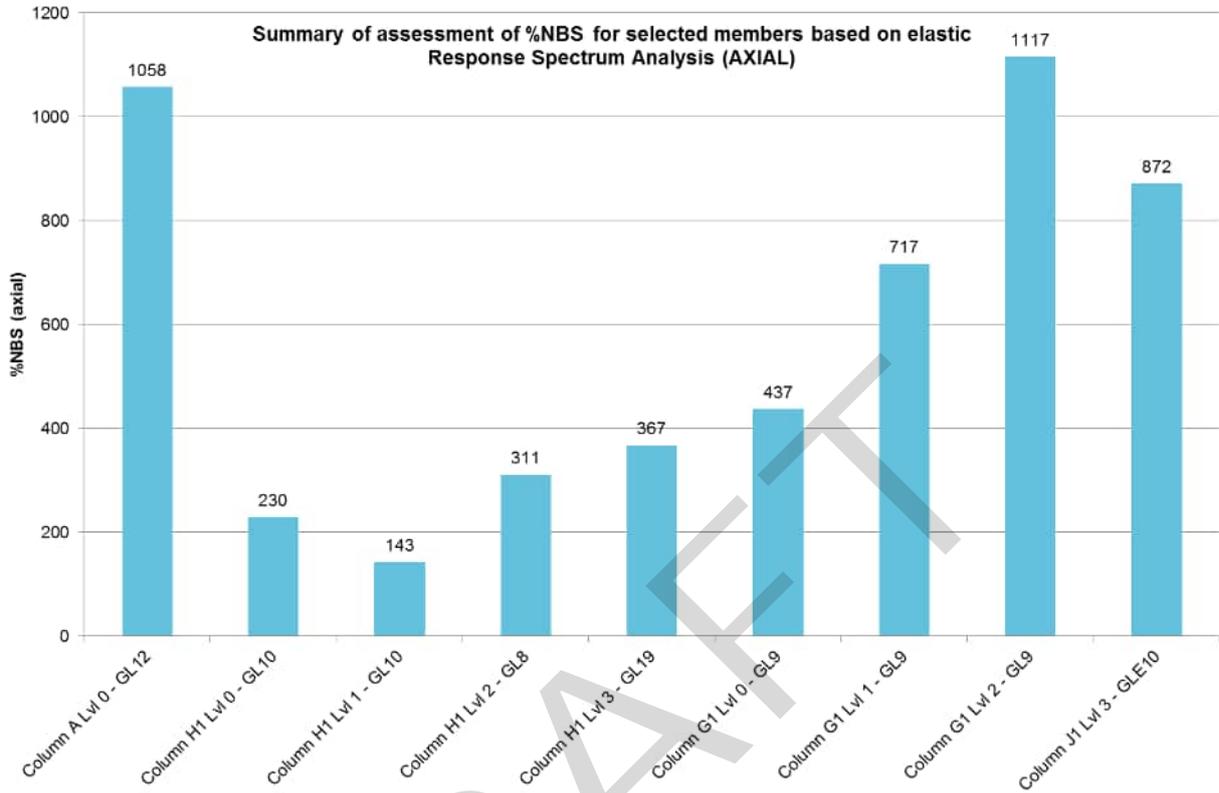
Figure 4-5 RSA selected member axial capacities

Cursory check of axial capacity-demand ratios on the selected columns indicated no problems with their axial strength.

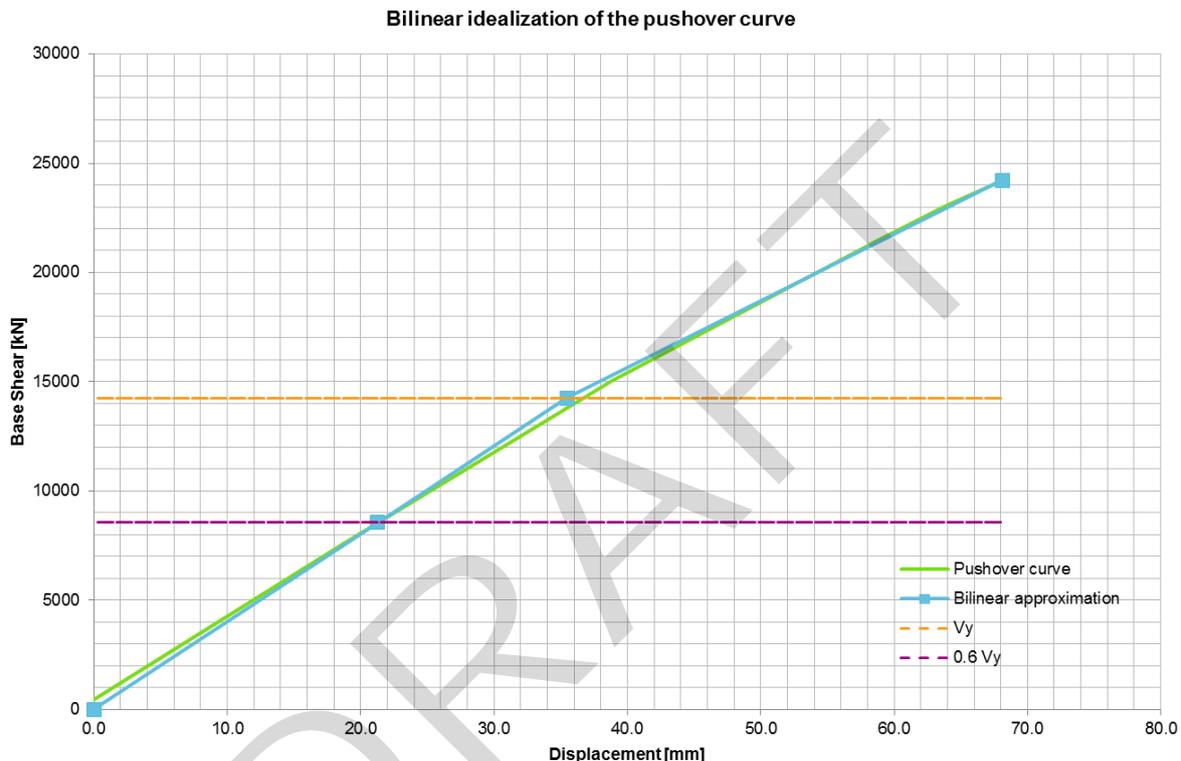
Figure 4-9 Pushover and bilinear idealization plots for push in east direction

The pushover curve and its bilinear idealization are presented in Figure 4-9. The figure also shows the effective yield strength of the building (V_y) as calculated in accordance with ASCE 41-13. It should be noted that the pushover curve is relatively linear with no characteristic plateau observed.

The progression of the inelastic behaviour within the structure is demonstrated in Table 4-8 which shows the development of links and their status at different drift levels. As the structure is analysed a total number of 246 links yielded and 26 exceeded their ultimate capacity.

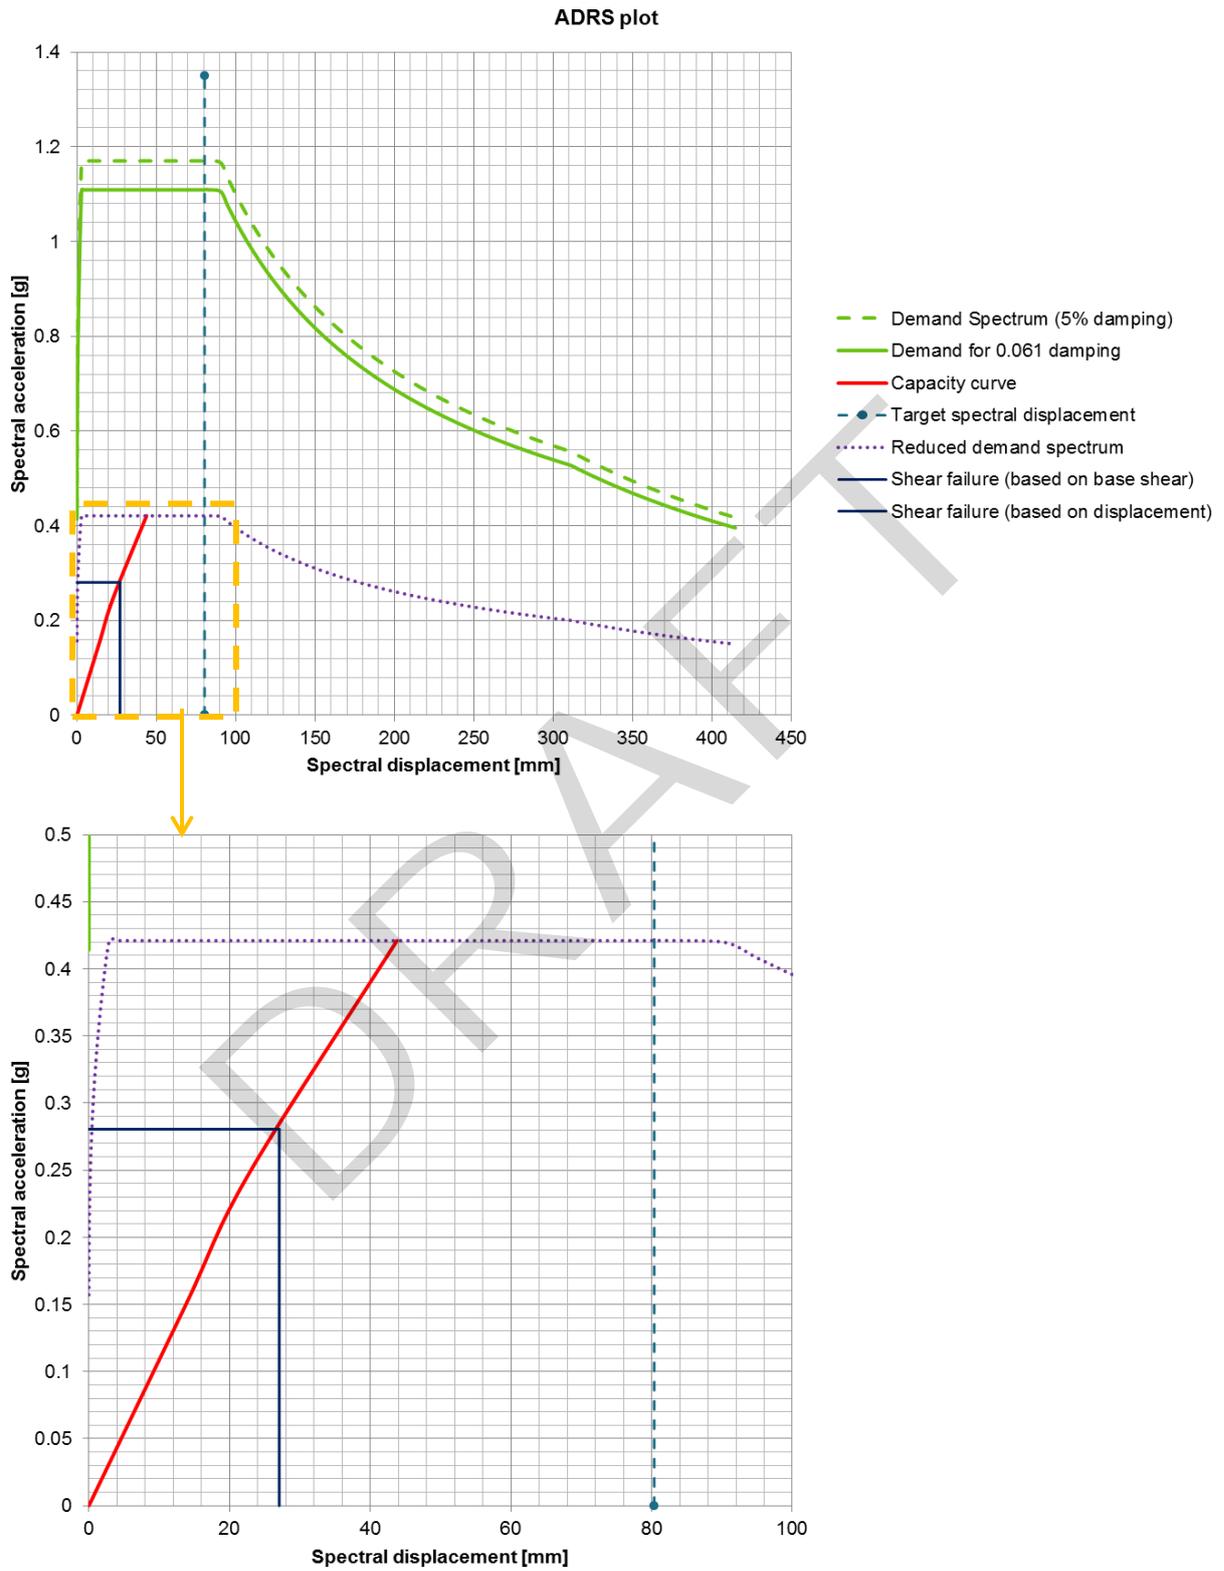
Figure 4-11 ADRS plot push in east direction

Figure 4-11 presents the ADRS representation of the pushover analysis with the demand spectrum and capacity curves shown.

Load case	Pushover curve			First shear failure		%NBS		
	Max base shear (kN)	Max displacement (mm)	Target displacement (mm)	Main building/elevator core Base shear (kN)	Displacement (mm)	Displacement based assessment (%NBS)	Force based assessment (%NBS)	Shear failure (%NBS)
PUSH-X D1	24208	68	125	16132	42	54%	38%	25%

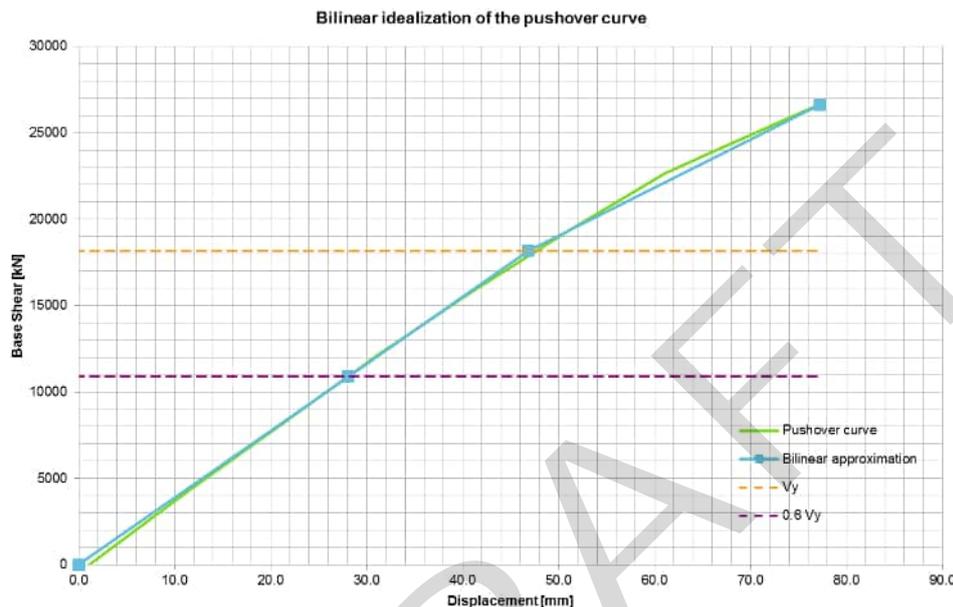
Figure 4-12 Pushover and bilinear idealization curves for push in west direction

The pushover curve and its bilinear idealization are presented in Figure 4-12. The figure also shows the effective yield strength of the building (V_y) as calculated in accordance with ASCE 41-13. It should be noted that the pushover curve is relatively linear with no characteristic plateau observed.

The progression of the inelastic behaviour within the structure is demonstrated in Table 4-10 which shows the development of links and their status at different drift levels. As the structure is analysed a total number of 255 links yielded and 49 exceeded their ultimate capacity.

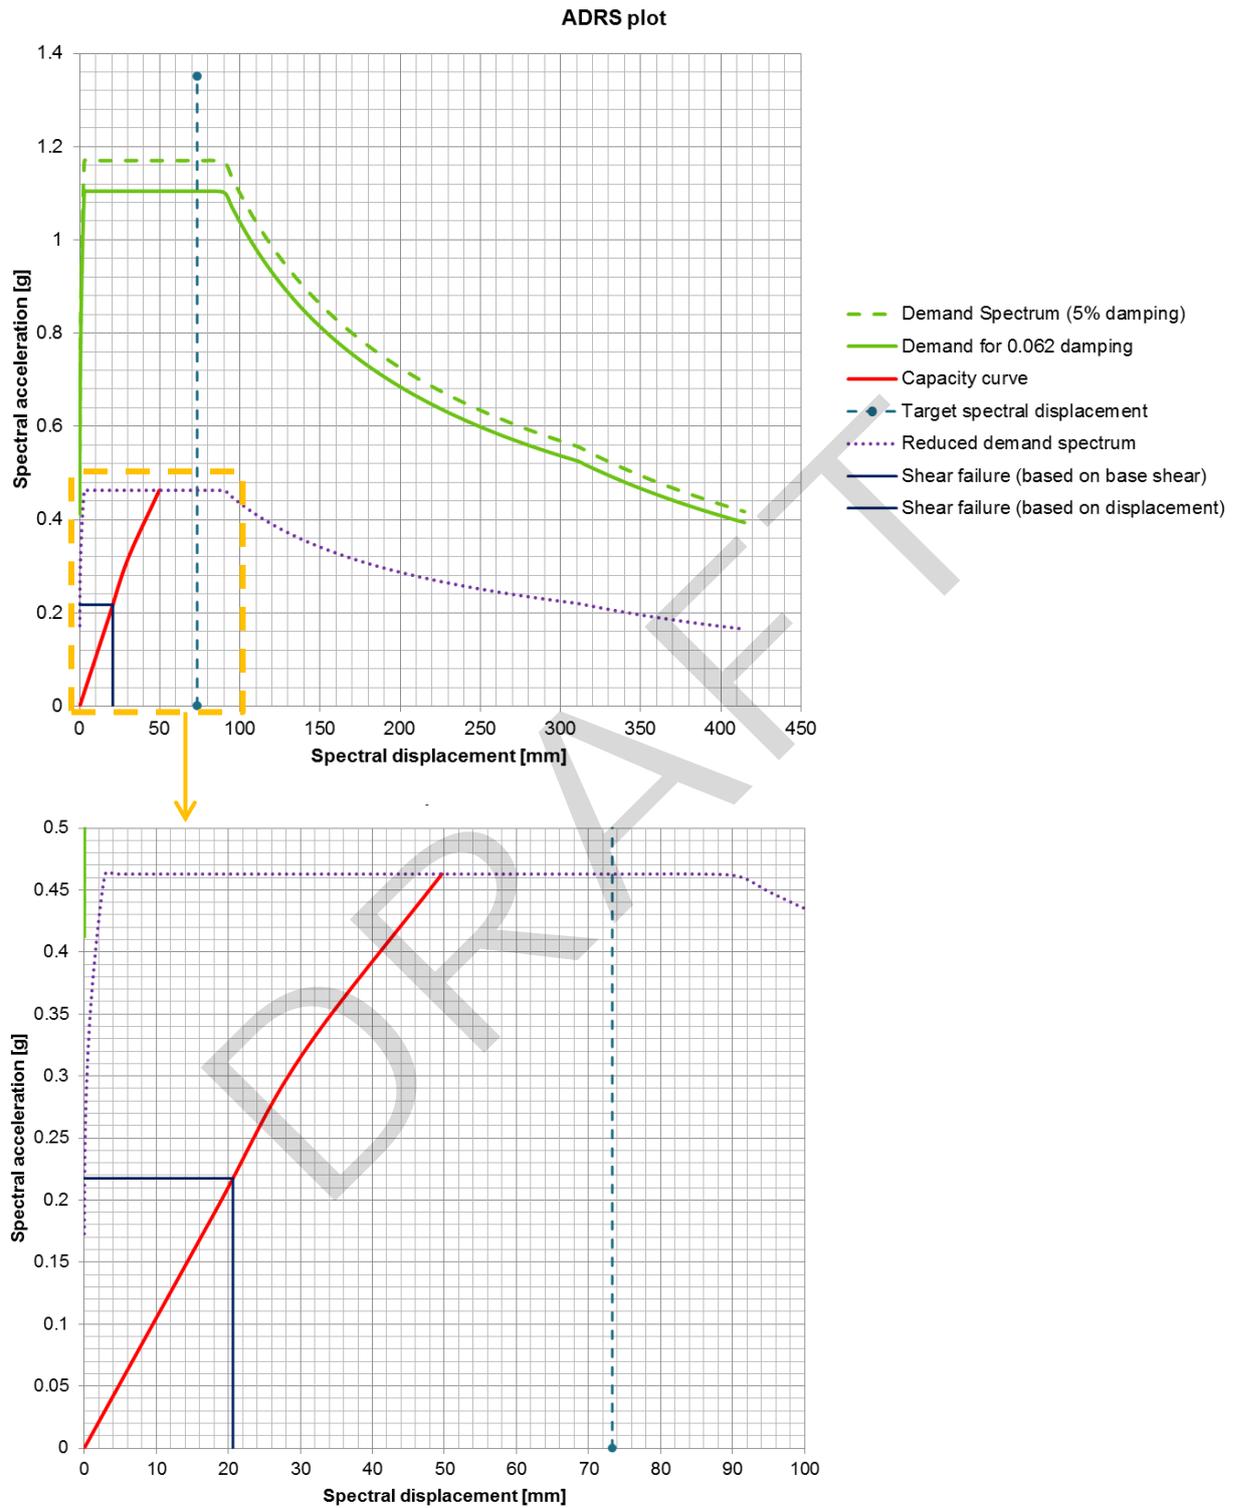
Figure 4-14 ADRS plot push in west direction

Figure 4-14 presents the ADRS representation of the pushover analysis with the demand spectrum and capacity curves shown.

Load case	Pushover curve			First shear failure		%NBS		
	Max base shear (kN)	Max displacement (mm)	Target displacement (mm)	Main building/elevator core Base shear (kN)	Displacement (mm)	Displacement based assessment (%NBS)	Force based assessment (%NBS)	Shear failure (%NBS)
PUSH-X D2	26618	77	114	12507	32	68%	42%	20%

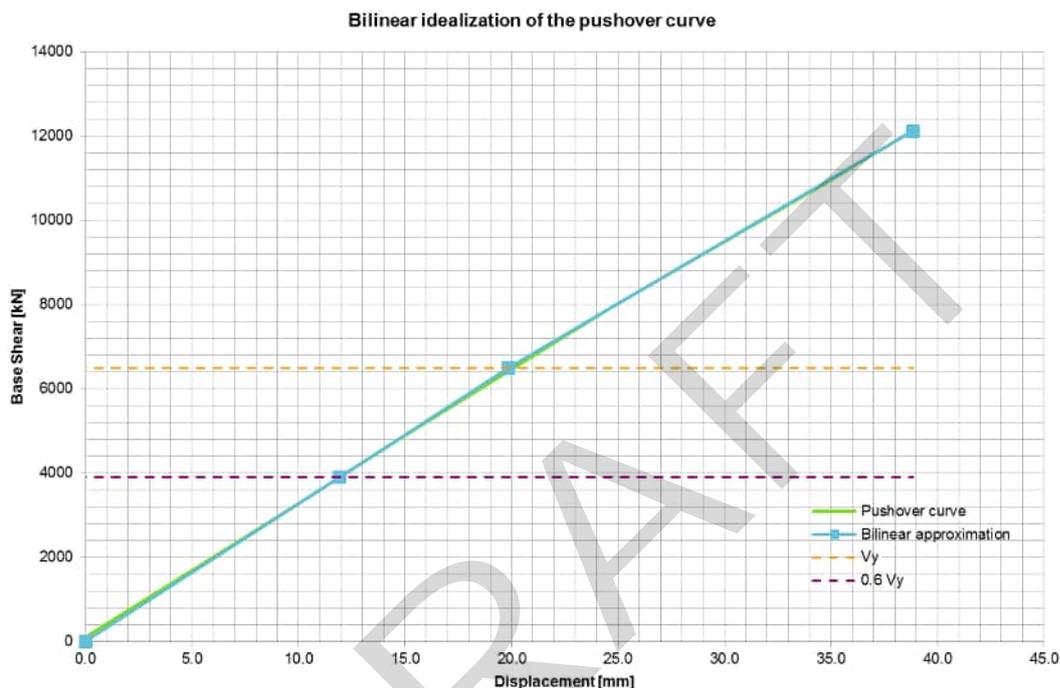
Figure 4-15 Pushover and bilinear idealization curves for pushover analysis in north direction

The pushover curve and its bilinear idealization are presented in Figure 4-15. The figure also shows the effective yield strength of the building (V_y) as calculated in accordance with ASCE 41-13. It should be noted that the pushover curve is relatively linear with no characteristic plateau observed.

The progression of the inelastic behaviour within the structure is demonstrated in Table 4-12 which shows the development of links and their status at different drift levels. As the structure is analysed a total number of 167 links yielded and 5 exceeded their ultimate capacity.

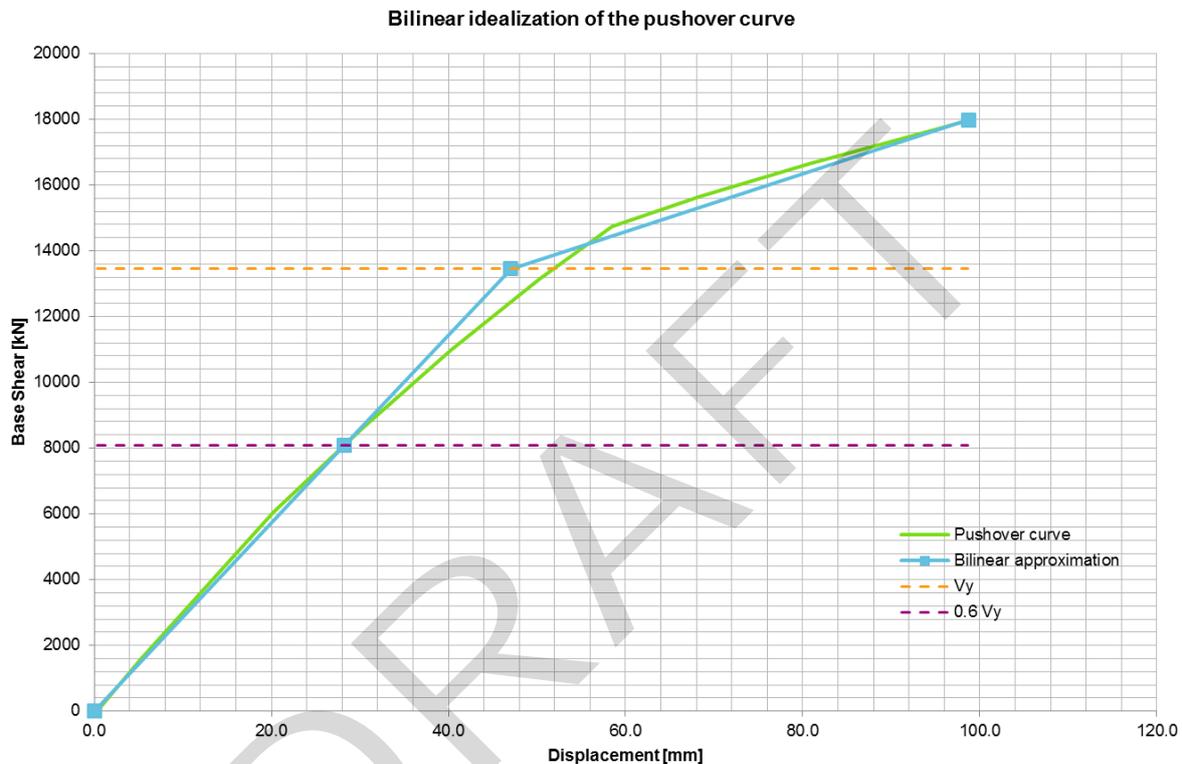
Figure 4-18 Pushover and bilinear idealization curves for push in south direction

The pushover curve and its bilinear idealization are presented in Figure 4-18. The figure also shows the effective yield strength of the building (V_y) as calculated in accordance with ASCE 41-13. It should be noted that the pushover curve is relatively linear with a minimal plateau observed.

The progression of the inelastic behaviour within the structure is demonstrated in Table 4-14 which shows the development of links and their status at different drift levels. As the structure is analysed a total number of 251 links yielded and 30 exceeded their ultimate capacity.

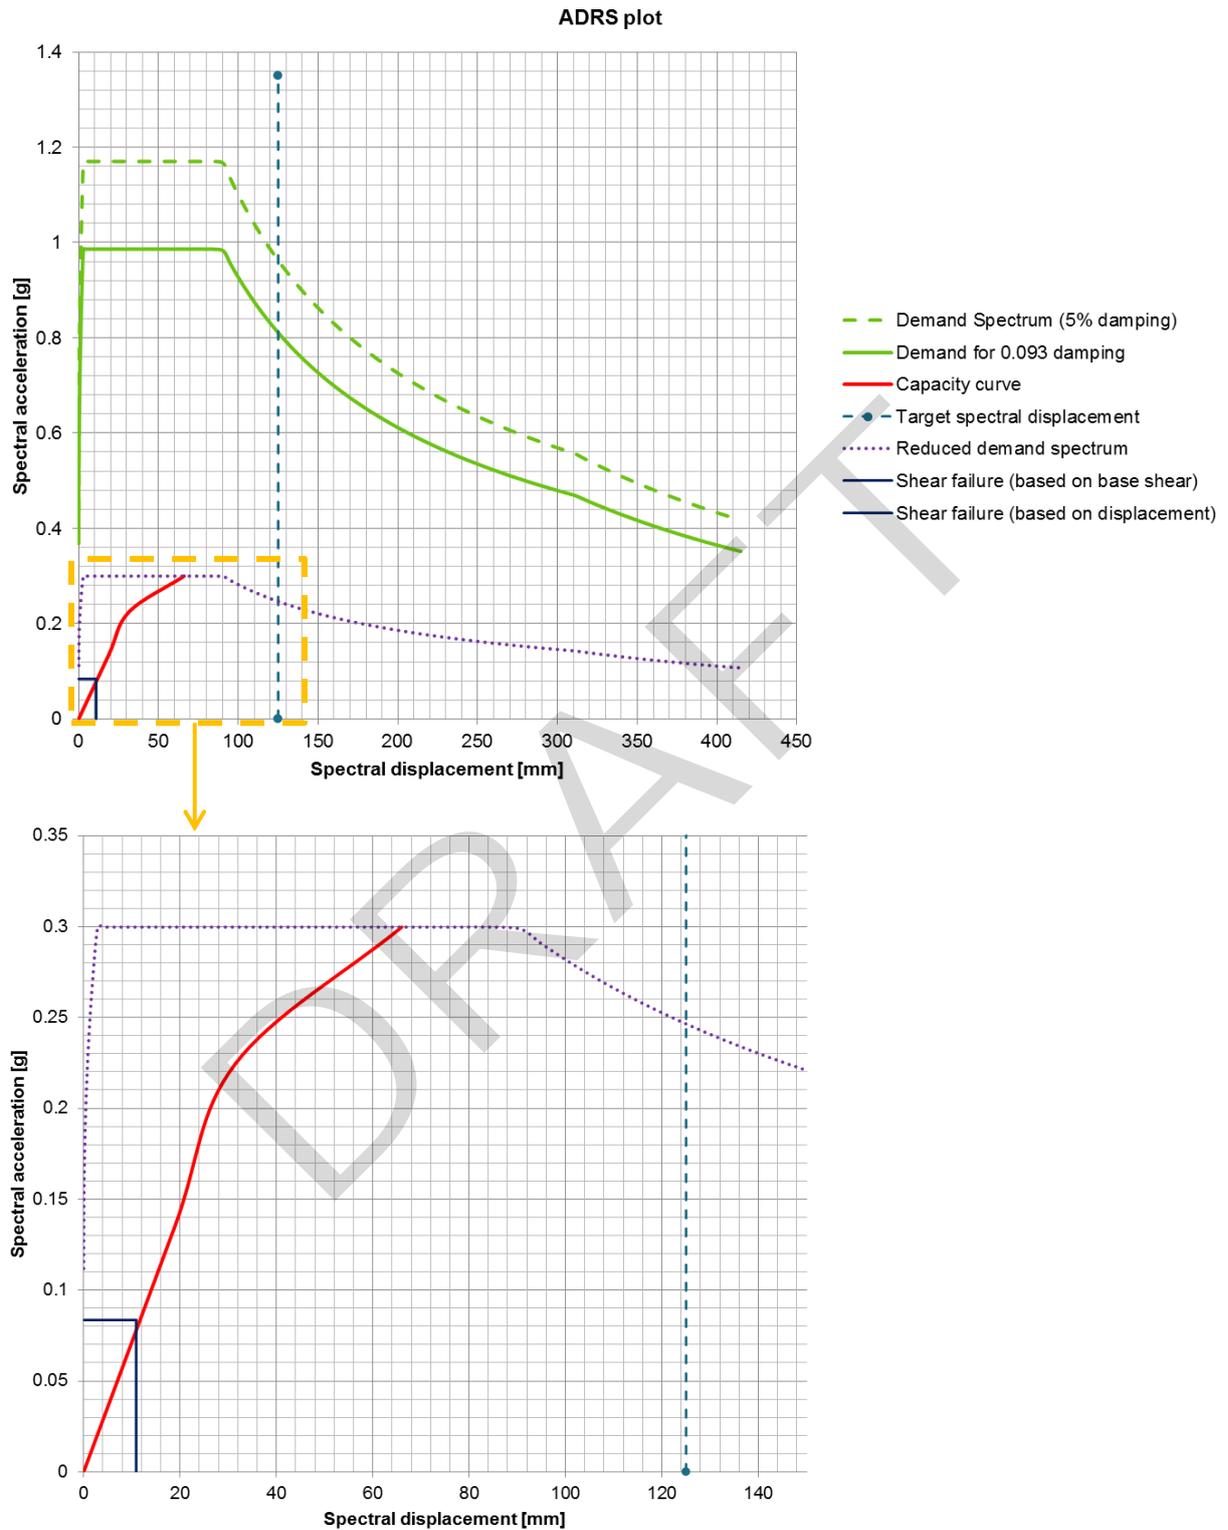
Figure 4-20 ADRS plot push in south direction

Figure 4-20 presents the ADRS representation of the pushover analysis with the demand spectrum and capacity curves shown.

Load case	Pushover curve			First shear failure		%NBS		
	Max base shear (kN)	Max displacement (mm)	Target displacement (mm)	Main building/elevator core Base shear (kN)	Displacement (mm)	Displacement based assessment (%NBS)	Force based assessment (%NBS)	Shear failure (%NBS)
PUSH-Y D2	17980	99	187	5013	16	53%	30%	8%

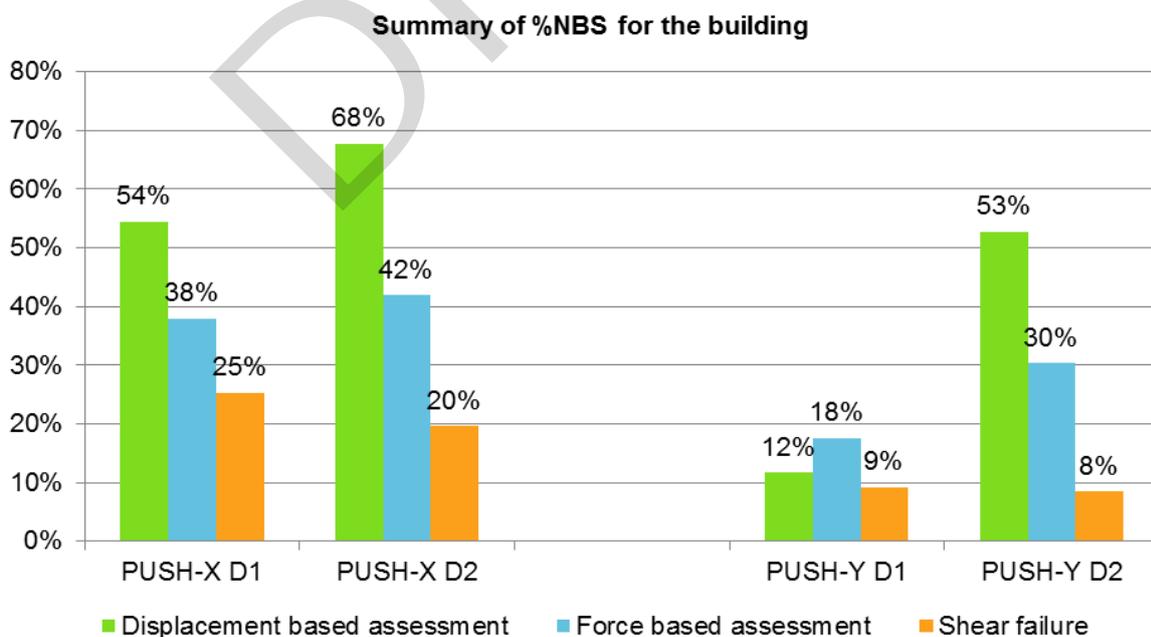
Figure 4-21 Graphical summary of results

A summary of the results from the nonlinear pushover analyses is shown in Table 4-16 and illustrated in Figure 4-21.

Load case	Pushover curve			First shear failure		%NBS		
	Max base shear (kN)	Max displacement (mm)	Target displacement (mm)	Main building/elevator core Base shear (kN)	Displacement (mm)	Displacement based assessment (%NBS)	Force based assessment (%NBS)	Shear failure (%NBS)
X D1	24208	68	125	16132	42	54%	38%	25%
X D2	26618	77	114	12507	32	68%	42%	20%
Y D1	12116	39	333	9673	31	12%	18%	9%
Y D2	17980	99	187	5013	16	53%	30%	8%

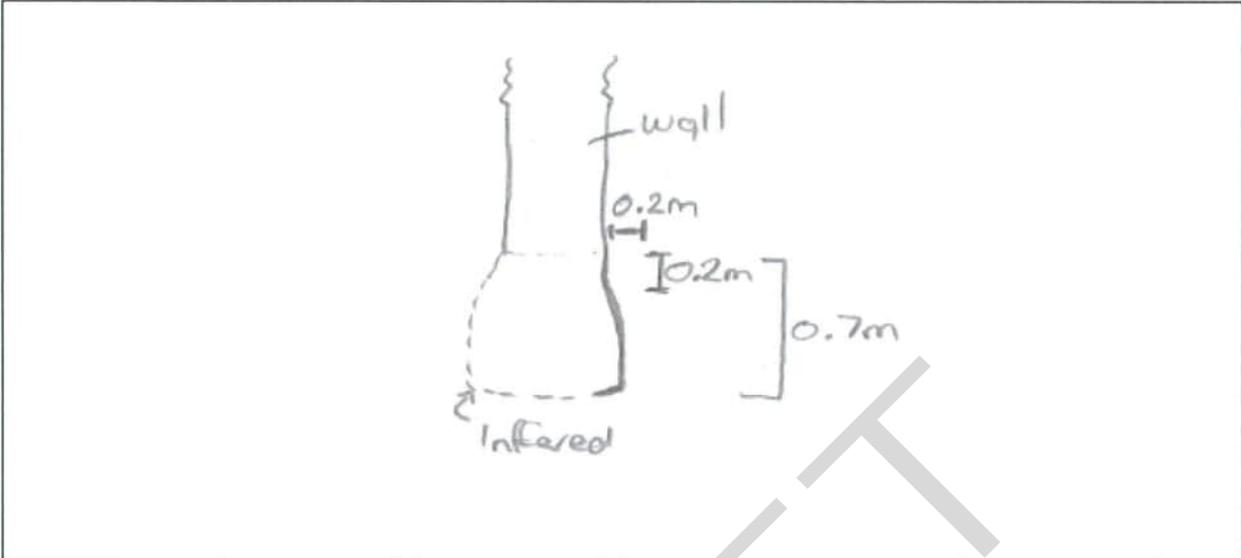
Figure 1 Level 0 gridline A4 foundation diagram

- Dominion has broken out the concrete slab adjacent to the strip foundation on the internal side of the ground floor, exposing a length of the strip foundation down to the base, see Figure 1 for graphical representation.
- The foundation consists of a concrete strip founded at 0.7 m below the base of the slab in natural silt material. The foundation has been boxed for the top 0.2 m with the remaining 0.5 m being poured against the excavation face.
- A single hand auger with an adjacent Dynamic Cone Penetrometer (DCP) test and shear vane tests in cohesive materials was undertaken in the excavation. The log of this investigation is attached to this memo.

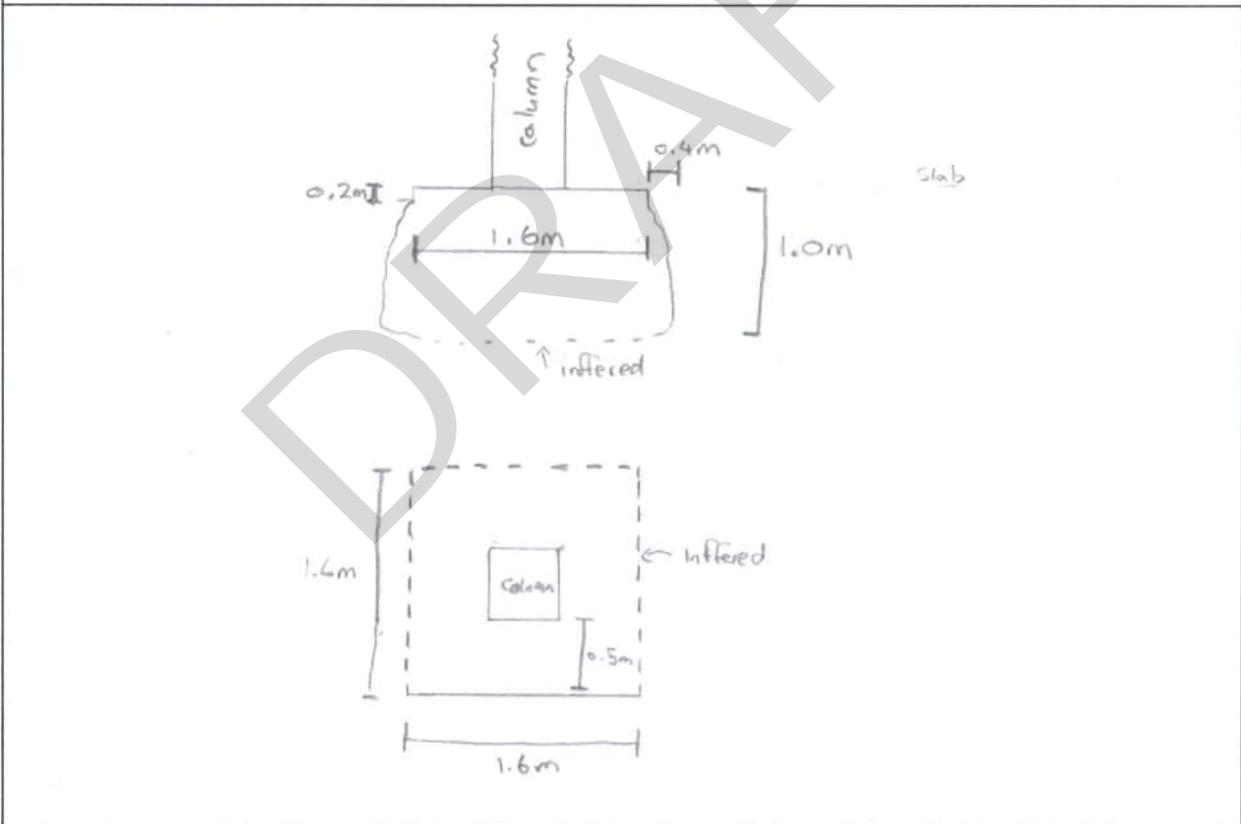
Figure 2 Level 0 gridline B4 foundation diagram

- Dominion has broken out the concrete slab adjacent to the pad foundation on one side and excavated alongside the pad to expose the approximate base and two edges see Figure 2 for graphical representation.
- The foundation consists of a concrete pad foundation 1.6 m by 1.6 m wide founded at 1.0 m below the base of the slab. The foundation has been boxed for the top 0.2 m with the remaining 0.8 m being poured against the excavation face forming a curve that extends 0.4 m outside the boxed edge. This pad is founded in natural silt material.
- A single hand auger with an adjacent Dynamic Cone Penetrometer (DCP) test and shear vane tests in cohesive materials was undertaken in the excavation. The log of this investigation is attached to this memo.

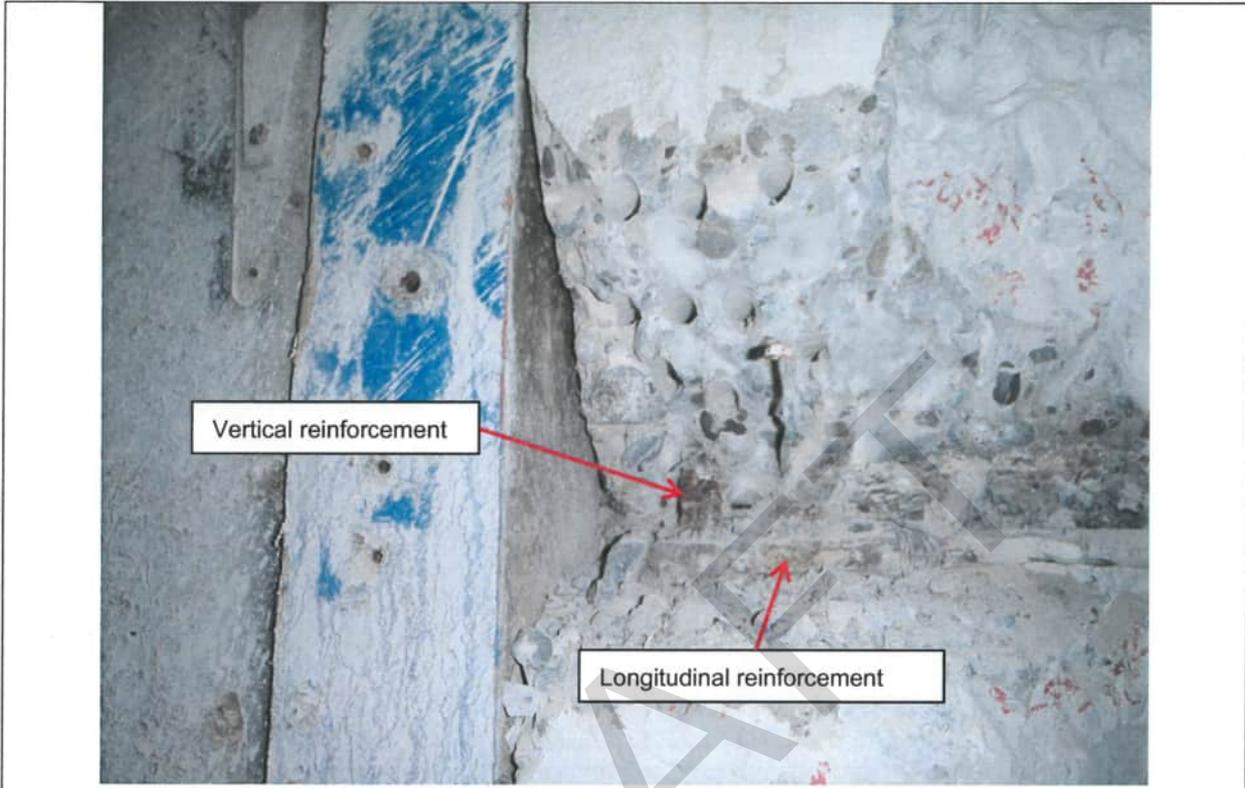
- The concrete wall between the column and the doorway was investigated for possible vertical reinforcing which the longitudinal bars links to.
- A single, vertical 19 mm diameter bar of reinforcement was found 40 mm from the doorway. The horizontal bar looped around this vertical bar.

Photo 1 Vertical reinforcement adjacent to door with longitudinal bar coming in

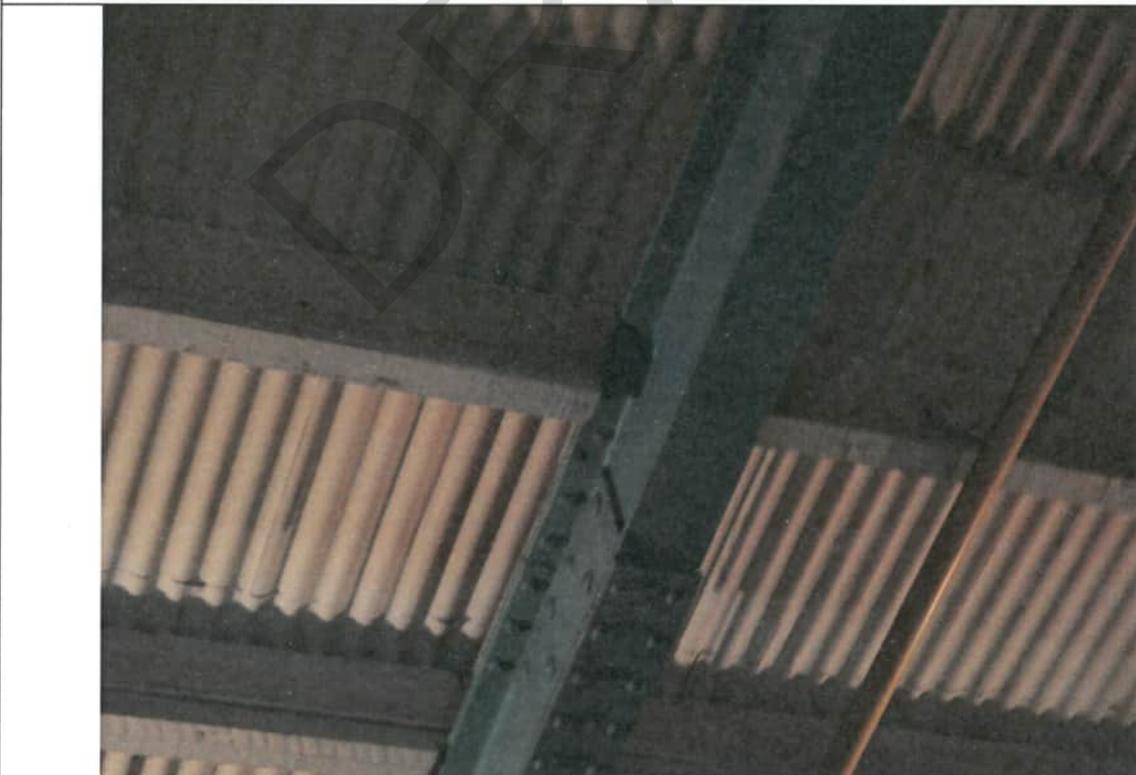
Photo 2 Steel splice plate on beam supporting bleachers

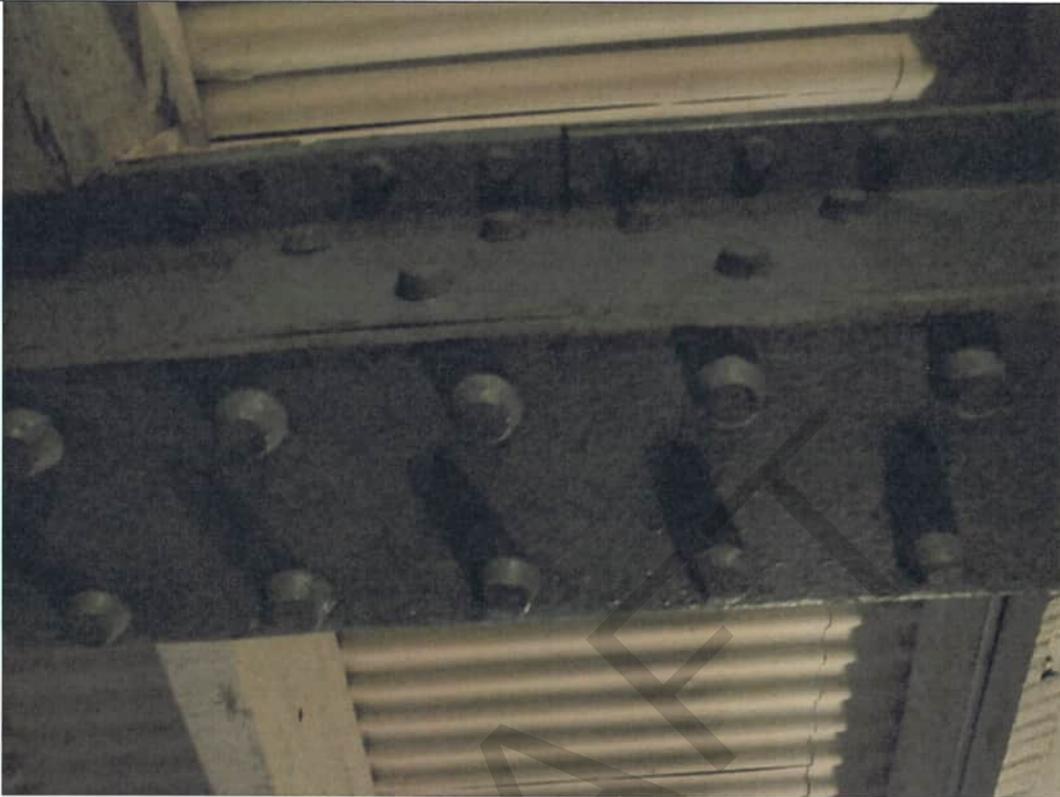
Photo 3 Steel splice plate on beam supporting bleachers, showing rivets

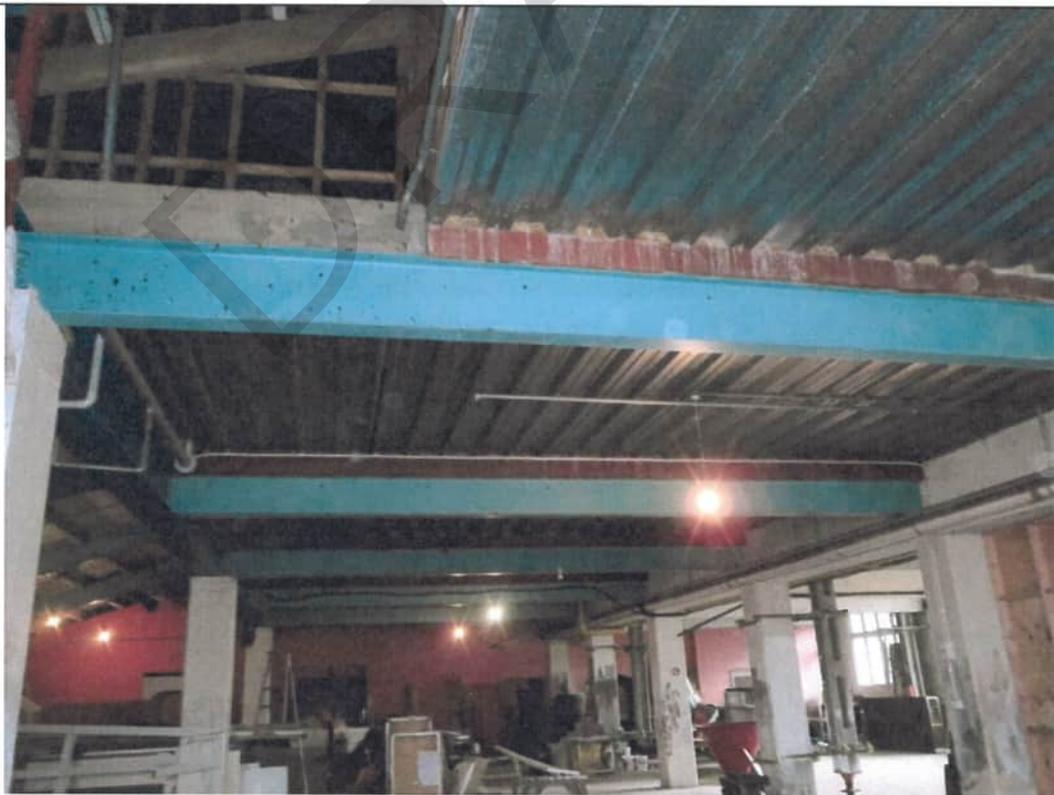
Photo 4 Tray slab supported on beams between gridline B and C

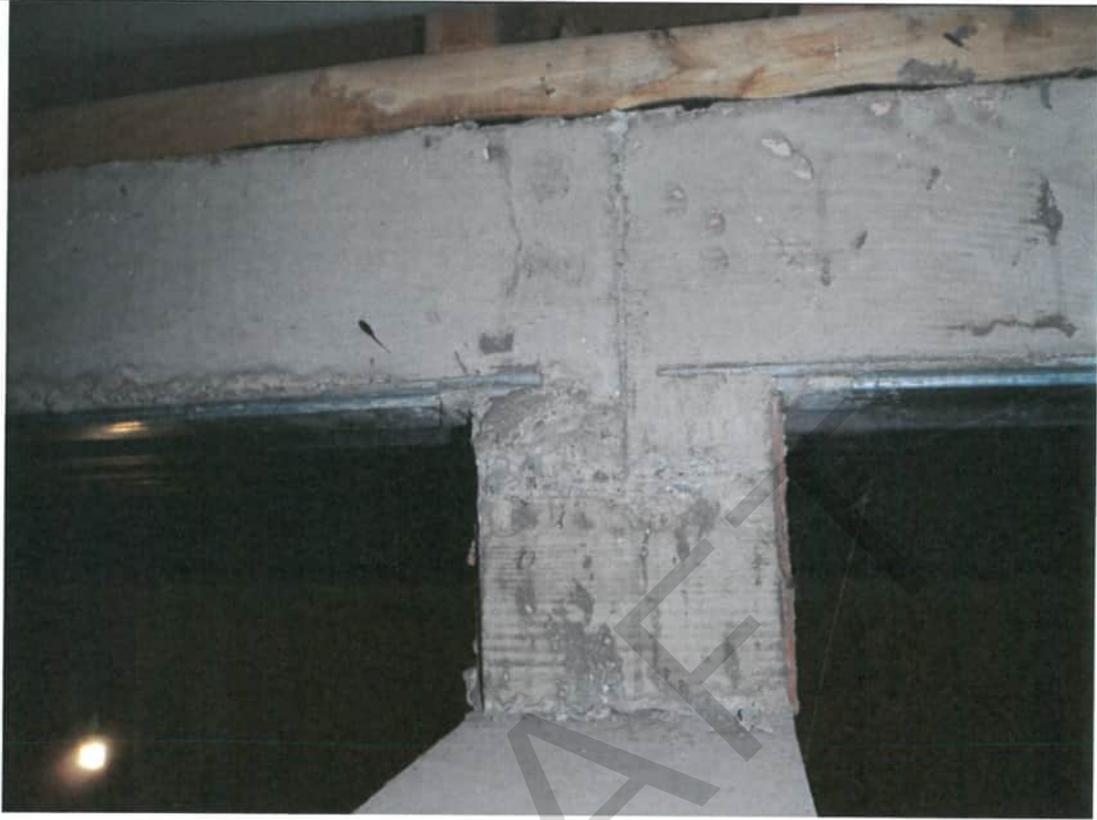
Photo 5 Concrete strip with steel plates supporting tray slab above beam.

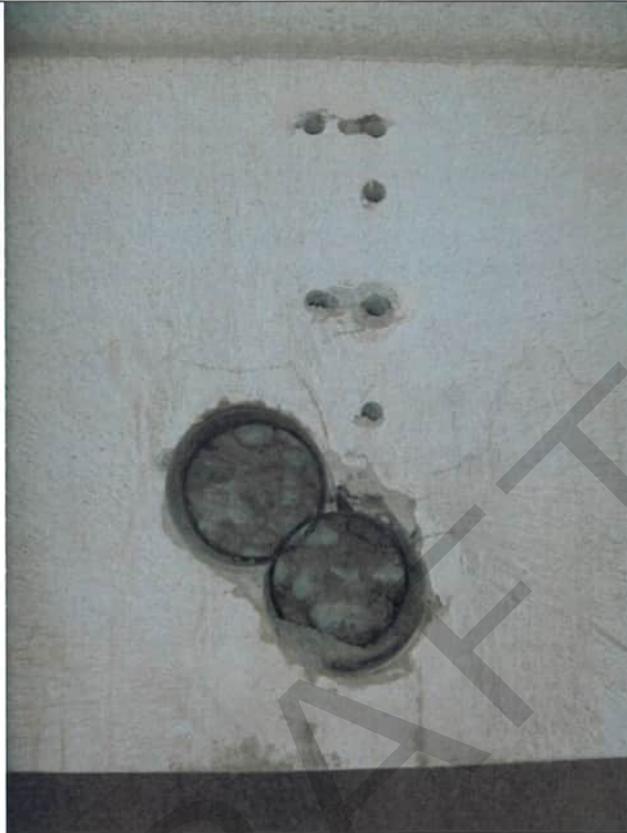
- Two cores have been drilled into the beam supporting the level 3 floor and six holes drilled approximately 220 mm at varying heights up the height of the beam, see photo 1.
- The six holes have been drilled approximately 20m m past the centre line of the beam, further intrusive works would be required to confidently determine the structural form of the beam.
- The lower core as shown in photo 1 had a stirrup running vertically through the centre of the core. The cover to the stirrup is approximately 10 mm and is shown in photo 2. The bottom of the core, as shown in photo 3, appears to have cut through the bend in the stirrup and there doesn't appear to be a longitudinal bar seated in the bend.

Photo 1 Internal stair core and hole locations

- No further action is required at this location at this stage. This may be reviewed depending on further findings at a later date.
- Intrusive works are to continue at the lower end connection as shown in memo dated 22 Oct 2015, photo 4. Approximately six holes are to be drilled at different faces as discussed on site.

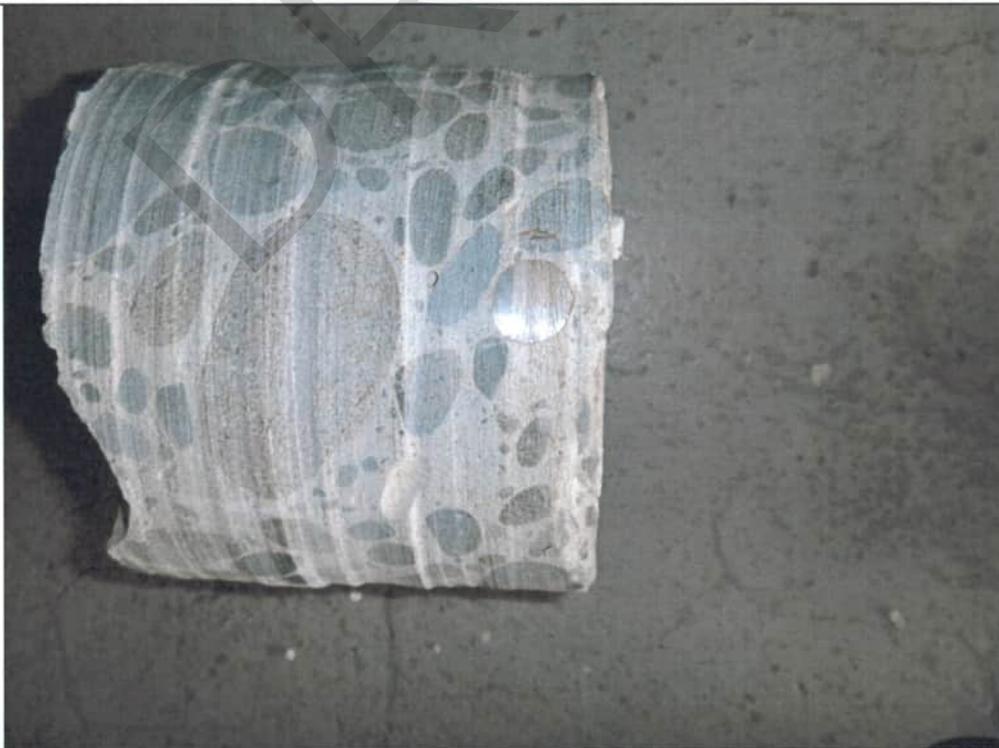
Photo 2 Stirrup in core approximately 10mm cover

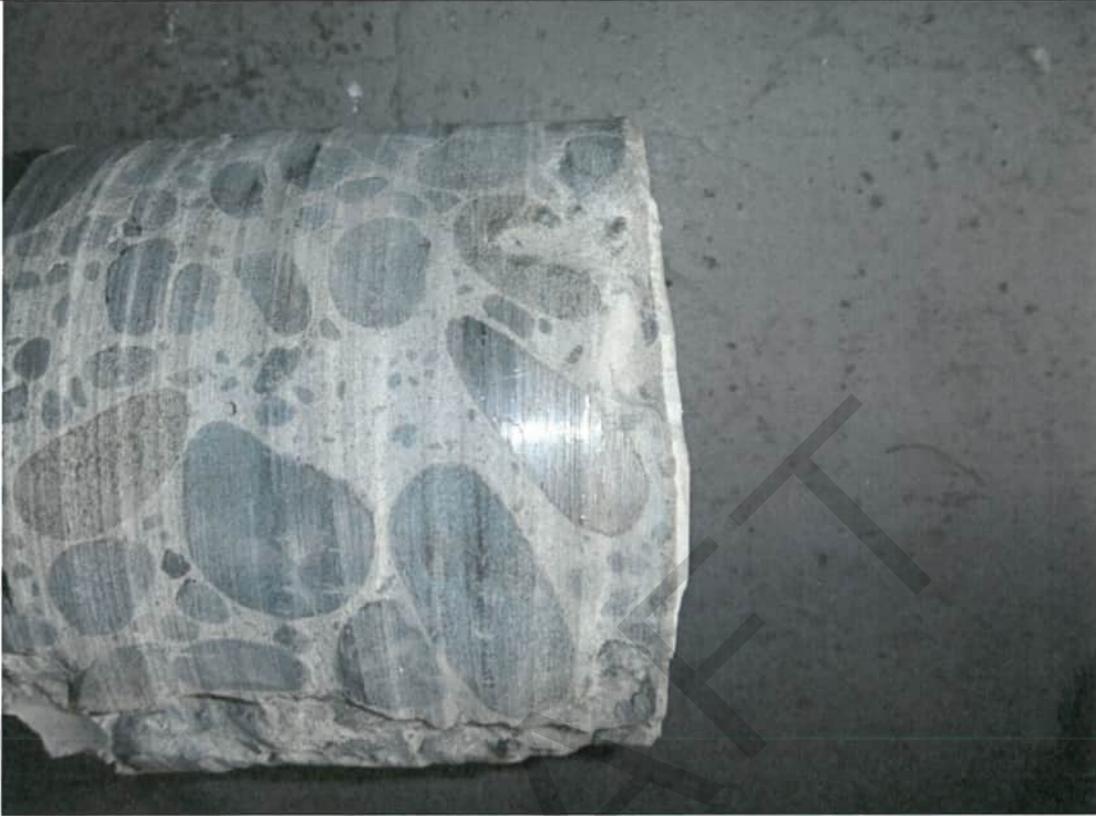
Photo 3 Stirrup in core base

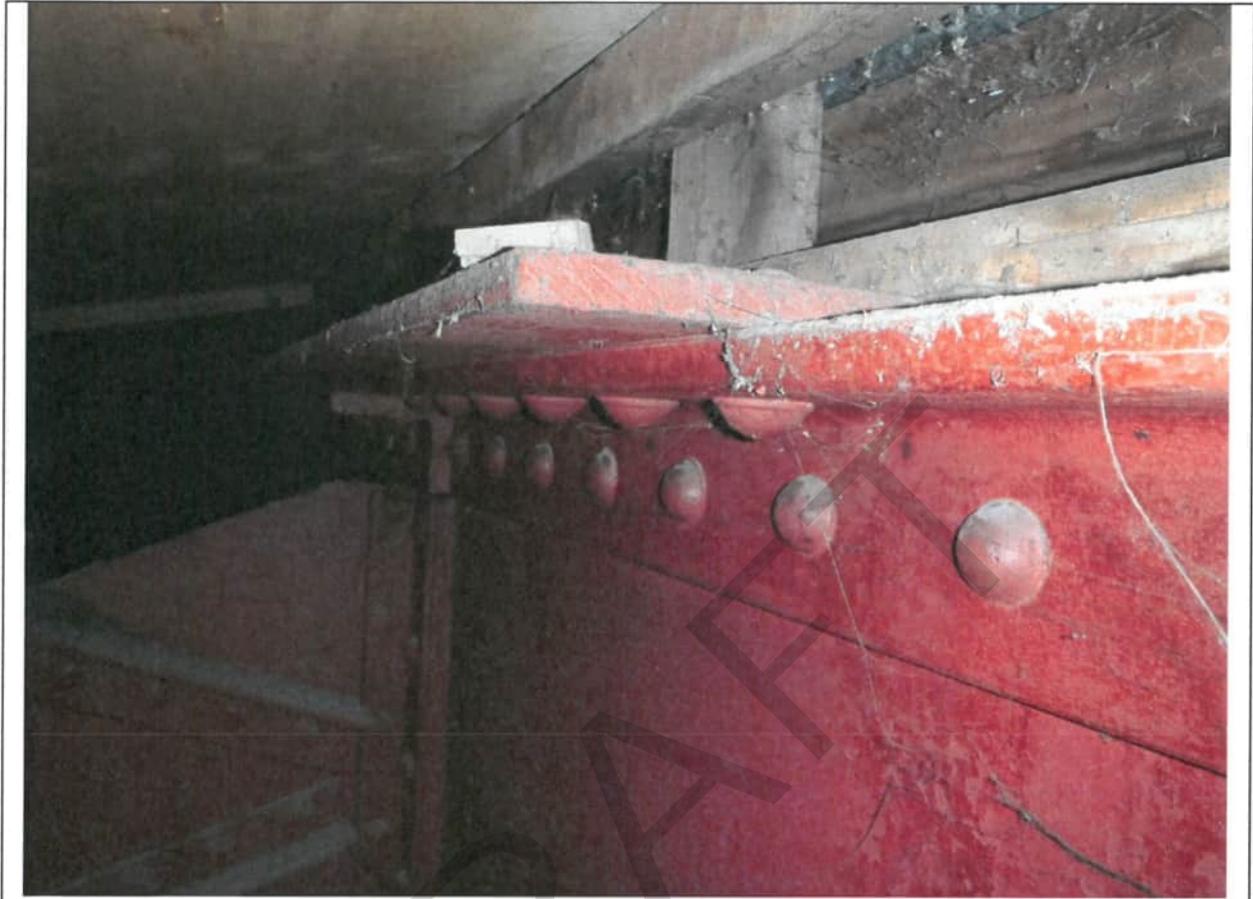
- The top and bottom plate were observed at the column connections, as shown in photo 6.
- The top and bottom plate was terminated adjacent to the column and was absent for 2.5 m either side of the column, as shown in photo 7.
- The girder is spliced together at approximately 12 m centres by a 1.25 m high, 0.3 m wide, 20 mm thick plate of steel riveted to the two pieces of girder. 30 Rivets are used in the splice, as shown in Photo 8.

Photo 7 Top plate beginning again approximately 2.5m from column
