Grand National Stand - Detailed Damage Evaluation

3D Response Spectrum, 3D Non-linear Pushover & Vertical
analysis

Client: Canterbury Jockey Club

27-Jan-2015

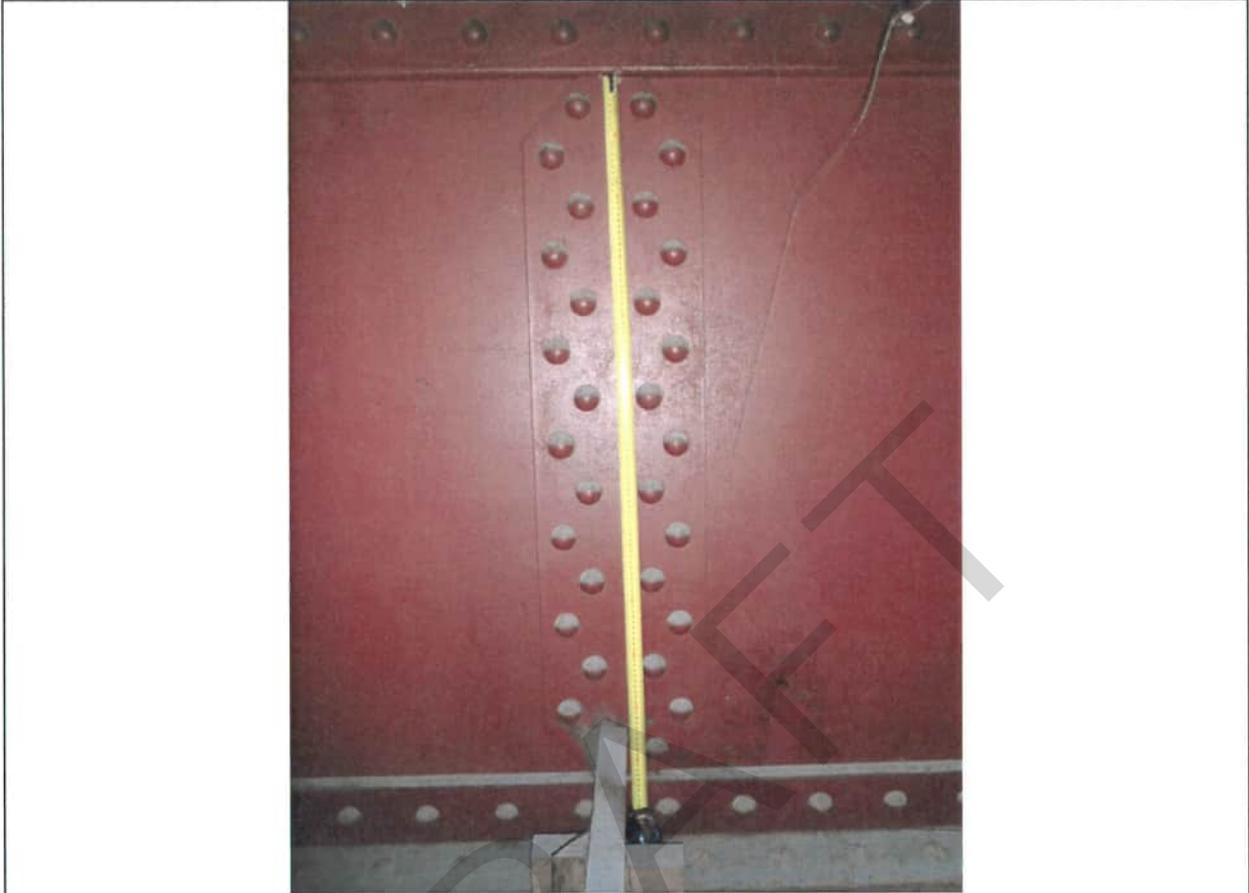
- The top and bottom plate were observed at the column connections, as shown in photo 6.
- The top and bottom plate was terminated adjacent to the column and was absent for 2.5 m either side of the column, as shown in photo 7.
- The girder is spliced together at approximately 12 m centres by a 1.25 m high, 0.3 m wide, 20 mm thick plate of steel riveted to the two pieces of girder. 30 Rivets are used in the splice, as shown in Photo 8.

Photo 8 Plate girder splice connection

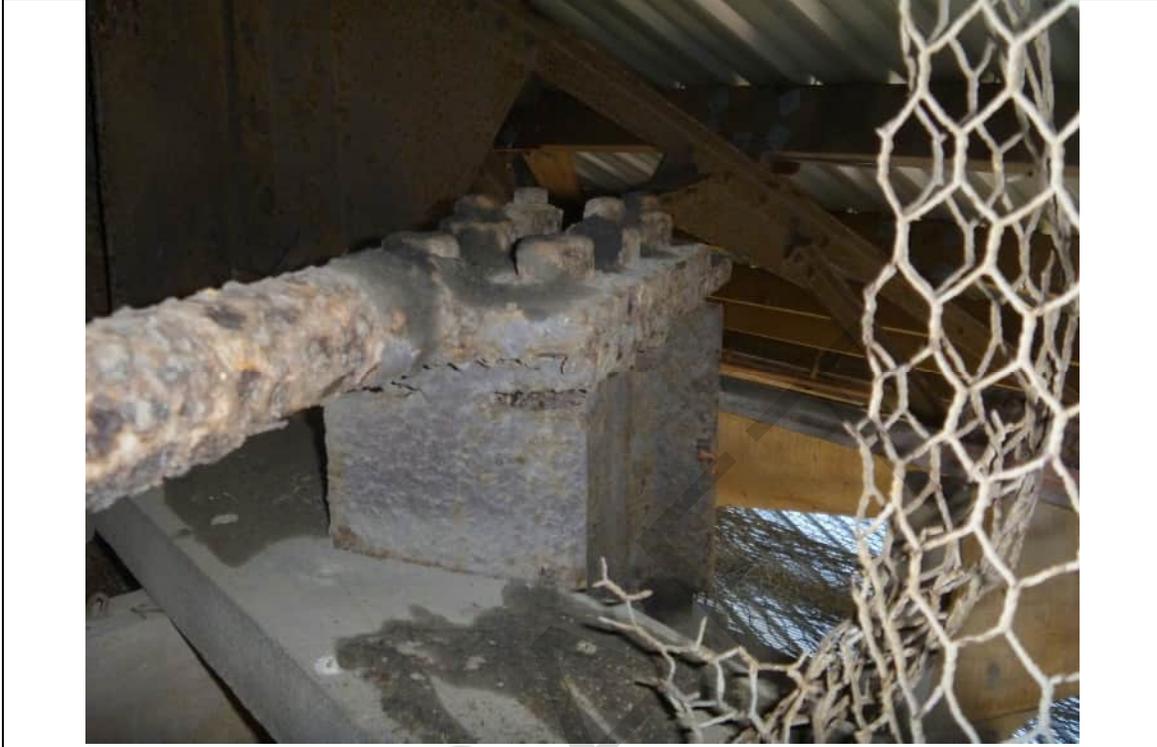
Photo 1 Roof brace connection

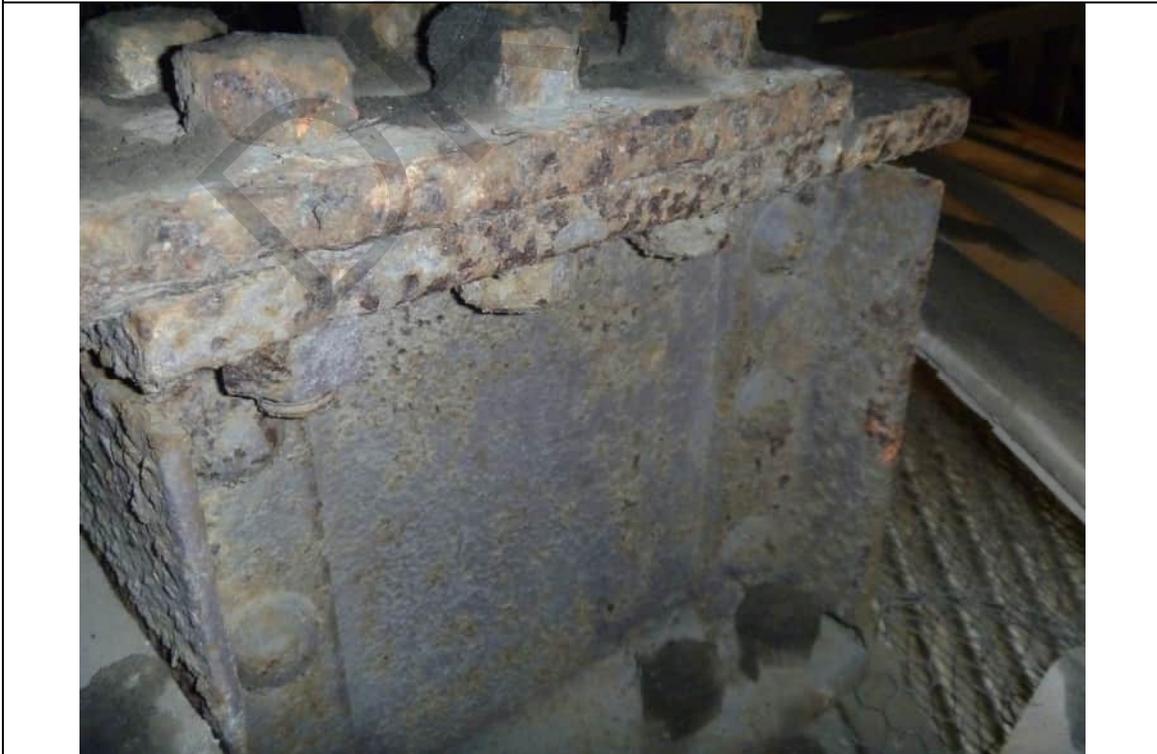
Photo 2 Roof brace connection

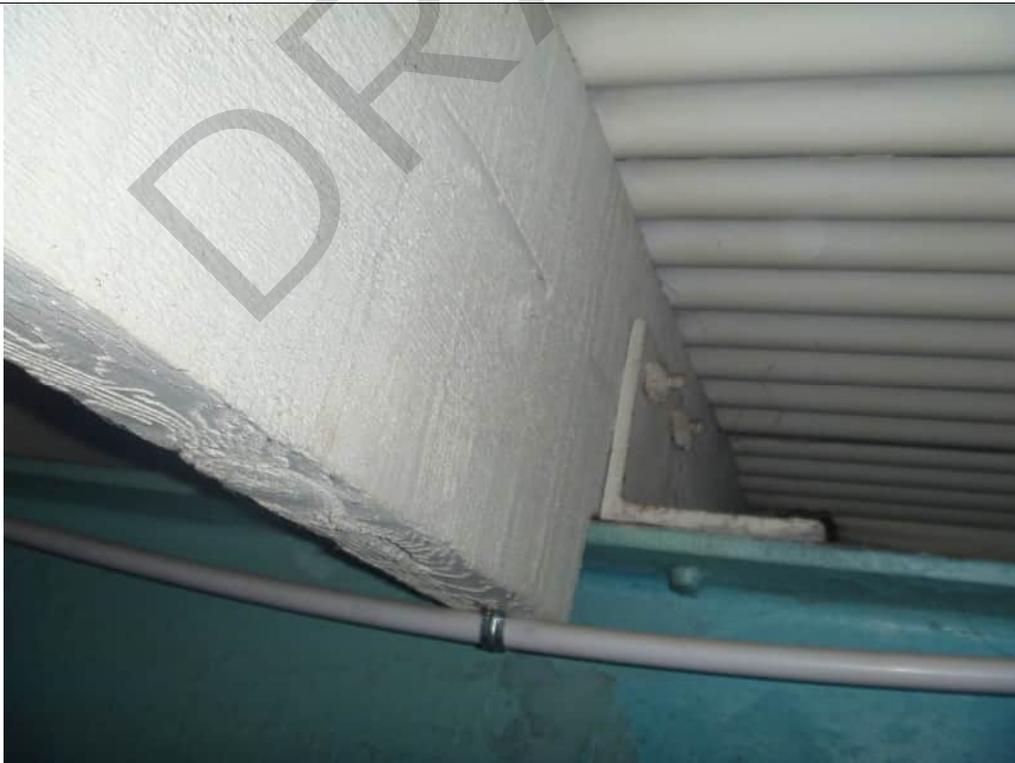
- The timber purlins supporting the lower stand bleachers were accessed from a mobile work platform approximately at the intersection of Grid B and Grid 6,
- Two types of purlins were identified, single and double members. The single members are 310x75mm with an approximately but varying notch of 80mm and the double members are 250x110mm with an approximately but varying notch of 20mm. See Photo 4 and 5.

Photo 4 Single member timber purlin

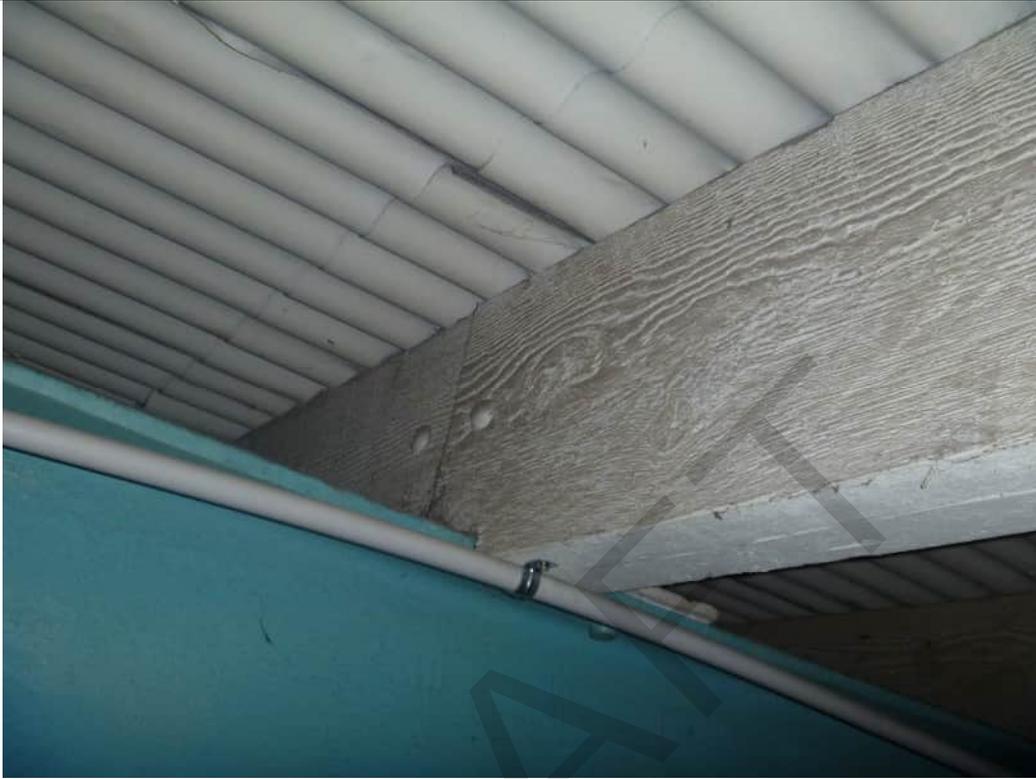
Photo 5 Double member timber purlin

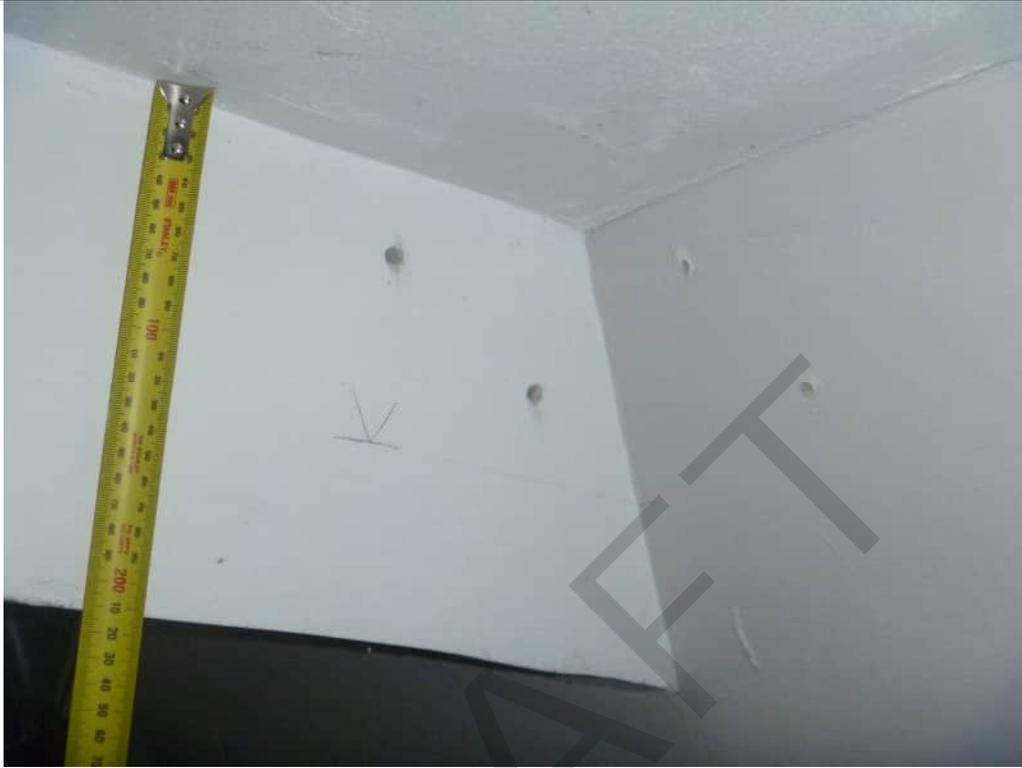
- Six 8mm holes have been drilled into the lower end connection, hitting steel at all locations, see Photo 6,
- The cover to the assumed steel beam has been marked on the side of the beam with pencil and is approximately 80mm, see Photo 7,
- Two 8mm hole were drilled into the upper connection and again no steel was found, see Photo 8.

Photo 7 Pencil line showing cover to assumed steel beam

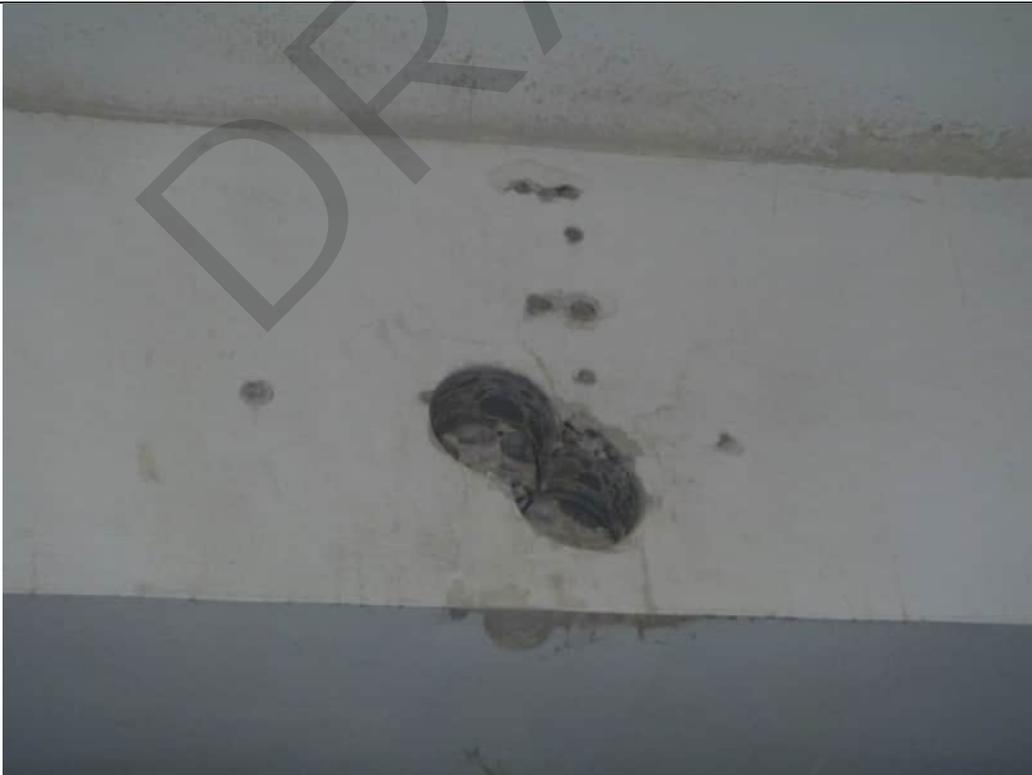
Photo 8 Two more 8mm diameter holes drilled into top connection of internal stairs

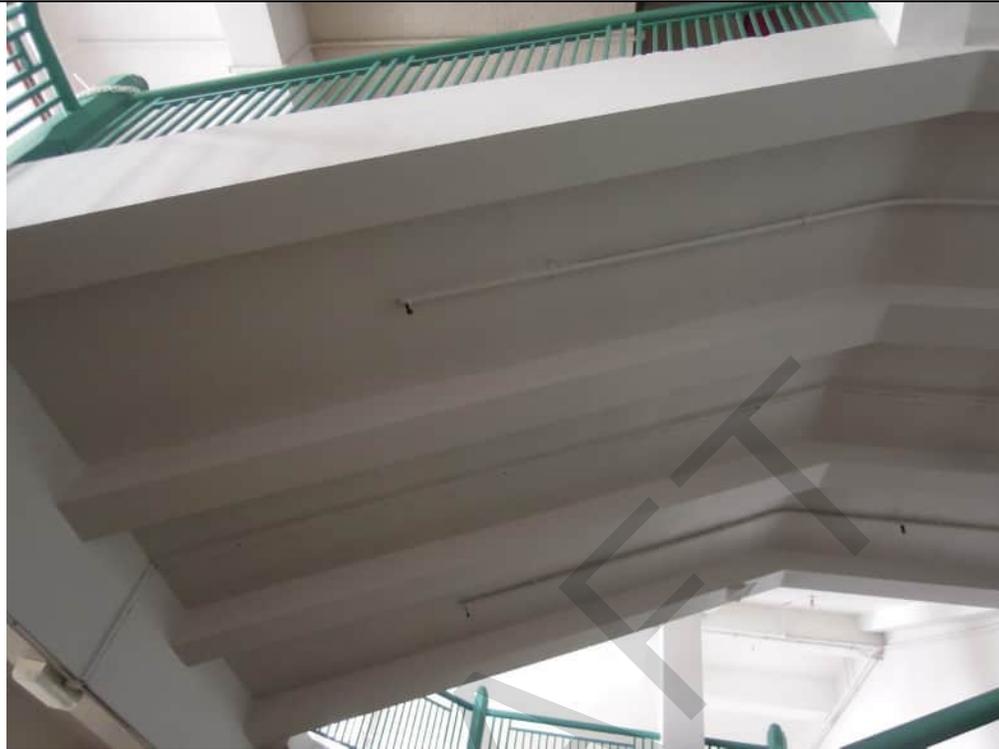
Photo 9 Location of intrusive works, drill top and bottom of stringer

- See attached mark up for locations of further intrusive works, these include the following items:
 - o Drill top and bottom of the stringer beam to determine if a steel beam is present and the depth of the beam, see Photo 9 for location,
 - o Break out joint to determine how crank has been constructed and how other steel beam is connected, see photo 10 for location,
 - o Drill bottom of middle stringer to see if steel beam is present, see photo 11 for location,
 - o Drill bottom of top landing beam to see if steel beam is present, see photo 12 for location.

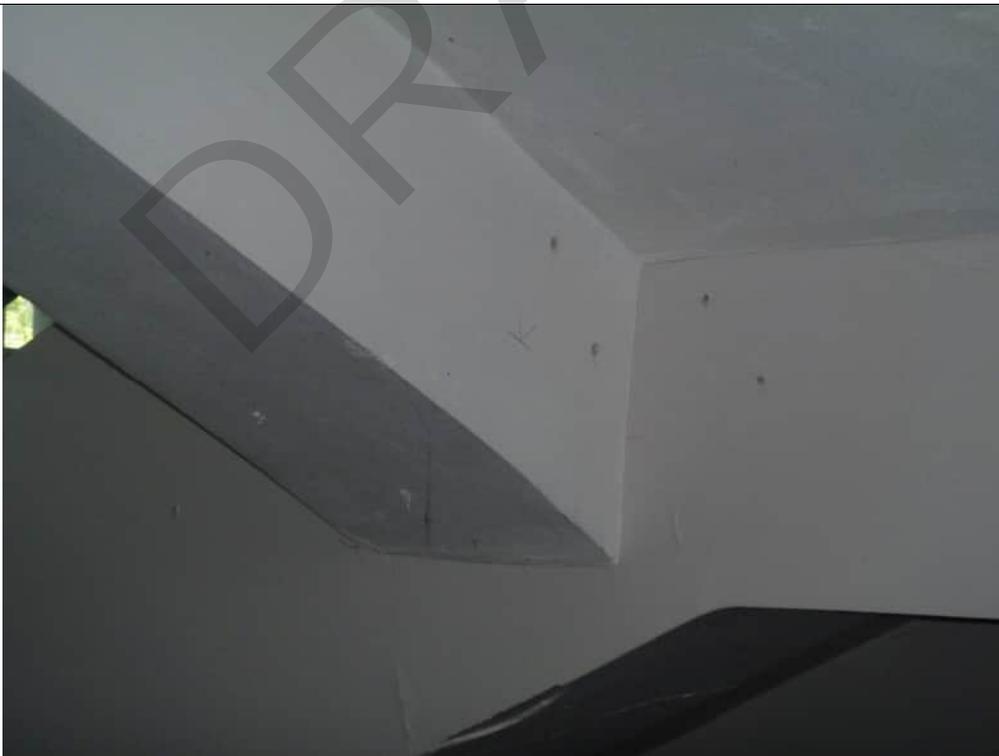
Photo 10 Location of intrusive works break out joint

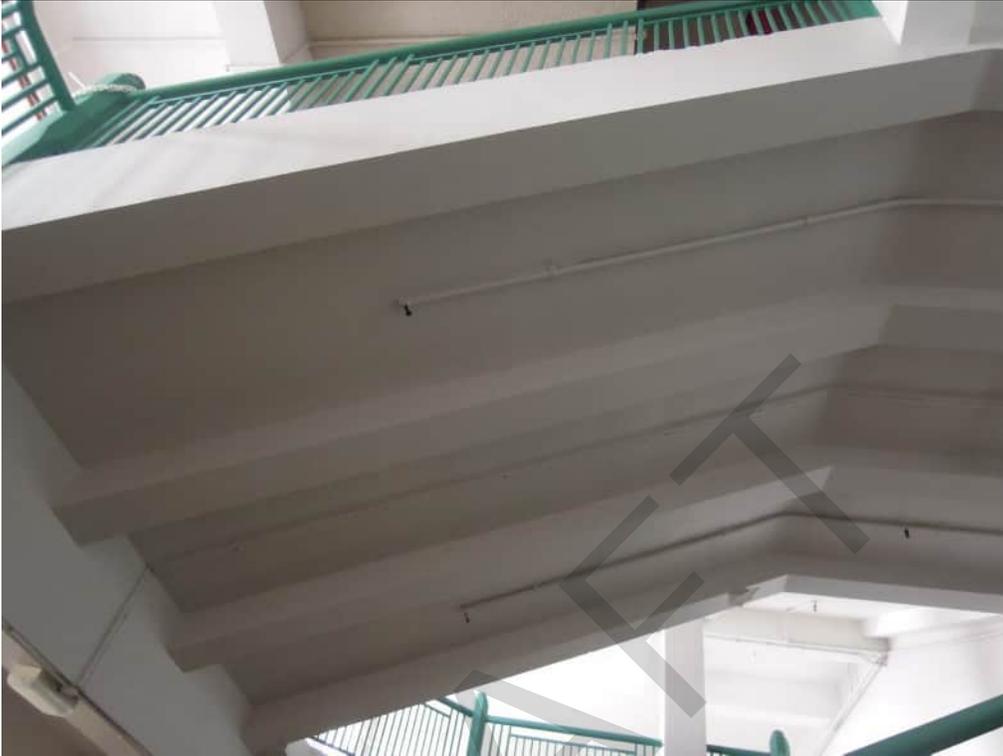
Photo 11 Location of intrusive works drill bottom of stringer

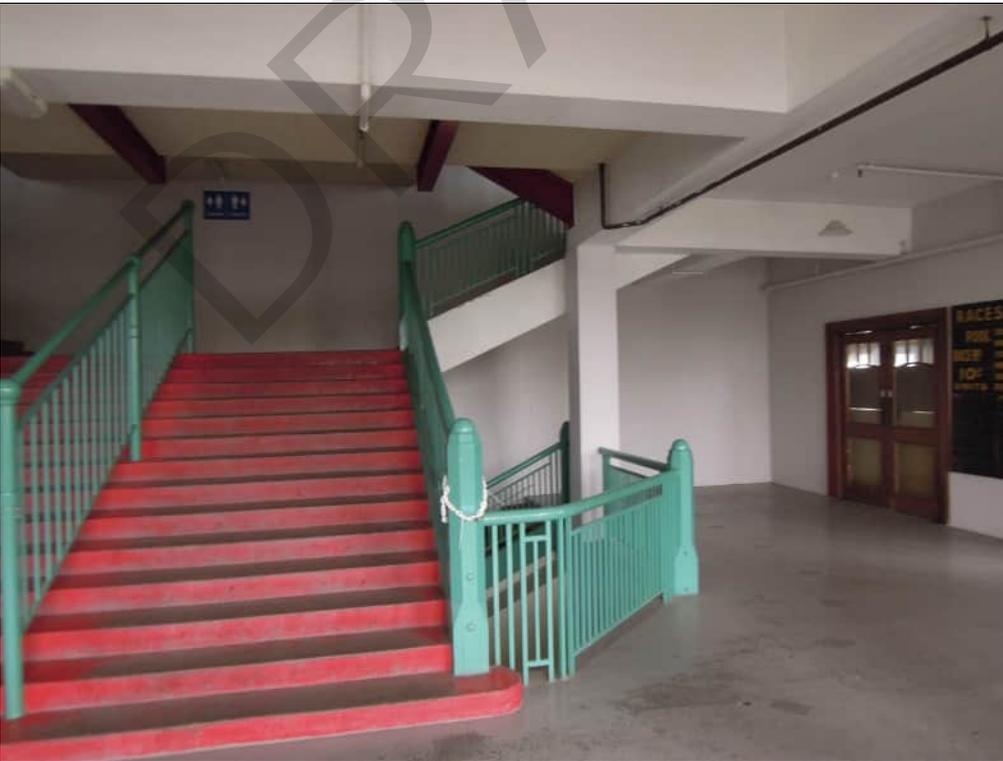
Photo 12 Location of intrusive works, drill bottom of landing

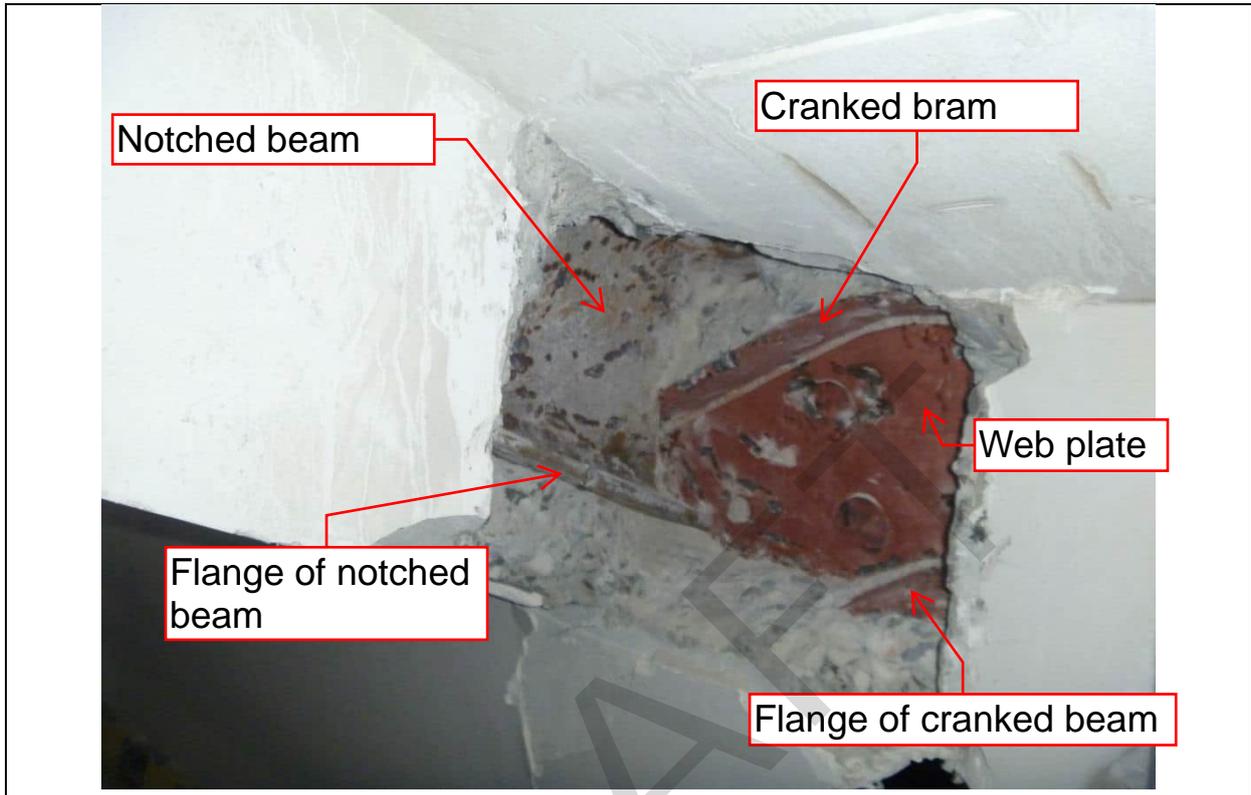
- The beam connection located on the ceiling of the level 2 to 3 stairs has been broken out exposing the connection of the cranked beams and adjacent stringer beam, see photo 1.
- The cranked beams are butted against each other and connected by a web plate riveted to each beam, see photo 2.
- The adjacent stringer beam has had its bottom flange and part of its web notched to sit on top of the cranked beam, see photo 3.
- The cranked beams and adjacent stringer beam are assumed to be BSB13 sections based on approximate measurements taken on site consisting of height 200mm, single leg of flange 50mm less web plate and flange thickness of 10mm.

Photo 1 Exposed connection

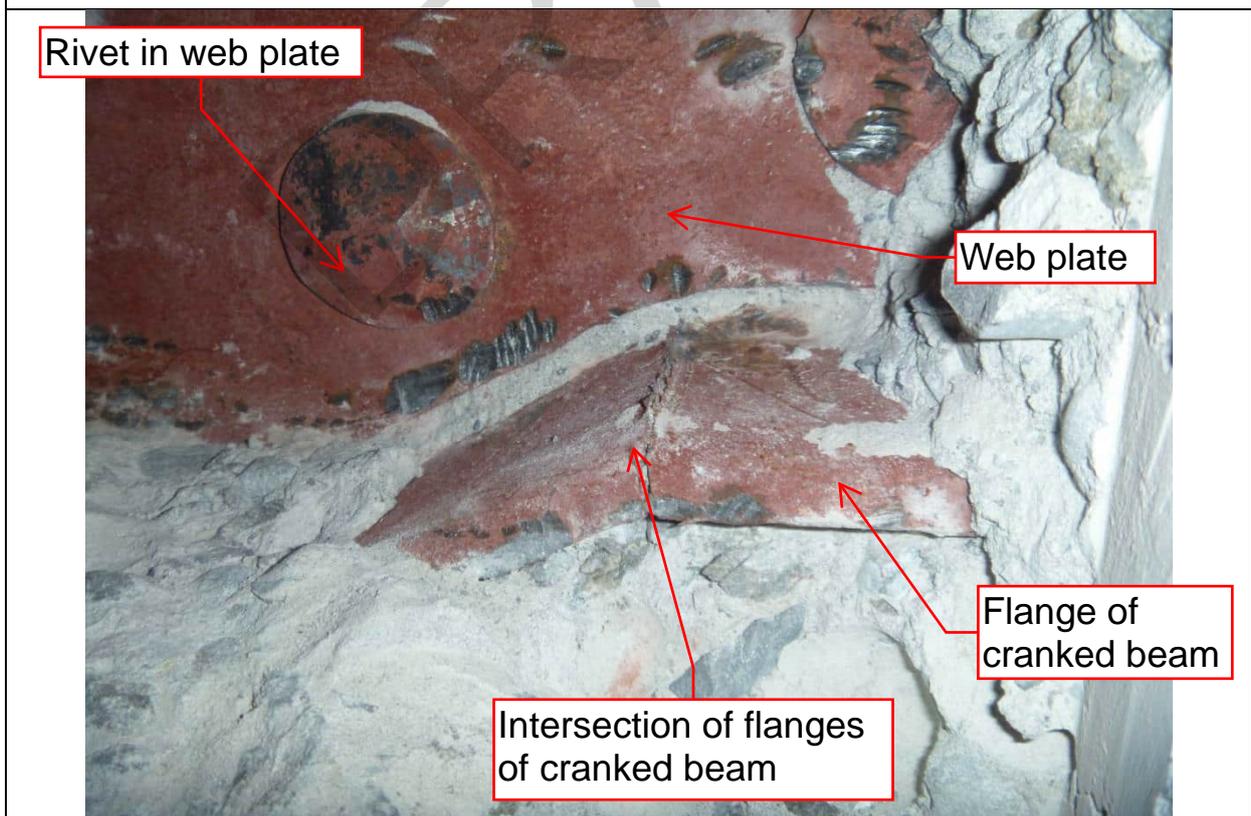
Photo 2 Cranked beam connection showing riveted web plate

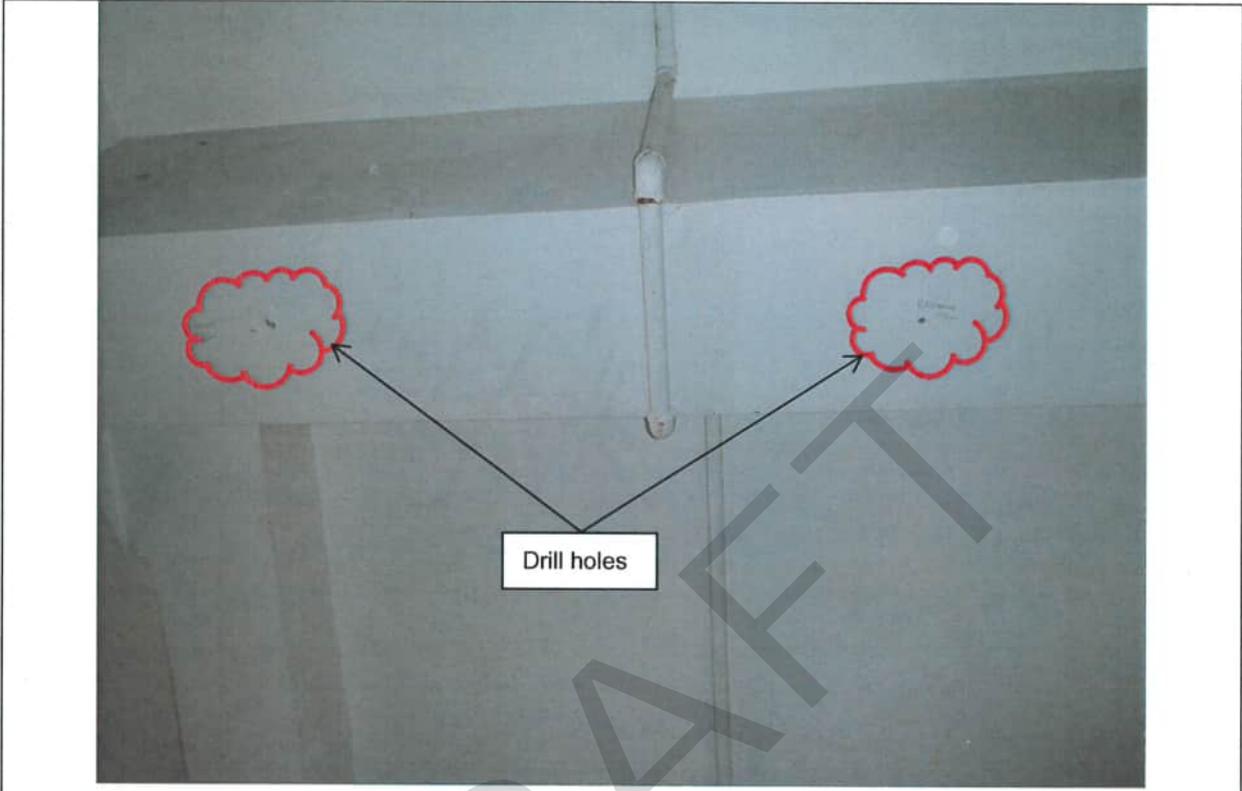
Photo 1 Drill holes in ceiling beams on level 2-3 stairs.

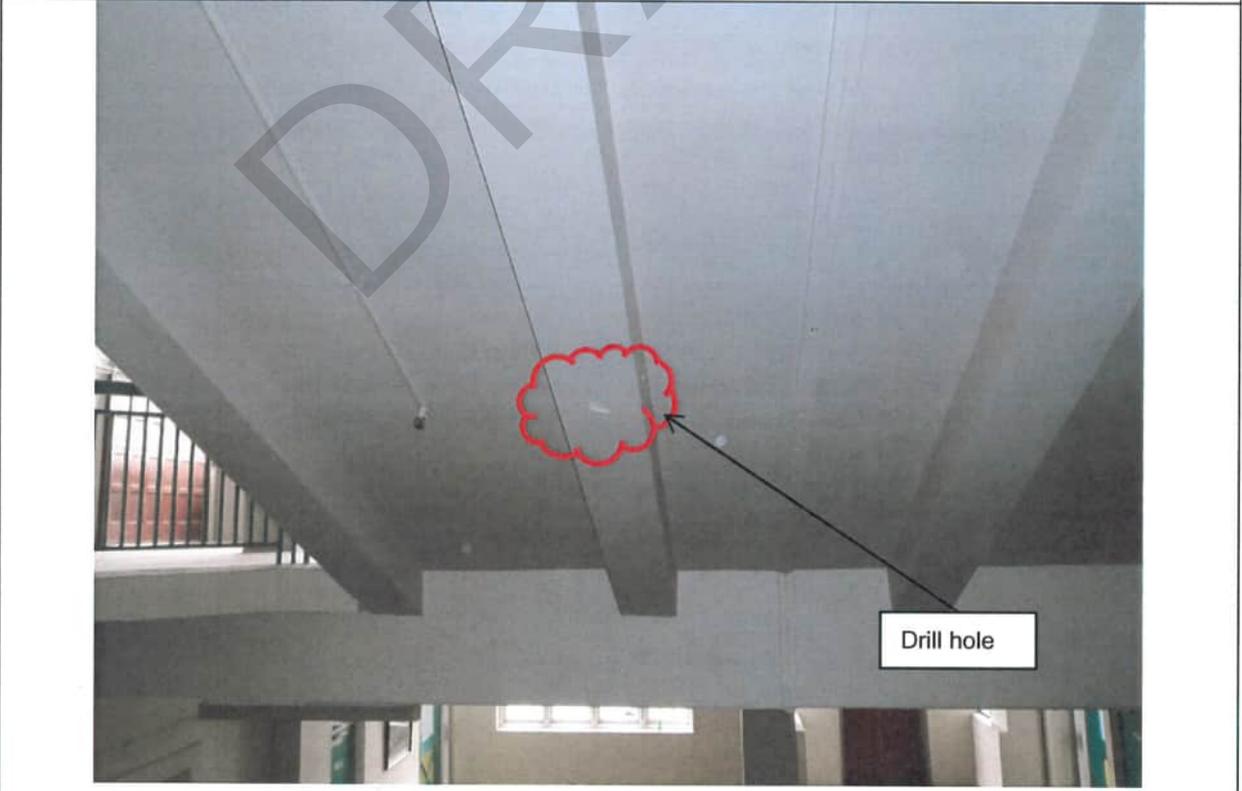
Photo 2 Drill holes in ceiling beams on level 2-3 stairs.

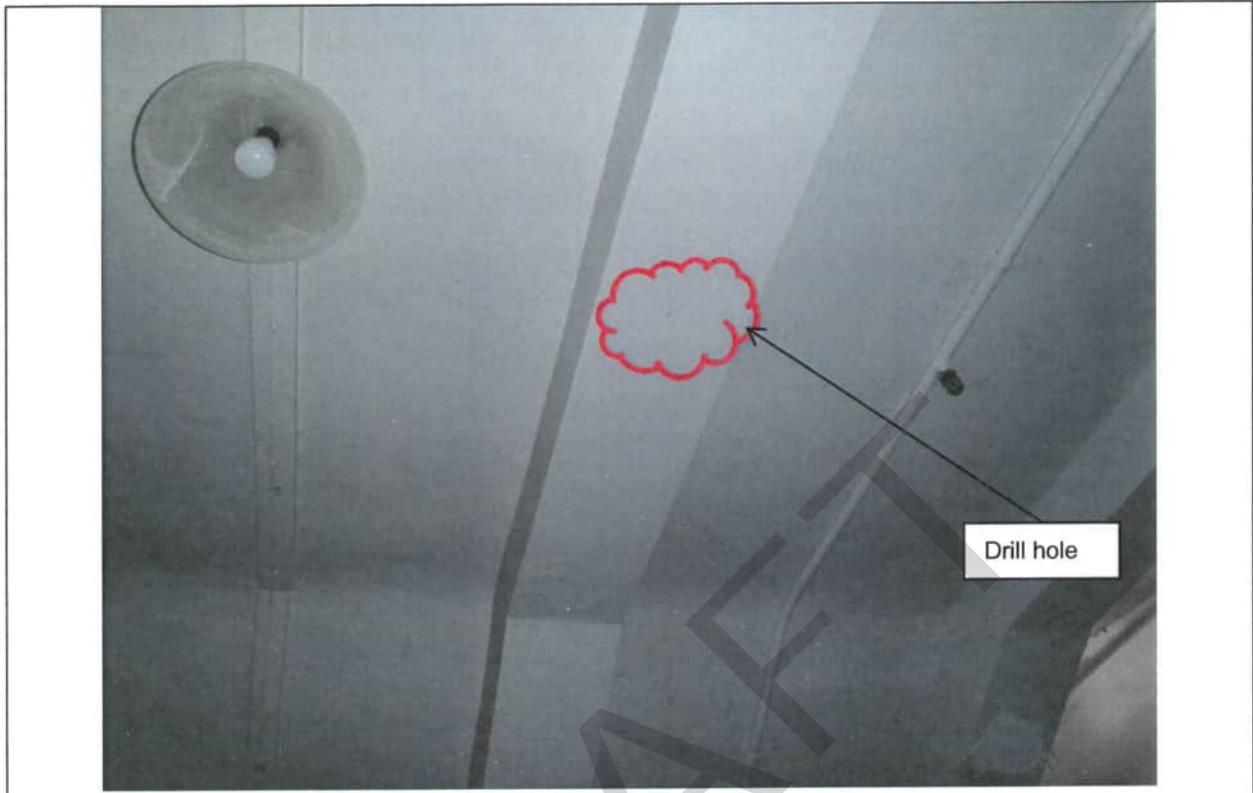
Photo 3 Drill holes in ceiling beams on level 2-3 stairs.

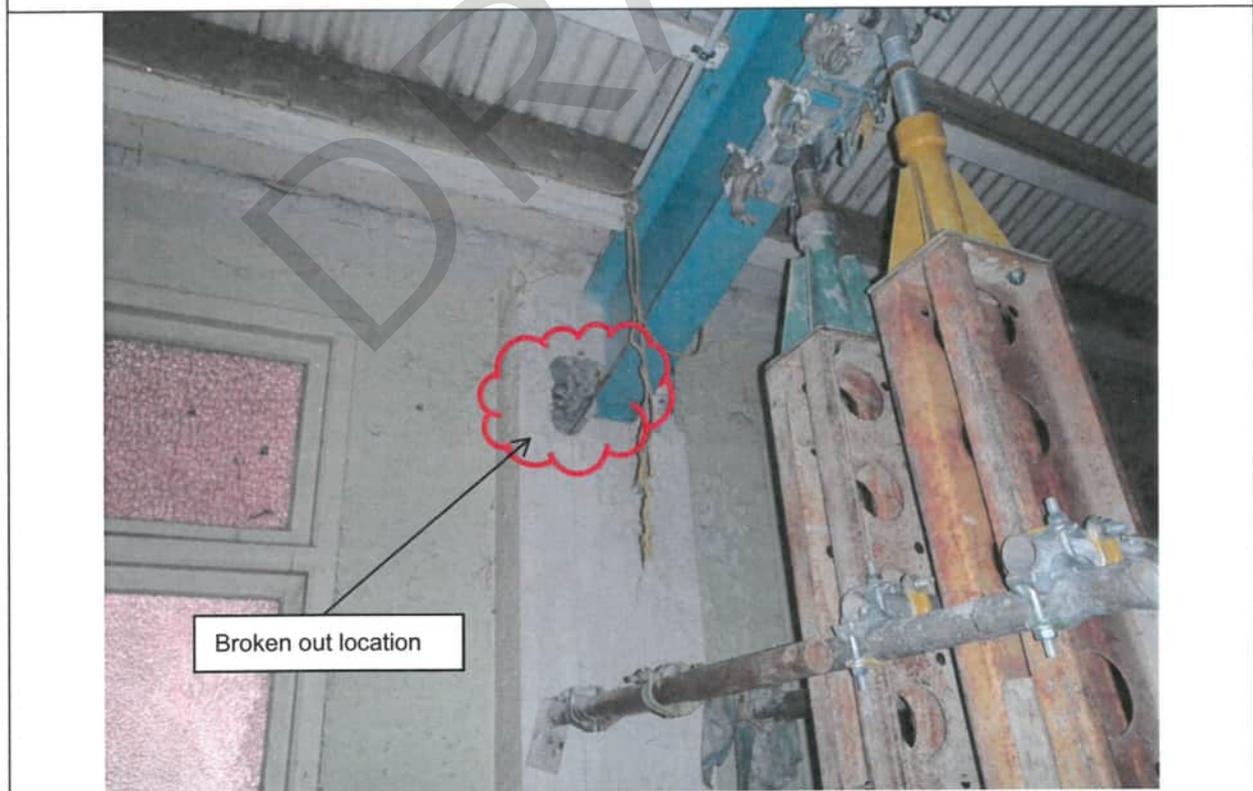
- The joint was cored out with three 85 mm diameter cores and then broken out to expose the beam, see photo 4.
- The beam is embedded into the column 200 mm. No connection was observed from the web of the steel beam into the column, see photo 5.
- No steel was encountered in the column with the exception of one horizontal 19 mm reinforcing bar, see photo 6.

Photo 4 Broken out beam-column location on gridline A5.

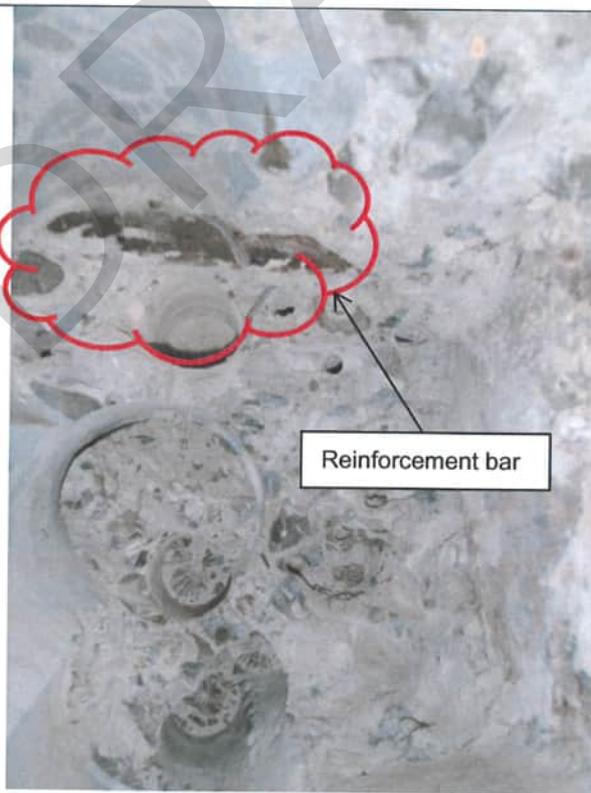
Photo 6 Horizontal reinforcing bar in broken out area.

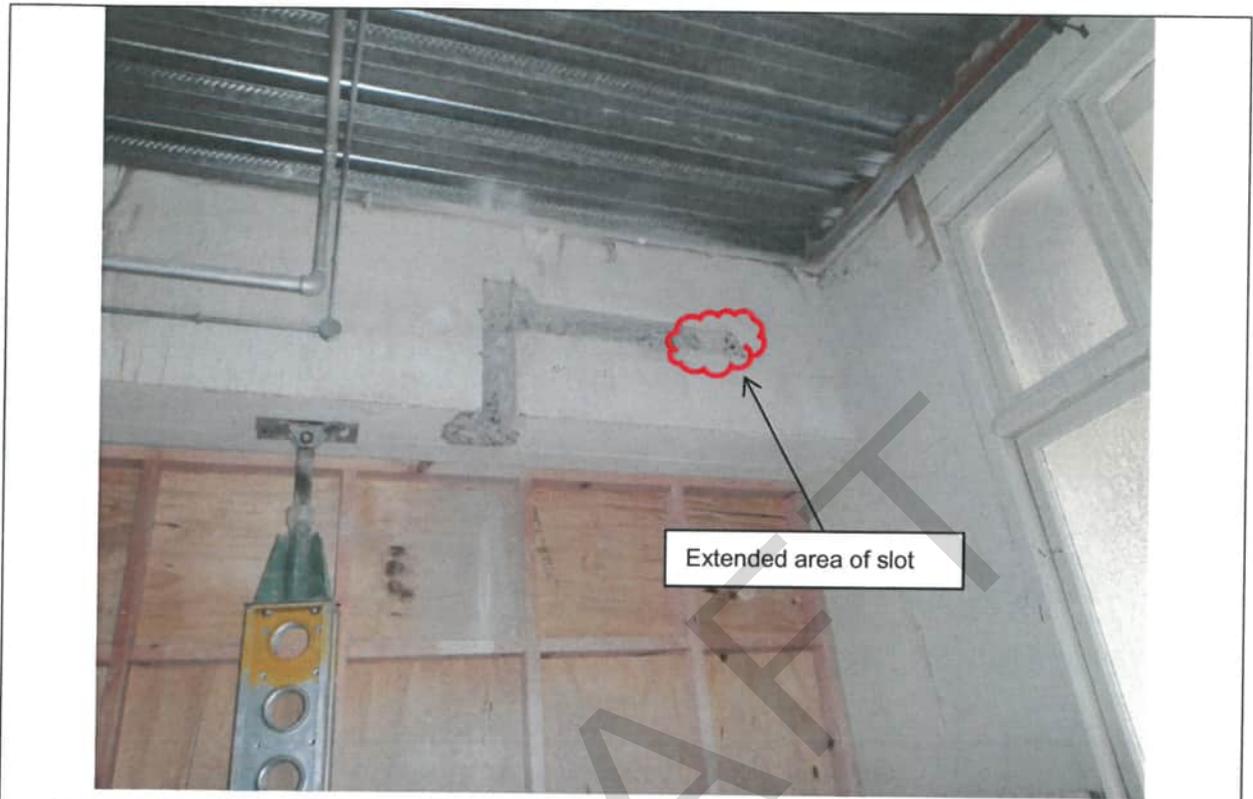
- The existing slot in the horizontal beam was extended by approximate 150 mm. The extended slot was 50 to 60 mm deep, see photo 7.

Photo 7 Existing slot between Gridline 2 and 3 on gridline C.

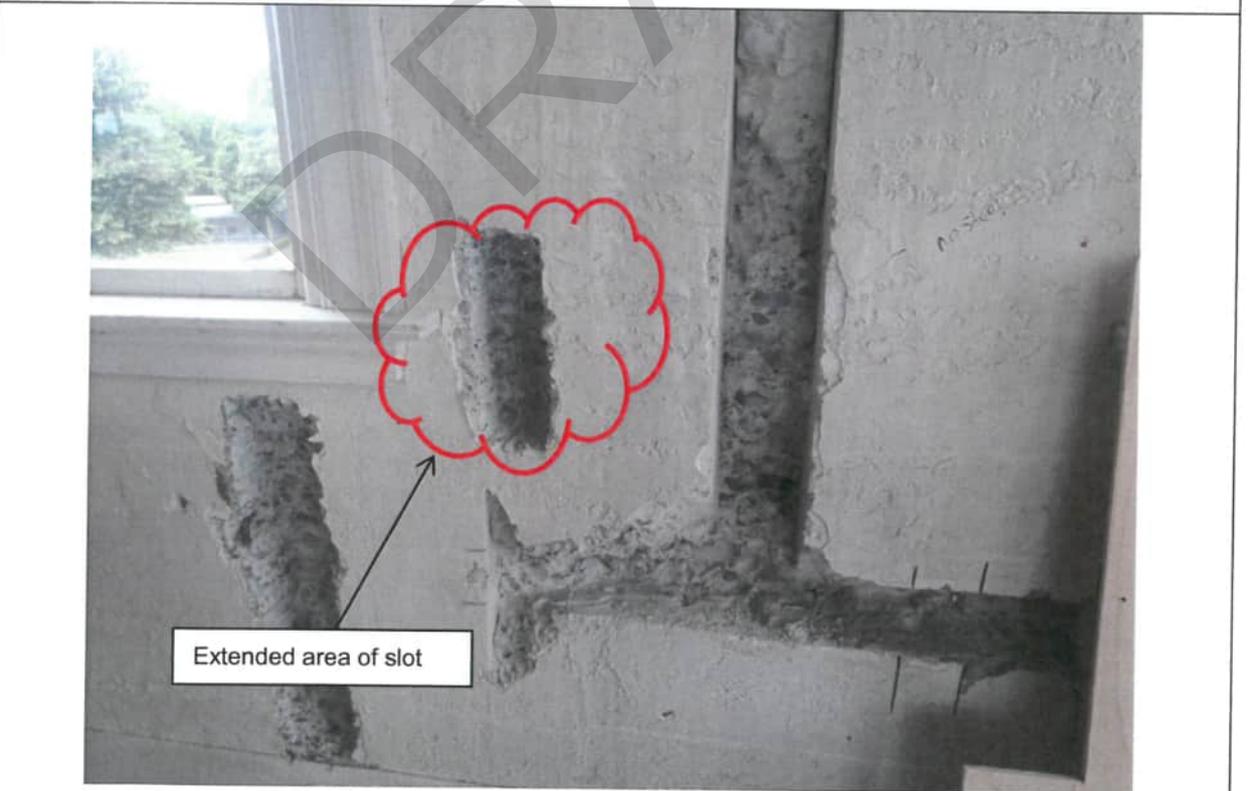
- An additional vertical slot was cut into the column, see photo 8.
- No steel was encountered

Photo 8 Vertical slot at gridline D2.
