## National Grandstand Canterbury Jockey Club

165 Racecourse Road, Sockburn  
Christchurch

JOB No.: 1910036  
DATE: 18 November 2021  
ISSUE: 1

Seismic Upgrade – Impact Assessment on  
Existing Building Fabric

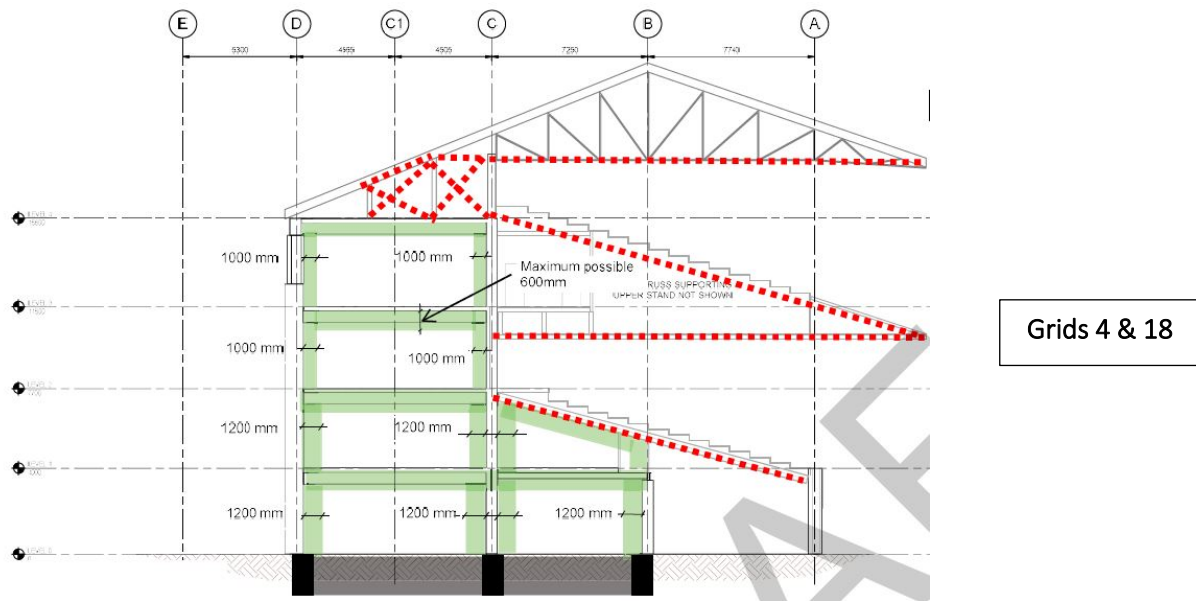
Figure 4: Typical Section on Gridlines 4 & 18 showing new columns, beams (shaded green) and Reid brace ties (dashed red) (AECOM 60332326-DRG-C5)

In conjunction with the reinforced concrete frames within the building the seating and roof structure will need tying back to this new frame structure. It is envisaged 32mm diameter Reid brace (or similar) will be used as shown in **Figures 4 & 5**. It should also be noted that plan bracing of similar type will be provided to each of the levels shown for the full length of the building to transfer lateral loads back to the main concrete frames.

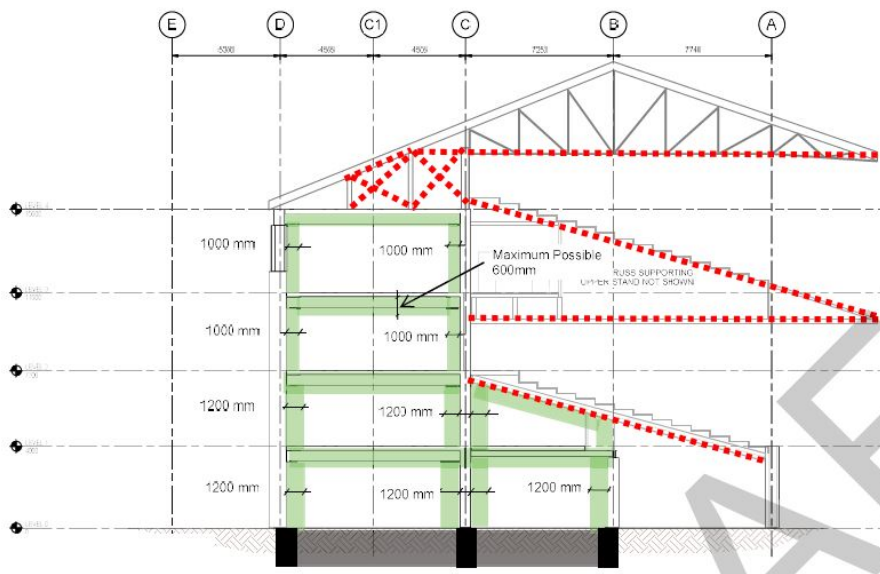
Figure 15: Typical Section on Gridlines 4 & 18 showing new columns, beams (shaded green) and Reid brace ties (dashed red) (AECOM 60332326-DRG-C10)

In conjunction with the reinforced concrete frames within the building, the seating and roof structure will need tying back to this new frame structure. It is envisaged 32mm diameter Reid brace (or similar) will be used as shown in **Figures 15 & 16**. It should also be noted that plan bracing of similar type will be provided to each of the levels shown for the full length of the building to transfer lateral loads back the main concrete frames.

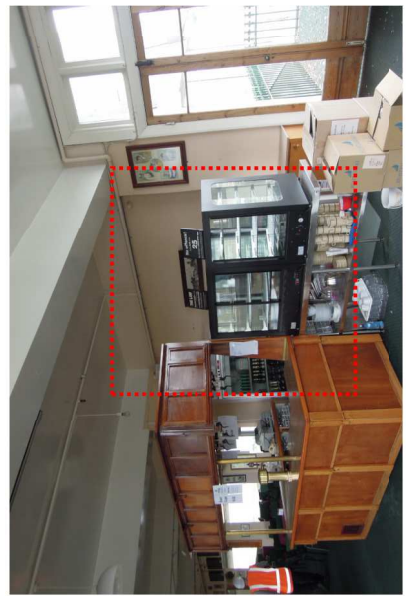
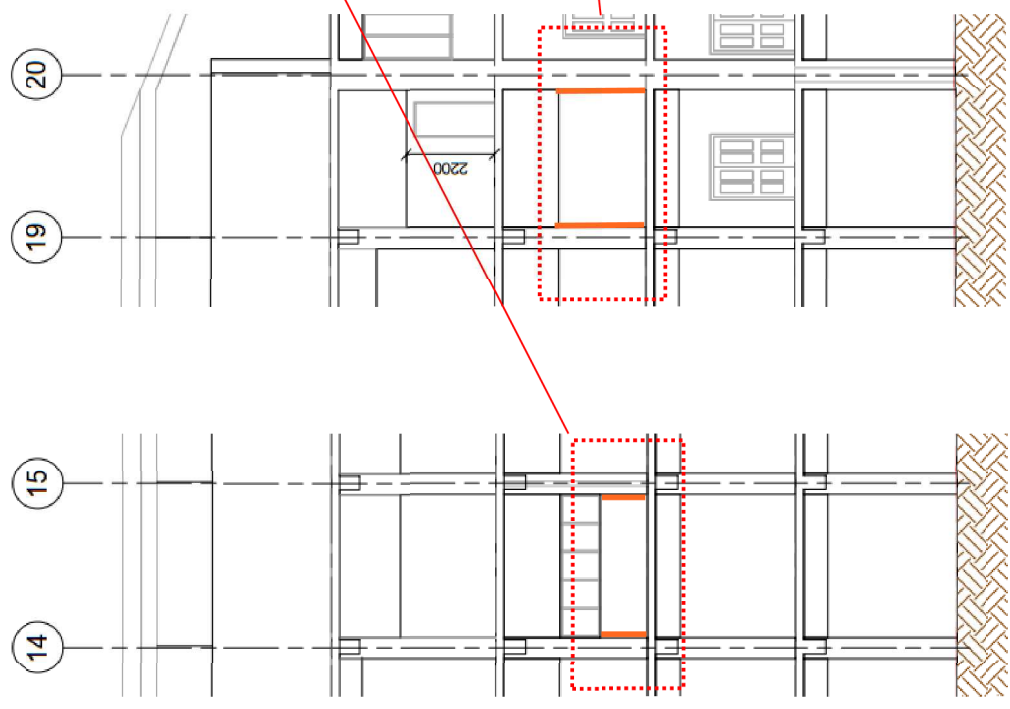
**SECTION ON GRID C (14-15)**  
 Cut slots in the parapet beam adjacent to the columns  
 Level 2  
 (N.T.S.)

**SECTION ON GRID C (19-20)**  
 Cut slots in the infill wall adjacent to the columns.  
 Provide bracketry for out-of-plane loads  
 Level 2  
 (N.T.S.)
