**Canterbury Earthquakes 2010/11 Port Hills Slope
Stability: Risk assessment for Cliff Street**

**GNS Science Consultancy Report 2014/73
August 2014 FINAL**

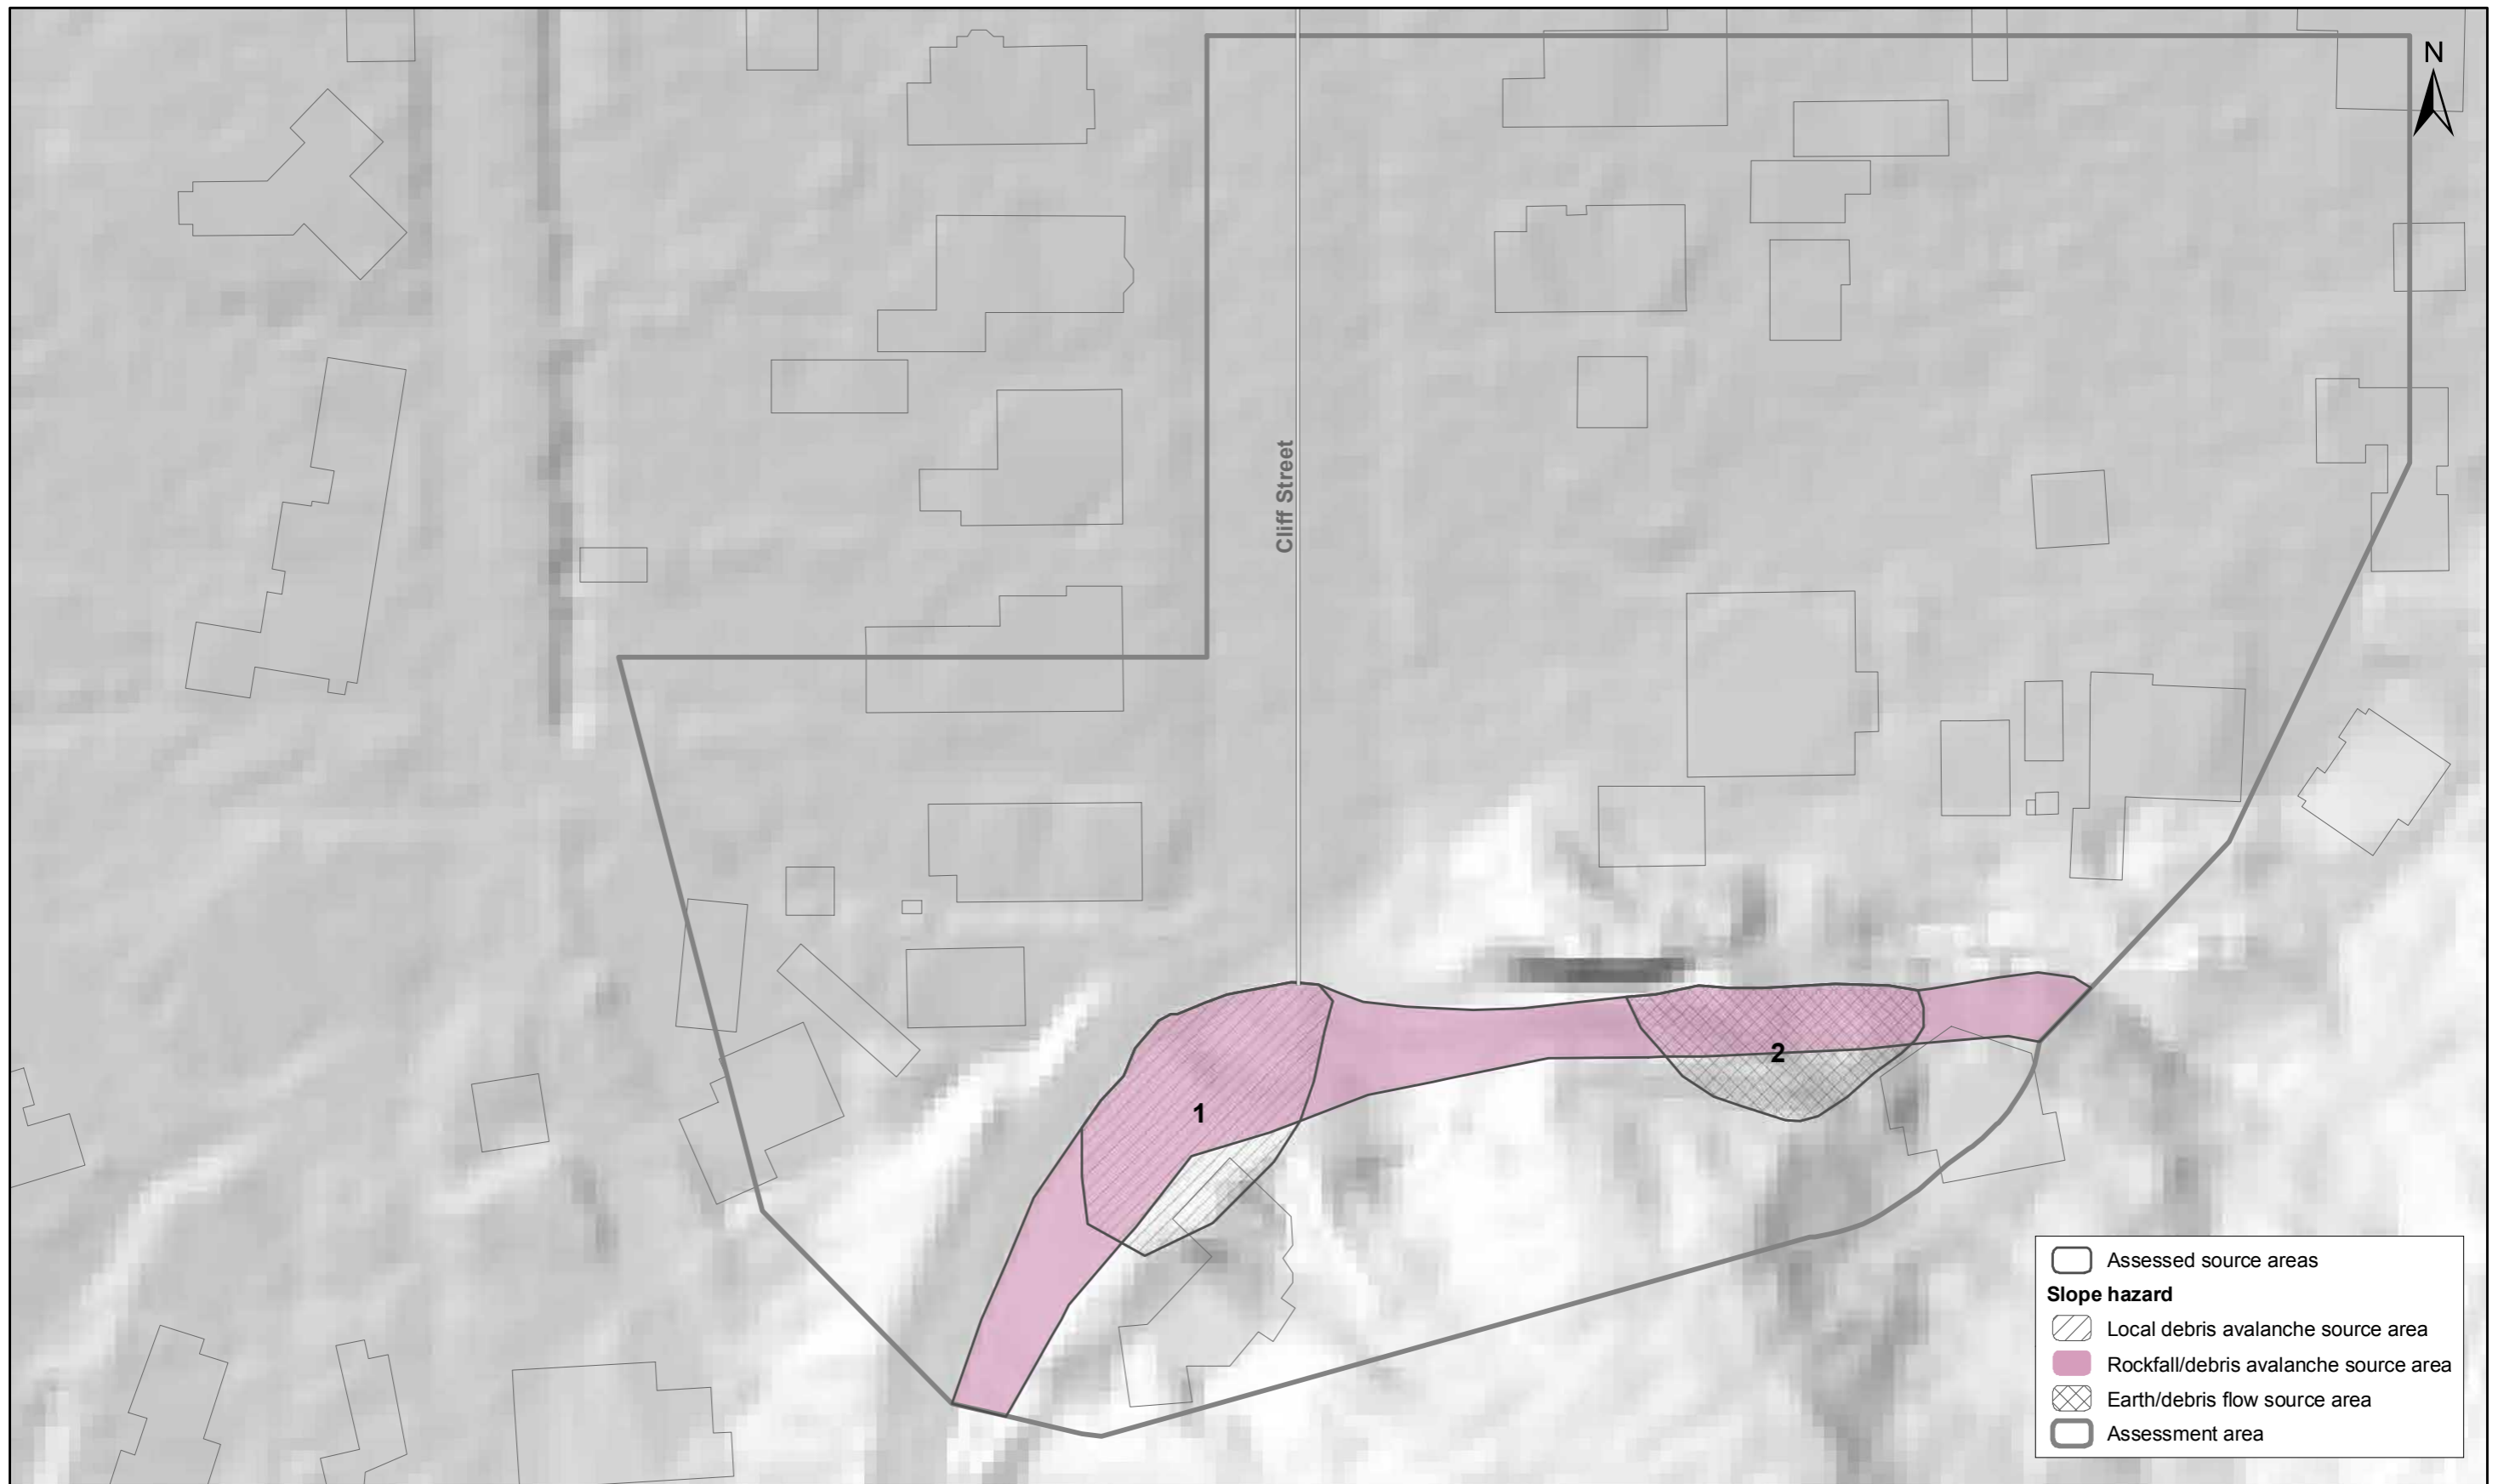
FIGURE 2

This report presents the risk assessment results for the Cliff Street Class I mass movement. The map in Figure 2 outlines the assessed potential landslide source areas within the assessment area, while Figure 3 shows the approximate boundary of the assessment area.

These are located in areas where the bulk strength of the slope could have been degraded as a result of earthquake-induced cracking. The assessed source areas (shown in Figure 2) represent the potential locations of the source areas for the assessed hazards that could occur in the assessment area. These are additional to the smaller volume cliff collapses previously assessed by Massey et al. (2012a). For these two additional landslide hazards:

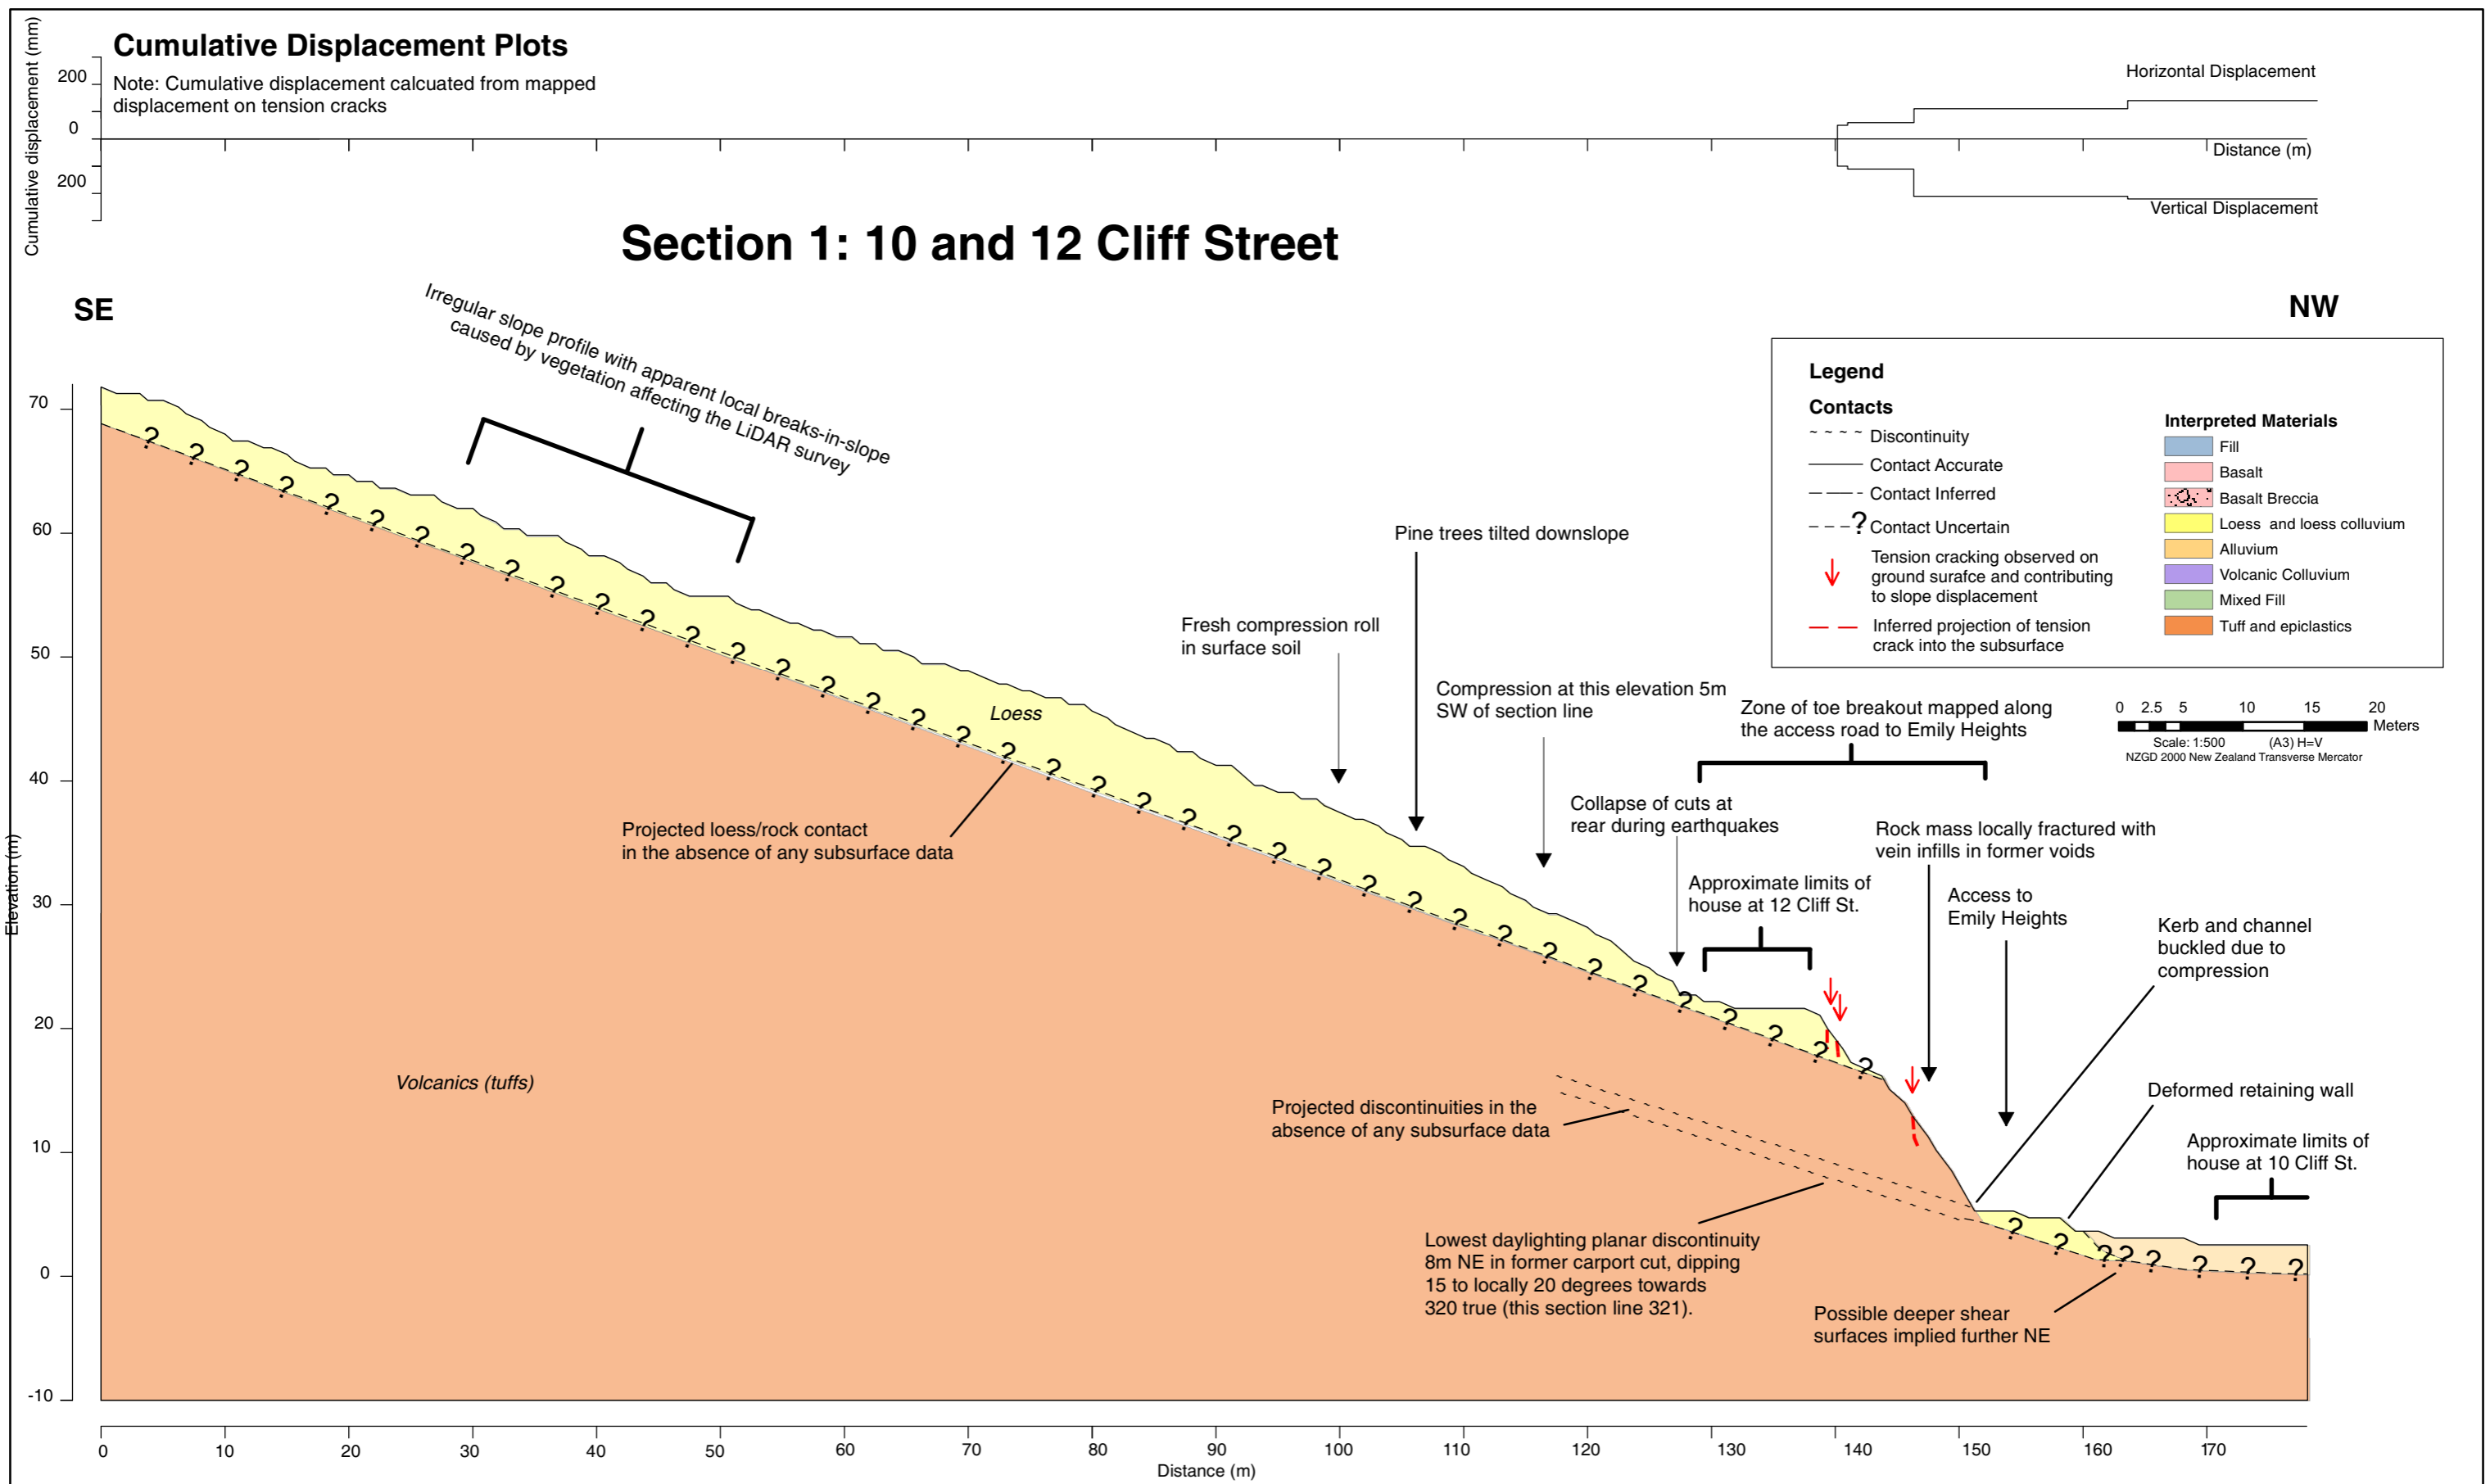
The drawing is reproduced from URS (2014), Port Hills land damage studies Cliff Street field investigations. Report prepared for Christchurch City Council. (Yetton, M. 2014).	DRW: PC	 	URS LTD. ENGINEERING GEOLOGY CROSS SECTION 1		FIGURE 5
	CHK: CM		Reproduced from Yetton (2014)		
			Cliff Street Christchurch		
			REPORT: CR2014/73	DATE: June 2014

The vector of displacement for cross-section 2 is only slightly steeper than the dip of the loess/colluvium and rock interface (Figure 5), suggesting displacement of the mass occurred along this interface.

As well as those discontinuities that are exposed near the base of the former coastal cliff, there is a buried zone of compression close to Cliff Street road level shown by buckled seal for the first 30–40 m northeast from Emily Heights (Figure 5). These features may relate to movement along a deeper (buried) discontinuity (Yetton, 2014).

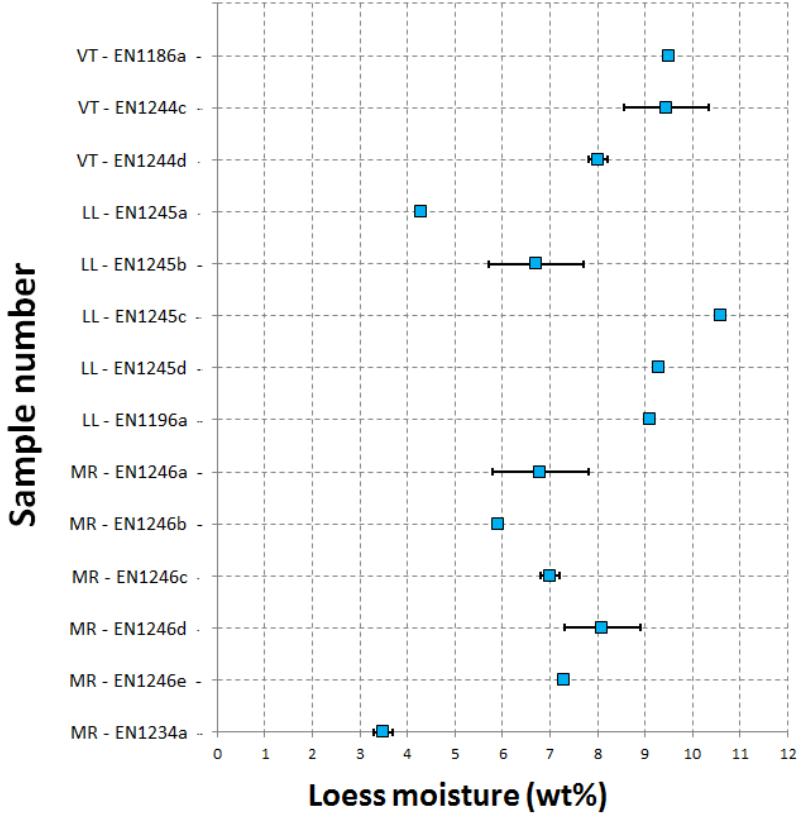
The water contents of the loess in drillhole samples were all substantially higher than those for the block samples. The difference may reflect the sampling method, where drilling includes using water as a flush, and block sampling does not, or that the outer face of the slope is naturally drier (Table 5).

Figure 11 In-ground moisture (water, wt%) content of collected loess samples.

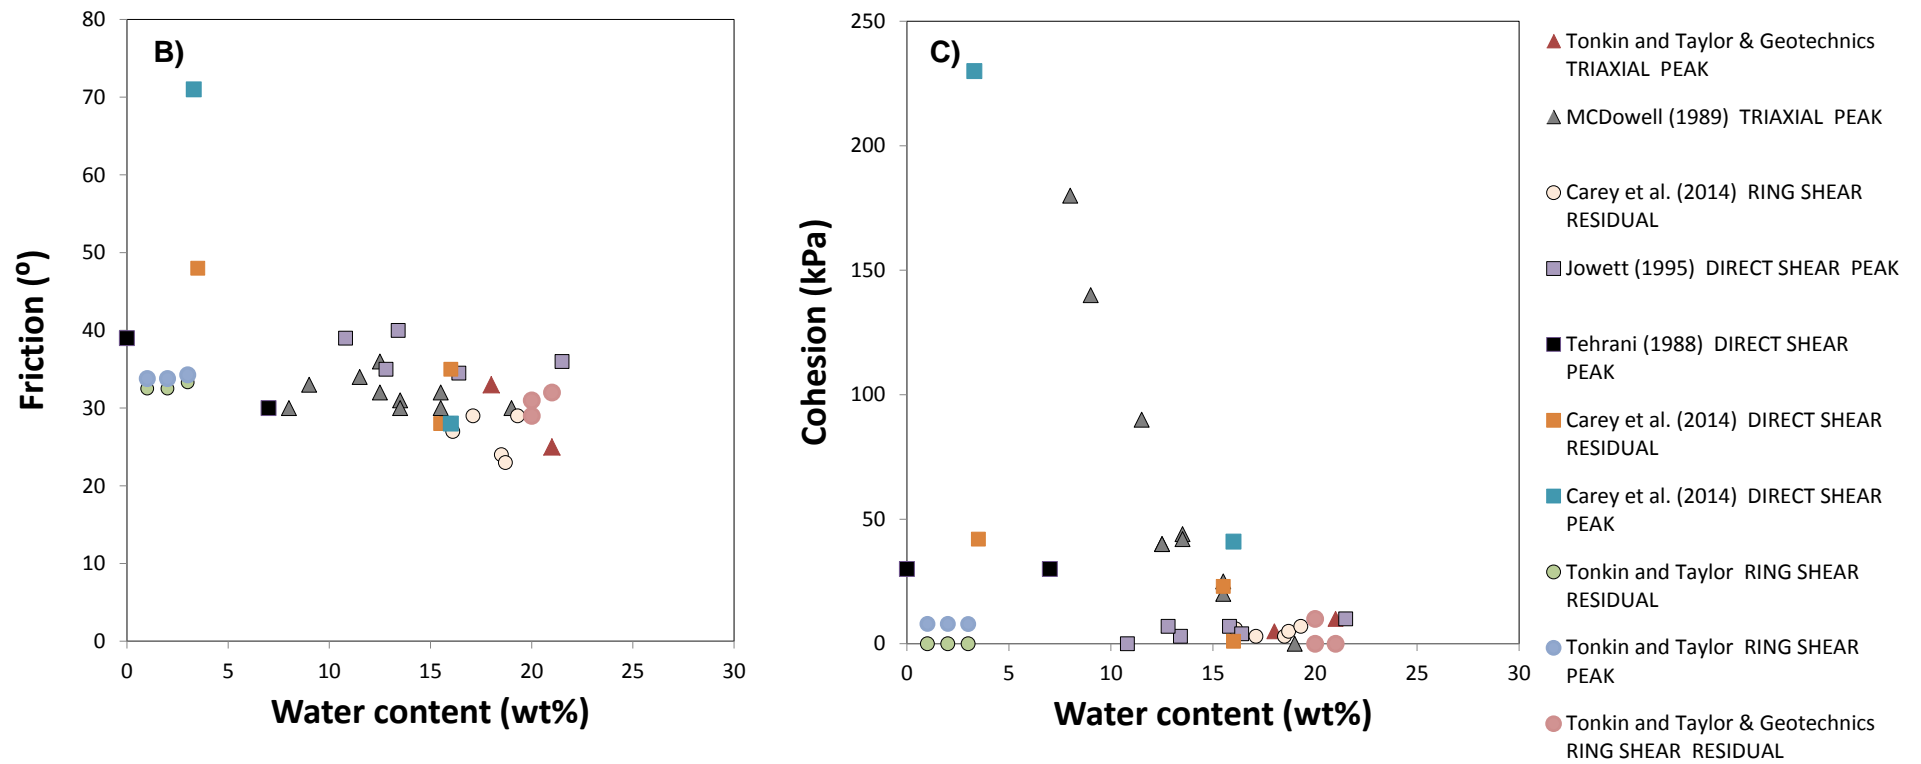
The shear strength of the loess was tested in-house at GNS Science using two types of ring shear equipment and on type of direct shear equipment (Carey et al., 2014). The results are summarised in Table 5 and Table 6 and plotted in Figure 12. The results show a wide variability in the tested friction and cohesion values. Where shear box tests indicated peak and residual strength characteristics, both the peak and residual friction and cohesion values have been plotted with “tie” lines joining the data points together.

For water contents between 10 and 20 wt%, the cohesion of the tested loess is very sensitive to changes in water content. These results illustrate a large variability in the strength parameters of the loess in the Port Hills, and that the complex effects of the water content may be critical to the loess strength. These results are consistent with the findings of others (e.g., McDowell, 1989; Goldwater, 1990).

Figure 12 Loess residual shear strength results (from Table 8 and Table 9). A) Cohesion and friction laboratory results plotted for loess. B) Loess residual cohesion plotted against water content. C) Loess residual friction plotted against water content.

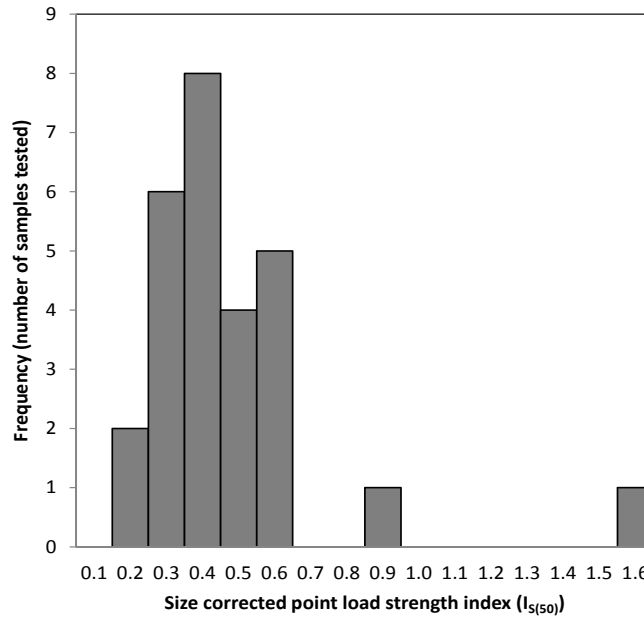
The size corrected point load strength index $I_{S(50)}$ was obtained using the size correction factor given in Ulusay and Hudson (2007), for tests near the standard 50 mm size. The mean $I_{S(50)}$ for the tuff was 0.4 (± 0.1 at one standard deviation). This is based on 23 test results and excludes the two highest and lowest values from the 27 valid tests (Figure 15).

Figure 15 Size corrected point load strength testing results on samples of the Cliff Street tuff.

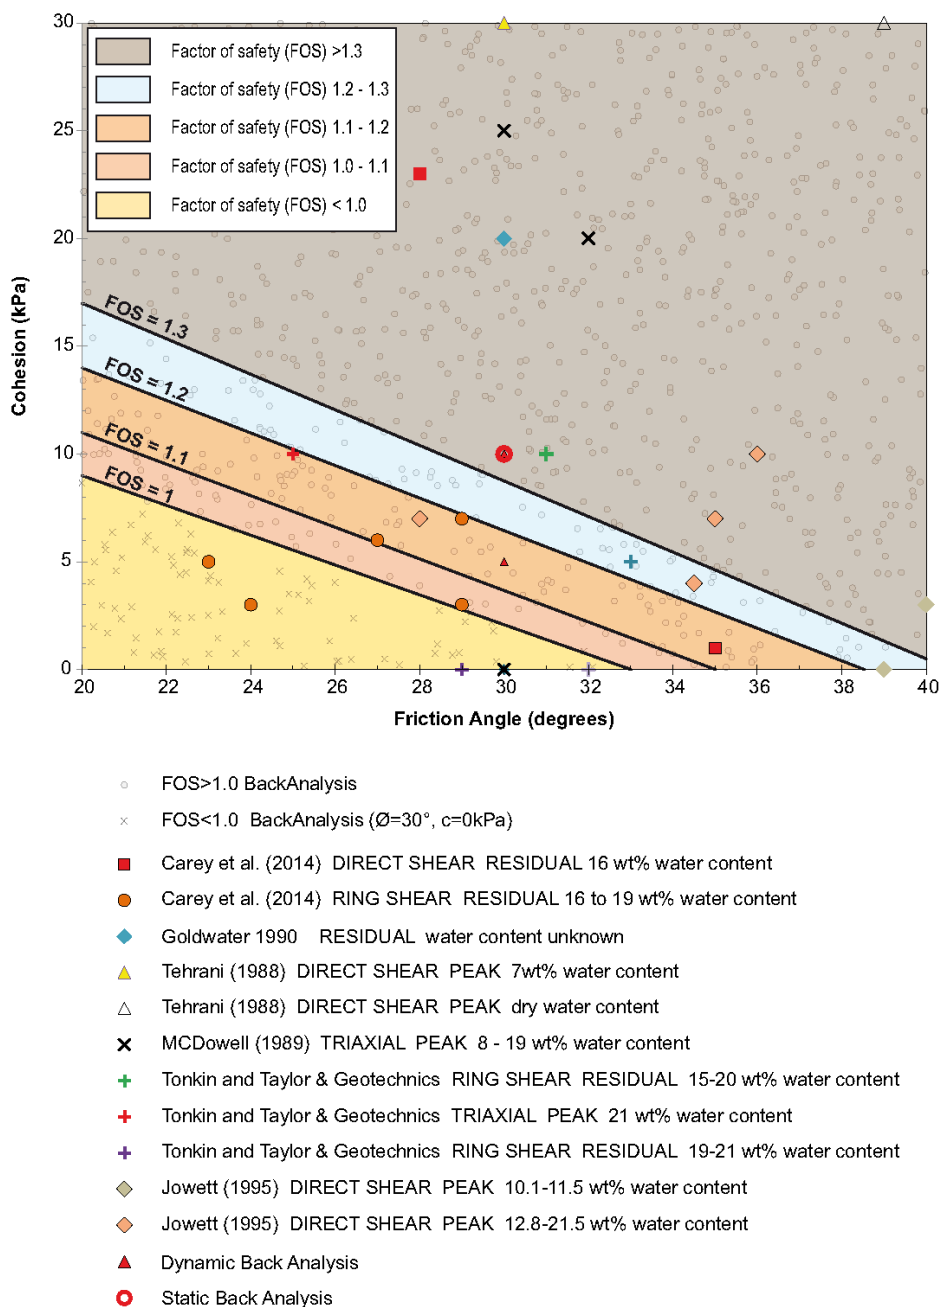
Figure 16 shows an example of the back-analysed friction and cohesion values that yield different factors of safety. Factors of safety greater than 1 are shown as circles and factors of safety less than 1 are shown as crosses. Each circle and cross represents a modelled slide surface. If a slope has a static factor of safety of 1, then the slope is assessed as being unstable.

Figure 16 illustrates that the factor of safety of the slope can be highly sensitive to variations in cohesion, supporting the results from the laboratory testing. For example at a friction angle of 30°, a drop in cohesion from 10 to 5 kPa represents a decrease in factor of safety from greater than 1.3 to about 1.1.

Typical lower estimates of the bulk shear strength parameters of loess in the Port Hills adopted by local Geotechnical consultants are friction (ϕ) = 30° and cohesion (c) = 10 kPa (Port Hills Geotechnical Group, personal communication 2012). These data are shown as a red hollow circle on Figure 16.

Figure 16 Sensitivity assessment of the loess slope (cross-section 1) bulk shear strength parameters of friction and cohesion.

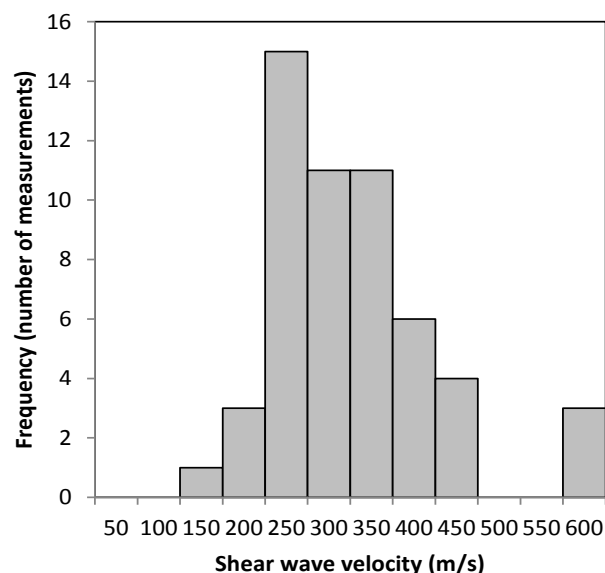
The *in situ* shear modulus of the materials was derived from the downhole shear-wave velocity surveys carried out by Southern Geophysical Ltd. (Southern Geophysical Ltd., 2013) based on nearby survey available from Redcliff drillholes BH-MB-02, and results from the dynamic probing carried out by Tonkin and Taylor for the Earthquake Commission at Clifton Terrace (Tonkin and Taylor, 2012a). The results from the dynamic probing are summarised in Figure 17. The mean shear wave velocity is 306 m/s (± 93 m/s at one standard deviation) and the mode is 222 m/s.

Figure 17 Loess shear wave velocity results from dynamic probing reported by Tonkin and Taylor (2012a) for the loess at Clifton Terrace.

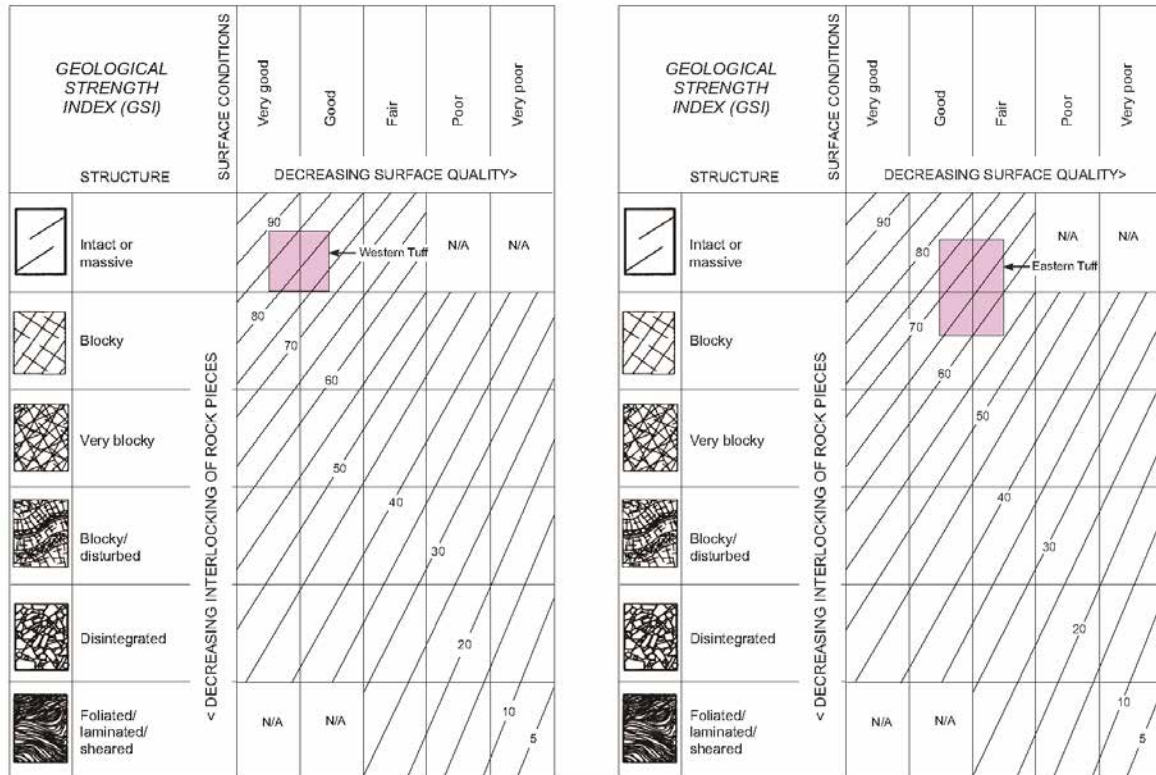
In order to derive rock mass strength parameters for the tuff that take into account the nature of the discontinuities, the geological strength index (Hoek, 1999) was adopted to reduce the strengths derived from the point load testing of intact samples by using the Rocscience RocLab software. The geological strength index values adopted for the tuff are shown in Figure 18.

Figure 18 Geological strength index plot for tuff exposed at Cliff Street.

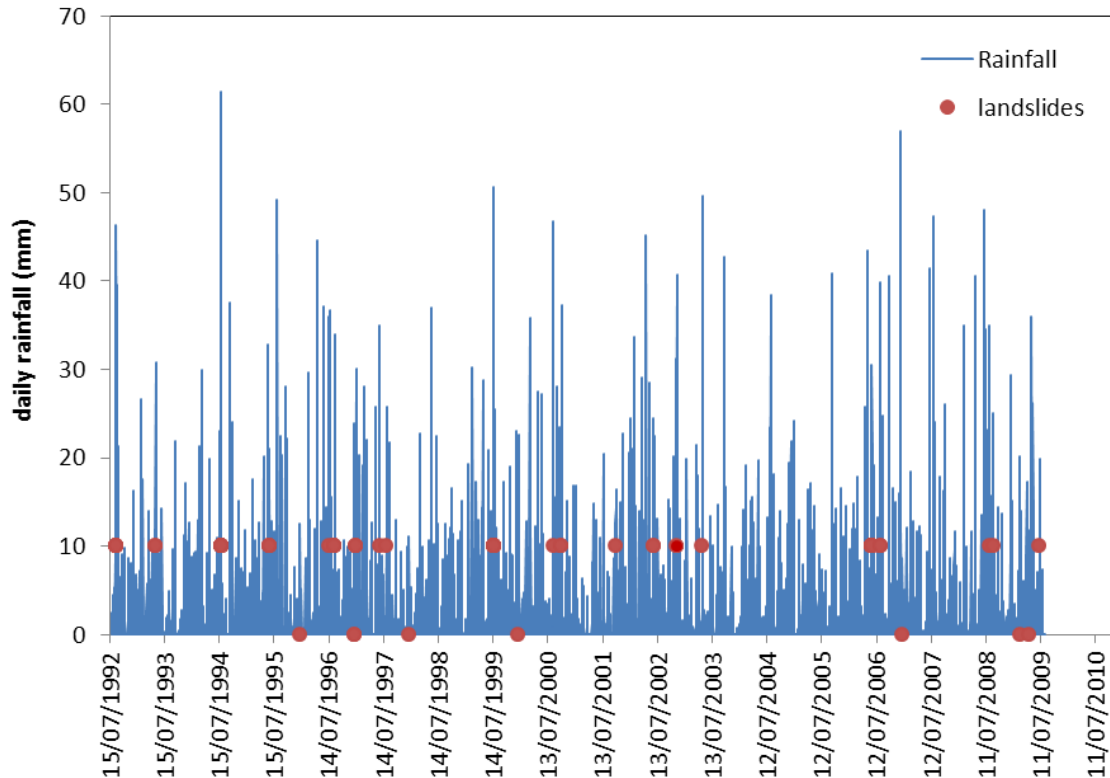
McSaveney et al. (2014) examined a list of Earthquake Commission claims for landslide damage for the period 1997–2010, and a Geotechnical Consulting Ltd. landslide investigations list, which covers much of the period 1992–2009. Any duplicate records for the period 1997–2009 contained in the data sets were removed. These records, though incomplete with respect to all of the landslides that occurred over those intervals, may be approximately complete with respect to the episodes of rain associated with landslide occurrences that damaged homes and urban properties (Figure 19).

Figure 19 Daily rainfalls at Christchurch Gardens and landslides in the Port Hills. Daily rainfalls at Christchurch Gardens and landslides in the Port Hills investigated by Geotechnical Consulting Ltd, or listed by the Earthquake Commission as causing damage to homes. Landslides without rain are plotted at 0 mm, all others are plotted at 10 mm of rain (the minimum rainfall for triggered landslides).

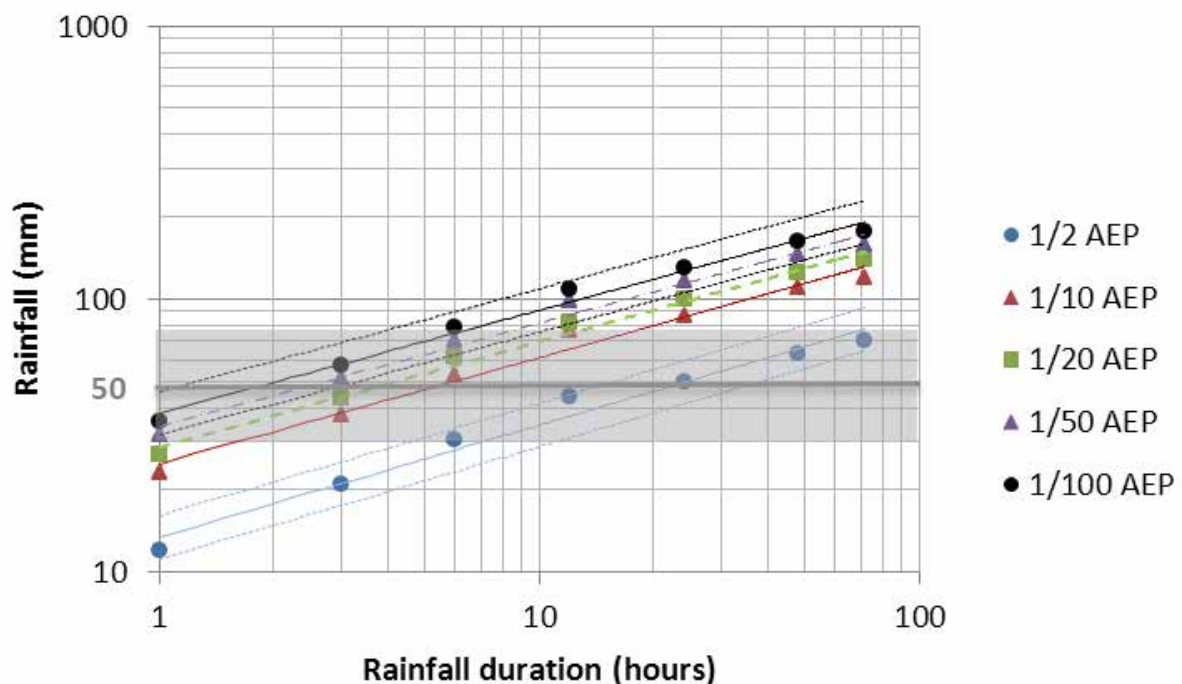
Regardless of the dataset used, both suggest that the heavy rainfalls recorded in the Port Hills following the 2010/11 Canterbury earthquakes are unexceptional. Although the three-day rainfall of 118 mm had an annual frequency of 0.05–0.1 (once every 10 years), it occurred at the end of summer when the ground would have had a seasonally low water content.

Figure 20 Rainfall depth-duration-return period relations estimated by Griffiths et al. (2009) using recorded rainfall data. Error limits of 20% are shown by dotted lines for the 1/2 and 1/100 AEP curves. Shaded area covers the range of 30–75 mm of rainfall over which the expected number of soil landslides in the Port Hills rises from very few to many. Rockfalls can occur without rain, but the probability of rockfalls occurring increases with increasing intensity of rainfall.

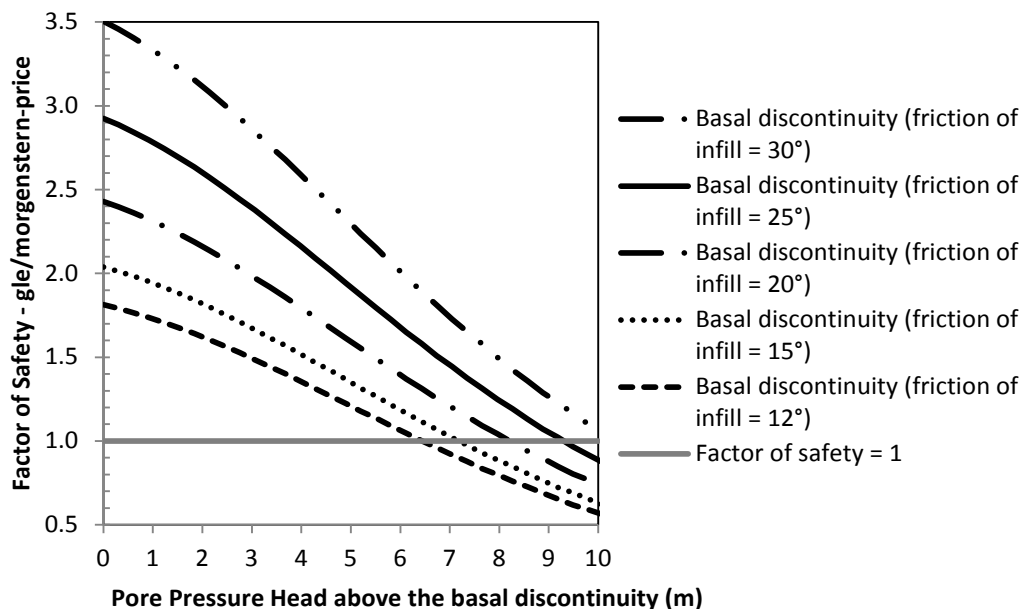
Sensitivity of the rock slope to changes in pore pressure acting both in tension cracks and within the basal discontinuity has been assessed, as movement of at least part of the slope was identified after 2010/11 Canterbury earthquakes during a long period of wet weather. The results from the sensitivity assessment are shown in Figure 21, for different shear strengths of the basal discontinuity (from Table 9). The modelled slide surfaces are shown on Figure 22 and were calculated when pore pressure head levels were assumed to be 0 m (i.e., the defect was assumed to be dry).

Figure 21 Sensitivity of the slope along cross-section 1 to changes in pore pressure. A pore pressure head of 0 m corresponds to the lower basal discontinuity. The pore pressure head was varied at different levels above the basal discontinuity, with the corresponding pore pressure head level being used to establish the amount of water acting in the tension crack. The shear strength of the basal discontinuity was derived using the relationship of Barton (2008) for various friction angles of the clay material infilling the discontinuity.

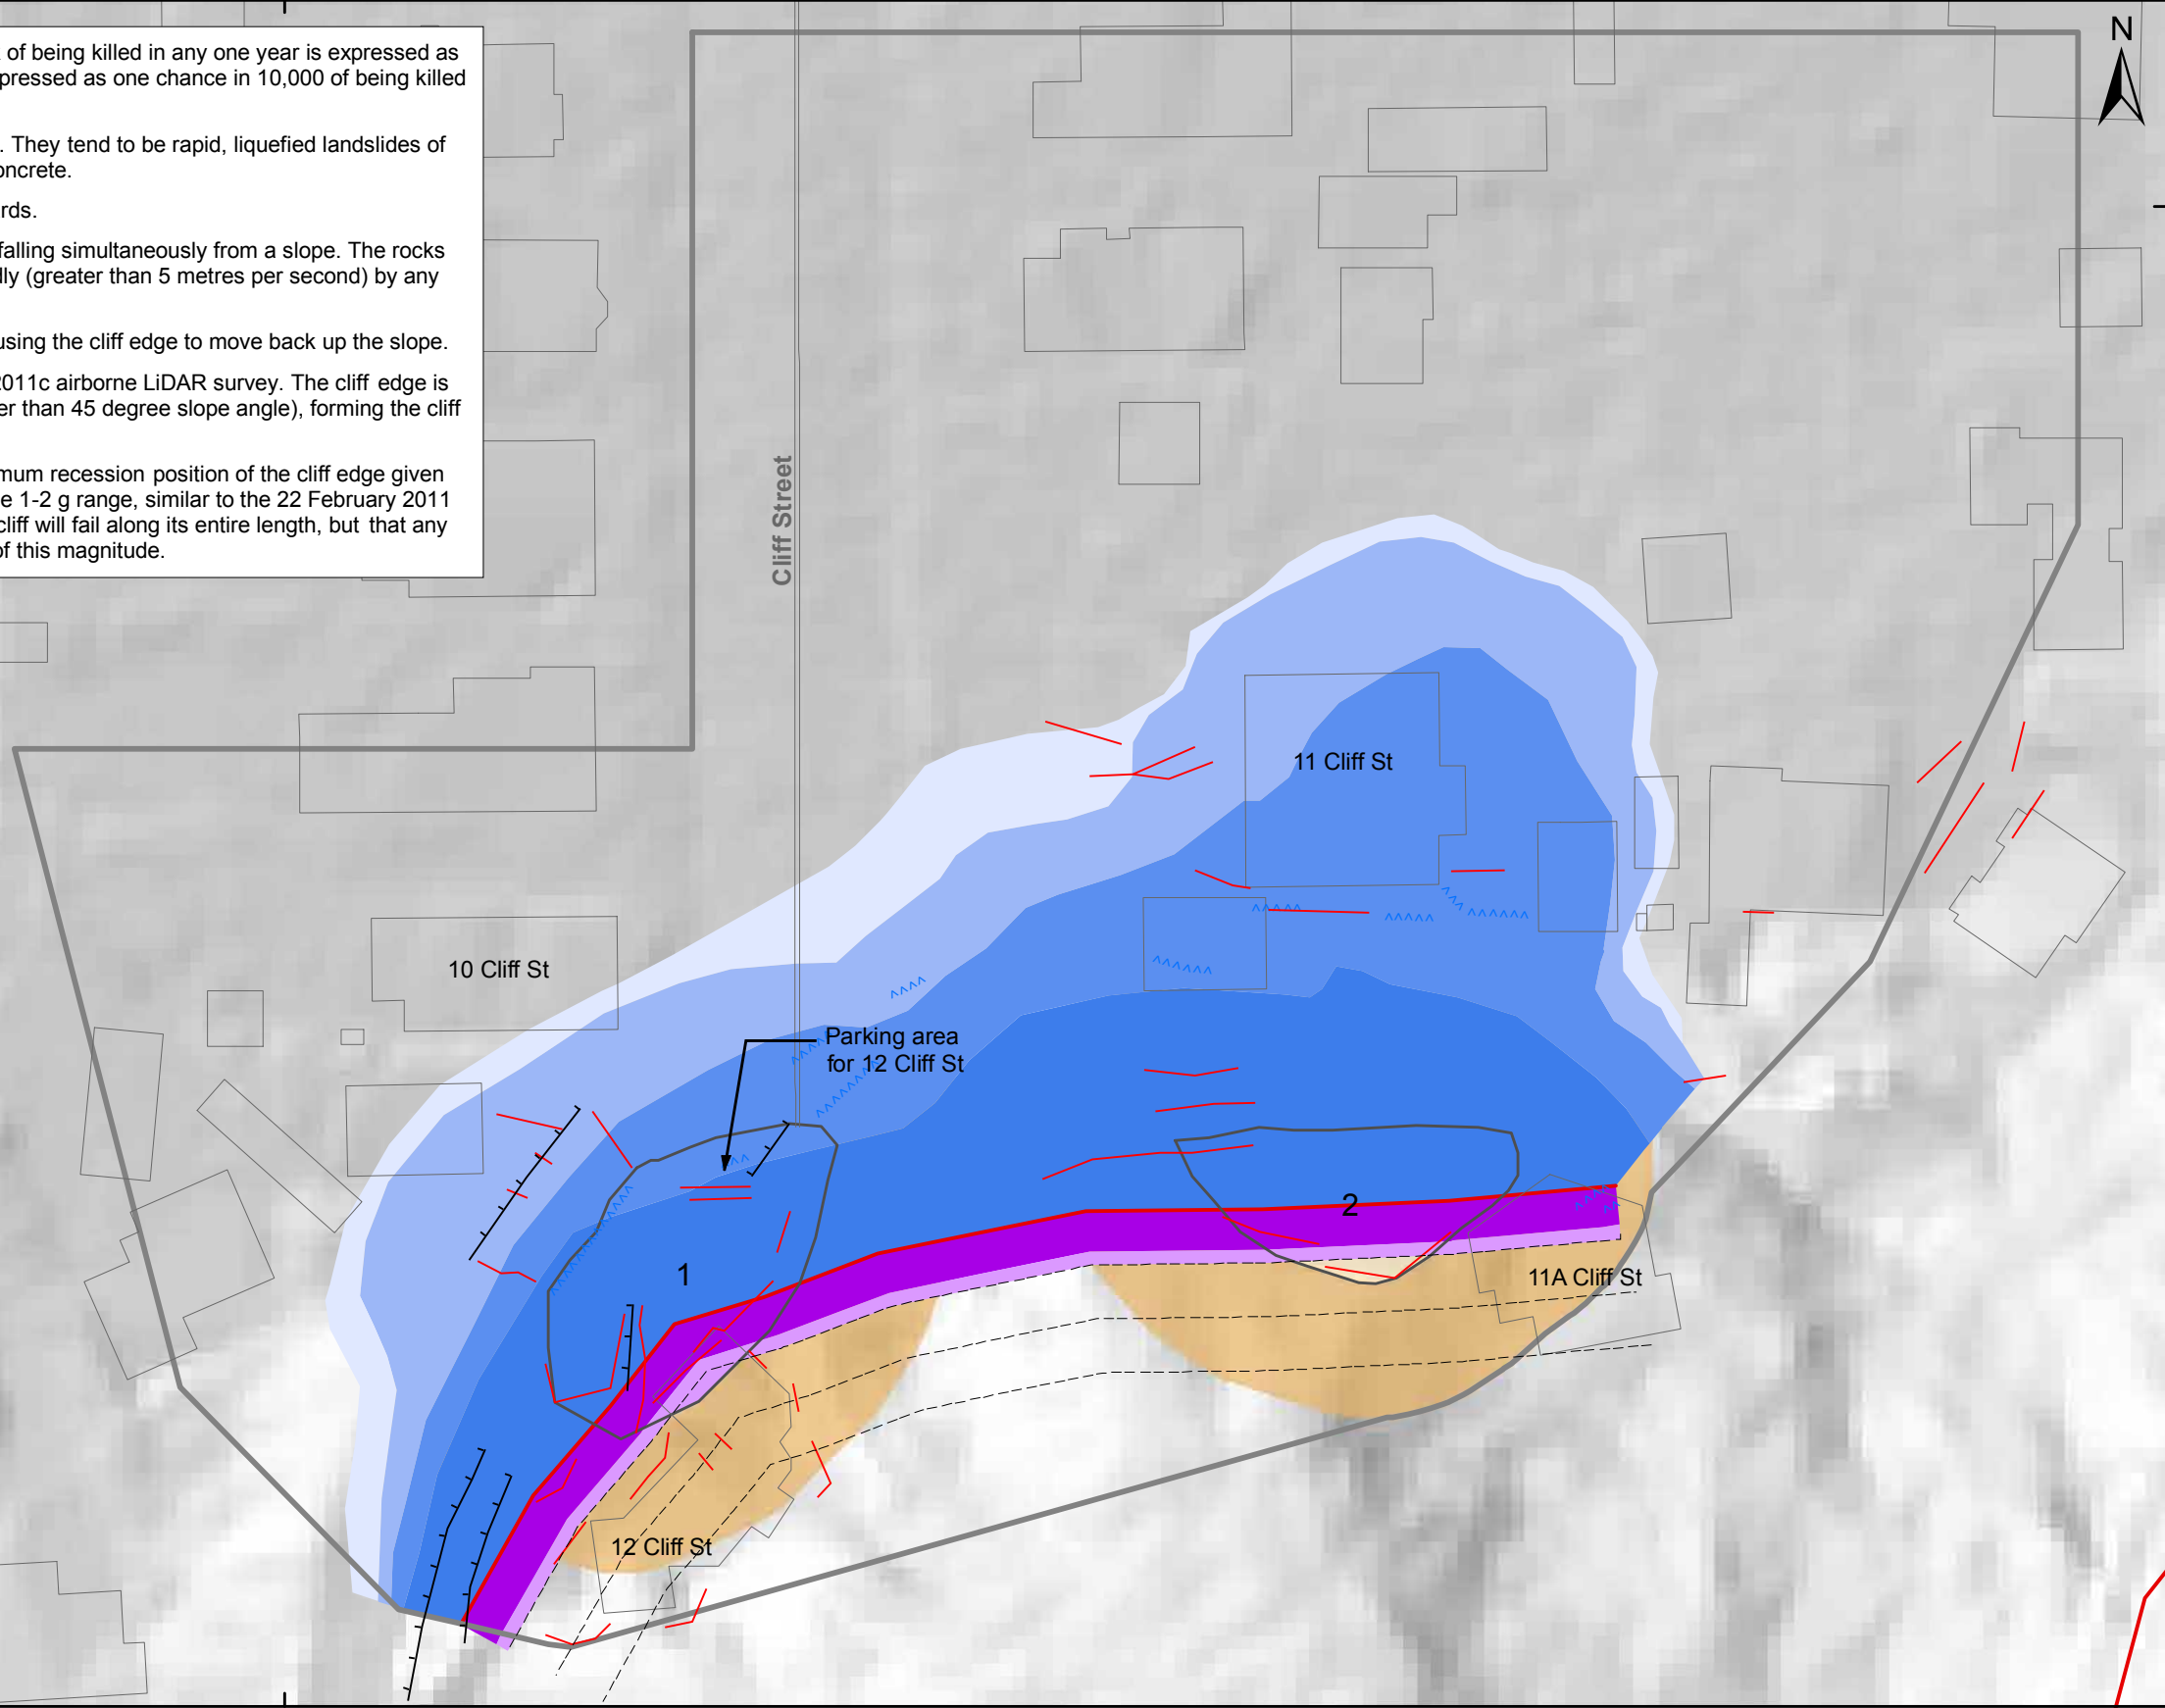
EXPLANATION:
 * Modified from report CR2012/124
 ** Taken from report CR2012/317
 The results combine the annual individual fatality risk modified from report CR2012/124 with the annual individual fatality risk from source areas 1 and 2, adopting Scenario B
 Background shade model derived from NZAM post earthquake 2011c (July 2011) LiDAR survey resampled to a 1 m ground resolution.
 Roads and building footprints provided by Christchurch City Council (20/02/2012).
 PROJECTION: New Zealand Transverse Mercator 2000

The total risk from the combined hazards is shown in Map 4 of Figure 43. The results combine the risk presented in Massey et al. (2012a) from cliff collapse of the slope with the annual individual fatality risk estimated adopting scenario B (the middle volume estimates) for both the debris avalanche and earth/debris flow hazards (source areas 1 and 2 respectively) assessed in this report.

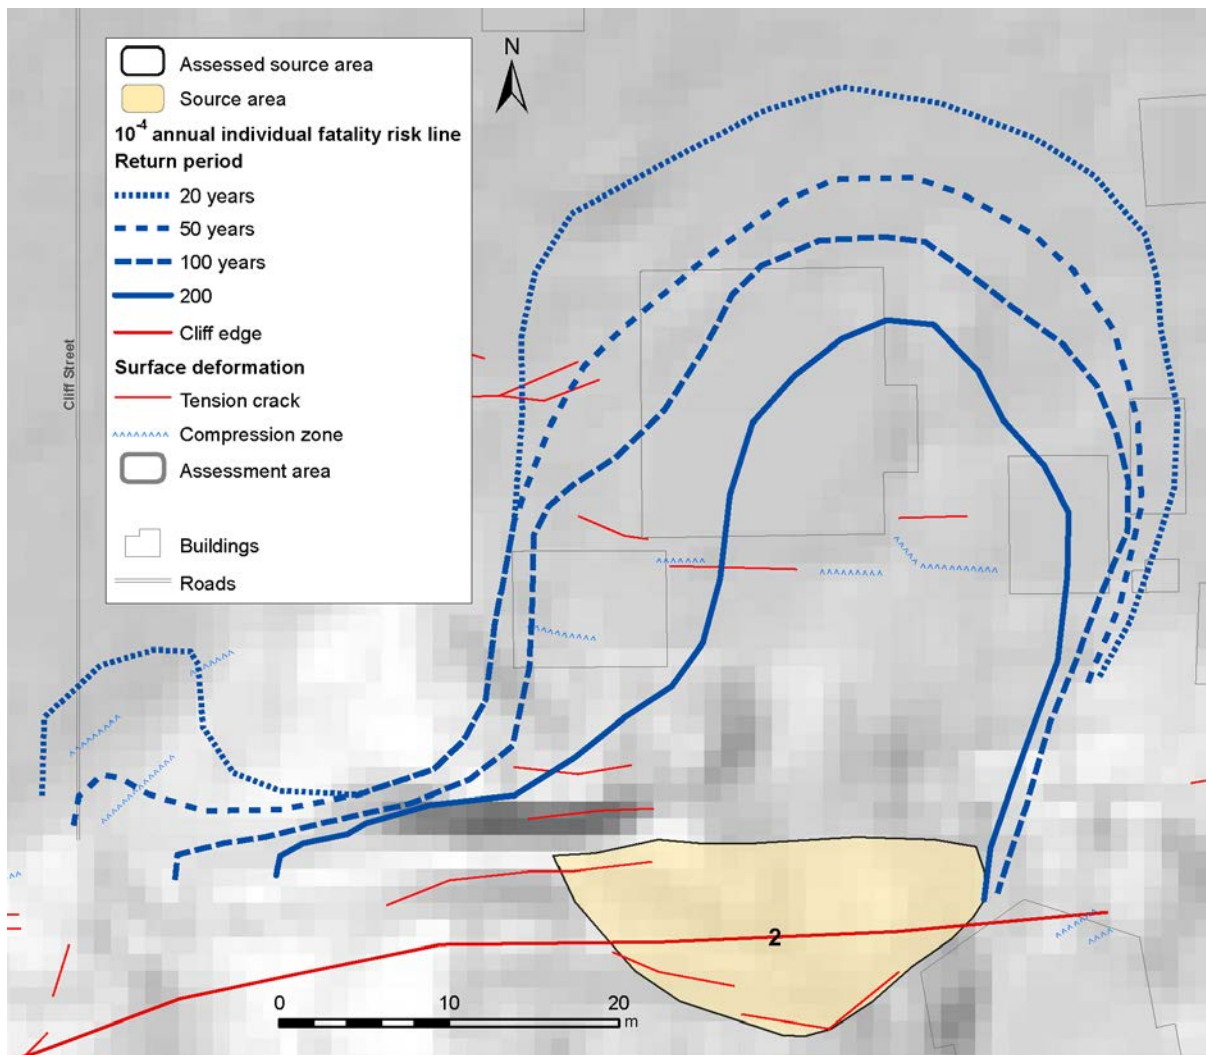
Figure 44 Sensitivity of the risk estimates, upper volume estimates, for triggering event return periods of 20, 50, 100 and 200 years.

The results show that area within the 10^{-4} risk contour reduces between the 20 and 100 year return periods. This is because the volume of the failure, and therefore runout distance of the debris, remains fixed, but the return period of the event increases, leading to a reduction in the risk at the longer return periods.

The results (Figure 44) show that largest impact on the risk is from the volumes of material that could be generated in an event, and secondly from the annual frequency of the event that could trigger them. These combine for the debris avalanche risk (source area 1) to give slightly less than an order of magnitude uncertainty, in either direction, on the risk estimates. For the earth/debris flow risk (source area 2), these combine to give about an order of magnitude uncertainty, in either direction, on the risk estimates.
