**Canterbury Earthquakes 2010/11 Port Hills Slope
Stability: Risk assessment for Cliff Street**

**GNS Science Consultancy Report 2014/73
August 2014 FINAL**

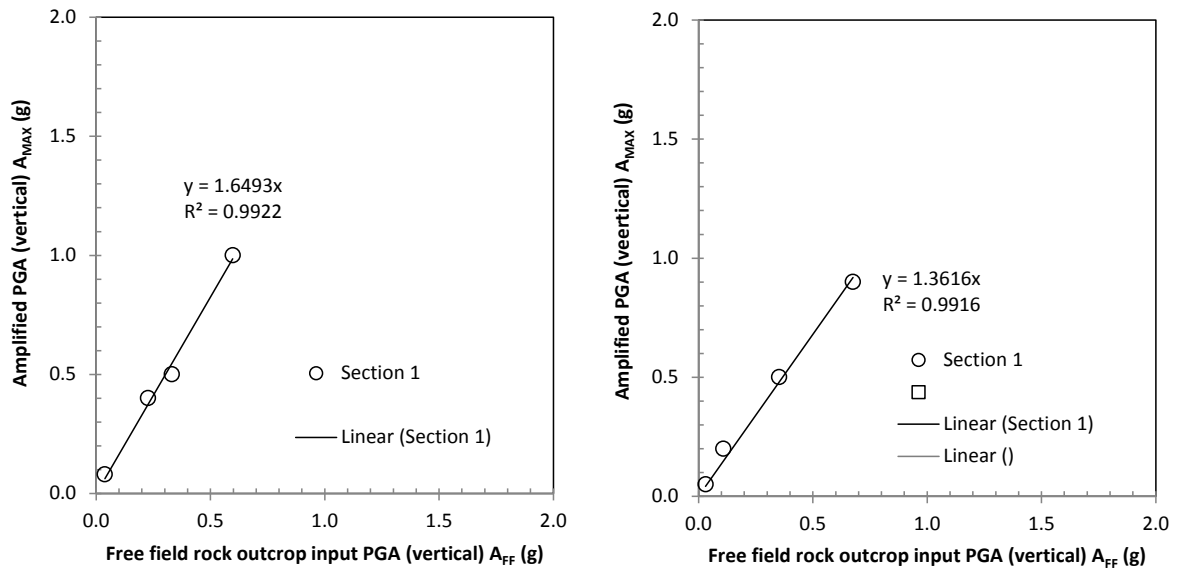
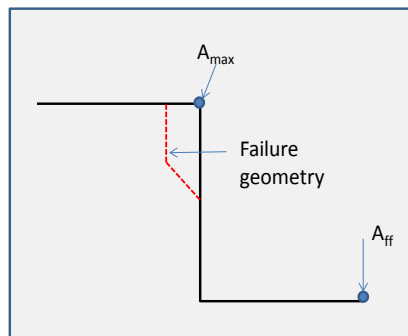
Figure A3.1 Amplification relationship between the synthetic free field rock outcrop input motions (A_{FF}) and the modelled cliff crest maximum accelerations (A_{MAX}) for cross-section 1. A schematic diagram showing the locations of the various recorded accelerations is shown.

Results from this assessment have shown that the relationship between the peak ground acceleration of the free field input motion and the corresponding modelled peak acceleration at the slope crest (A_{MAX}) is generally linear. In the range of modelled peak horizontal accelerations, the mean horizontal amplification factor (S_T) is typically in the order of about 1.7 times the input free field peak horizontal acceleration.

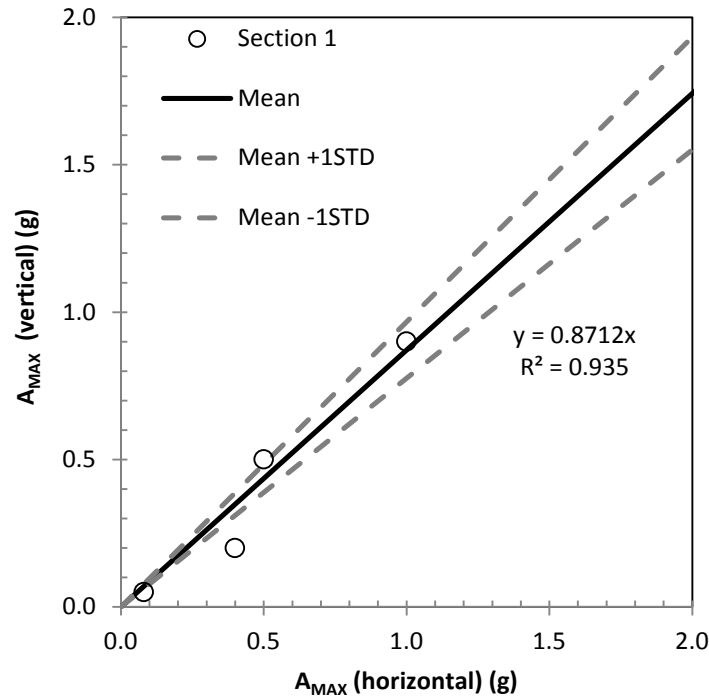
The relationship between the modelled vertical and horizontal peak ground accelerations recorded at the slope crest (A_{MAX}) is shown in Figure A3.2. The gradient of the linear fit (cross-section 1) is $0.87 (\pm 0.01)$ – errors at one standard deviation, with a gradient of 0.9 being the mean plus two standard deviations. The relationship between horizontal and vertical peak ground accelerations appears linear.

Figure A3.2 Relationship between the modelled horizontal and vertical maximum accelerations modelled at the slope crest (A_{MAX}) for cross-section 1, using the synthetic free field rock outcrop motions for the Cliff Street site by Holden et al. (2014) as inputs to the assessment. The mean and standard deviation trend lines are fitted for A_{MAX} all data. Errors are shown as the mean \pm one standard deviation (1 STD).
