**Canterbury Earthquakes 2010/11 Port Hills Slope  
Stability: Risk assessment for Maffeys Road**

**GNS Science Consultancy Report 2014/79  
August 2014 FINAL**

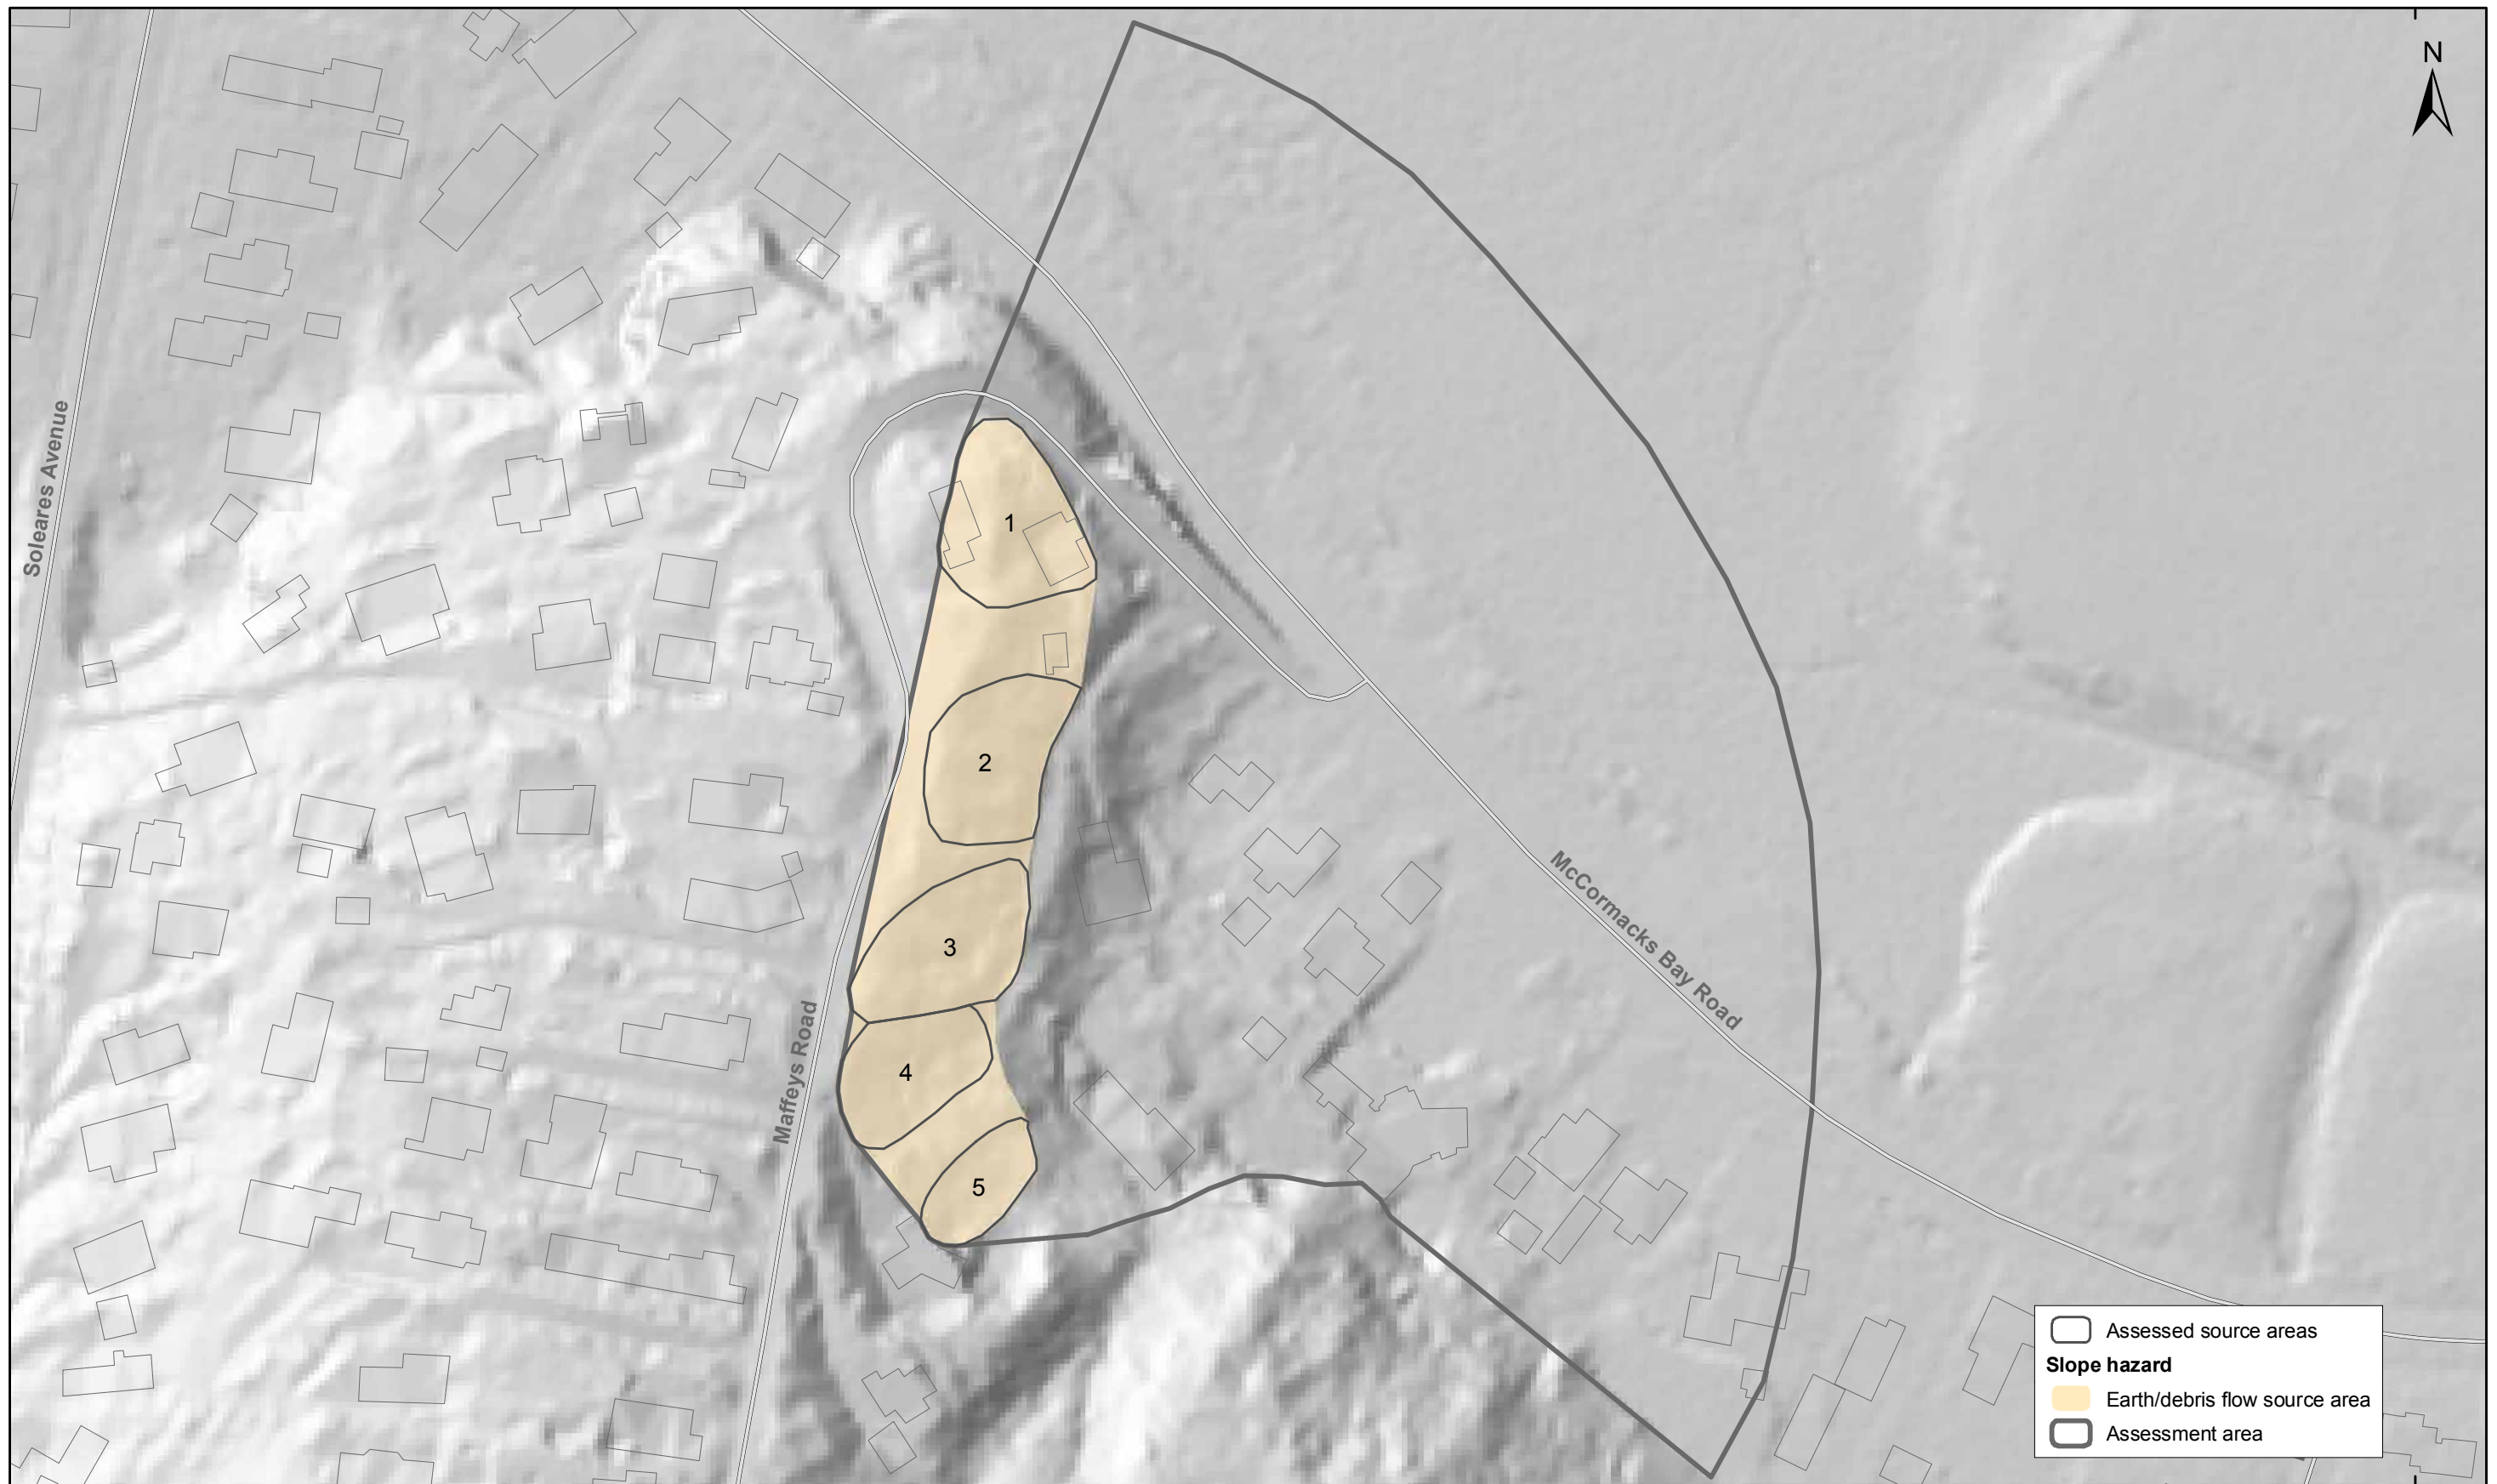
**FIGURE 2**

This report presents the risk assessment results for earth/debris flows from the five assessed source areas identified within the Maffey's Road mass movement. The map in Figure 2 outlines the assessed potential landslide source areas within the assessment area, while shows the approximate boundary of the assessment area. Figure 4 shows a view looking along Maffey's Road.

The results of the URS Ltd. engineering geological assessments (Yetton and Engel, 2014) and the slope stability modelling carried out by GNS Science have been used to define five potential landslide source areas. The assessed source areas (shown in Figure 2) do not represent the only potential locations of the source areas that could occur in the assessment area. The assessed source areas are intended to represent the range of potential landslide locations and volumes that could occur in the assessment area.

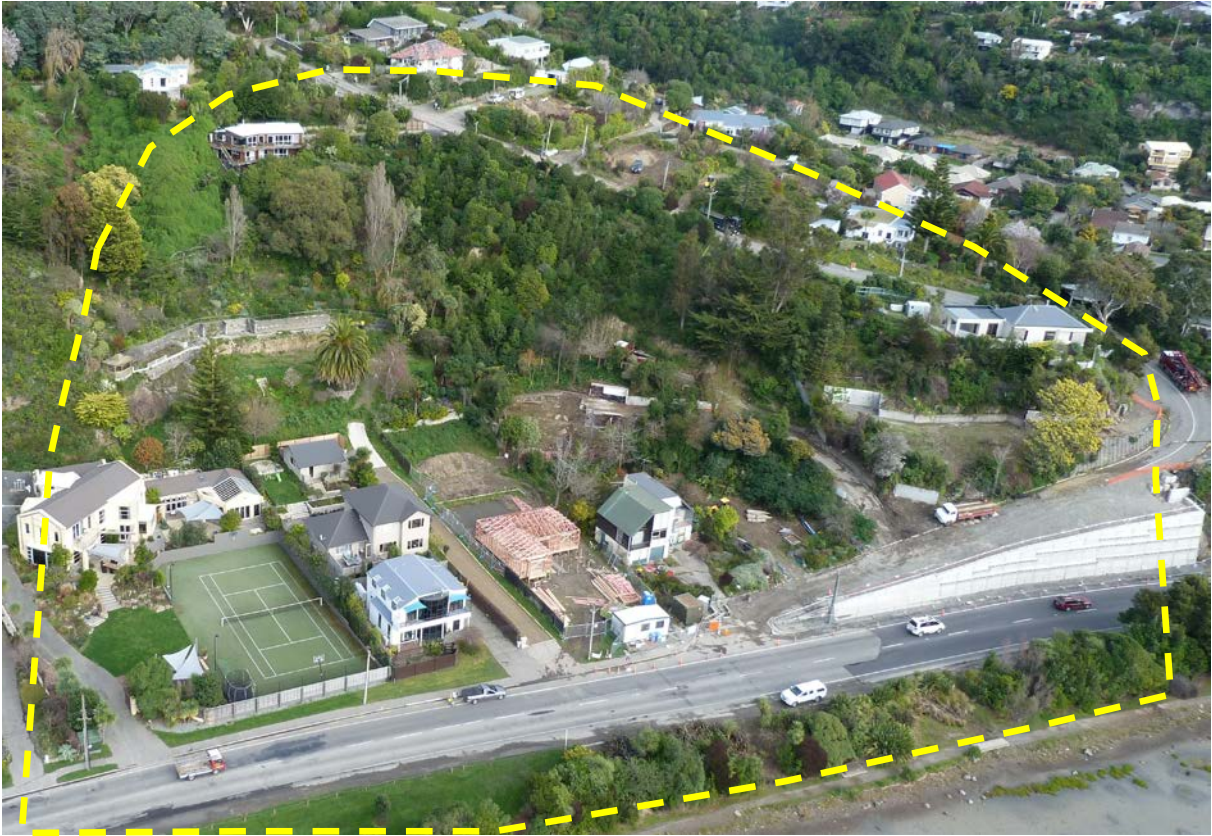
**Figure 3** Aerial view, looking west, of the Maffey's Road assessment area. The approximate extent of the assessment area is shown by the yellow dashed lines, the actual mapped extent of the assessment area is shown on Figure 2). Photograph taken by M. Yetton (2013).

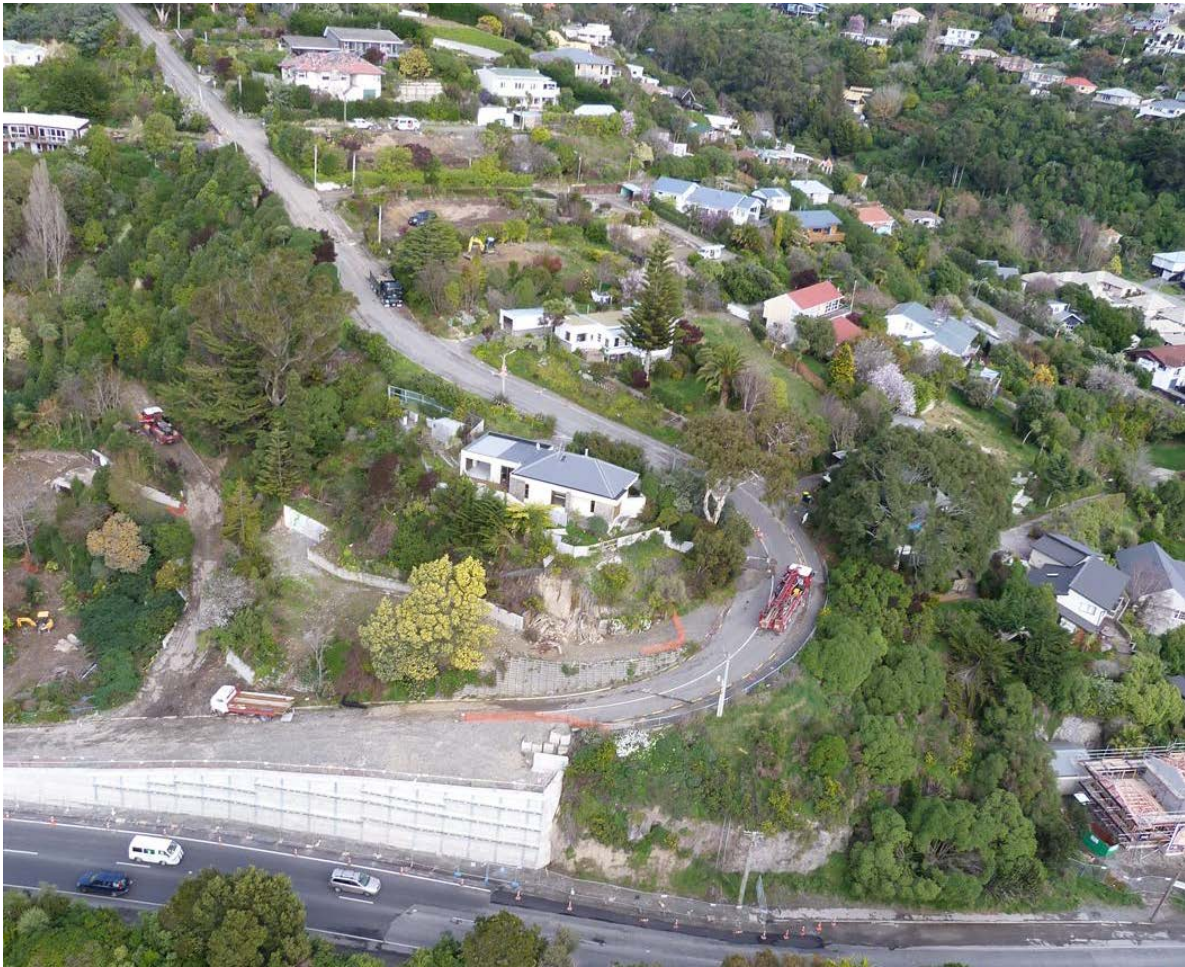
**Figure 4** Aerial view, looking south, of the Maffey Road mass movement. Photograph taken by M. Yetton (2013).

Following the 22 February 2011 earthquakes, significant localised cracking was noted on the slope surface within the Maffey Road mass movement. Previous investigations of the site comprised:

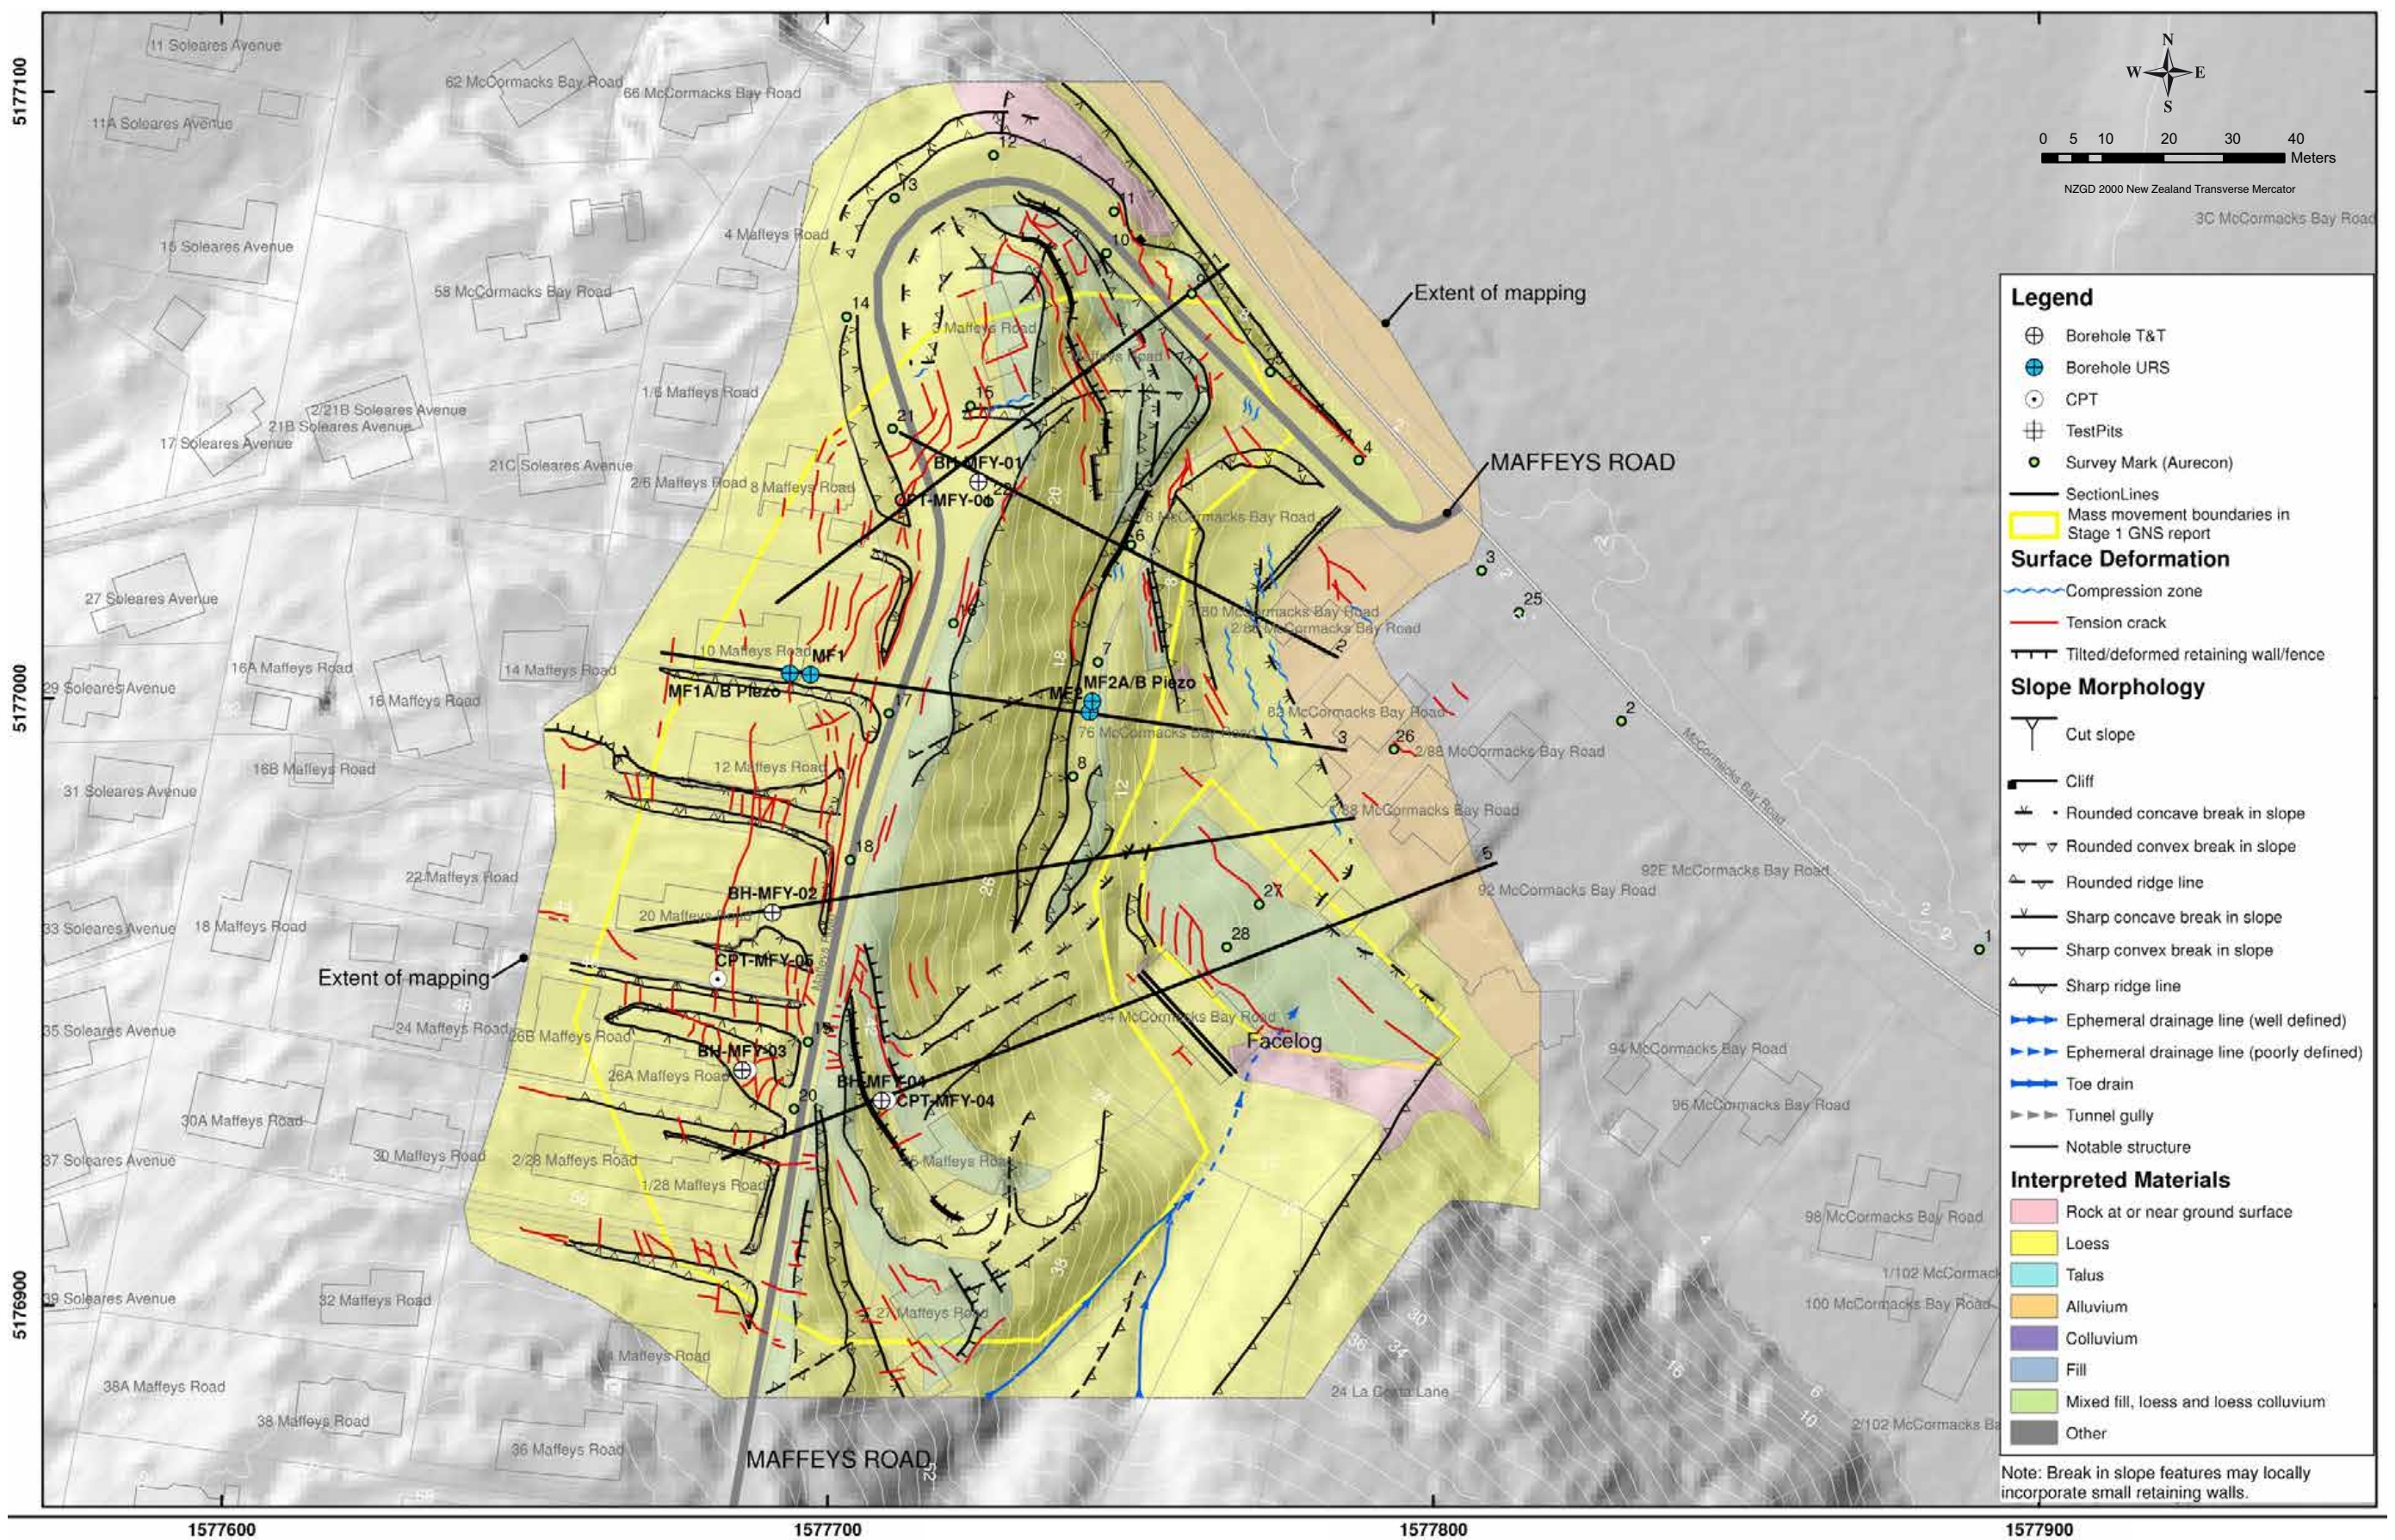
- In the northern part of the slope, post-earthquake displacement of the area occurred in response to retaining-wall excavation at the junction of Maffeys Road and McCormacks Bay Road, below 11 Maffeys Road.
- Very slow, post-earthquake creep at the interface between the loess and rock is suggested by survey and inclinometer data (MFY02 only, Figure 5).

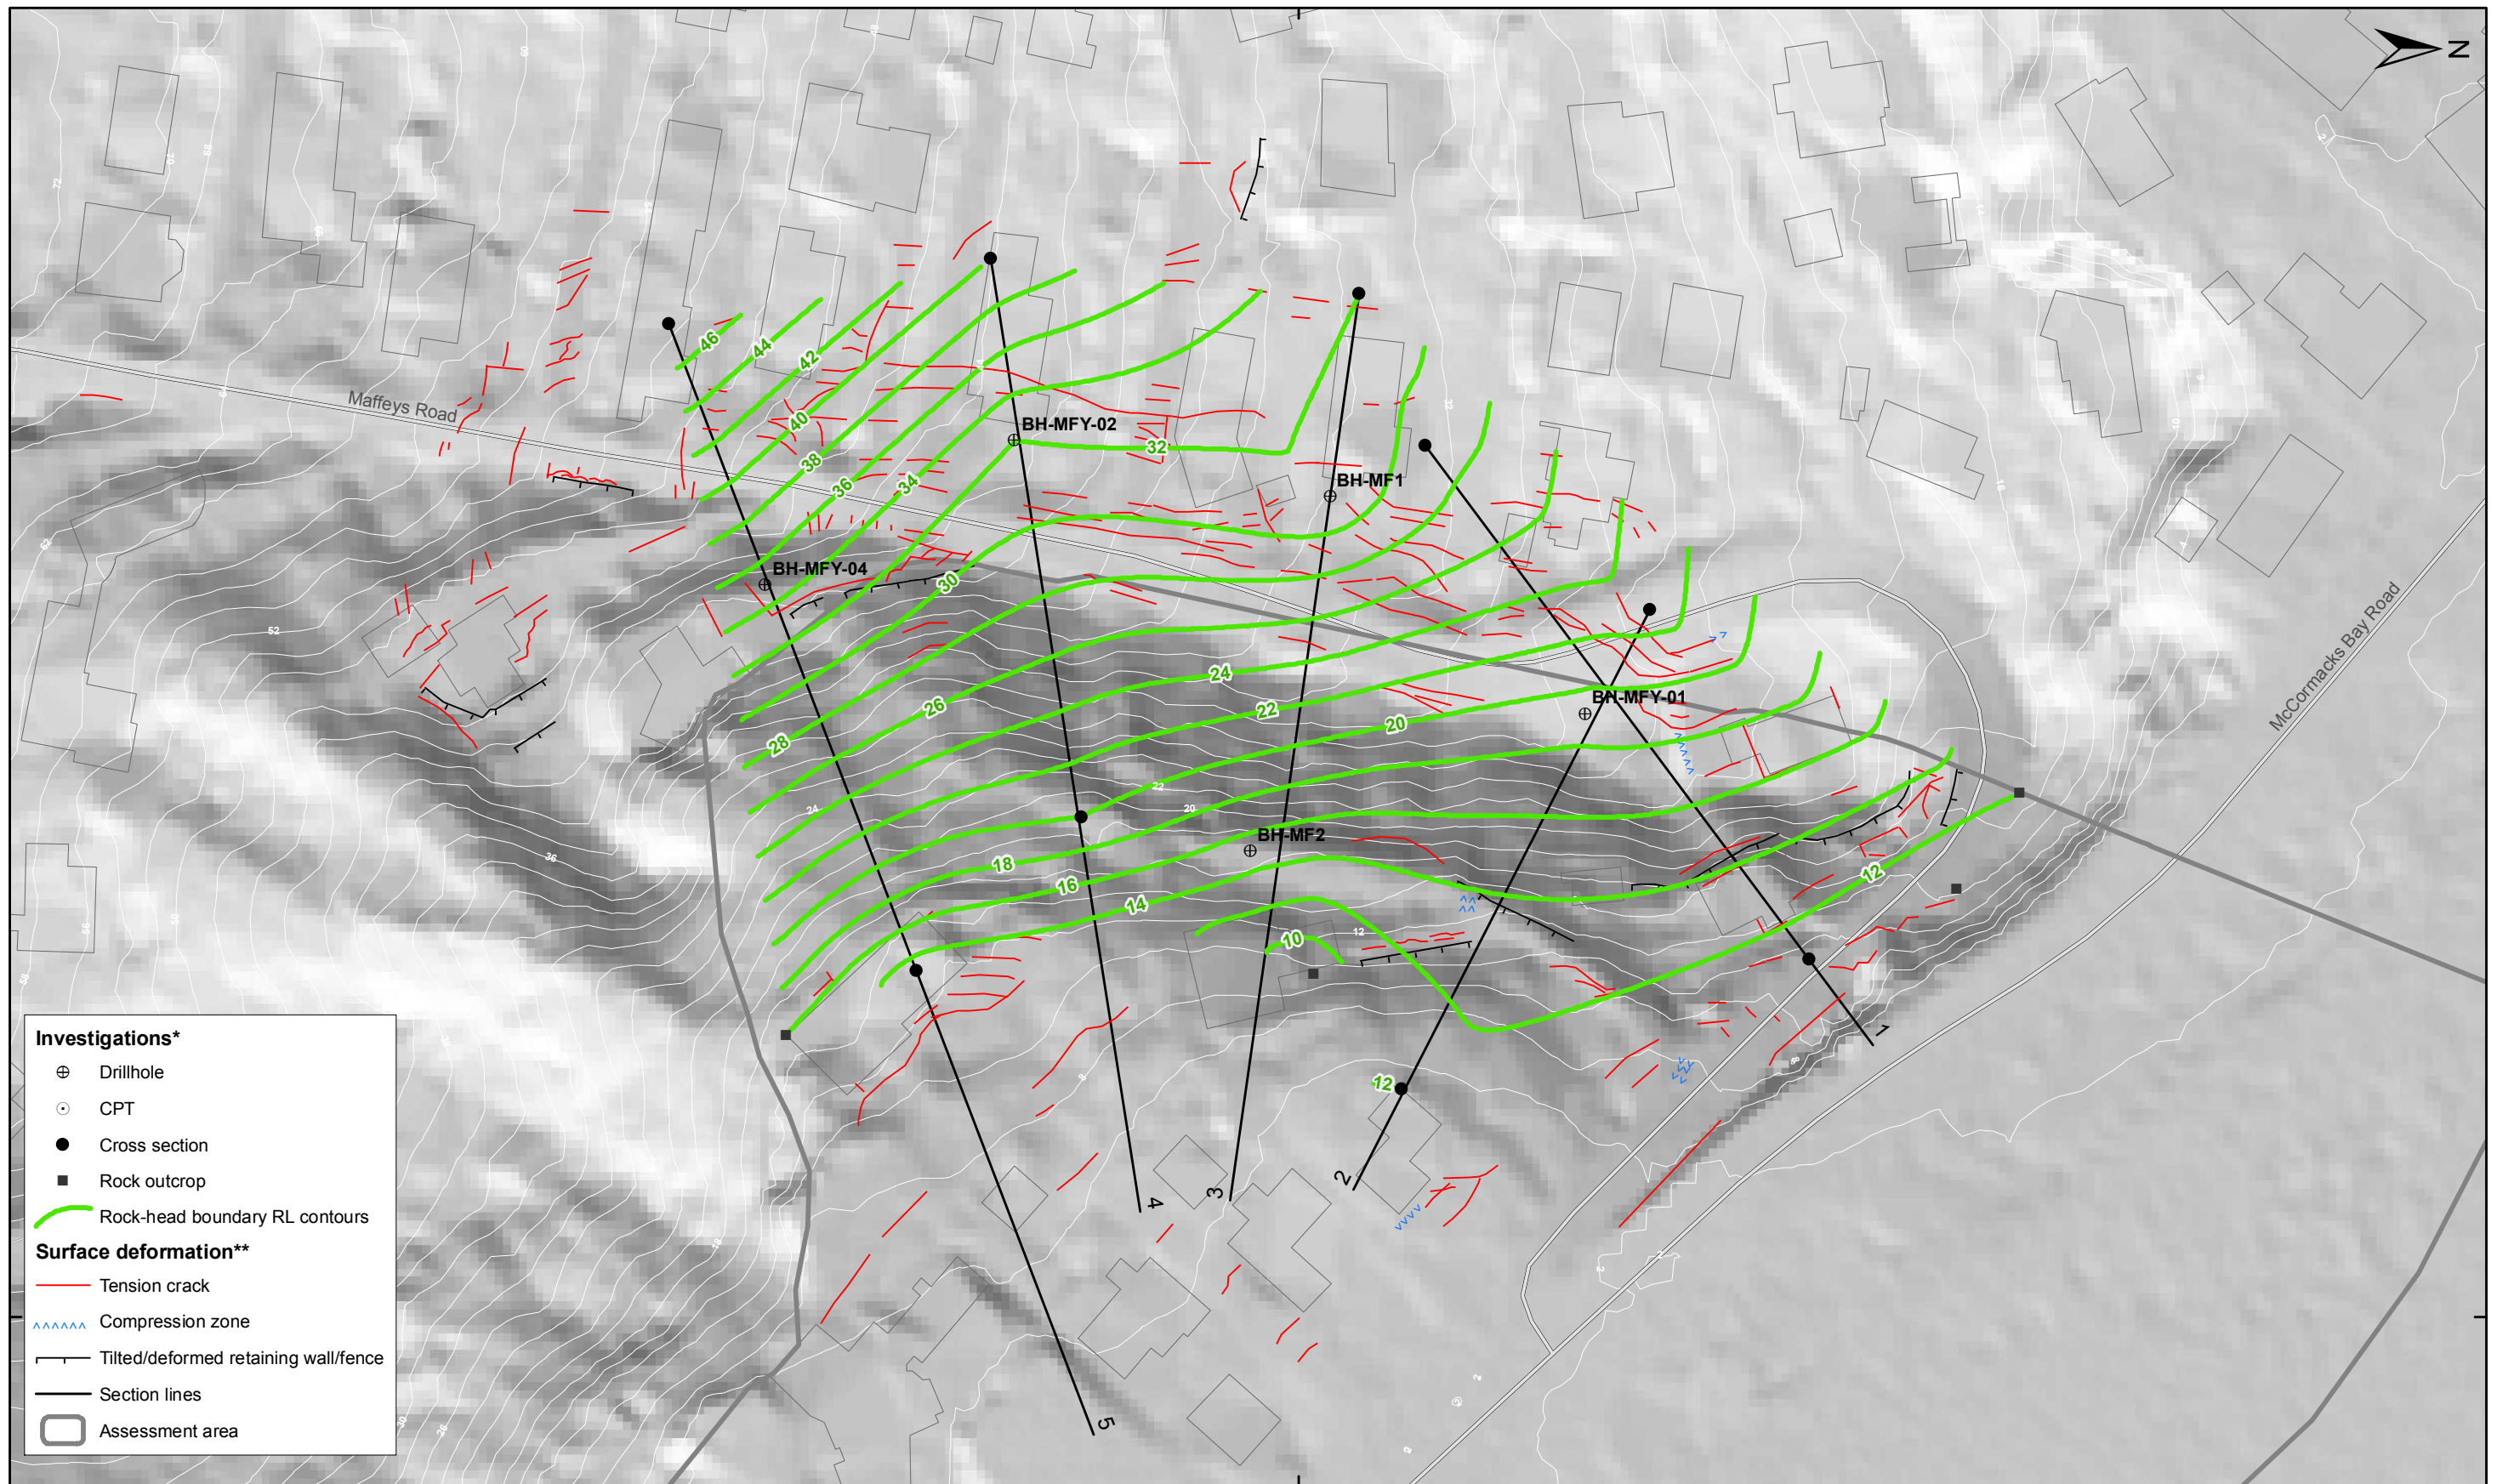
The boundary between the base of the volcanic colluvium and loess and the underlying volcanic rock (rockhead) was interpolated by GNS Science using: drillhole intersections, cone penetrometer test depths of refusal and field mapped rock outcrop exposures, as control points. The resulting rockhead surface (Figure 7) shows an overall dip towards the east-southeast of about 16°, which is approximately coincident with the surface slope aspect. It should be noted that the trend of cracks is roughly parallel to the strike of rockhead.

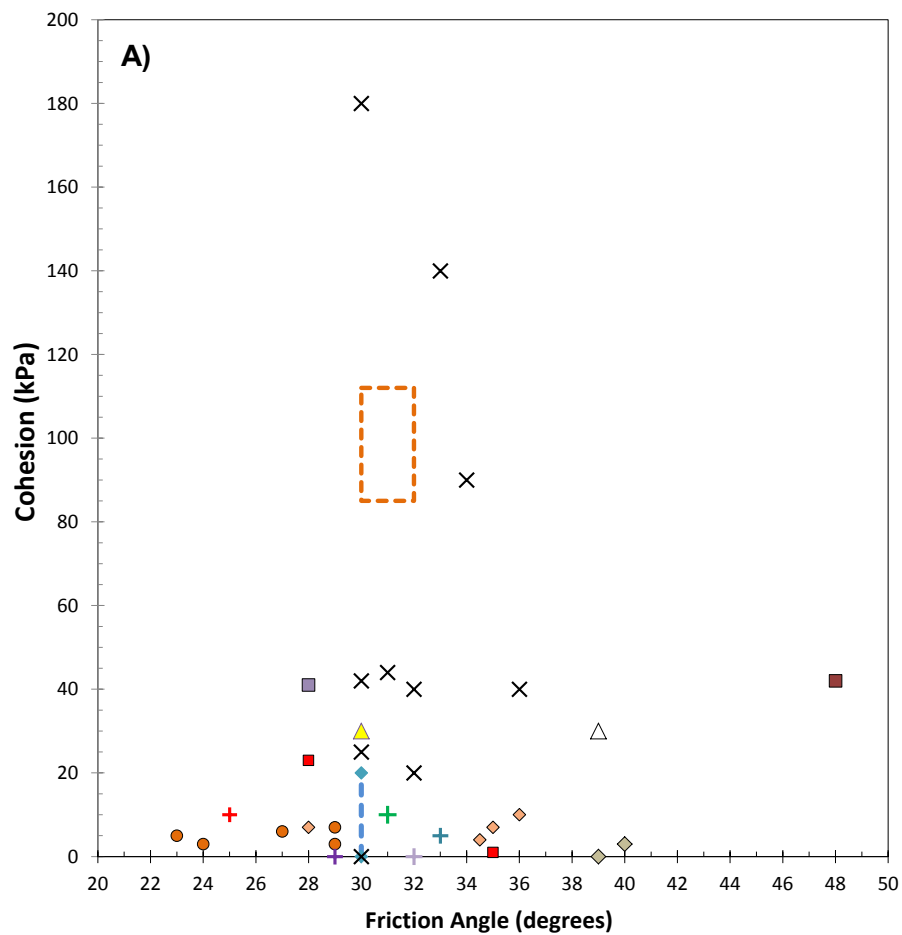
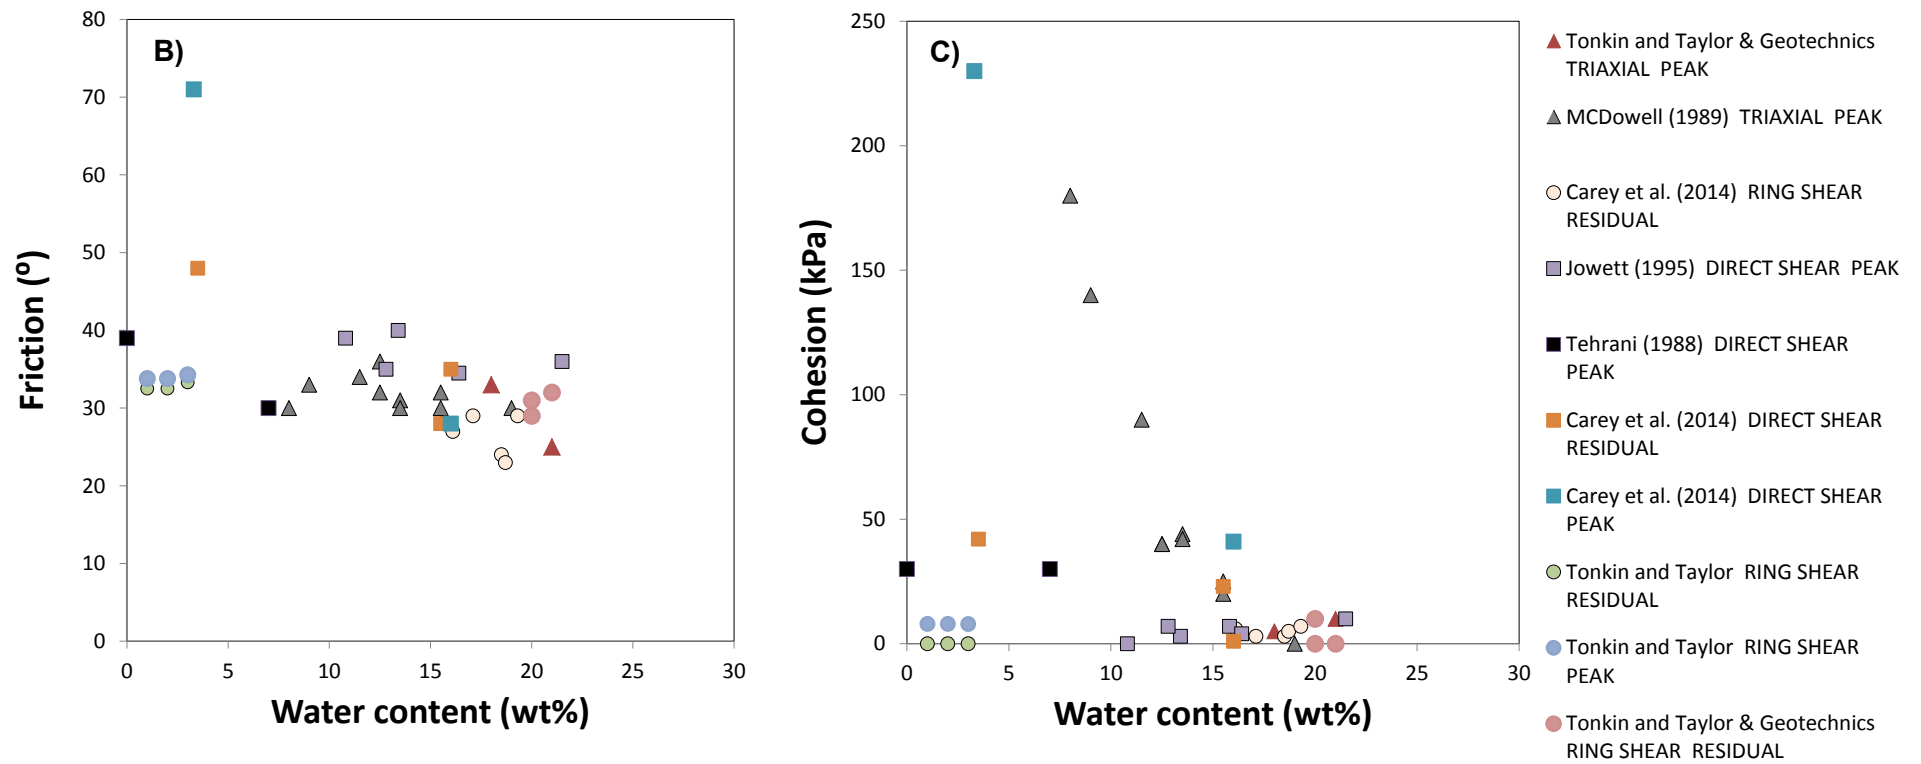
For water contents between 10 and 20 wt%, the cohesion of the tested loess is very sensitive to changes in water content. These results illustrate a large variability in the strength parameters of the loess in the Port Hills, and that the complex effects of the water content may be critical to the loess strength. These results are consistent with the findings of others (e.g., McDowell, 1989; Goldwater, 1990).

The block samples of loess were all taken at the end of periods of dry weather (summer), where water contents were between 3.5 and 11 wt%, and therefore the shear strength of loess would likely be at the upper end of the range. During periods of prolonged wet weather it is feasible for water contents in the loess to increase to >15 wt% leading to a reduction in the cohesion and increased susceptibility to failure. The data plotted in Figure 9 probably represent the range of strength parameters at the likely range of moisture contents that could be anticipated in the Port Hills loess.

**Figure 9** Loess residual shear strength results (from Table 7 and Table 8). A) Cohesion and friction laboratory results plotted for loess. B) Loess residual cohesion plotted against water content. C) Loess residual friction plotted against water content.

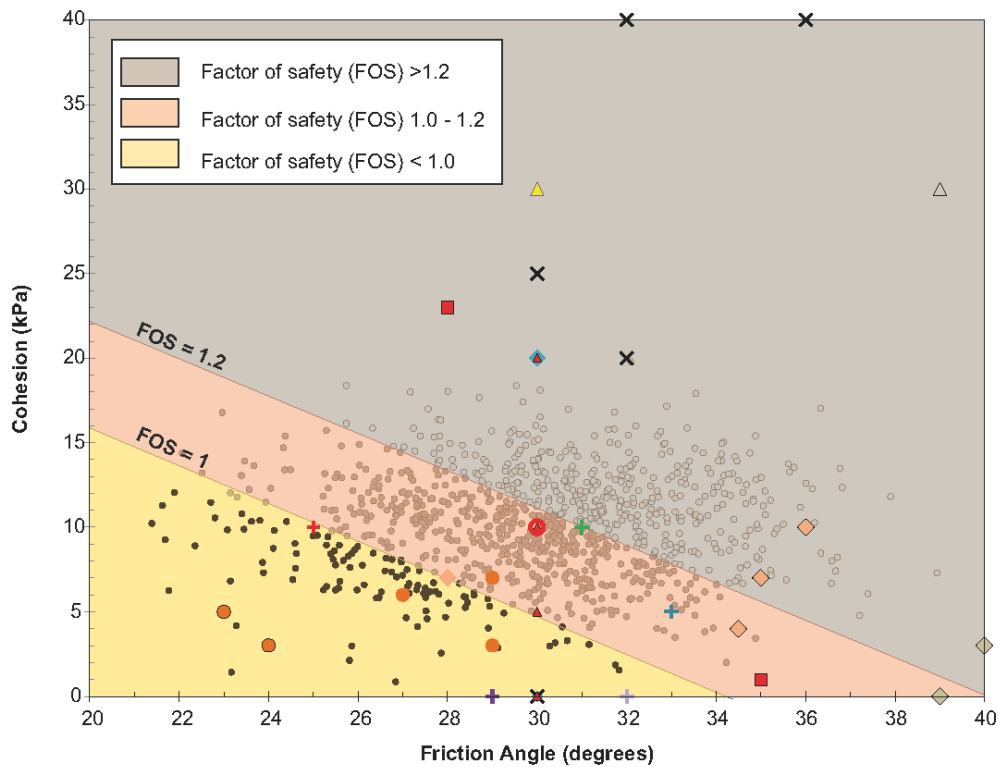
The bulk value of cohesion and friction for the loess slope was assessed by numerical back-analysis of slope stability for two geological cross-sections (cross-sections 3 and 5). Figure 13 shows an example of the back-analysed friction and cohesion values that yield different factors of safety (each data point represents a modelled slide surface). Factors of safety greater than one are shown as diamonds and factors of safety less than one are shown as crosses. If a slope has a static factor of safety of one, then the slope is assessed as being unstable. The shear strength values obtained from the laboratory testing of loess samples are shown for comparison. The results show that:

- *In situ* measurements of loess samples from Maffey's Road range from 6 to 9 wt%, which are below the range moisture content of ring shear tests. The sensitivity of the loess slope to changing water contents was therefore addressed in this study by adopting a range of strength parameters for the stability assessments (of friction angle ( $\phi$ ) of 25–35° and cohesion ( $c$ ) of 5–30 kPa) to reflect the range in moisture content.

**Figure 13** Back-analysis of the loess material based on cross-section 4. Note: each data point represents a modelled slide surface at a given combination of cohesion and friction adopted for loess. Those slide surfaces shown as crosses, represent those combinations of cohesion and friction that would yield a static factor of safety of less than 1.

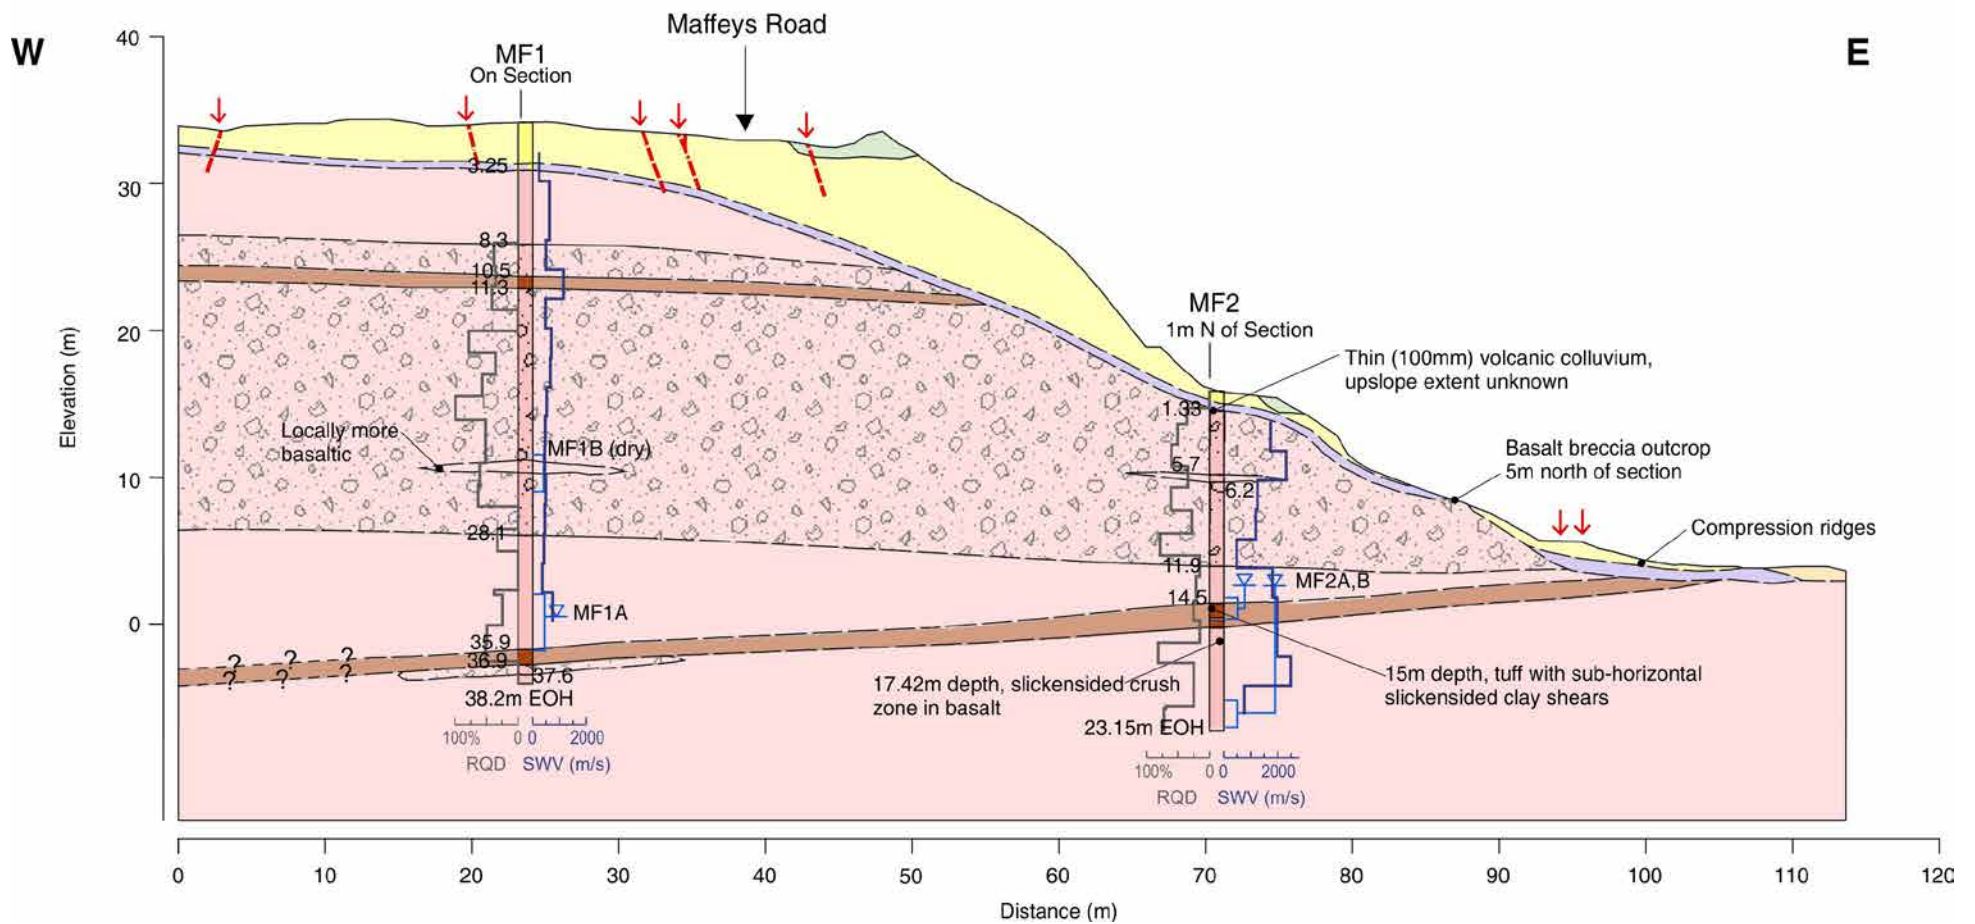
The shear moduli for mixed volcanic breccia and lava were derived from the downhole geophysical surveys carried out by Southern Geophysical Ltd. (Southern Geophysical Ltd., 2013) in drillholes MF1 and MF2 (Figure 16).

**Figure 16** Cross-section 3 (Yetton and Engel, 2014) modified by including the shear wave velocity profile after Southern Geophysical Ltd. (Southern Geophysical Ltd., 2013) and rock quality designation values for drillholes MY1 and MY2.

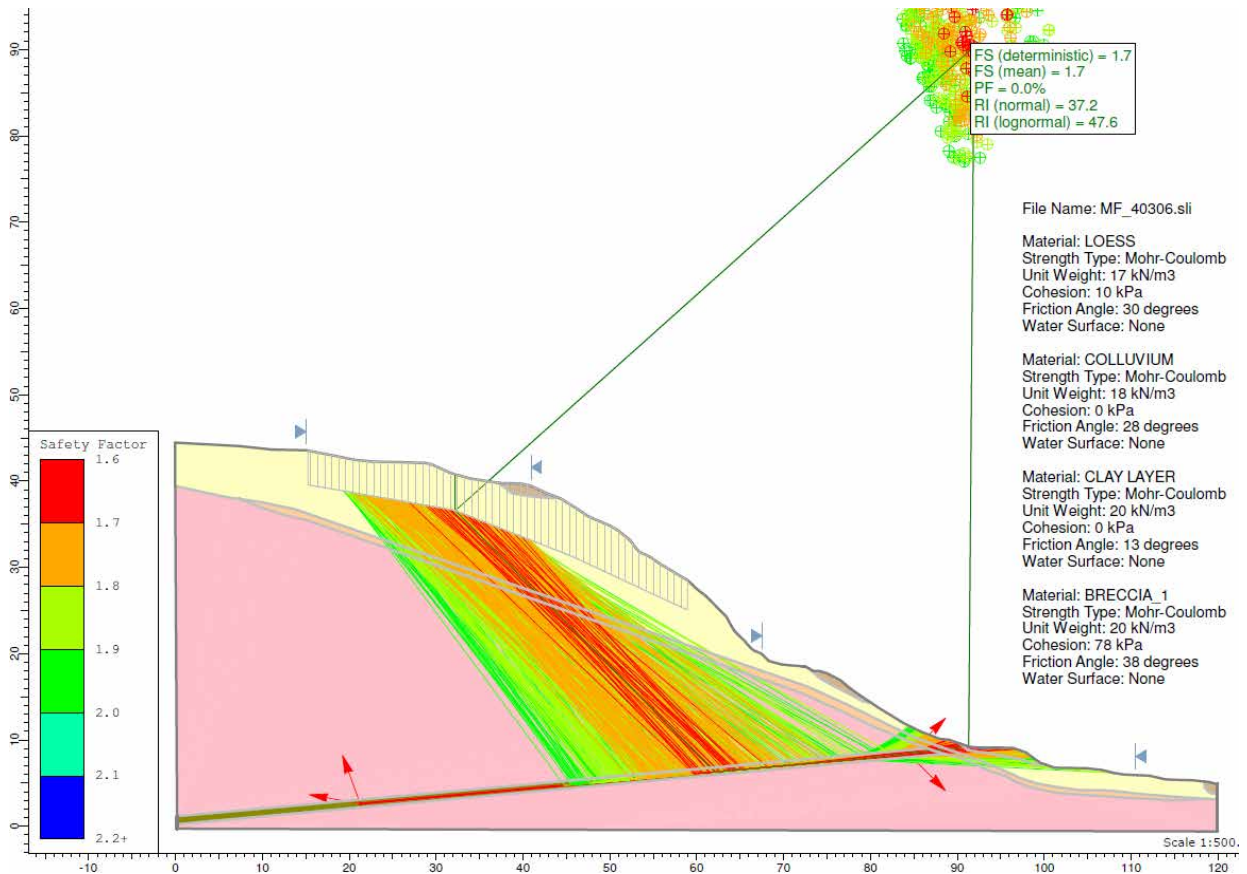
Figure 23 Example of limit equilibrium modelling results for cross-section 4, mechanism 3 (block slide).

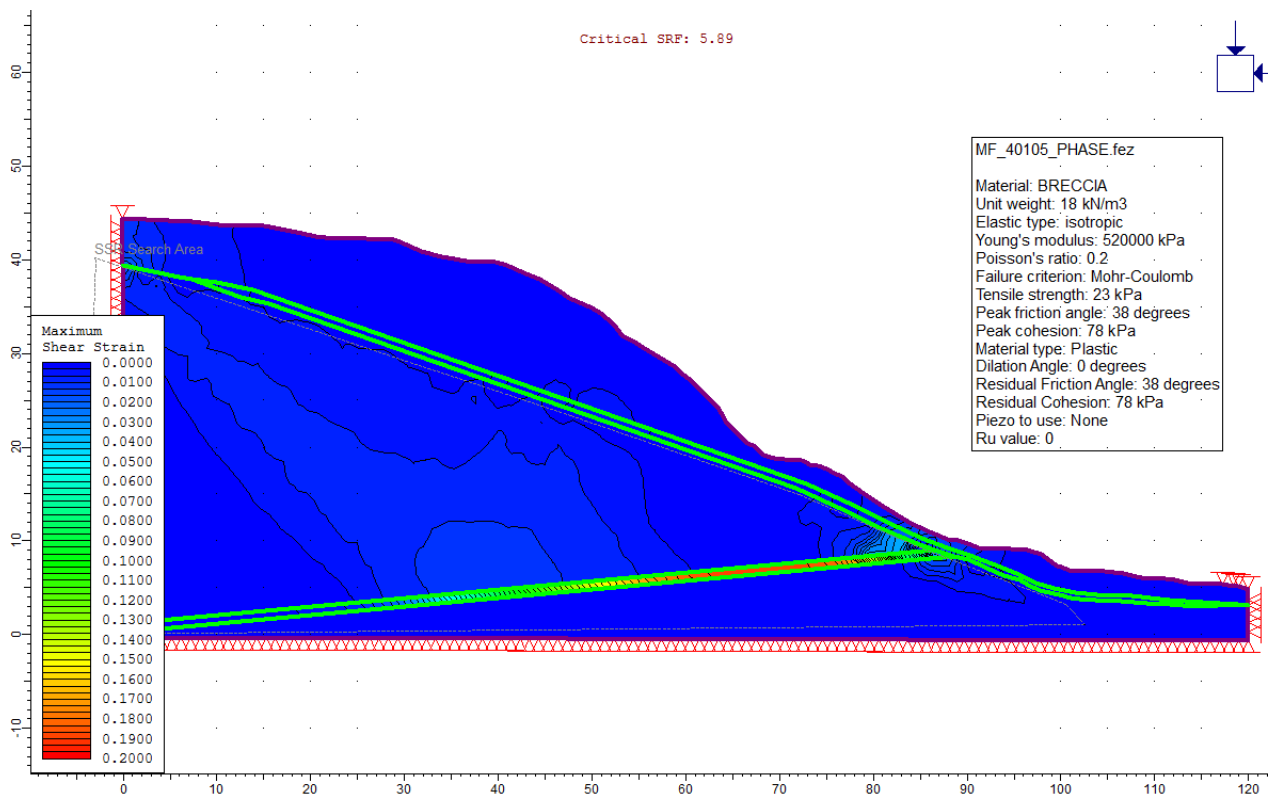
Figure 24 Example of finite element modelling results for cross-section 4, mechanism 3 (block slide).

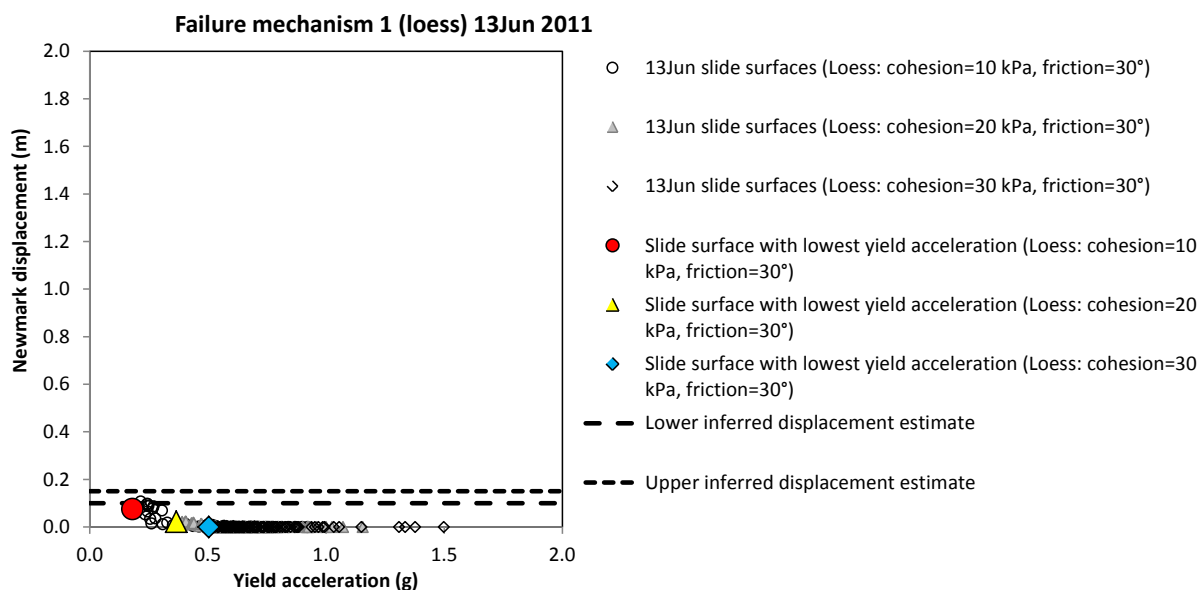
**Figure 28** 13 June 2011 earthquake, modelled Slope/W decoupled displacements for cross-section 4, and adopting variable estimates of the material strength of the loess. Each datapoint represents a modelled slide surface and the corresponding estimate of its displacement as a result of the 13 June 2011 earthquake – adopting the synthetic free-field rock outcrop earthquake acceleration time histories. The dashed lines represent the inferred coseismic permanent displacement for the cross-section during the given earthquake.
