**Canterbury Earthquakes 2010/11 Port Hills Slope  
Stability: Risk assessment for Maffeys Road**

**GNS Science Consultancy Report 2014/79  
August 2014 FINAL**

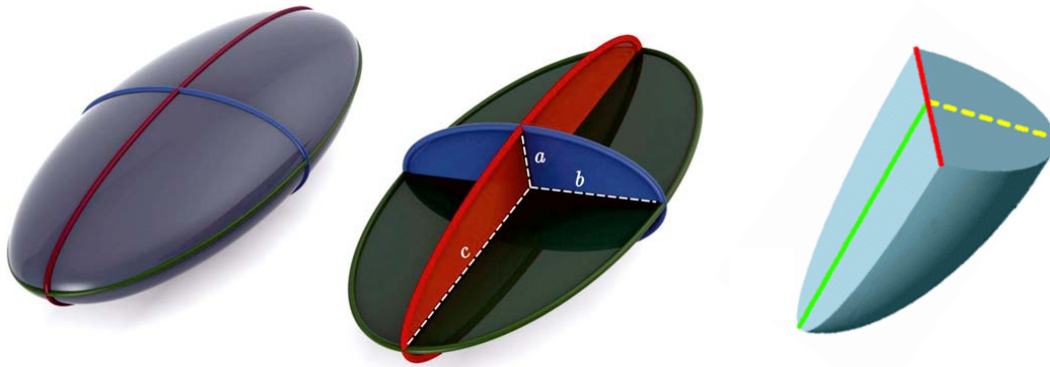
Volumes were calculated by estimating the shape of any future failures as quarter-ellipsoids (half-spoon shaped) (following the method of Cruden and Varnes, 1996) (Figure 36). Estimated volumes are shown in Table 20. Source areas 1–5 represent the range (volume and locations) of potential earth/debris flows that could occur at the site.

**Figure 36** Estimation of landslide volume assuming a quarter-ellipsoid shape.

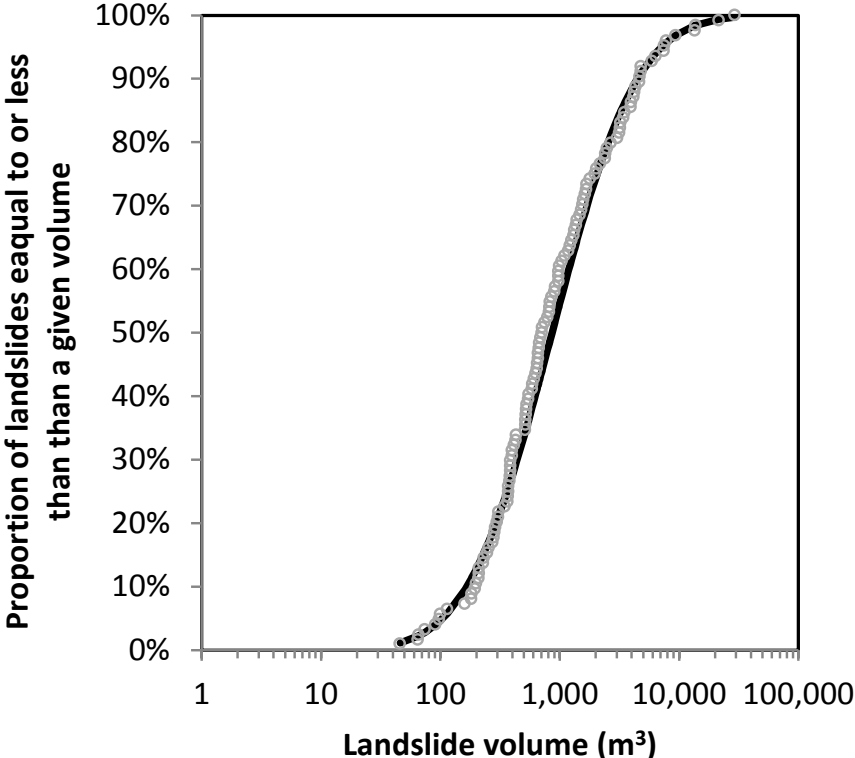
The credibility of these potential failure volumes has been evaluated by comparing them against estimated volumes of individual landslides (mainly earth/debris flows) in loess and loess derivative materials, such as colluvium in the Port Hills, mapped by Townsend and Rosser (2012). The distribution of the 124 landslides is shown in Figure 37 and the data are well modelled by a log normal distribution, adopting the area depth relationships of Larsen et al. (2010). The estimated range of source volumes shown in Table 20 (about 320–2,900 m<sup>3</sup>) are well within the range of other loess landslides in the Port Hills mapped by Townsend and Rosser (2012).

**Figure 37** Estimation of landslide volumes in the Port Hills loess from Townsend and Rosser (2012), adopting the area depth relationships of Larsen et al. (2010).

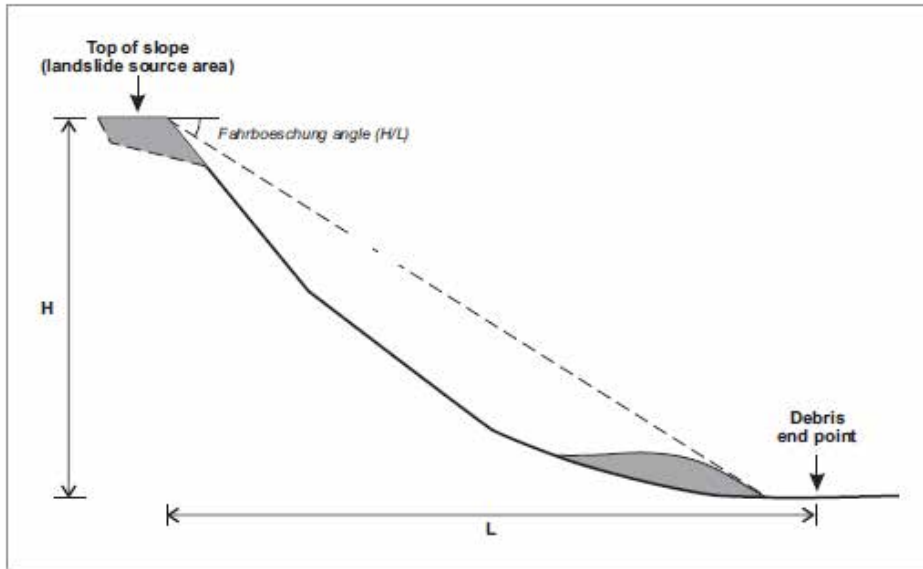
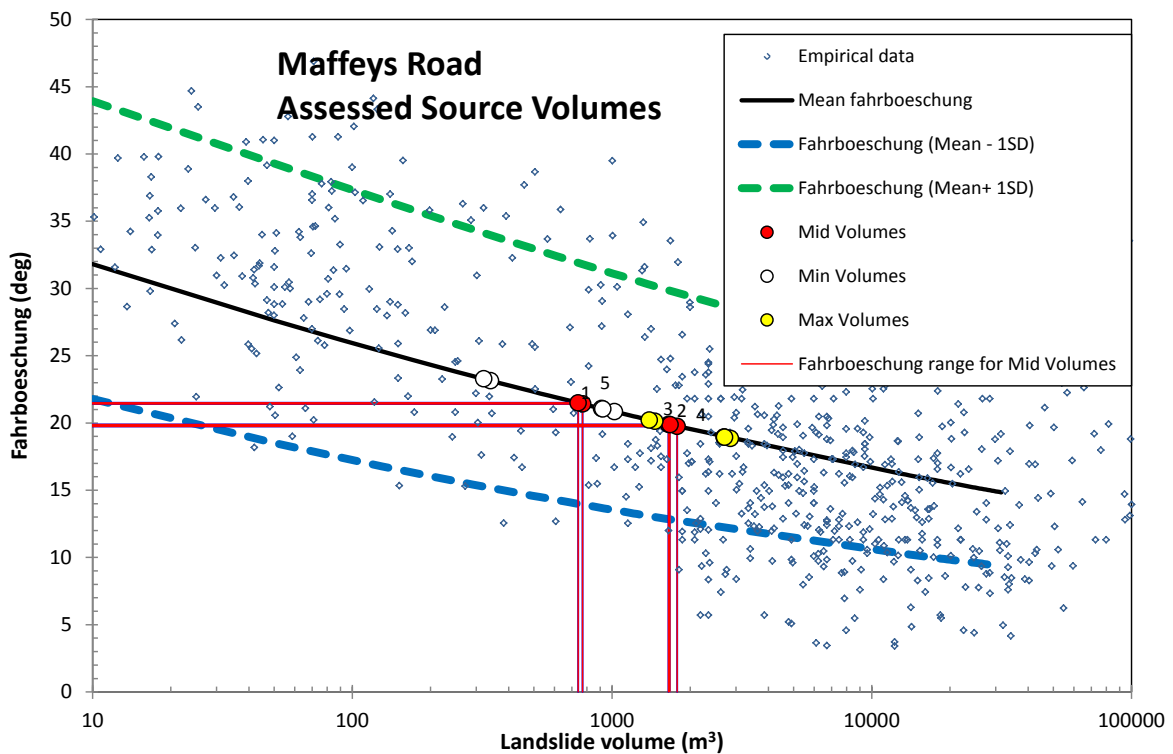
Figure 38 shows the estimated mean and mean minus one standard deviation debris flow fahrboeschung angles derived for assessed source areas 1–5. For each source a range in fahrboeschung angles is estimated based on the range in volumes (min, mid, max) as shown in Table 20.

**Figure 38** Estimation of debris flow Fahrboeschung angles based on empirical runout data presented by Massey and Carey (2012).

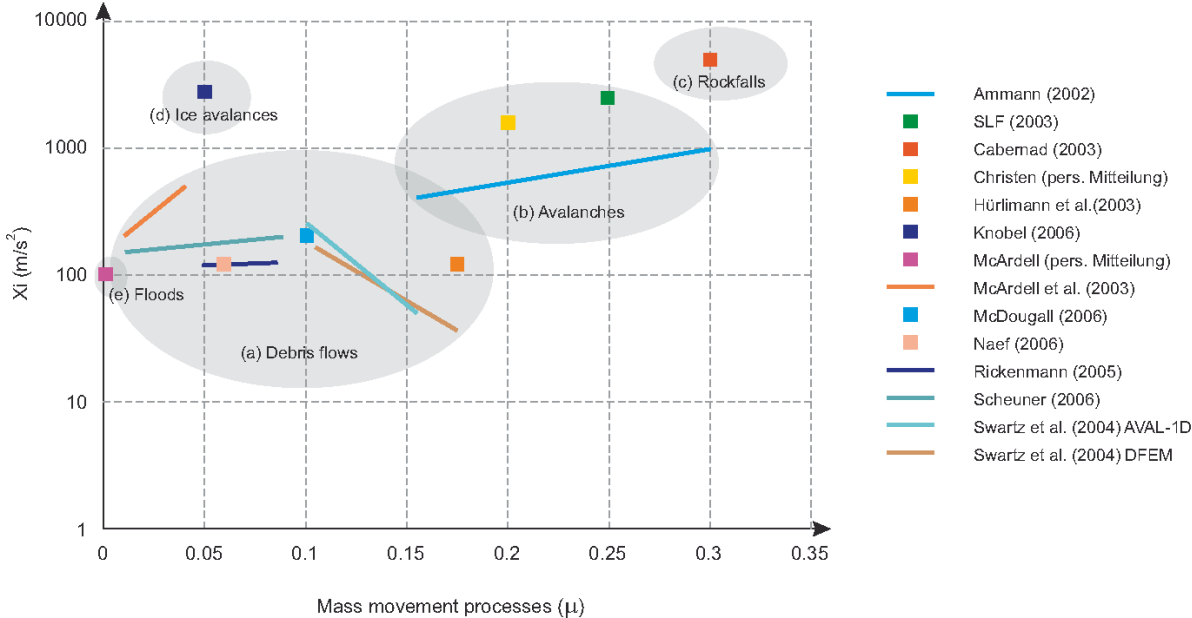
The RAMMS model parameters were calculated from the back-analysis of four Port Hills debris flows. The modelled parameters  $\mu$  and  $x_i$  were optimised to obtain a good correlation between the modelled versus actual runout and deposited debris heights. The model, with calibrated input parameters ( $\mu = 0.06$  ( $7^\circ$ ) and  $x_i = 200 \text{ m/s}^2$ ), were used to estimate the likely velocity and depth of the debris at given locations down the slope for the given failure volumes. The  $\mu$  and  $x_i$  values are comparable to results from other assessments compiled by Andres (2010) for debris flows (Figure 39).

**Figure 39** Range of parameters for different assessed source areas processes: **a)** debris flows, **b)** snow avalanches, **c)** snow avalanches, **d)** ice avalanches, **e)** debris floods. Modified from Andres (2010).

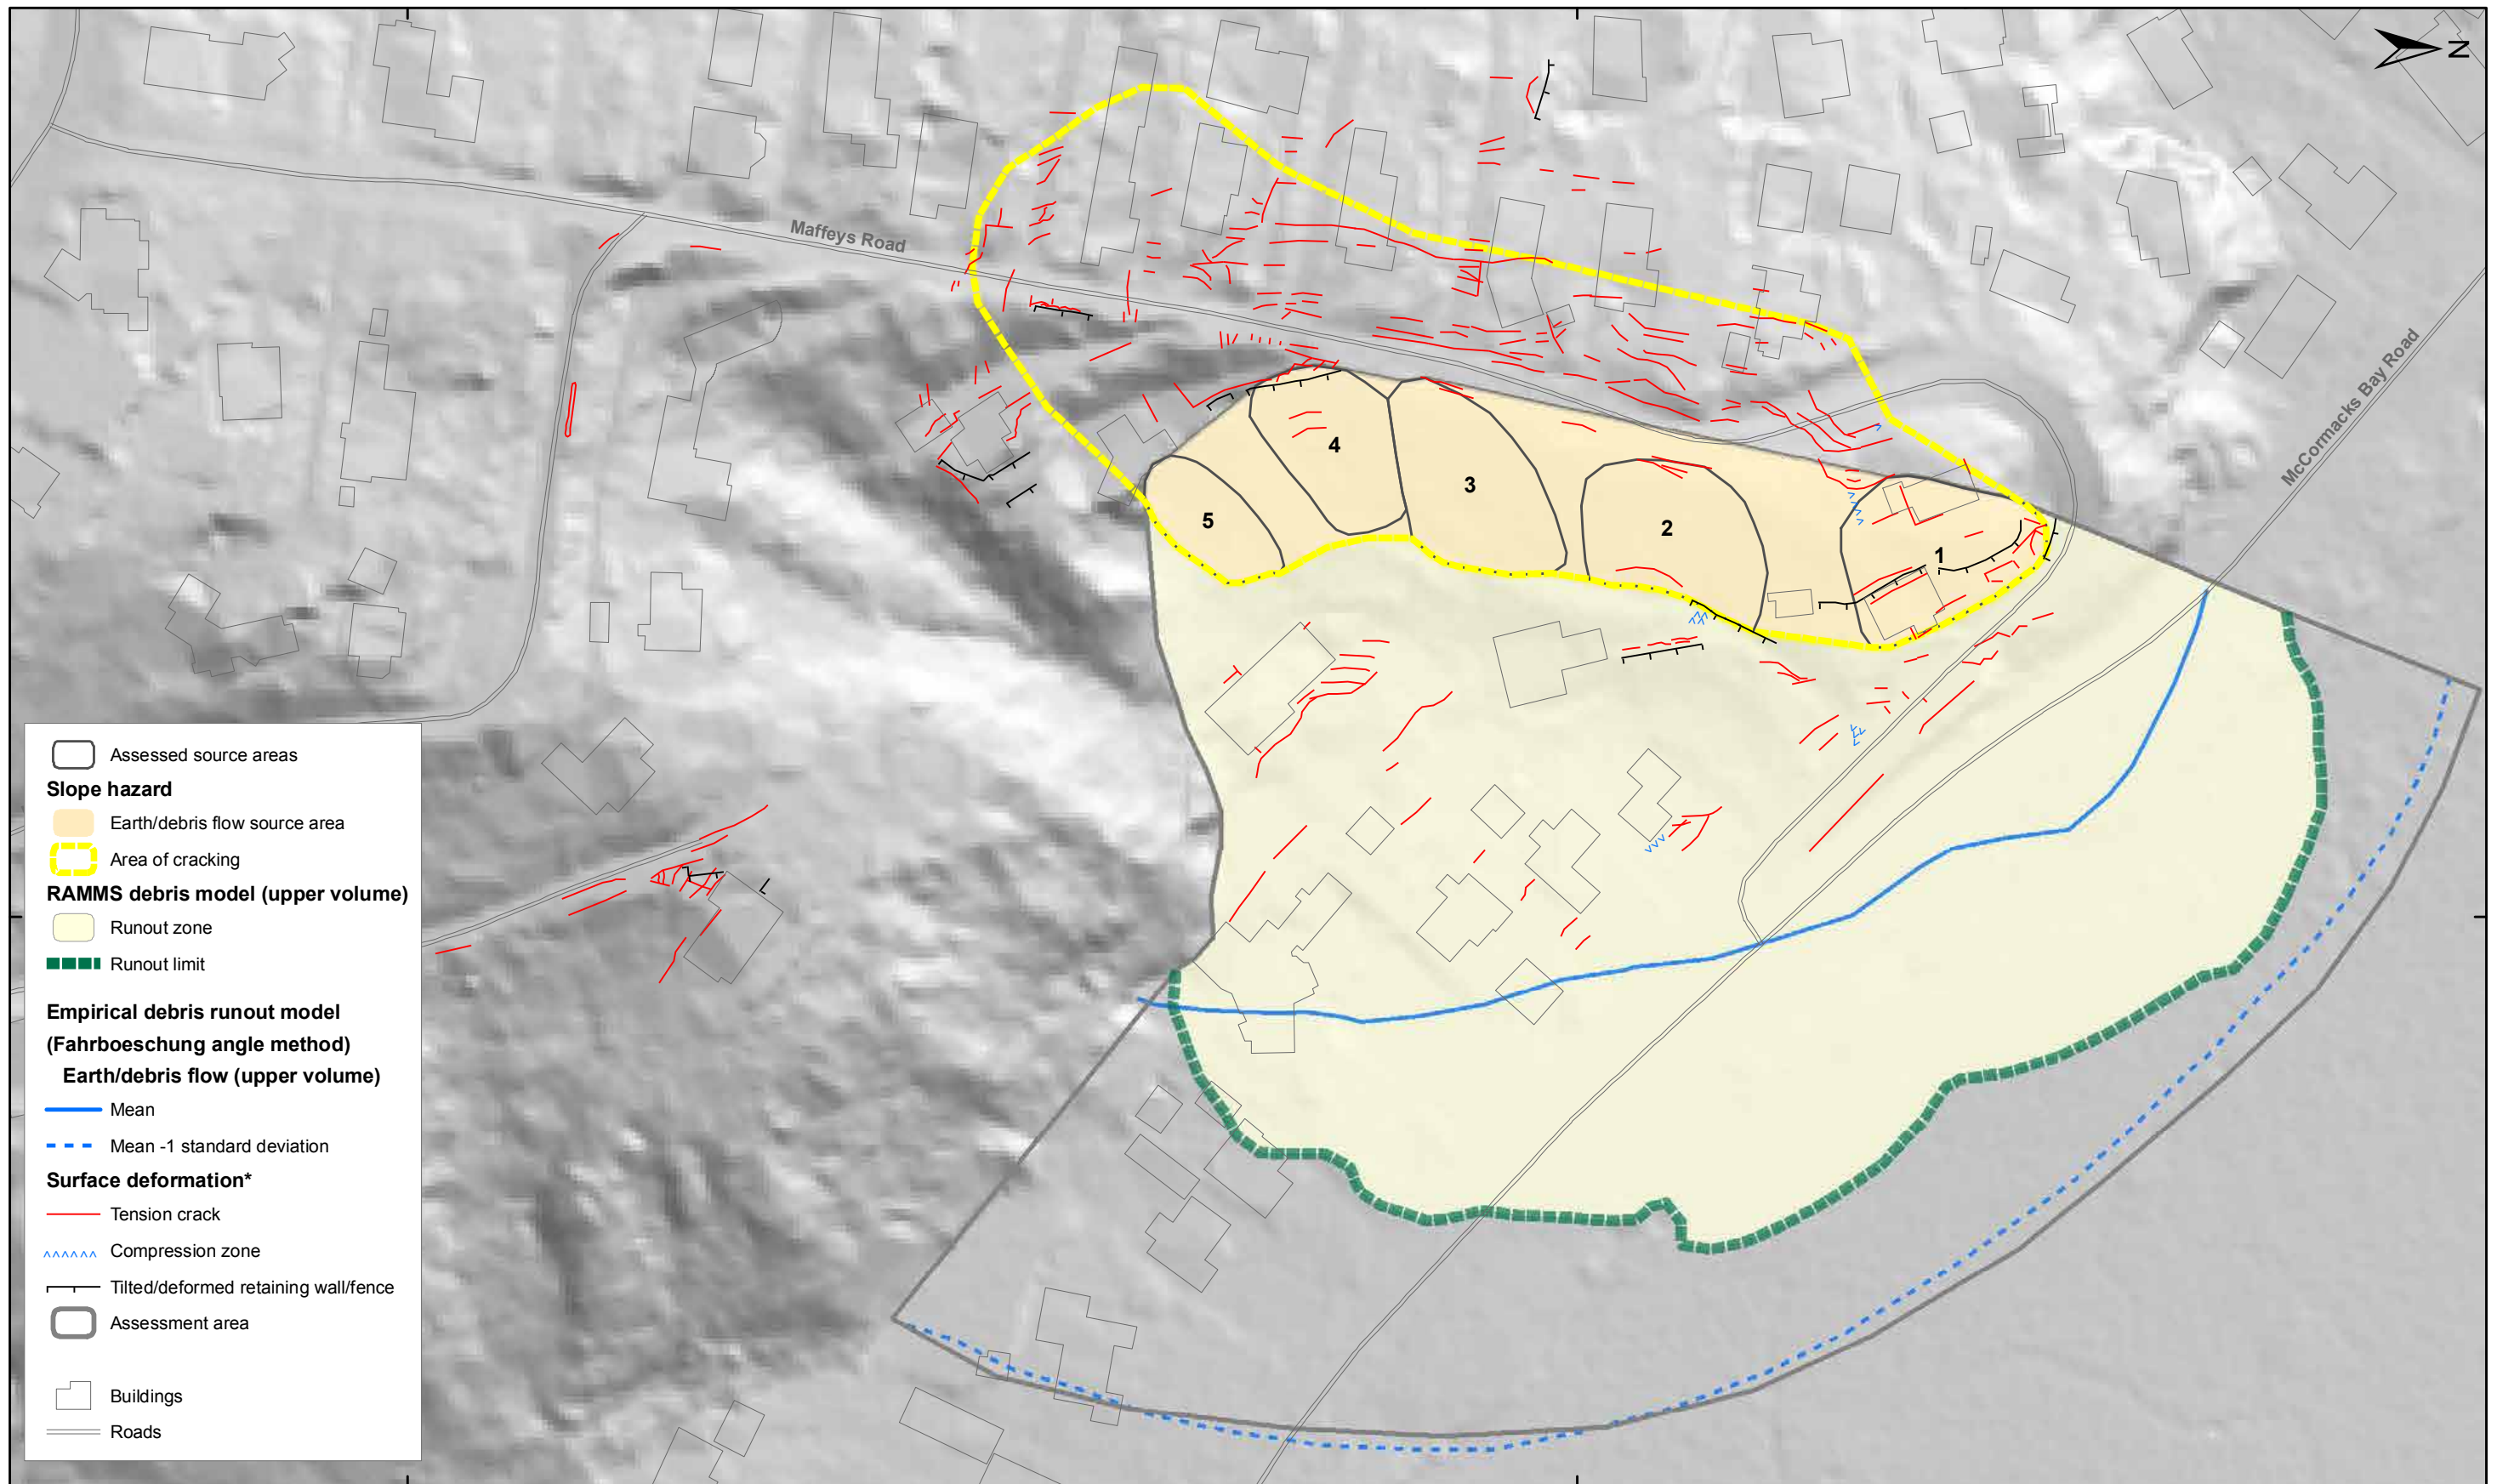
**FIGURE 40**

A hazard map (Figure 40) presents the empirical and numerical runout limits from all of the modelled source areas (1–5) for the upper volume source estimates.

The mean and mean minus one standard deviation fahrboeschung angles for each potential source area (1–5) are shown in Figure 40. The empirically derived fahrboeschung runout lines are based on combining the runout lines from each of the source areas for the upper source volume estimates only. The estimated runout distances from RAMMS are shown in Appendix 5 (debris height) and Appendix 6 (debris velocity) for source areas 1–5, along with the corresponding mean and mean minus one standard deviation fahrboeschung angles.

**EARTH/DEBRIS FLOW HAZARD MAP**

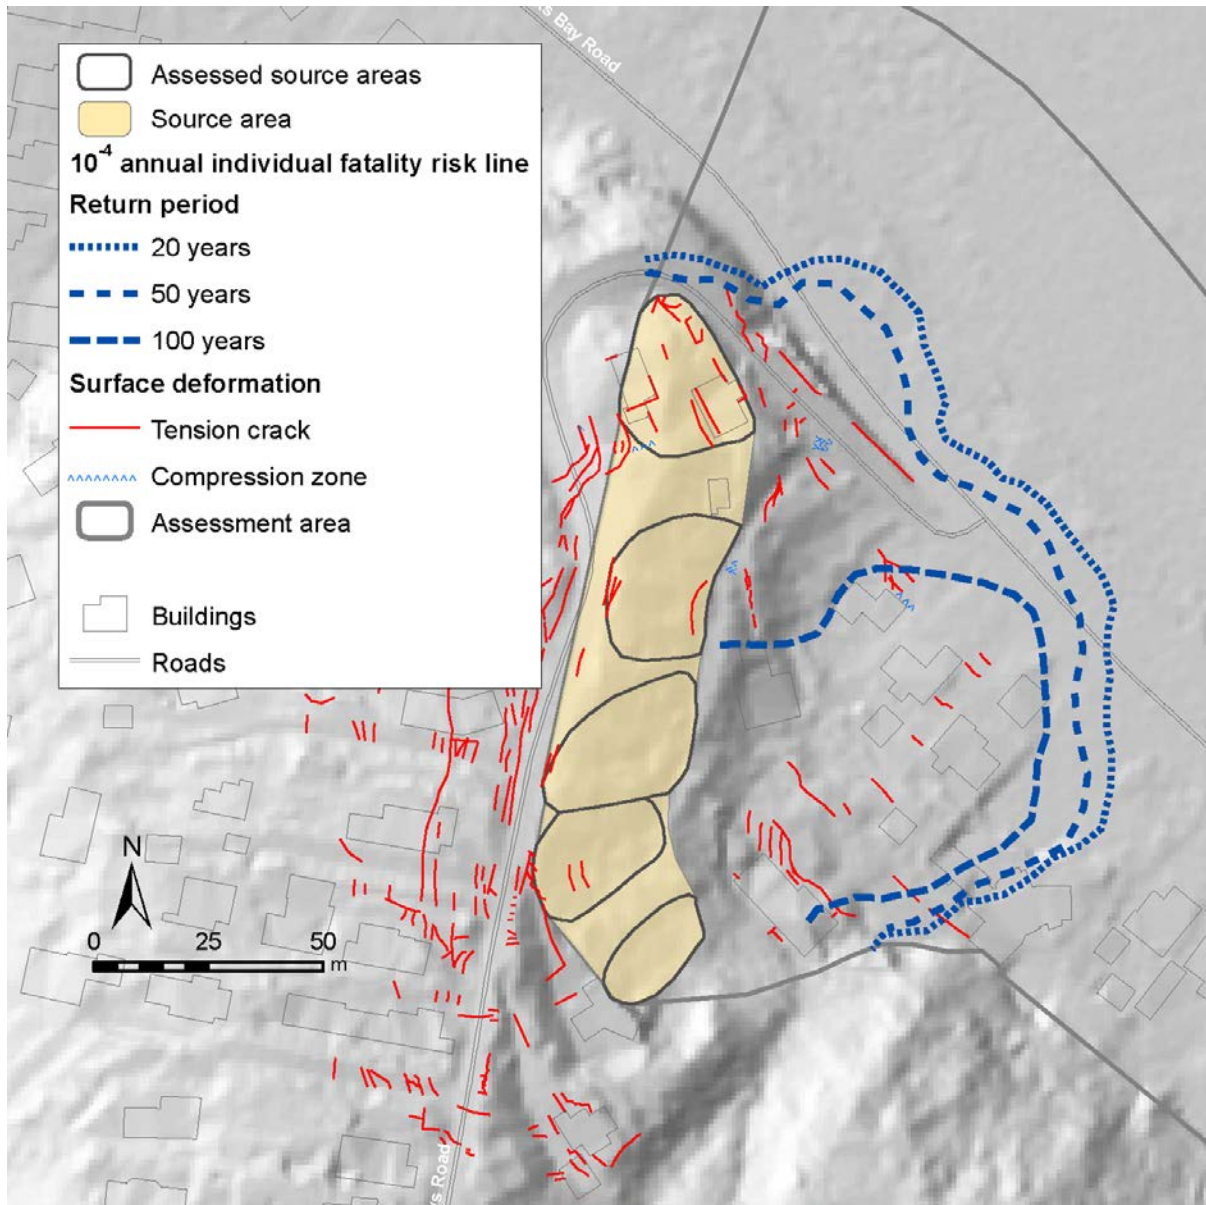
The return period of the event that could initiate failure is unknown. The sensitivity of the risk estimates for the assessed source areas to different event return periods has been assessed. This was done by plotting the location of the  $10^{-4}$  annual individual fatality risk contour, for the upper source volume estimates only, adopting return periods of 20, 50 and 100 years for the triggering event. The results are plotted for in Figure 42. The risks adopting the 200 year triggering event frequency are all less than  $10^{-4}$  and cannot therefore be plotted in Figure 42.

**Figure 42** Sensitivity of the risk estimates, upper volume estimates, for triggering event return periods of 20, 50, 100 and 200 years. Note: No 200 year  $10^{-4}$  annual individual fatality risk line is shown, as the risk is less than  $10^{-4}$  for this return period.

The results show that area within the  $10^{-4}$  risk contour reduces between the 20 year and 100 year return periods. This is because the volume of the failure, and therefore runout distance of the debris remains fixed, but the return period of the event increases, leading to a reduction in the risk at the longer return periods.

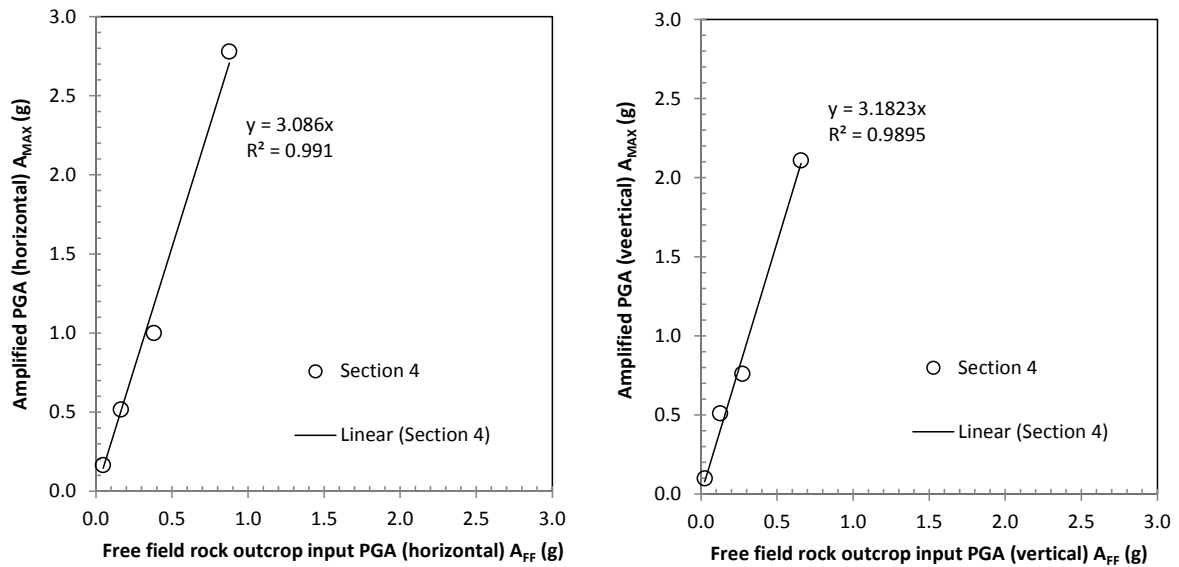
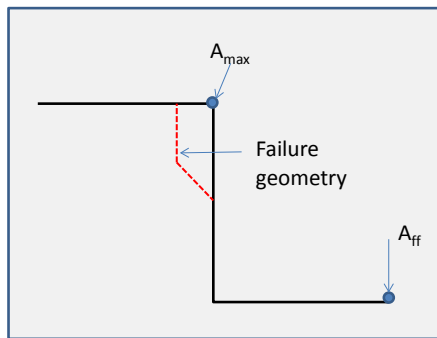
**Figure A4.1** Amplification relationship between the synthetic free-field rock outcrop input motions ( $A_{FF}$ ) and the modelled cliff crest maximum accelerations ( $A_{MAX}$ ) for cross-section 4. A schematic diagram showing the locations of the various recorded accelerations is shown.

Results from this assessment have shown that the relationship between the peak ground acceleration of the free-field input motion and the corresponding modelled peak acceleration at the slope crest ( $A_{MAX}$ ) is approximately linear. In the range of modelled peak horizontal accelerations, the horizontal amplification factor ( $S_T$ ) is typically in the order of about 3.1 times the input free-field peak horizontal acceleration.

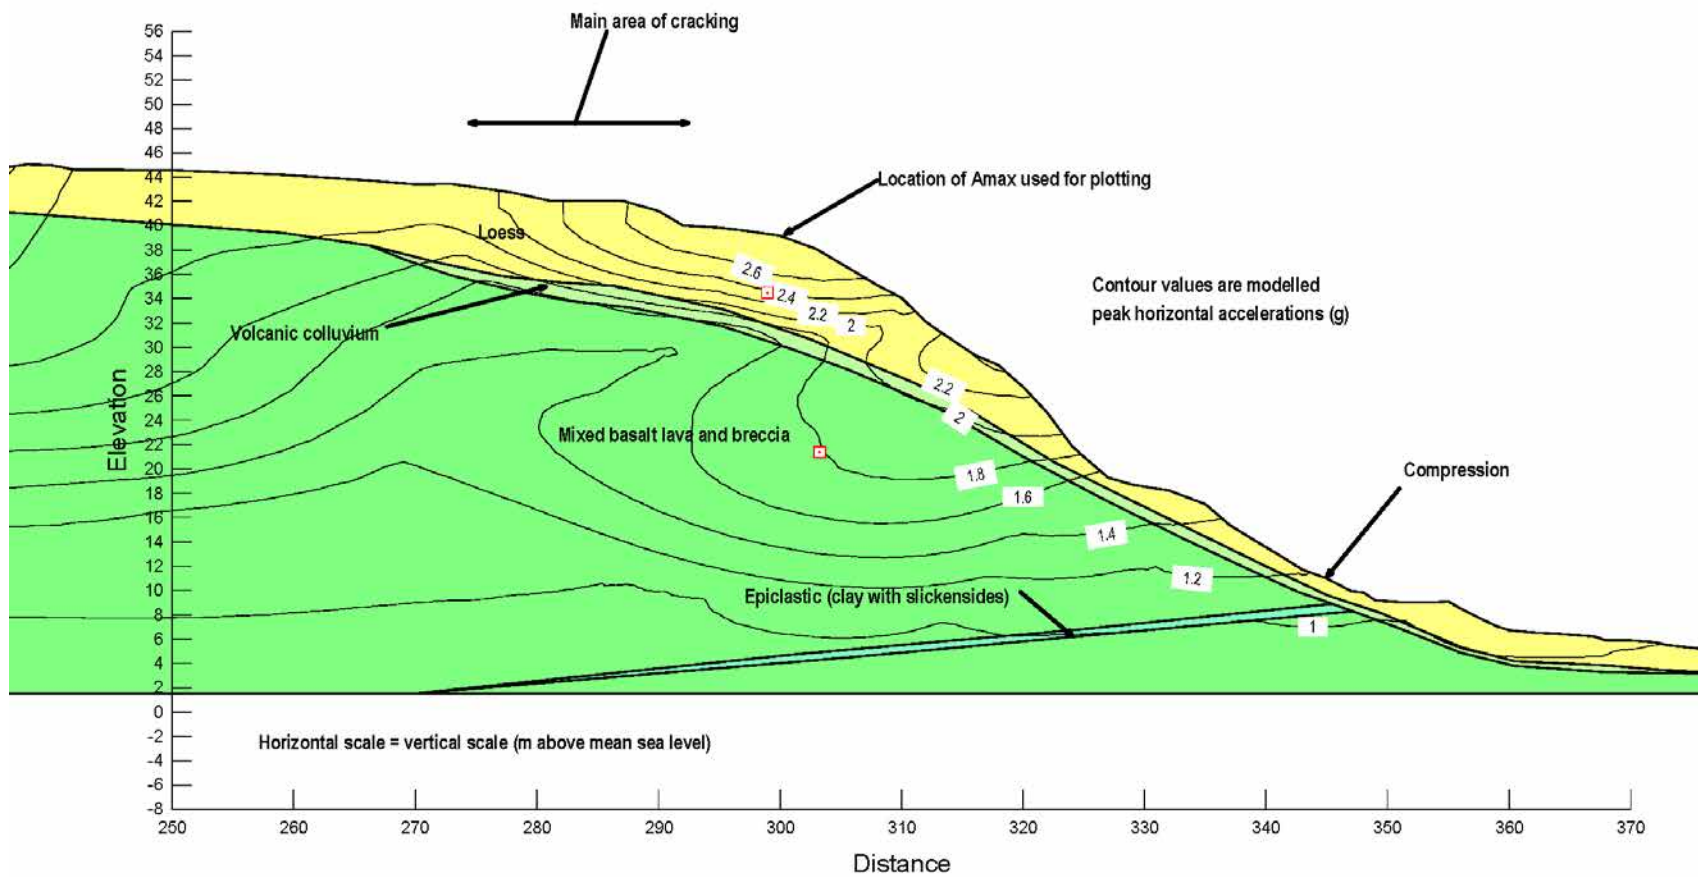
Cross-section 4 comprises about 9 m of loess and colluvium overlying mixed basalt lava and breccia, where the mean shear wave velocities of the materials change from 400–700 m/s in the basalt breccia and lava, to 200–400 m/s in the loess (Figure A4.2). The results suggest that the impedance contrasts between the materials contribute most to the amplification of shaking, but that the peak horizontal accelerations (for all modelled earthquakes) concentrate around the convex break in slope, corresponding to where the largest permanent slope displacements were recorded from cadastral survey marks and inferred from crack apertures. These results are similar to those reported by others (e.g., Del Gaudio and Wasowski, 2010), where material impedance contrasts have been shown to have a significant effect on the amplification of shaking, which could explain the significant shaking damage to those dwellings at the slope crest (4, 6 and 8 Maffey's Road) within and above the area of mapped cracks.

**Figure A4.2** Modelled peak horizontal ground acceleration contours for the 22 February 2011 earthquake at Maffey's Road, cross-section 4.

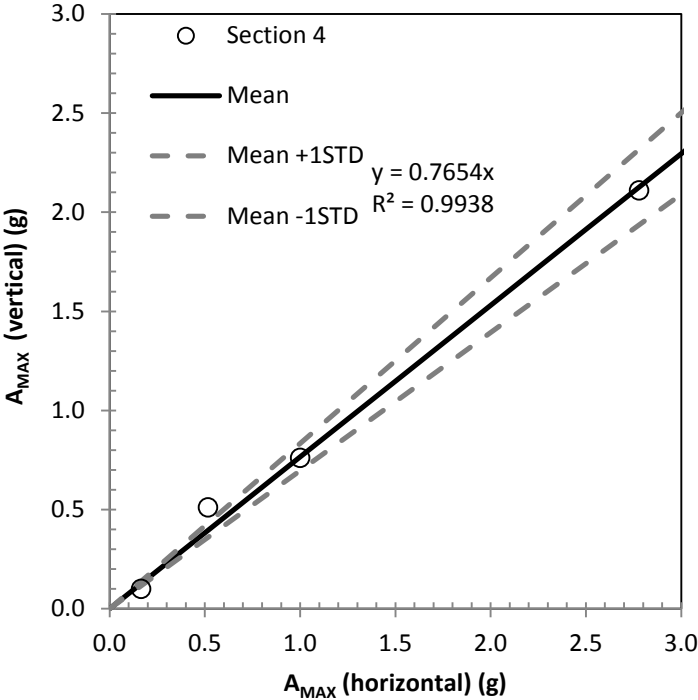
The relationship between the modelled vertical and horizontal peak ground accelerations recorded at the slope crest ( $A_{MAX}$ ) is shown in Figure A4.3. The gradient of the linear fit is 0.77 ( $\pm 0.03$ ) – errors at one standard deviation. The relationship between horizontal and vertical peak ground accelerations appears linear.

**Figure A4.3** Relationship between the modelled horizontal and vertical maximum accelerations modelled at the slope crest ( $A_{MAX}$ ) for cross-section 4, using the synthetic free-field rock outcrop motions for the Maffey's Road site by Holden et al. (2014) as inputs to the assessment. The mean and standard deviation trend lines are fitted for  $A_{MAX}$  all data. Errors are shown as the mean  $\pm$  one standard deviation (1 STD).
