Christchurch Fish Barriers Update: 2023

October 2023

Prepared for:
Christchurch City Council

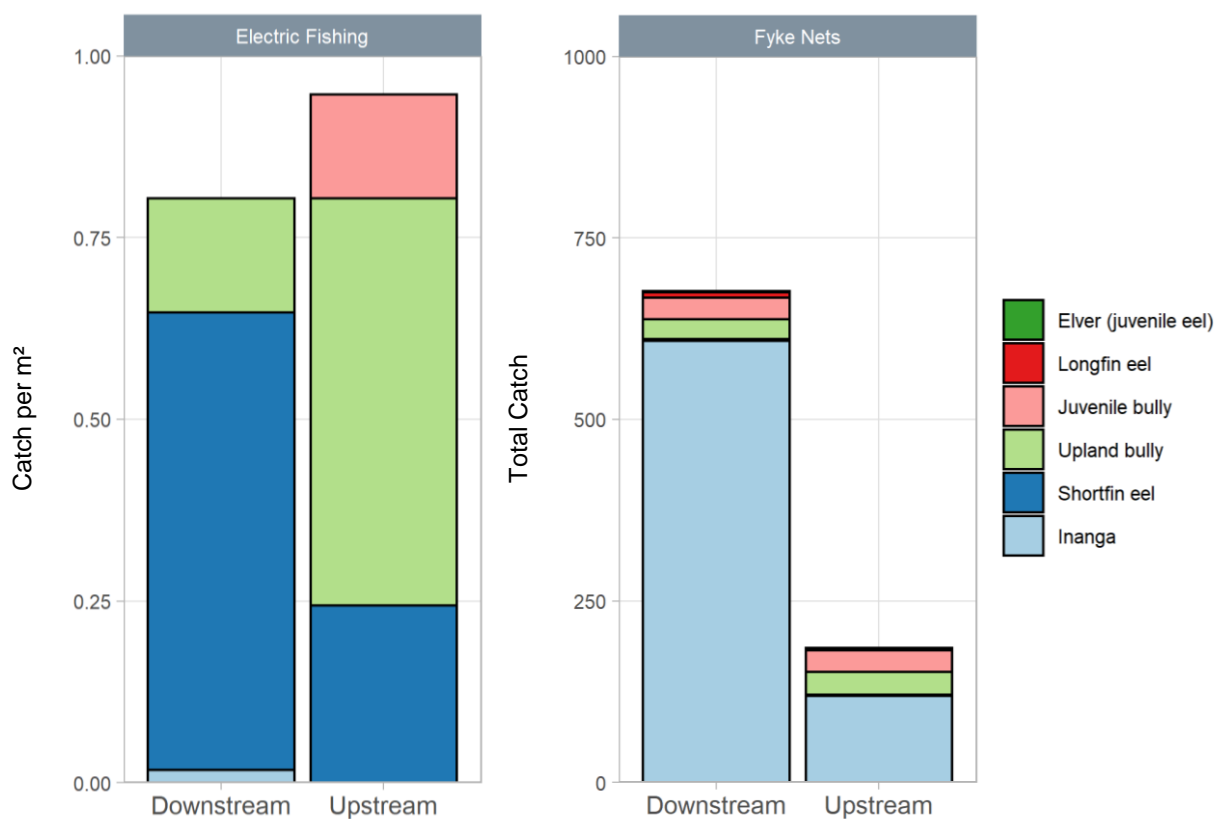
Figure 3: Fish catch downstream and upstream of the Sutherlands Road culvert in Cashmere Stream.

This is the first record of inanga upstream of the Sutherlands Road culvert. Inanga have comparatively weak climbing ability compared to many other native fish species (Baker and Boubée 2003; Baker 2003), so their presence upstream of Sutherlands Road confirms the new culvert has improved fish passage. Lower numbers of inanga upstream of the culvert suggests that the culvert still presents a partial barrier to fish passage, or that there has been insufficient time for fish to colonise the newly available habitat. Alternatively, it may be due to habitat differences, with deeper pools downstream of the culvert. We therefore recommend further fish monitoring and modifying the fish ramp to ensure enhanced fish passage during lower and higher water levels in Cashmere Stream.

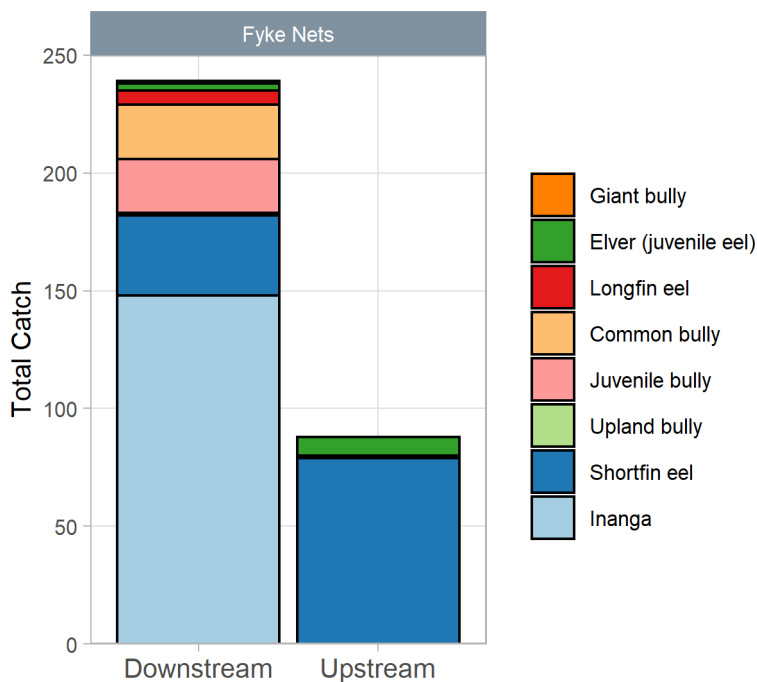
A total of 242 fish were caught downstream and 88 fish were caught upstream of the culvert (Figure 5). The fish catch in the Pūharakekenui River downstream of the culvert comprised six native species, including shortfin eel, longfin eel, inanga, upland bully, common bully (*Gobiomorphus cotidianus*), and giant bully (*G. gobioides*). Upstream of the culvert, only two species were caught, shortfin eel and longfin eel. The catch downstream was dominated by inanga, with 148 caught, followed by shortfin eels, with 34 caught. By comparison, the catch upstream of the culvert was almost entirely dominated by shortfin eels, with 79 caught. During

Overall, there is a clear impact of the flap gate on the fish community and likely also water quality upstream. Therefore, we recommend investigating options for enhancing fish passage at this location. One solution would be to replace the existing flap gate with a fish-friendly tide gate that delays gate closure on an incoming tide.

Figure 5: Fish catch downstream and upstream of the flap gate in Sheppard's Drain, at the confluence with Pūharakekenui – Styx River.

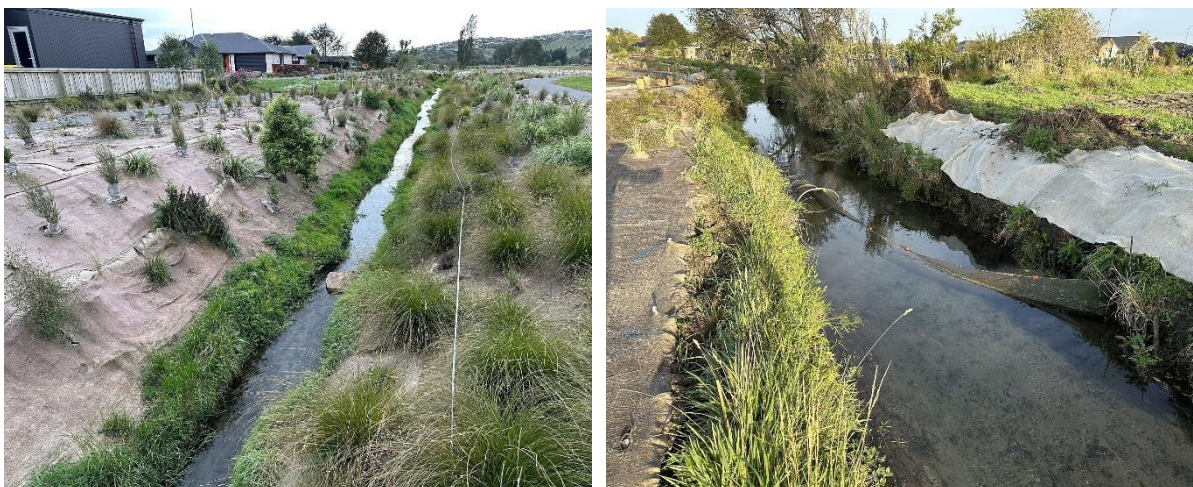
Figure 5: Cashmere Stream downstream of Sutherlands Road culvert, showing fish sampling habitat.

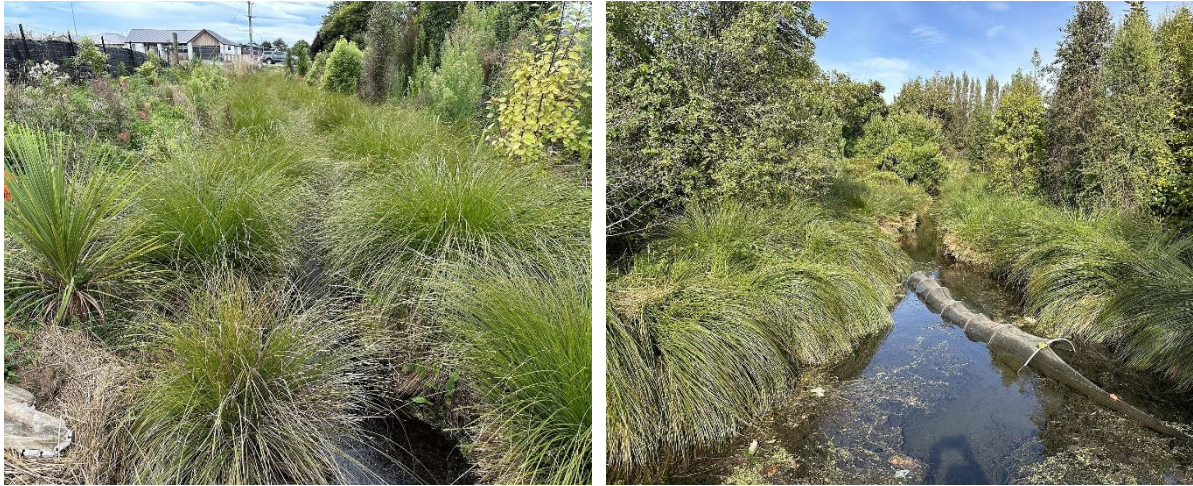
Figure 6: Cashmere Stream upstream of Sutherlands Road culvert, showing fish sampling habitat.
