Fish Passage Barriers in Christchurch City Waterways

April 2020

Prepared for:
Christchurch City Council

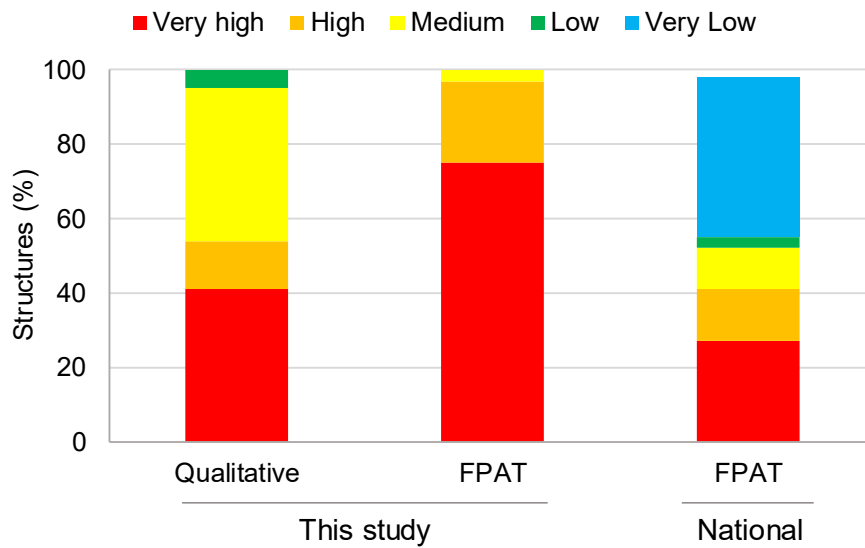
Figure 3: Risk to fish passage for structures, assessed qualitatively by the observer and assessed using the FPAT app. Data for this study are compared to national data from the FPAT website, downloaded on 31 March 2020.

The qualitative risk to fish passage (estimated in the field by the assessor) was often lower than the calculated FPAT risk assessment (Figure 3). This was mainly the case for structures in tributary waterways, where the structures were often small weirs made of material such as wood and stacked rocks. These structures were considered by the assessor to present less of a fish passage risk, as the structures had often degraded over time, creating better fish passage. For example, a low weir made of rocks at Site 20 was judged by the assessor to present only a medium risk to fish passage, when compared to a taller weir such as Site 12 (Figure 4). Similarly, a low wooden weir at Site 19 was constructed with logs that had slumped in places along its length, providing opportunities for fish to swim past, and so the structure was judged by the assessor to present a medium risk to fish passage (Figure 5).

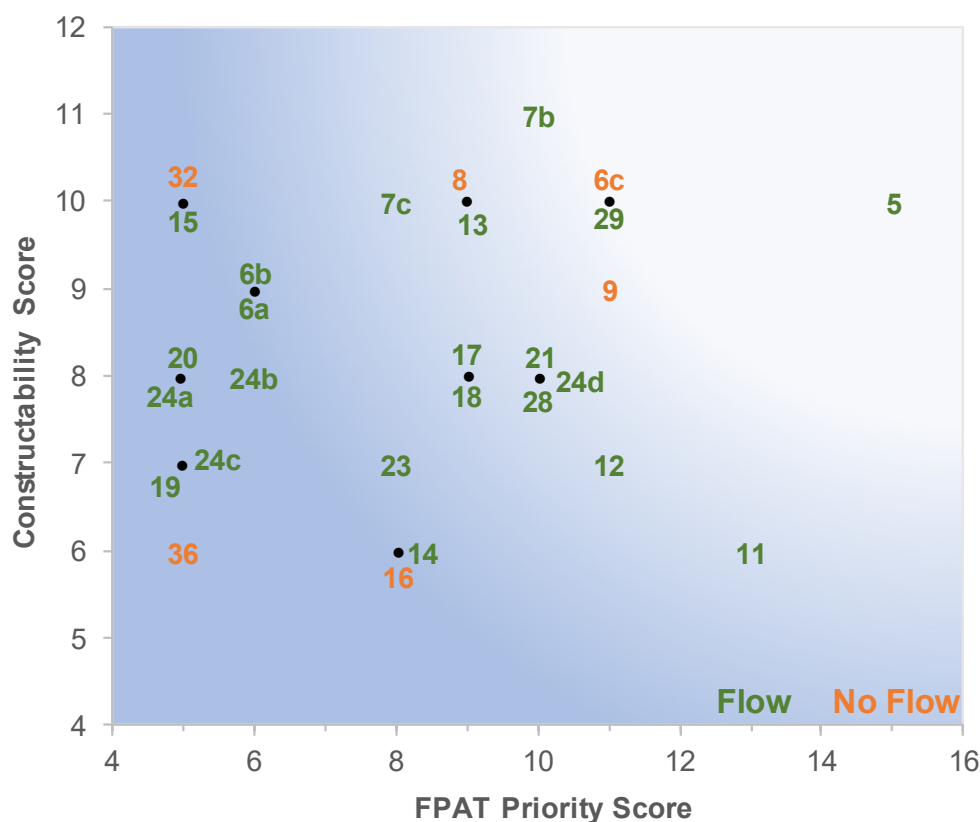
Figure 7: FPAT priority and constructability scores for the structures assessed. Coloured numbers on the plots are site numbers, with the site colour indicating whether flow was present (green) or absent (brown).

Constructability scores ranged from 4 to 11 with 11 being the highest possible score. We plotted FPAT priority scores against constructability scores to help identify sites that are the highest priority for remediation and relatively easy to repair (i.e., sites located to the top right of Figure 7). While the plot is useful for displaying the data, individual sites should still be scrutinised to check their prioritisation score makes sense from an ecological and engineering perspective. For example, the culvert at Site 5 on Sherrings Drain has the highest FPAT priority score (15), but the entire upstream catchment is piped, so there is little point improving fish passage through the culvert.

Of the structures surveyed, greatest priority should be given to remediating fish barriers in the Avon River catchment, starting with the large weirs on the Avon River near Mona Vale (Sites 12 and 13, Figure 8). That is because these structures have the largest upstream catchment of all those assessed, they are clearly significant barriers, and there is plenty of fish habitat upstream. The next highest priority should be given to the weir on the Avon River at Christchurch Boys High School (Site 13), followed by a weir on the Avon River downstream of Clyde Road (Site 14). Improving fish passage past these four weirs would provide by far the greatest opportunity for increasing native fish diversity and abundance upstream.
