Signalised Intersection Layout and Street Tree Removals

LANDSCAPE ASSESSMENT REPORT
TREE REMOVAL ASSESSMENT | PAPANUI PAK'n SAVE
171 MAIN NORTH ROAD | CHRISTCHURCH

Report Name: Landscape Assessment Report:
Tree Removal Assessment | Papanui PAK'n SAVE
171 Main North Road, Christchurch

Project No: 17136

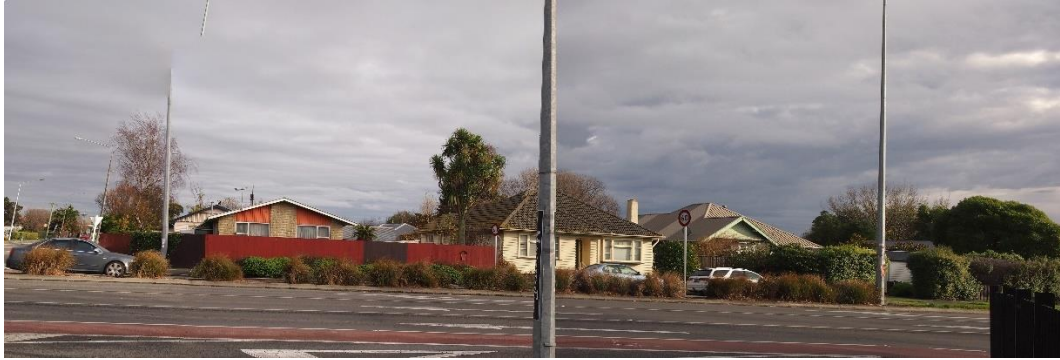
Figure 1: Example of boundary treatment along Main North Road

However, they do not currently screen views of the industrial buildings on the western side of Main North Road from the residential buildings on the eastern side of Main North Road. Instead, most of the residential properties along this stretch of Main North Road use high fences or vegetation as a boundary treatment, providing internal screening. With the generous setback, planted street front, and appropriate building form and mass of the proposed PAK'n SAVE building, it is unlikely that the retention of Tree 3 will provide any benefit or additional screening of the site activity for the residential property's opposite.

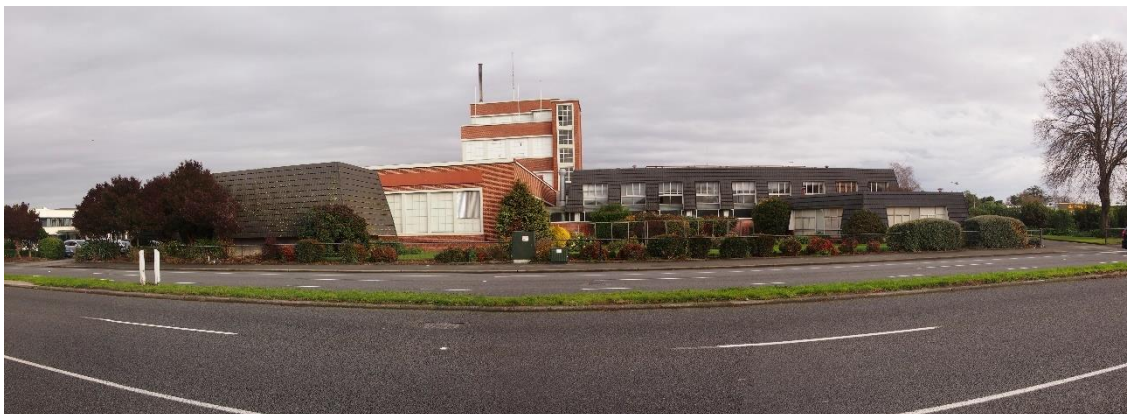
The Main North Road frontage has mixed native and exotic planting, and large areas of lawn which are well maintained. A large, healthy, well-formed Common Lime tree (*Tilia* spp.) is located in the north-eastern corner of the site. The remainder of the site to the south and west is utilised for asphalted car parking, roadways and further lawn and landscaped areas with few mature trees.

Figure 2: Existing site boundary treatment along Main North Road

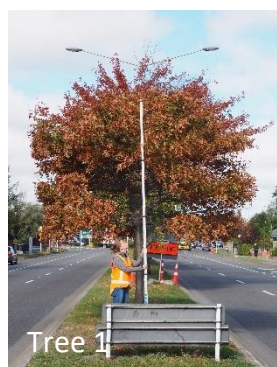
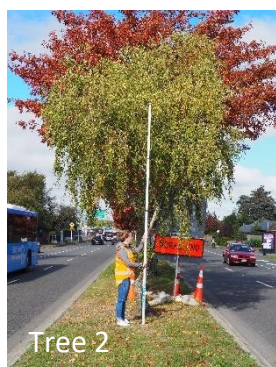
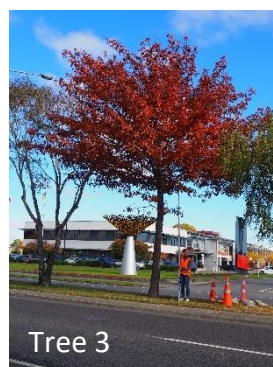
TREE NO.	ID	BOTANICAL NAME	COMMON NAME	HEIGHT / SPREAD approx. (m)	CONFLICT
1	Qu p	<i>Quercus palustris</i>	Pin Oak	4.5 (H) x 4 (S)	with intersection hardscape
2	Be p	<i>Betula pendula</i>	Silver Birch	4.5 (H) x 3 (S)	with intersection hardscape
3	Qu p	<i>Quercus palustris</i>	Pin Oak	8 (H) x 7 (S)	with traffic signals

Figure 3, 4, & 5: Median Trees with Conflicts

An 8m high Pin Oak *Quercus palustris* (Tree 3) requires removal to accommodate the traffic signals associated with the new signalised intersection on Main North Road. This tree is required to be removed as in its current location it will be a threat to vehicle and pedestrian safety, given it will obscure the new traffic signals. There are no reasonable alternatives to avoid the felling of the 8m high Pin Oak street tree with a traffic signal required to be near this tree in the central median.

1. Works shall be undertaken in accordance with *Christchurch City Council Construction Standard Specifications, Part One, Section 19.4 Protection of Existing Trees*.

2. An initial exploratory dig by hand be undertaken before any demolition takes place to locate any prominent roots. All roots larger than 25mm diameter connecting to remaining trees shall be retained in an undamaged state and protected, unless the Council's Arborist gives permission in advance for them to be cut.
