Te Waipapa Diamond Harbour

Coastal hazards in Te Waipapa-Diamond Harbour – today

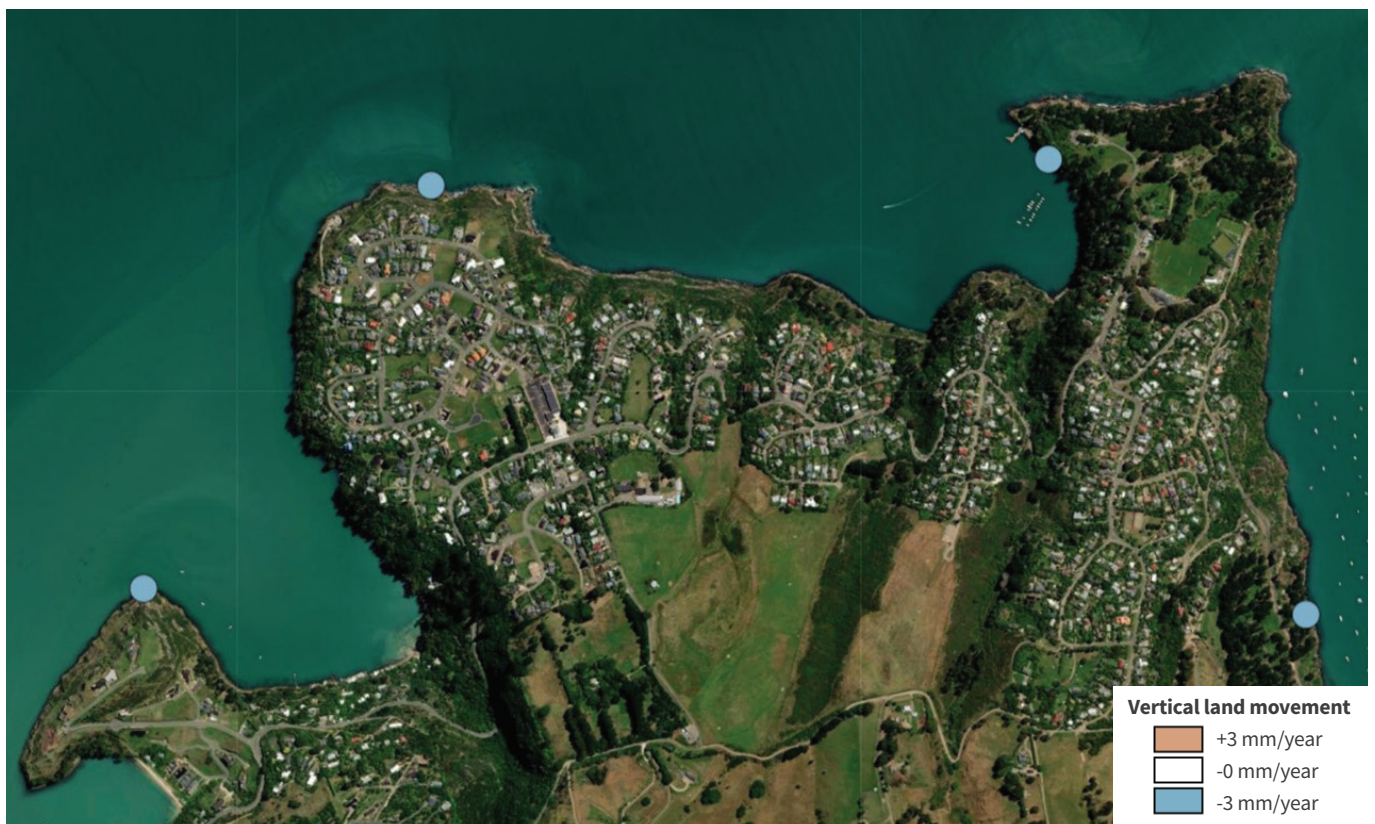
Land is shown to be subsiding, as per blue-coloured dots (Source: NZ SeaRise). There is uncertainty associated with this data, so this information should be considered indicative only.

Te Waipapa-Diamond Harbour has experienced subsidence of around 1.5mm/year (shown in image below). If these rates of subsidence continue over the next 30 years (to 2050), we would expect to see the rate of sea level rise accelerated by around 20 percent, from around 7mm/year to around 8.5mm/year.

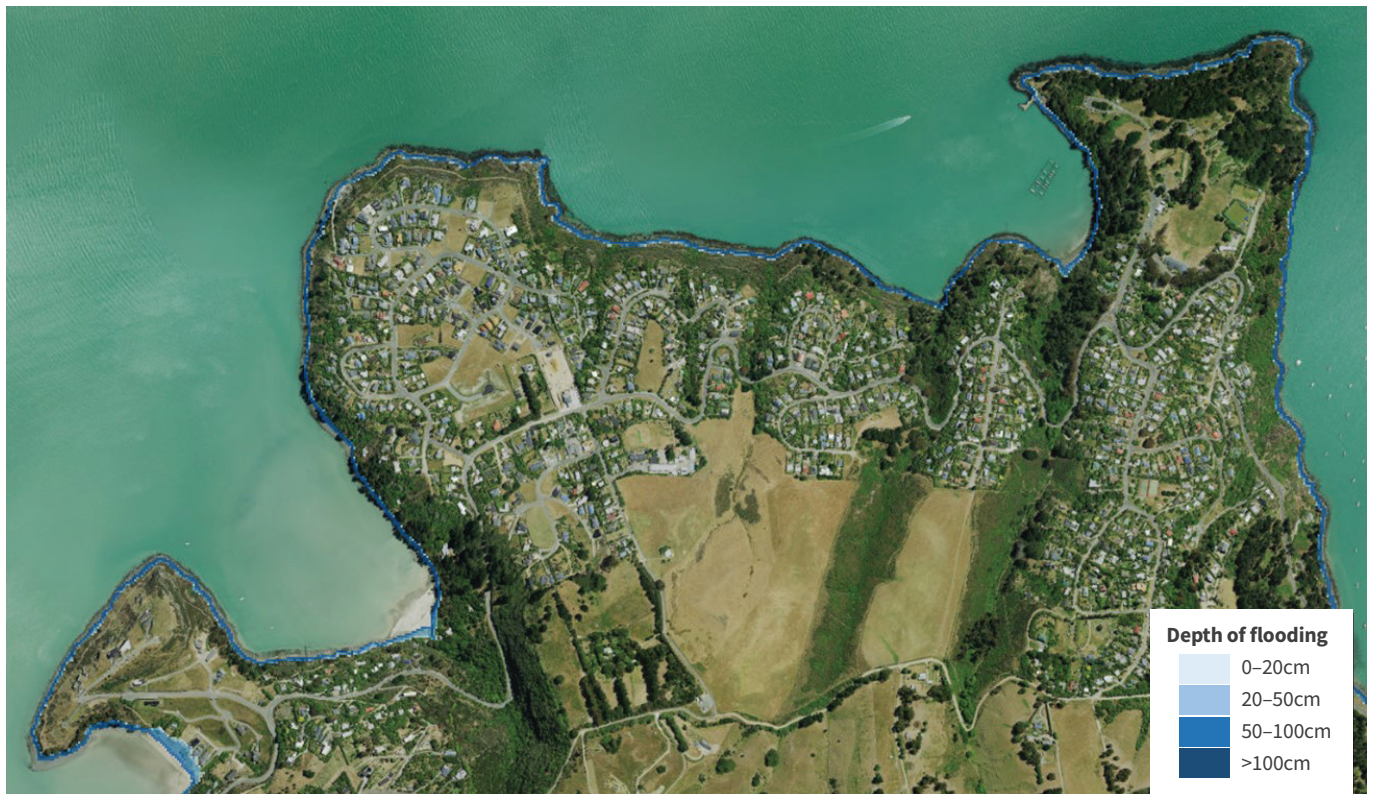
Coastal flooding extent and depths with 40cm of sea level rise during a rare (1 in 100 year) storm event – sourced from Coastal Hazard Assessment 2021 (Tonkin & Taylor).

In Te Waipapa-Diamond Harbour rising sea levels are unlikely to increase the extent of coastal flooding or rising groundwater by large amounts because of the elevation of land. Rising sea levels will however increase the frequency and severity of flooding events that occur in any low-lying areas at the base of the cliff, such as the jetty, Church Bay and Hays Bay. Such flooding will be most significant when storm surge and spring/king tides occur at the same time.

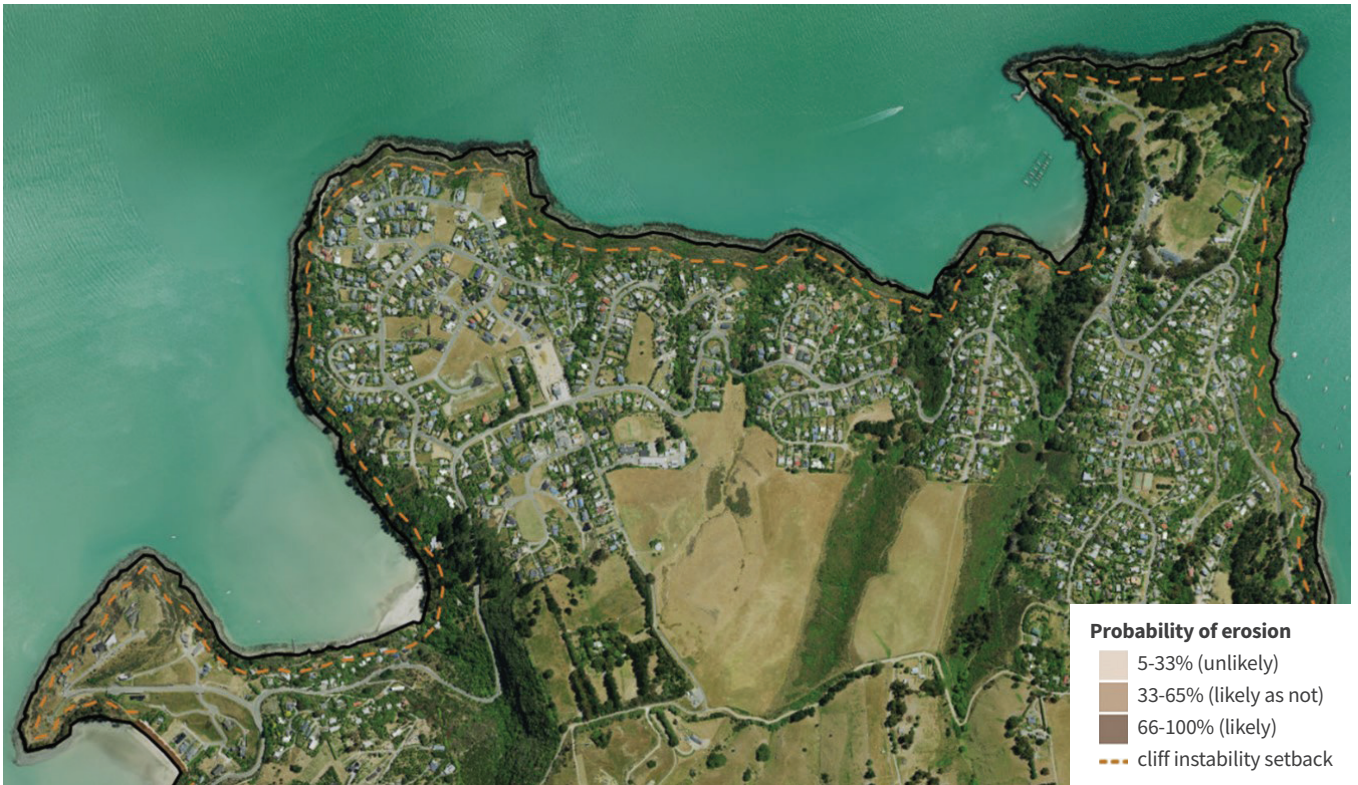
The dashed orange lines represent areas of cliff prone to future instability – sourced from Coastal Hazard Assessment 2021 (Tonkin & Taylor).

We don't have a detailed assessment of erosion risk for this area. A high-level assessment of erosion risk shows us the area which may be at risk of slope instability caused by coastal processes. This area of instability is shown to be around 30m wide (dashed line) and is a setback distance based on the cliff-angle and other contributing factors. This is not a site-specific projection of erosion. *See image on the next page.*
