# memorandum

**Christchurch City Council** 10 May 2023 DATE

Living Earth Odour Monitoring: 10th April 2023 to 23rd April 2023 Summary

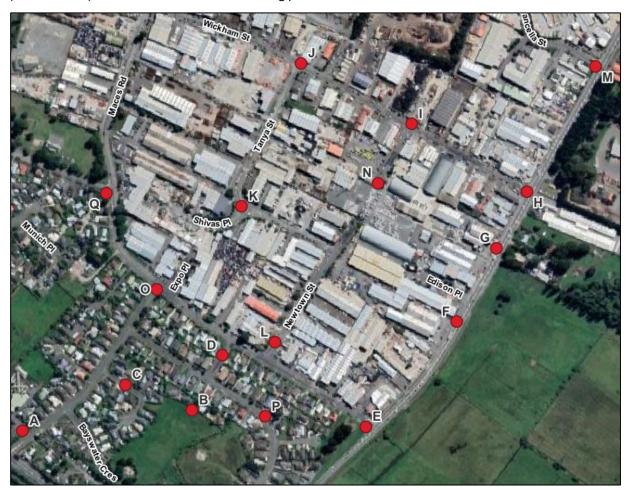
**Figure 1: Odour Observation Locations**

During an assessment, scouts walk at a comfortable pace through the area downwind of the LE Site, making note of odours detected. PDP has defined a series of observation points in the area where the scout makes more detailed observations, shown in **Figure 1**. The exact route and observation points visited in an assessment depend on the meteorological conditions (wind speed and direction) and the odour (if any) detected by the scout on the route.

Sites H and M are immediately downwind of the site, located along Dyers Road with sites G and F. Sites I, J, K, and N are located in the heavy industrial zone. Sites A, C, B, D, and P are located in the residential zone around Bayswater Reserve. Sites E, L, O and Q are located roughly along the residential-industrial boundary. In assessments, Sites E, O, and Q are used to represent the closest (to the LE Site) downwind edge of the residential zone. Site L is located in the general industrial zone - Site D is used as the closest (to the LE Site) downwind residential monitoring point in this area.

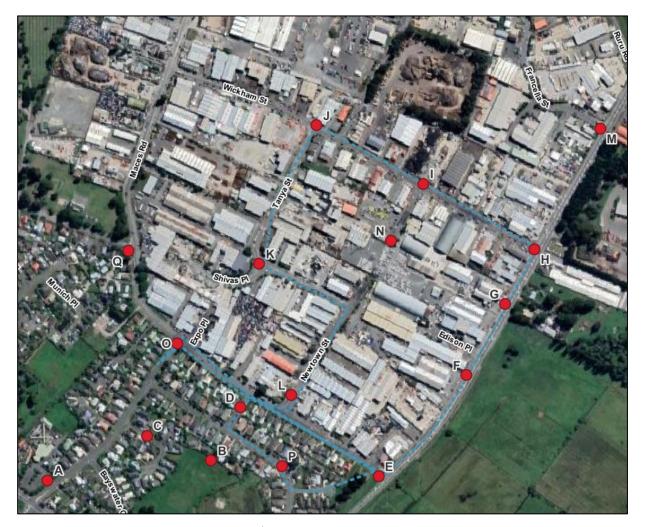
Figure 2: 11th April 2023 - Odour Scout Route

was the PDP odour scout. The scout was present for approximately 1 hour. The weather was clear, with a temperature of 16 °C and north-easterly to north-north-easterly winds ranging from 4.0 m/s to 5.4 m/s as a 10-minute average. The scout started and finished at Site O. The objective was to undertake odour monitoring in the area downwind of the LE Site. The odour scout route (blue dots) and key scouting locations are shown in **Figure 2**.

Intermittent, weak (2) compost odour was detected at Site E. This intermittent odour was not offensive or objectionable.

Distinct (3) compost odour was detected in the industrial zone along Dyers Rd, closest to the LE site. Being in a heavy industrial zone, this odour was not offensive or objectionable for the location.

The character of the compost odour matched PDP's experience with the odour generated by the outdoor material, namely the unscreened compost, oversize stockpiles and screened fines. The odour did not match PDP's experience with the odour from the processing hall or associated biofilter.

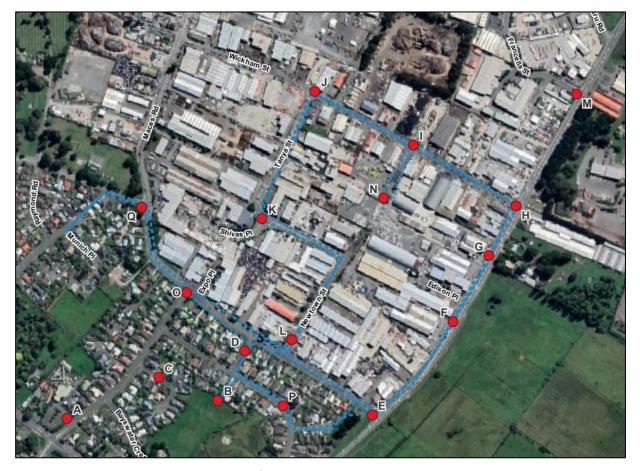
Figure 3: 17<sup>th</sup> April 2023 - Odour Scout Route

Katherine Gray was the PDP odour scout. The scout was present for approximately 1 hour. The weather was clear, with a temperature of 16 °C and easterly winds ranging from 6.4 m/s to 7.4 m/s as a 10-minute average. The scout started and finished near site L. The objective was to undertake odour monitoring in the area downwind of the LE Site. The odour scout route (blue dots) and key scouting locations are shown in **Figure 3**.

Intermittent, weak (2) compost odour was detected at Site Q. This intermittent odour was not offensive or objectionable. No odour was detected at Site O or on Munich Place.

Distinct (3) compost odour was detected in the industrial zone along Wickham St and Dyers Rd, closest to the LE site. Being in a heavy industrial zone, this odour was not offensive or objectionable for the location.

The character of the compost odour matched PDP's experience with the odour generated by the outdoor material, namely the unscreened compost, oversize stockpiles and screened fines. The odour did not match PDP's experience with the odour from the processing hall or associated biofilter.

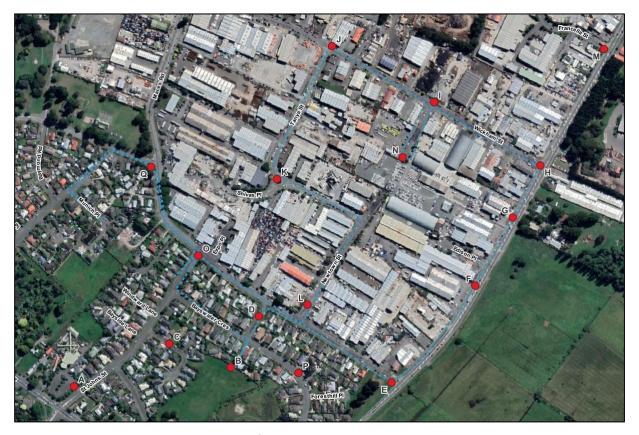
Figure 4: 20th April 2023 - Odour Scout Route

was the PDP odour scout. The scout was present for approximately 1 hour. The weather was clear, with a temperature of 15 °C and easterly winds ranging from 5.4 m/s to 6.2 m/s as a 10-minute average. The scout started and finished near site O. The objective was to undertake odour monitoring in the area downwind of the LE Site. The odour scout route (blue dots) and key scouting locations are shown in **Figure 4**.

Intermittent, weak (2) compost odour was detected at Sites O and Q and Munich Place. This intermittent odour was not offensive or objectionable.

Distinct (3) compost odour was detected in the industrial zone along Dyers Rd, closest to the LE site. Being in a heavy industrial zone, this odour was not offensive or objectionable for the location.

The character of the compost odour matched PDP's experience with the odour generated by the outdoor material, namely the unscreened compost, oversize stockpiles and screened fines. The odour did not match PDP's experience with the odour from the processing hall or associated biofilter.
